Bonito Capital Corp.

December 4, 2017

RE: REVISED - 2BM-ULU1520 – Inspection Report “Actions Required” Responses

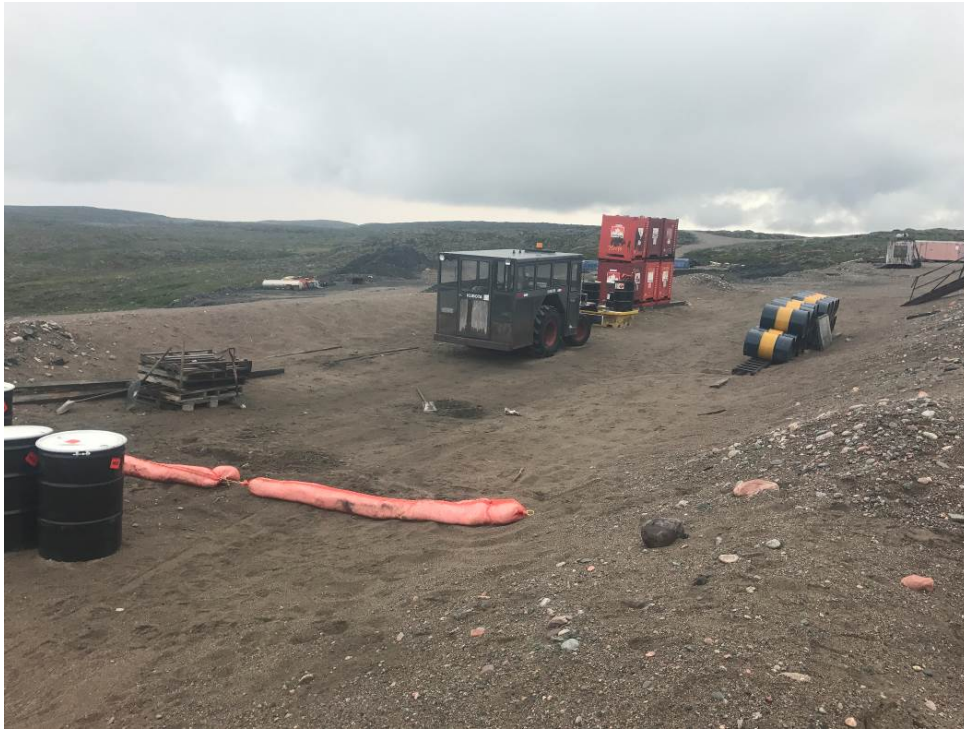
July 10th, 2017 – pre-cleanup

BCC delineated the spill trails with some wooden stake to match the inspectors sample program, excavated the visible spill outside the berm area until there was no further discoloration and suspicious odours. (12 drums of soil in total) and emptied the area of all barrels, containers etc. Norwest Engineering attended site to assess the spill and provide our crew with some instructions to mediate the risk of future spills. Norwest Engineering also carried a sampling program to determine the extent of the spill (see attached). Repairs to the area, including elevating the down slop side of the berm, were carried to prevent the risk of future spills. The photos below are before, during and after clean-up.

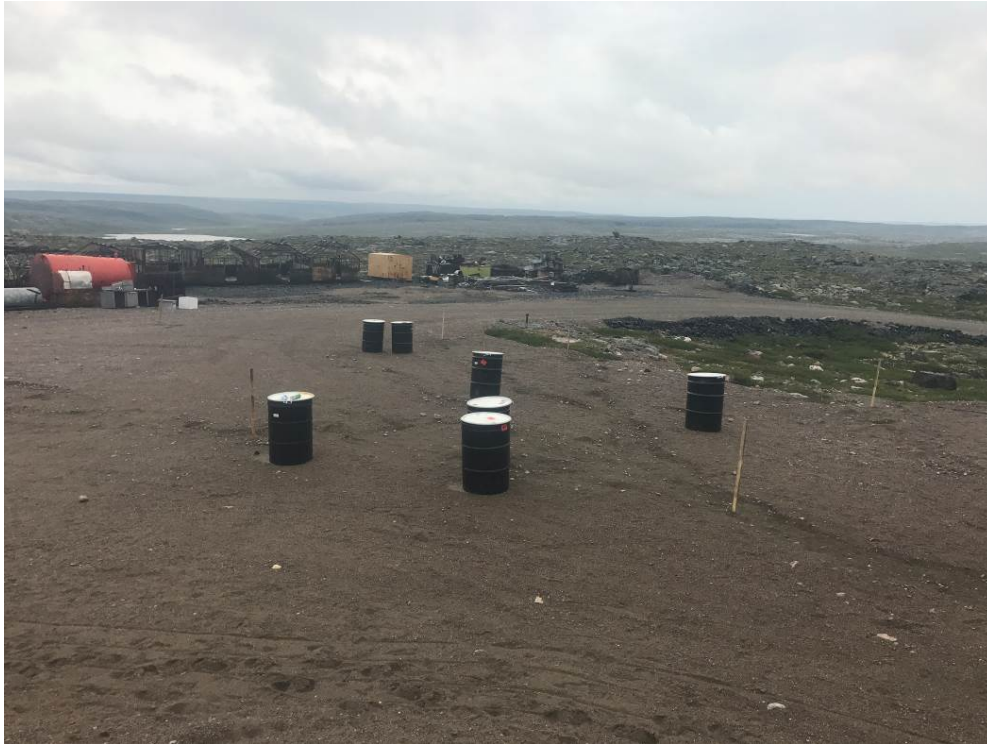
Clean-up process

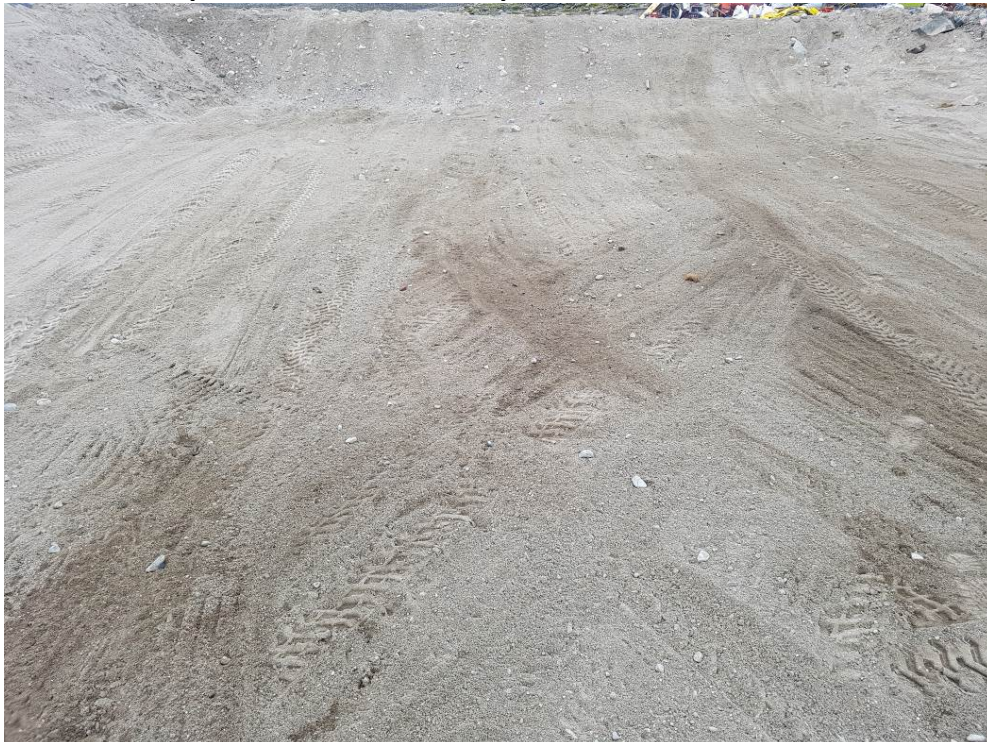
Down side slope of the berm after Repairs

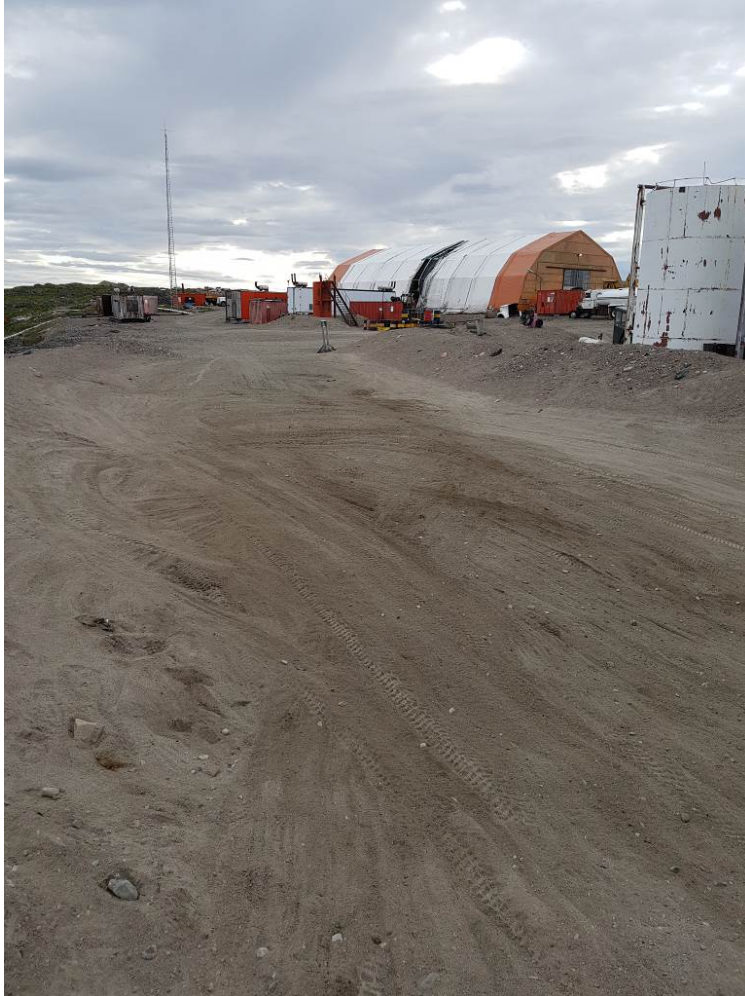
Inside of berm after repairs
