Water Licence Inspection Report

Authorization	Representative
Blue Star Gold	Darren Lindsay
Authorization No. / Expiry	Representative's Title
2BM-ULU2030/May 12, 2030	
Inspection Date	Inspector
August 6, 2025	Isaiah James Bolt
Other Authorization/s	
2BE-HRP1932, N2022C0006	
Activities Inspected	
<input type="checkbox"/> Municipal <input checked="" type="checkbox"/> Camp, Commercial <input type="checkbox"/> Drilling <input type="checkbox"/> Mining <input type="checkbox"/> Construction <input type="checkbox"/> Reclamation <input checked="" type="checkbox"/> Fuel Storage <input type="checkbox"/> Roads/Hauling <input type="checkbox"/> Winter Hauling <input type="checkbox"/> Camp, Private <input type="checkbox"/> Other Click or tap here to enter text.

On August 6th, 2025, Resource Management Officer Isaiah James Bolt (Inspector) for Crown Indigenous Relations and Northern Affairs Canada (CIRNAC), conducted an inspection of 2BM-ULU2030 (License) issued to Blue Star Gold Corp (Proponent) to ensure compliance against their license.

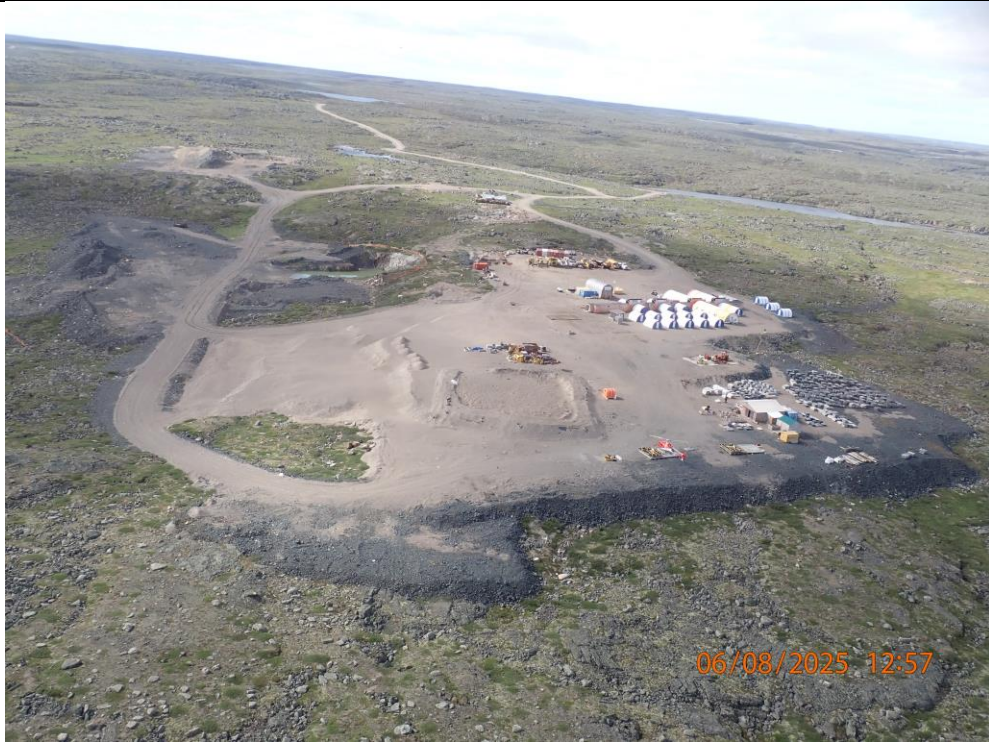
Photo #	1	Coordinates:	
---------	---	--------------	--

Description:
Ulu camp looking West.

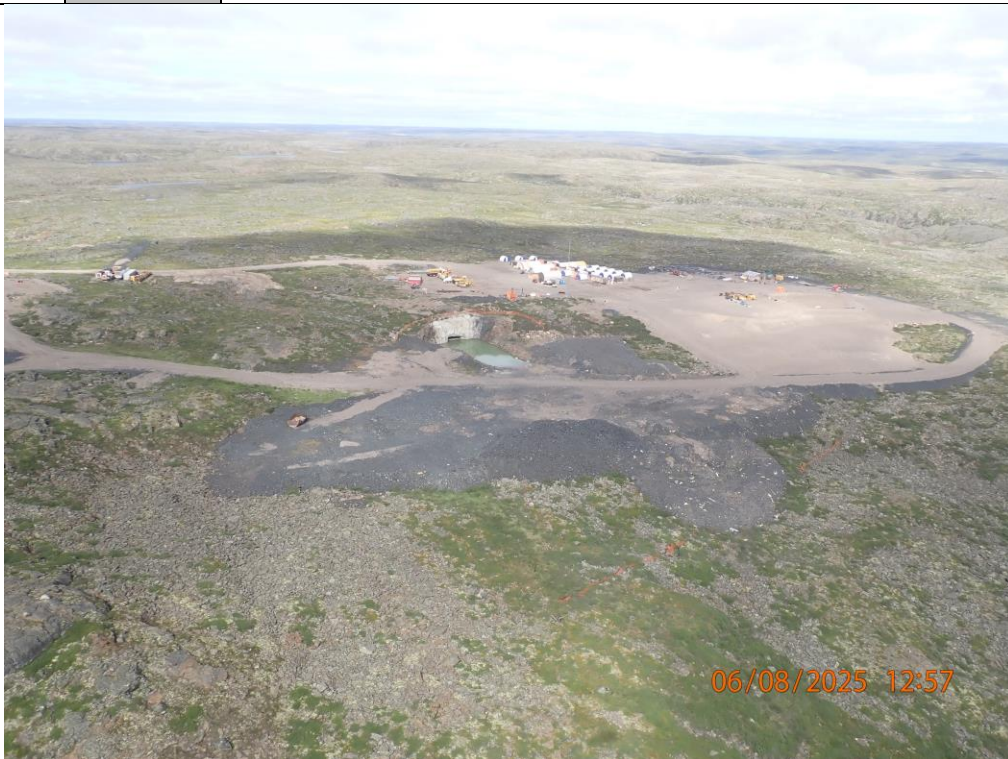
Photo #	2	Coordinates:	
---------	---	--------------	--

Description:
Ulu Camp looking North.

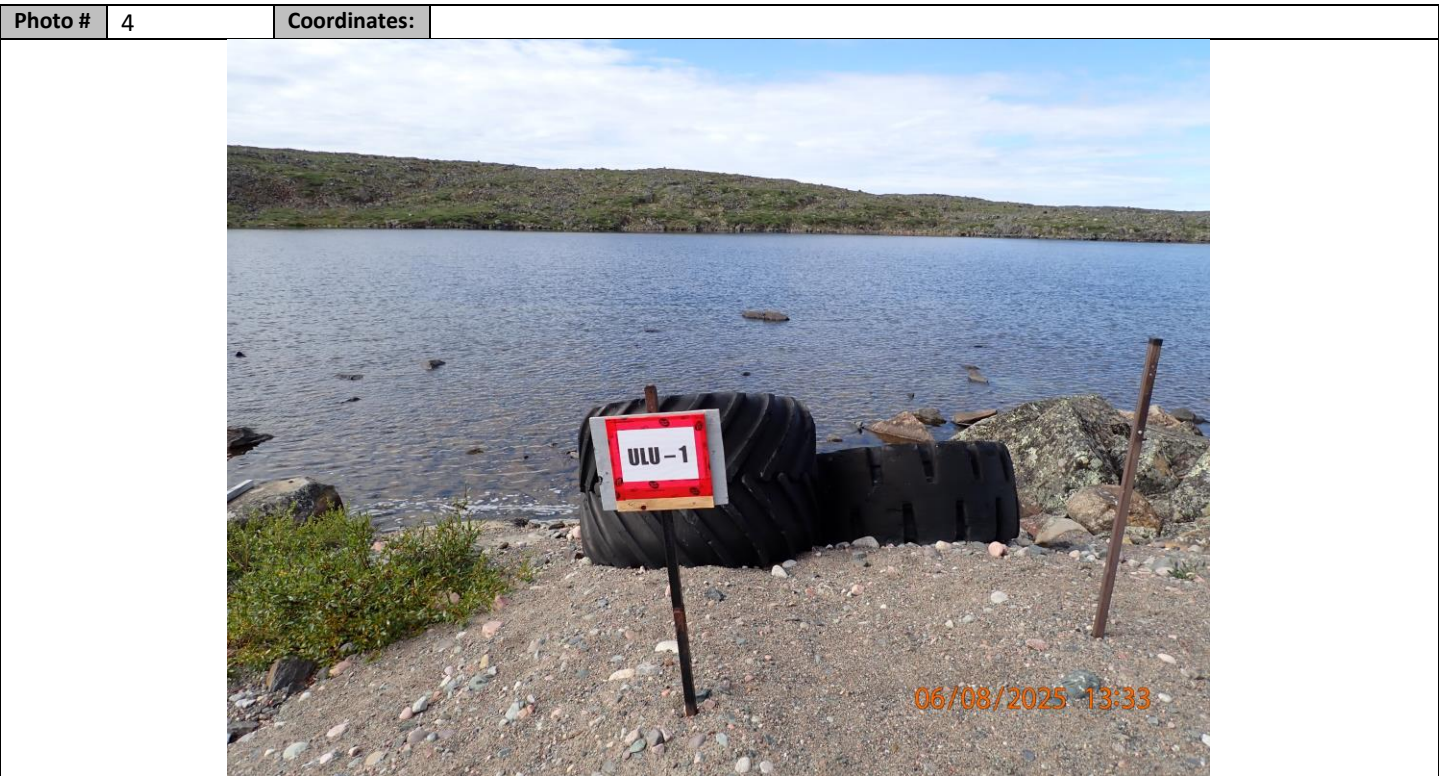
1. Aerial photos were taken (Photo #1 and #2).
2. The water use log for August 1st to 13th, 2025 is provided on (Photo #3.)
3. Ulu-1 was observed at West Lake water intake (Photo #4). The intake pipe was placed in a bucket and was equipped with screen mesh on the pipe (Photo #5). Water is pumped through a hose which is equipped with a water flow meter. The meter showed 2,531.13m³ at the time of inspection.

Description:
Ulu-1 at West Lake water intake location.

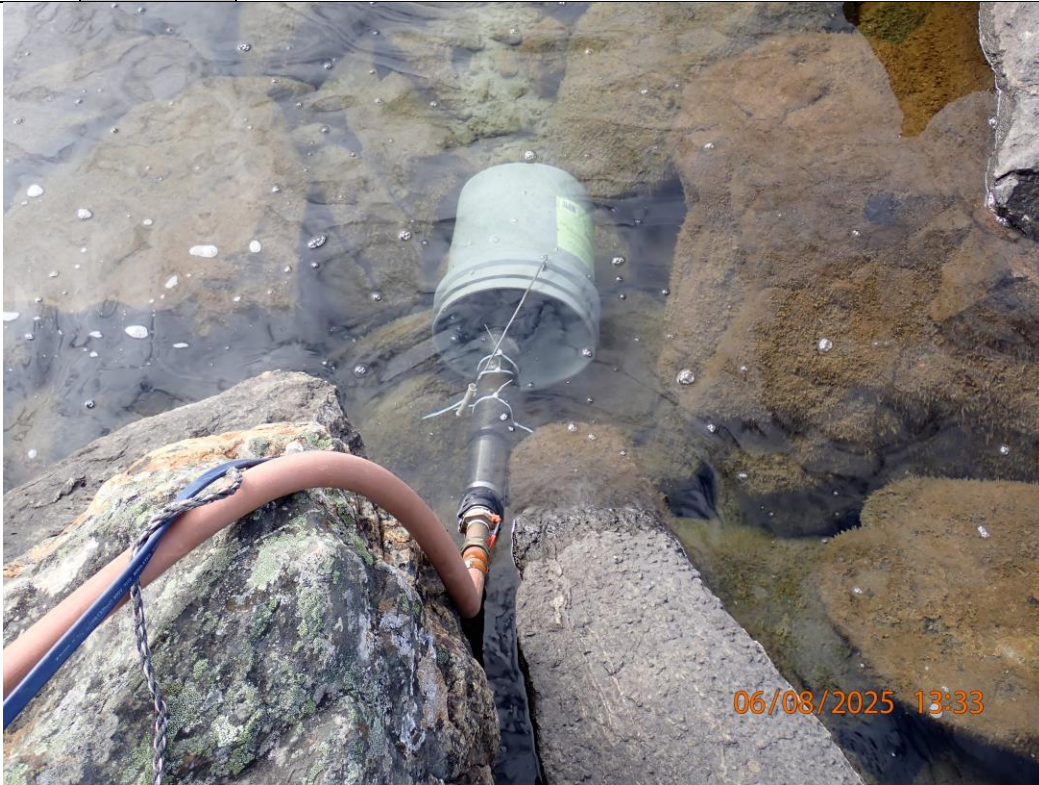
Photo # 5

Water intake hose with screen mesh and bucket.

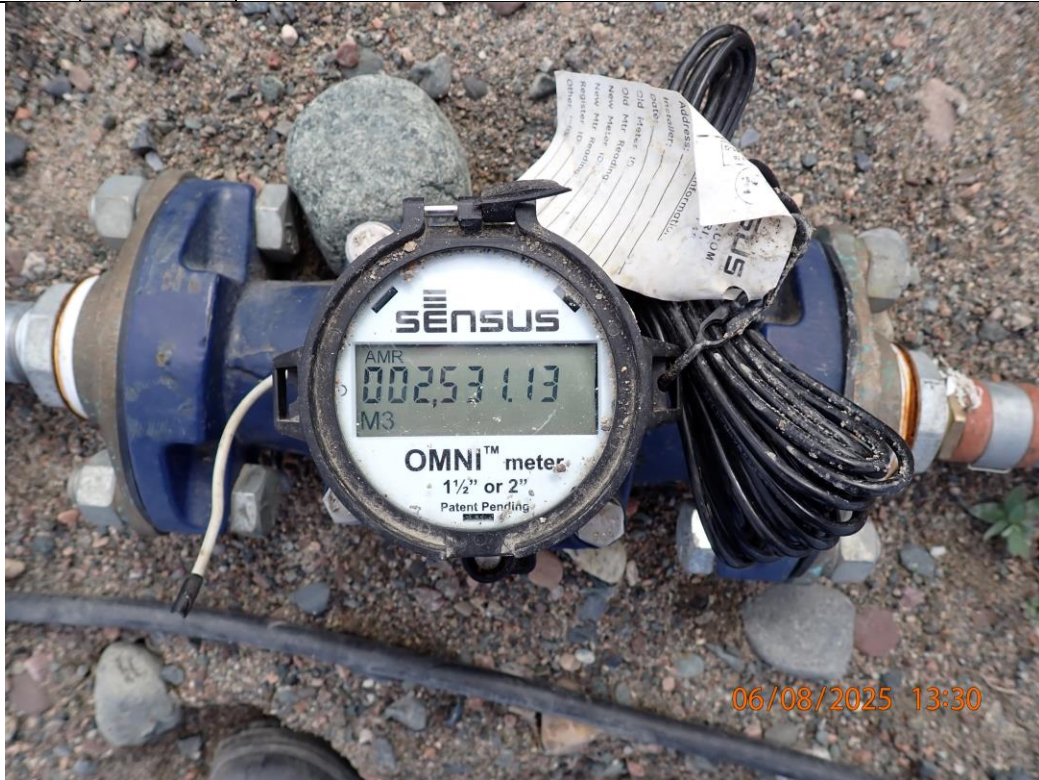
Photo # 6

Water meter that is attached to the water intake line.

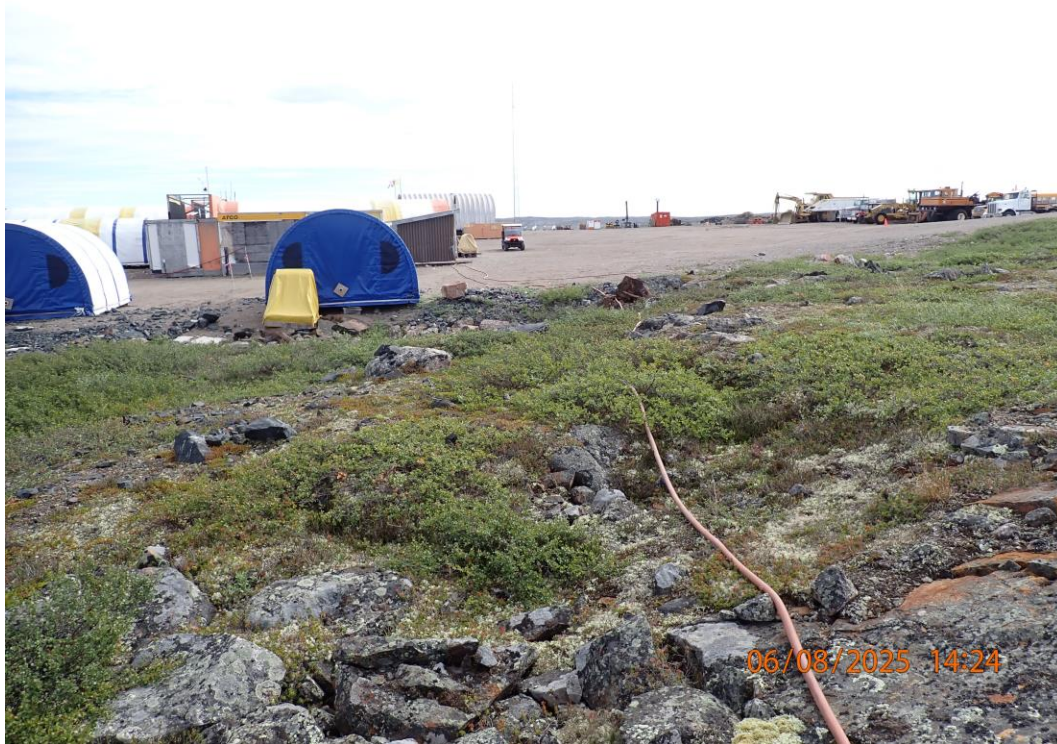
Photo # 7

4. The grey water discharge location was observed (Photo #7). The end of the discharge line is situated approximately 36m NW of the accommodations. The end of the hose is placed into a rocky outcrop that drains to the north and then east to Ulu Lake. No signage present at the discharge location. No sampling location identified downstream for effluent monitoring.

The grey water discharge line as seen from the end of the line looking back to camp.

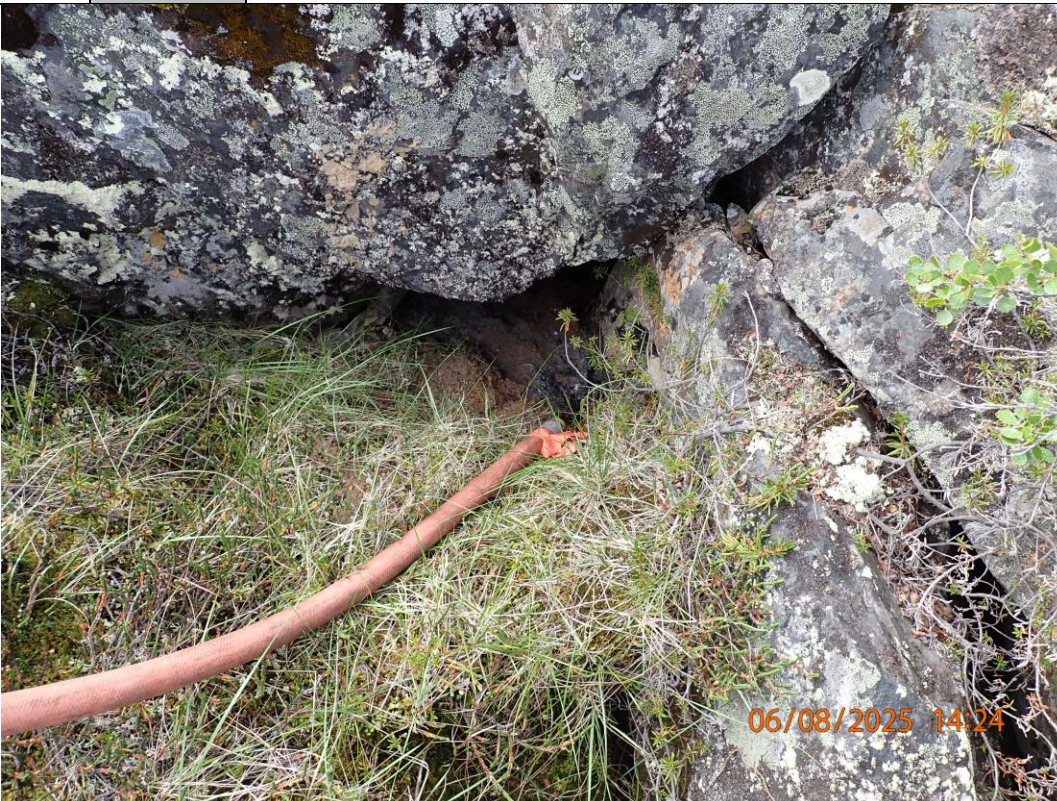
Photo # 8

Part B item 2 of the issued water license states: The Licensee shall post signs in the appropriate areas to inform the on-site personnel and public of the location of the facilities related to Water use and Waste deposit, and the Monitoring Program Stations. All signs shall be in English, Inuktitut, and Inuinnaqtun.

The end of discharge line shown discharging into the rocks. No signage was present at the end of the line.

-Post signage at designated Grey water discharge location. Please have all actions required completed by September 18 2025.

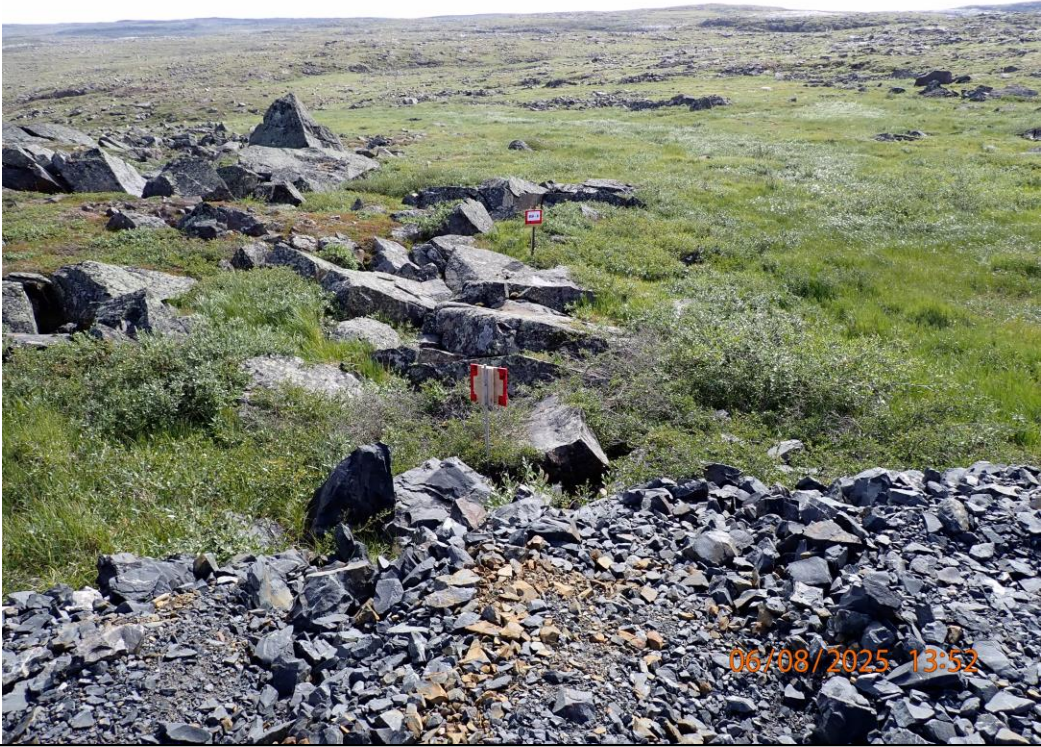
Photo #	15	Coordinates:

8. Ulu-8 and Ulu-8a were observed. (Photo #15 and #16) They are basically in line with each other on the edge of the SE side of the ore pad. The water and land show no sign of stress or discolouration.

Description:			
Ulu-8 and Ulu-8a shown in the image. Looking from the SE ore pad to downstream. Discoloured rock shown on the ore pad.			
Photo #	16	Coordinates:

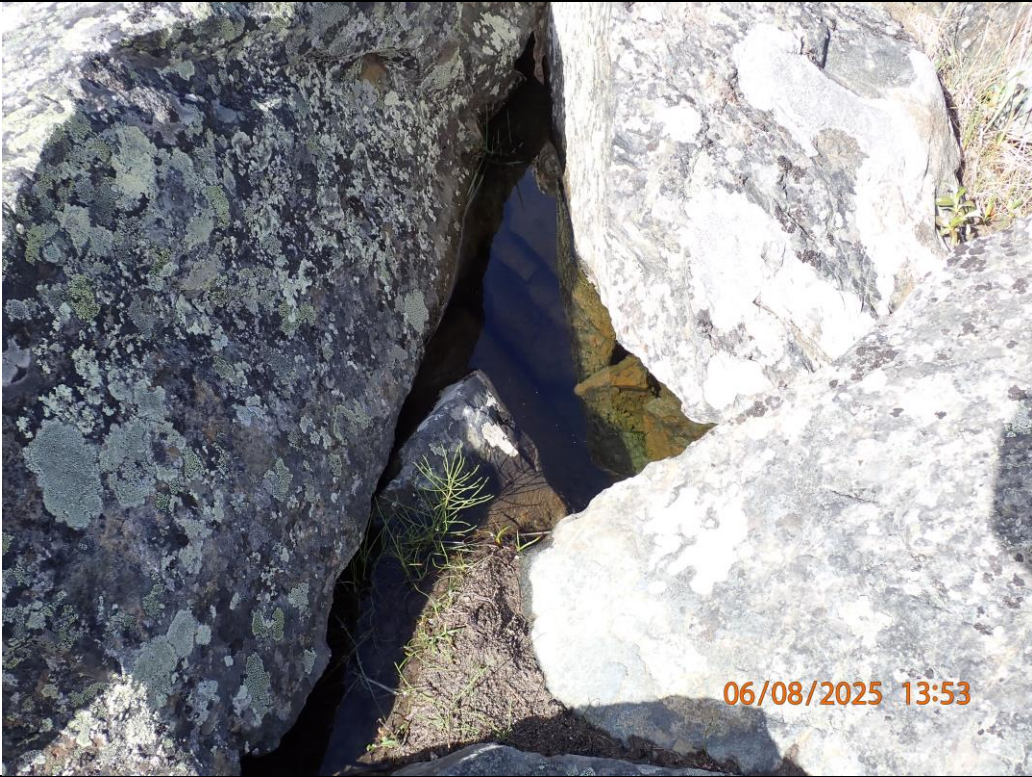
Description:			
Ulu-8 sampling location. No signs of discolouration

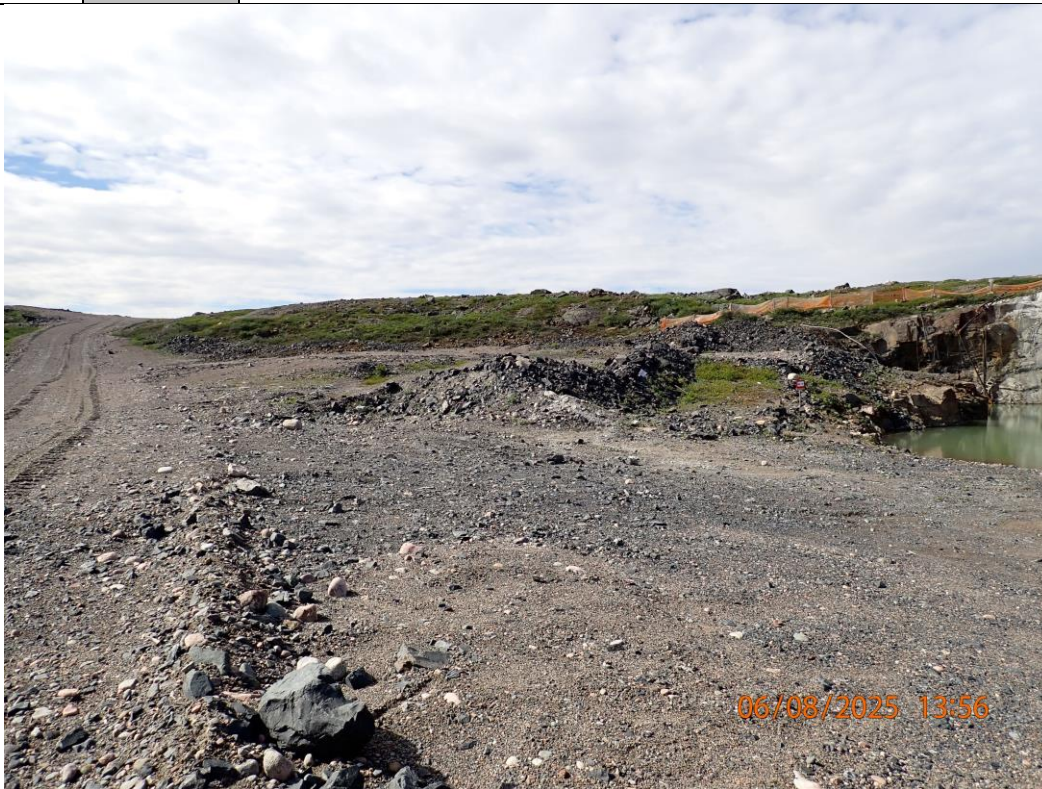
Photo # 17

9. Ulu-4 and Ulu-4b were observed (Photo #17, #18 and #19). Some PAG material is still present on the west side of the portal pond. There are stockpiles still present on the east of the pond above the mine sump (Ulu-4B). The stockpile mineralized rock is being treated as PAG rock and therefor follows the plans for PAG rock at the site, with eventual removal and storage. (Photo #20) shows the inside of the mine sump. No water was present during the inspection.

Ulu-4 looking west. Showing piles and discoloured rock beside the portal.

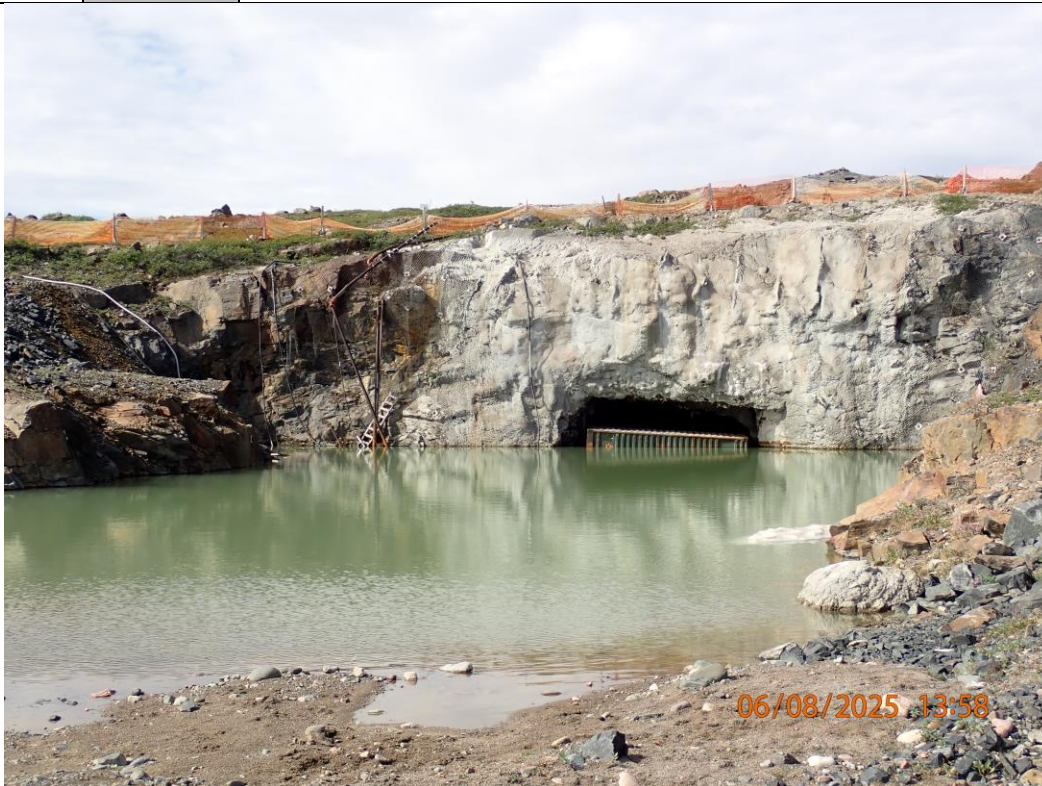
Photo # 18

The mine portal pond. Sea can shown blocking entrance.

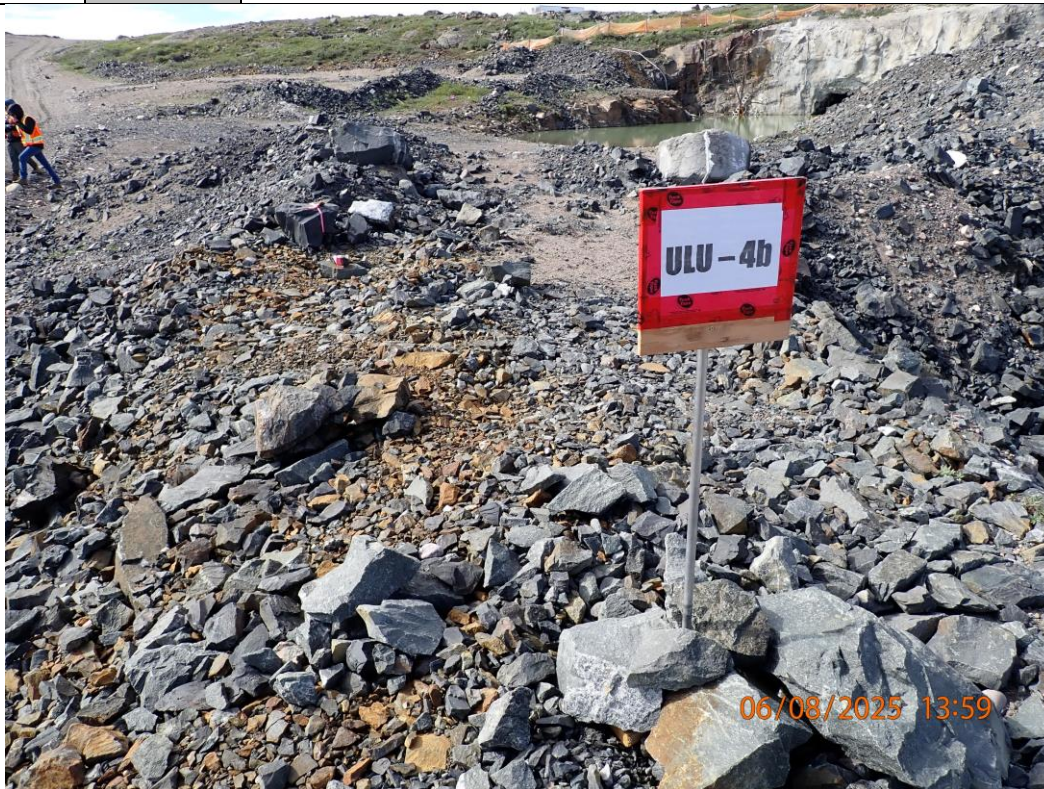
Photo # 19

Ulu-4B, showing the portal in the back ground.

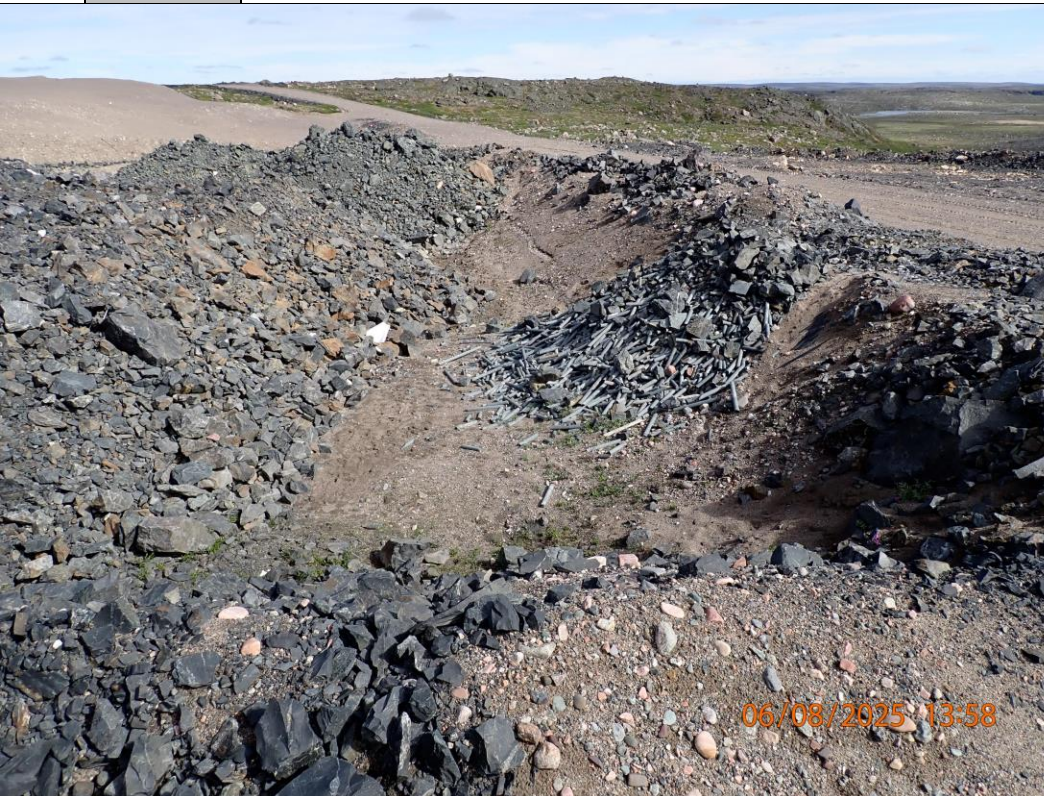
Photo # 20

Ulu-4B, no water present.

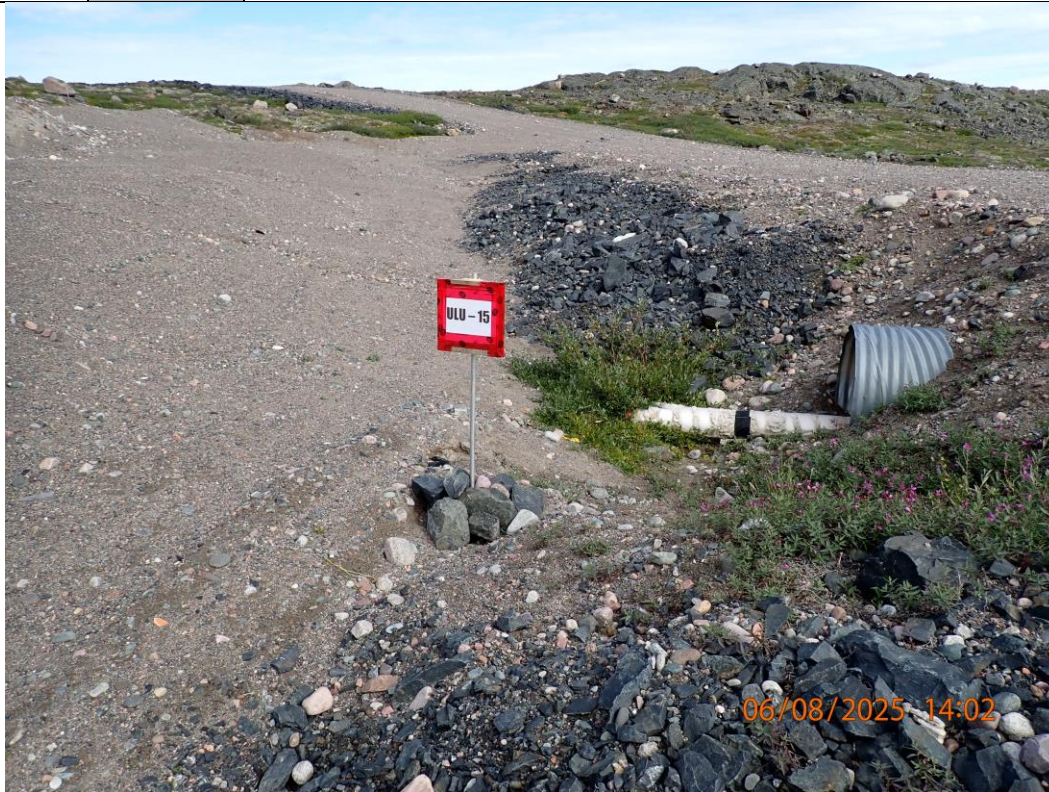
Photo # 21

10. Ulu-15 was observed and the sampling location is confirmed to now be up stream of the culvert. (Photo #21)
11. The Vent raise was observed and confirmed to have no signs of subsidence. (Photo #22 and #23)

Ulu-15. The sampling location is now upstream of the culvert. No water present.

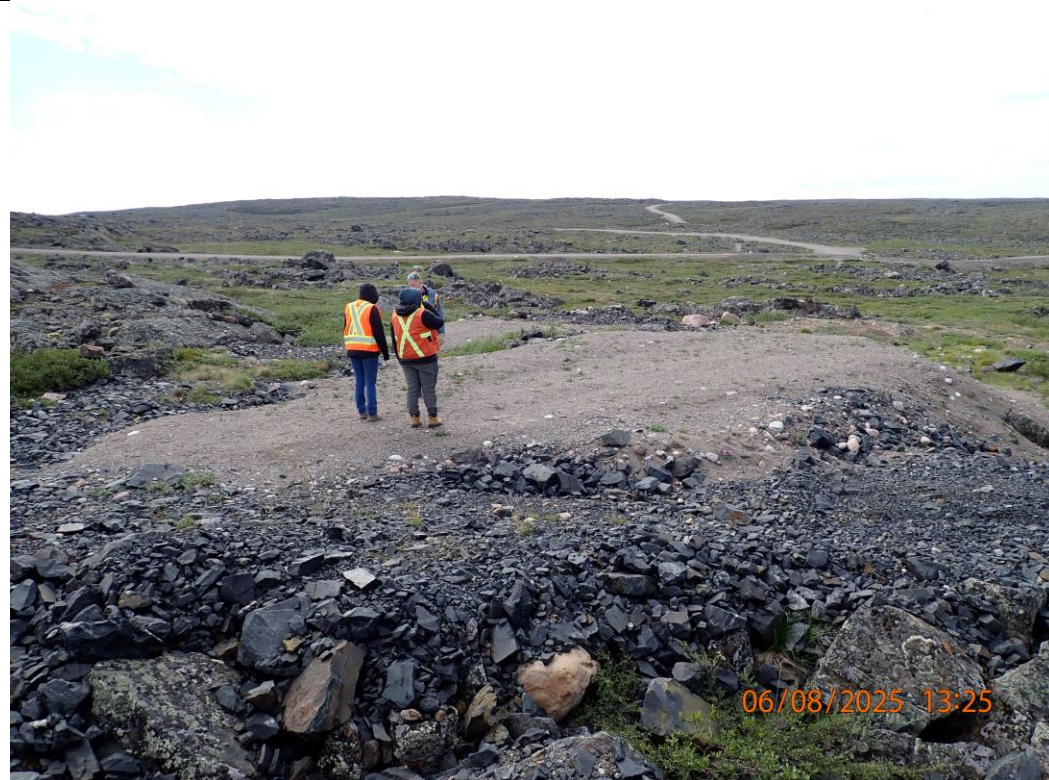
Photo # 22

The vent raise looking SW. No sign of subsidence or slumping.

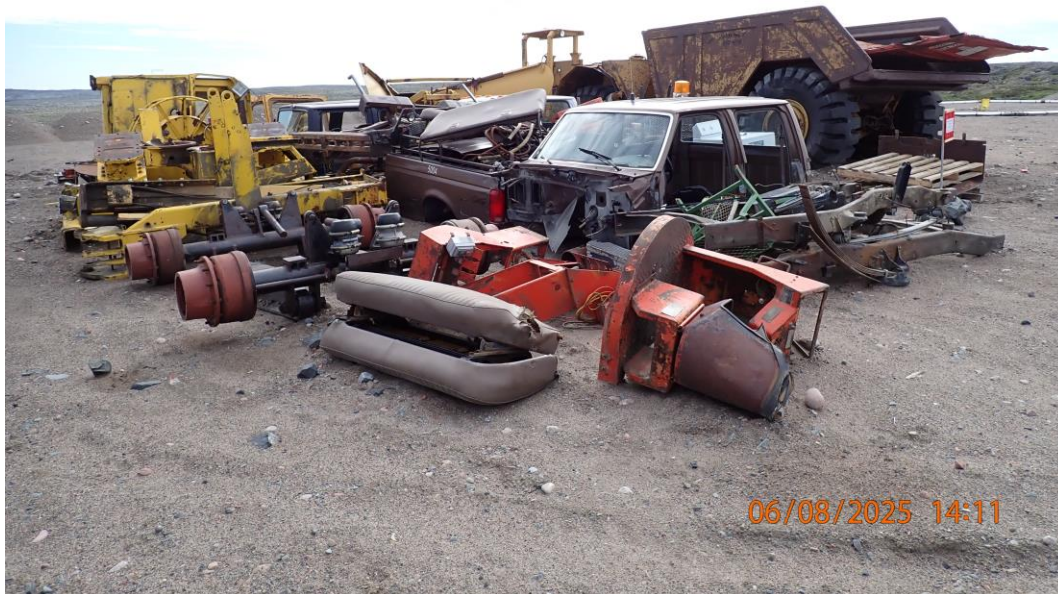
Photo # 25

12. The equipment storage areas were observed. There are 2 areas where old equipment and camp refuse is stored. (Photo #24 and #25) show the equipment stored near the land farm on top of the landfill and (Photo #26 and #27) show the equipment stored near the vent raise. No concerns with storage.

Another view of the equipment storage area near the landfarm.

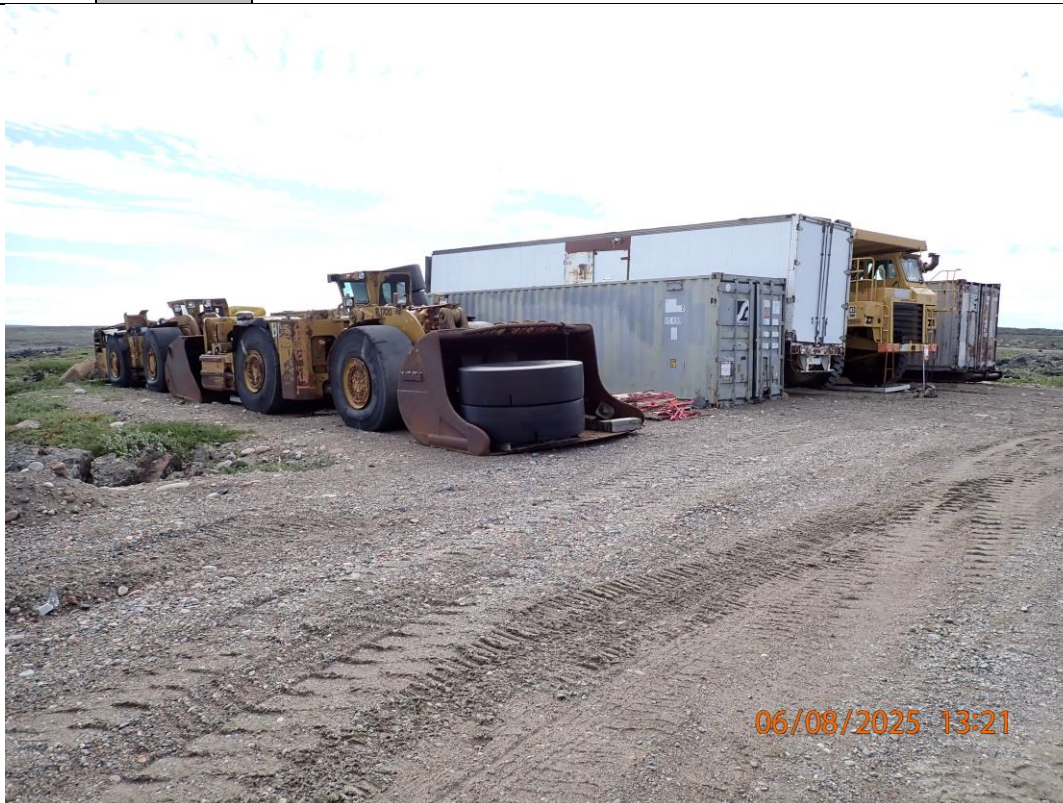
Photo # 26

Equipment storage area near vent raise.

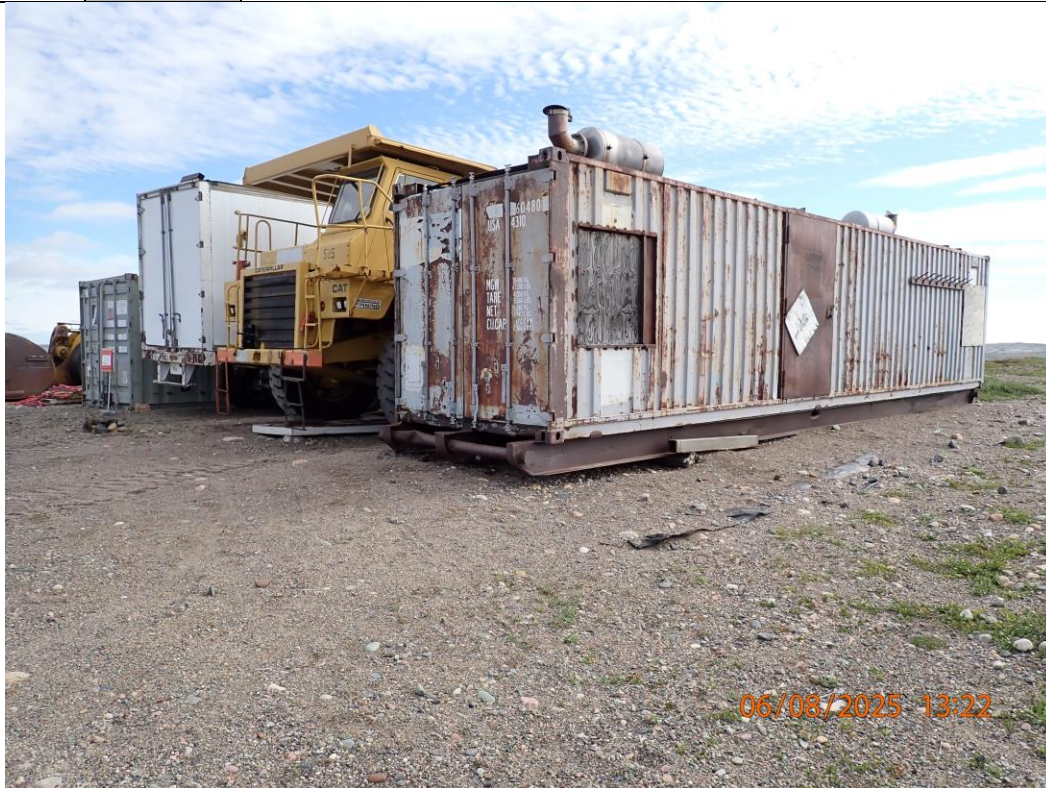
Photo # 27

Another view of the equipment storage near the vent raise.

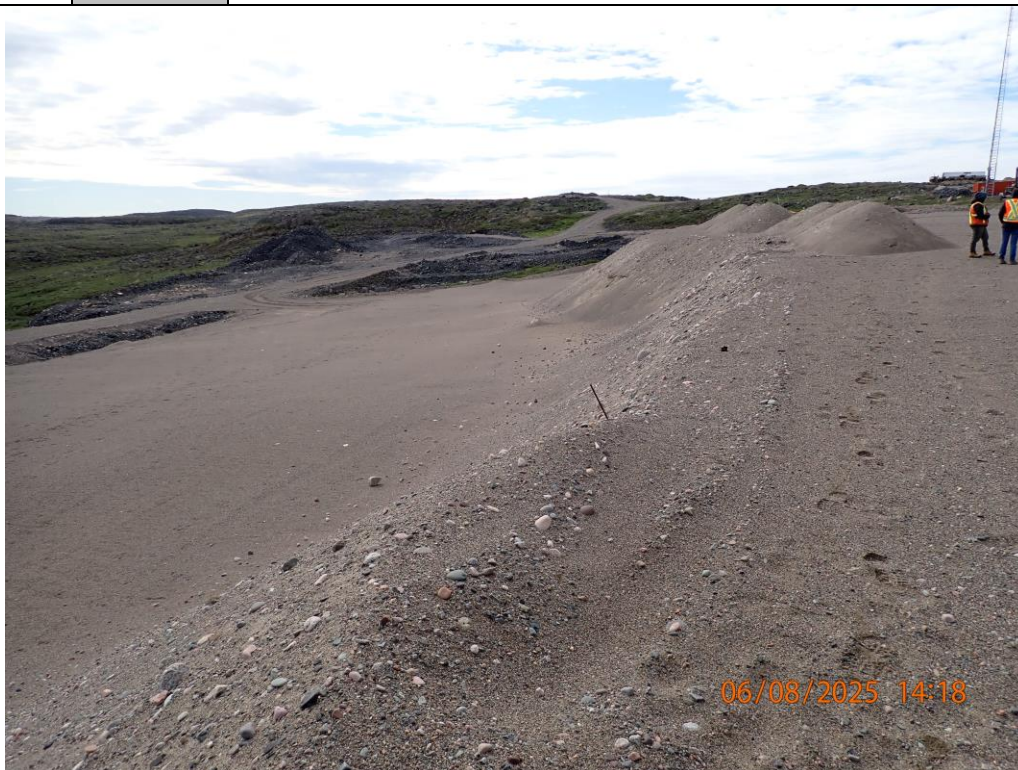
Photo # 28

13. (Photo #28 and #29) show the landfill as seen from on top. No signs of erosion and no signs of metals/material showing. The placement and coverage of 250m³ of non-hazardous waste was confirmed by Darren Lindsay by photos in an email.

View of the landfill looking SW.

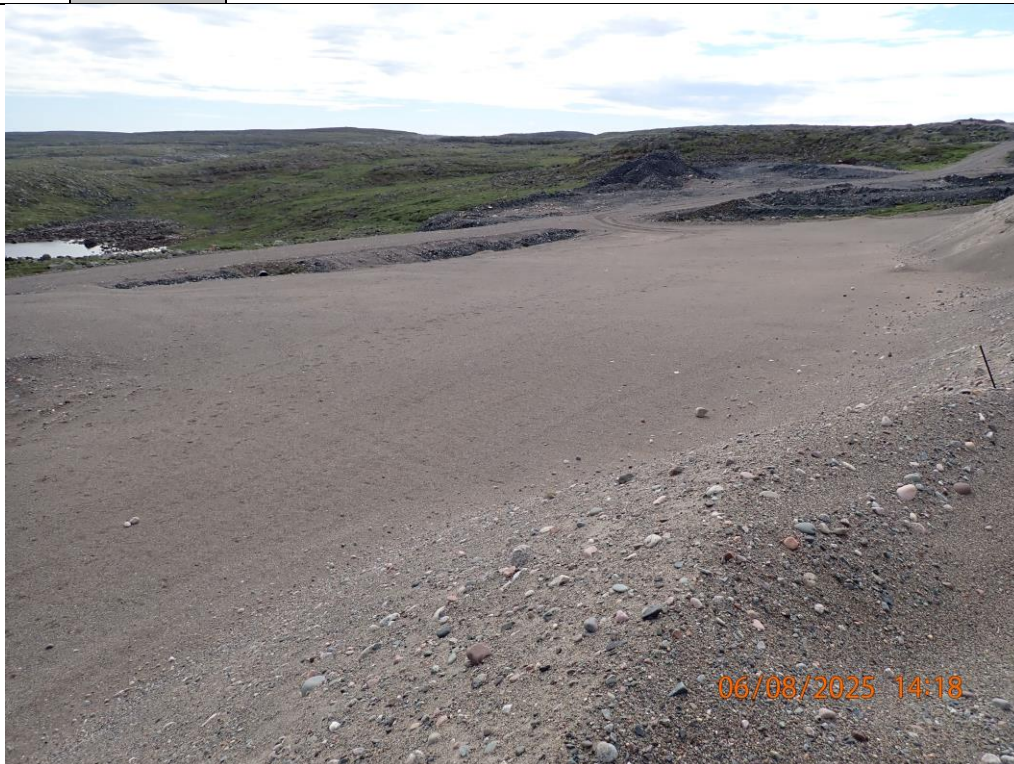
Photo # 29

View of the landfill looking south.

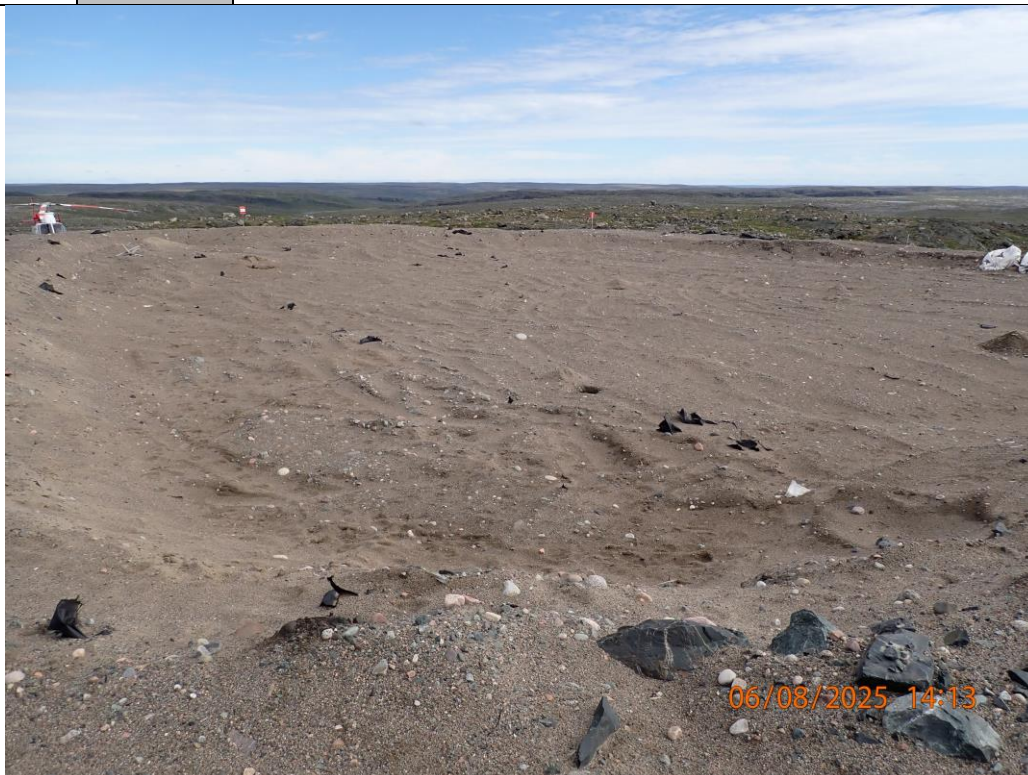
Photo # 30

14. The land-farm was observed (Photo#30). No concerns were noted. The piles of contaminated soil were spread out to help aeration. The land-farm is lined and was noted during inspection.

The land-farm above the landfill. All piles of contaminated soil were flattened.

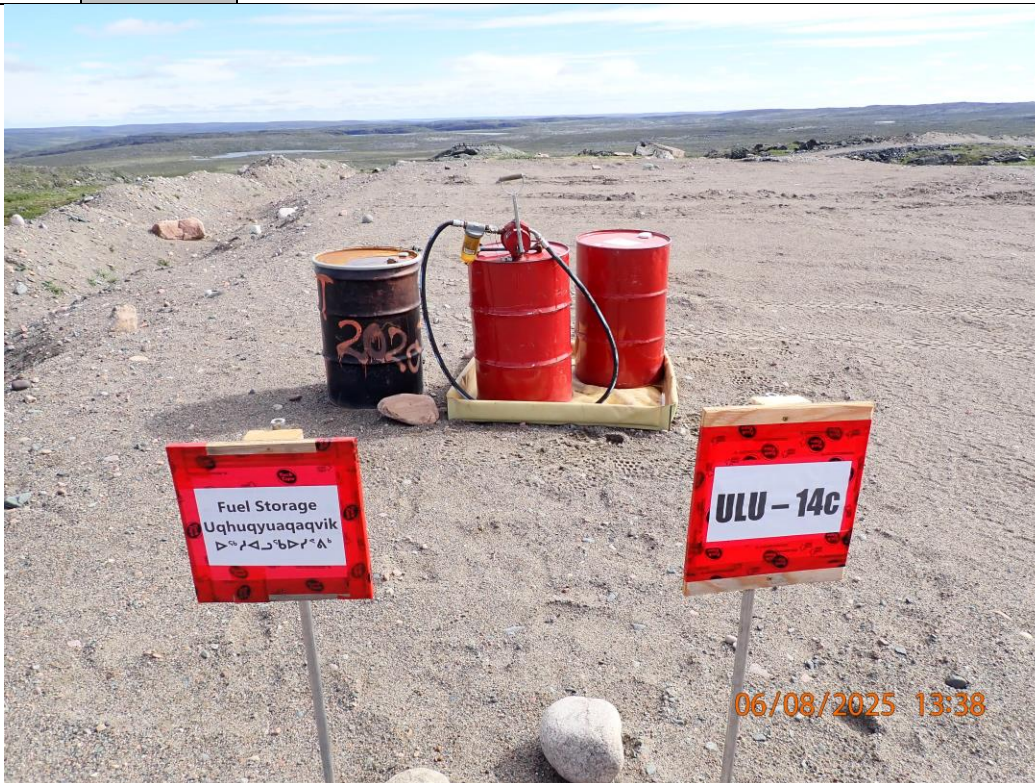
Photo # 31

15. All fuel observed in camp was in secondary containment. (Photo #31, #32, and #33) show examples of fuel storage.
16. The incinerator was observed (Photo #34 and #35). No concerns were noted. The facility has labelled sorting and signage in 3 languages.

Fuel storage are Ulu-14c

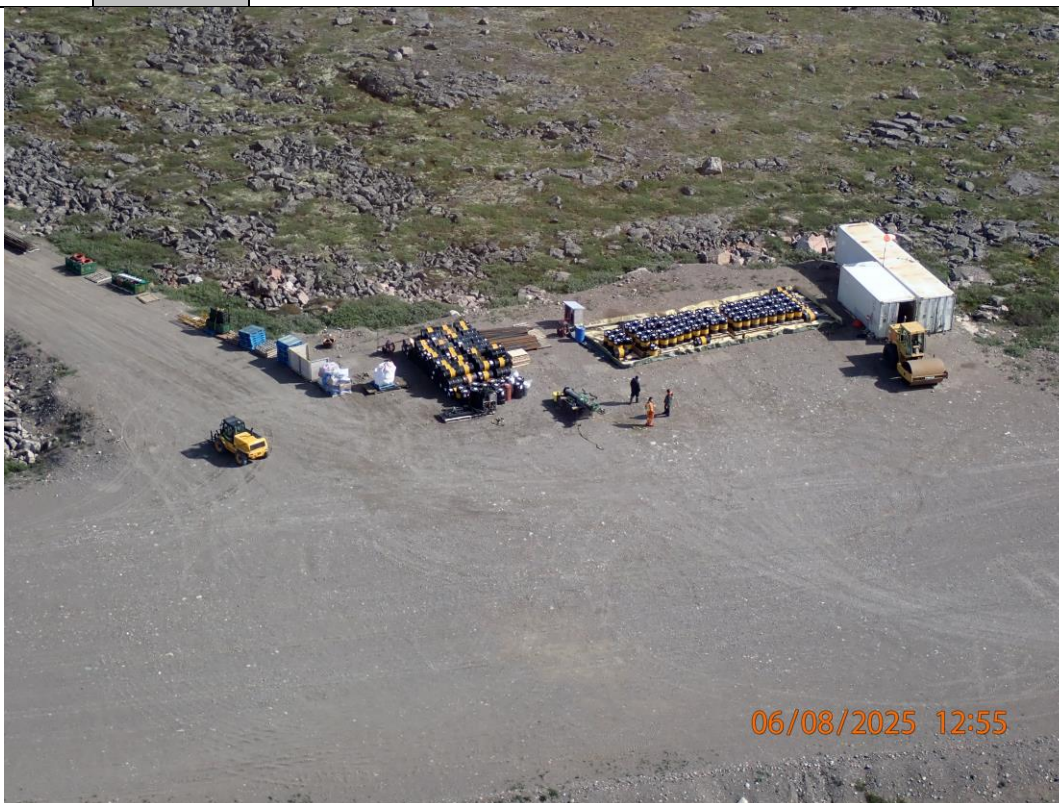
Photo # 32

Runway fuel storage. Full containers in the berm, empty drums are stacked on their sides.

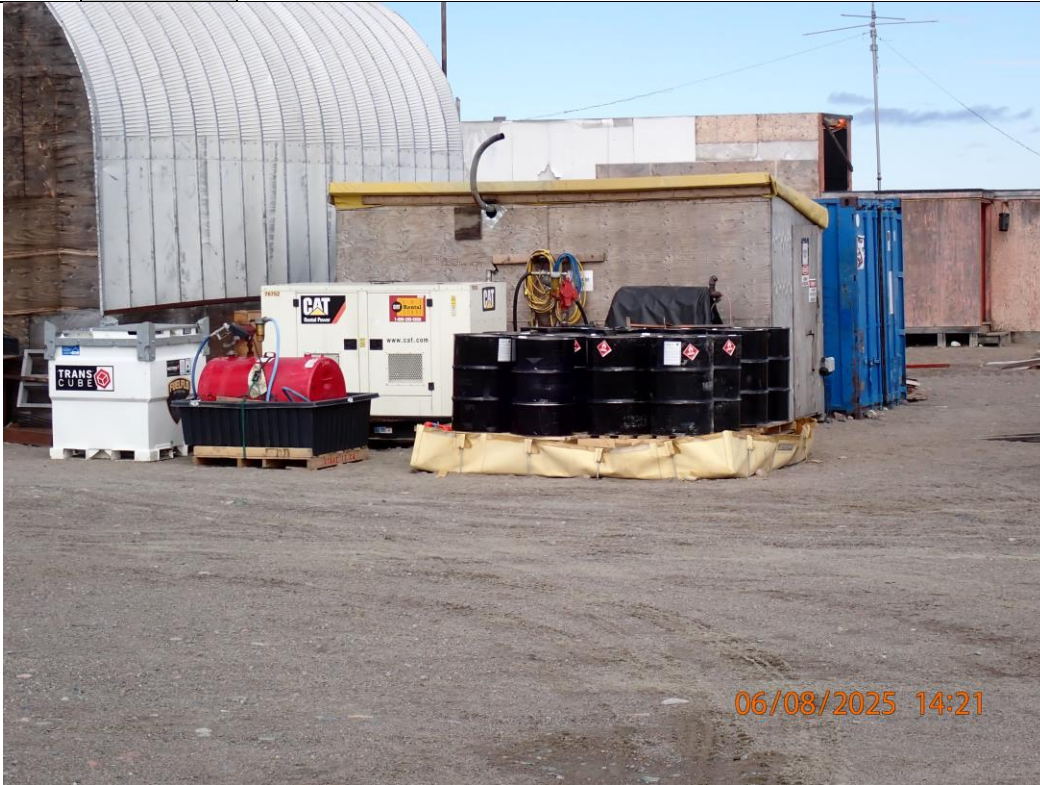
Photo # 33

Fuel storage in camp behind the carpenters shop.

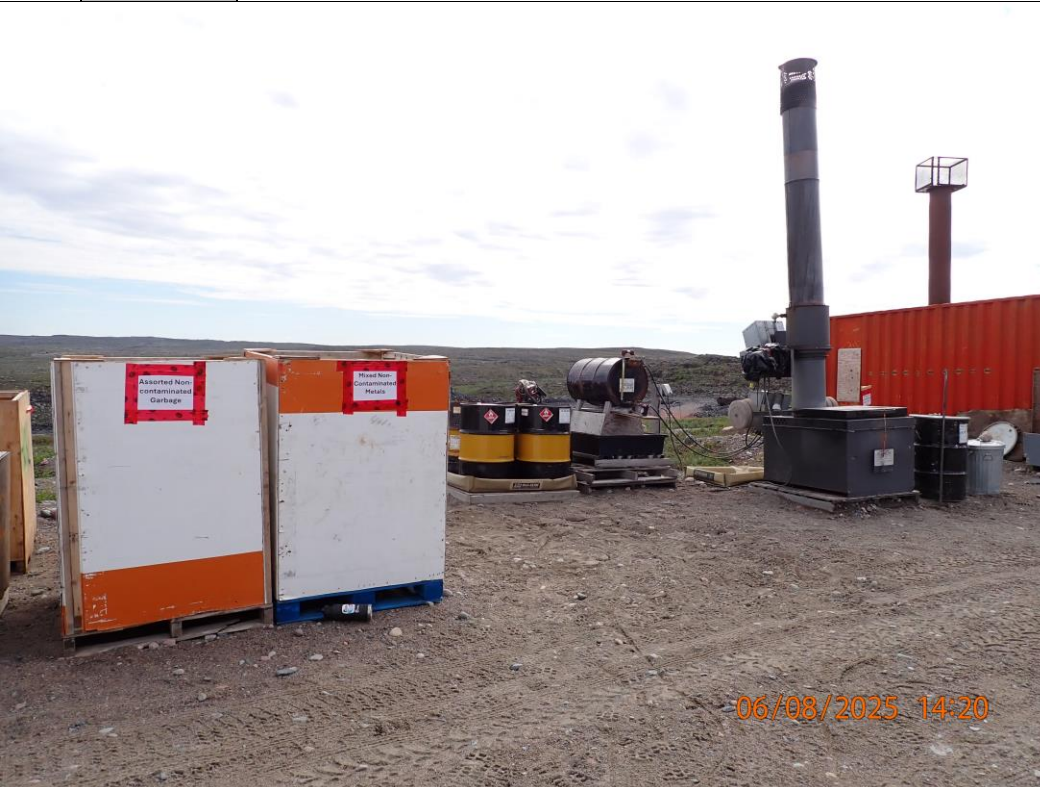
Photo # 34

The incinerator, image showing proper fuel storage and sorting requirements. Signage is posted at the facility.

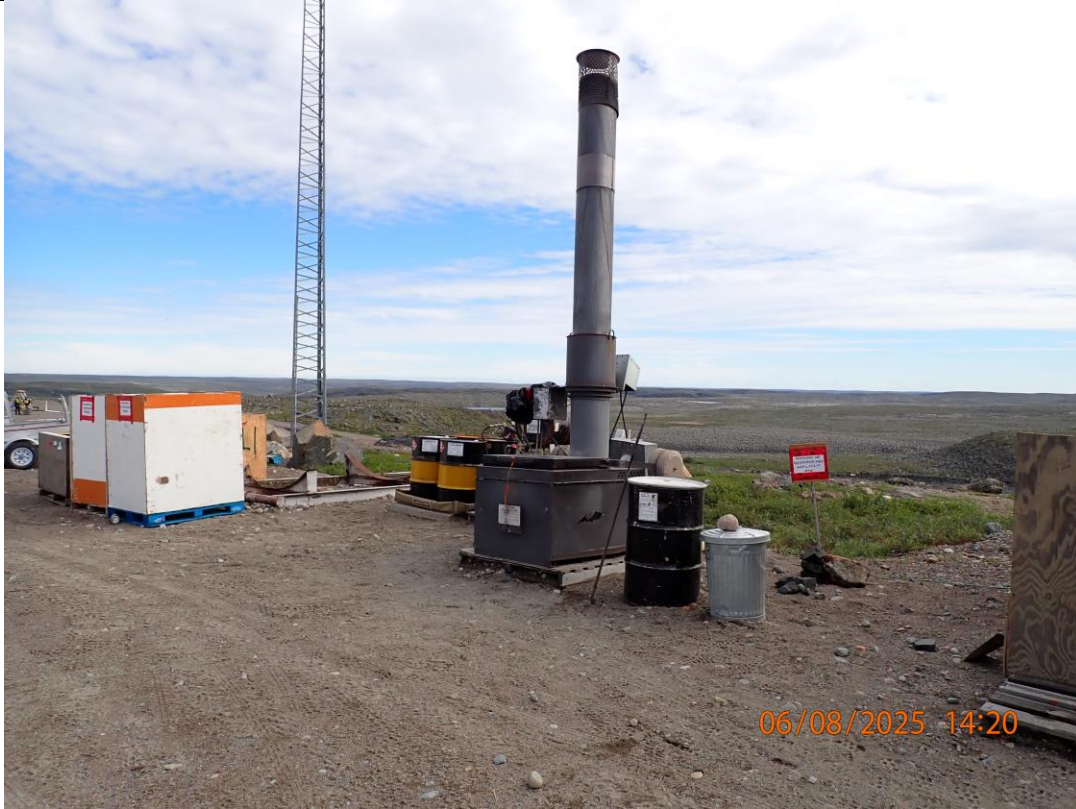
35

Another view of the incinerator. Showing signage and ash barrel.
