WATER LICENCE INSPECTION FORM

Licensee		Licensee Representative	
Blue Star Gold Corp		Darren Lindsay	
Licence No. / Expiry		Representative's Title	
2BM-ULU2030		Vice President, Exploration	
Land / Other Authorizations		Land / Other Authorizations	
IOL KTL 311C013			
Date of Inspection		Inspector	
11 August 2021		Baba Pedersen	
Activities Inspected			
<input checked="" type="checkbox"/> Camp	<input checked="" type="checkbox"/> Drilling	<input type="checkbox"/> Mining	<input type="checkbox"/> Construction
<input type="checkbox"/> Roads/Hauling	<input type="checkbox"/> Other:	<input type="checkbox"/> Other:	<input checked="" type="checkbox"/> Reclamation
		<input checked="" type="checkbox"/> Fuel Storage

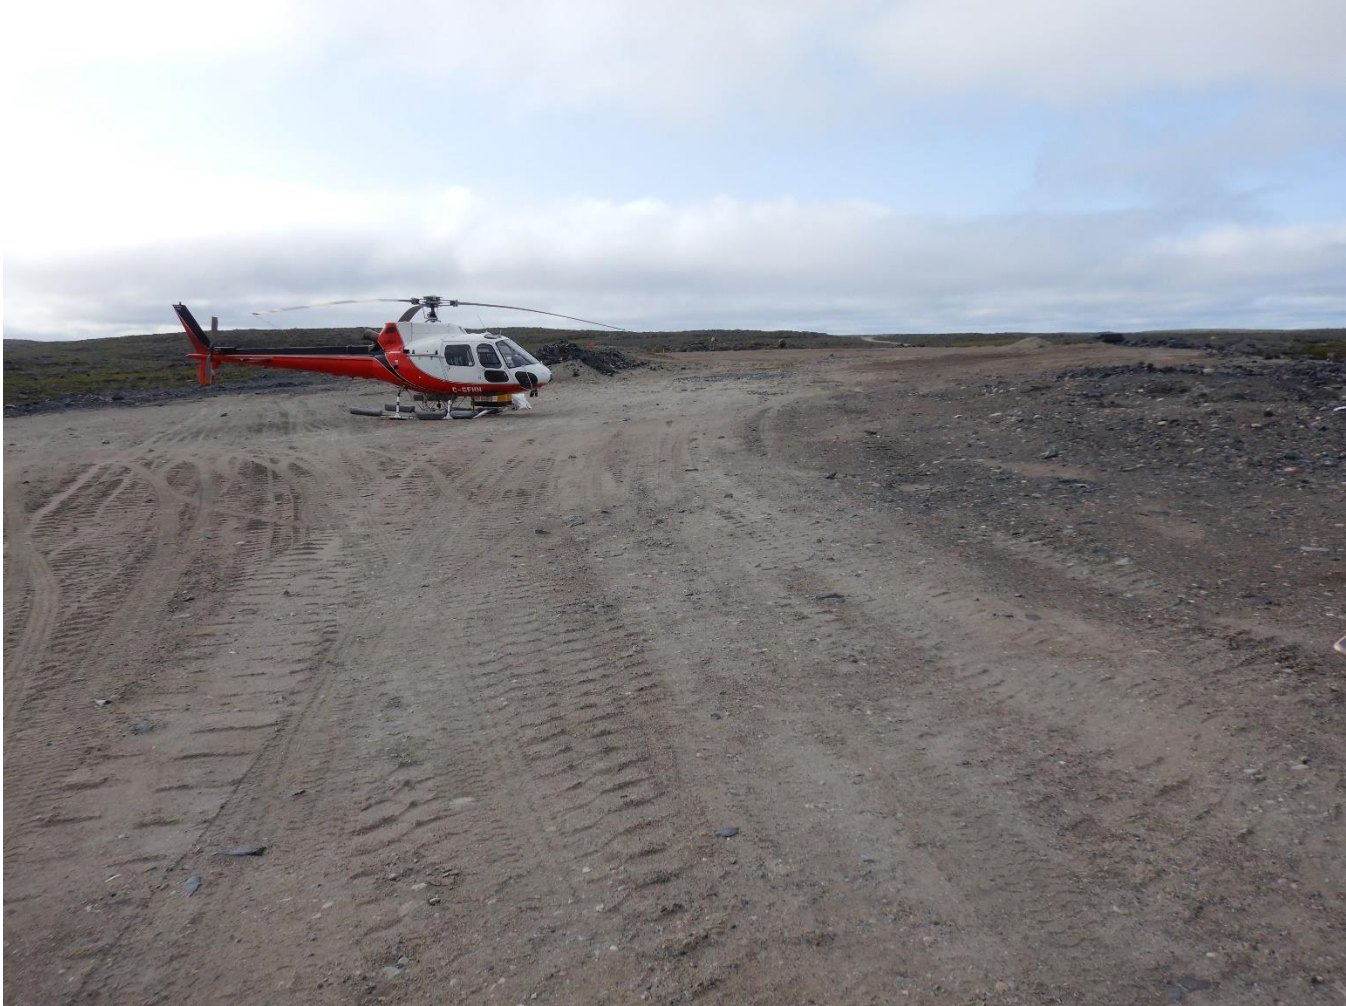
Photo 3

Description: Location of planned future Soil Treatment Facility

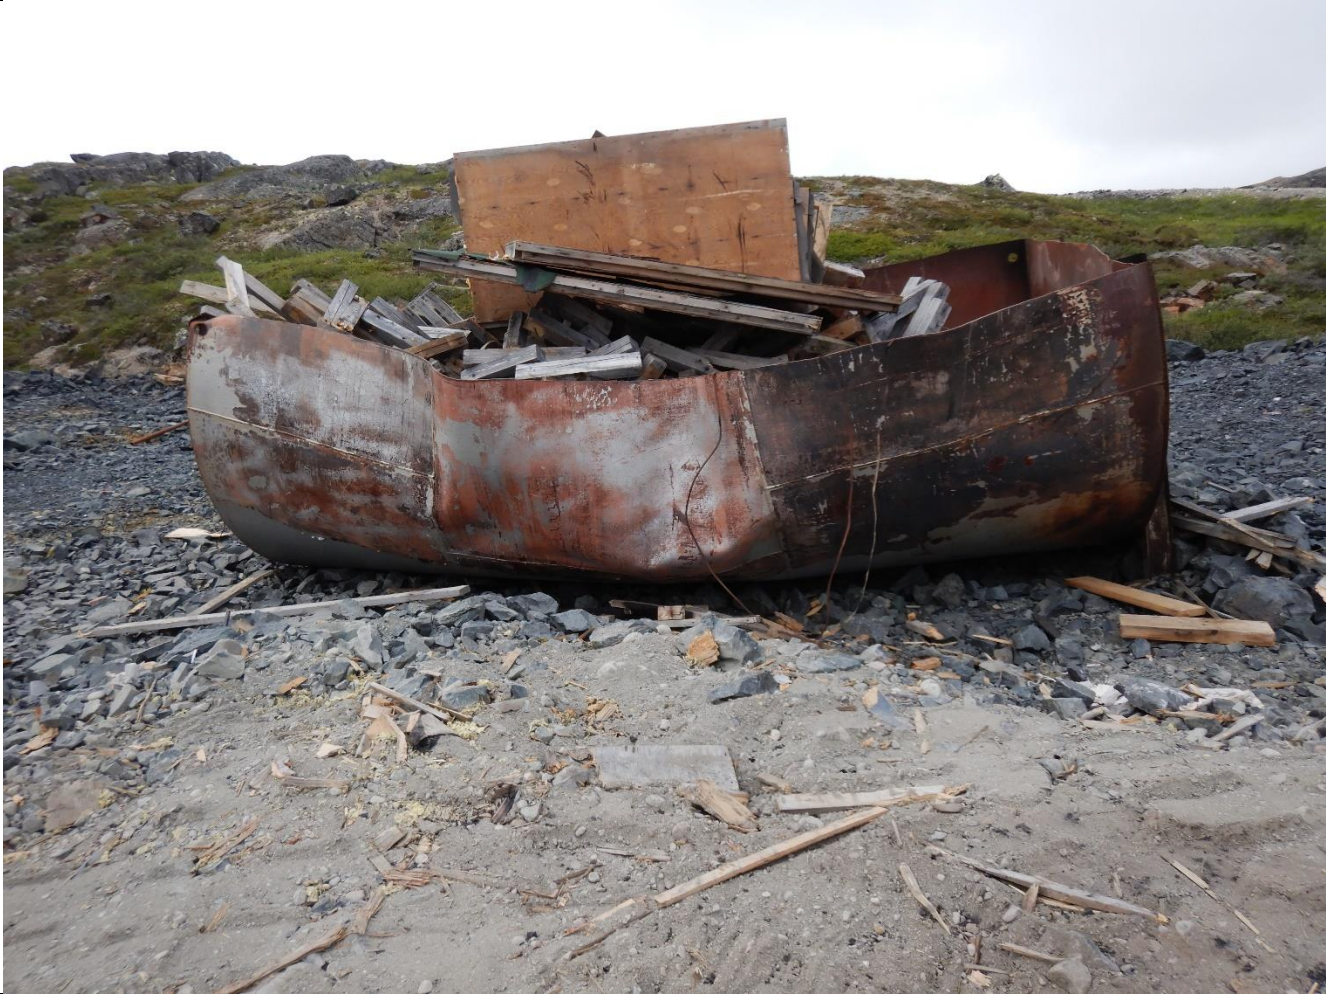
Photo 4

Description: Raw Lumber Burn Barrel

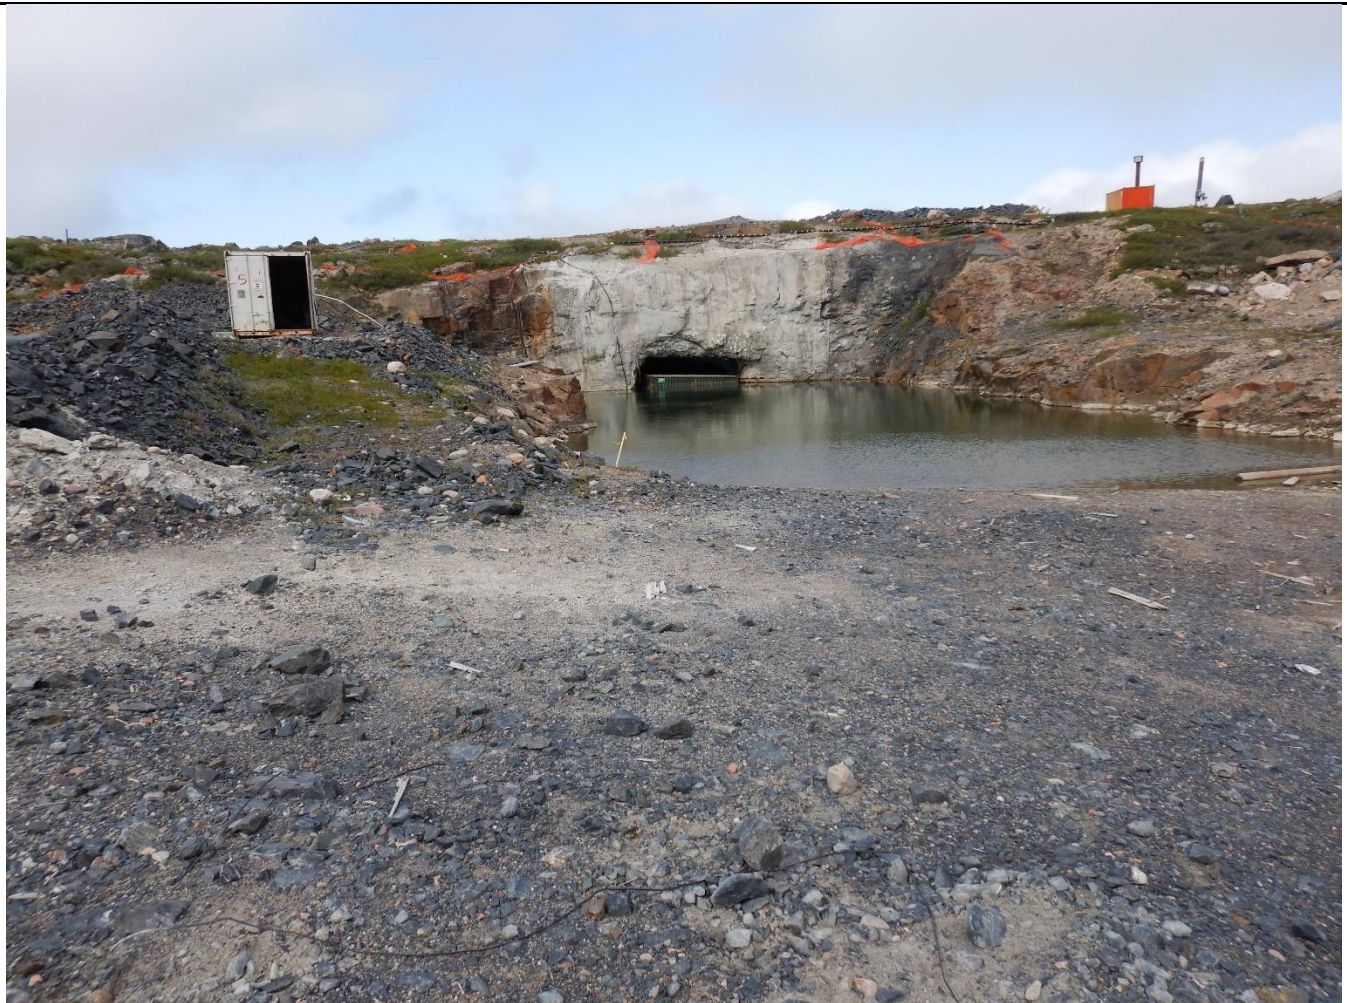
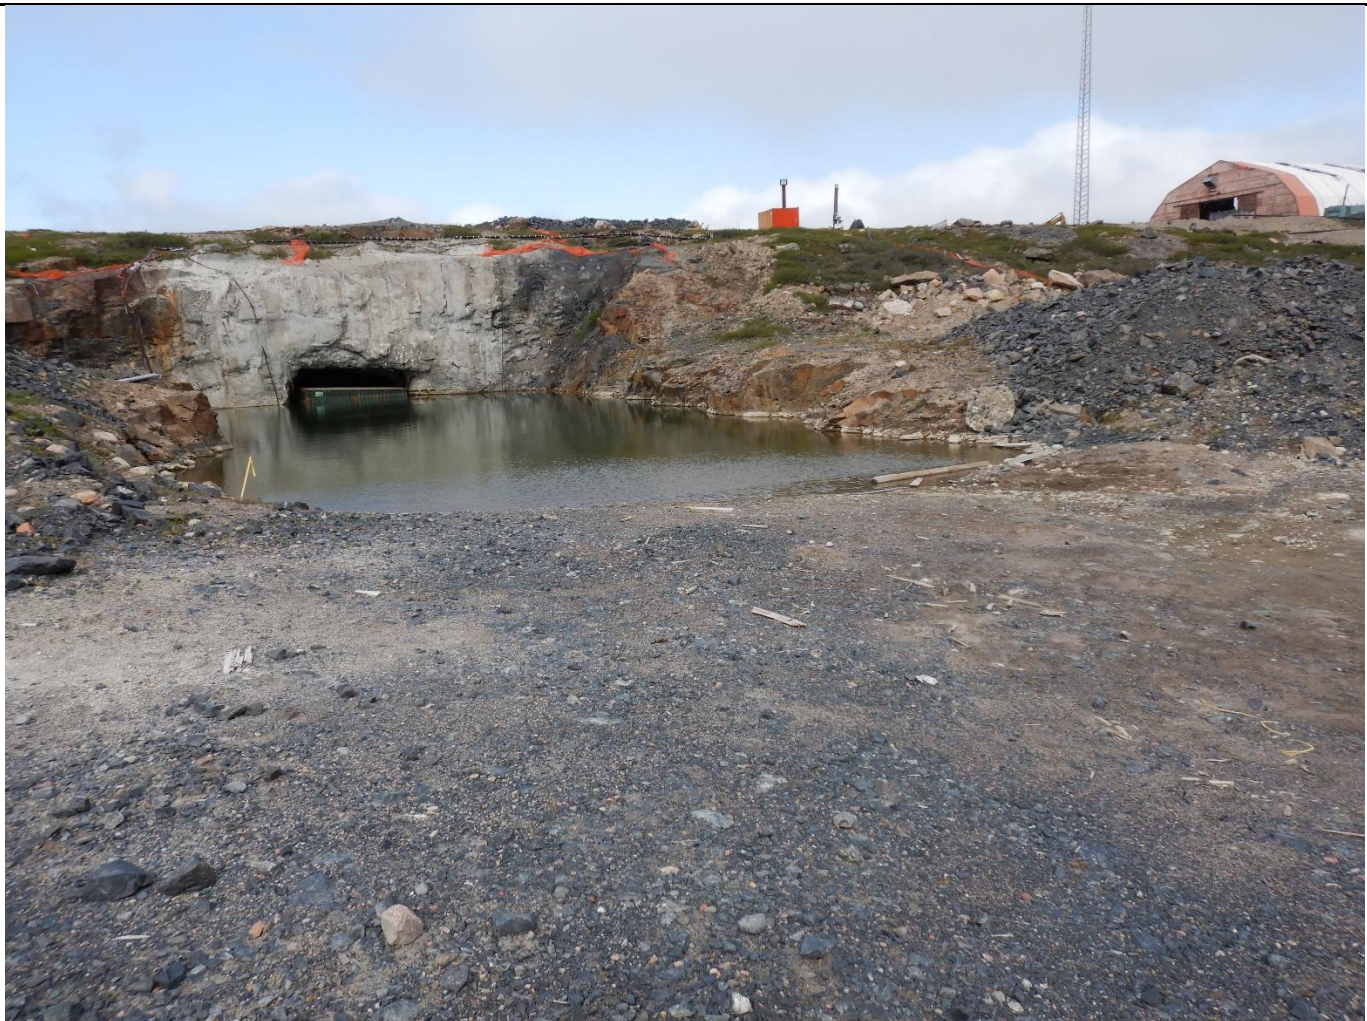
4 Old Portal (Photos 5 & 6)

Reclamation of this area is NOT being done this year. Reclamation for this area is planned in future

Description: Old Portal – View 1

Description: Old Portal – View 2

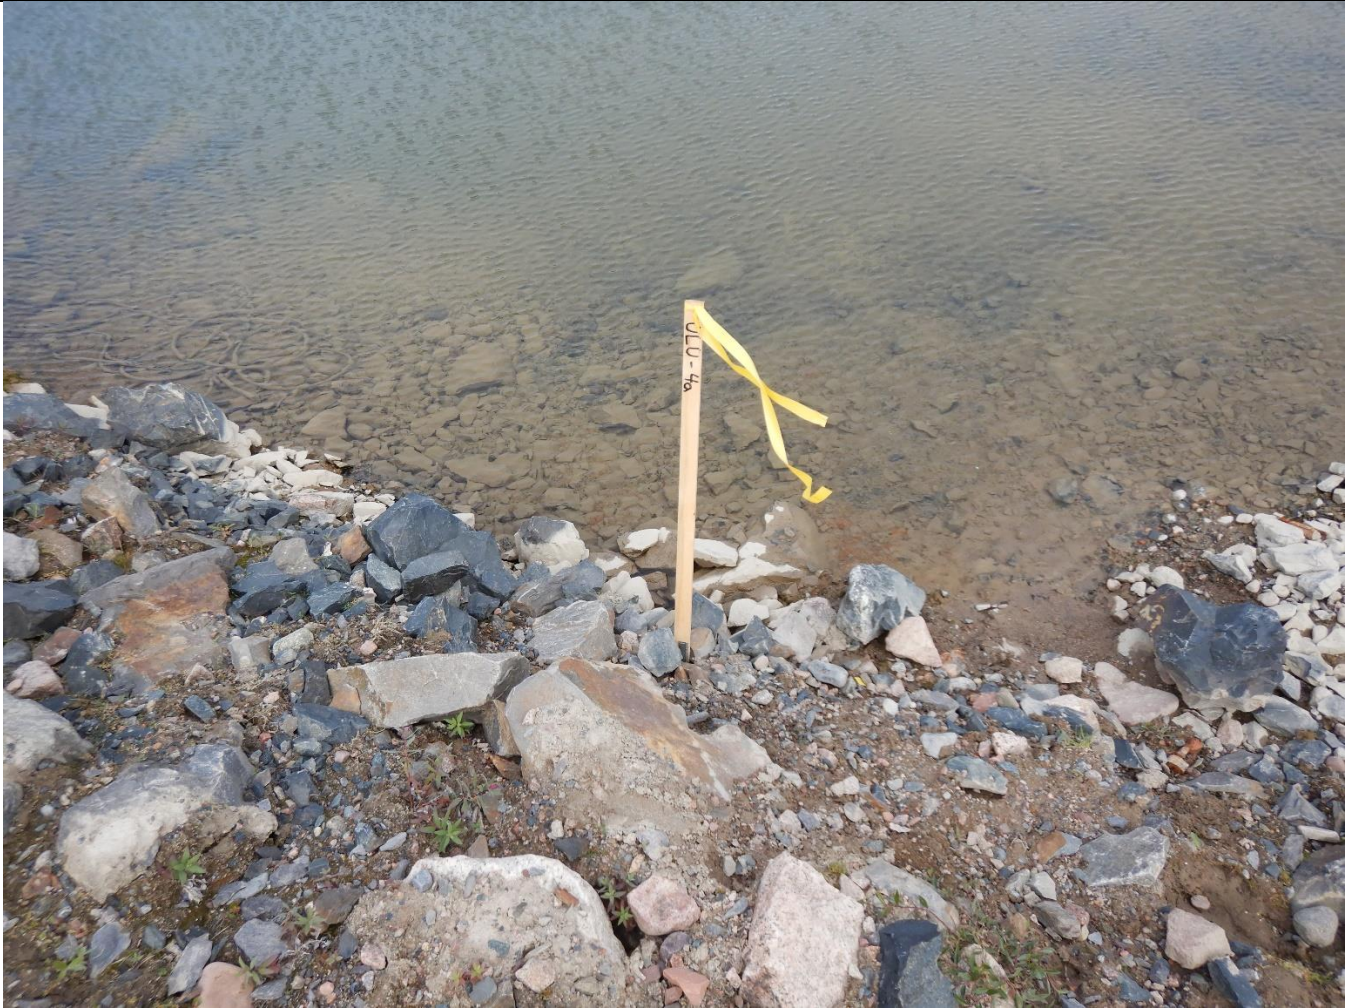
Photo 7

Signage is inadequate. All Signage must be Permanent in nature and easily readable and found both in summer and winter.

Description: Sample Station ULU-4a showing inadequate Signage

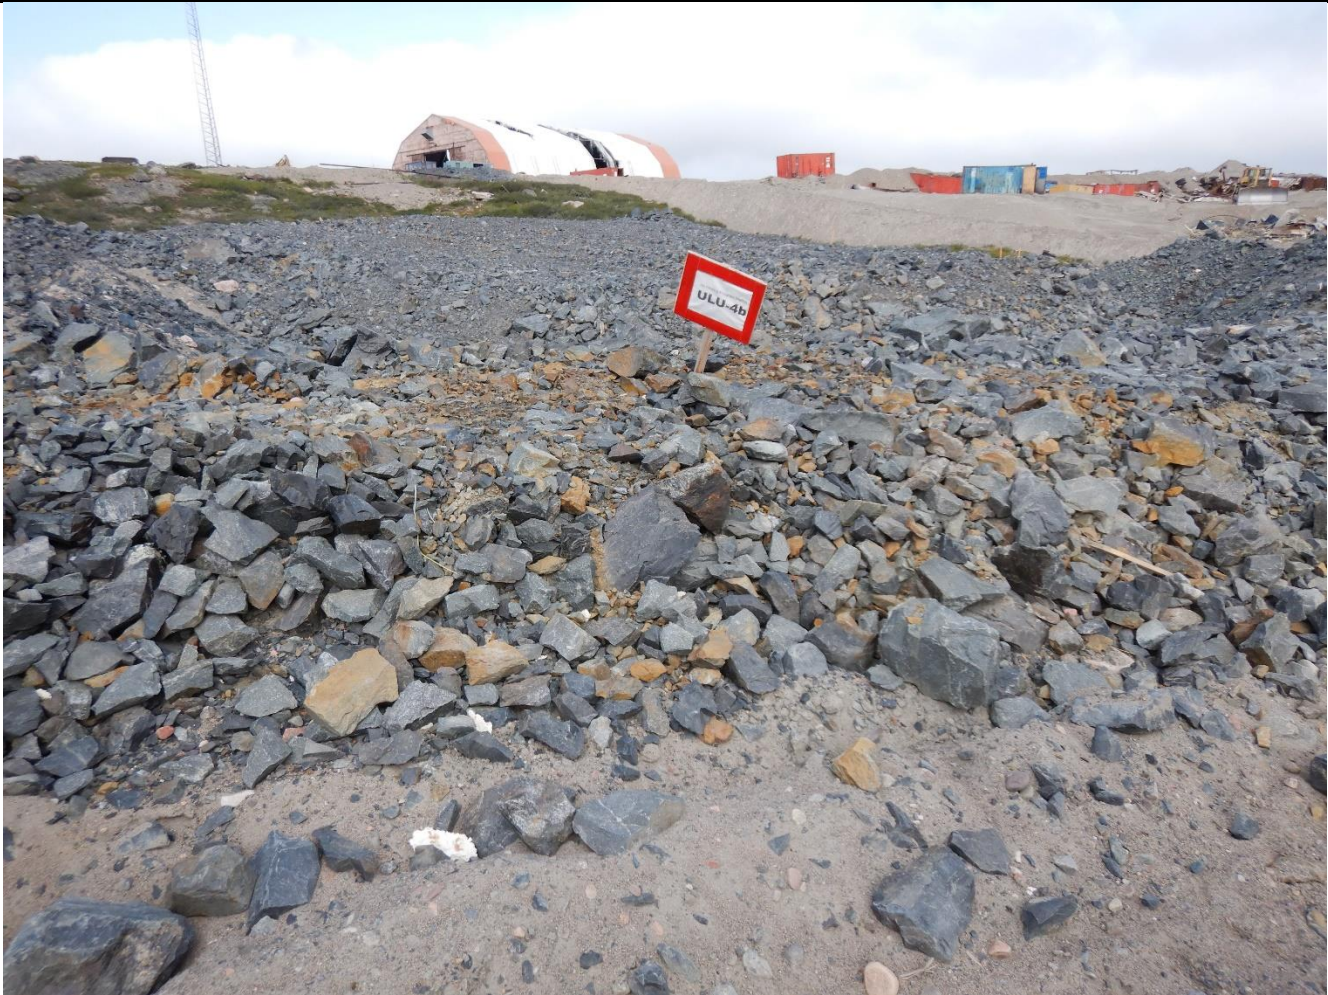
Photo 8

Signage is inadequate. All Signage must be Permanent in nature and easily readable and found both in summer and winter.

Description: Old Mine Sump Sample Station ULU-4b

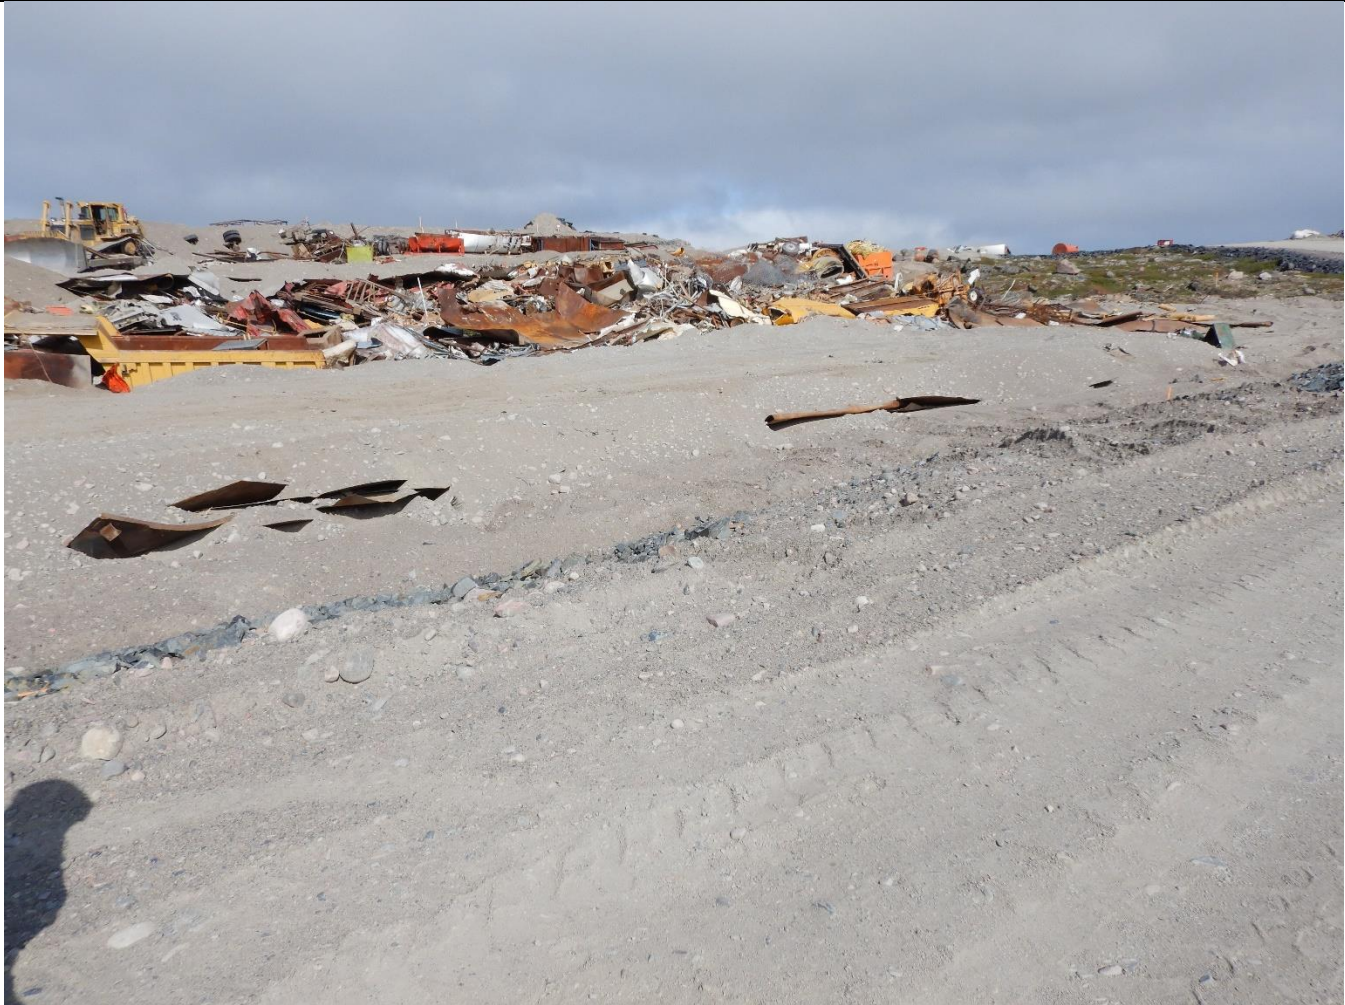
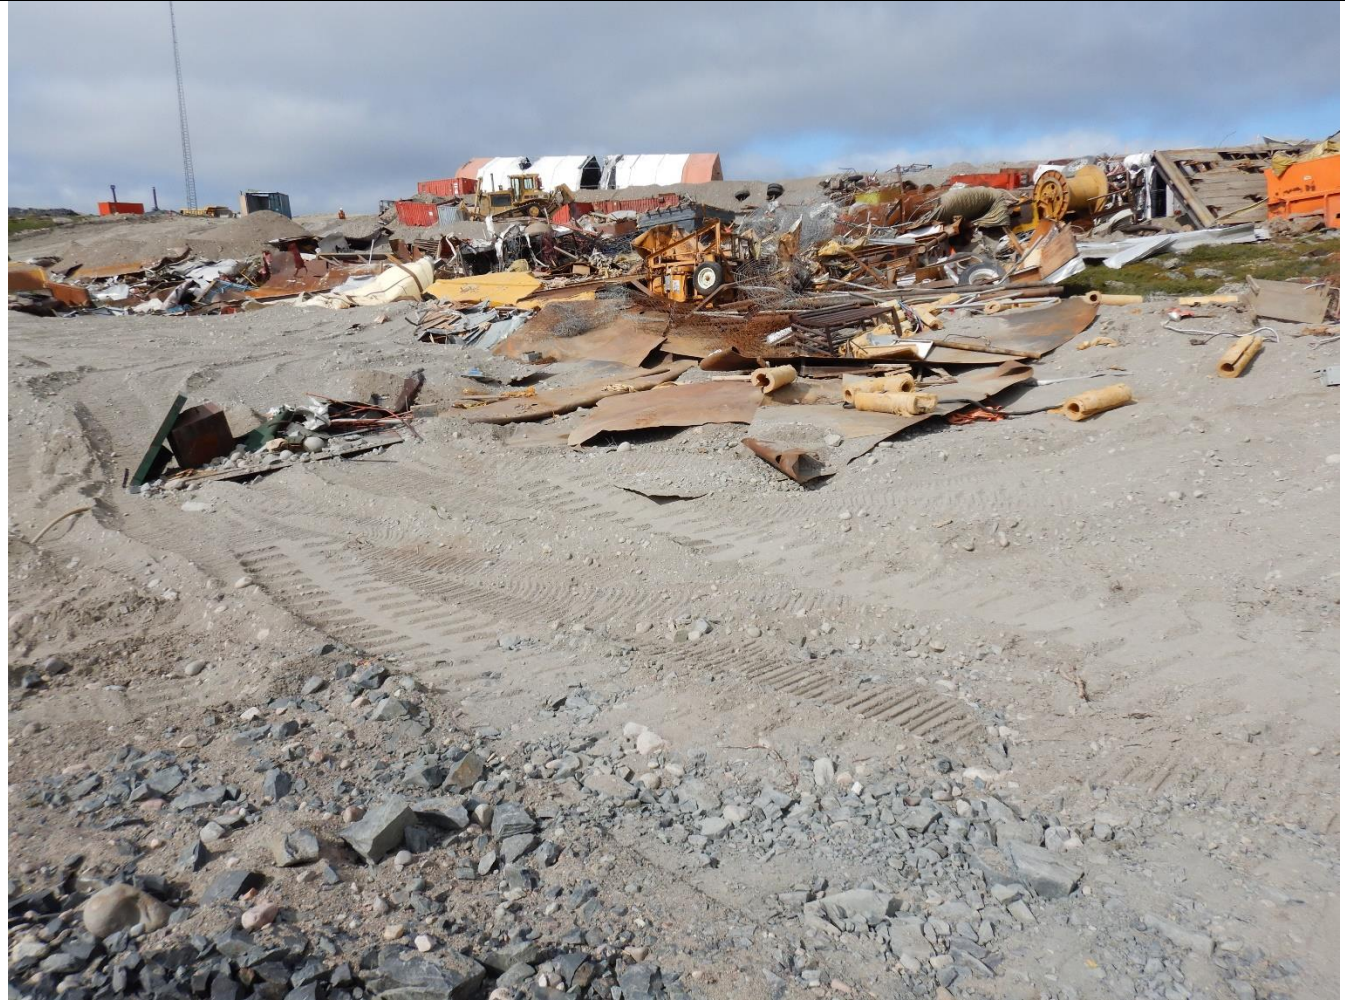
7 Land Fill Area (Photos 9 & 10)

Active Land Fill Area being used as part of ongoing Reclamation Activities on site.

The Inspector has NO Concerns about this at this time

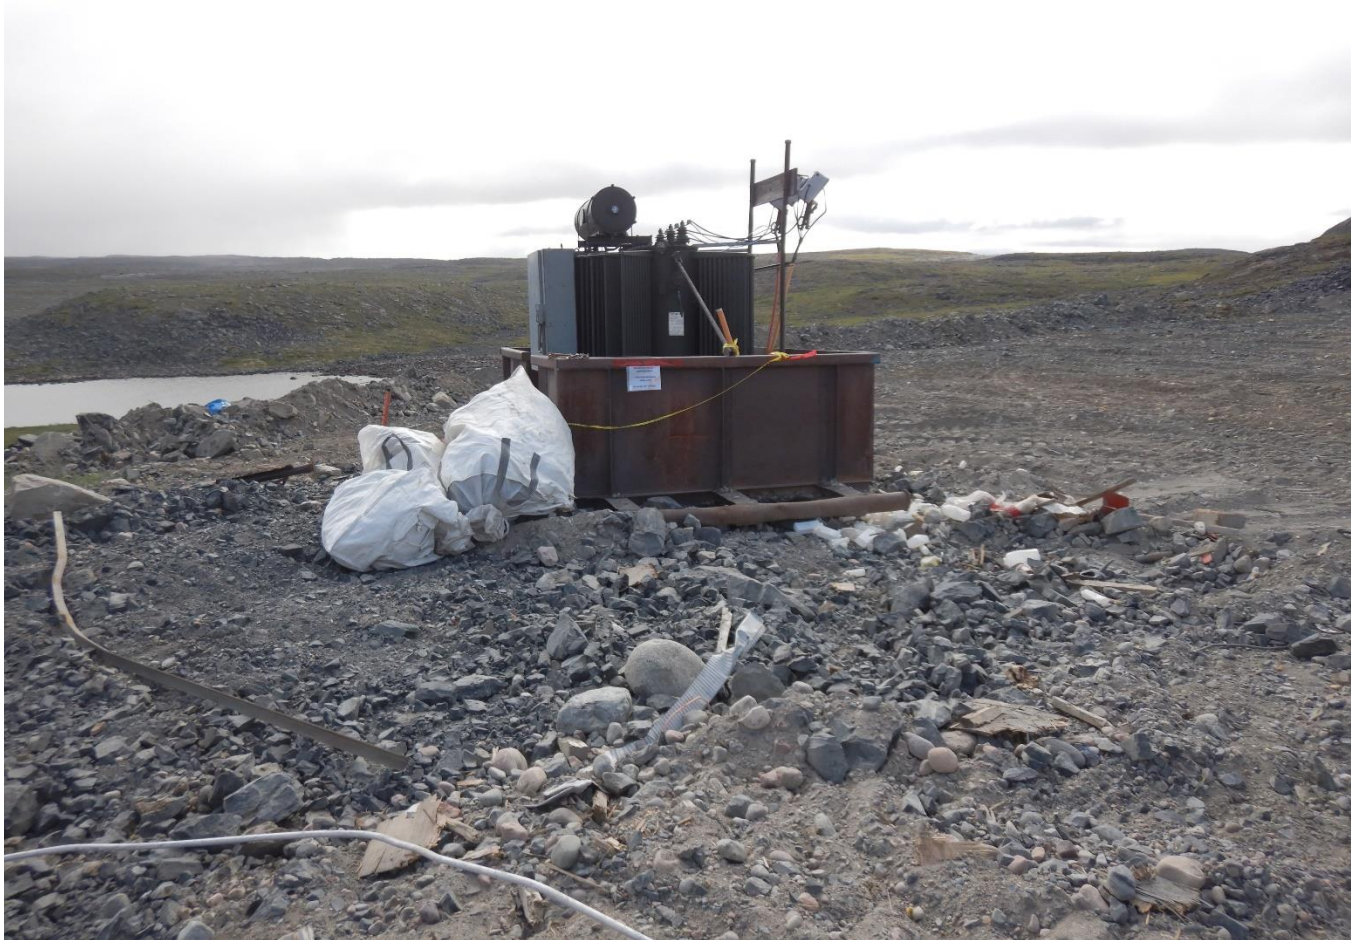
Photo 11

There is NO Oil in it at this time. Plans are for KBL to clean it out in 2022 and then it will be placed in the Land Fill

Description: Old PCB Transformer, contains NO Oil, to be cleaned in 2022 then placed into Land Fill

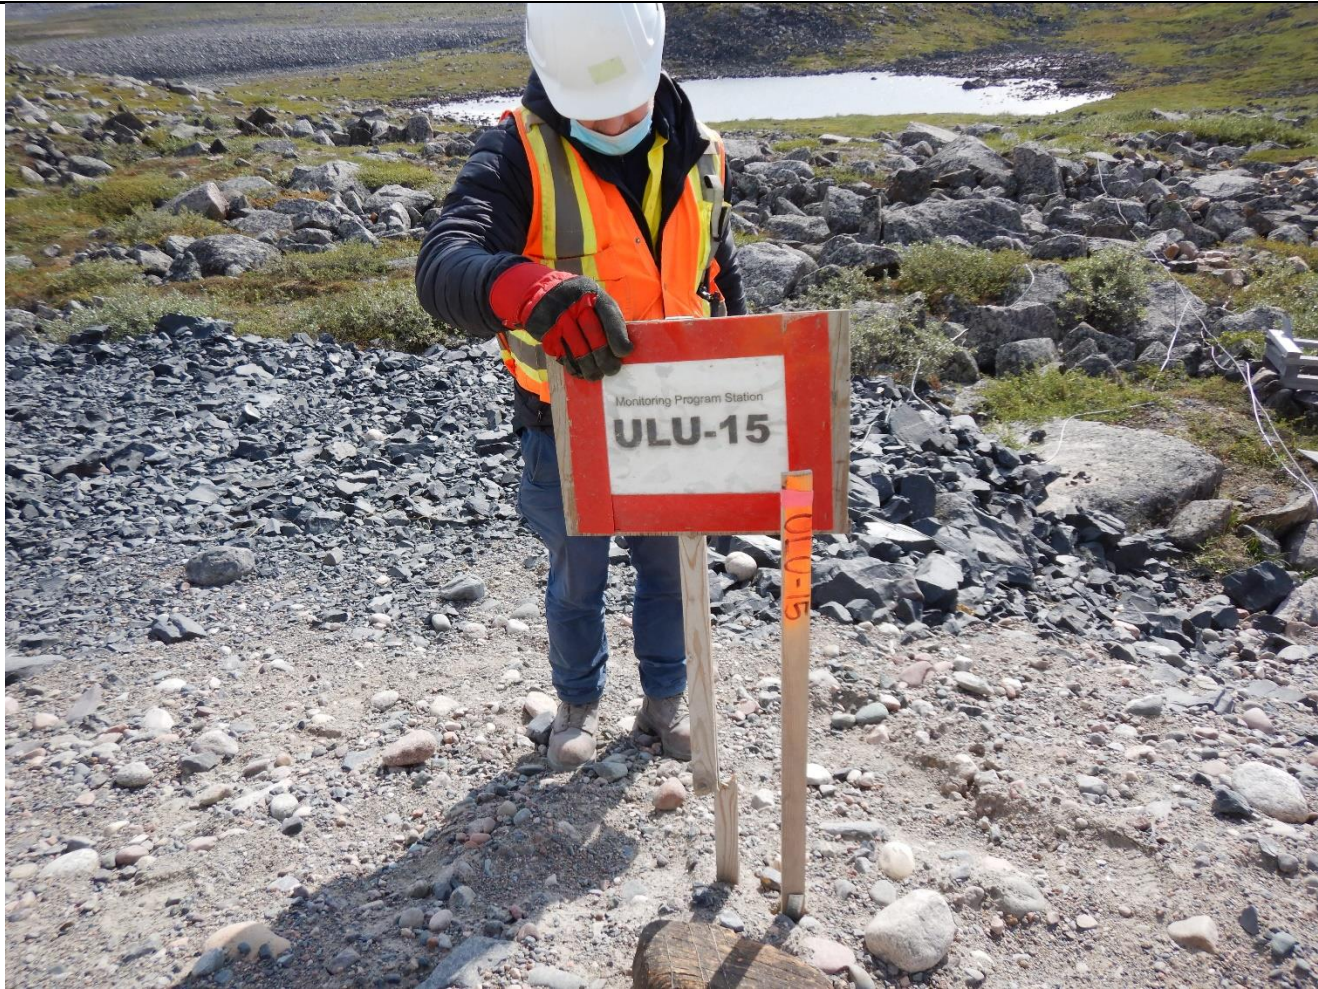
Photo 12

Signage is Broken. All Signage must be Permanent in nature and easily readable and found both in summer and winter.

Description: Broken Signage at Sample Station ULU-15

Signage is Broken and **requires replacement this season Before Camp Closure**

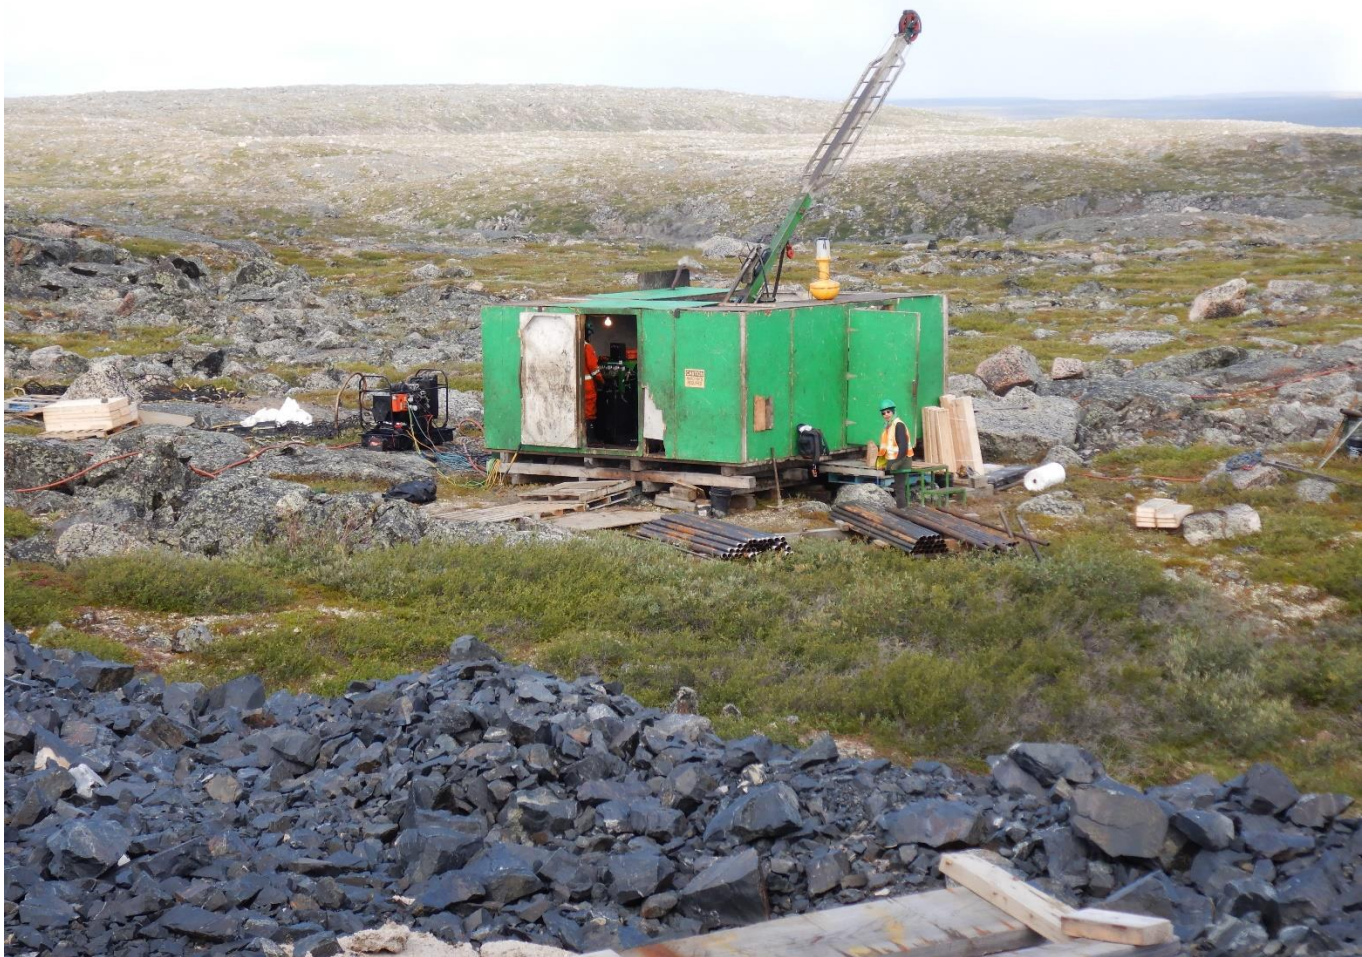
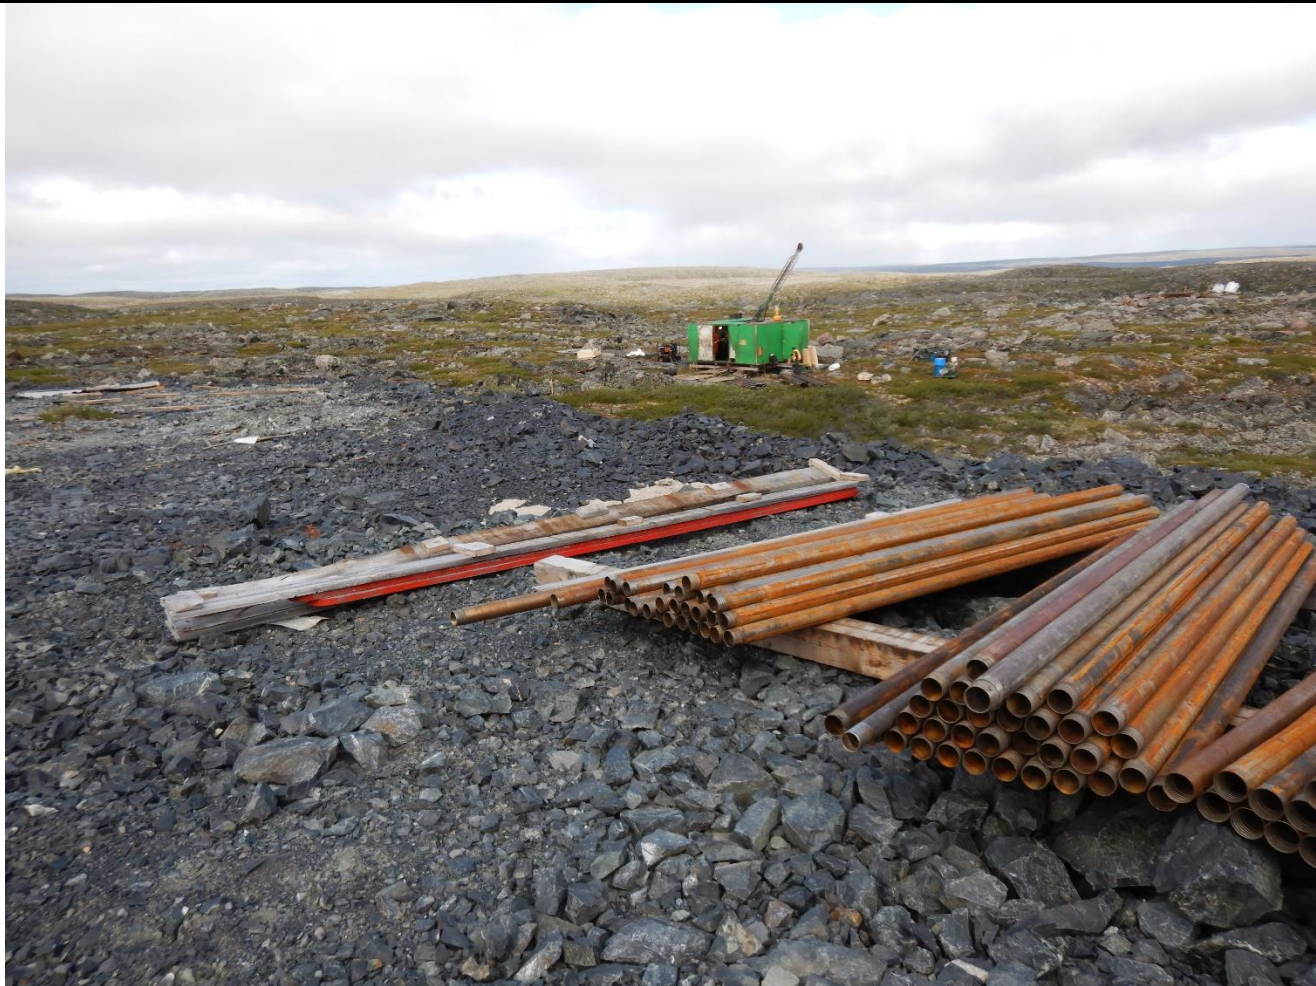
10 Active Drill Site (Photos 13 & 14)

This is the 2nd Drill Site being used for this season. Water being used for Drilling Purposes is coming from the same site, West Lake, as the Potable Water is coming from.

The Inspector has NO Concerns about this at this time

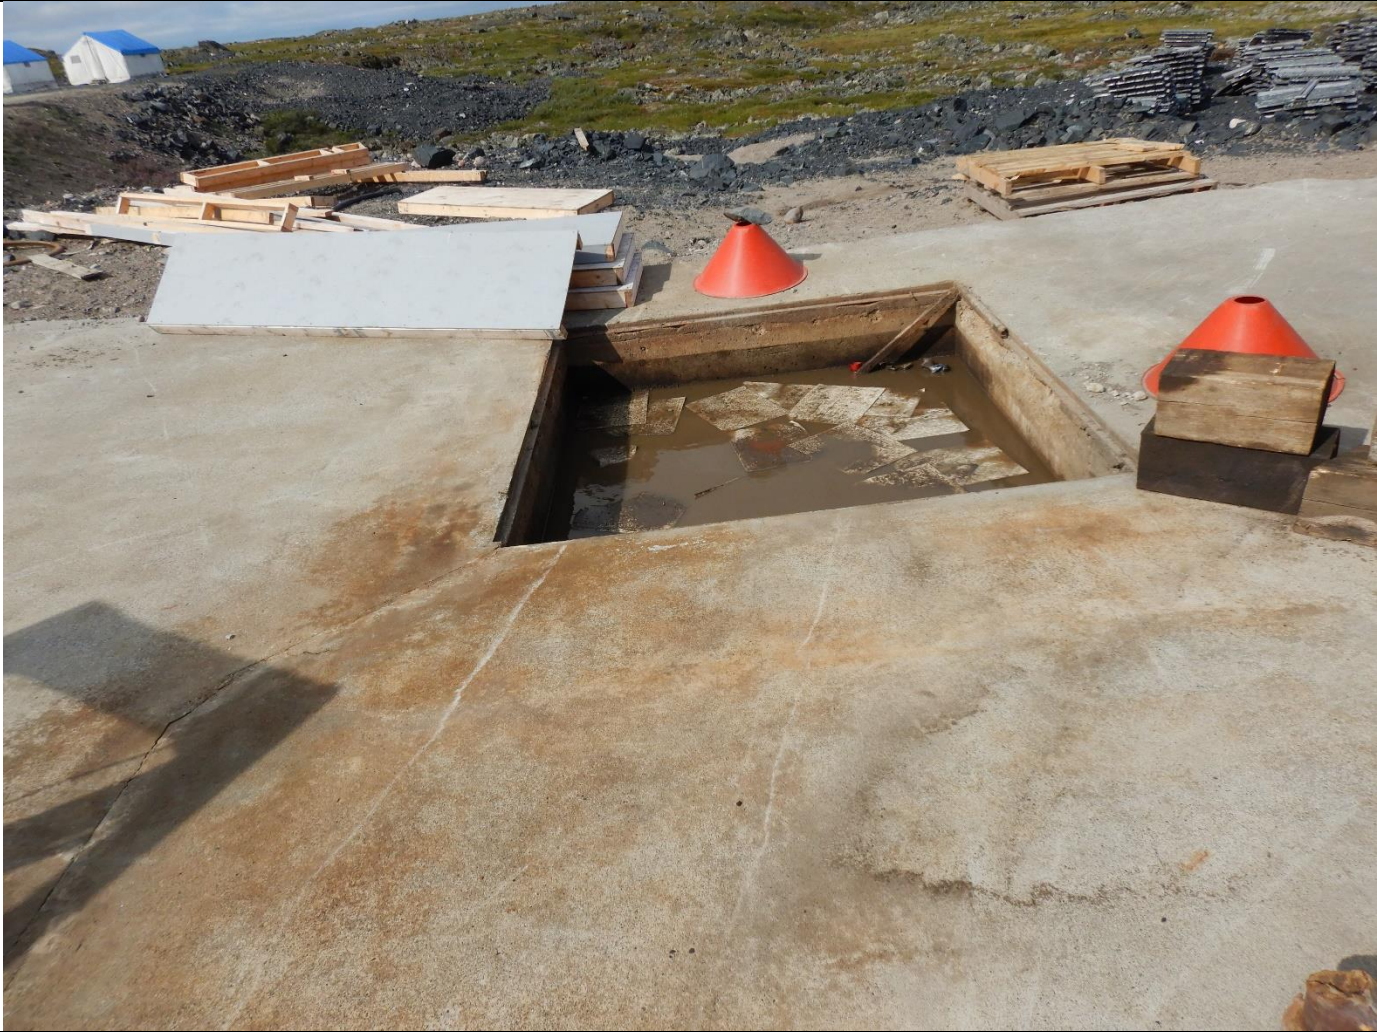
Photo 15

This is where all Contaminants are Washed Off of items before being placed into the Land Fill

The Inspector has NO Concerns about this at this time

Description: Wash Area and Sump

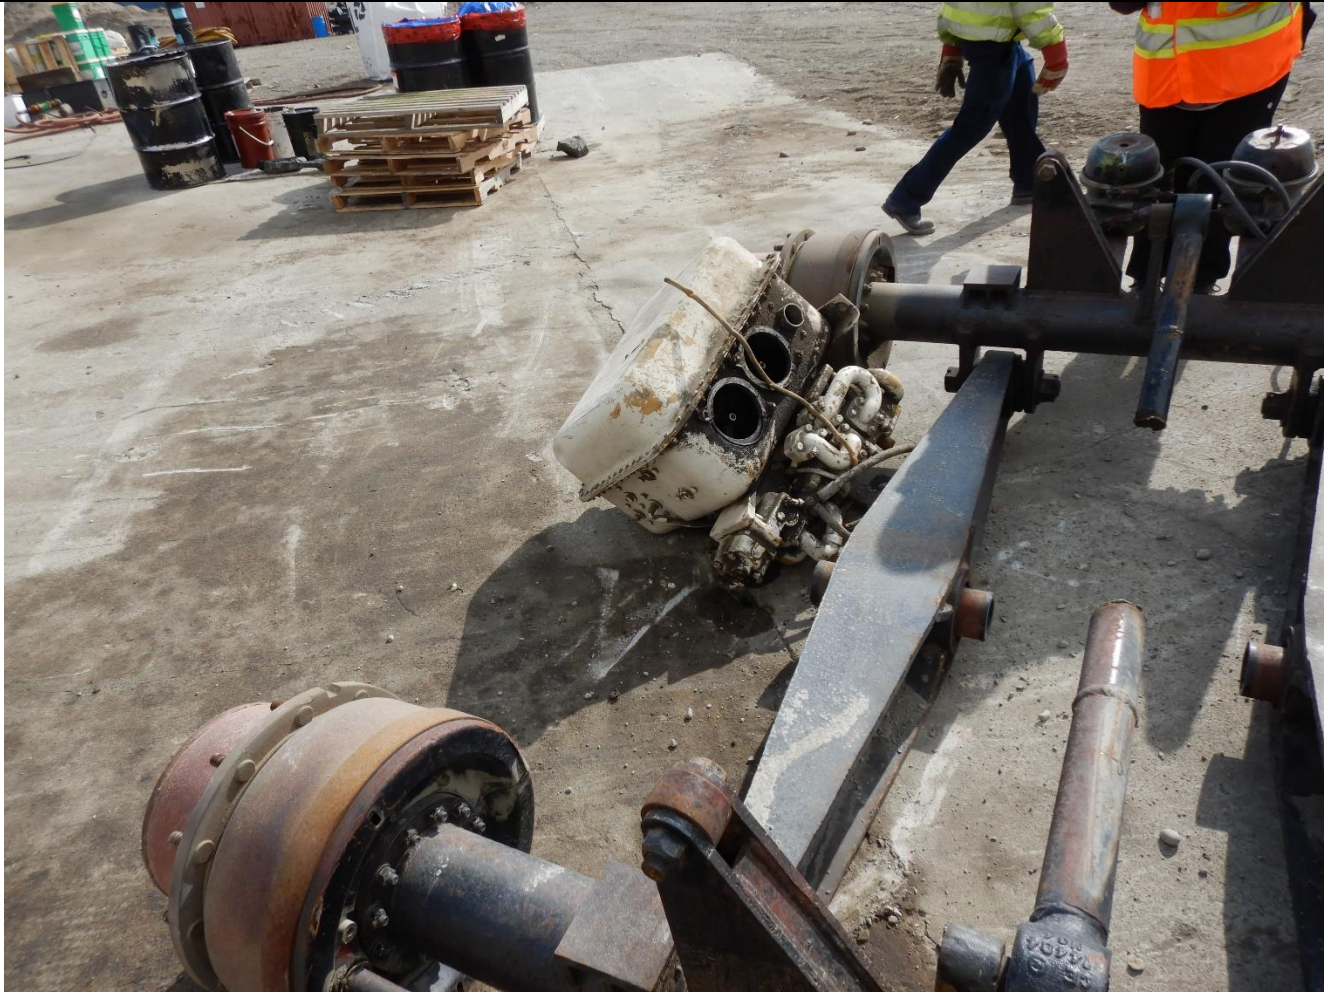
Photo 16

A White Tank and a Yellow Cab from a piece of Heavy Equipment were dug up and reported by Blue Star

Description: White Tank shown is part of Non-Compliance Disclosure Letter from Blue Star to the NWB on 6 Aug 2021

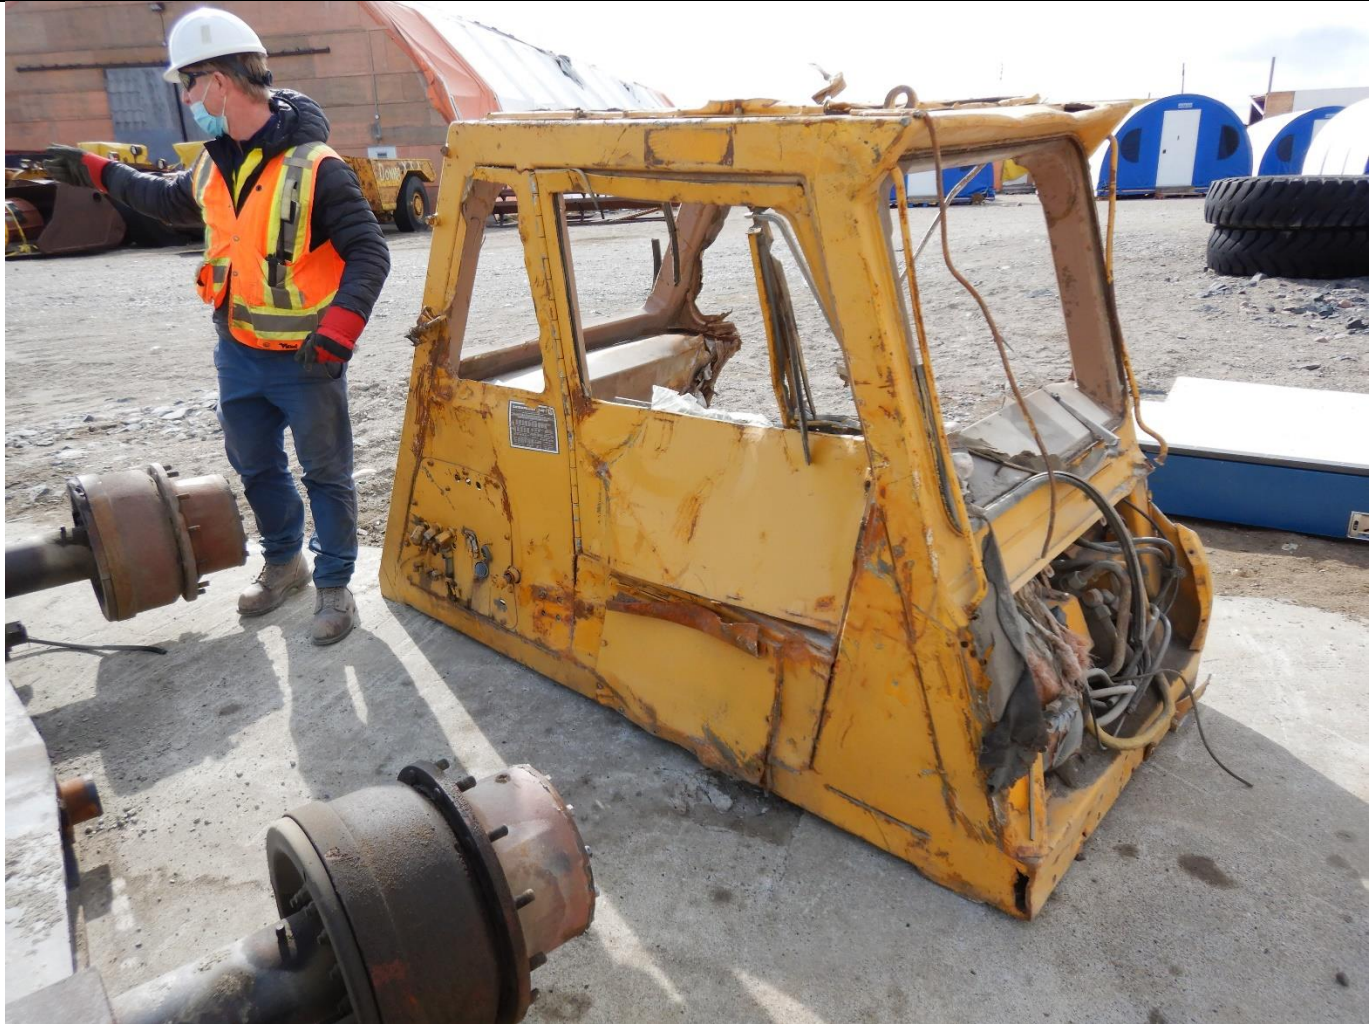
Photo 17

Description: Yellow Cab shown is part of Non-Compliance Disclosure Letter from Blue Star to the NWB on 6 Aug 2021

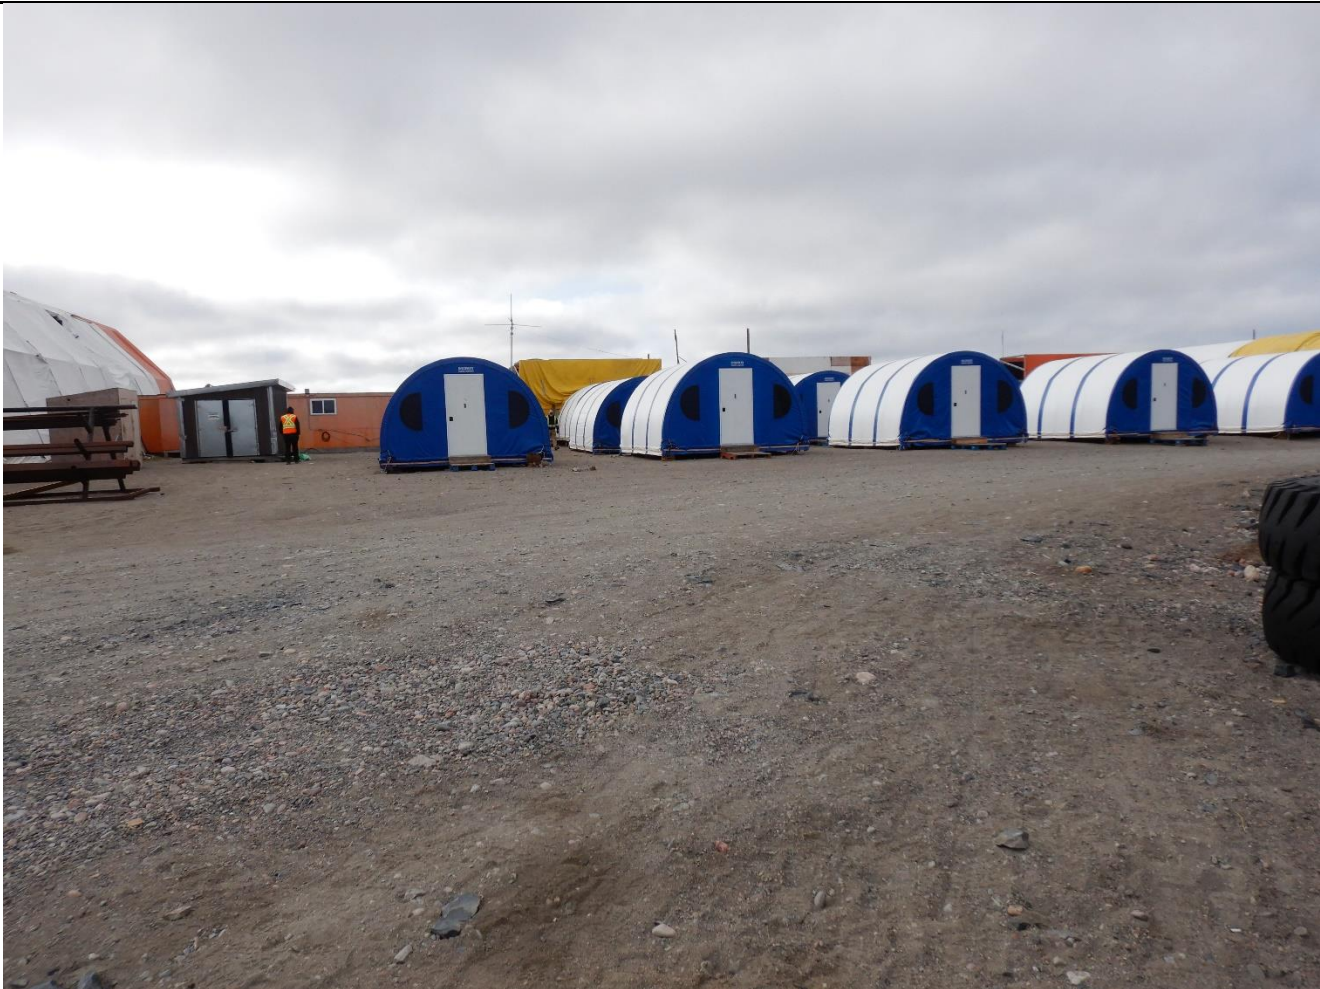
Photo 18

Recently built new Accommodation Tents for staff

Description: New Accommodations Tents (white & blue) recently installed
