WATER LICENCE INSPECTION FORM

Licensee		Licensee Representative	
Blue Star Gold Corp		Darren Lindsay	
Licence No. / Expiry		Representative's Title	
2BM-ULU2030		Vice President, Exploration	
Land / Other Authorizations		Land / Other Authorizations	
IOL KTL 311C013			
Date of Inspection		Inspector	
11 August 2021		Baba Pedersen	
Activities Inspected			
<input checked="" type="checkbox"/> Camp	<input checked="" type="checkbox"/> Drilling	<input type="checkbox"/> Mining	<input type="checkbox"/> Construction
<input type="checkbox"/> Roads/Hauling	<input type="checkbox"/> Other:	<input type="checkbox"/> Other:	<input checked="" type="checkbox"/> Reclamation
		<input checked="" type="checkbox"/> Fuel Storage

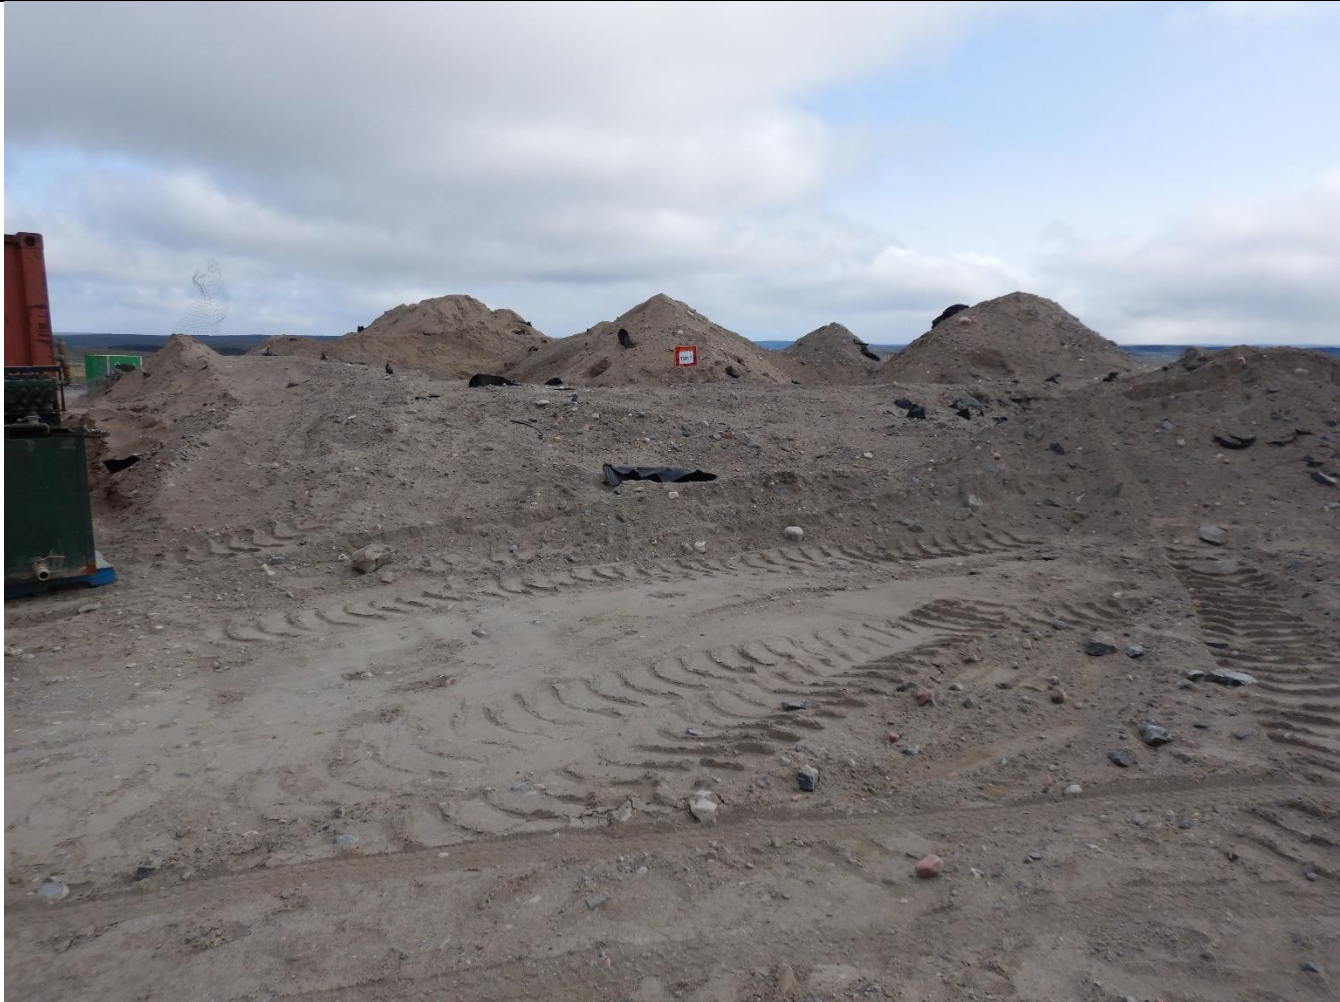
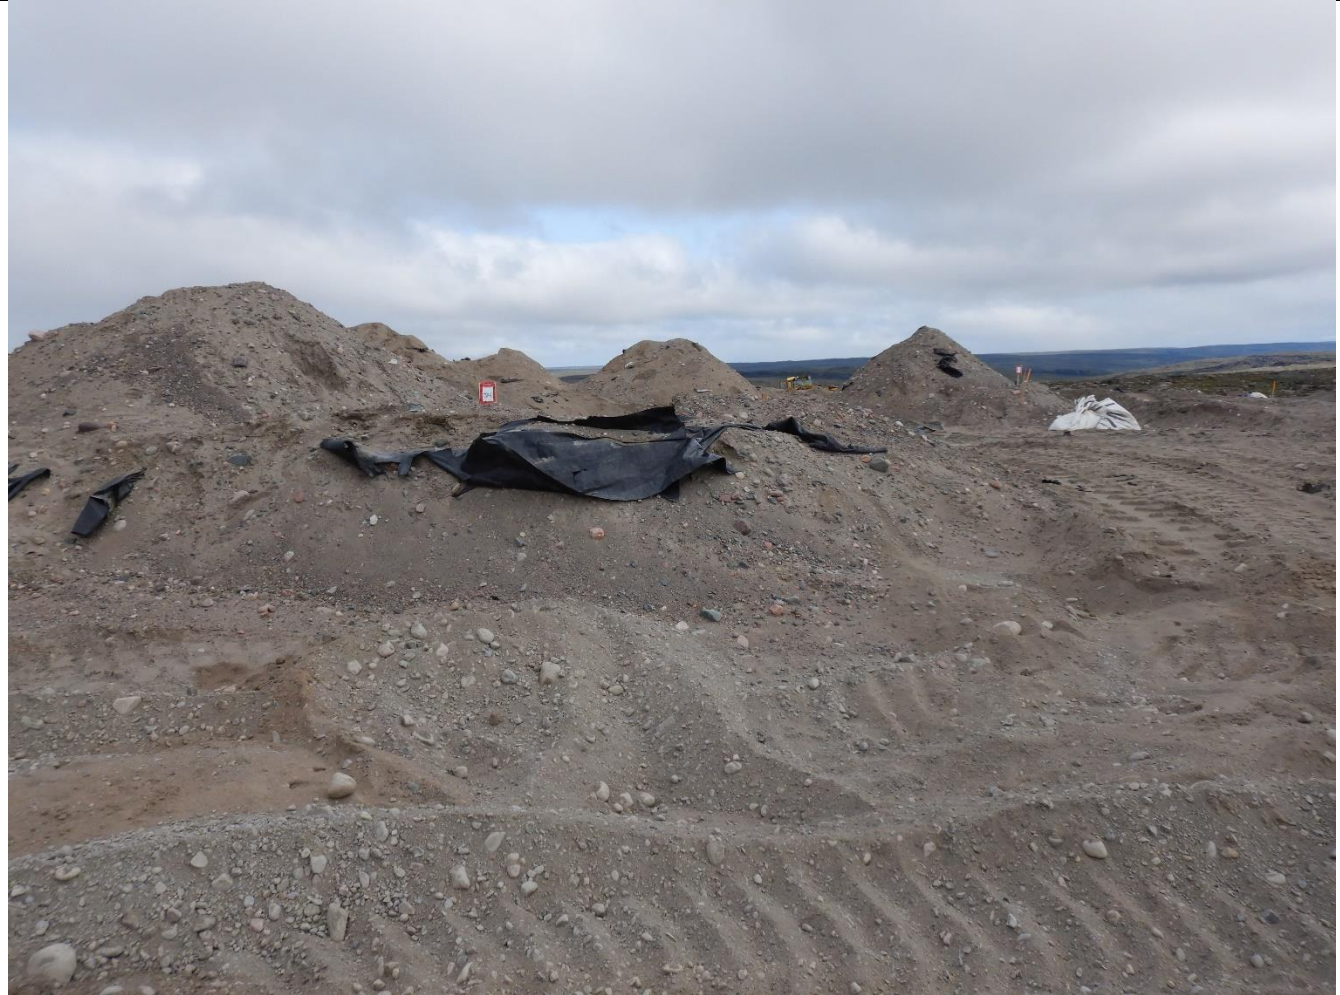
14 Contaminated Soil Pile Stations (Photos 19, 20 & 21)

This is where all Contaminated Soils are stored and Signage for same

The Inspector has NO Concerns about this at this time

Description: Contaminated Soil Piles – View 1

Description: Contaminated Soil Piles – View 2

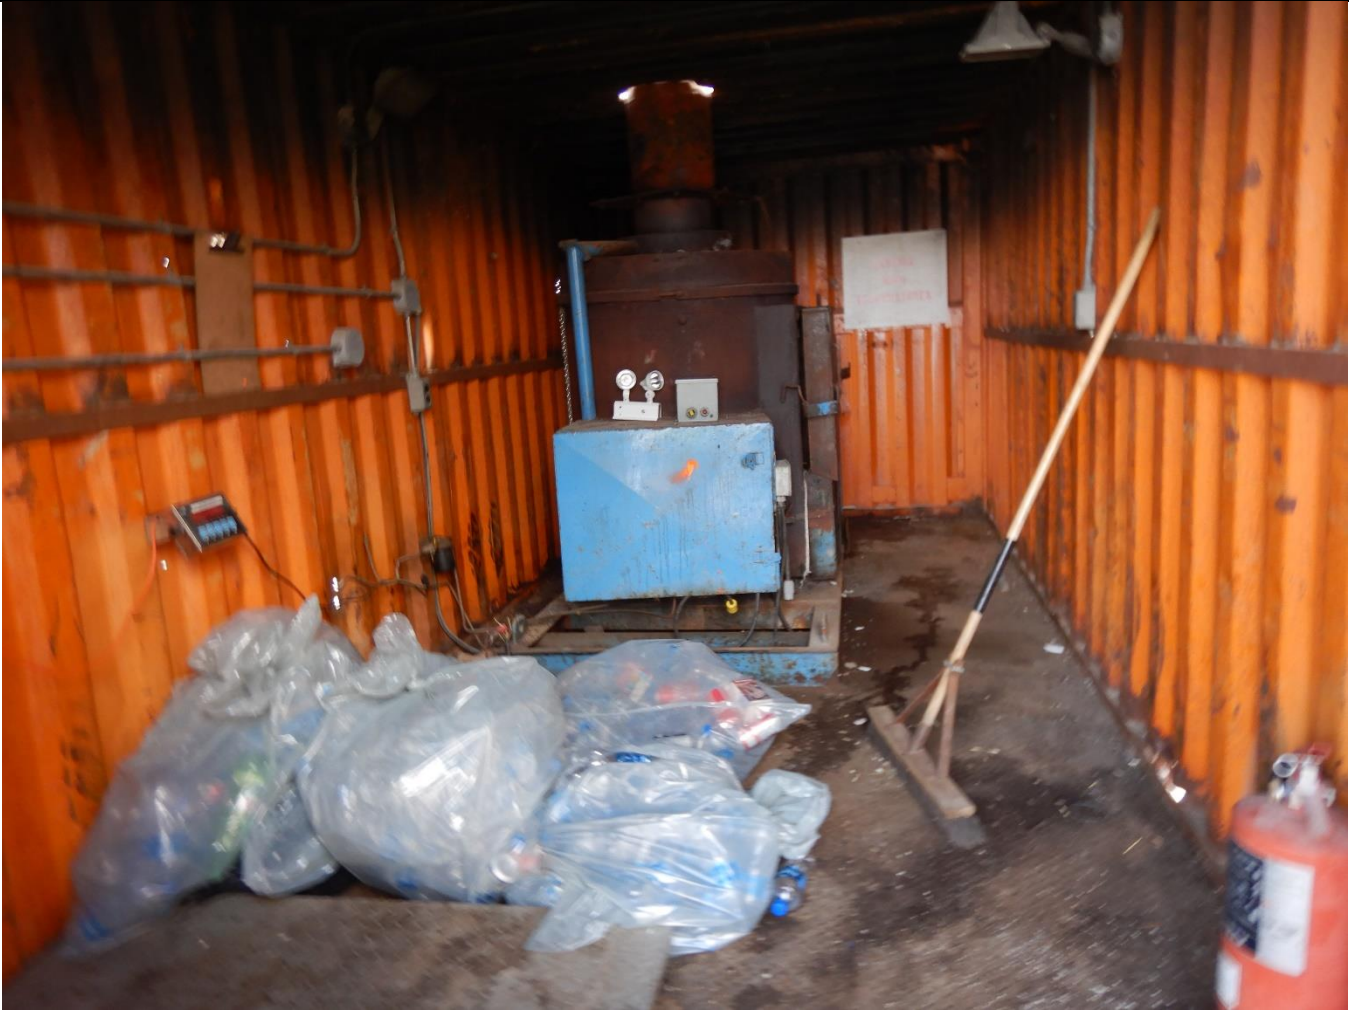
Photo 23

This is NOT currently in use

Description: Inactive Old Incinerator in Sea Can – Not in Use

This should be De-Commissioned and properly Disposed Of in 2022 if there are no plans to use this again

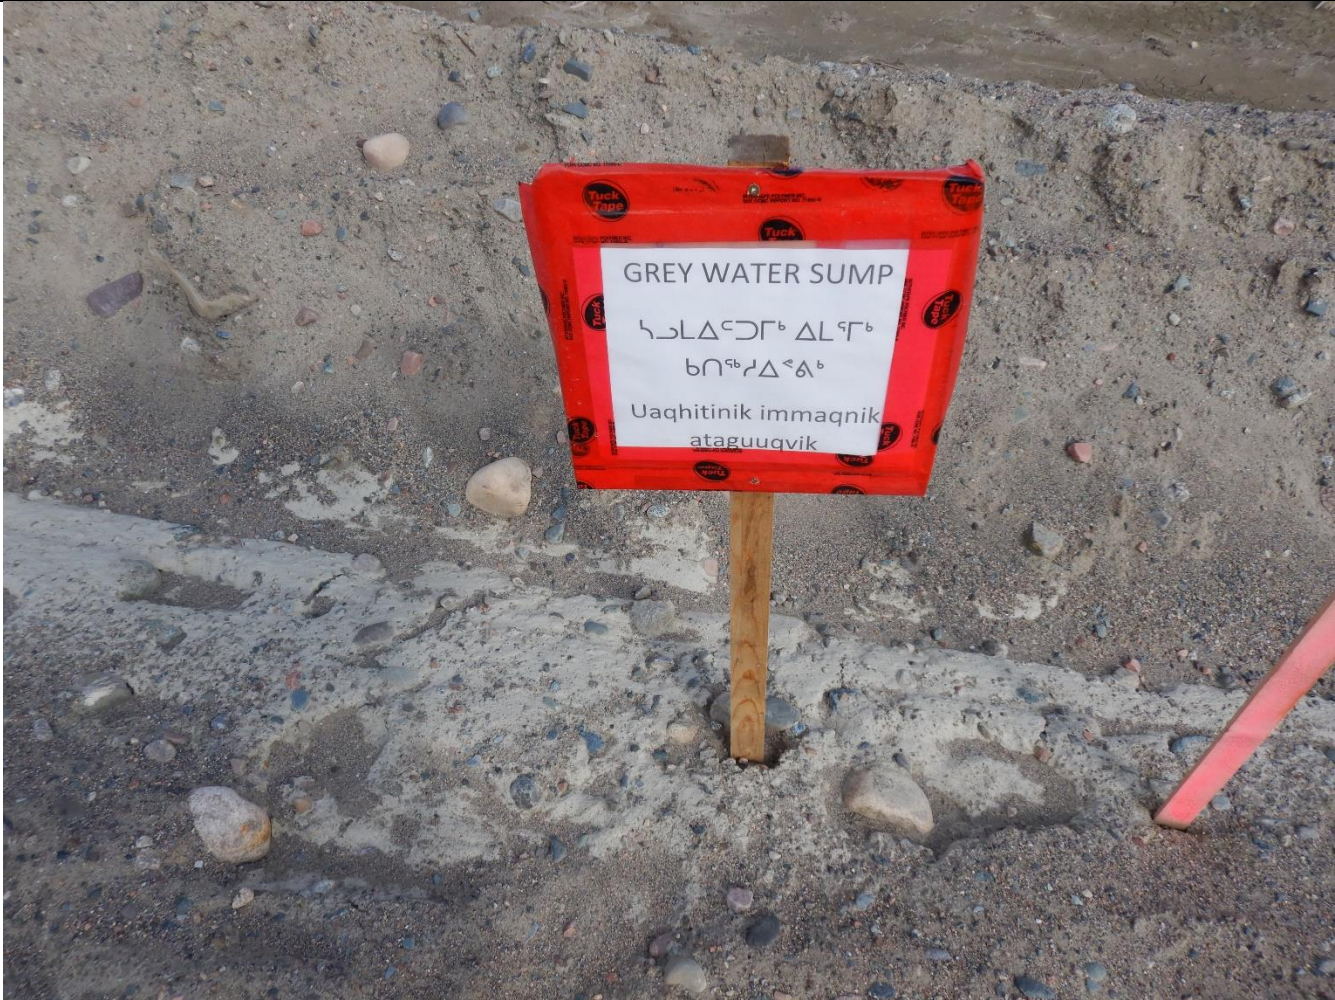
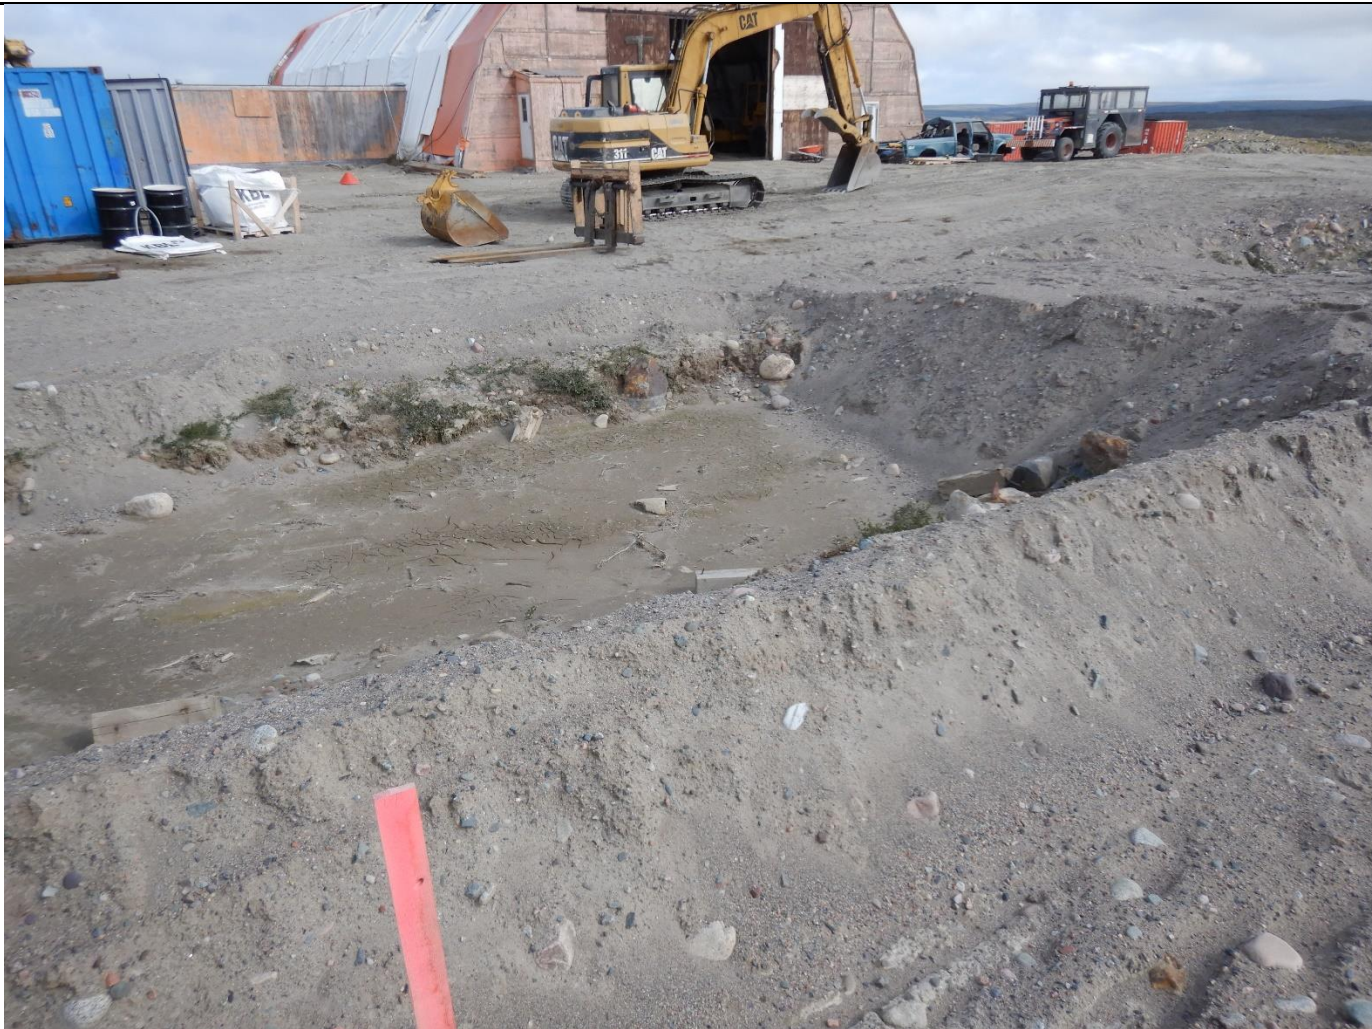
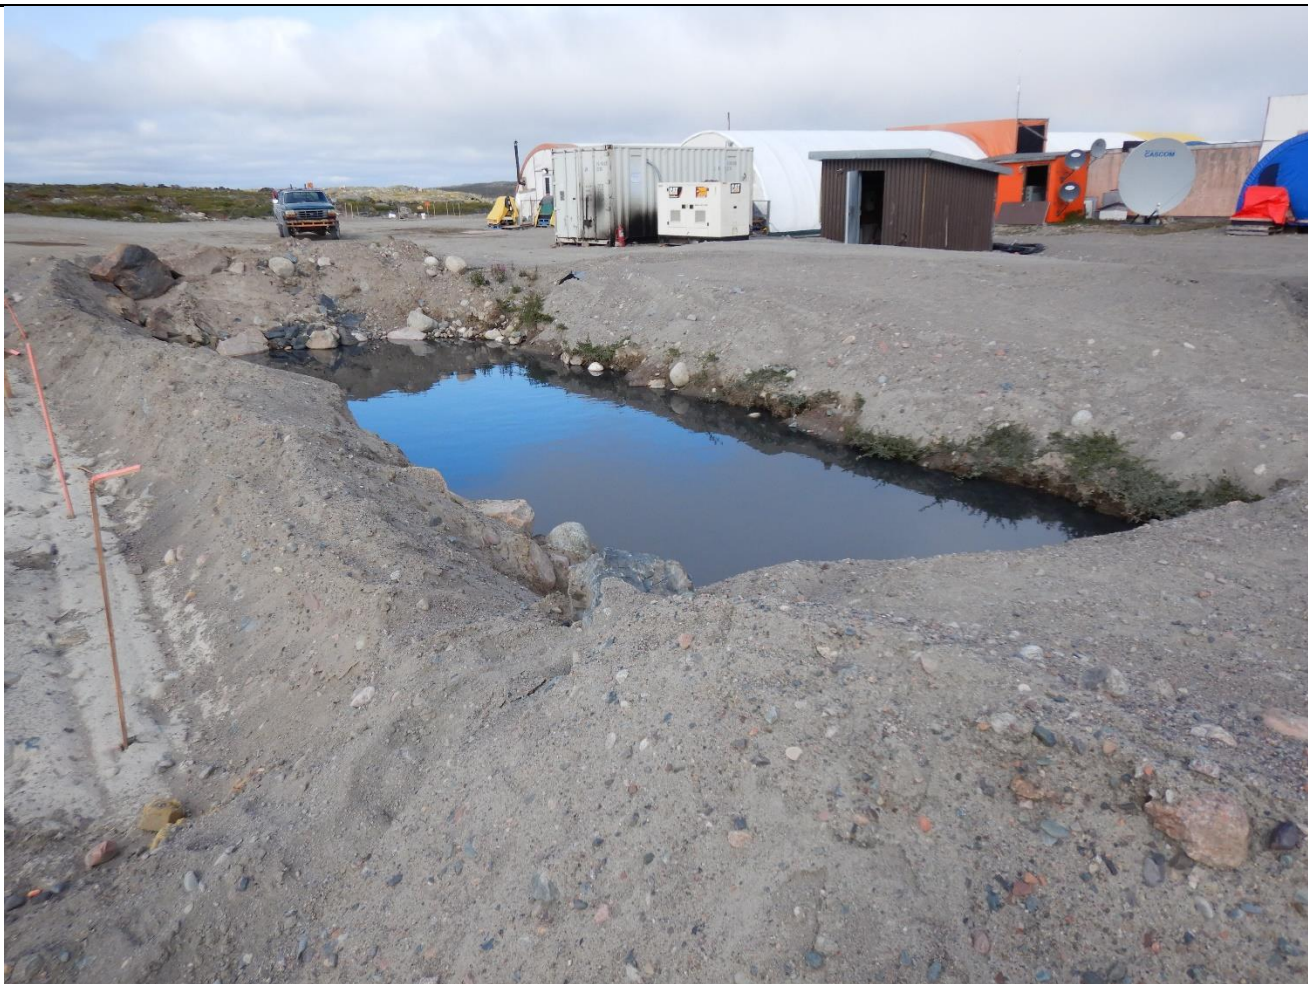
17 Grey Water Sumps (Photos 24, 25 & 26)

This is where Grey Water from Camp Use is Stored and Treated as well as Signage for same

Description: Signage at Grey Water Sump area

Description: Grey Water Sump #2 – empty – not in active use

Description: Grey Water Sump #1 – In Active Use

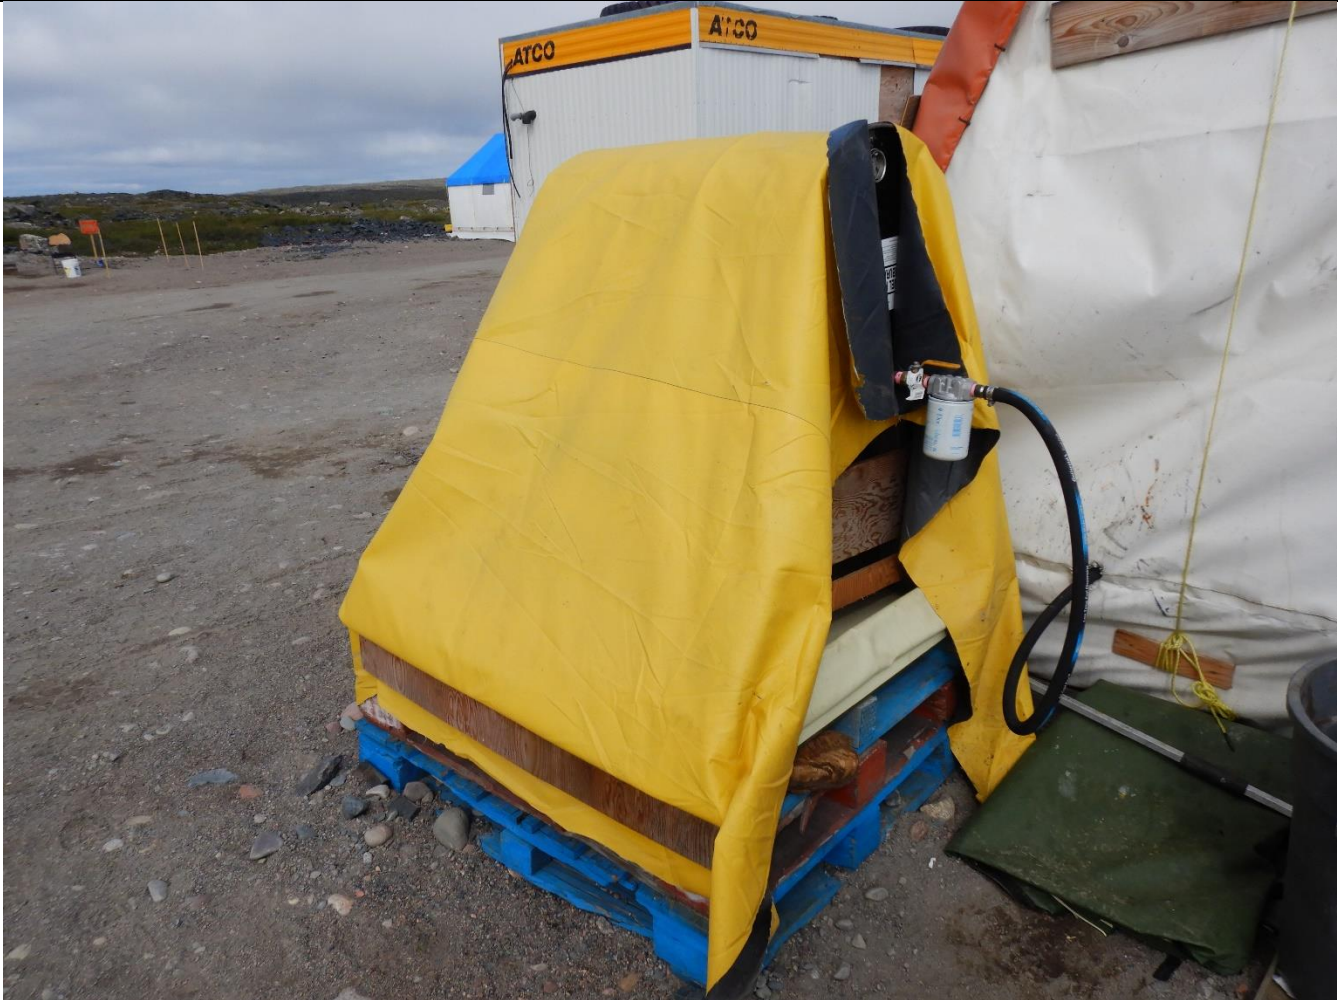
Photo 27

Very Nice Secondary Containment found on most Tent Structures within Camp! The Inspector has NO Concerns about this at this time

Description: Typical Secondary Containment of Fuel Drum outside most Tent Structures – Very Nice

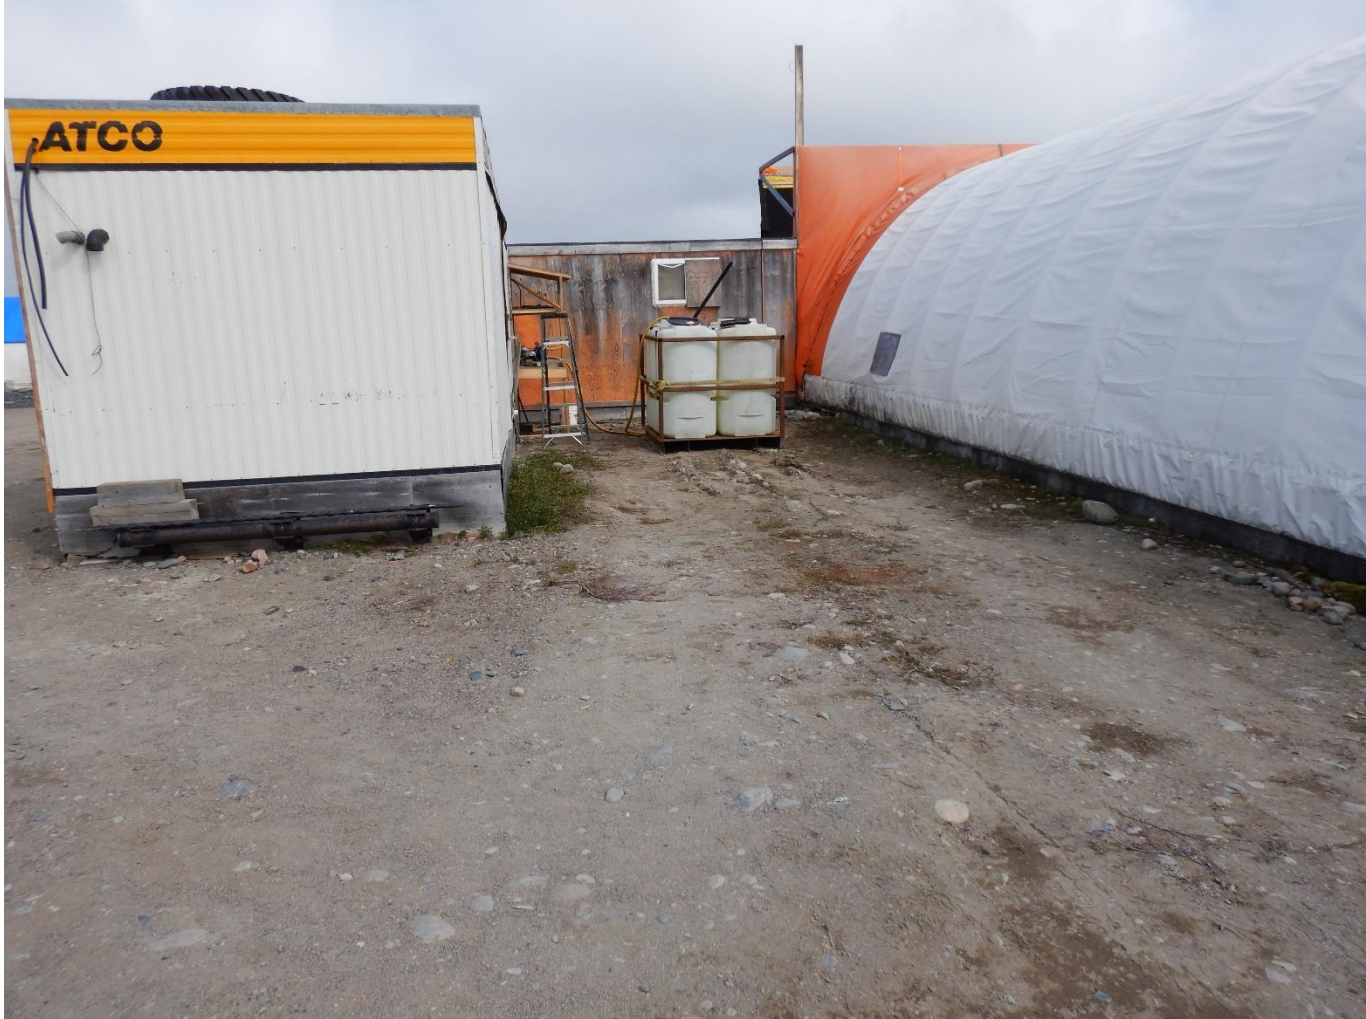
Photo 28

3 Water Tanks are located inside the White ATCO Trailer used for storage of Potable Water. The 2 White Tanks outside the Trailer are used to haul the Water up from the Source at West Lake

Due to COVID Restrictions at the time of this Inspection, the Inspector was not able to see inside this building. The Inspector does confirm that Darren Lindsay did provide email photos of the interior of this building right after the Inspection was completed. The Inspector has NO Concerns about this at this time

Description: Water Tank Building (white Trailer on Left) with 3 Tanks inside, 2 Tanks shown outside are for hauling water from the lake

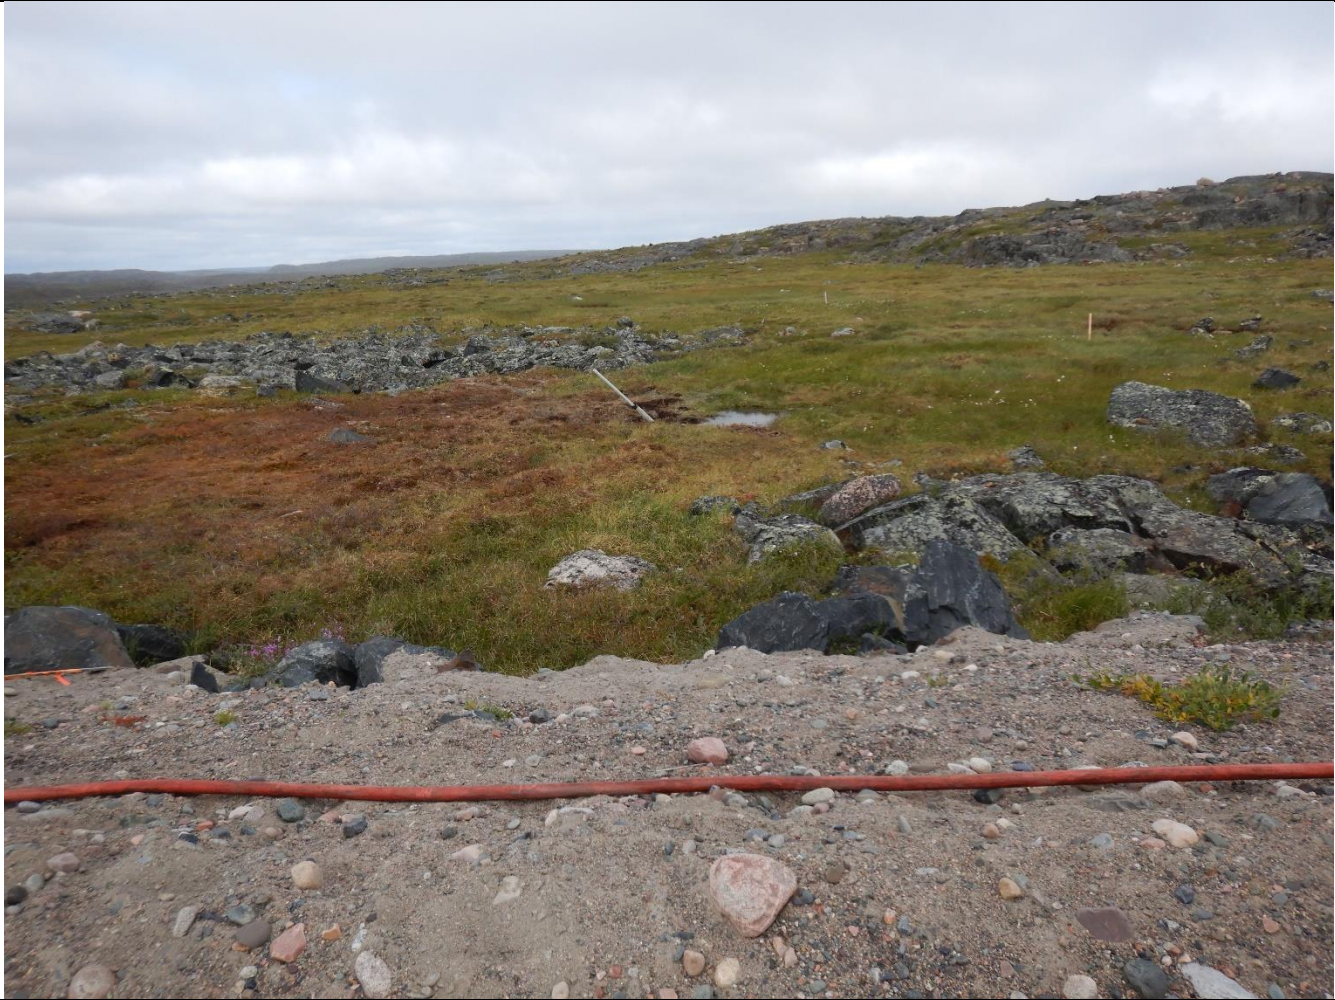
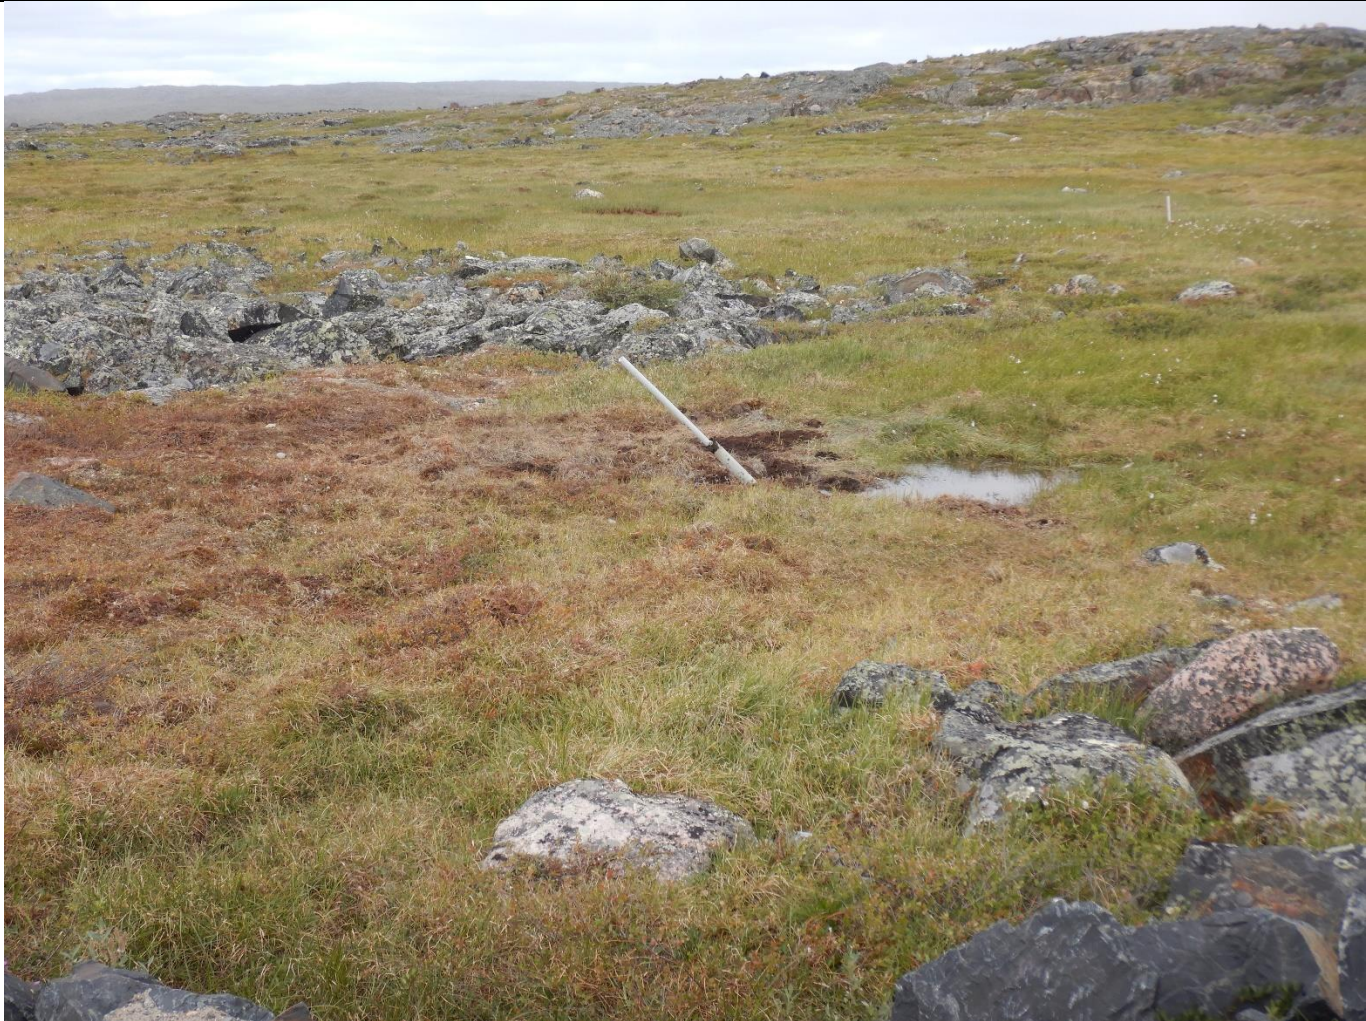
20 Drill Hole used this year in 2021 (Photos 29 & 30)

Site of First Drill Hole used this season

Description: First Drill Site from this 2021 Season – View 1

Description: First Drill Site from this 2021 Season – View 2

The Drill Adit must be Cut Off as close to the ground as possible and Capped this season before Camp Closure

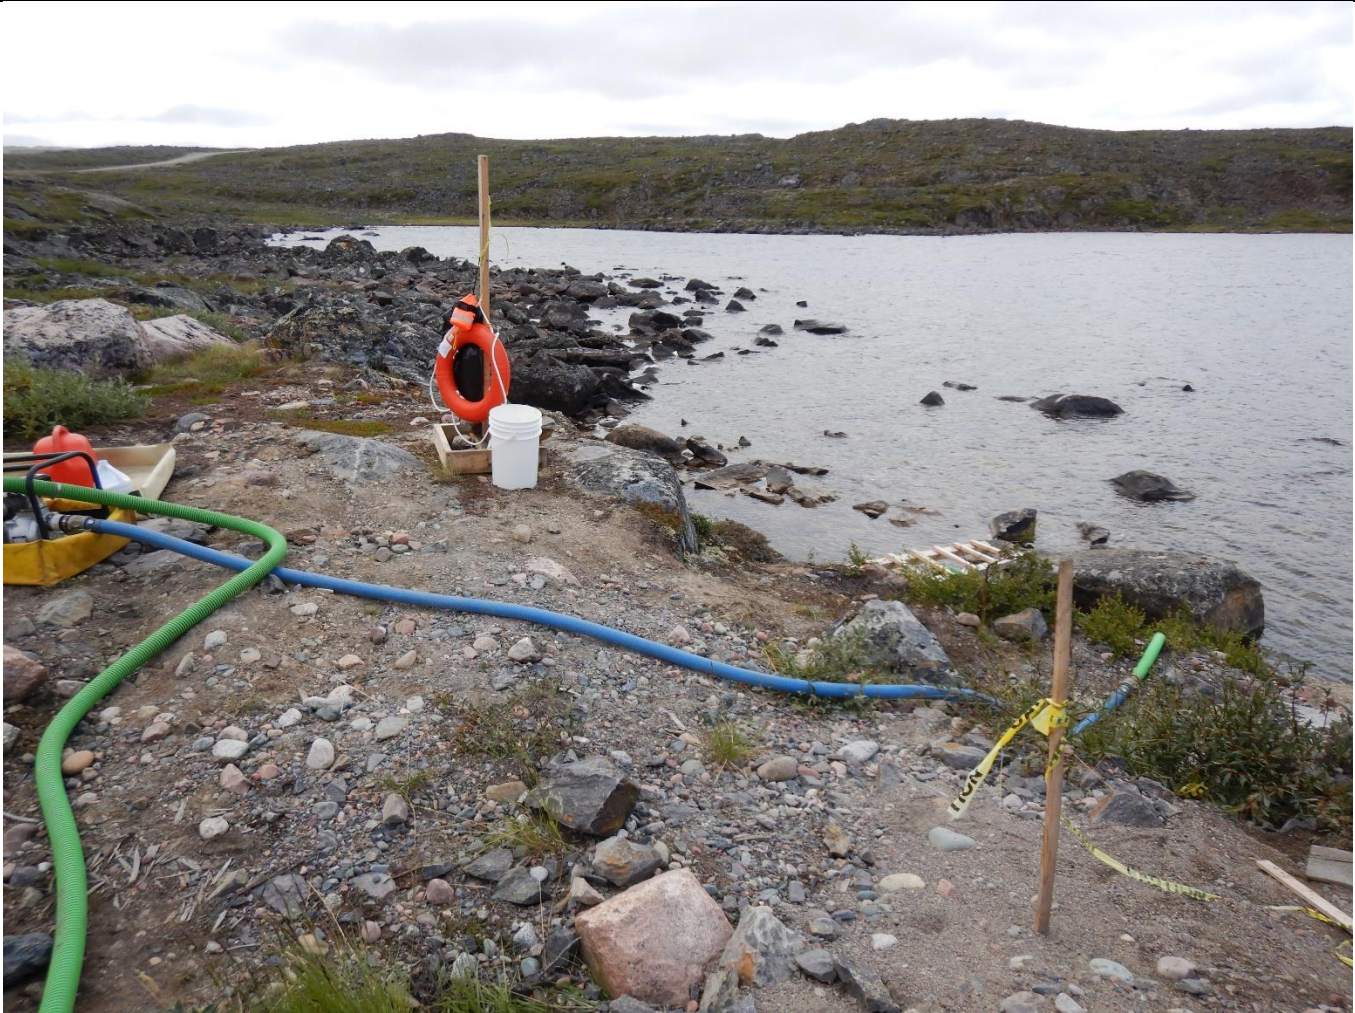
Photo 31

West Lake Water Intake Site for Potable Water. There is NO Signage. Water is Metered inside the Camp Water Storage Building

Description: Sample Station ULU-1 (a-for Camp Use), Water Intake at West Lake – NO SIGNAGE

**All Water Use MUST be Metered AT THE SOURCE. Daily records must be kept and made available to the Inspector upon request
Appropriate Signage must be installed this season before Camp Closure**

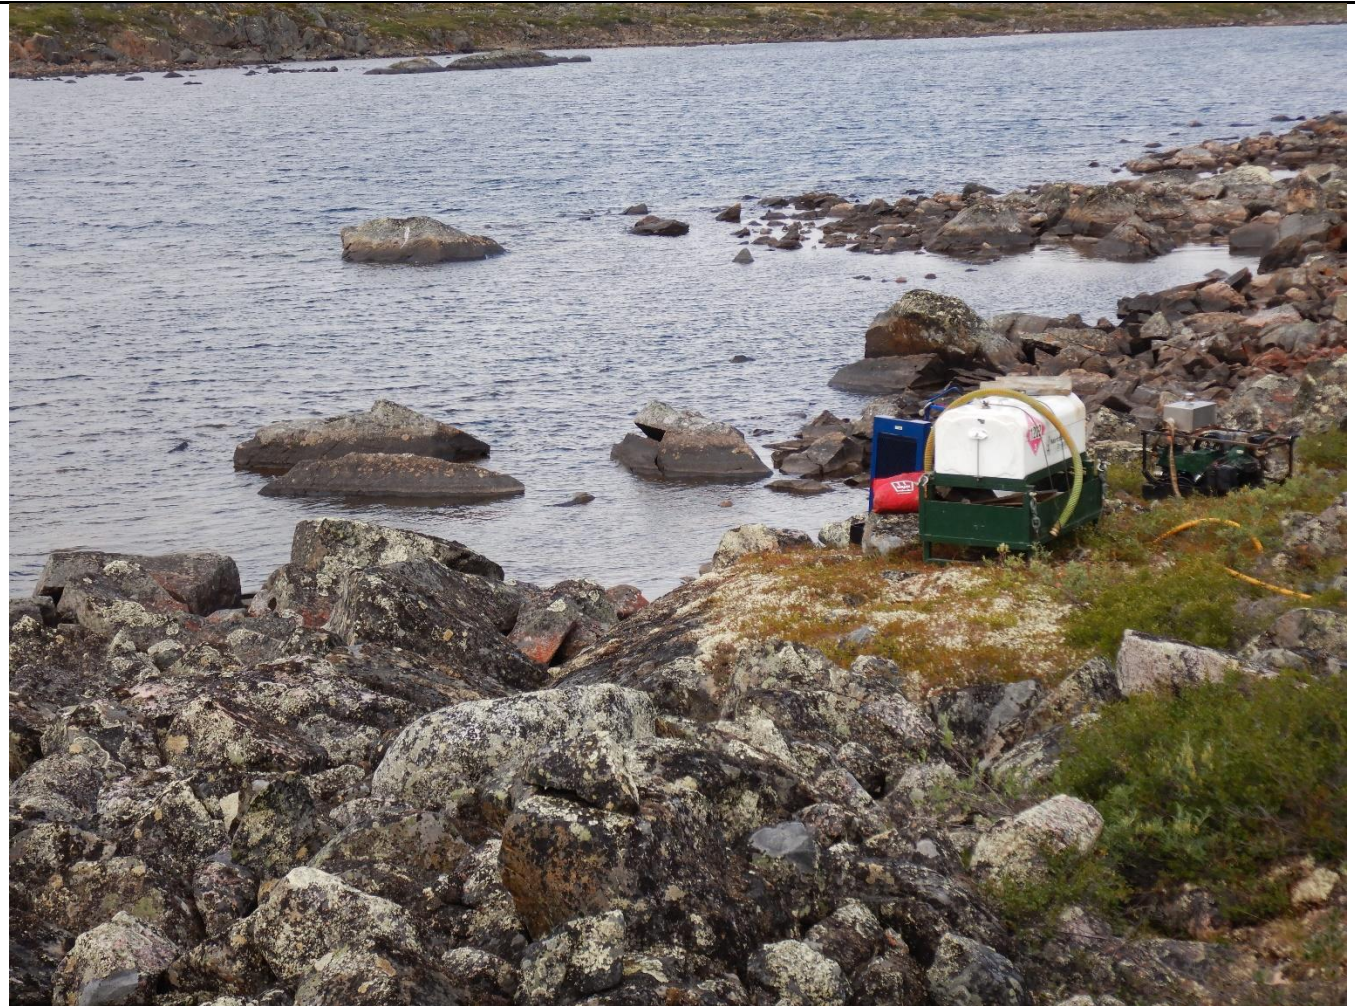
Photo 32

West Lake Water Intake Site for Drill Use. There is NO Signage. Water is Metered at the Drill Site

Description: Sample Station ULU-1 (b-for Drill Use), Water Intake at West Lake – NO SIGNAGE

**All Water Use MUST be Metered AT THE SOURCE. Daily records must be kept and made available to the Inspector upon request
Appropriate Signage must be installed this season before Camp Closure**

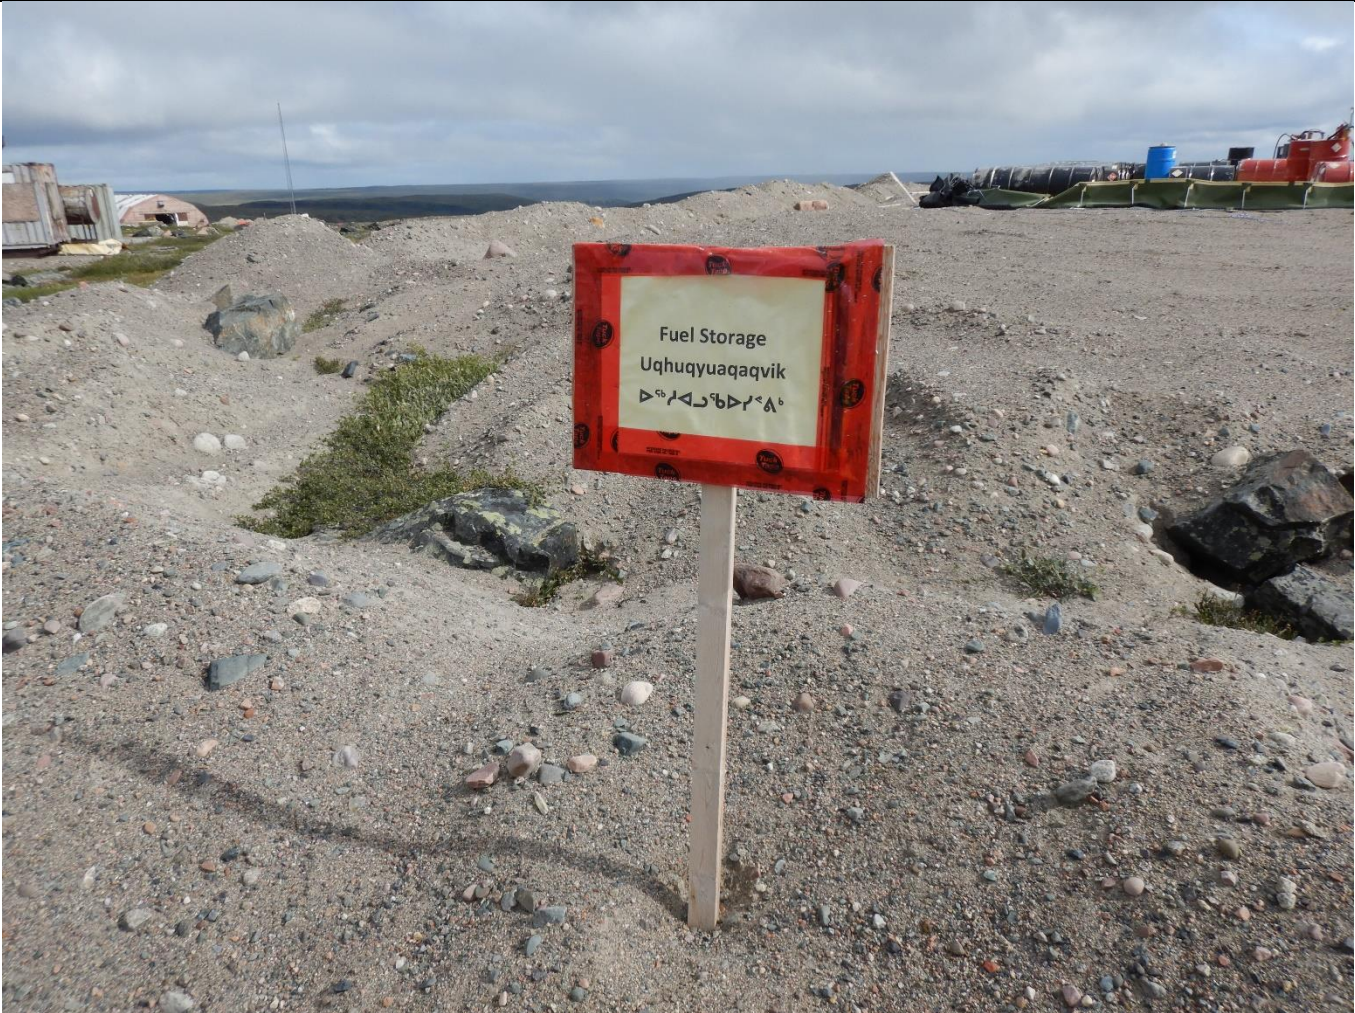
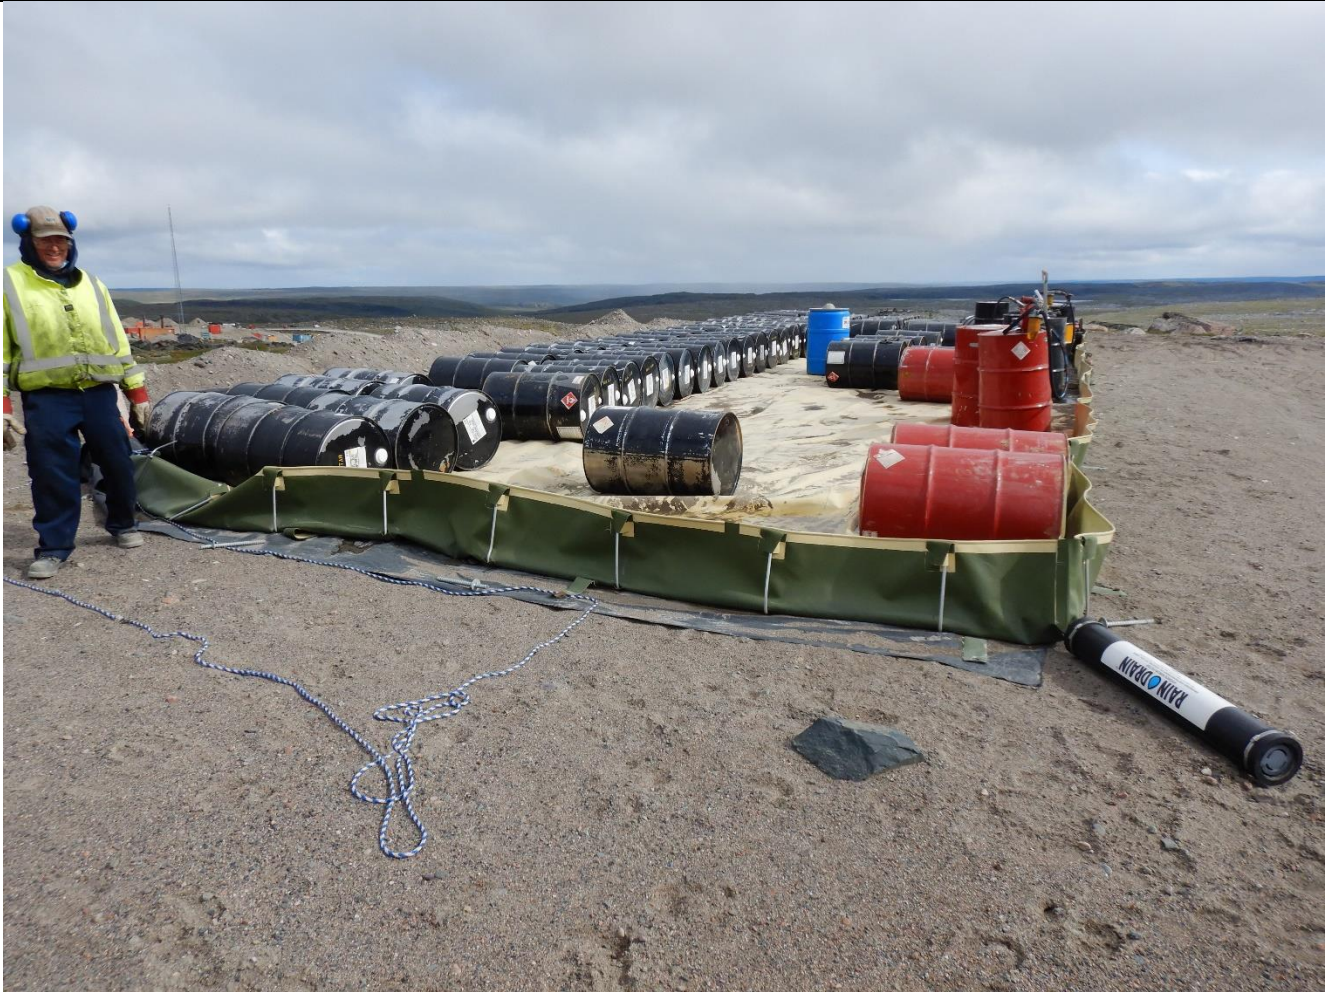
23 Camp Fuel Cache and Signage (Photos 33 & 34)

In Camp Fuel Storage Area within Secondary Containment and Signage for same. Contains 68 Drums of Diesel and 2.5 Drums of Gas

Description: Signage at In-Camp Fuel Storage Area

Description: In-Camp Fuel Storage Area containing 68 Diesel Drums and 2.5 Gas Drums

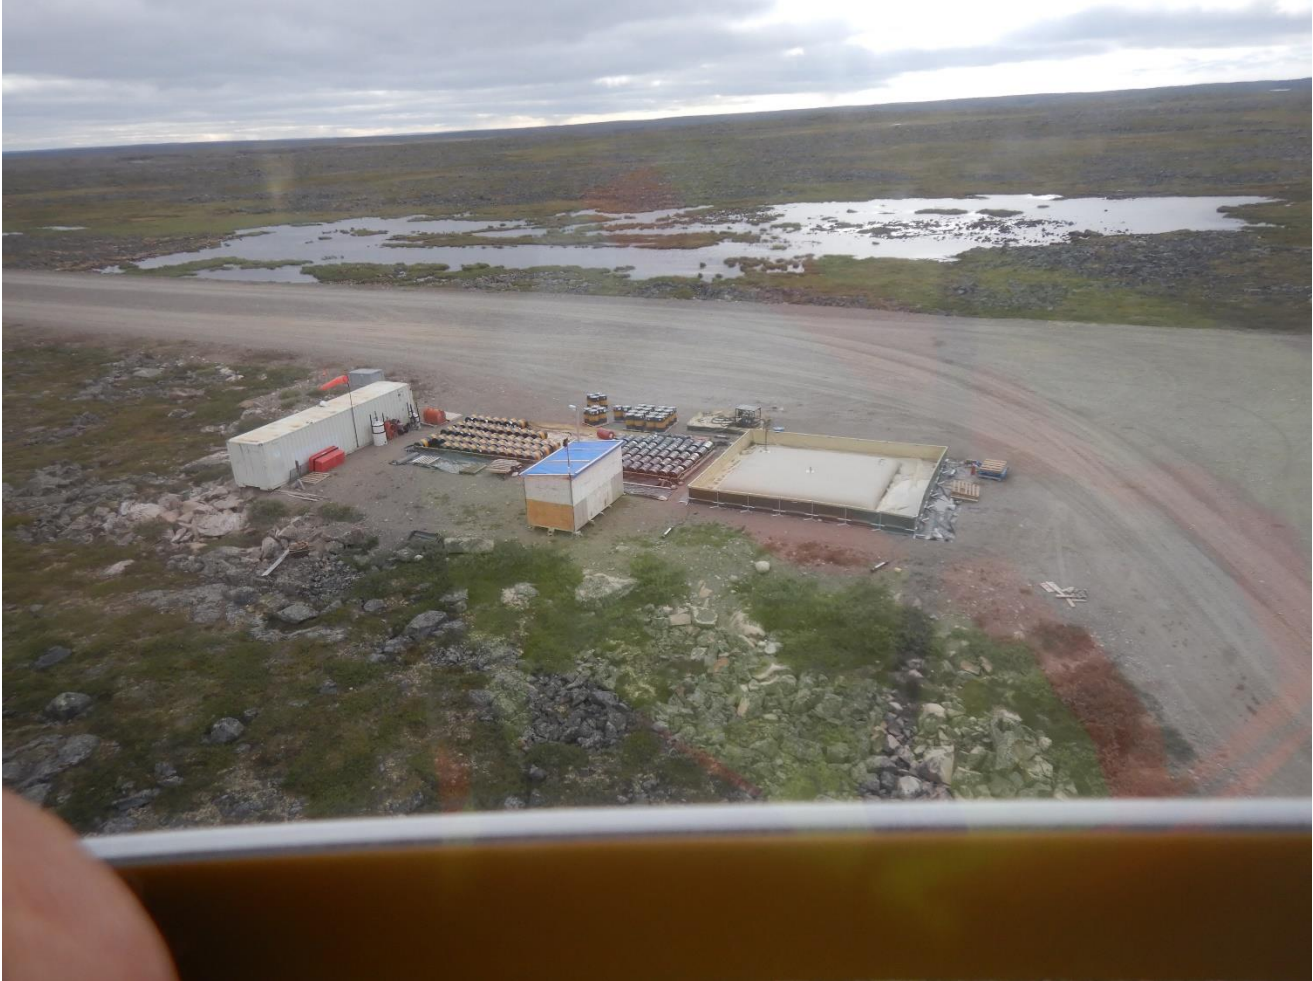
Photo 35

Aerial View of Airport Fuel Storage Area within Secondary Containment. Bladder contains about 31,000 Litres of Diesel. Drums include 64 Diesel, 84 Jet-A and 1 Gas

Description: Airport Fuel Storage Area – Bladder contains about 31,000 ltrs of Diesel, Drums = 64 Diesel, 84 Jet-A and 1 Gas

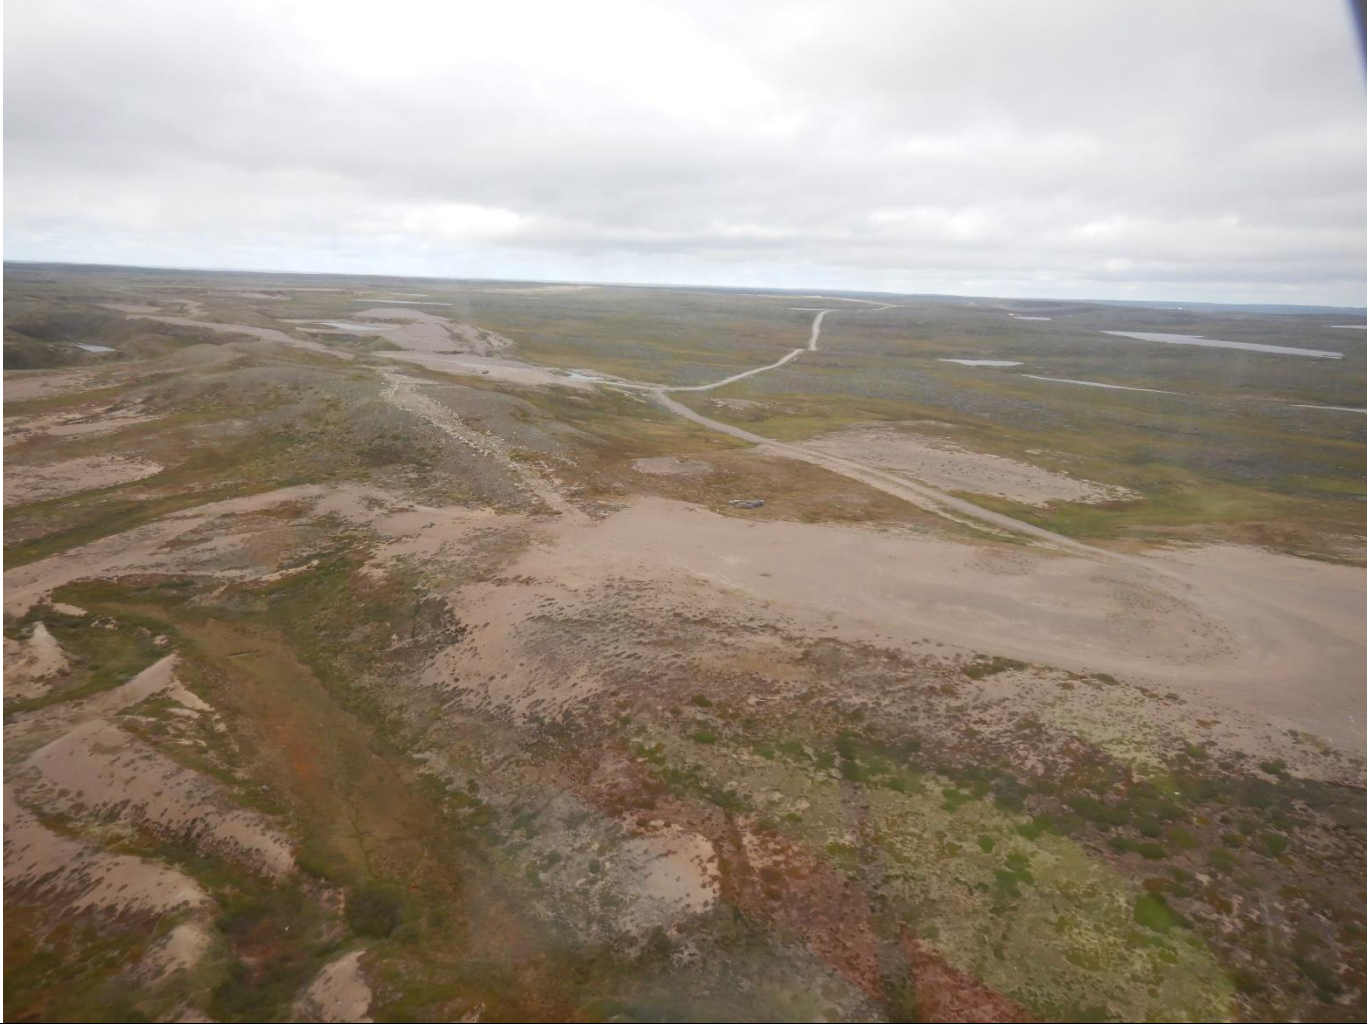
Photo 36

Aerial View of the old Camp Site area and active Gravel Borrow Source area

Description: Aerial View of Old Camp Area and Active Borrow Pit
