**RE: Echo Bay Mines Ltd., Lupin Gold Mine, Contwoyto Lake, NT.; Water Licence
No. NWB1ULU0008; 2002 ANNUAL REPORT - ULU PROJECT**

2002 ANNUAL REPORT

ULU PROJECT, NUNAVUT

WATER LICENCE NWB1ULU0008

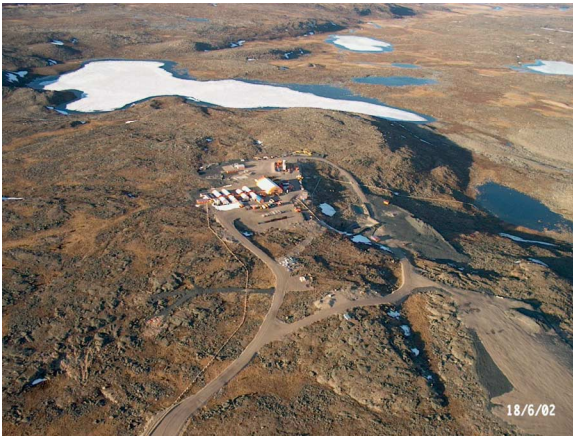
Photo 1 - Ulu site; aerial

- Camp 3; a section of the shop roof had blown off, laying around the site. The was the same area of the shop that was repaired in 1999.
- The airstrip had a washout on the east side, about 300 metres from the south end stretching about 1/4 way across the strip. A number of potholes were also observed.
- Three DIAND barrels were still on the west side of the airstrip. A number of 'non' EBM barrels were located near the lakeshore of Reno Lake.
- The Ulu camp tankfarm contained some water, contaminated with minor amounts of fuel (see photo 1). This was noted and would be checked upon return visits later in the summer.

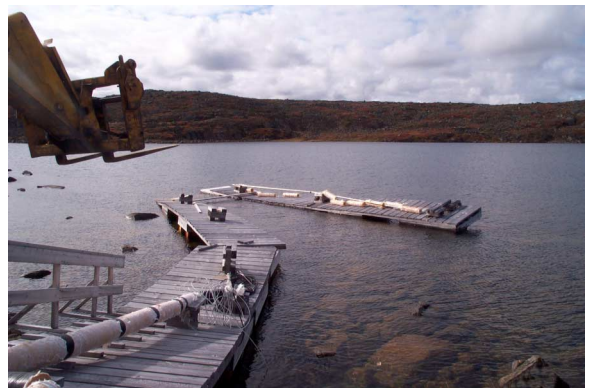
- A new communications tower was erected by Prostruct Construction while on site. (See Photo 3)
- Replaced all damaged or missing insulation on the water line. It was noted that the water level of the lake has gone down 12-14 inches and some of the floatation barrels were punctured by rocks and were badly damaged. (Photo 4)

Photo 4 - Ulu site; Potable water line
Dock, line was removed.

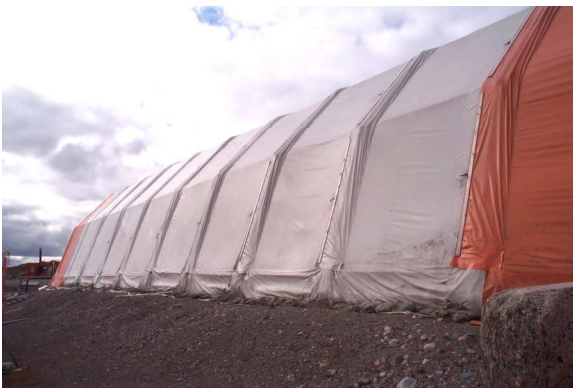
Photo 5 - Ulu site; Repaired shop (2001)

- The Weatherhaven shop was inspected by Weatherhaven staff and EBM maintenance personnel and determined that no further repair work was required at this time. (see photo5)

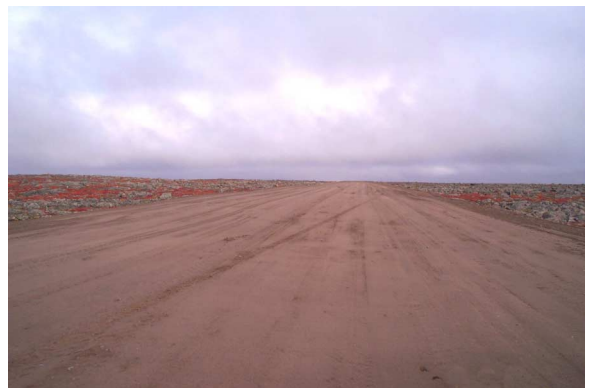
Photo 6 - Airstrip graded and packed

- Roads and the Airstrip were gravel filled, graded and packed to minimize erosion over the next winter/spring season. (Photo 6)
