# **Canada – Ulu Advanced Exploration Site NWB Water License No: 2BM-ULU0914 2010 Annual Report to the Nunavut Water Board**

# 2010 Annual Geotechnical Inspection Various Earth Structures Ulu, Nunavut

**2010 Annual Geotechnical Inspection  
Various Earth Structures  
ULU Mine, Nunavut**

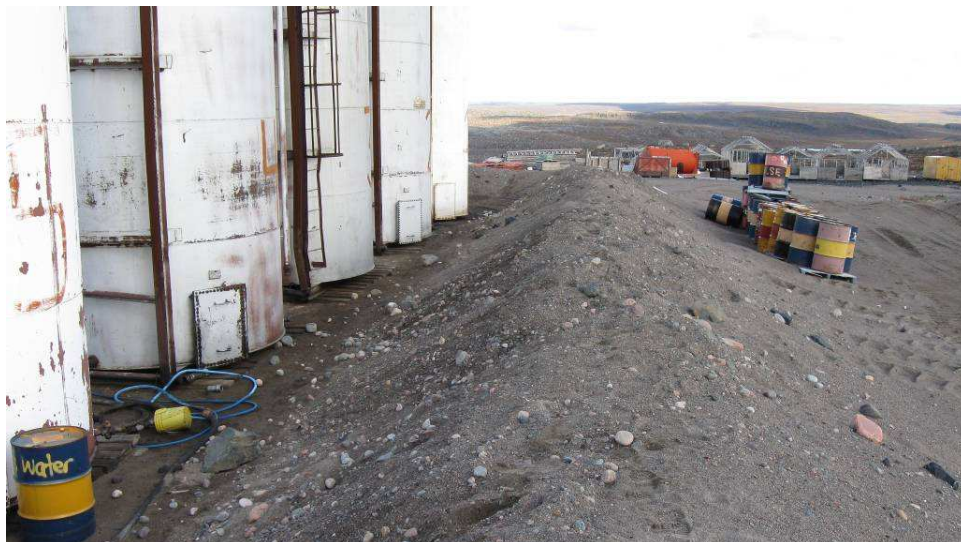
Exterior Berm

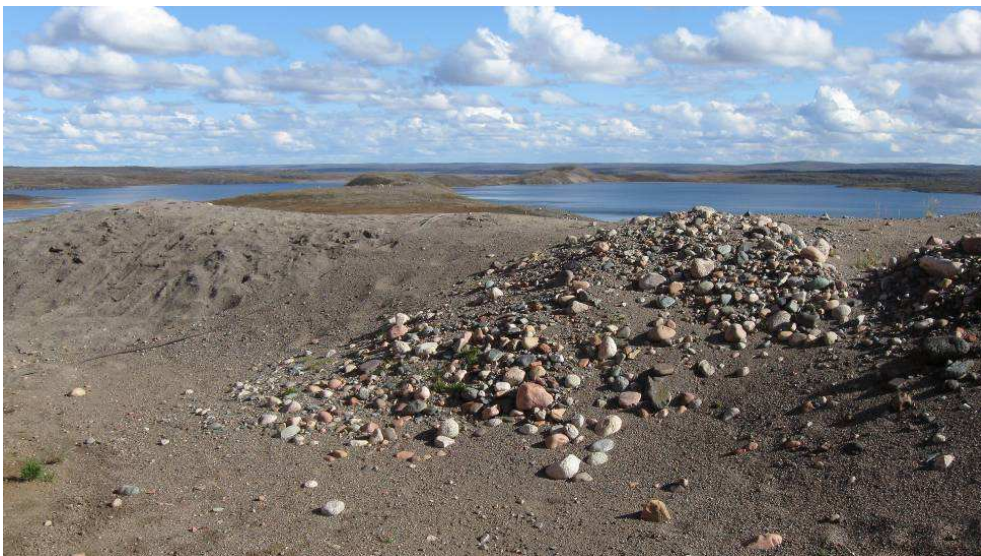
Last Year Exposed Liner – Now Covered

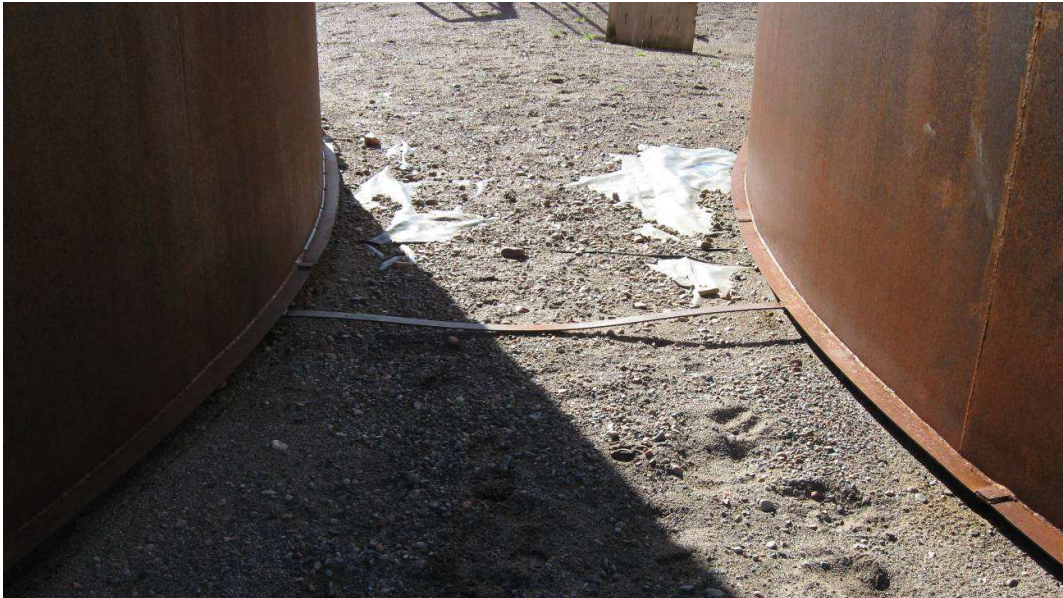
Exposed Liner Between Tanks

<b>SEEPAGE:</b>	No evidence of seepage observes at the berm toe.
<b>MAINTENANCE/MONTORING RECOMMENDATIONS:</b>	Two areas of exposed liner should be recovered with granular fill. The one area of cut slope near the toe and the one erosion gully should be repaired.
<b>CONCLUSIONS:</b>	The berm appears in generally satisfactory condition. See above maintenance items. The leaning tank should be repaired

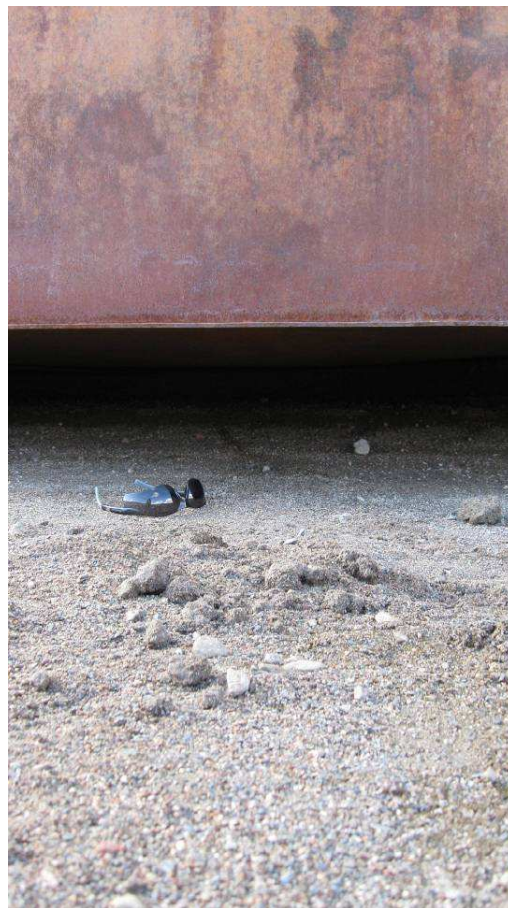
Gap below tank

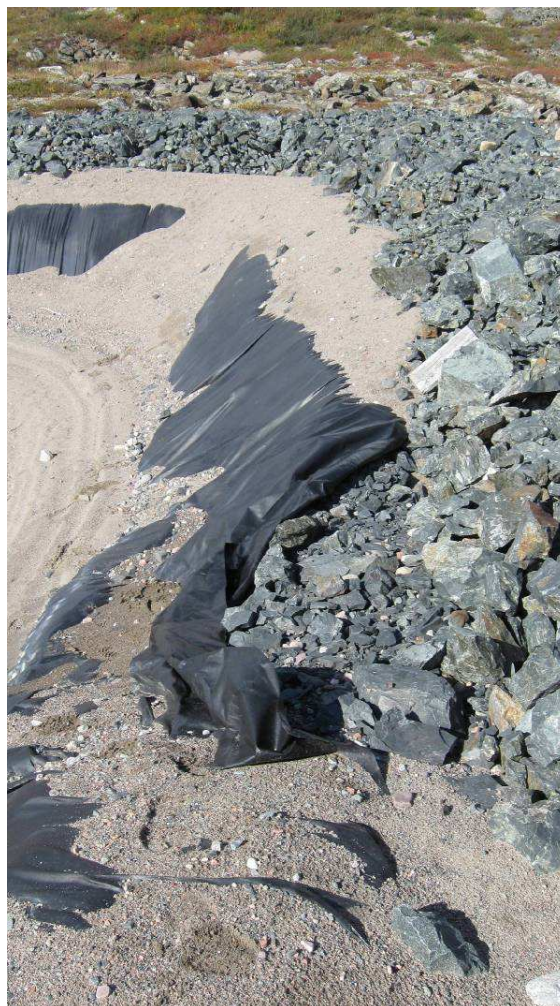
Exposed and Loose End of Liner

<b>CONCLUSIONS:</b>	The berms are suitable for the interim. Before the sump is put back into use, the liner and slopes must be repaired.

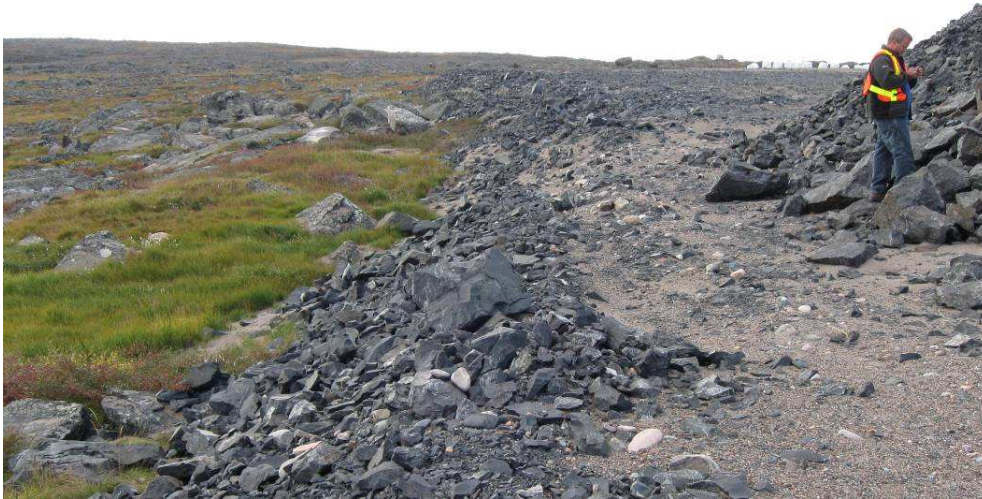
<b>CONCLUSIONS:</b>	The pad appears stable with no signs of erosion or instability.

Storage Pad Outside Edge
