Re: 2014 Annual Report: Ulu Advanced Exploration Project Type B Water Licence
 (2BM-ULU0914).

2BM-ULU0914 2014 Annual Reporting: Part B, Item 8 Requirement

Compilation of Inspection Reports, Responses and Photos

Appendix A: Photo Log

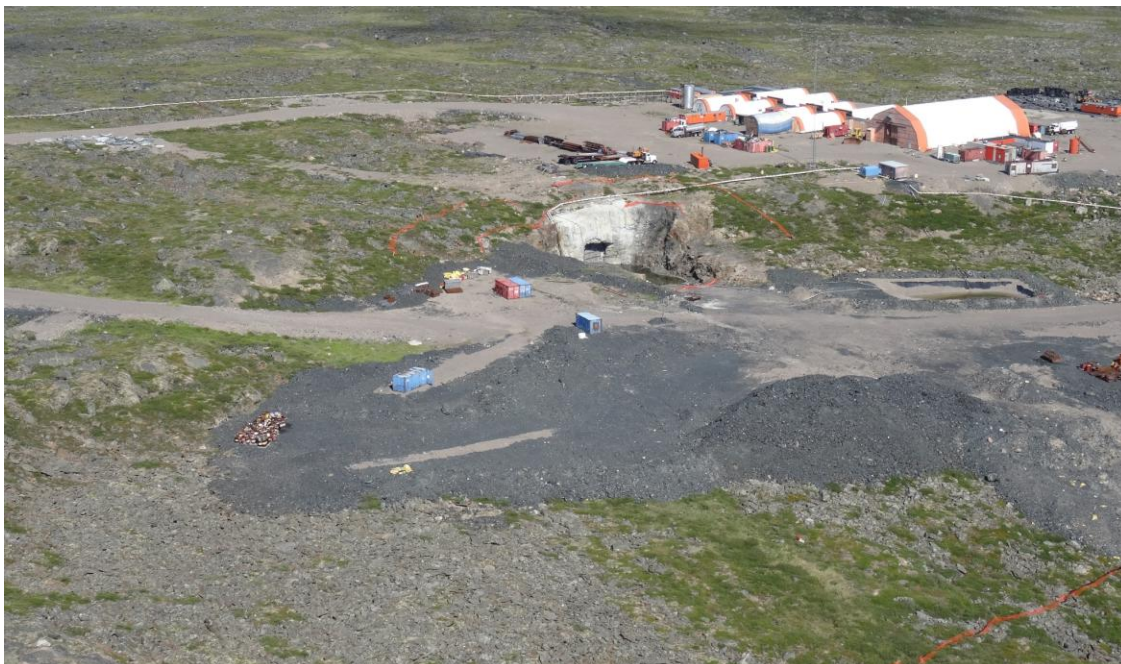
Figure 2. Barrels of waste noted on Mine Waste Pad.

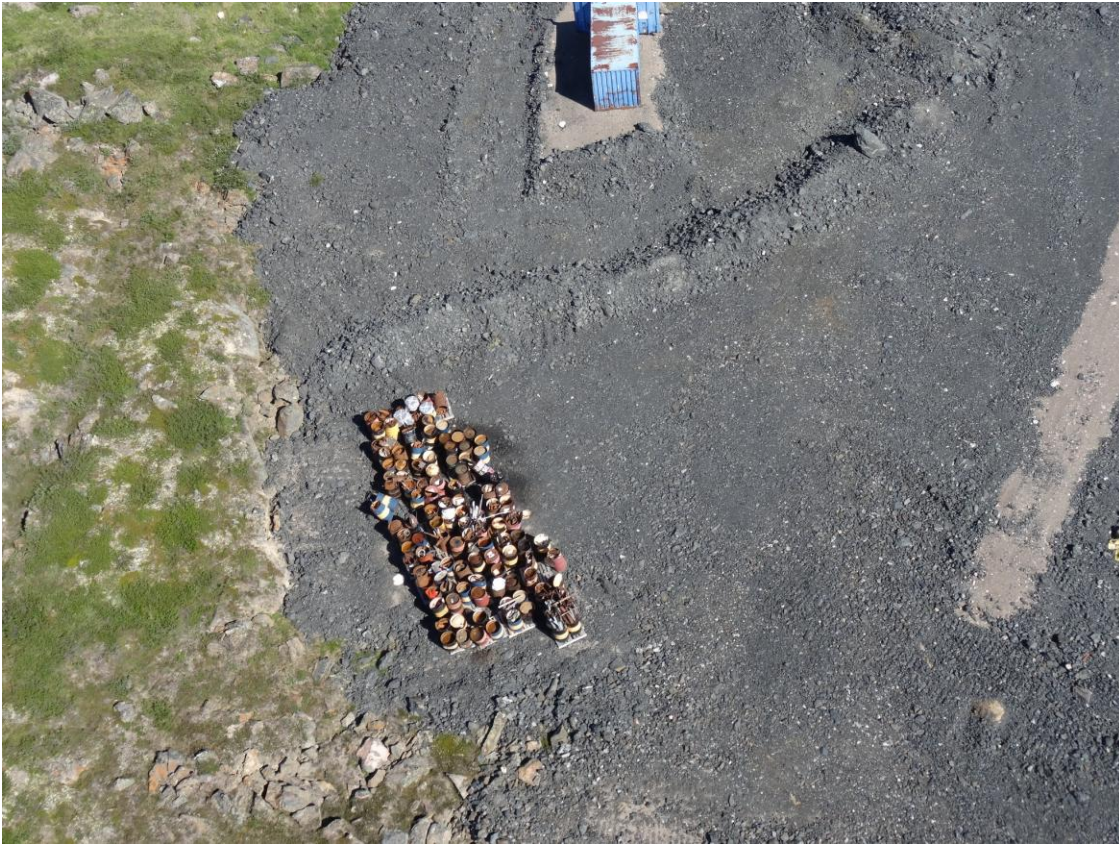
Figure 3. Barrels of waste on Mine Waste Pad. Staining noted.

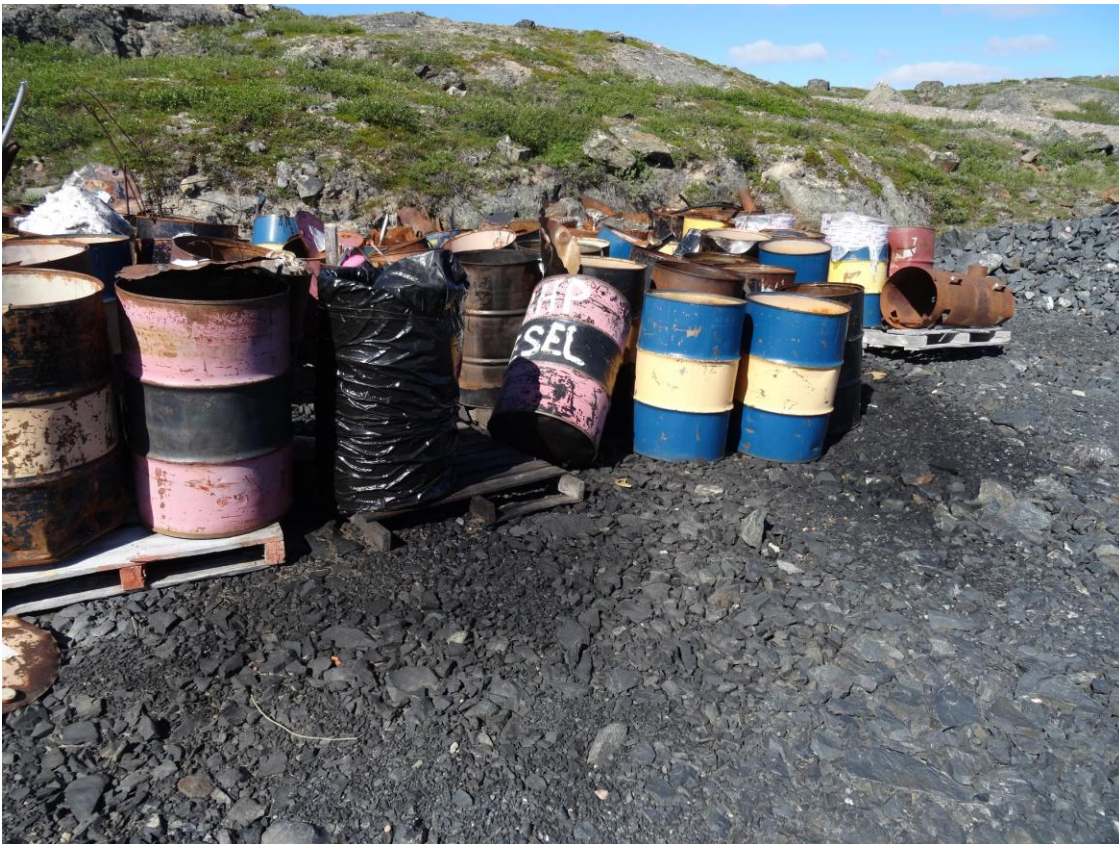
Figure 4. Barrels at Mine Waste Pad. Hazardous waste noted, with no containment.

The eleven barrels that were in the waste dump were moved to the containment area.
A number of oil spills were cleared up. The material is now held in six barrels that have been put into the containment area. We had planned some more work on this area but with the early snow we got what we could get done.
The ten barrels in the photos that were along the road by the airport have been moved to the containment area.
Since I had not gotten a response to my July 29th and 30th emails we were going to include the above within our annual report.
I hope this helps. Let me know if you need anything further. I also hope that you see that we did respond to your inquiries asap per the email chain below.
On another note I hope you have a great festive season and all the best for 2015.
Kind Regards
patrick

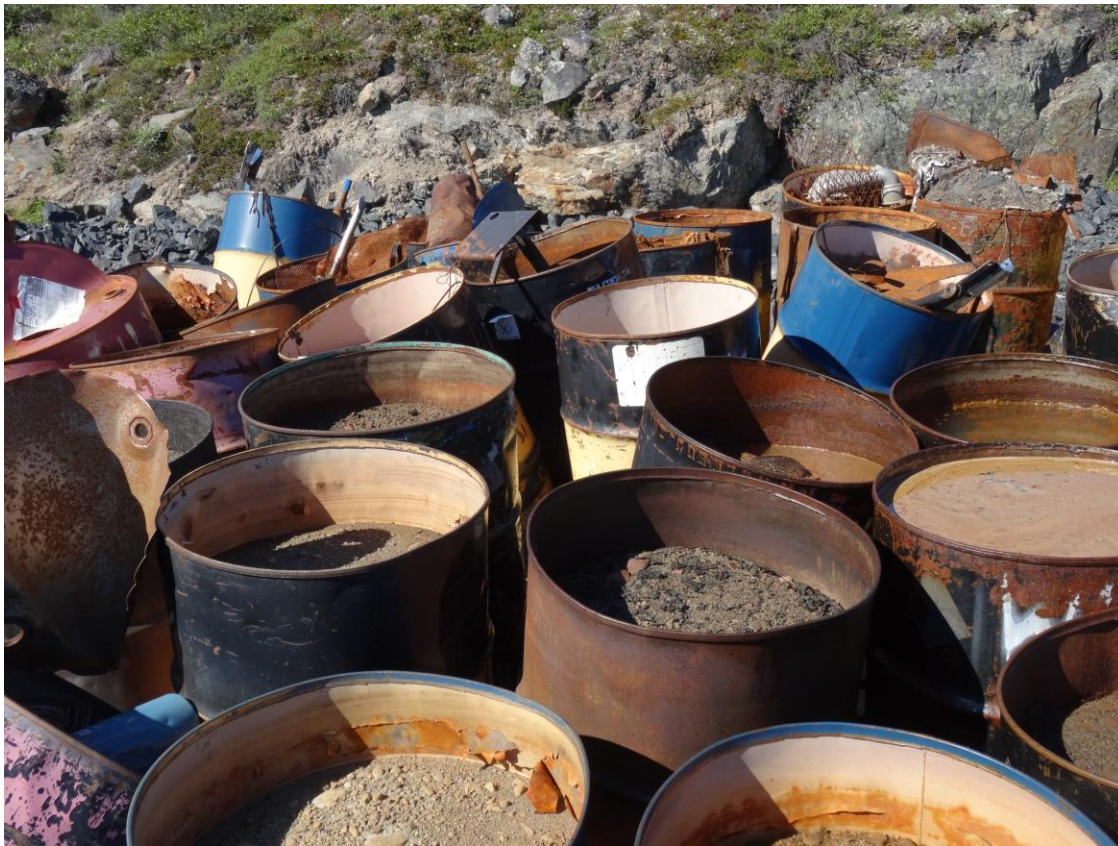
Figure 5. Contents of barrels at Mine Waste Pad consistent with hazardous waste.

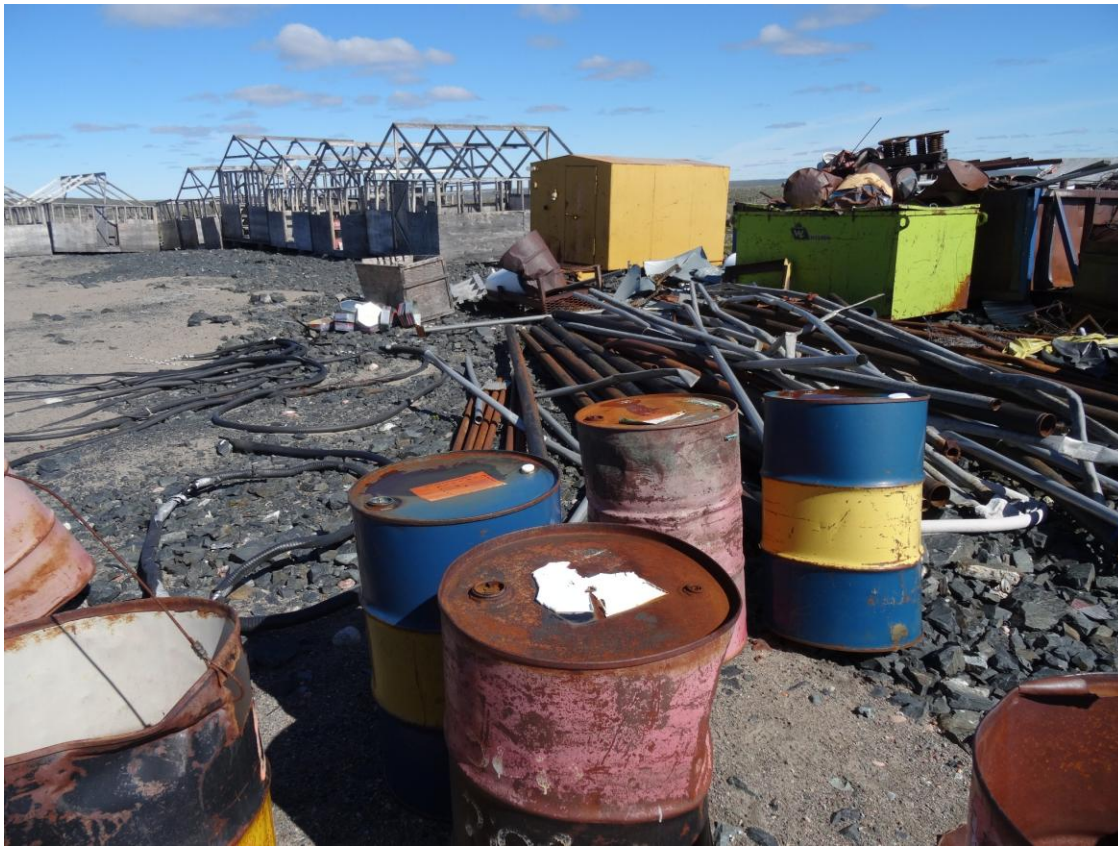
Figure 7. Barrels of unknown content found in waste piles to east of helipad.

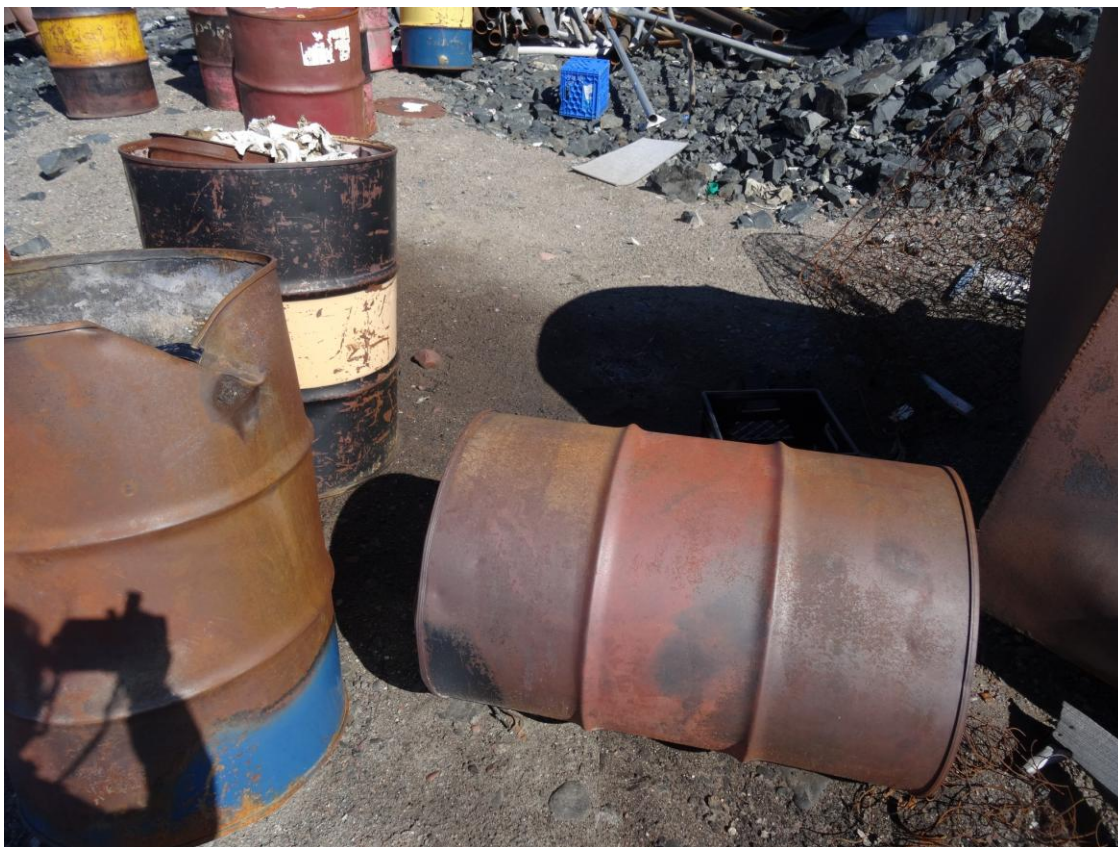
Figure 8. Staining noted from barrels to east of helipad.

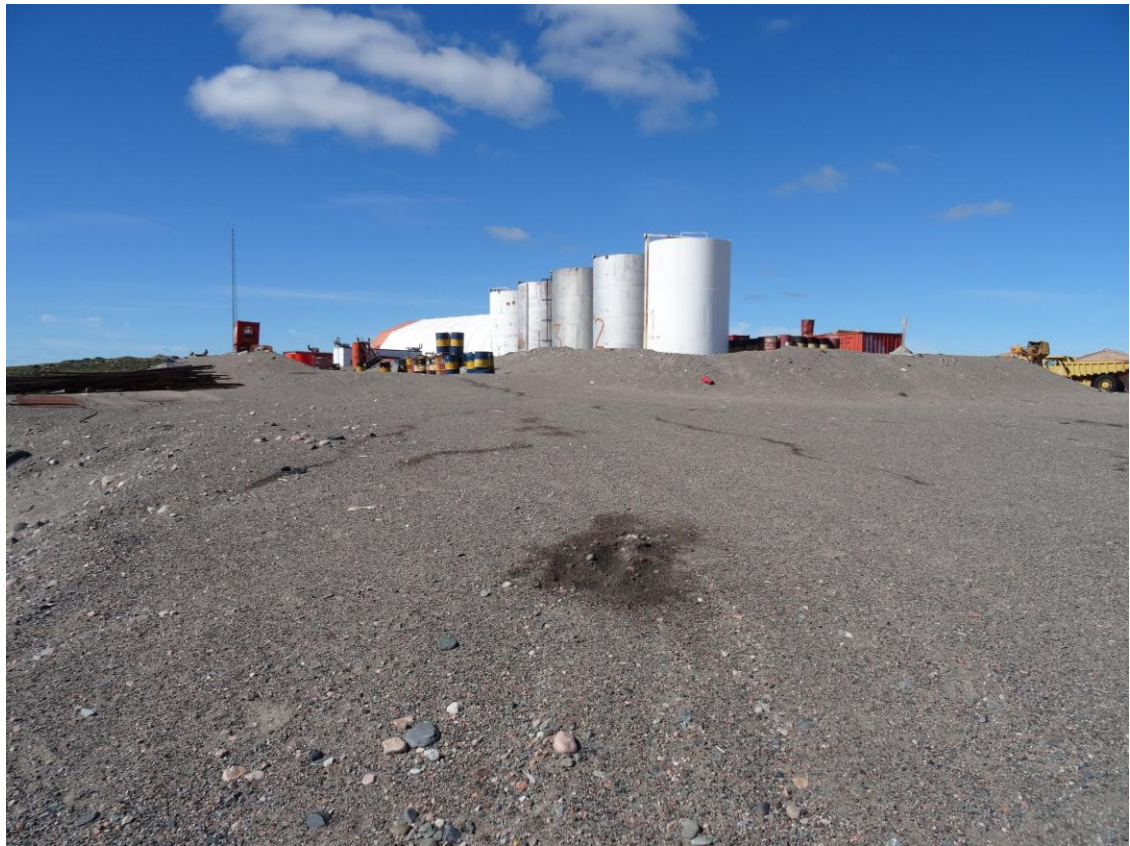
1. It does not appear that waste was backhauled since 2012. No records were provided in the annual report.
2. While the 2013 Annual Report indicates that drums and waste were addressed as per the 2013 Inspection report, however, I found hazardous waste in numerous areas without containment. It was not removed as indicated in the annual report. I found leaking barrels of hazardous waste on the mine waste pad, at the barrel storage area beside the tank farm, amid the waste piles east of the helipad and barrels at the airstrip which should have been removed in 2013. The waste management plan and the Care and Maintenance Plan indicate that hazardous materials are to be stored in containment until backhaul. The Spill Plan is not being followed, as spills are occurring which are not being addressed. Proper mitigation for spills is not being employed by lack of containment, monitoring, and clean-up. Spilled fuel is migrating out of the storage pad and down-slope.

Figure 9. Fuel/barrel storage area to east of tank farm. Note staining running downhill from the lined area.

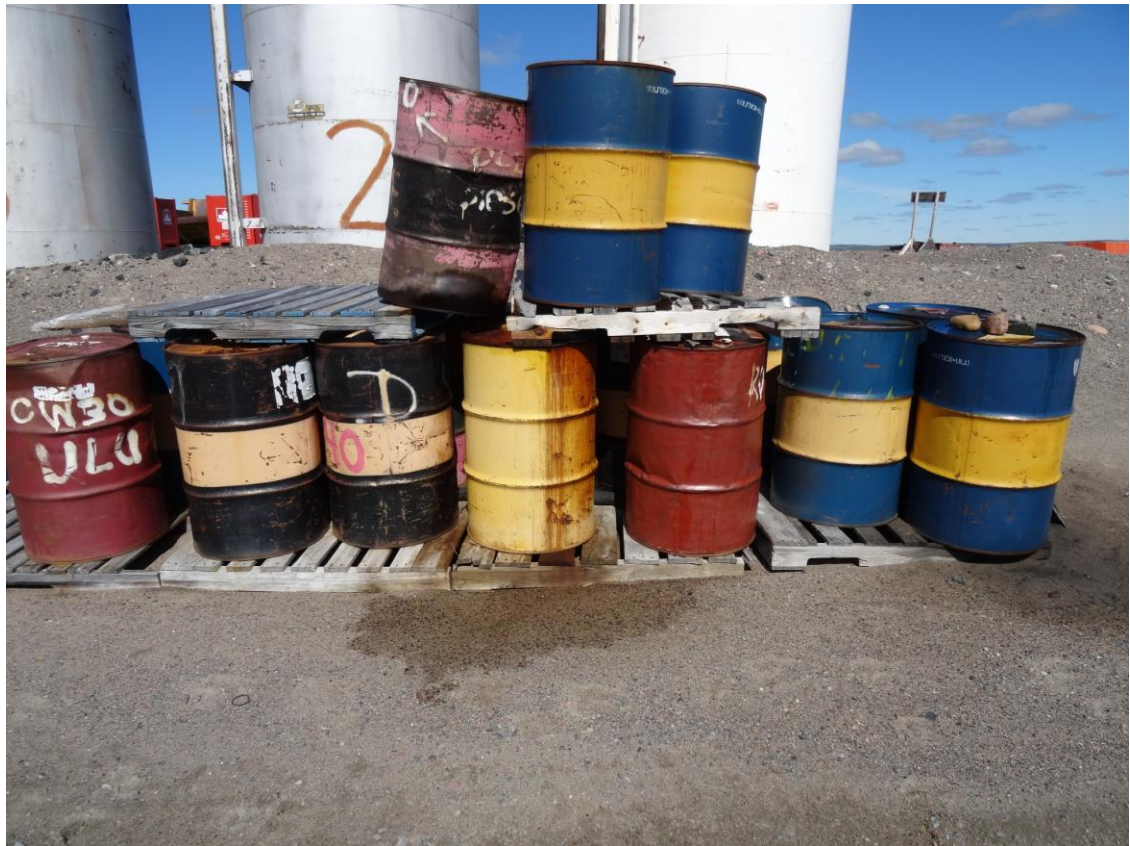
Figure 10. Several stains noted in the barrel storage area.

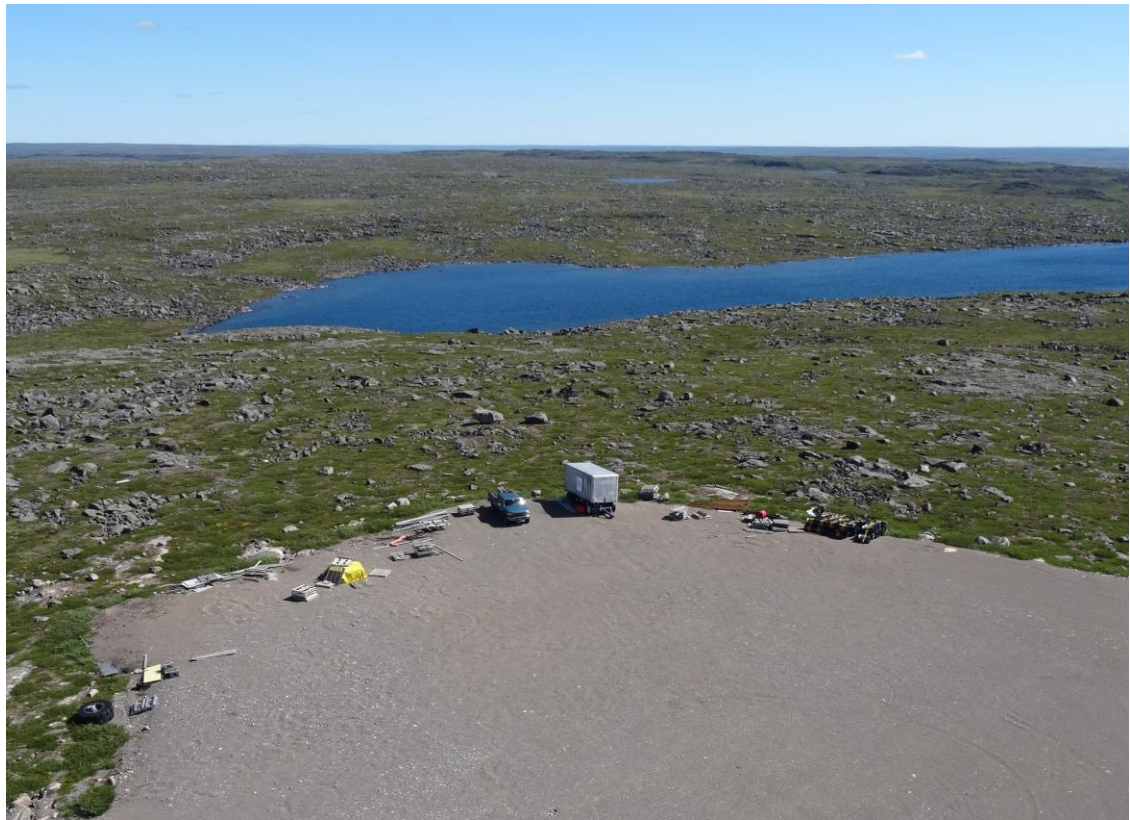
Figure 11. Airstrip apron. Yellow berm contains waste for backhaul. Other visible barrels are empty.

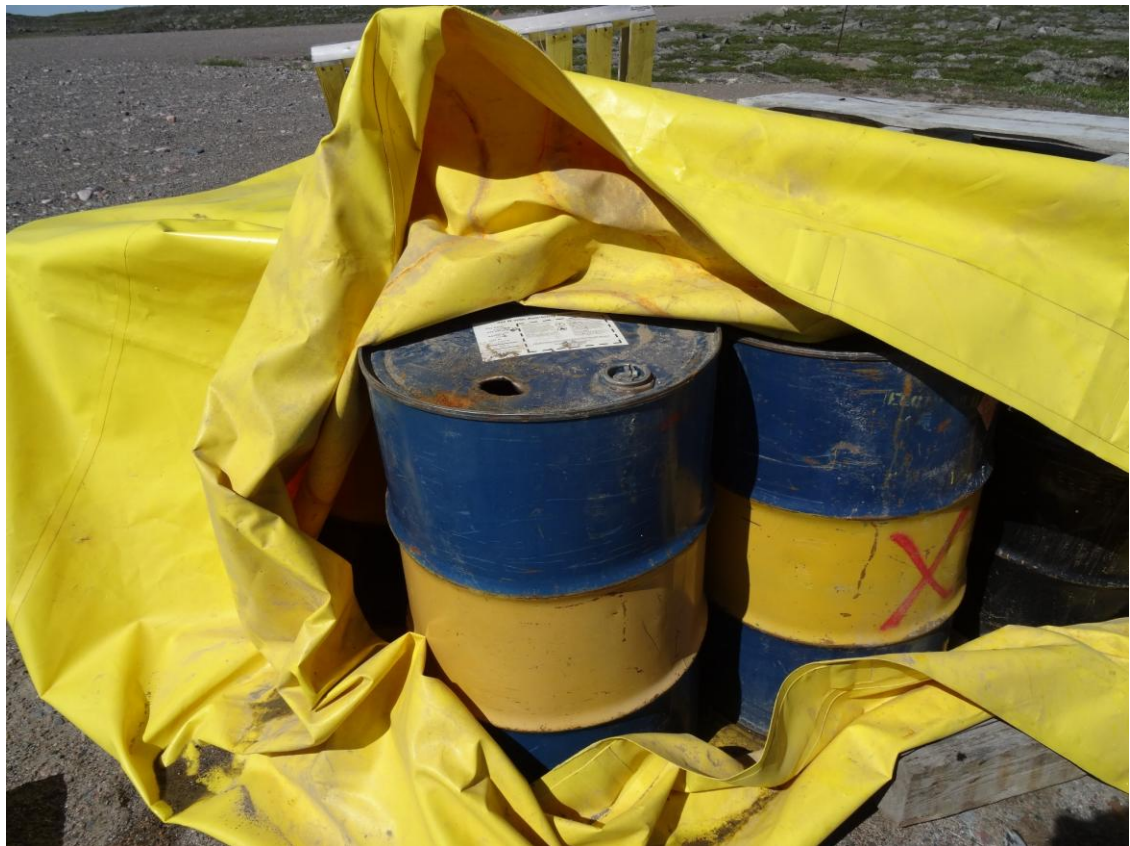
Figure 12. Yellow berm contains waste, including a punctured barrel.

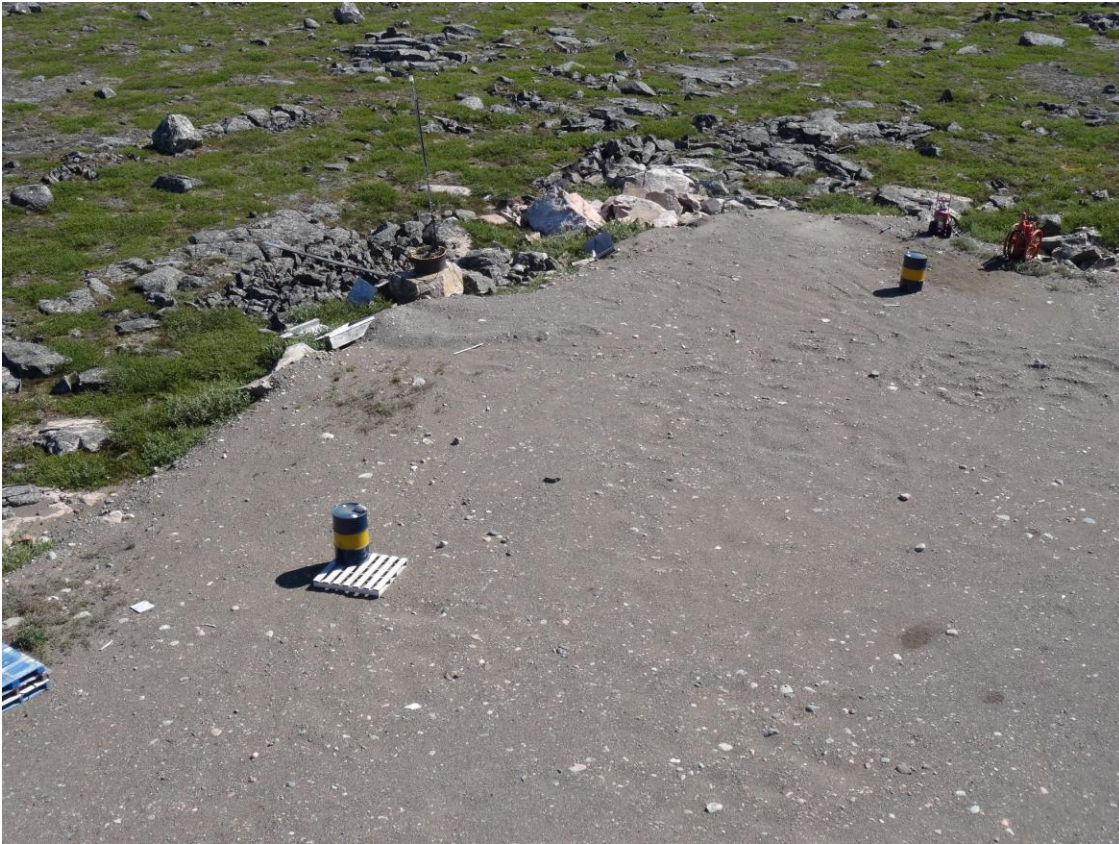
Figure 13. Opposite airstrip apron has full barrels of fuel, with no containment.

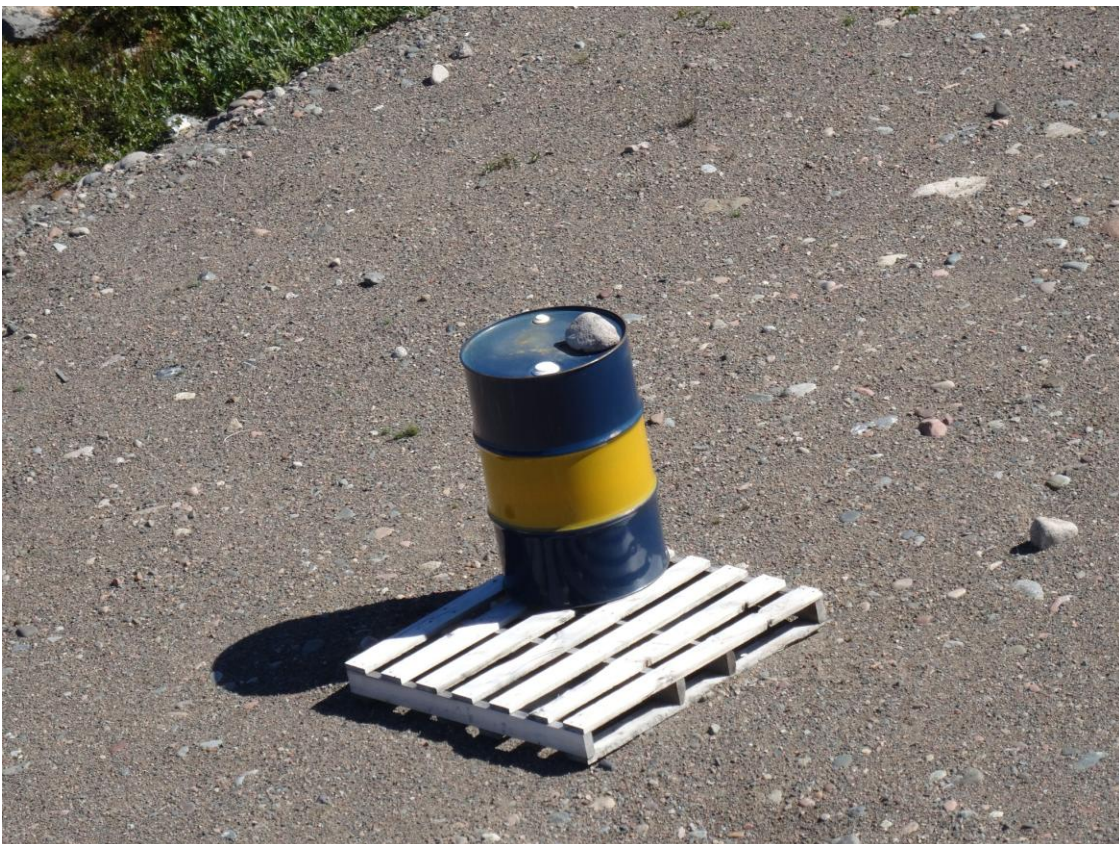
Figure 14. Caps on indicate full barrels.

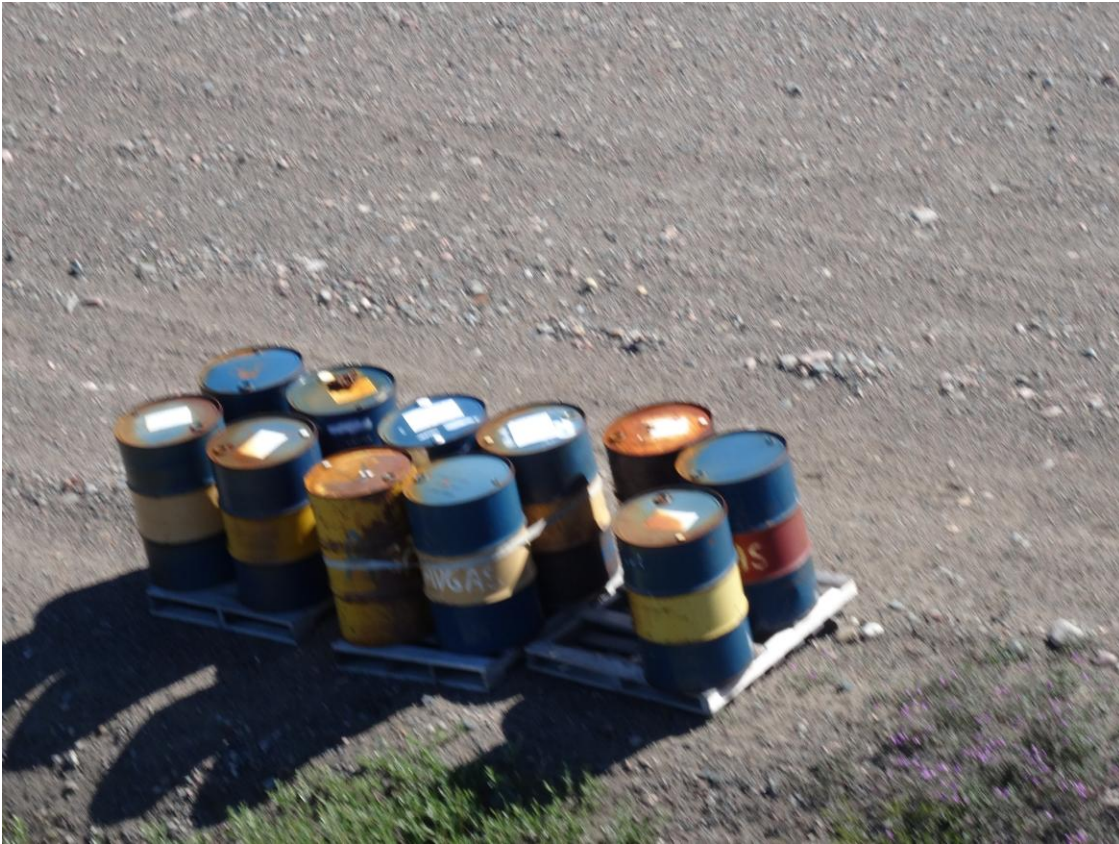
Figure 15. Barrels noted on pallets (without containment) on the roadside near the airstrip.

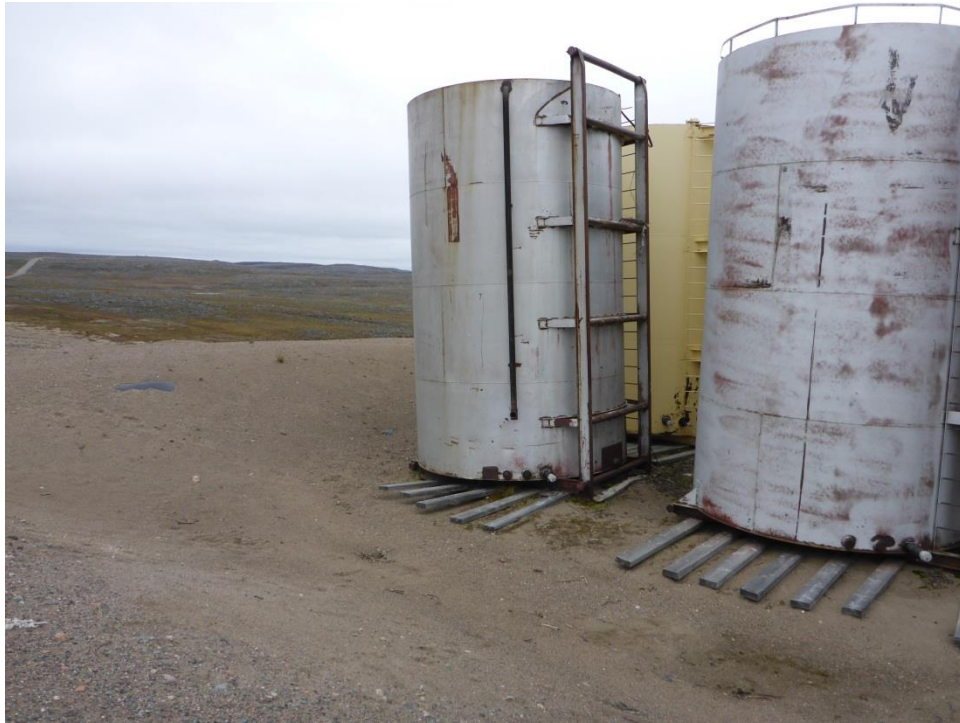
Similar to facilities at Ulu, minor damage was noted in the liner and left exposed from erosion. The main concern observed during the Camp 3 inspection is that three fuel tanks are leaning because of broken cribbing at their base. It is recommended that the cribbing be repaired. The tanks should be set upright and leveled to prevent toppling and damage to the tanks and containment berm. Alternatively, the leaning tanks could be decommissioned and removed from the containment berm. The fuel tank farm containment berm was generally in good condition with no visual stability concerns. The parts of the liner that are damaged should be repaired and covered with appropriate backfill.

Photo 1: Looking north at one of the leaning tanks in the front of the Camp 3 fuel tank farm.

The cribbing at Camp 3 tank farm will be repaired prior to any fuel delivery to the farm. Currently all the tanks in Camp 3 tank farm are empty.

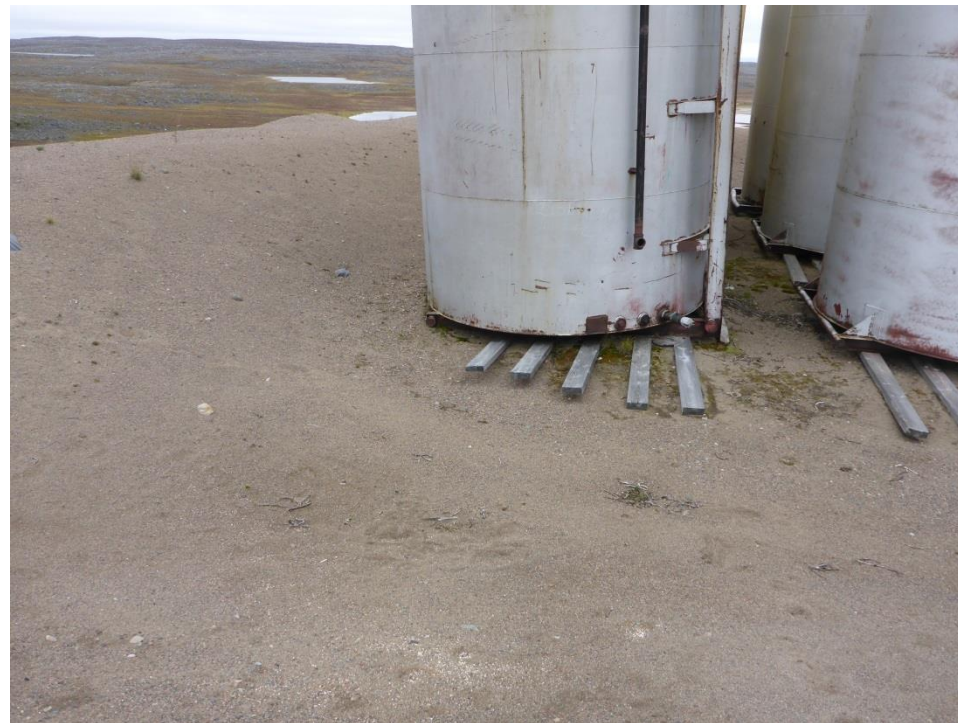
Photo 2: Close up view of the broken cribbing underneath the tank.

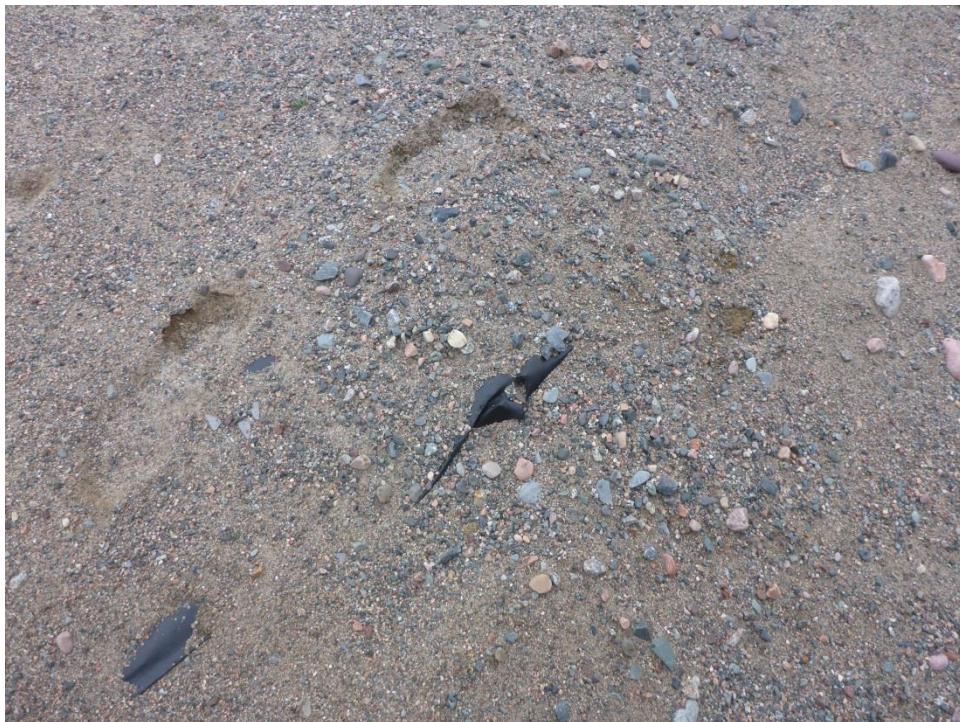
Photo 4: Close up view of the damaged liner in the southern bank of the Camp 3 fuel tank farm.

There are no issues requiring immediate attention identified in the report. The exposed and/or damaged liners will be covered and/or repaired in the 2015 summer season.

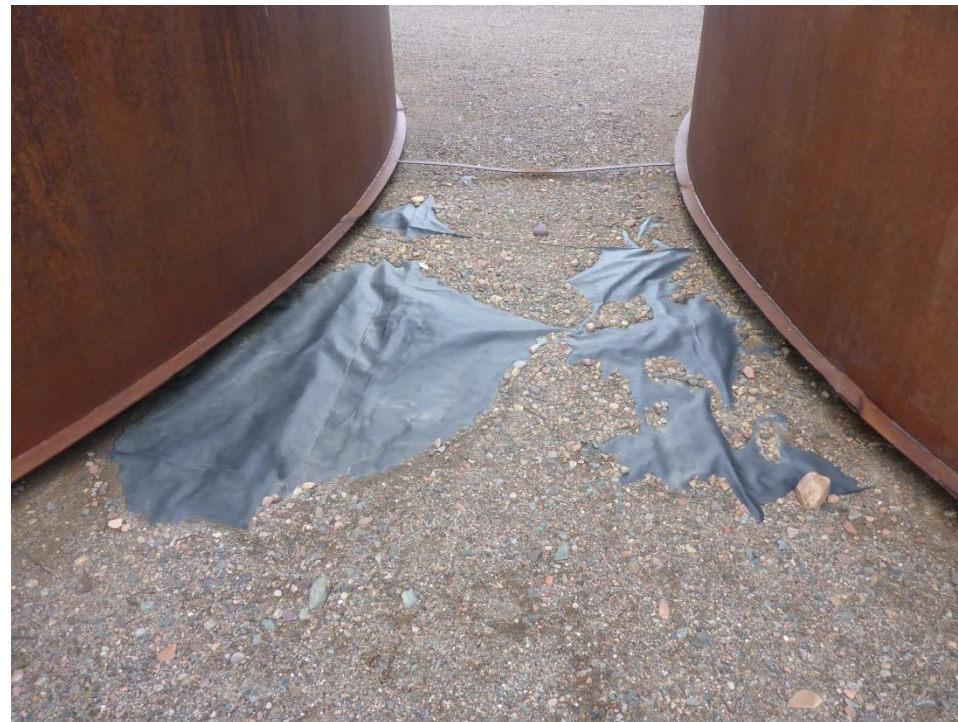
Photo 5: Close up view of the exposed liner between the 2 large tanks in Camp 3 fuel tank farm.

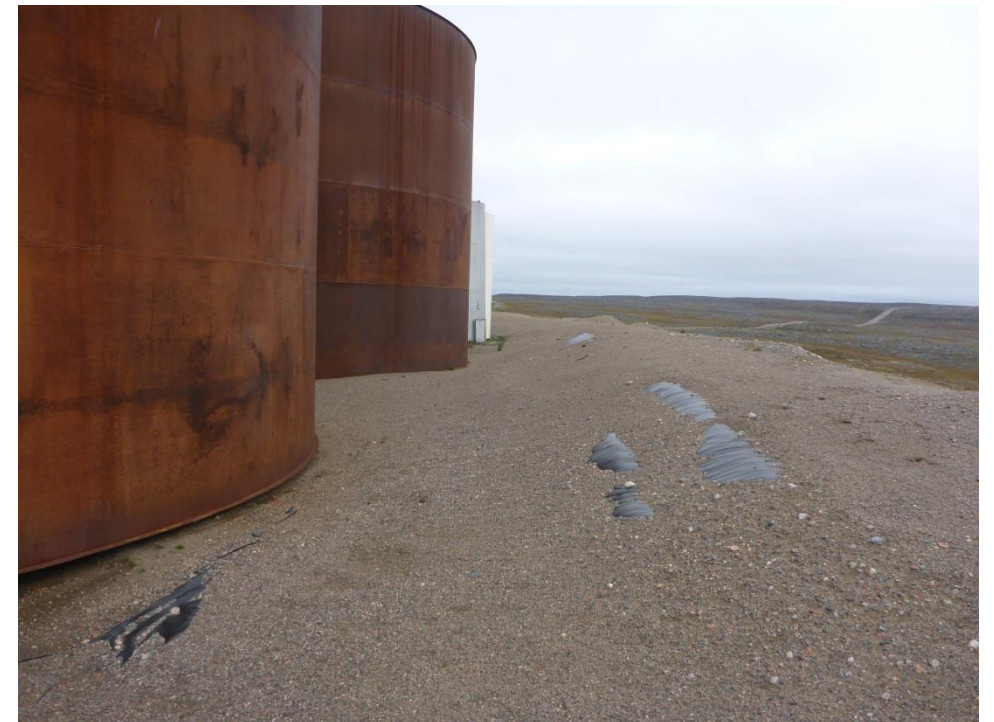
Photo 6: Looking at the exposed liner in the north bank of the Camp 3 fuel tank farm.

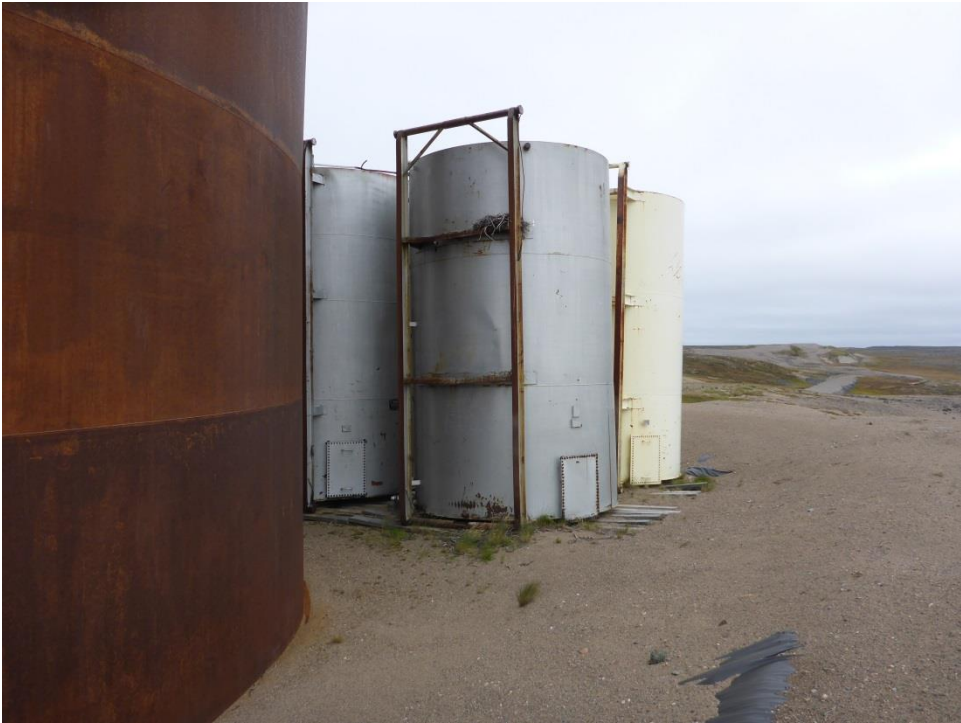
Photo 7: Looking north at the leaning tanks at the back of the Camp 3 fuel tank farm.

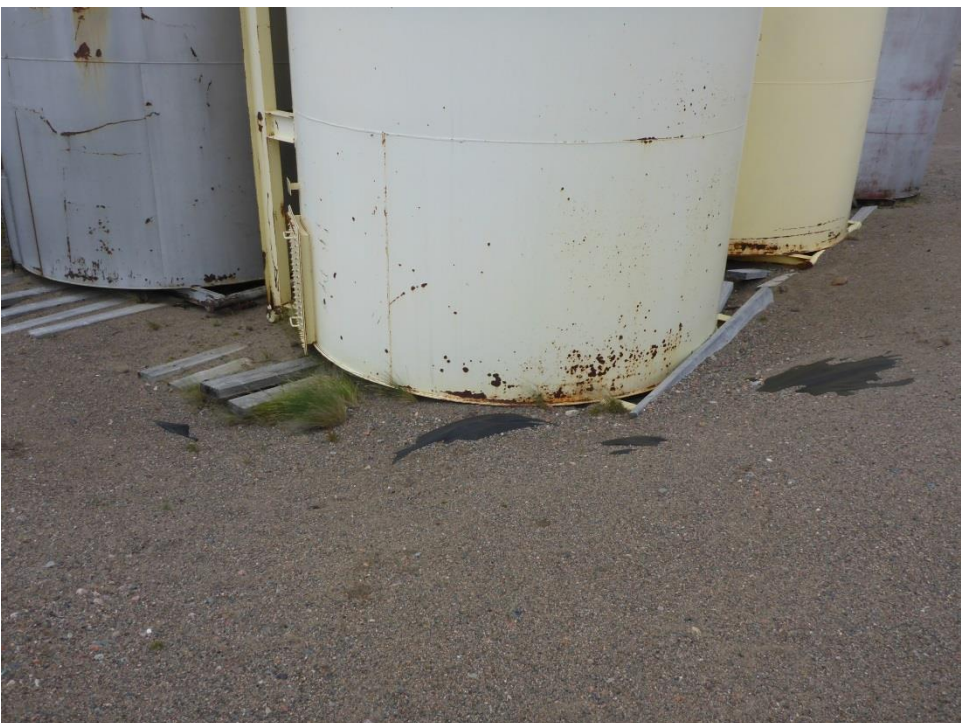
Photo 8: Close up view of the broken cribbing underneath the leaning tanks.

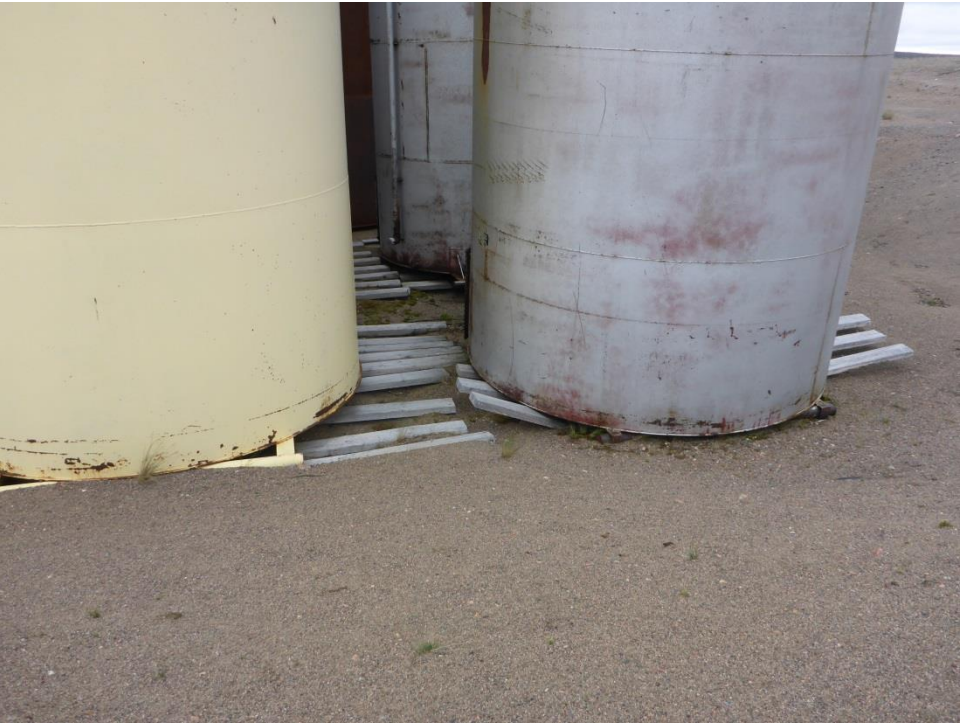
Photo 9: Close up view of the broken cribbing underneath the leaning tanks.

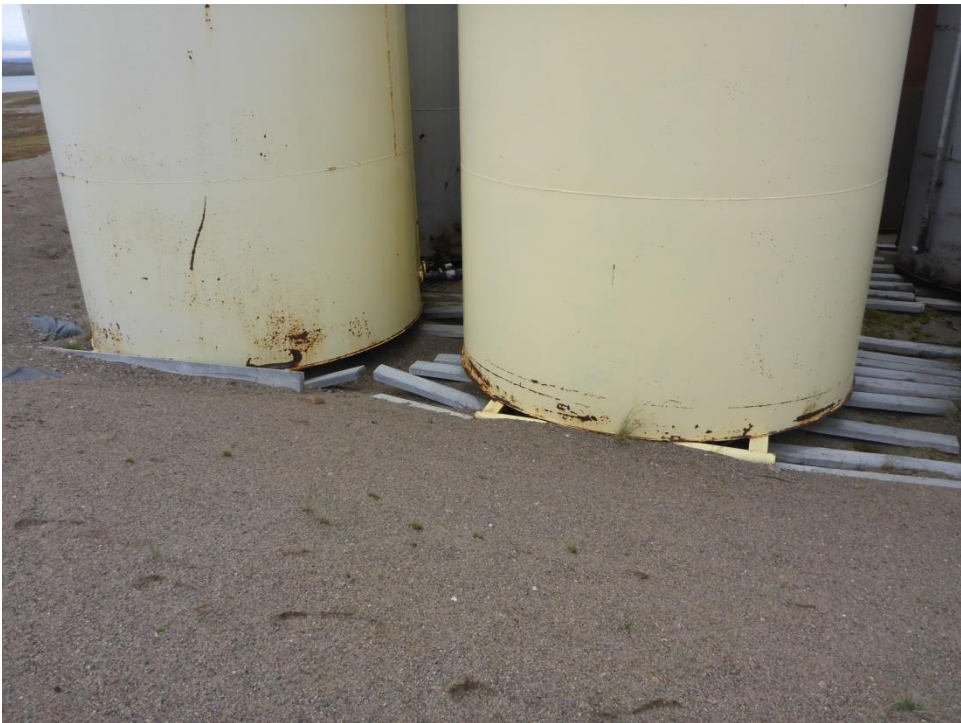
Photo 10: Close up view of the broken cribbing underneath the leaning tanks.

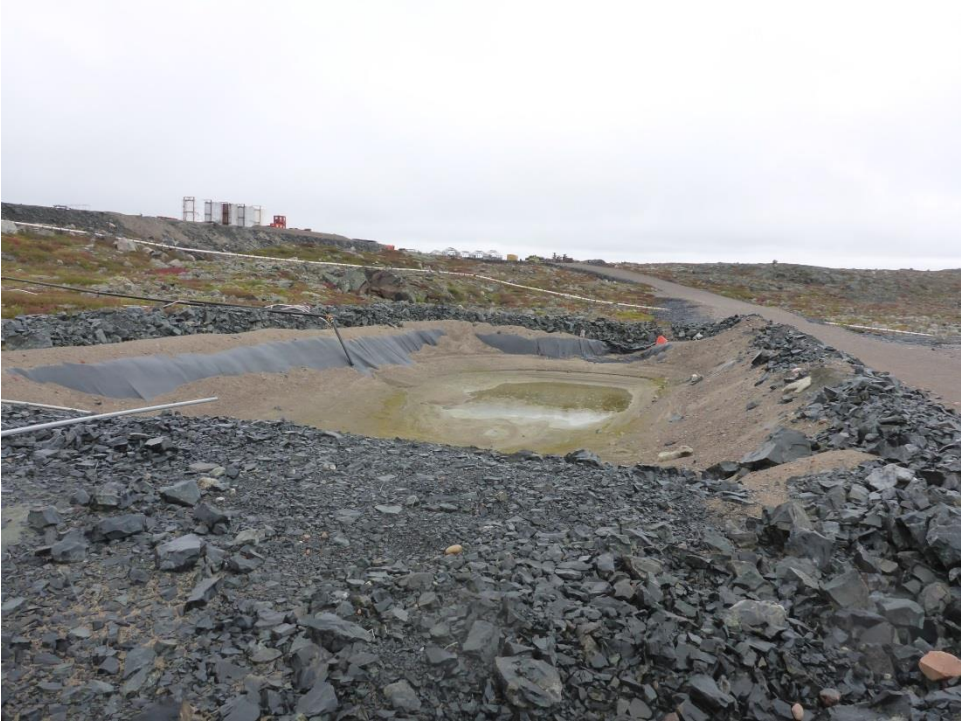
Photo 14: Looking northwest at the mine sump.

During the inspection, part of the leading edge and the slopes of the liner in the mine sump were found to be exposed and should be covered at the first opportunity to protect the liner. Damage to the sump liner was also observed and should be repaired. These repairs and maintenance should be performed prior to utilizing the sump.

As recommended, repairs and maintenance on the liner in the mine sump will be completed prior to utilize it.

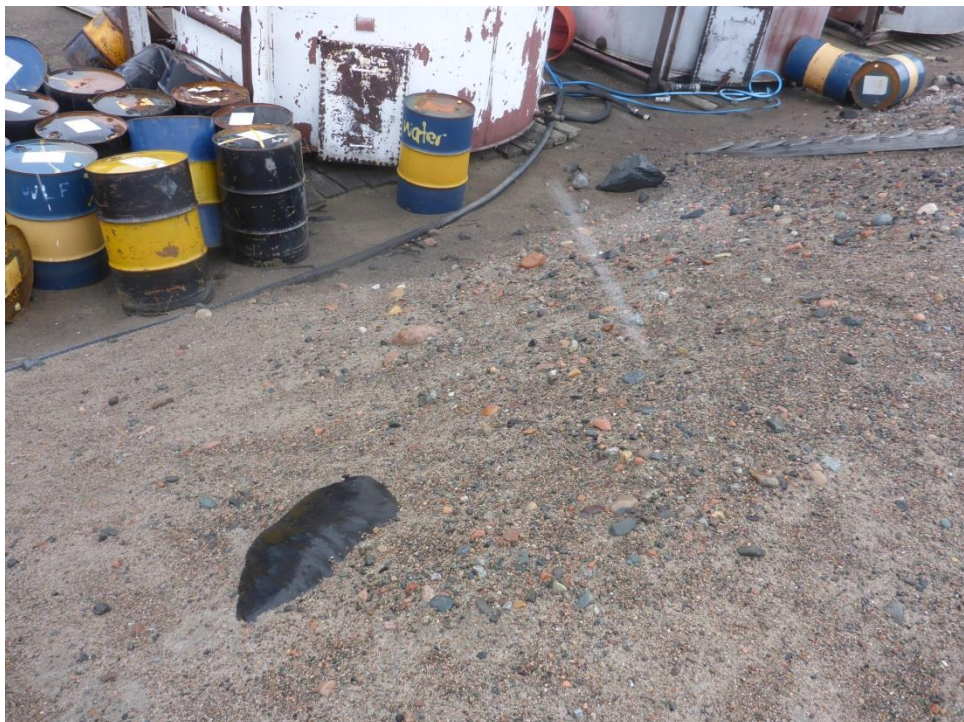
There are minor erosion issues near each crest of the fuel containment berms where liners are exposed and damaged. The erosion should be repaired to prevent further damage to the liner, as well as to prevent leakage during periods of high water levels. Both the ore storage and portal laydown pads are in satisfactory geotechnical condition.

Photo 23: Close up view of the exposed liner in the north banks.
