January 31, 2016

# 2015 Annual Geotechnical Inspection of Selected Structures – Ulu Gold Project, Nunavut

SRK Consulting (Canada) Inc.  
1CB027.003  
October 2015

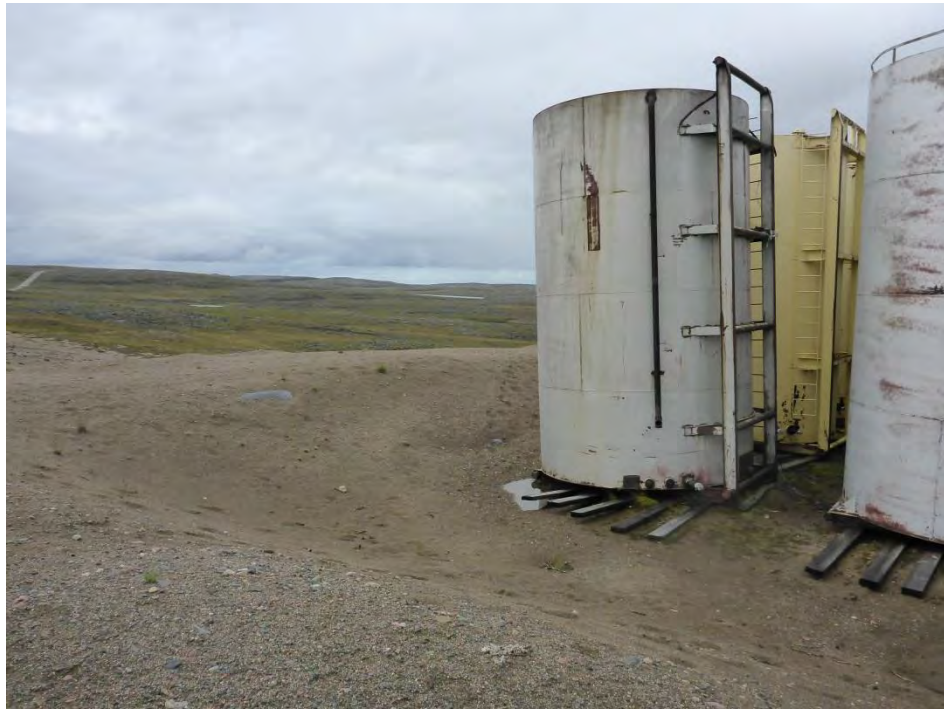
Similar to facilities at Ulu, minor damage was noted in the liner and left exposed from erosion. The main concern observed during the Camp 3 inspection is that three fuel tanks are leaning because of broken cribbing at their base. It is recommended that the cribbing be repaired. The tanks should be set upright and leveled so as to prevent toppling and damage to the tanks and containment berm. Alternatively, the leaning tanks could be decommissioned and removed from the containment berm. The fuel tank farm containment berm was generally in good condition with no visual stability concerns. The parts of the liner that are damaged should be repaired and covered with appropriate backfill.

Photo 1: Looking north at one of the leaning tanks in the front of the Camp 3 fuel tank farm.

- Cover all exposed liners and leading edges with granular fill for overliner protection.
- Repair all damaged liners in the fuel storage.
- Replace the broken cribbing at Camp 3 and re-level the fuel tank or decommission the tank.
- Repairs and perform maintenance on the liner in the mine sump shall be completed prior to utilizing it.
- Monitor the animal burrows in the fuel containment area for increased activities, damaged liner and fragments.

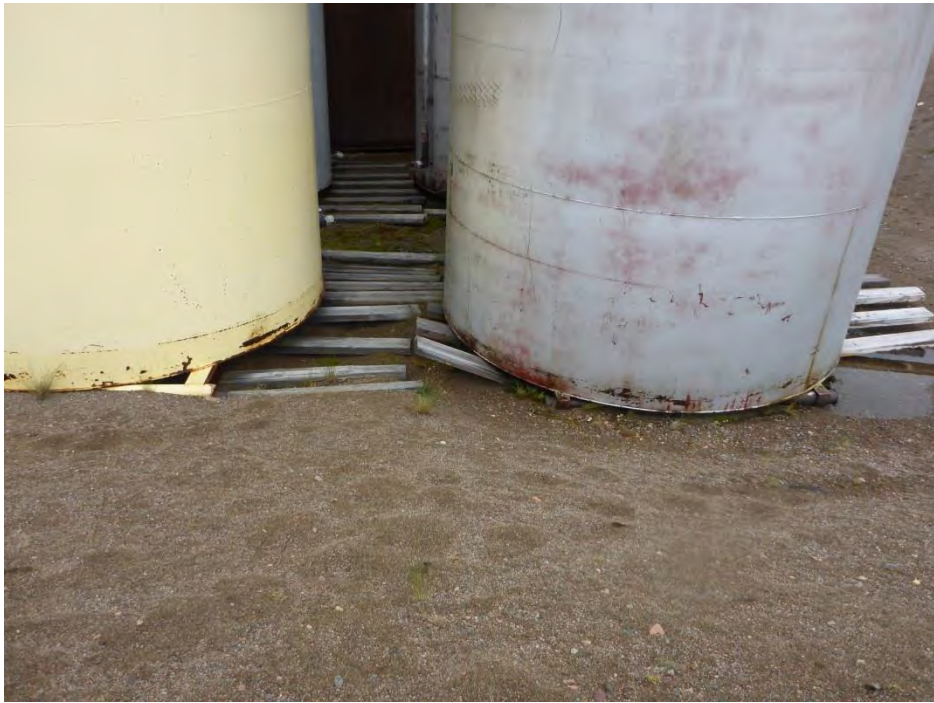
Photo 2: Close up view of the broken cribbing underneath the tank.

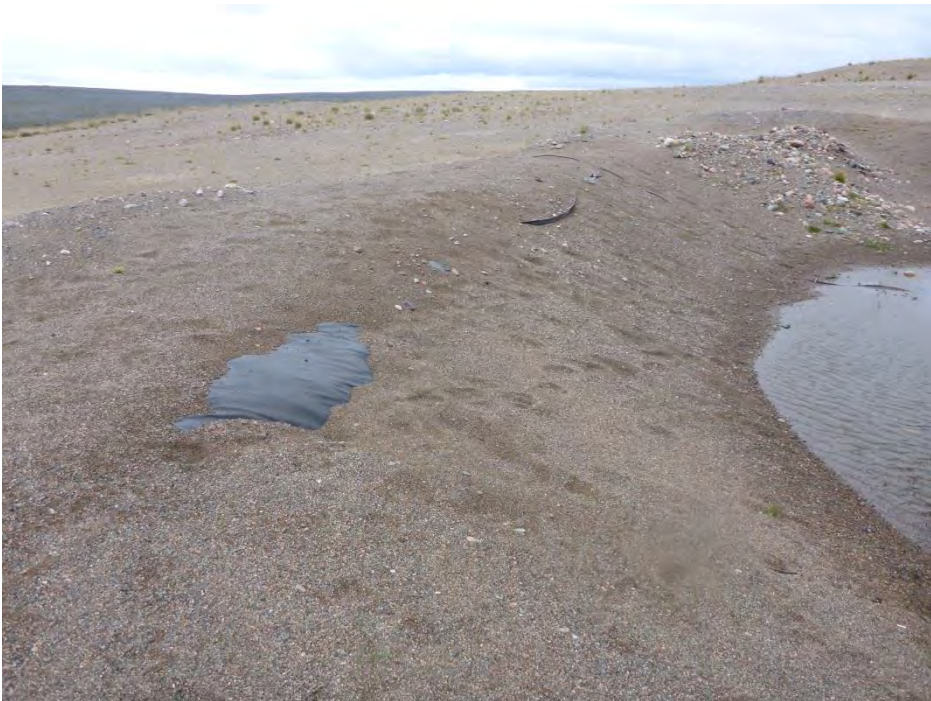
Photo 4: Close up view of the damaged liner in the southern bank of the Camp 3 fuel tank farm.

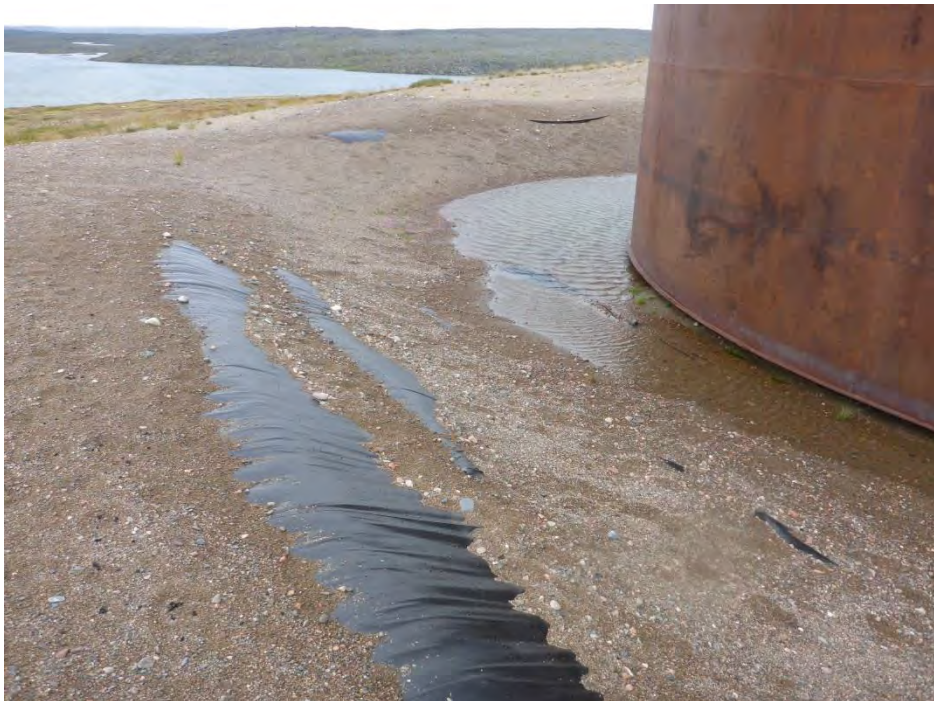
Photo 5: Close up view of the exposed liner and water ponding underneath the large tanks in Camp 3 fuel tank farm.

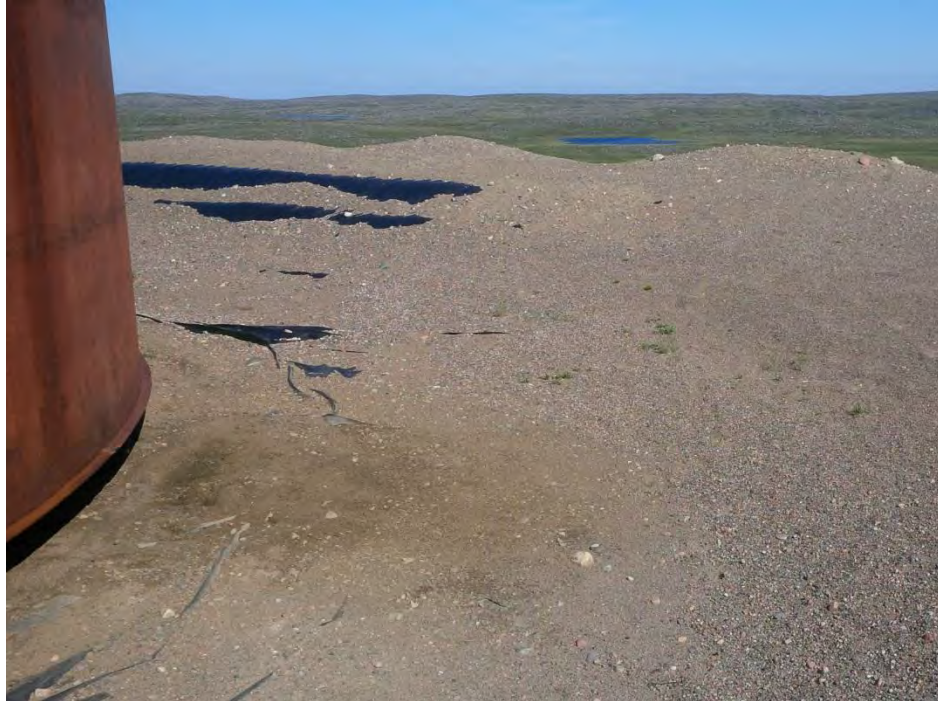
Photo 6: Looking at the exposed liner in the north bank of the Camp 3 fuel tank farm.

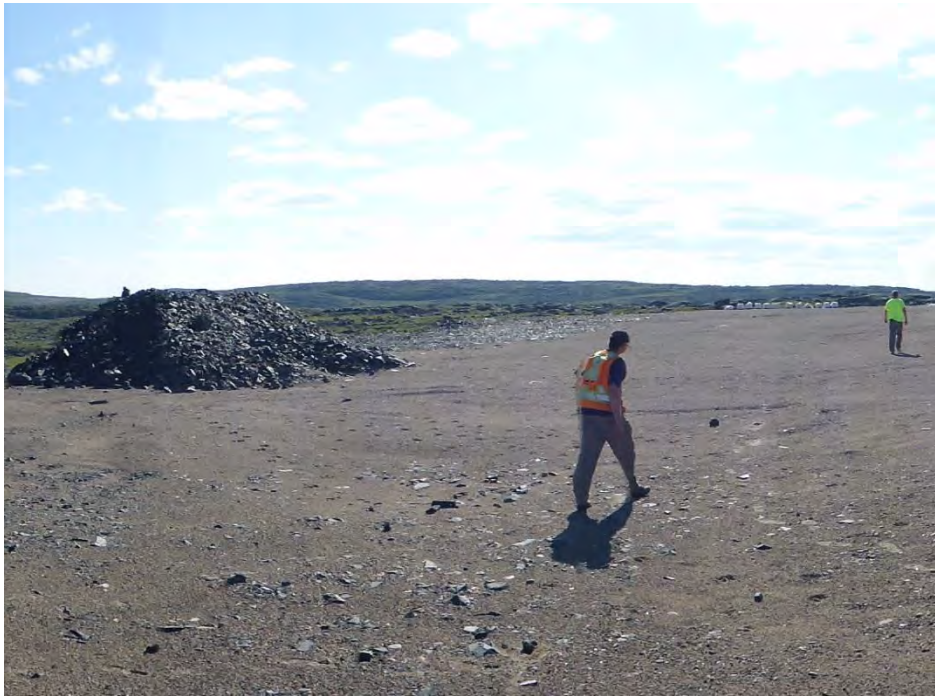
Both the ore storage and portal laydown pads are in satisfactory geotechnical condition.

Photo 7: Looking South at the Ore Pad.

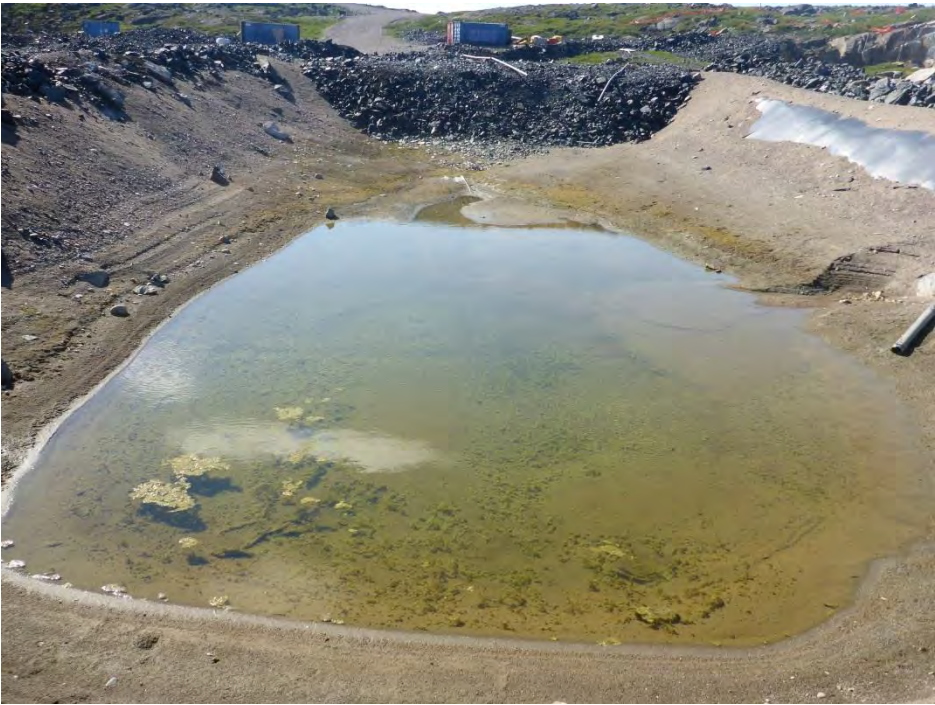
During the inspection, part of the leading edge and the slopes of the liner in the mine sump were found to be exposed and should be covered at the first opportunity to protect the liner. Damage to the sump liner was also observed and should be repaired. These repairs and maintenance should be performed prior to utilizing the sump.

Photo 8: Looking west at the mine sump. Note the exposed liner on the north bank.

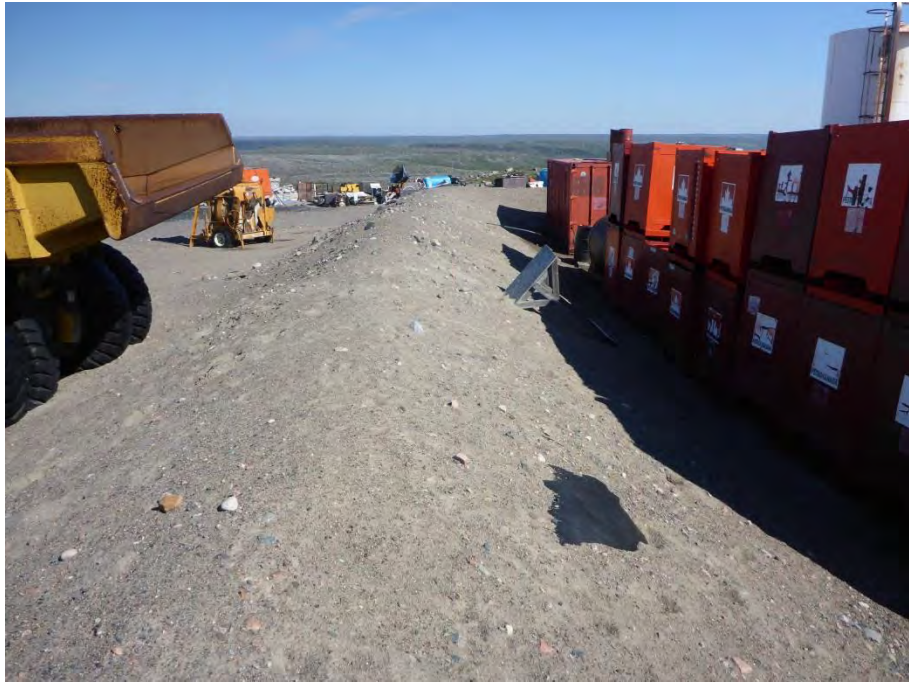
There are minor erosion issues near each crest of the fuel containment berms where liners are exposed and damaged. The erosion should be repaired to prevent further damage to the liner, as well as to prevent leakage during periods of high water levels. Burrows are observed in the main tank farm containment berm. It is undetermined what ground animal made these burrows. Liner fragments were not observed in 2015 around the burrows to indicate the animal had damaged the liner. While it is unlikely that the animal would damage the geosynthetic liner, periodic monitoring is recommended during the summer season to ensure the number of burrows does not increase and liner fragments are not observed.

Photo 14: Looking at the north banks and exposed liner at the Ulu Main Tank Farm.

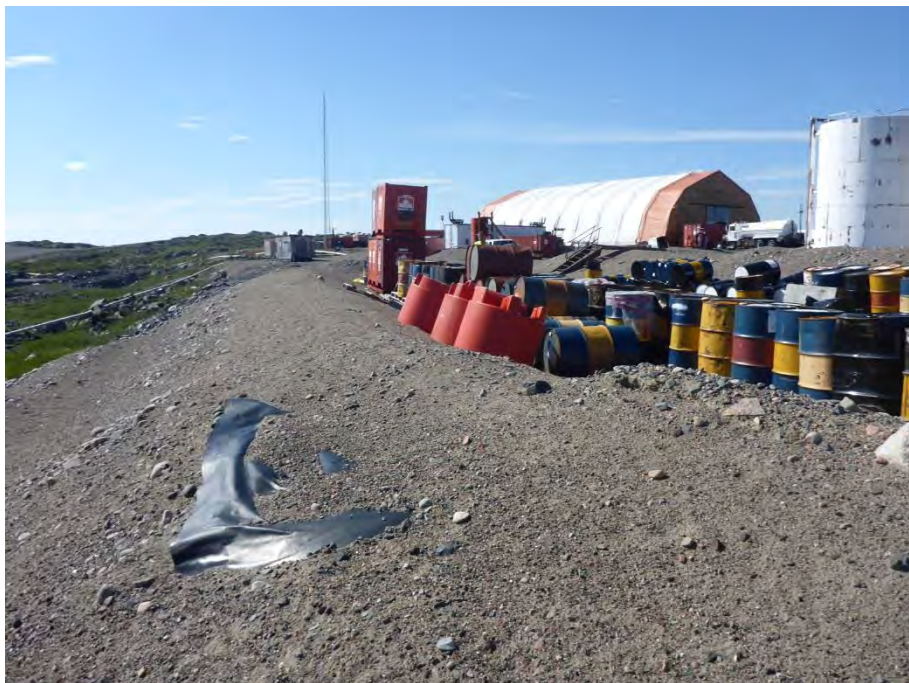
Photo 17: Looking west at the exposed liner in the south banks of the waste oil storage.

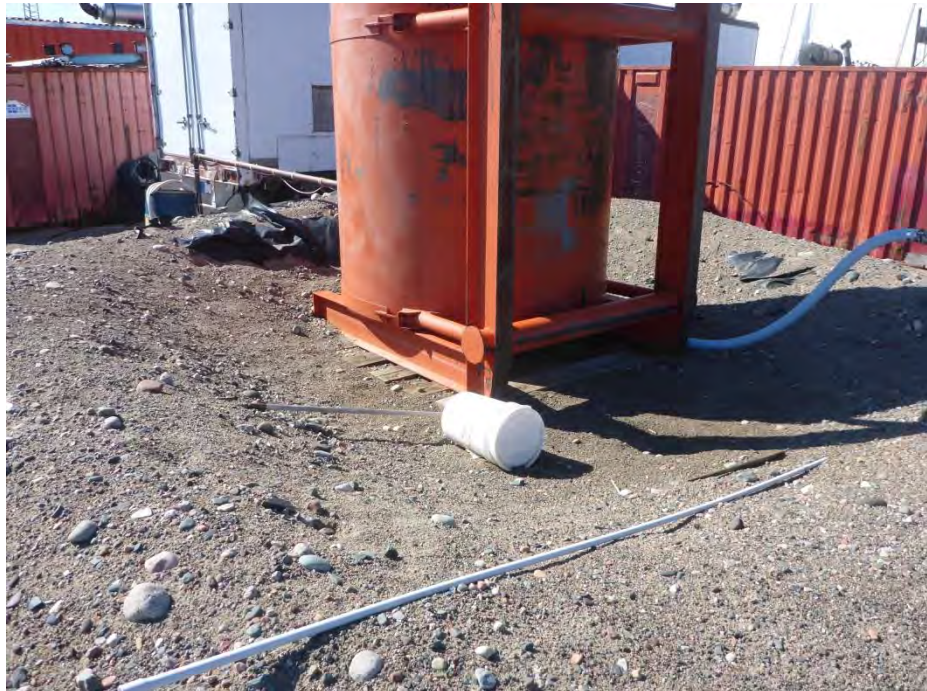
Photo 18: Looking west at the day use tank at Ulu. Note the exposed liner in the west bank.
