BONITO CAPITAL CORP.

Re: 2016 Annual Report: Ulu Advanced Exploration Project Type B Water Licence (2BM-ULU1520).

WATER LICENCE INSPECTION FORM

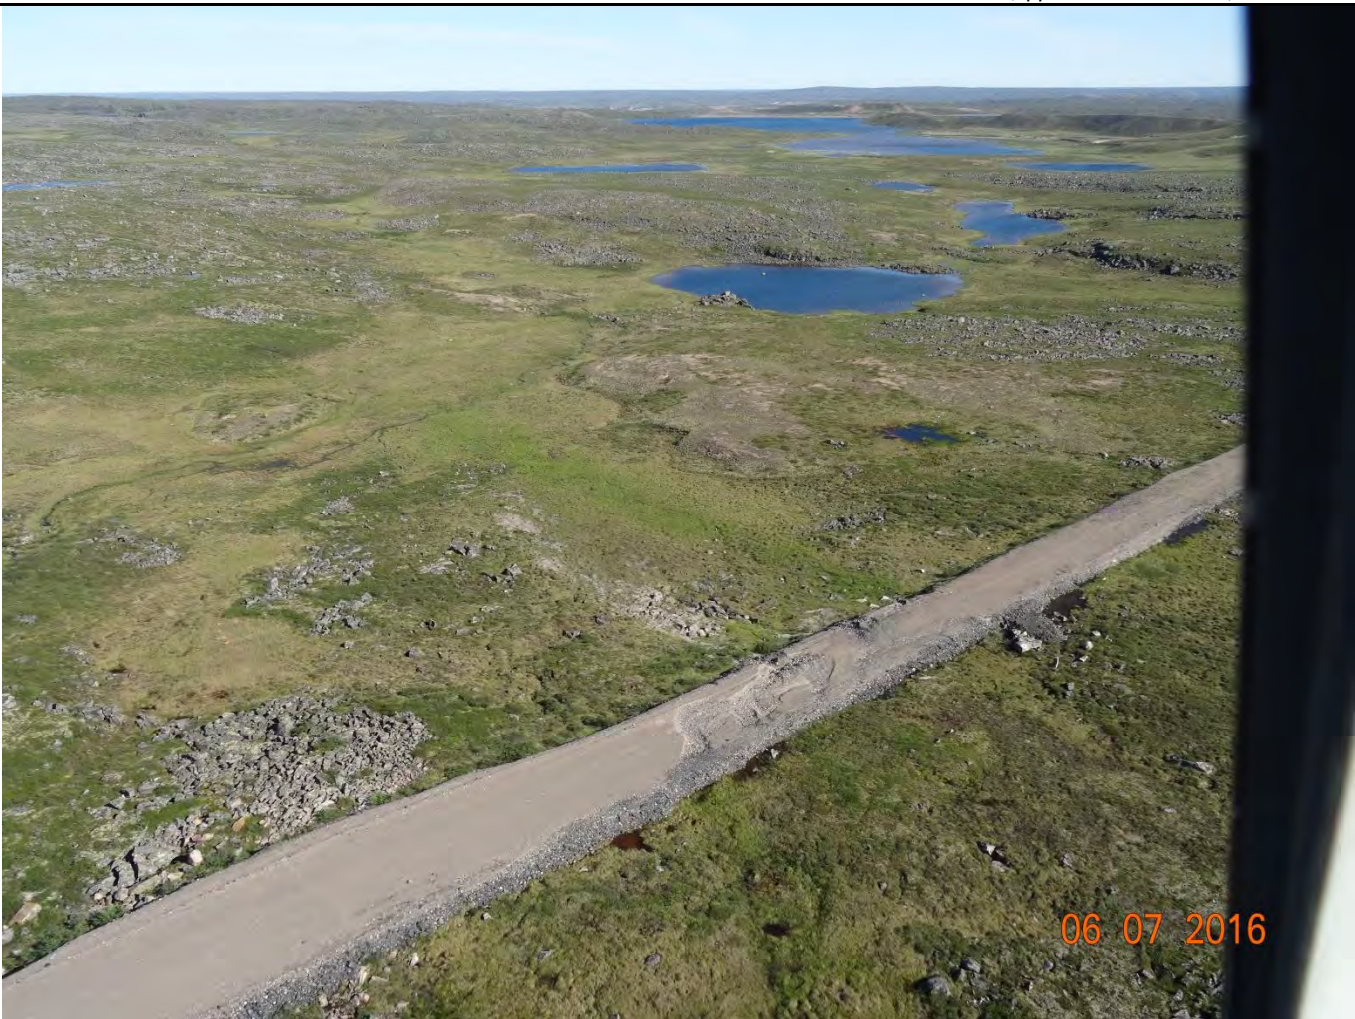
Photo Log # 10

Description: Washed out sections of road as discussed in 2015. No silt fencing or mitigation has been put in place.

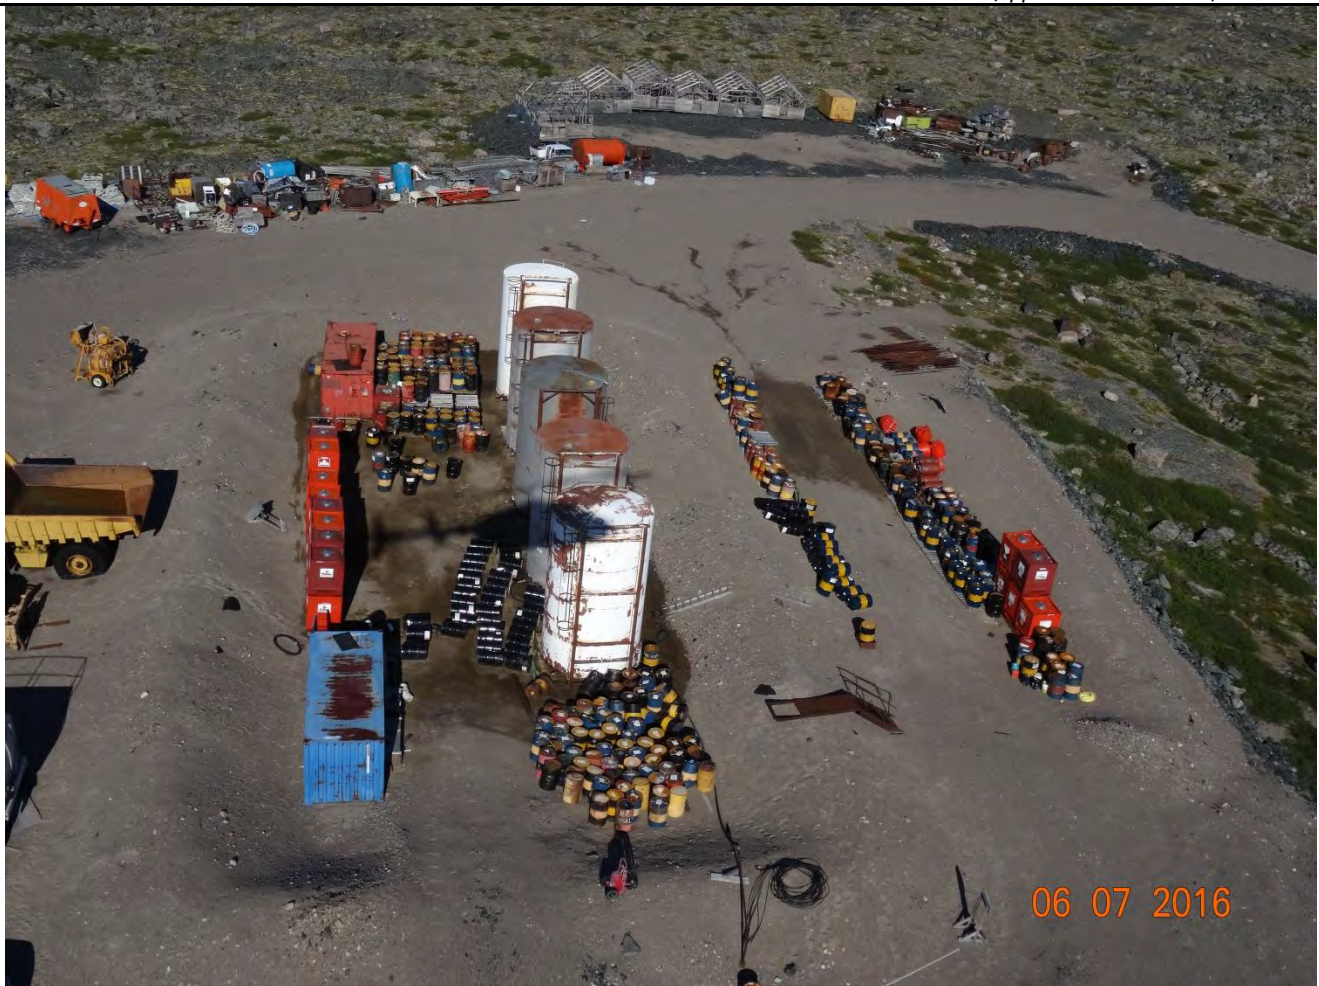
Photo Log # 13

Description: Comparative photo of the staining within the fuel storage pad (compare to next photo, taken in 2015).

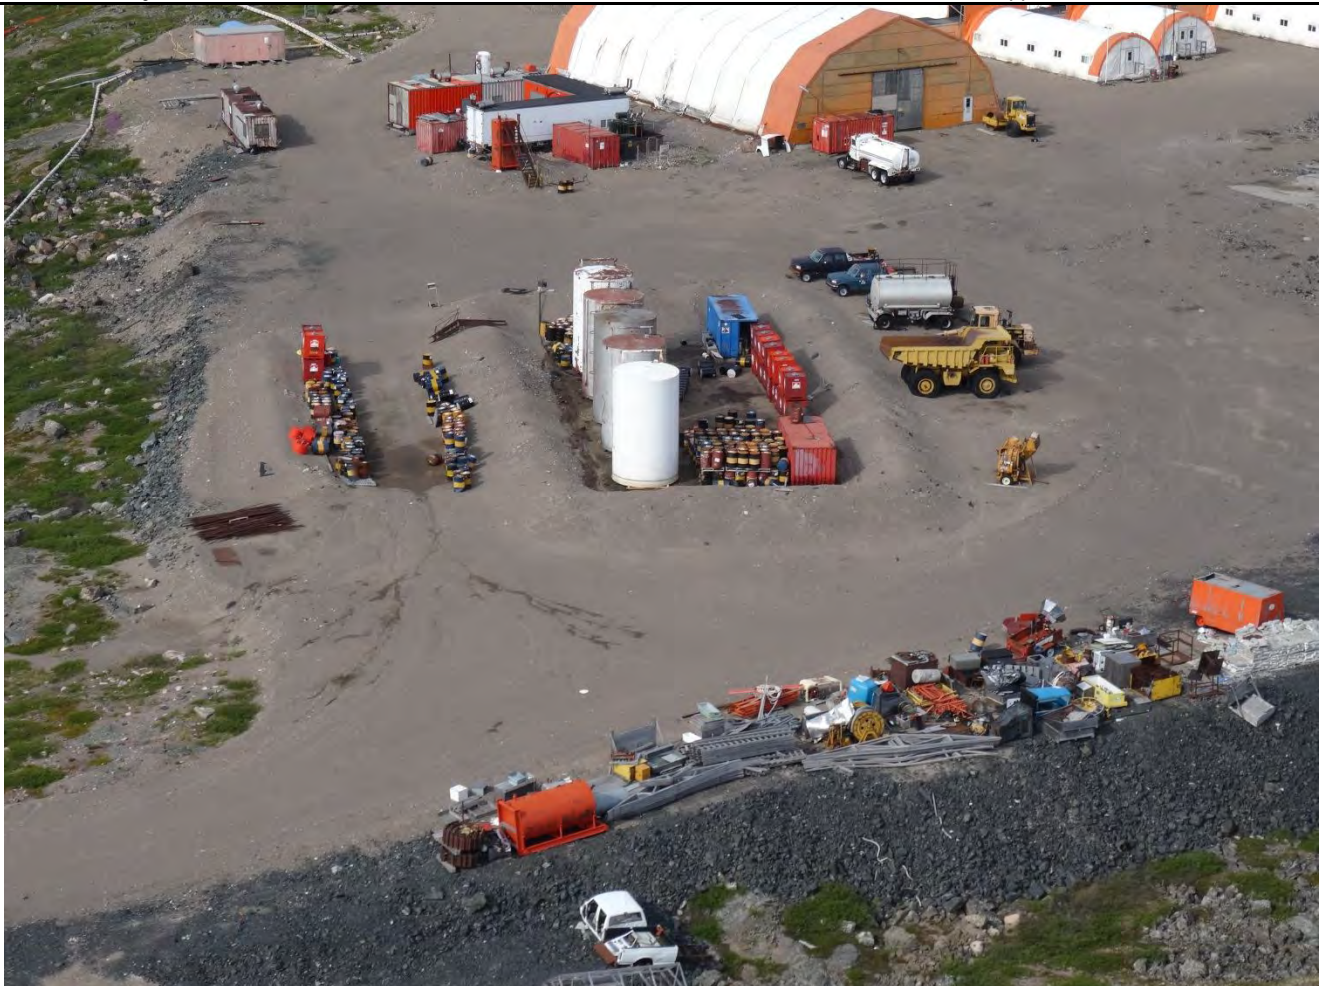
Photo Log # 14

Description: 2015 aerial view of the fuel storage pad; staining within the pad is less extensive than this year.

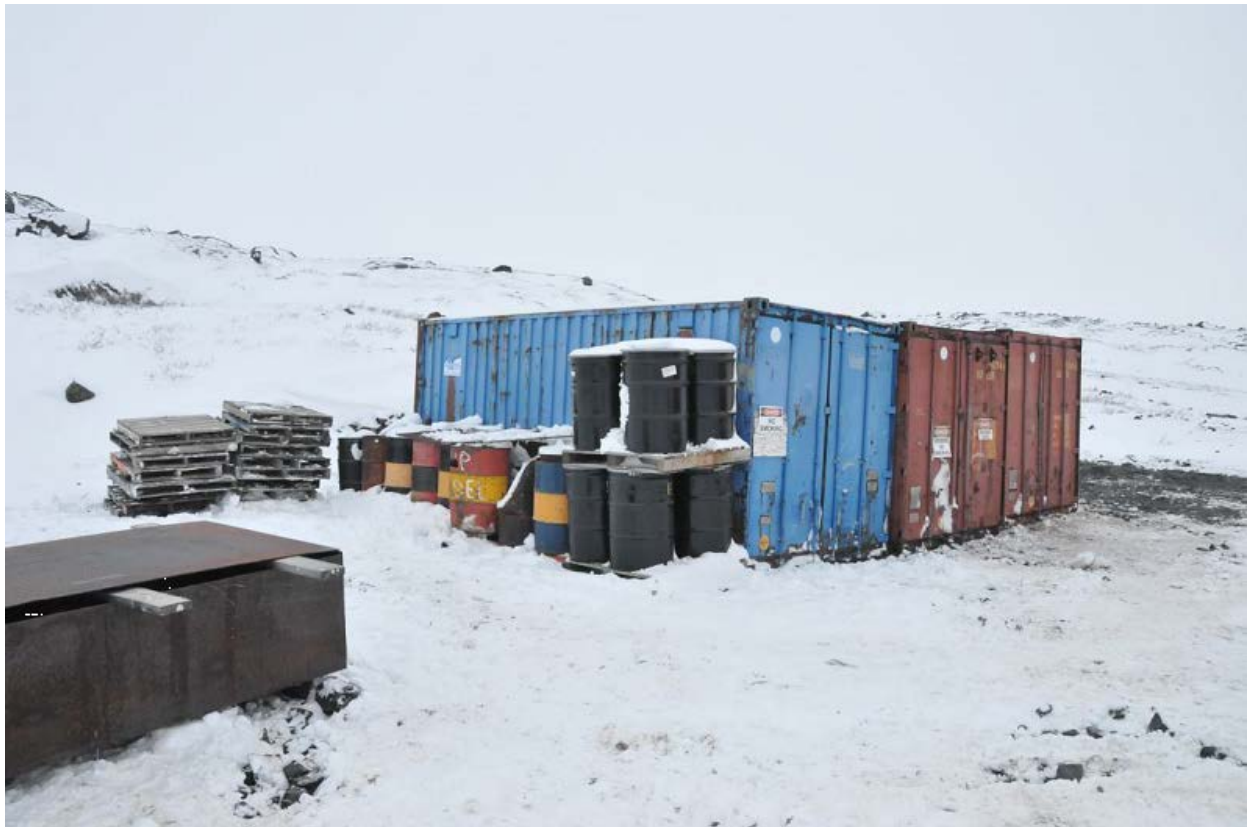
5. All hazardous (and unknown) waste is to be moved into SOUND secondary containment that meets the definition of 'secondary containment' in the current licence 2BM-ULU1520. *

- Sorted thru the waste drums by the mine storage pad
- Repack some of the waste into resalable drums ready for shipping
- Relocated 3 c-container at the mine storage pad
- Store inert waste outside the c-can
- Cover and store all hazardous waste in c-can away from the elements
- Cover and store all contaminated soil in c-can away from the elements
- All hazardous waste at the mine storage pad is secure in c-can and covered so water can't get into the drums.

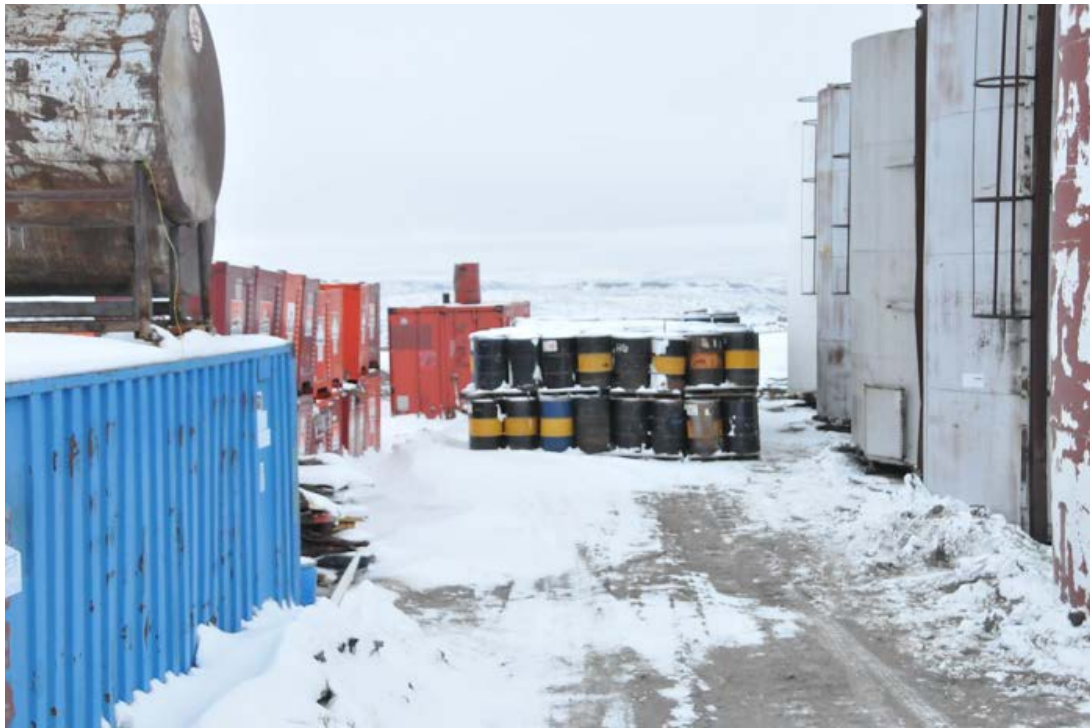
6. All barrels of fuel are to be moved into SOUND secondary containment that meets the definition of 'secondary containment' in the current licence 2BM-ULU1520. *

- Liquid product to Main berm
- Contaminated soil to mine storage pad
- Removed the contents of any damaged drums into new drums and store them into the main berm.

- Restack all waste drum in the center of the main berm
- Relocate all diesel drums to the drive thru berm
- Clean out blue c-can and store empty drum and fuel transfer hose
- Install Cam-lock Cap on some of the Vertical tank
- transfer some oil product from an old storage tank into drums

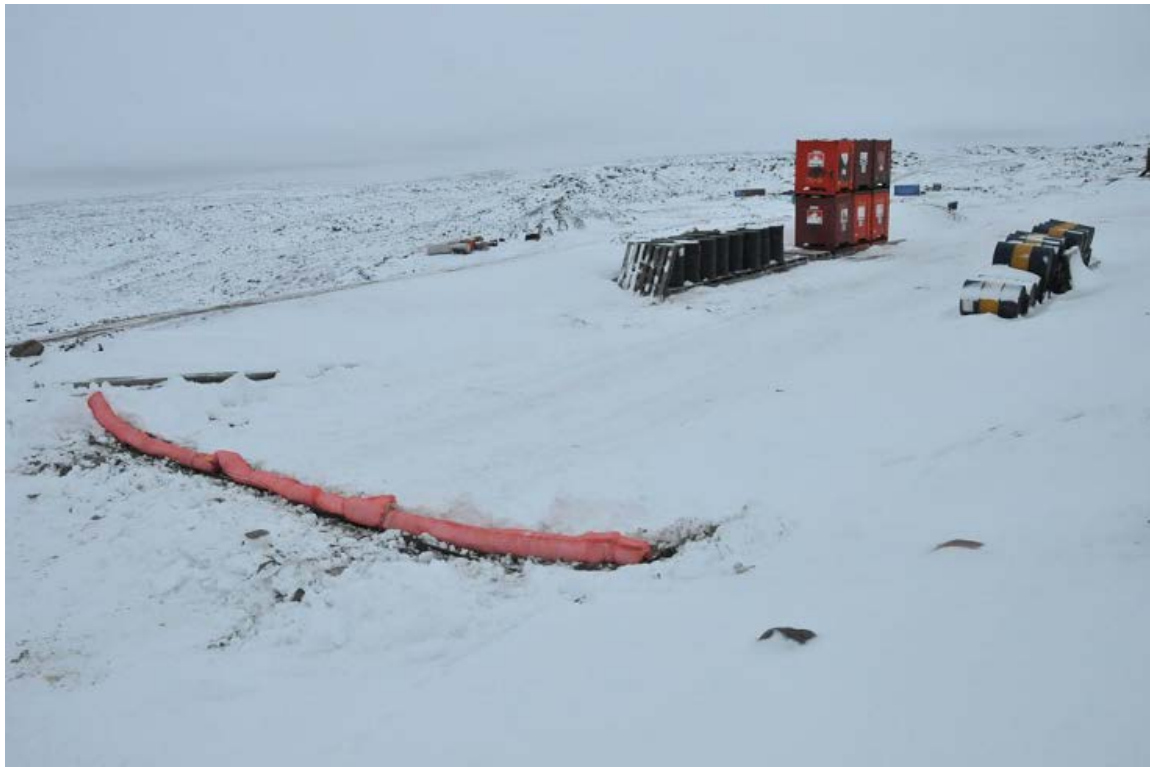
7. Spills are to be **reported** and addressed according to the approved Spill Contingency Plan. Steps are to be taken to a) stop the flow of hydrocarbons from the fuel storage pad, b) prevent any further migration of hydrocarbons down-slope from the fuel storage pad, and c) remediate the affected area.

The flow of hydrocarbons from the fuel storage pad is only easily visible when the sand is dry. I noted in 2015 that my photos showed the contamination clearly, but Andrew's (taken later and during a rain event) did not. This summer (2016) I recorded a GPS track of the perimeter of **what was visible on the surface**, which I have attached, along with the waypoints of the two shallow samples I took. Please note that this is a **starting point** of where sampling should occur to determine the extent of contamination; the actual extent under the surface may be greater. Please ensure qualified personnel are present to delineate the contamination and to guide the work.

Bonito did install a spill boom at the North end of the drive thru berm to prevent future migration and all waste drums were removed from the berm.

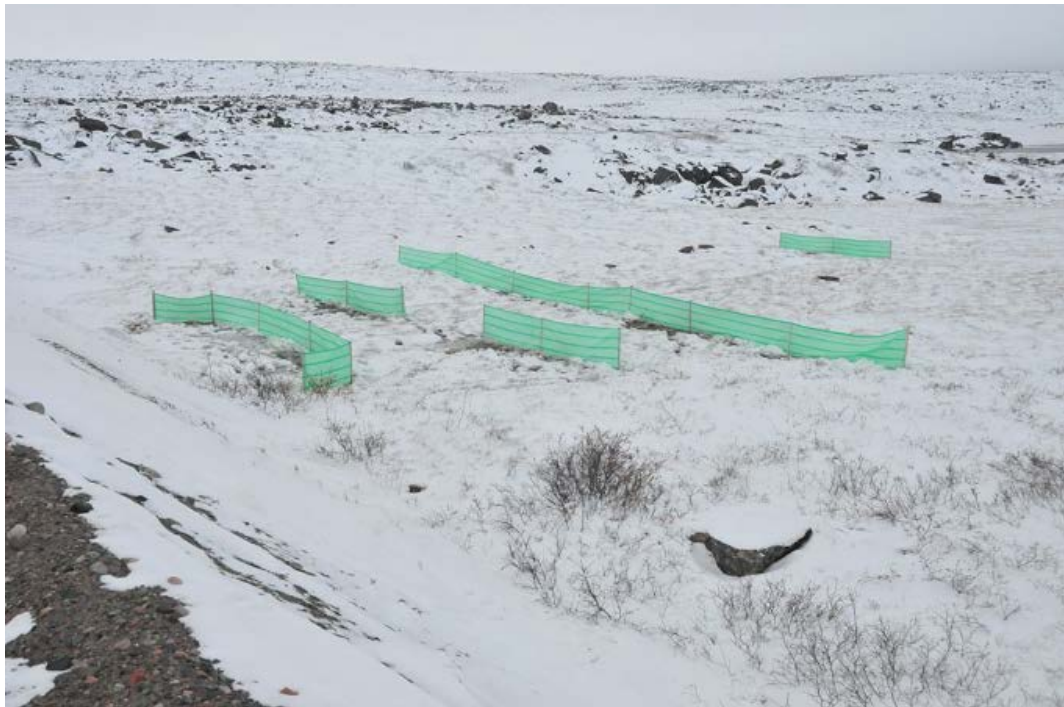
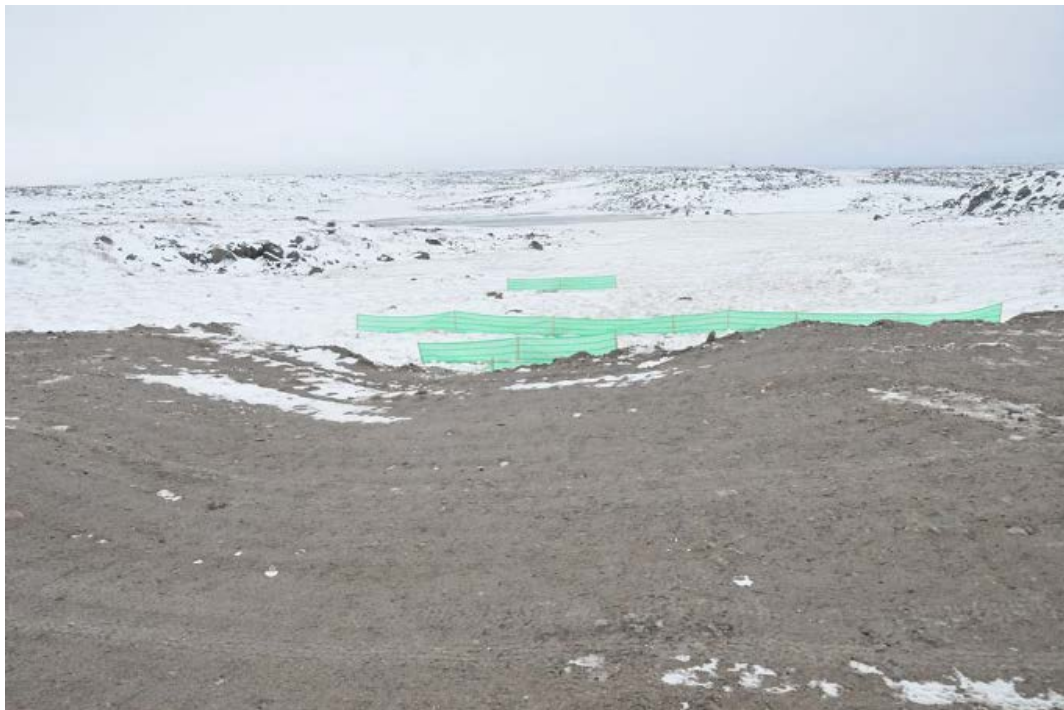
4. Establishment (and regular maintenance) of sediment control measures to prevent further sediment loading of streams that have been affected by road deterioration. These measures are to be put in place at freshet ([now 2017](#)).

- Installed silt fencing at 2 different location on the downstream side of the road around those coordinate (N66 51 59.75 W111 00 14.6)
- Cleaned 2 washouts with the excavator as best we could. We left a slight channel on the road, sloping downstream. The channel is shallow enough so you could drive thru.
- Additional work will be completed in 2017
