**ANNUAL REPORT:**  
***Ulu Gold Project***  
***Exploration and Progressive Reclamation***  
***20EN001***  
***2BM-ULU2030***

**Kitikmeot Region, Nunavut**

**March 2022**

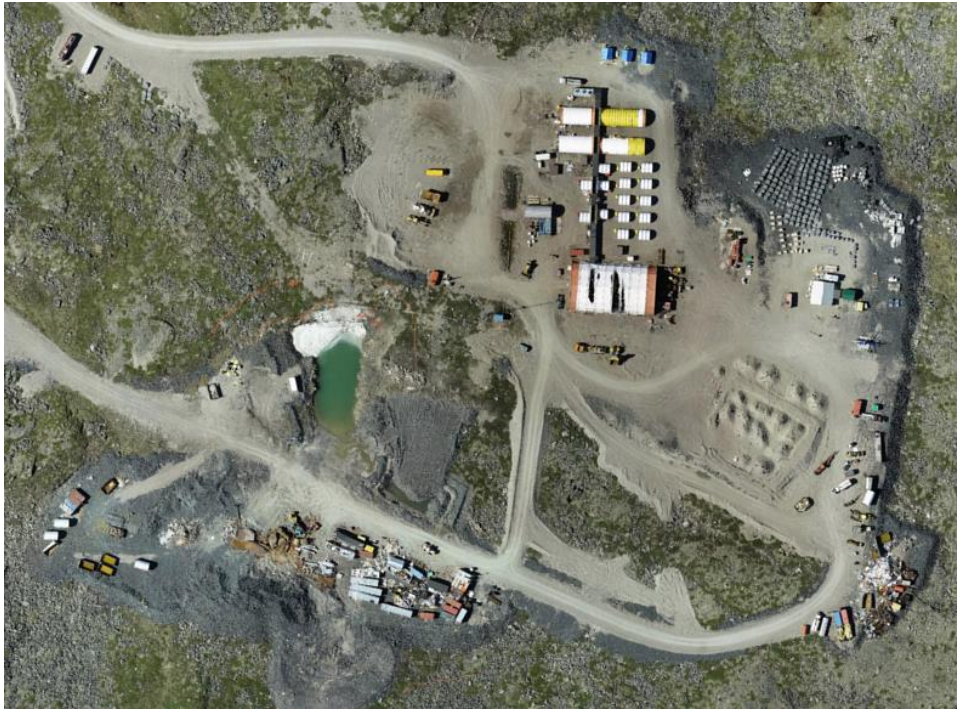
Photo 1. Ulu camp, July 2021.

Upon accessing the Ulu camp, some minor damage from wildlife was repaired and 10 additional tents constructed. The core shack was also expanded and modified and three temporary isolation tents were also constructed. Over the course of the season, the grey water sump was modified to enhance retention, expand capacity and improve safe access. Photos of the expanded camp and improved grey water sump are provided in Appendix C.

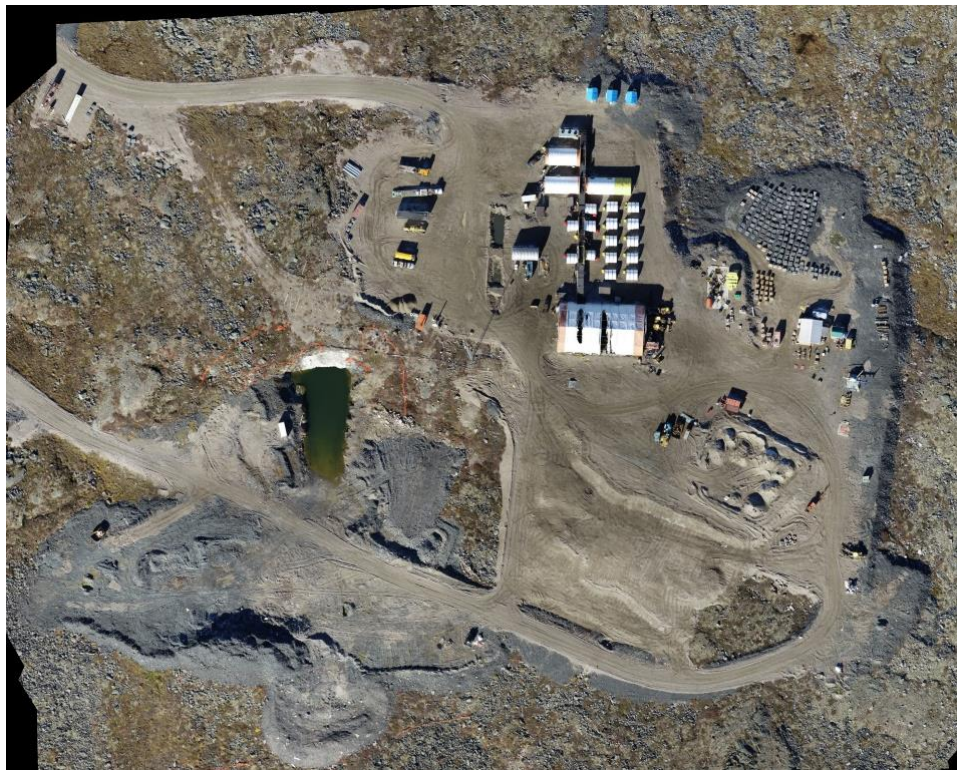
Photo 2. Ulu camp, September 2021.

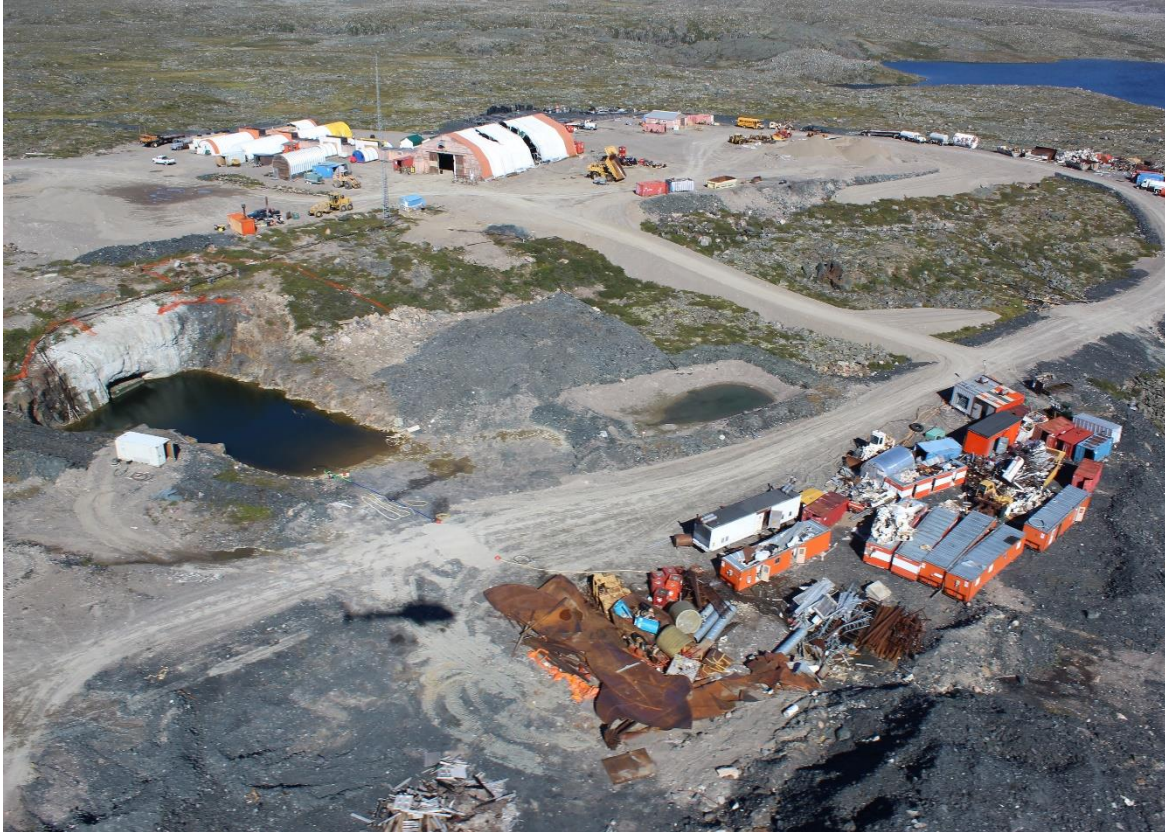
Photo 3. Legacy waste, lower landfill staging area, portal and mine sump.

Starting in late June, legacy solid waste was sorted, with near term useful or readily recyclable goods recovered and segregated. The remainder of the partially demolished sleeper was deconstructed. Equipment and machinery identified for disposal in the non-hazardous waste landfill (landfill) was decontaminated with all fluids flushed and hazardous components removed. Standing water accumulated in open waste vessels was tested prior to release, in accordance with criteria discussed in advance with the Landowner and the Inspector. Oily or greasy waste equipment was washed prior to disposal, with wash water captured and sent off site for treatment and disposal. Any residual hazardous waste was backhauled to a suitable waste receiver.

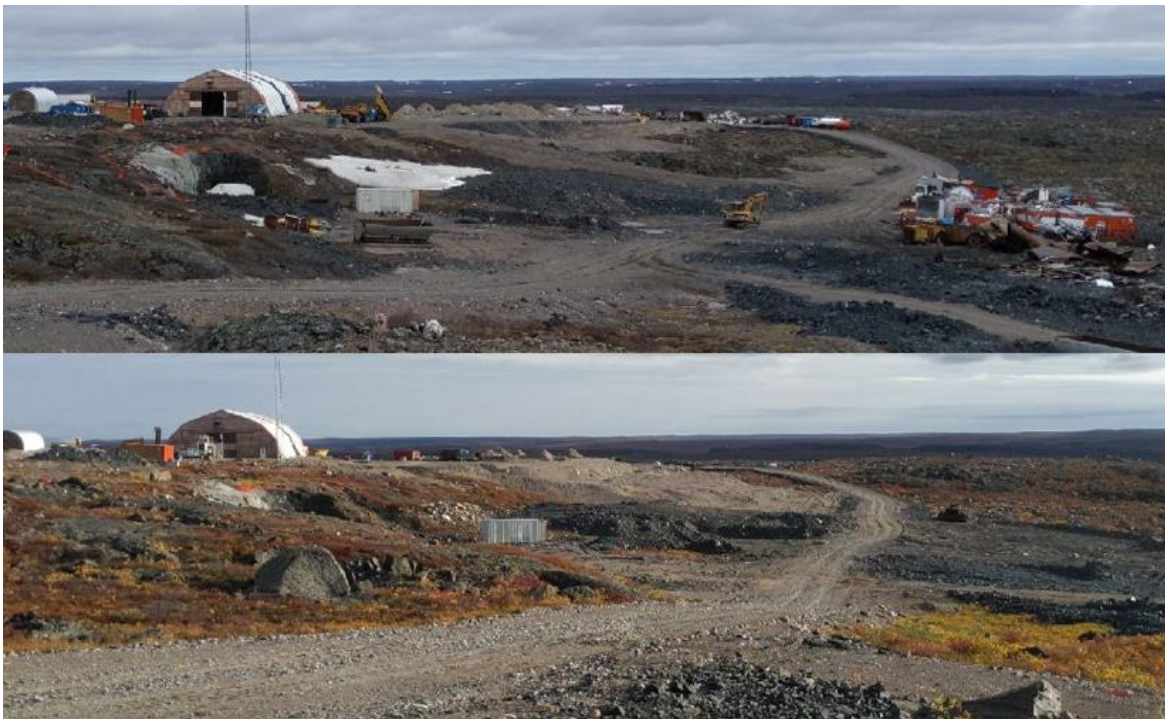
Photo 4. Ulu landfill area, before and after.

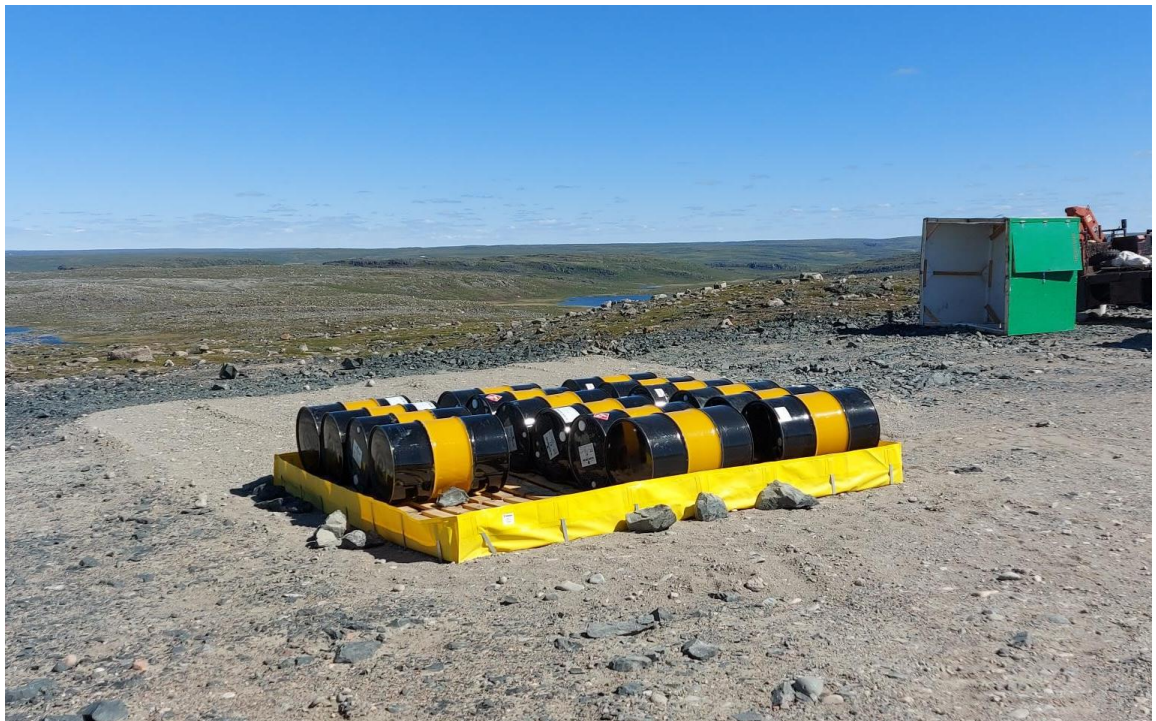
Photo 10. New drummed fuel cache established at Ulu camp helipad.

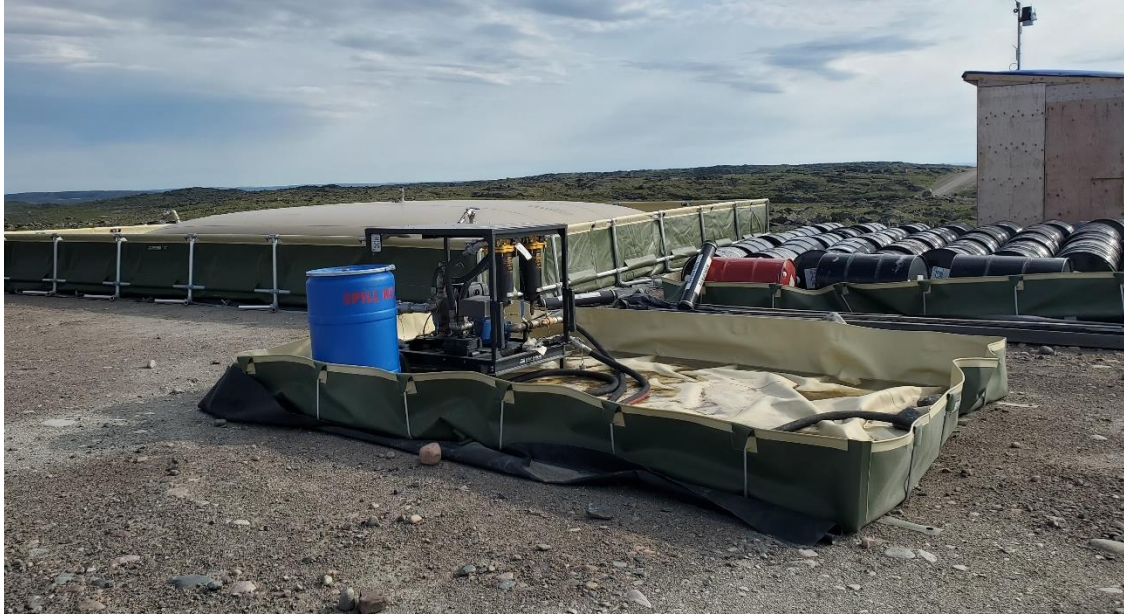
Photo 11. Airstrip fuel facilities

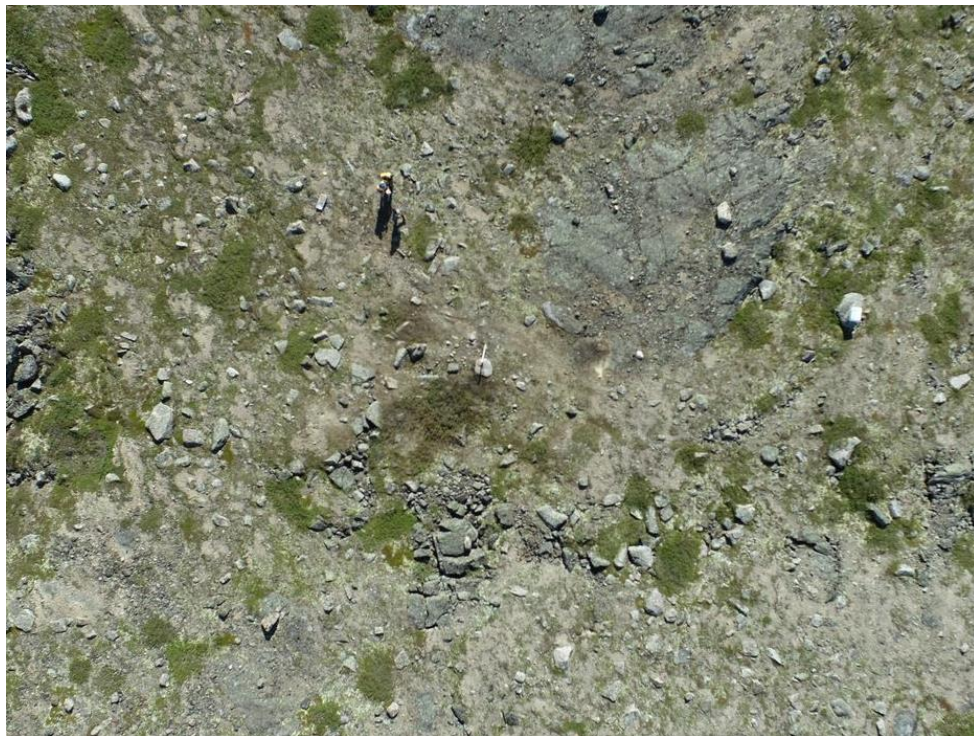
Photo 12. Aerial view of a drill site, post-drilling. Collar remains in place for future drilling (centre of image).

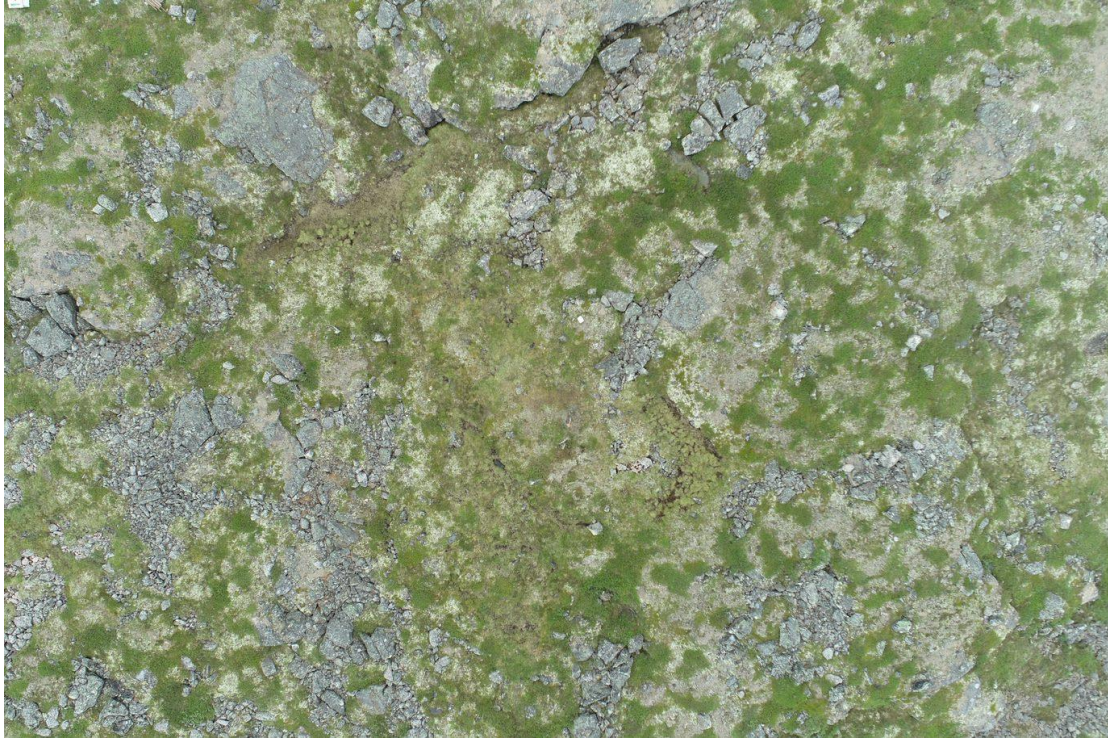
Photo 13. Aerial view of a drill site, post-drilling, collar removed

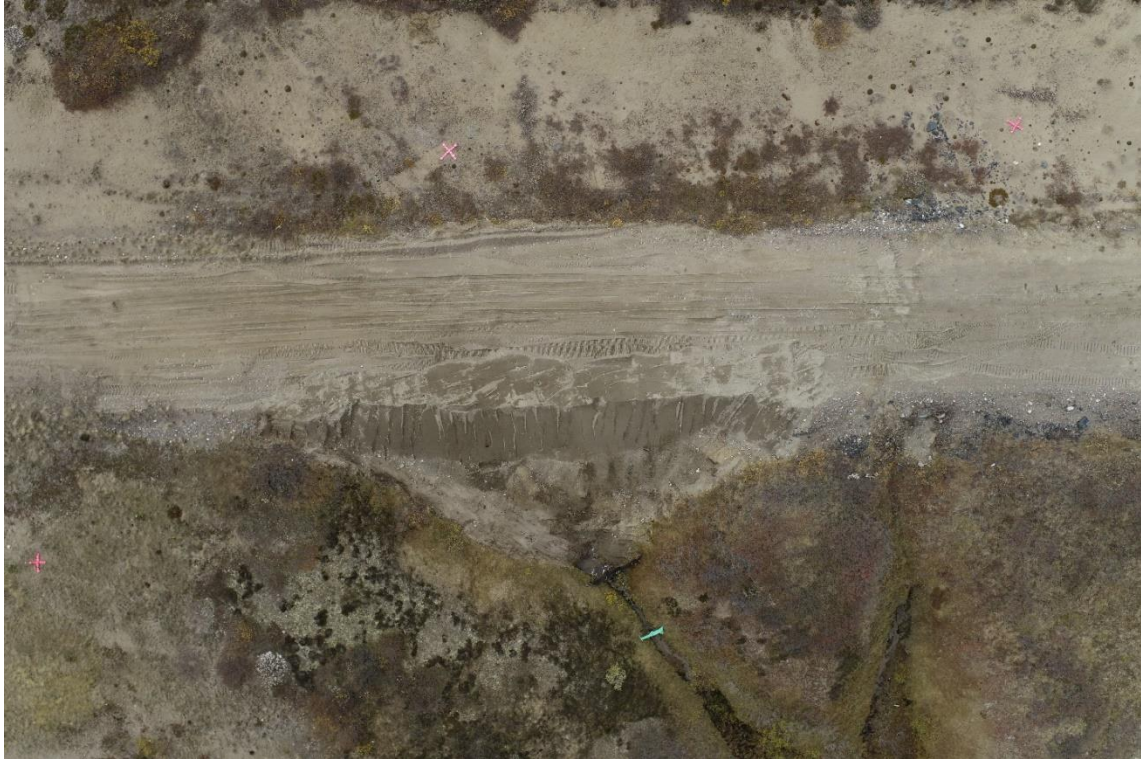
Historic water licence inspection reports (CIRNA 2015, CIRNA 2016, CIRNA 2017a) indicate that road washouts were observed along the road to the airstrip (Culvert 6) and near former Camp 3. The inspector indicated in 2017 that ore was reportedly used to repair the washout and requested confirmation to the Inspector and the NWB that construction materials used were from an approved source and free of metal leaching and acid rock drainage (MLARD; CIRNA 2017b). The previous owner's follow-up report (BCC 2017) disputes the use of waste rock in the repairs and indicates that confirmation of construction material characteristics would be provided in 2018. To date, no such records have been found. Accordingly, Blue Star undertook to have its project geochemist conduct a field reconnaissance of all infrastructure including the Culvert 6 and Camp 3 road repairs to identify areas where potentially acid generating (PAG) rock may have been used in construction.

Both the Culvert 6 and Camp 3 road repair locations were found to have PAG, intermittent flow and are located upstream of fish bearing waters. Given the potential for ARD and release of a deleterious substance harmful to fish, remedial measures were undertaken in September: the road bed and shoulders were excavated to remove PAG rock, and the road bed reconstructed with non-PAG esker materials. PAG rock that had rolled downslope from the road during past repair work was collected by hand to the greatest extent possible. Sediment and erosion control measures were in place throughout construction, water quality monitoring was undertaken, and silt fencing remains in place. PAG rock removed from the road bed has been relocated to the ore pad and temporarily stored with other PAG rock.

Photo 15. Completed road works near Camp 3

Blue Star confirms that materials used for road repairs were from an approved source, being the quarry licenced under KTCA20Q004, and are geochemically suitable as reported to the NWB in 2020.
