BGC Engineering Inc.

ULU MINE ANNUAL INSPECTION

| TITLE | ULU TANK FARM BERM CONDITION |

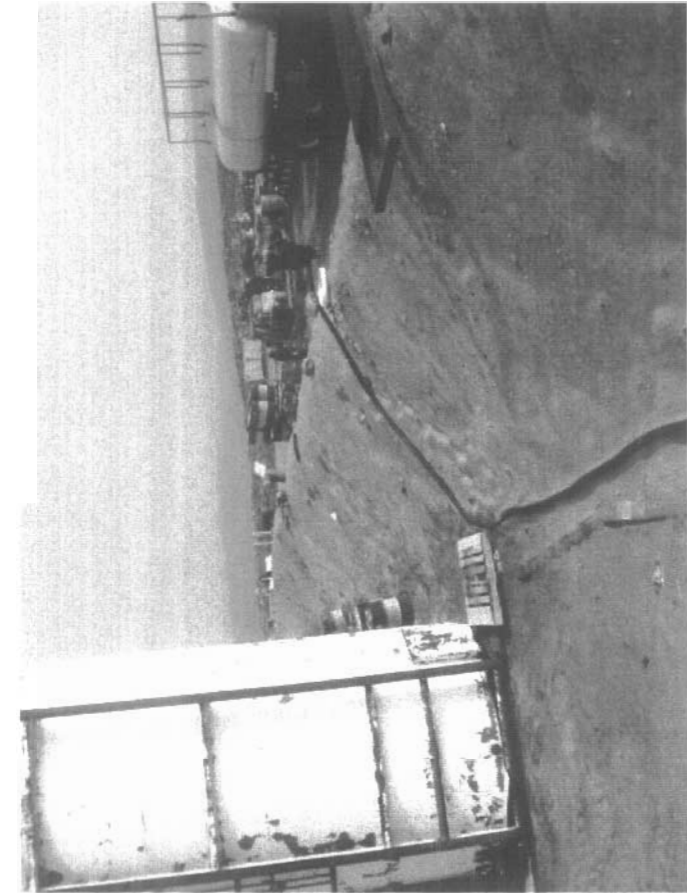
Photo shows a view of the inside of the main tank farm. The liner is exposed where the sand has been eroded off the inside face. The liner should be covered up.

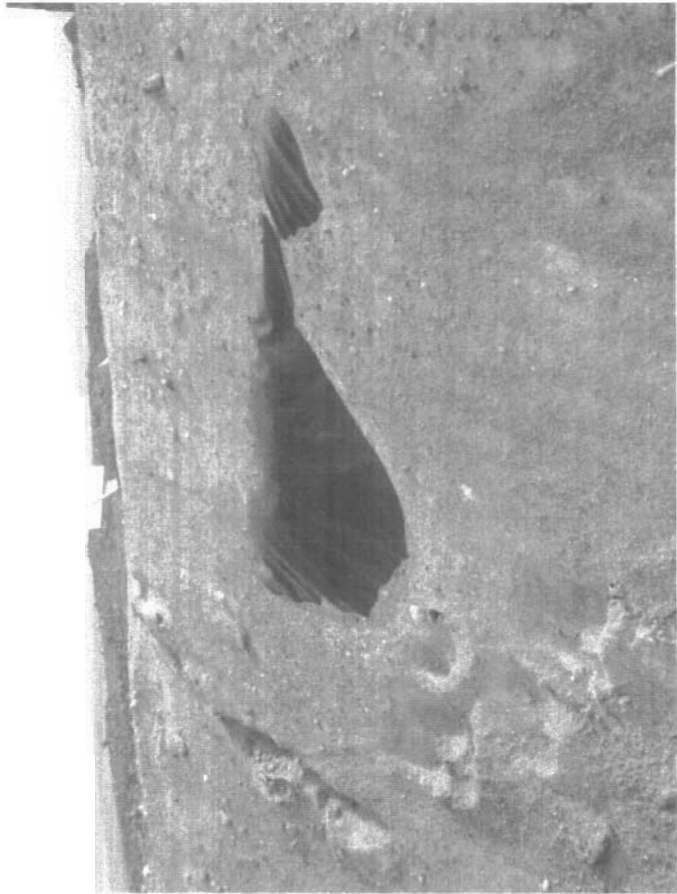
Photo shows the condition of the liner where the cover layer has eroded off.

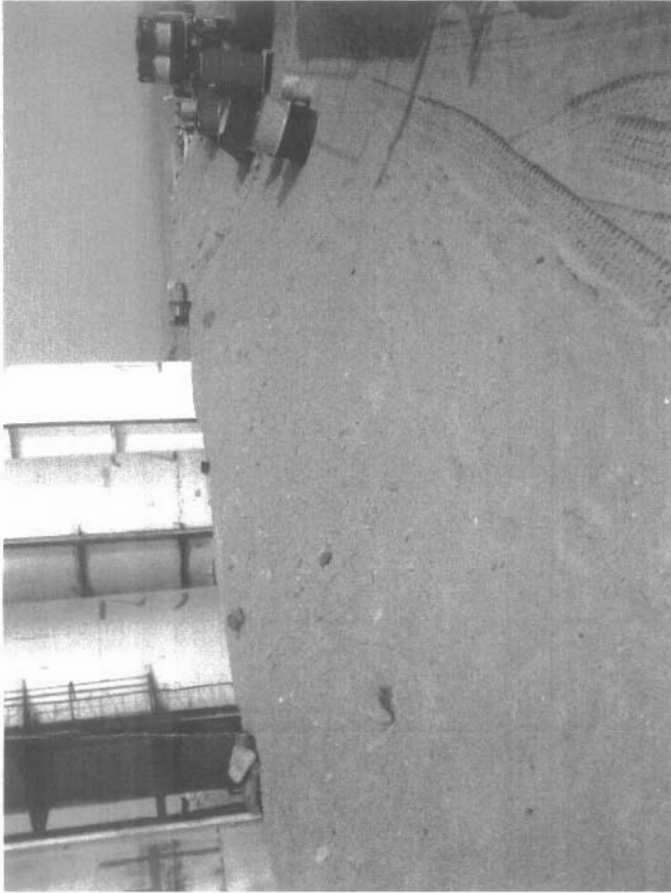
Photo shows the downstream side of the berm. This berm is approximately 1.2 to 1.5 m in height above the graded slope.

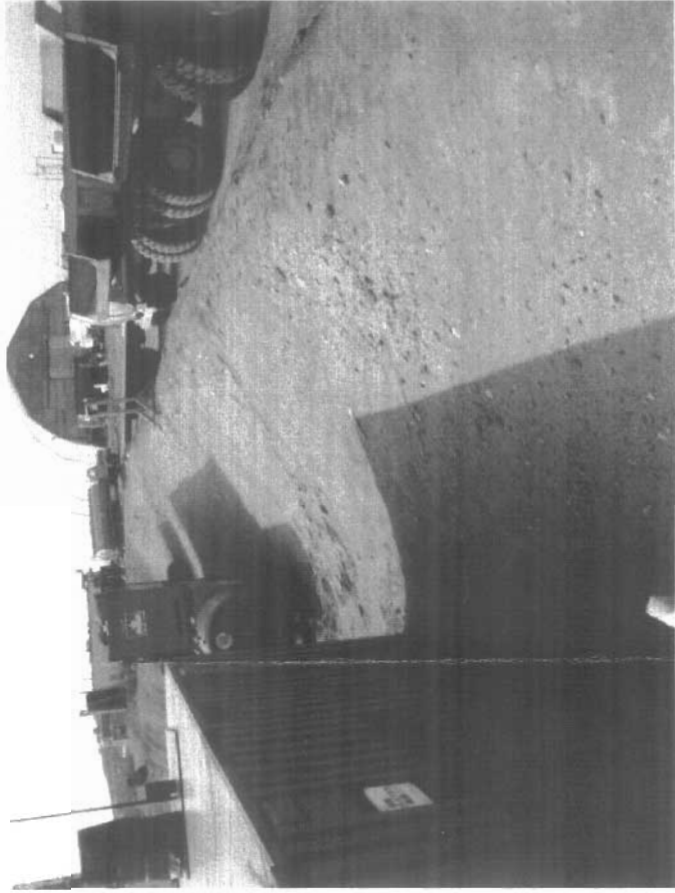
Photo shows the inside face of the western berm with no signs of exposure of the liner on this side.

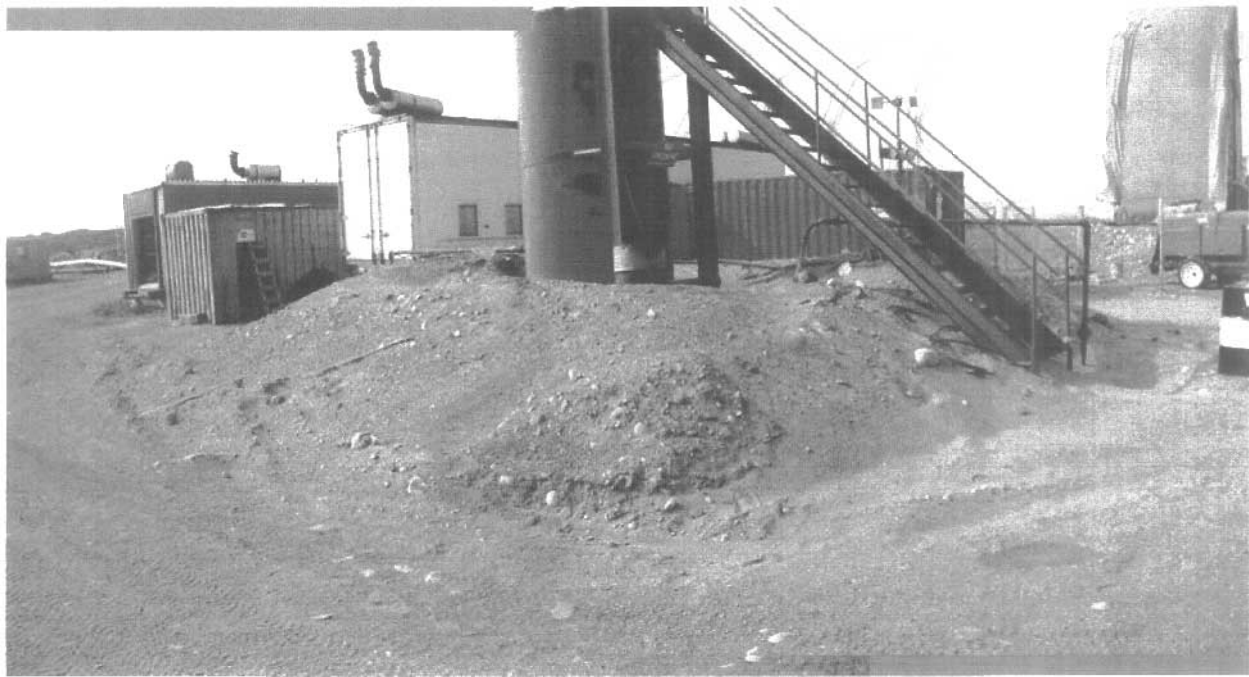
Photo shows the berm surrounding the day tank. It is a low berm approximately 1.2 m in height constructed of esker sand and gravel.

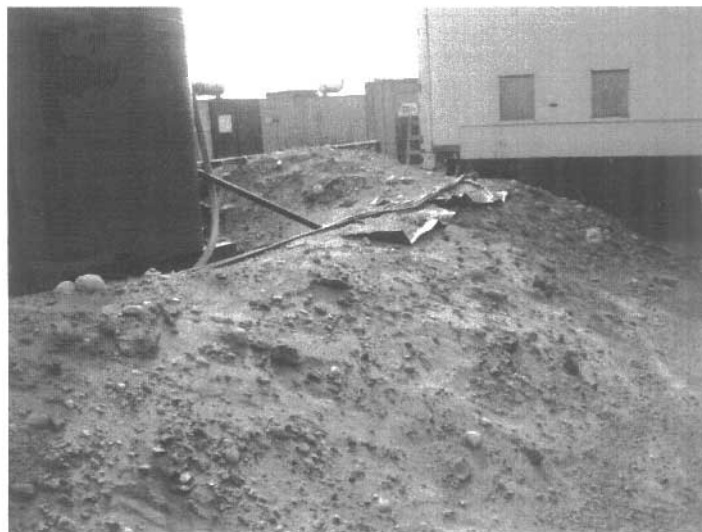
Photo shows the exposed edge of the liner.

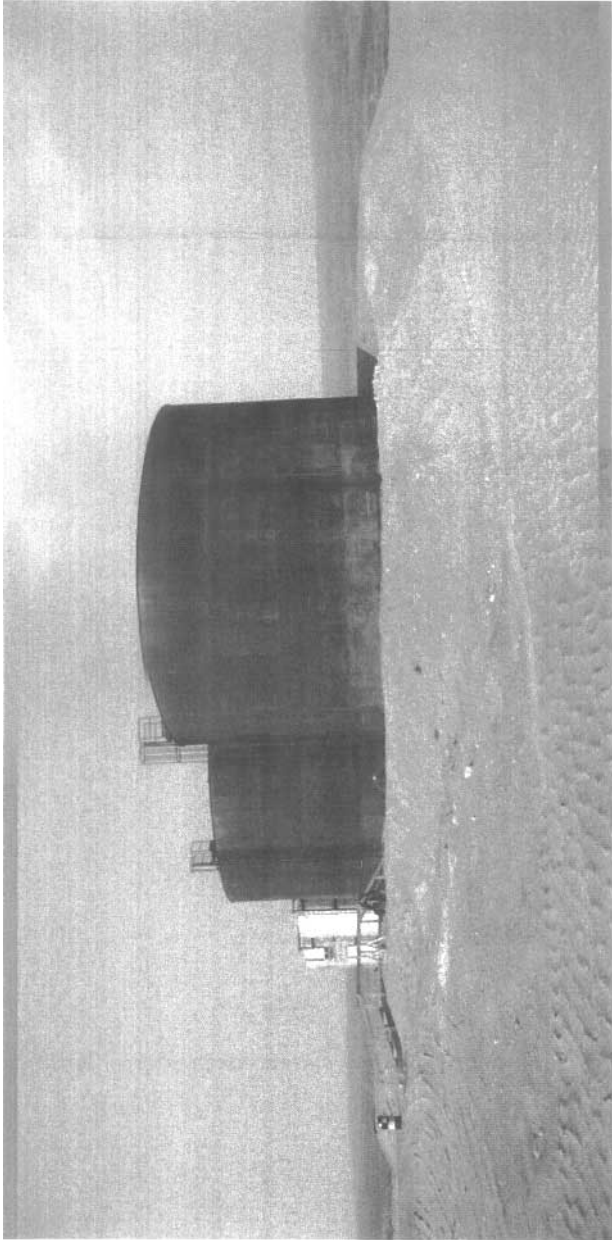
Photo shows the secondary berm located around the fuel tank farm at the Camp 3 area.

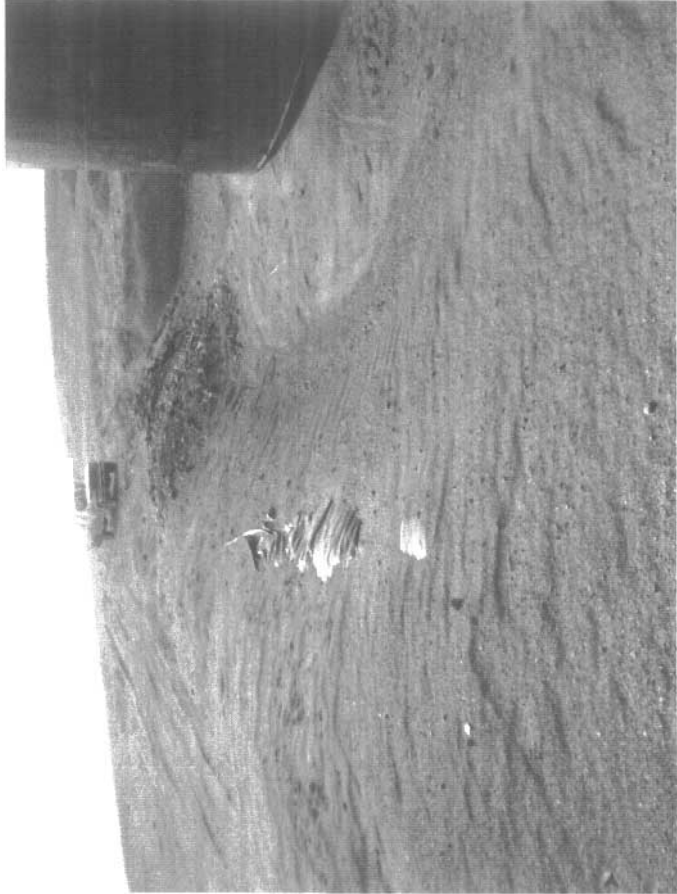
Photo shows exposure of the liner on the east side retention berm. On this side, the berm is approximately 1 to 1.2 m high.

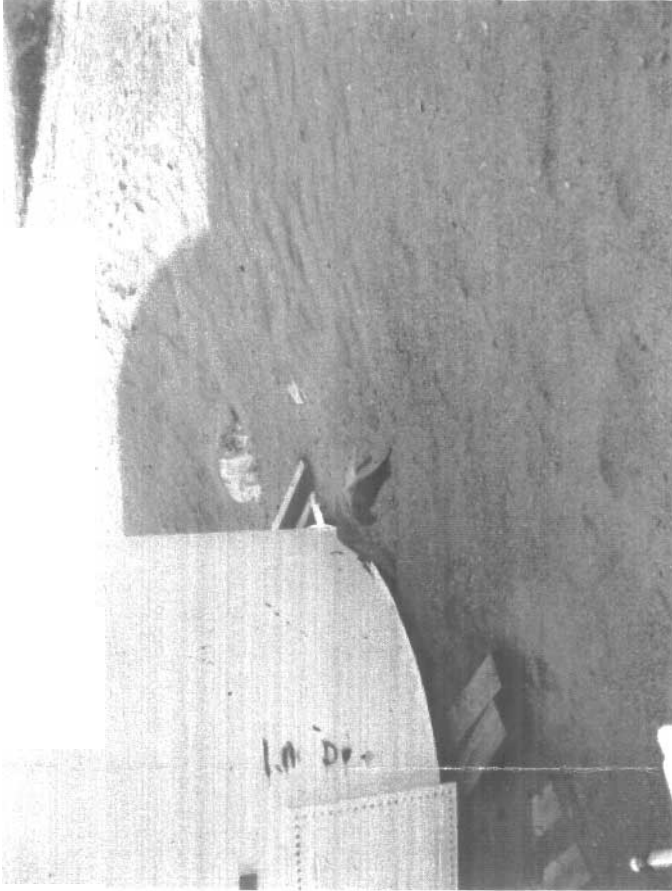
Photo shows some exposed liner right at the bottom of the stand up tanks.

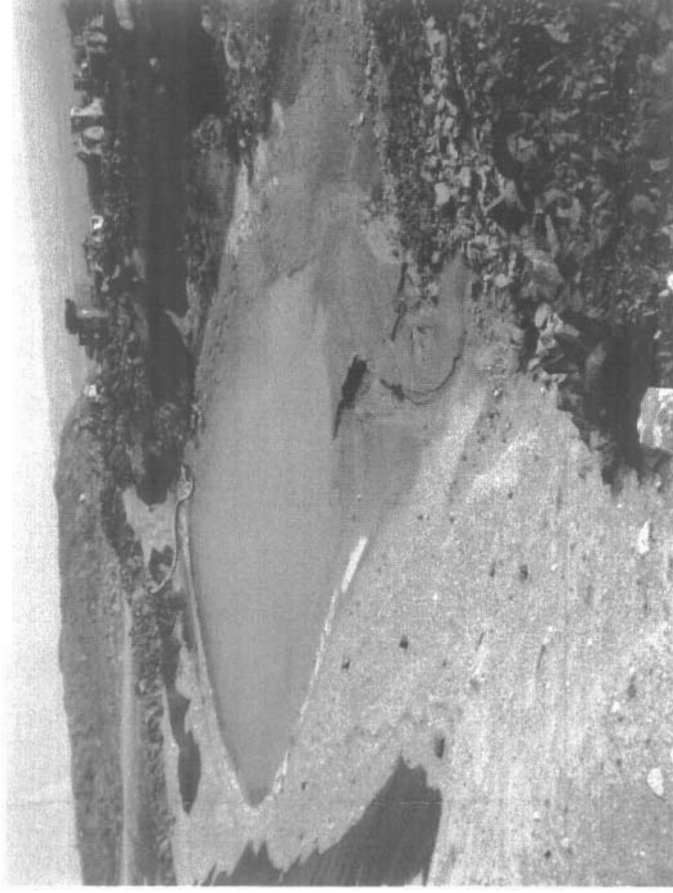
Photo shows the materials located in the bottom of the sump pond.

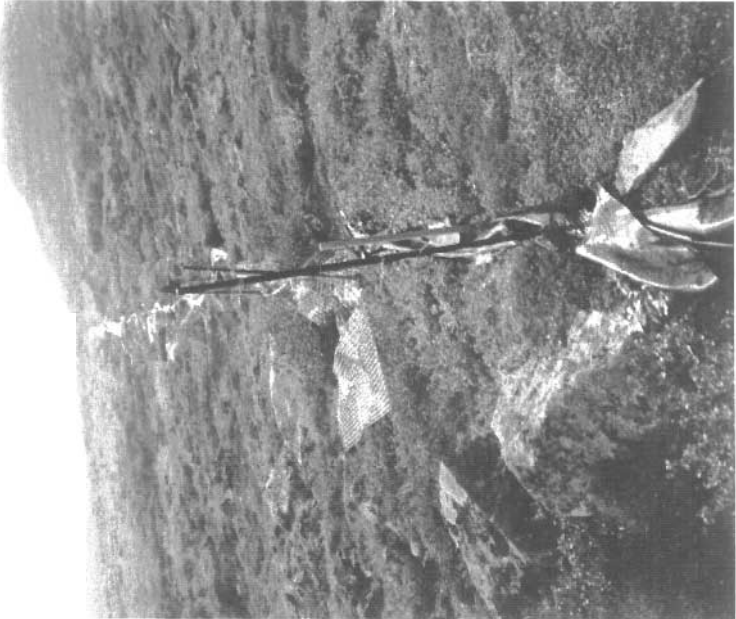
Photo shows a silt fence which had been installed approximately 10 to 15 m downhill from the waste rock storage pad area. The majority of this fence has been knocked down or is in disarray. The fence therefore, probably does not work.

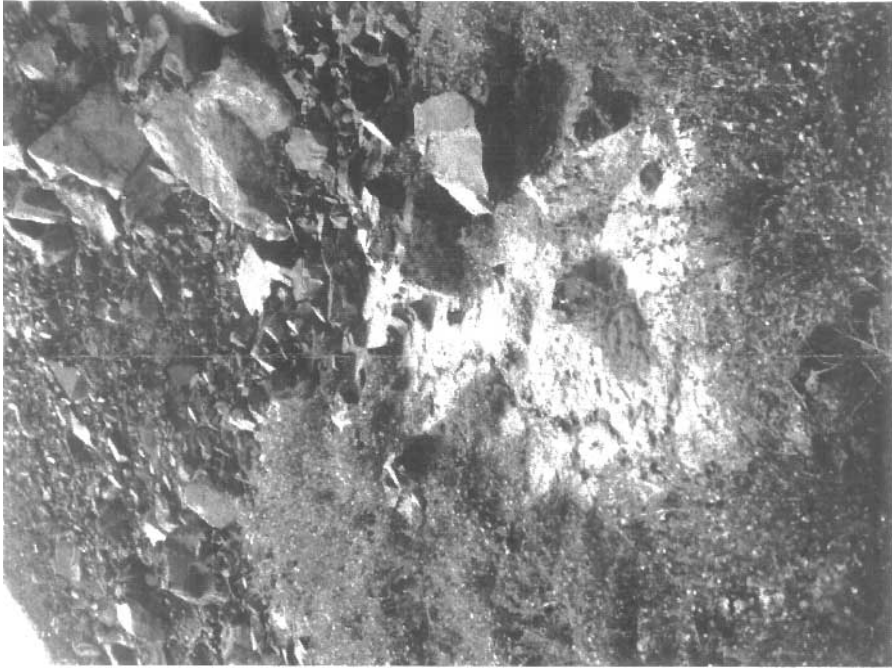
Photo shows a small flow of silt and sand located right at the toe of this lay down pad. At the current time, the material is slightly damp to moist but likely some seepage discharges from this location at other times of the year.

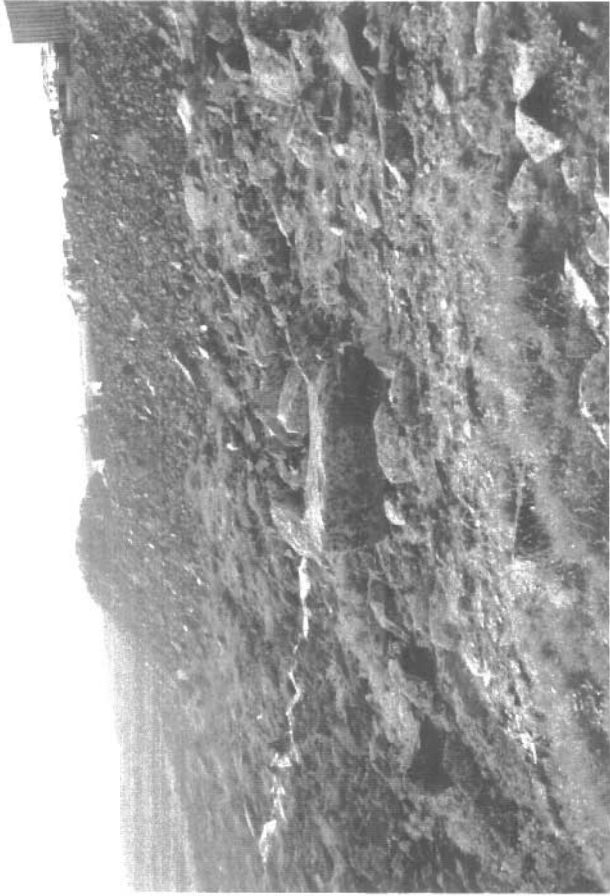
Photo shows the toe of waste rock lay down pad. The native ground conditions at the toe consists of frost jacked boulders with the odd isolated patch of till and organic material supplemented by grasses and low shrubs.

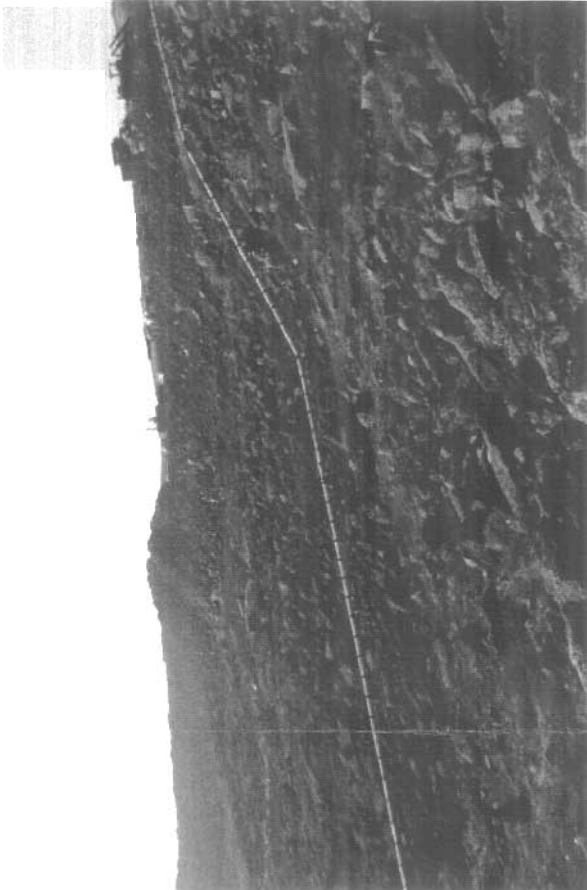
Photo shows the waste rock storage area and lay down pad located just downhill from the portal.

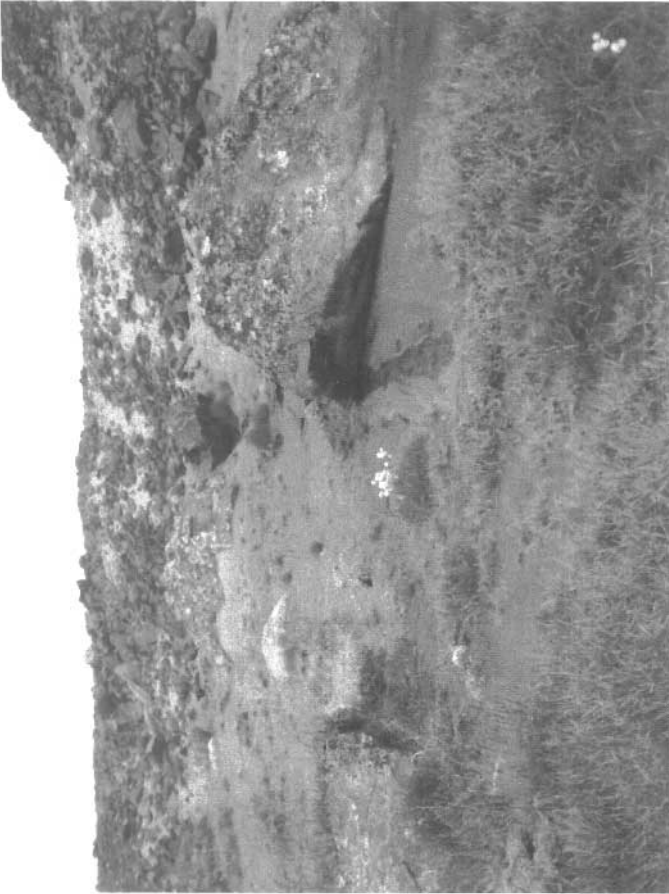
Photo shows one seepage discharge which is occurring approximately near the eastern corner of the exposed face. In association with this discharge can be seen a significant amount of sand in the area possibly due to surface water runoff or possibly due to wind blown movement.

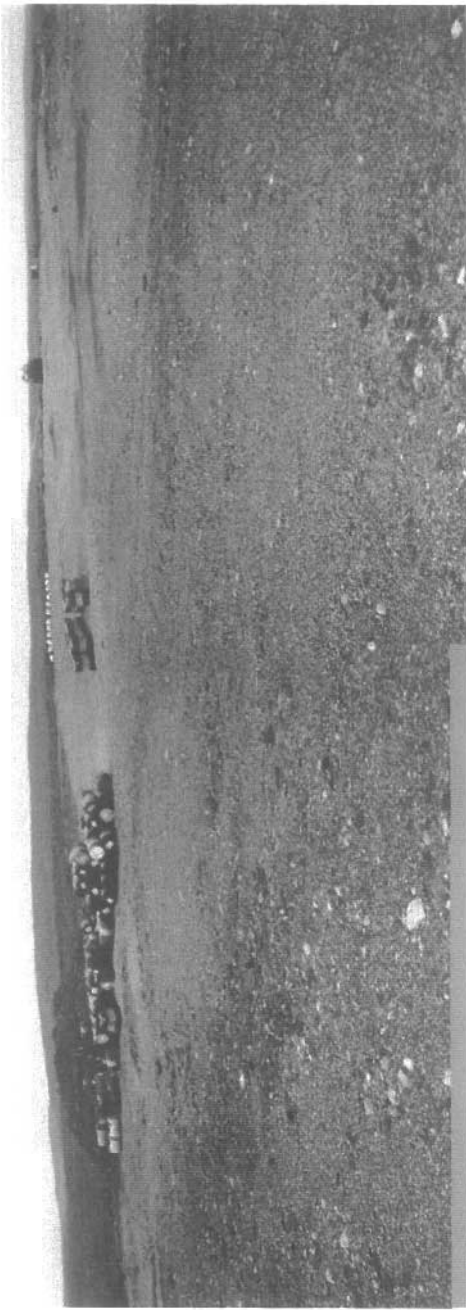
Photos shows the top of the ore storage pad looking towards the south

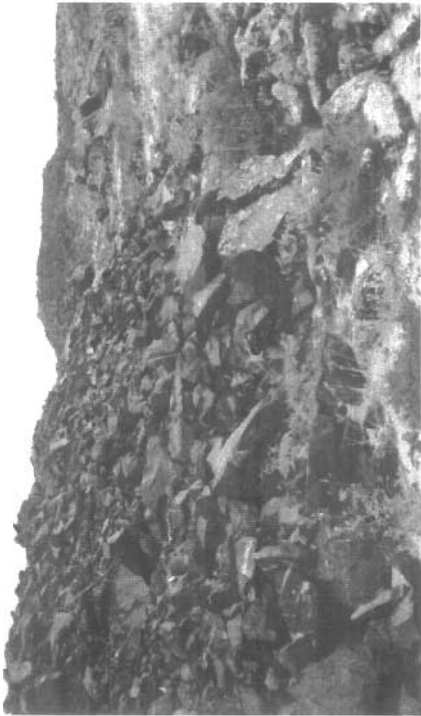
Photo shows a view looking along the east toe face looking towards the north. At this location, the pad appears to be approximately 3 m thick.

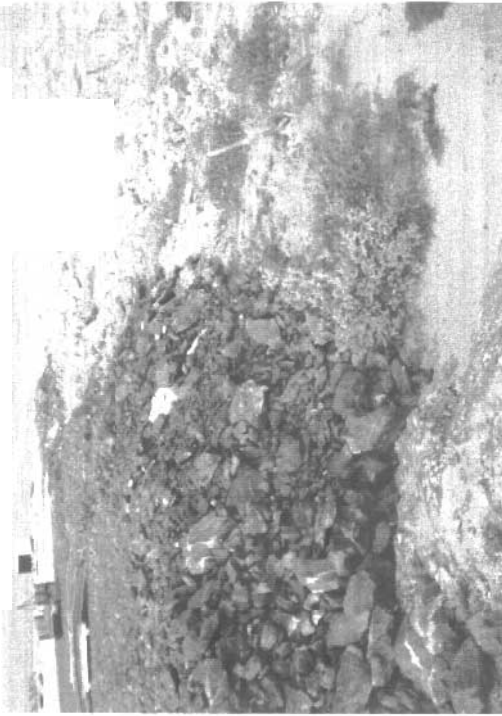
Photo shows the exposed toe of the storage pad looking along its southwest face. The fill in this area is approximately 1 to 1.5 m in thickness. Some frost jacked bedrock is noted at the toe. Surface runoff goes westward towards West Lake rather than the other direction

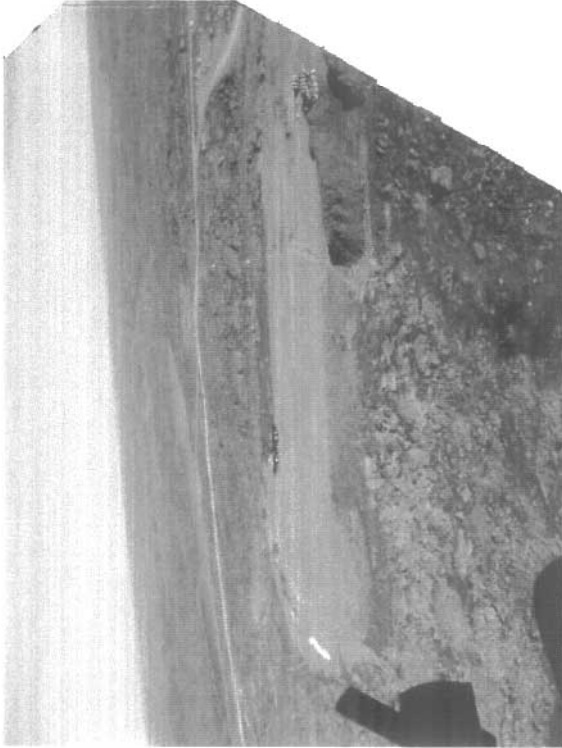
Photo shows an aerial view of the ore storage pad, looking towards the west.
