## **WOLFDEN RESOURCES INC.**

### **2006 ANNUAL GEOTECHNICAL INSPECTION SELECTED STRUCTURES**

### **ULU GOLD PROJECT, NU**

PROJECT NO.: 0385-004-03  
DATE: OCTOBER 5, 2006

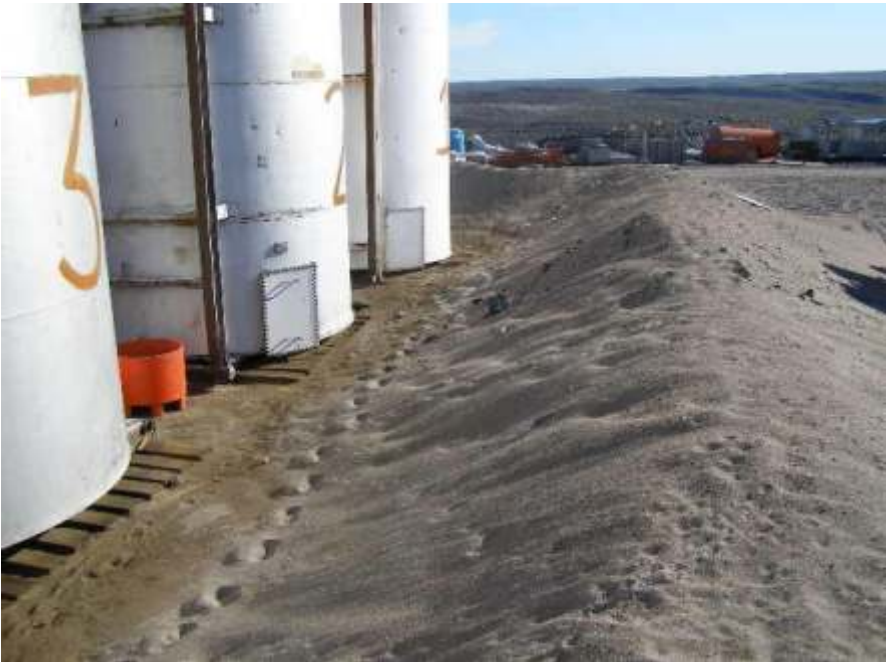
Shows the inside of the sand berm where there’s no sign of standing water.

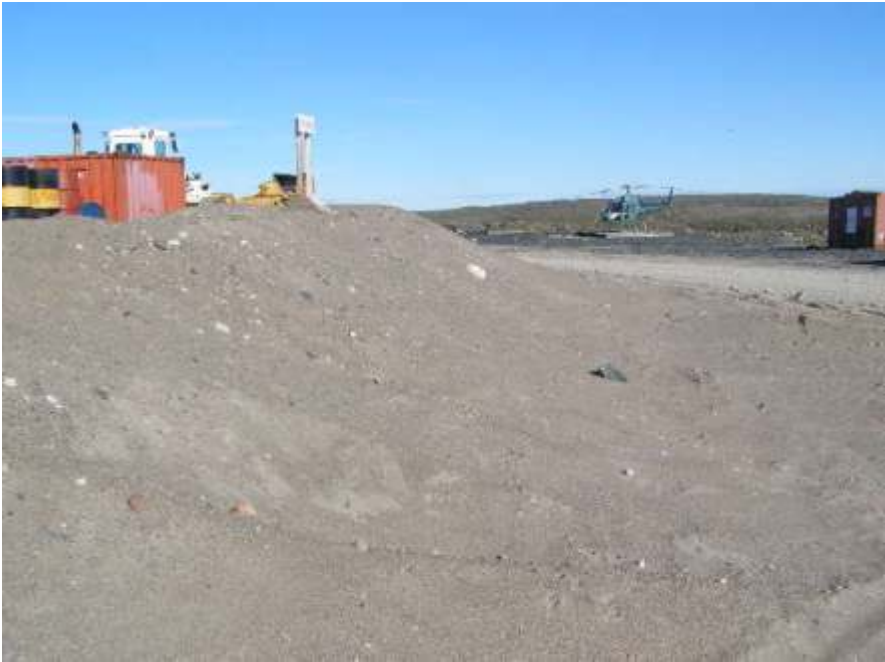
Shows the downstream side of the northern berm, where there is no sign of seepage, sloughing or erosion.

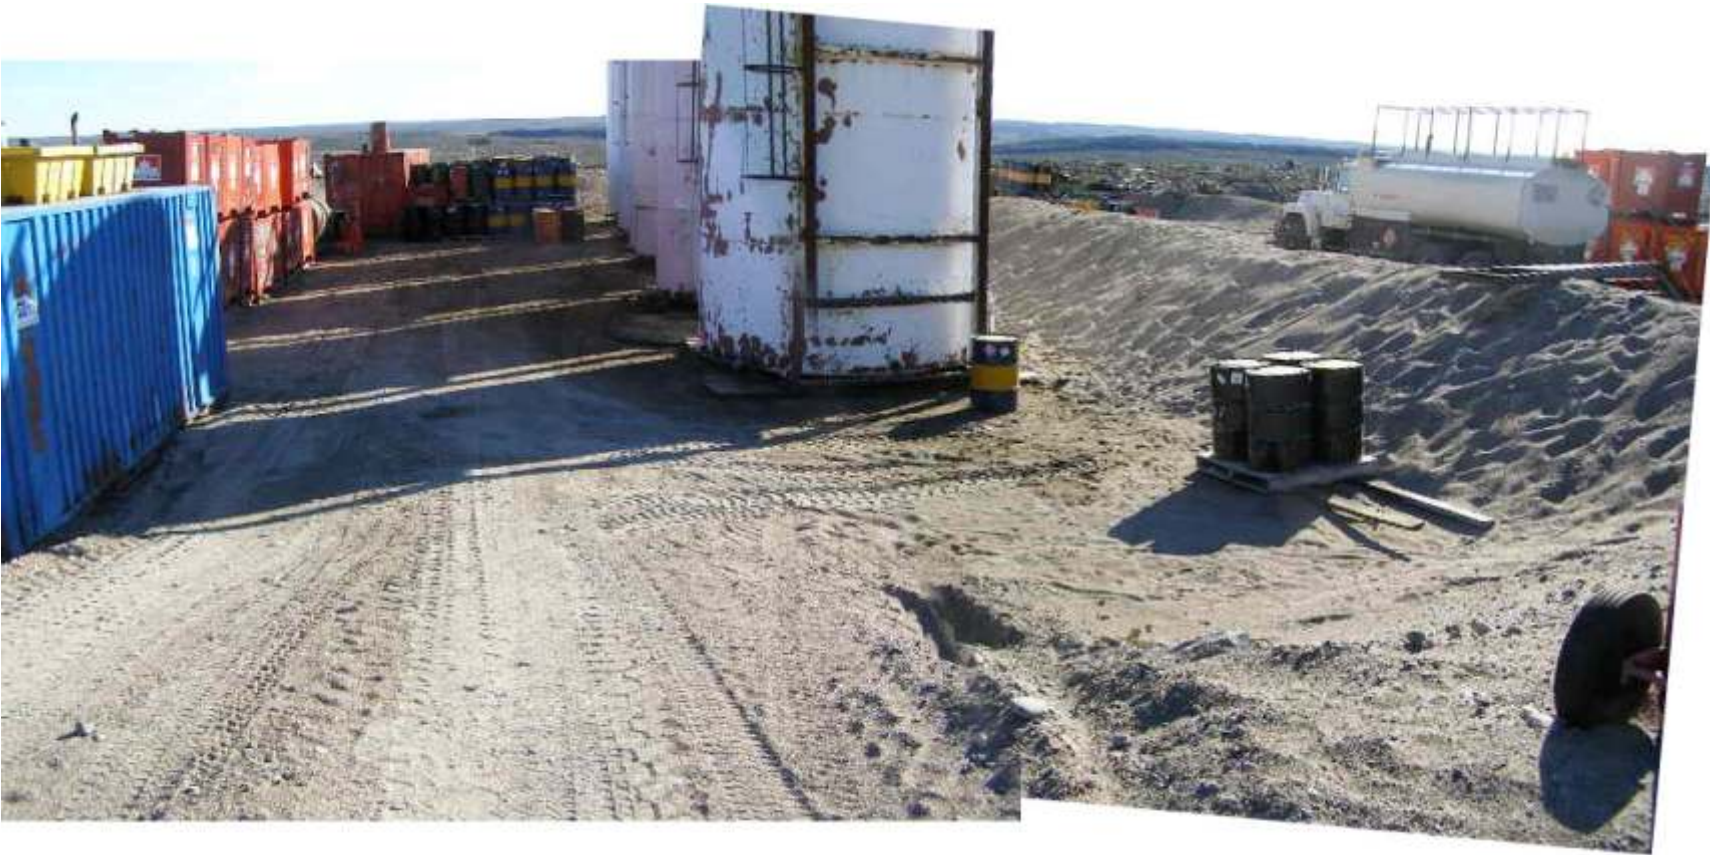
<b>LOCATION:</b>	Northeast corner of the Ulu camp pad.
<b>FUNCTION:</b>	Provides secondary containment for five large fuel tanks and numerous barrels of fuel.
<b>SIZE:</b>	~20 m wide by ~50 m long.
<b>BERM HEIGHT:</b>	~1.5 to 2 m above adjacent grade.
<b>CREST ELEVATION:</b>	No detailed survey information provided.
<b>BERM CONDITION:</b>	Berm is constructed from esker sand and gravel and appears in good condition, as shown on Figure 4. No current exposures of the internal geomembrane liner.
<b>SEEPAGE:</b>	No evidence of seepage observed at the berm toe.
<b>MAINTENANCE / MONITORING</b>	
<b>RECOMMENDATIONS:</b>	None.
<b>CONCLUSIONS:</b>	The berm appears in satisfactory condition.

View of the inside of the containment berm, with no signs of erosion, exposed liner or standing water.

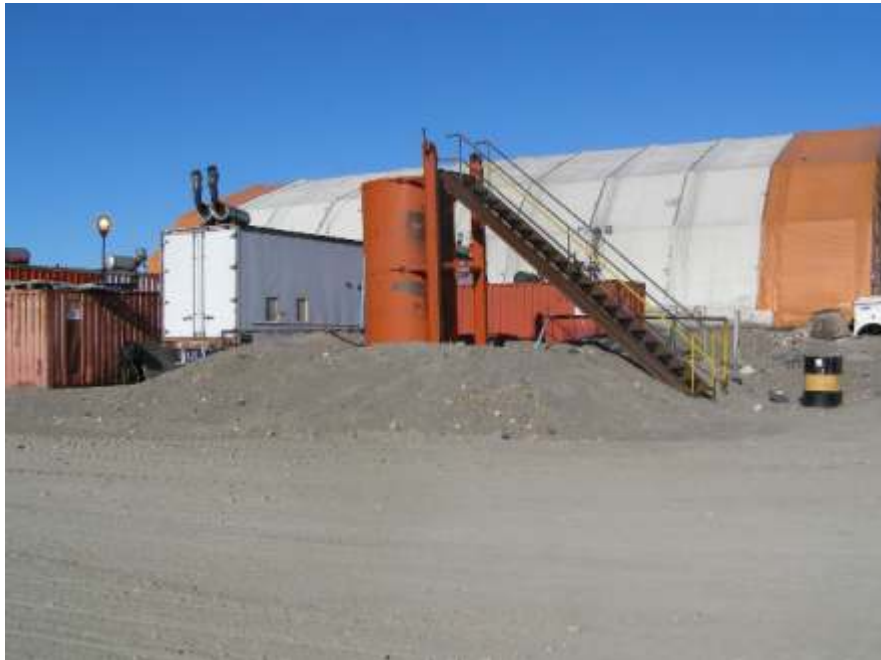
**BERM CONDITION:** Berm is constructed from esker sand and gravel and appears in good condition, as shown on Figure 5. No liner exposures.

View of the small berm located around the Day Tank.

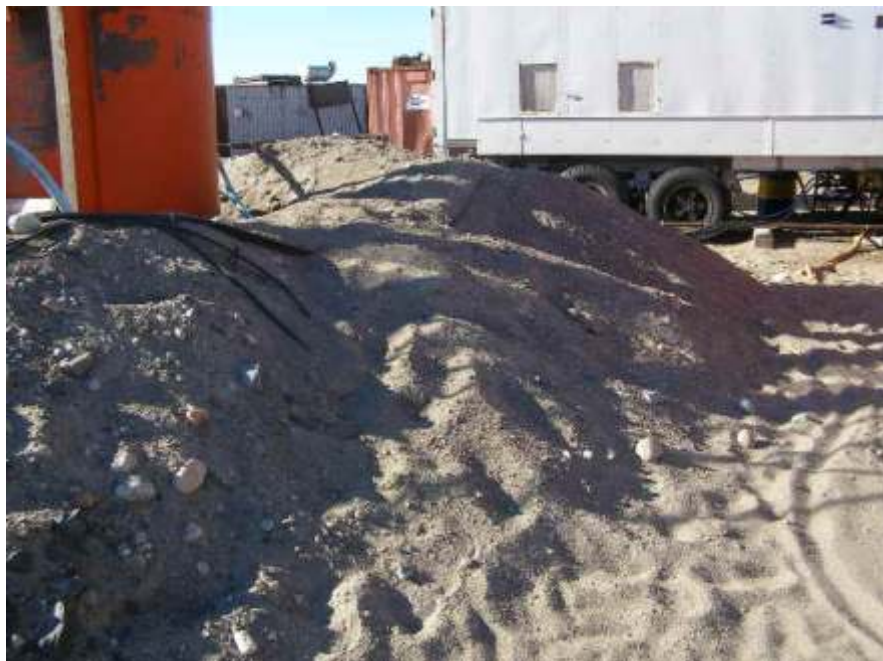
View of the berm located on the west side of the Day Tank.

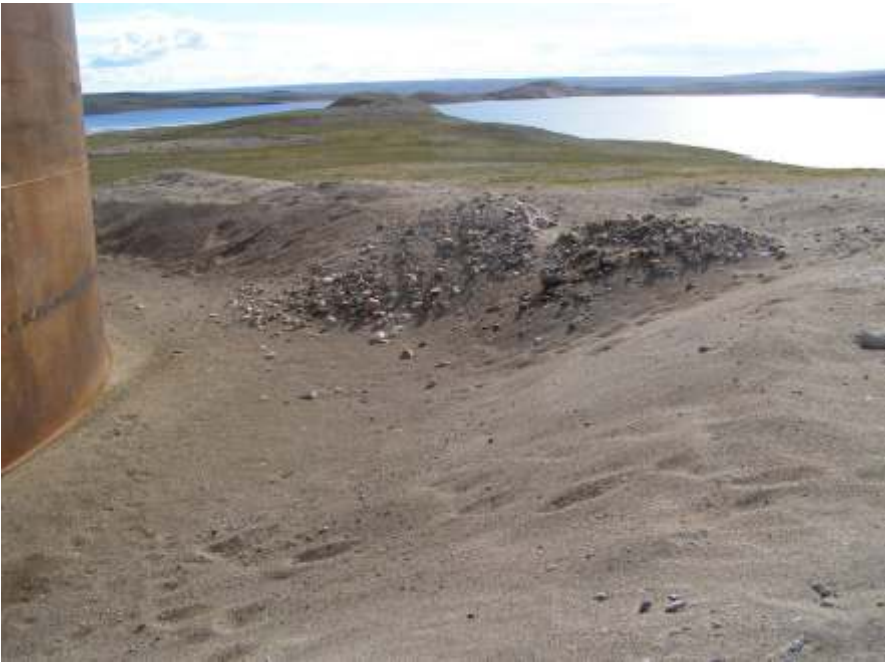
There are no signs of standing water inside the berm or any exposure of the liner at this area.

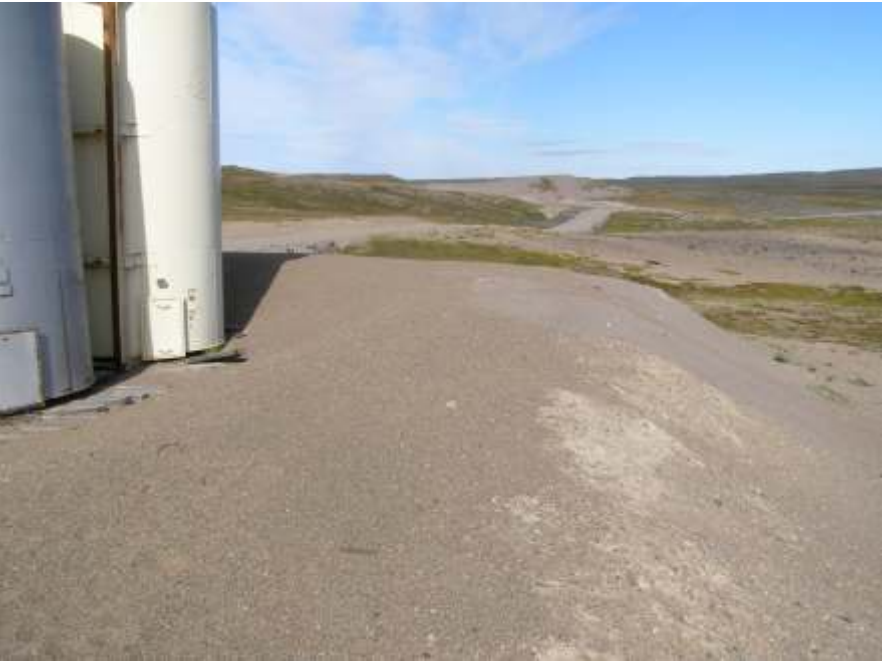
Shows the northeast corner berm with no signs of erosion or deformation.

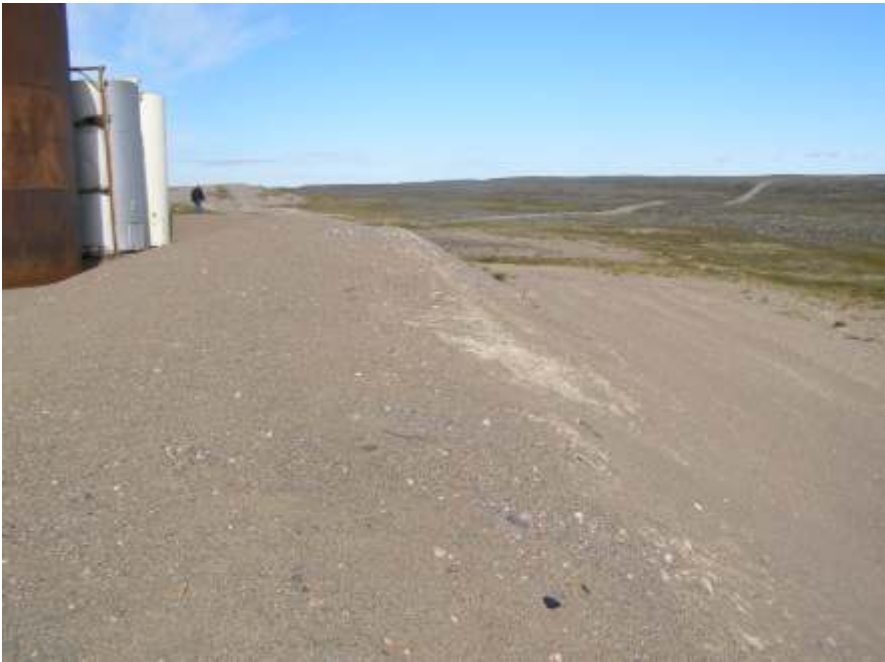
Shows the downstream toe of the east side berm. No signs of erosion, deformation or seepage at this location.

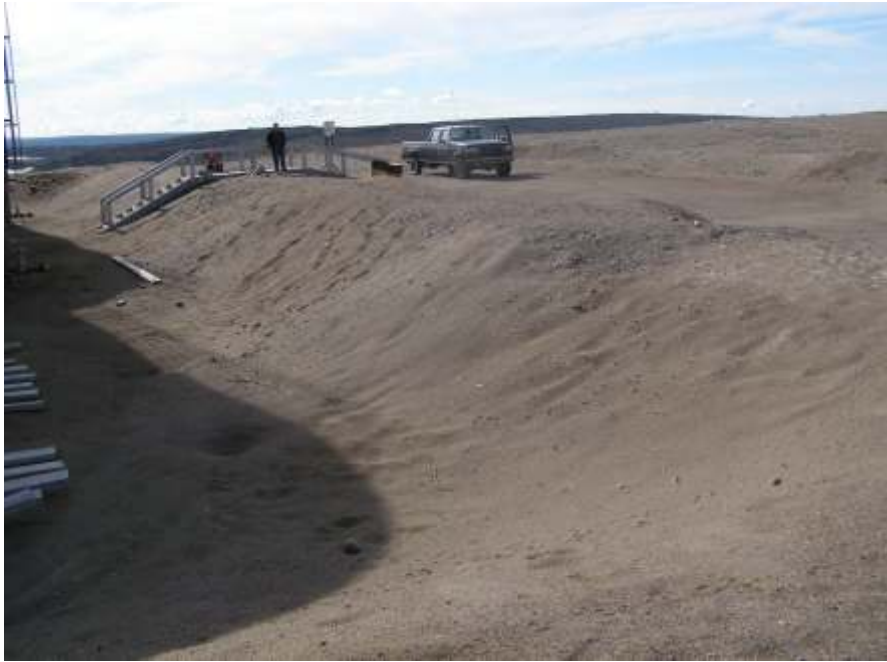
Shows the inside face of the west side berm. No signs of deformation, erosion, or exposed liner at this location.

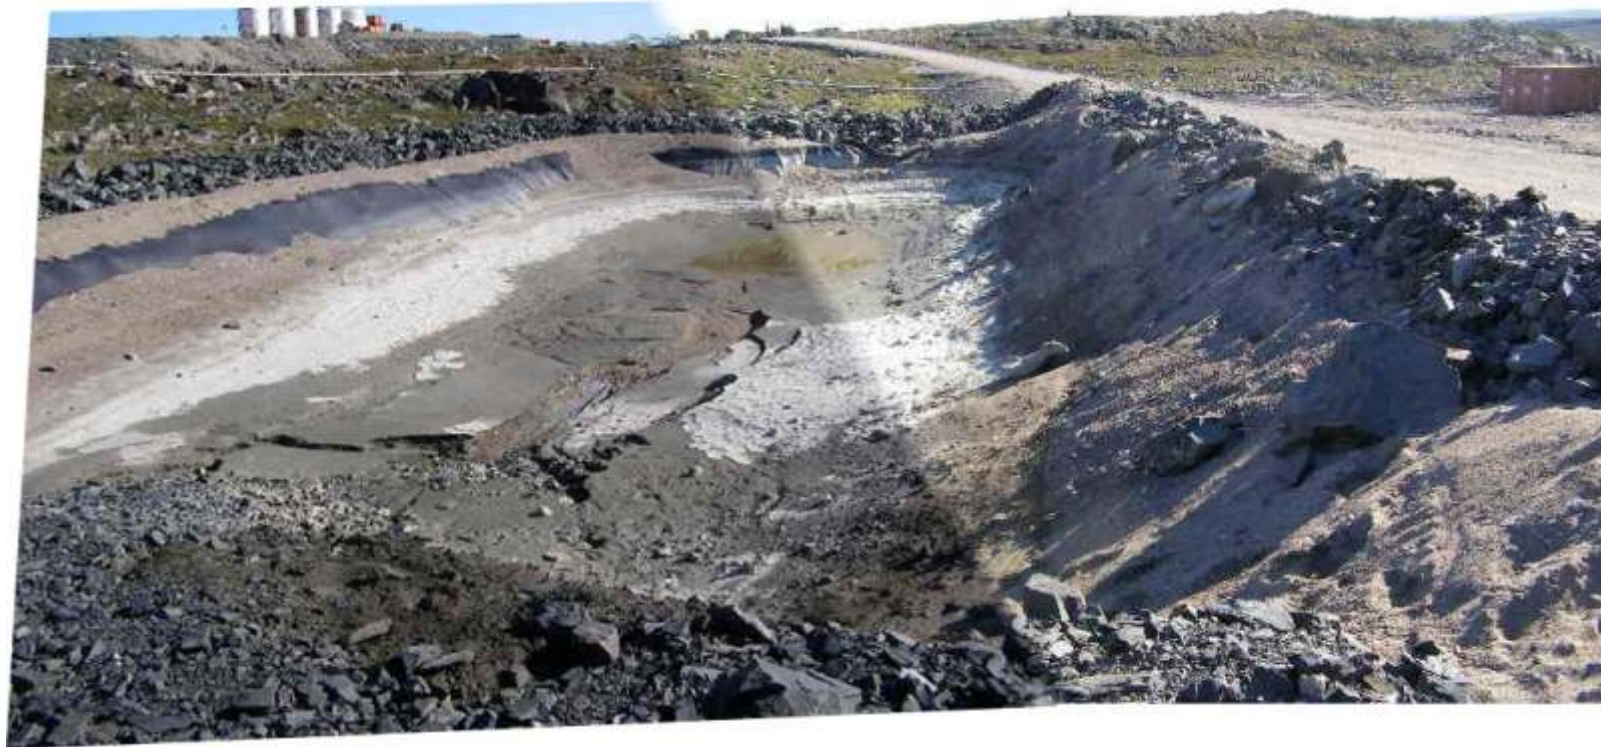
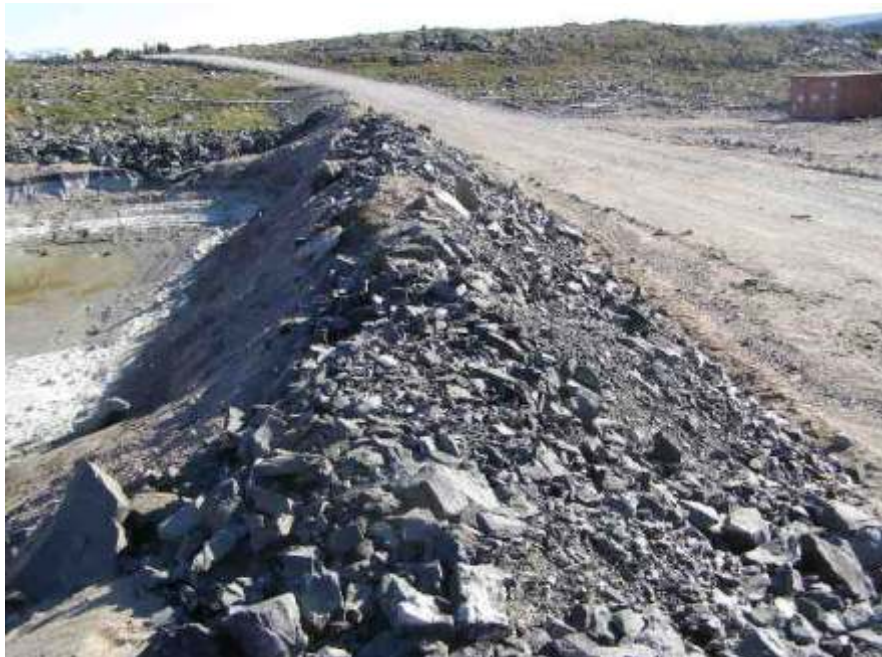
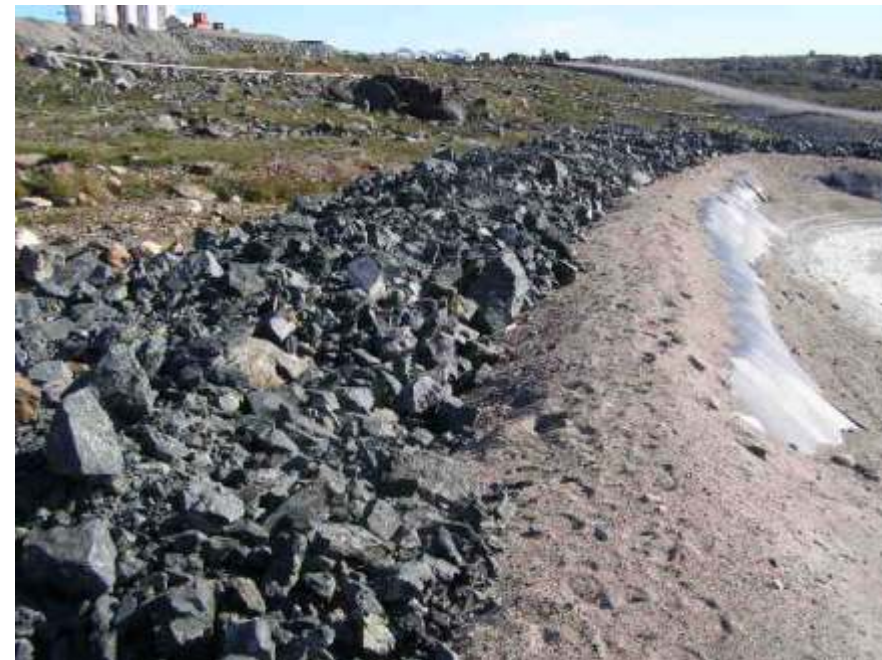
PROJECT			ULU MINE ANNUAL INSPECTION		
TITLE			MINE SUMP PHOTOS		
PROJECT No.		FIGURE No.		REV.	
0385-004-03		7		0

<b>LOCATION:</b>	Directly outside the portal, uphill from both a local access road and the portal laydown pad.
<b>FUNCTION:</b>	Provides containment for settling and sediment retention of mine water pumped from the decline ramp.
<b>SIZE:</b>	~20 m wide by ~30 m long.
<b>BERM HEIGHT:</b>	~1.5 to 2 m above adjacent grade.
<b>CREST ELEVATION:</b>	No detailed survey information provided.
<b>BERM CONDITION:</b>	<p>Berm is constructed from rockfill (waste rock) and esker sand and gravel, as shown on Figure 7. Geomembrane liner within berm is exposed at several locations. The liner at north end of the pond has become free. As noted previously, some 5 to 6 rockfill fragments have fallen onto the inside face of the berm.</p> <p>Access road and portal laydown pad located on the downhill side of the sump.</p>
<b>SEEPAGE:</b>	No evidence of seepage observed at the berm toe.

<b>CONCLUSIONS:</b>	Outside of the noted minor maintenance, the sump appears in satisfactory condition.
---------------------	-------------------------------------------------------------------------------------

<b>RECOMMENDATIONS:</b>	<ol style="list-style-type: none"><li>1. The folded free flap of liner at the north end could be held down with some fill to prevent it from becoming loose.</li><li>2. Anecdotal information from site indicates no leakage is occurring from the sump when used this year. As such, it appears that no leakage is occurring around the noted rock fragments.</li><li>3. Recent information provided by Wolfden notes that the liner used at site was "ArcticLiner", a PVC alloy material previously supplied by Layfield Plastics for secondary containment. Information for this material notes that it is for exposed applications and hence, no technical need for a covering layer.</li></ol>
-------------------------	-----------------------------------------------------------------------------------------------------------------------------------------------------------------------------------------------------------------------------------------------------------------------------------------------------------------------------------------------------------------------------------------------------------------------------------------------------------------------------------------------------------------------------------------------------------------------------------------------------------------------------------------------------------------------------------------------------

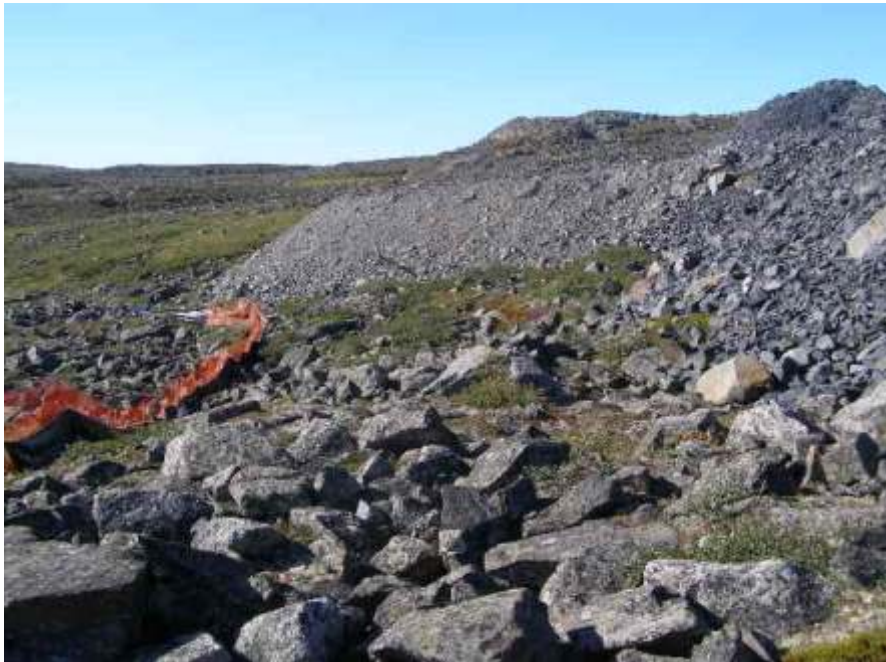
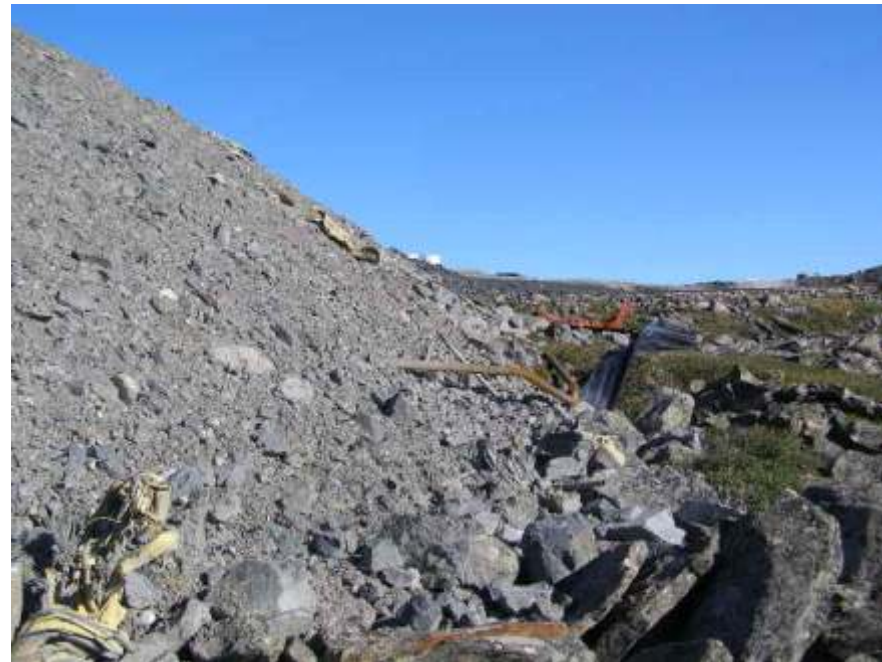
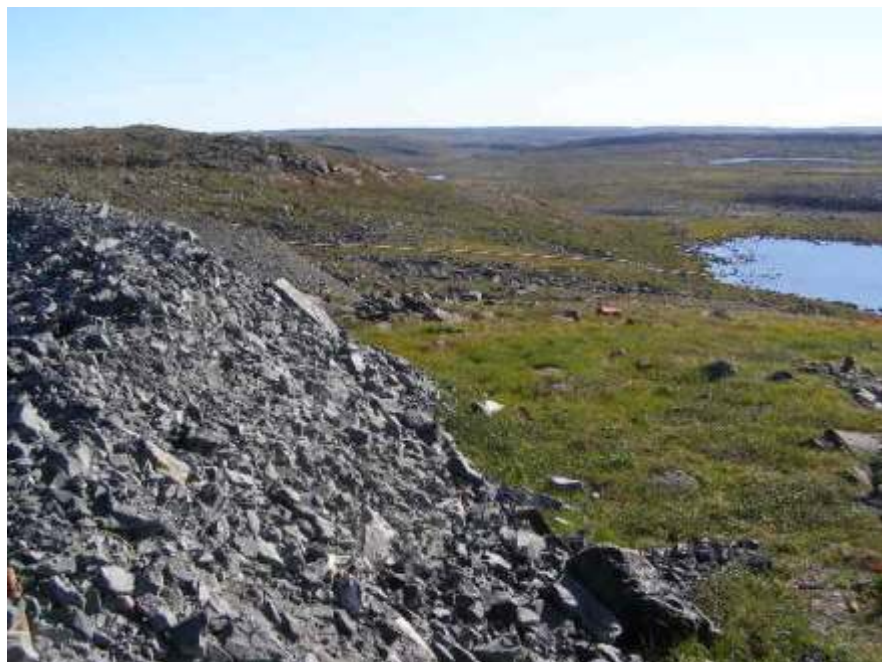
PROJECT			ULU MINE ANNUAL INSPECTION		
TITLE			WASTE ROCK PAD PHOTOS		
PROJECT No.		FIGURE No.		REV.	
0385-004-03		8		0

<b>LOCATION:</b>	Pad is located just downhill from the portal and local access road, approximately 150 m from East Lake.
<b>FUNCTION:</b>	Initially constructed from waste rock from the decline ramp development. Appears a minor amount of mine muck material was recently placed on the pad as well, as it now covers a portion of the silt control fence.
<b>SIZE:</b>	~50 m wide by ~200 m long.
<b>PAD THICKNESS:</b>	Ranges from 1 to 5 m above original topography.
<b>CREST ELEVATION:</b>	No detailed survey information provided. Pad surface graded down towards the southeast.
<b>PAD CONDITION:</b>	Pad is constructed from rockfill (waste rock), as shown on Figure 8. Toe of the pad sits at the angle of repose for rockfill.
<b>TOE DISCHARGE:</b>	No significant drainage watercourses observed downhill from the pad.  Any potential pad drainage heads downhill into East Lake.
<b>MAINTENANCE / MONITORING</b>	
<b>RECOMMENDATIONS:</b>	No concerns but seepage quantity and quality could be monitored for baseline information. Site staff have undertaken this task and all water sample results are within license requirements.

<b>CONCLUSIONS:</b>	The pad appears stable with no signs of erosion or instability. Runoff from the pad is collected within East Lake that passes through a wetland before entering Ulu Lake.

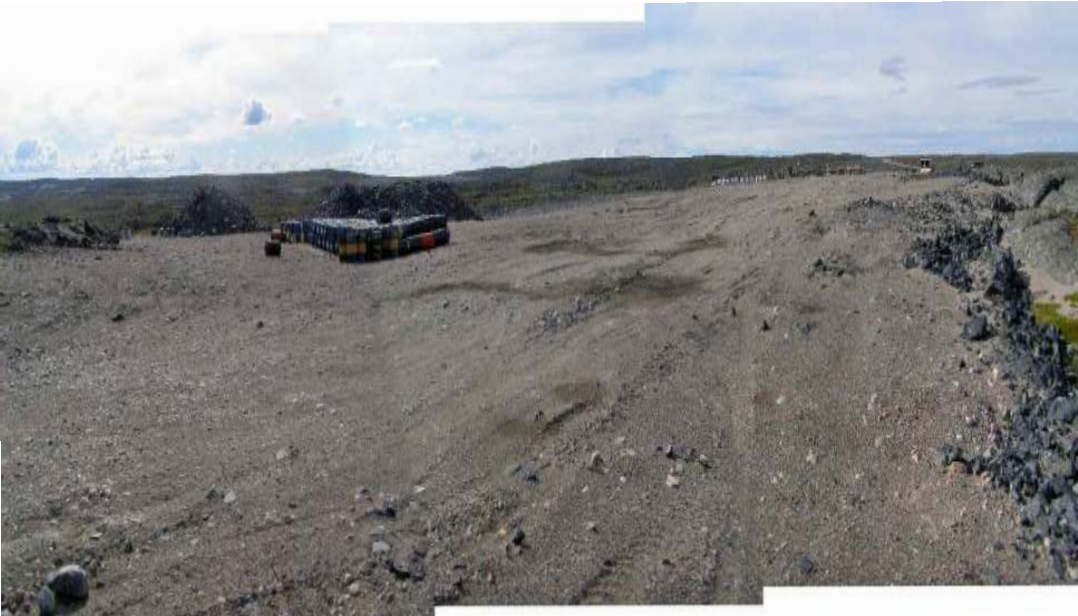
Shows the top of the Ore Storage Pad.

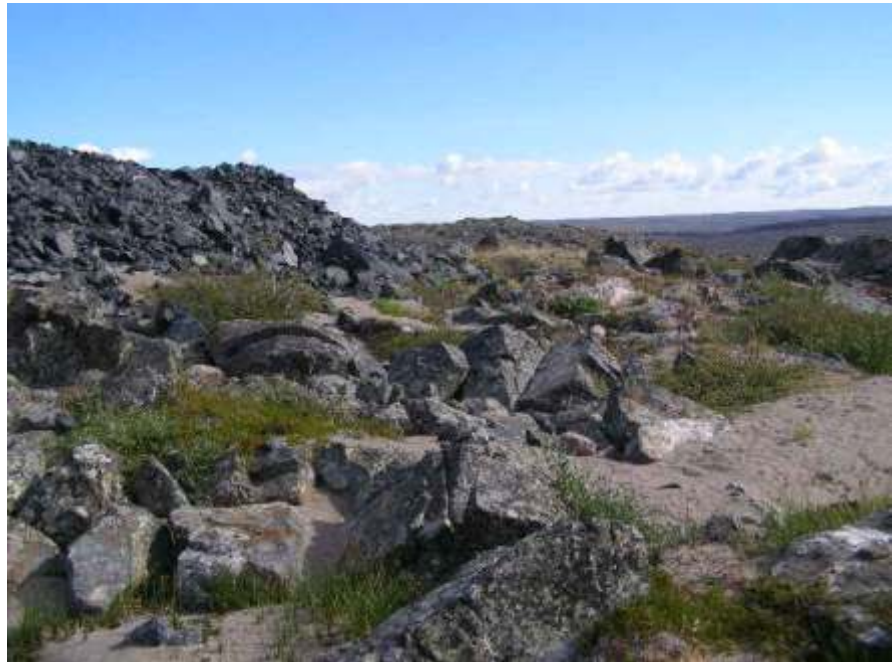
Shows a view taken along the toe, with no signs of discharge.

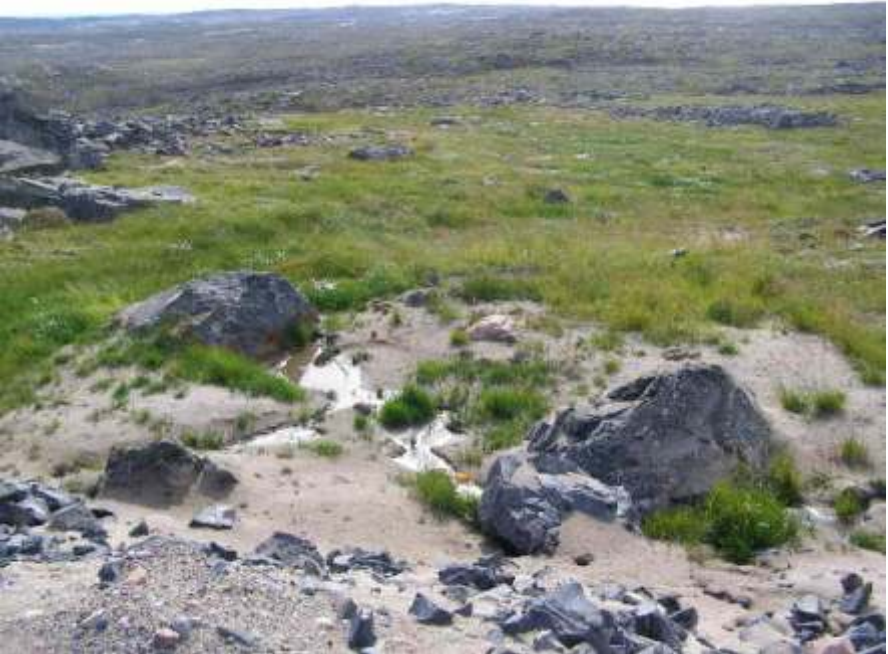
<b>LOCATION:</b>	Pad is located southwest of the Portal Laydown Pad, approximately 325 m from East Lake.
<b>FUNCTION:</b>	Constructed from waste rock and then partially covered with esker sand and gravel. The pad was originally constructed for temporary storage of ore before its proposed shipment. Two ore stockpiles are currently located on the pad. Ore appears visually fresh.
<b>SIZE:</b>	~100 m wide by ~200 m long.
<b>PAD THICKNESS:</b>	Ranging from 1 to 3 m above original topography.
<b>CREST ELEVATION:</b>	No detailed survey information provided.
<b>PAD CONDITION:</b>	Pad is constructed from rockfill (waste rock) and esker sand and gravel, as shown on Figure 9. Two ore stockpiles located on the east corner of the pad. Toe of the pad sits at the angle of repose for rockfill.
<b>TOE DISCHARGE:</b>	<p>One small flowing discharge, along with sediment (sand), noted at the toe. Water appeared clear. Small drainage watercourse observed downhill from the pad.</p> <p>Majority of the pad drainage heads downhill into East Lake.</p> <p>Some minor pad drainage would head west from the southwest corner of the pad. No drainage was observed in this direction.</p>

Shows a close-up of one small discharge at the toe. Two streams come together into one stream and then flow into a wetlands area located downstream of this pad

<b>MAINTENANCE / MONITORING</b>	
<b>RECOMMENDATIONS:</b>	Monitor ore pad seepage testing for quantity and quality (especially arsenic), in agreement with recommendations provided in BGC/Lorax (2005). Gartner Lee undertakes this sampling program on an annual basis.
<b>CONCLUSIONS:</b>	The pad appears stable with no signs of erosion or instability. Runoff from the pad is collected within East Lake that passes through a wetland before entering Ulu Lake.

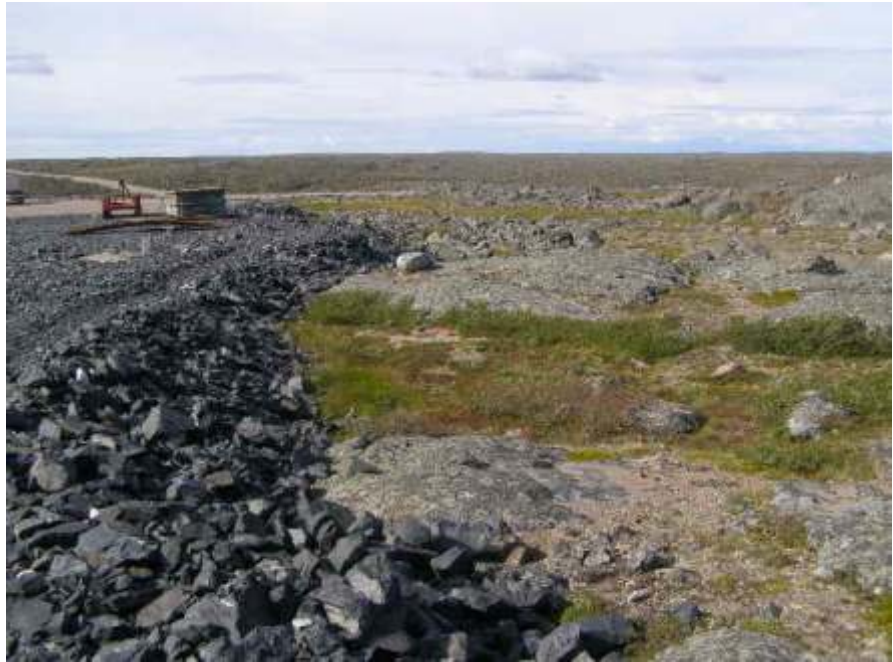
Shows a view along the northern edge of the pad; no signs of seepage or discharge were noted.
