ZINIFEX CANADA INC.

2007 ANNUAL GEOTECHNICAL INSPECTION SELECTED STRUCTURES

ULU GOLD PROJECT, NU

PROJECT NO.: 0385-006-02
DATE: OCTOBER 29, 2007

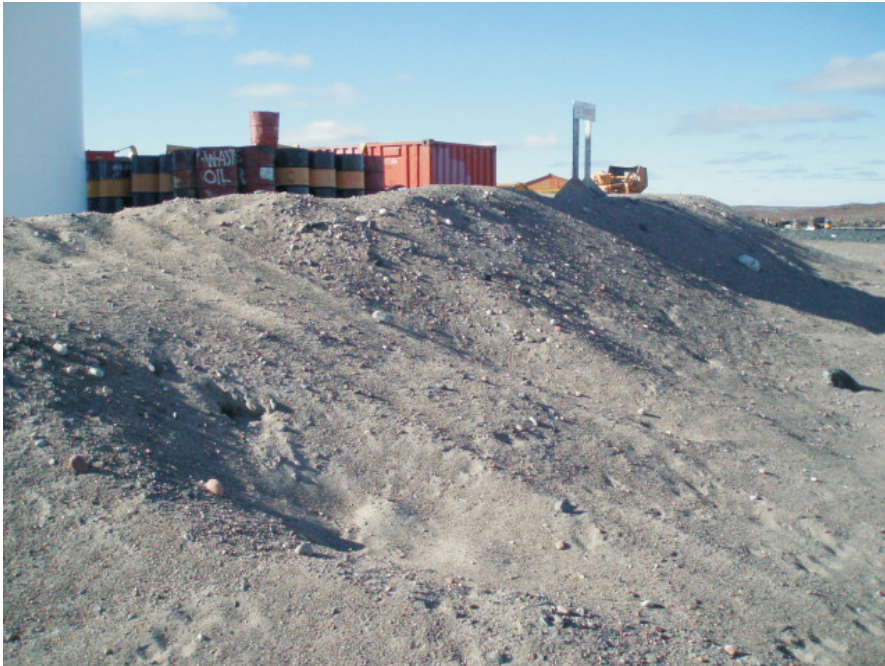
LOCATION:	Northeast corner of the Ulu camp pad.
FUNCTION:	Provides secondary containment for five large fuel tanks and numerous barrels of fuel.
SIZE:	~20 m wide by ~50 m long.
BERM HEIGHT:	~1.5 to 2 m above adjacent grade.
CREST ELEVATION:	No detailed survey information provided.
BERM CONDITION:	Berm is constructed from esker sand and gravel and appears in good condition, as shown on Figure 4. Numerous animal burrows observed on the outside slope of the berm. No current exposures of the internal geomembrane liner.
SEEPAGE:	No evidence of seepage observed at the berm toe.
MAINTENANCE / MONITORING	
RECOMMENDATIONS:	None.
CONCLUSIONS:	The berm appears in satisfactory condition.

View of the north side berm with no signs of deformation.

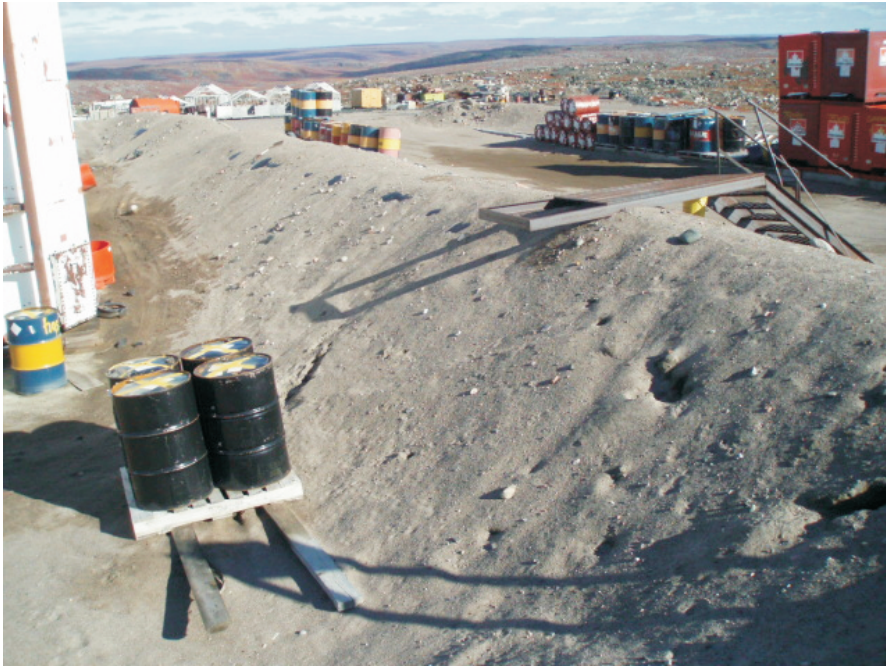
Shows the inside face of the easternmost berm.

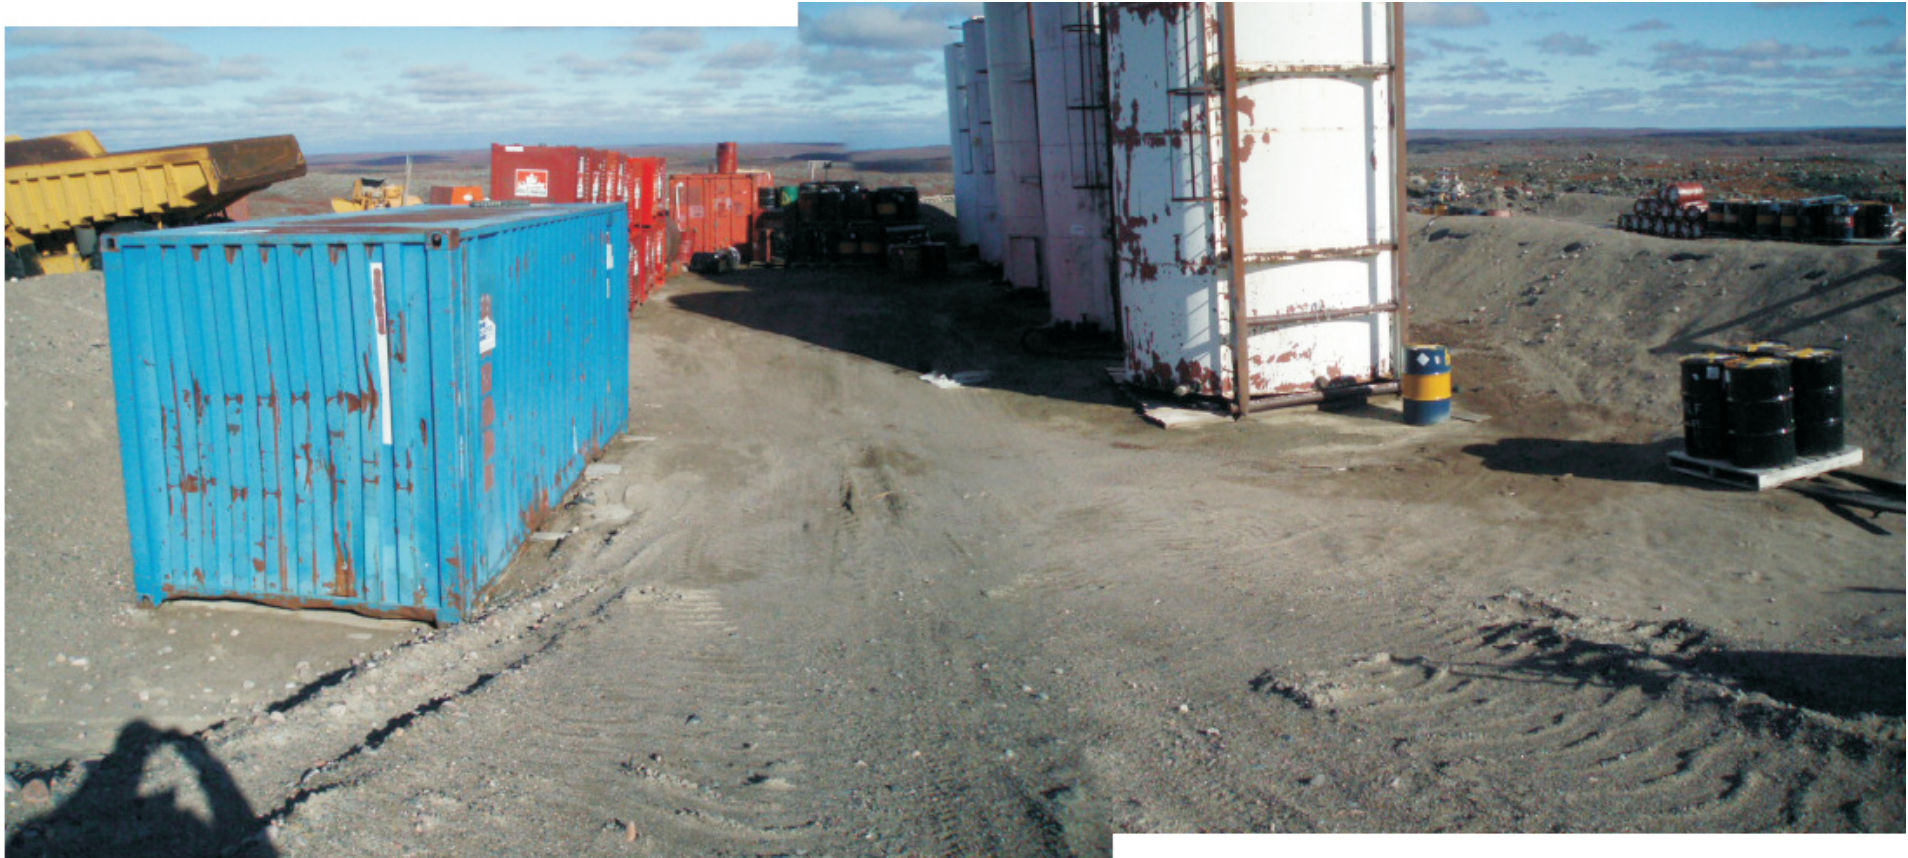
Panoramic showing the inside of the sand berm area. There are no significant accumulations of water within this area.

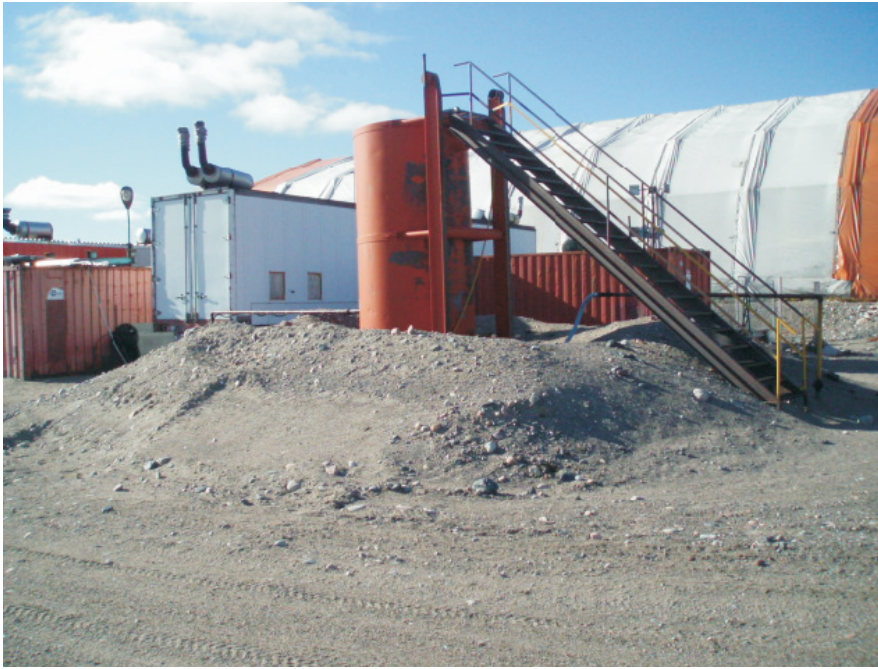
LOCATION:	Adjacent to powerhouse area.
FUNCTION:	Provides secondary containment for one fuel tank.
SIZE:	~5 m wide by ~5 m long.
BERM HEIGHT:	~1 to 1.2 m above adjacent grade.
CREST ELEVATION:	No detailed survey information provided.
BERM CONDITION:	Berm is constructed from esker sand and gravel and appears in good condition, as shown on Figure 5. Liner exposed in two locations.
SEEPAGE:	No evidence of seepage observed at the berm toe.
MAINTENANCE / MONITORING	
RECOMMENDATIONS:	None.
CONCLUSIONS:	The berm appears in satisfactory condition.

Shows an overall view of the Day Tank Farm. No signs of deformation or erosion of the containment berm.

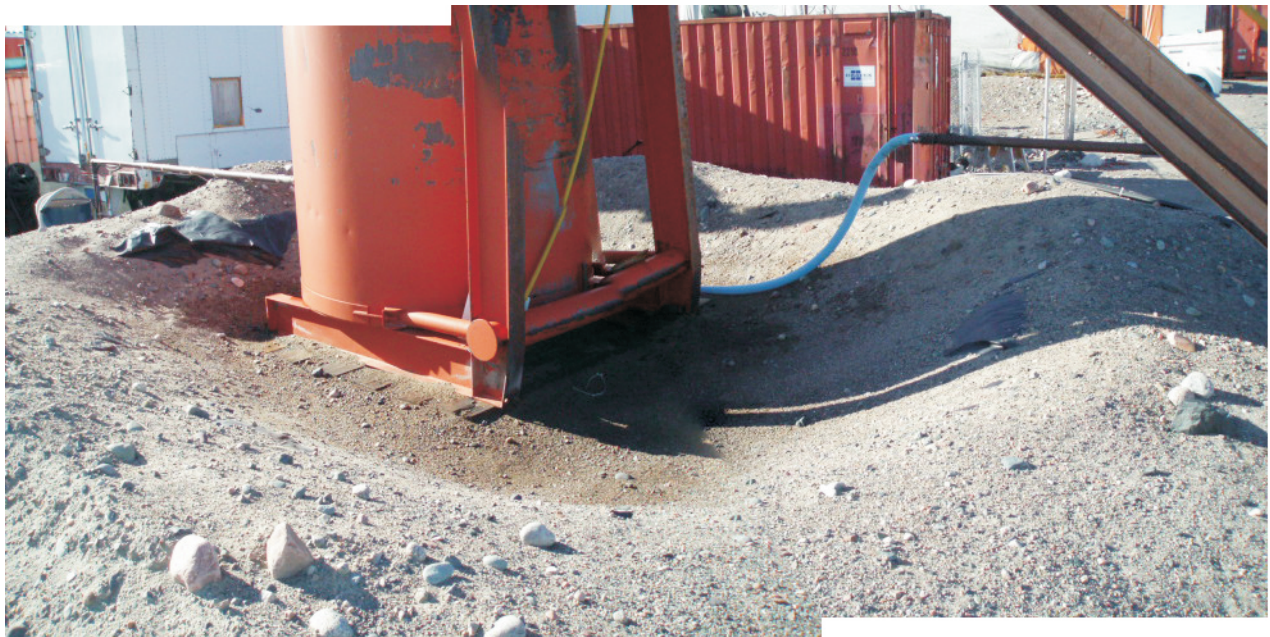
A panoramic of the inside of the containment berm. On the right can be seen one exposure of the liner. On the far left can be seen another directly proximal to the side of the tank.

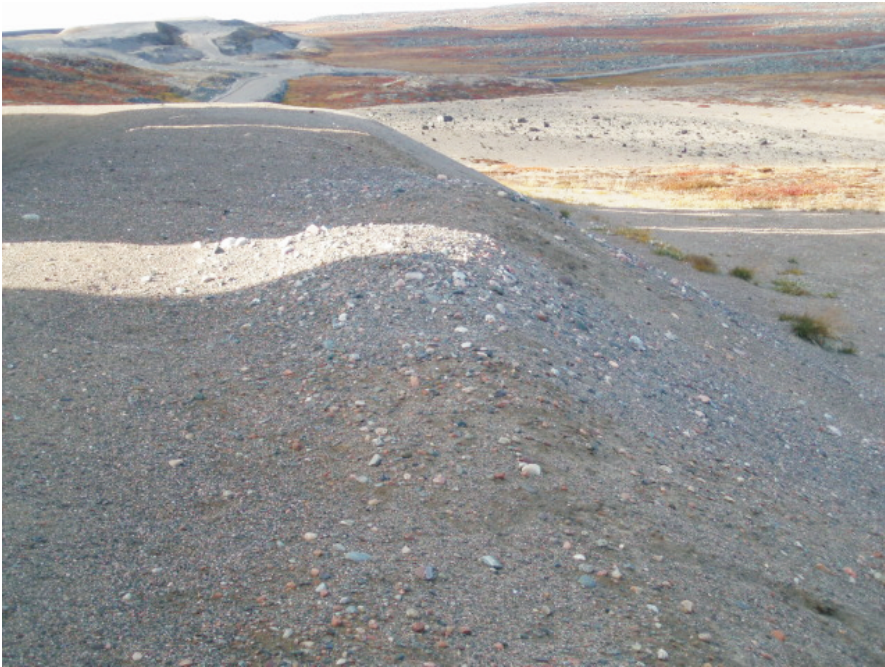
LOCATION:	Far southern end of the esker, west of Reno Lake North.
FUNCTION:	Provides secondary containment for two large fuel tanks and six smaller skid-mounted tanks.
SIZE:	~30 m wide by ~60 m long.
BERM HEIGHT:	~1.5 to 2 m above adjacent grade on one side and ~1 to 1.2 m on the other.
CREST ELEVATION:	No detailed survey information provided.
BERM CONDITION:	Berm is constructed from esker sand and gravel and appears in good condition, as shown on Figure 6. Liner exposed at three locations.
SEEPAGE:	No evidence of seepage observed at the berm toe.
MAINTENANCE / MONITORING	
RECOMMENDATIONS:	None.
CONCLUSIONS:	The berm appears in satisfactory condition.

Shows the crest and the downstream side of the berm with no signs of deformation or erosion at the current time.

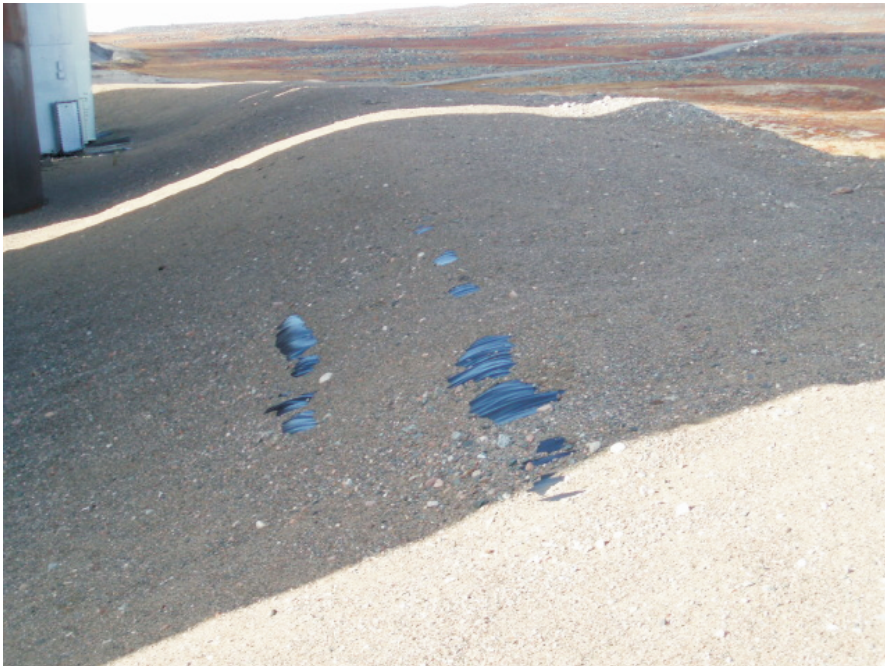
Shows a minor liner exposure on the northern berm.

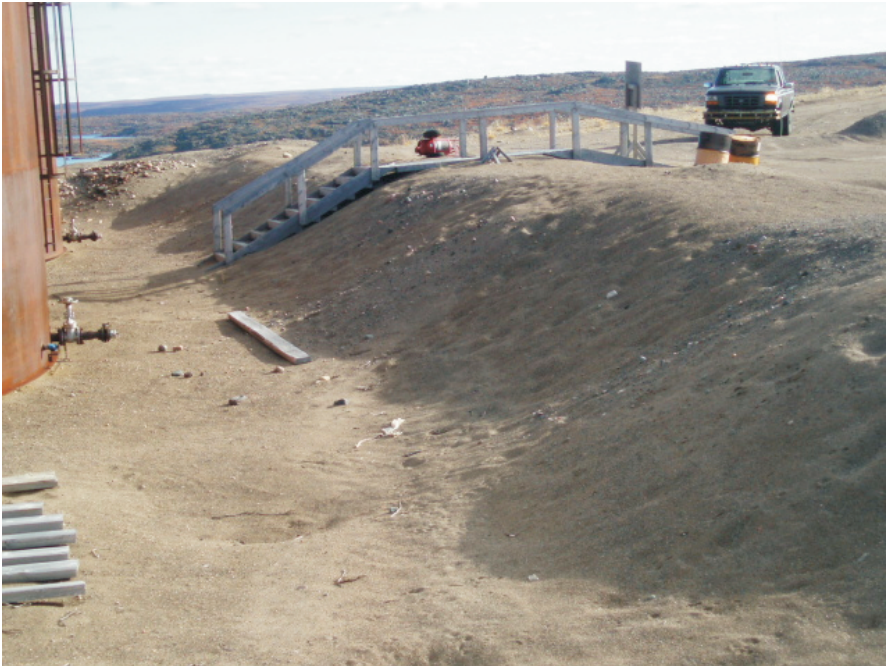
Shows the inside face of the western berm with no signs of deformation or erosion.

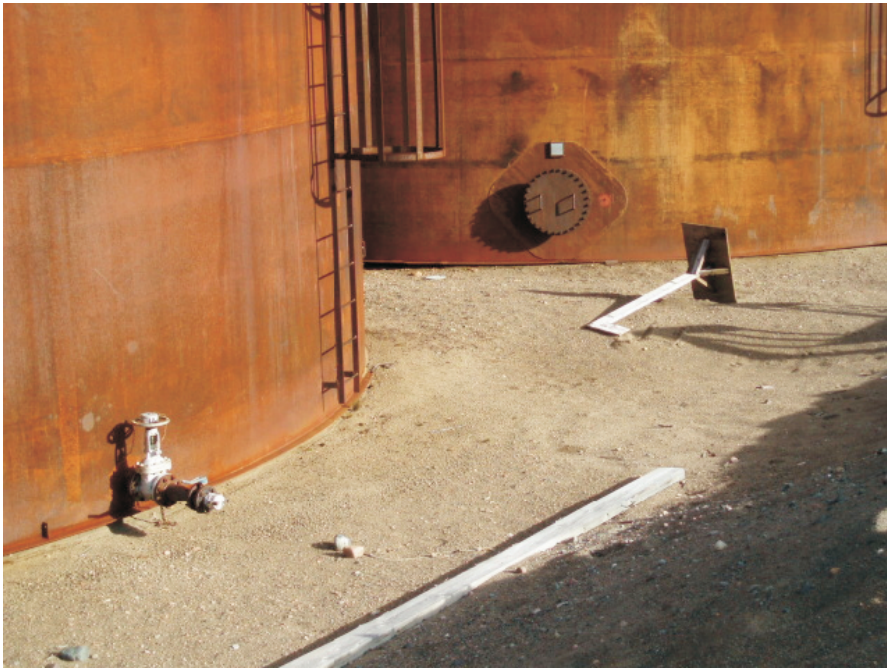
Shows the base of the inside of the tank farm area and there is no standing water or fluids of any kind.

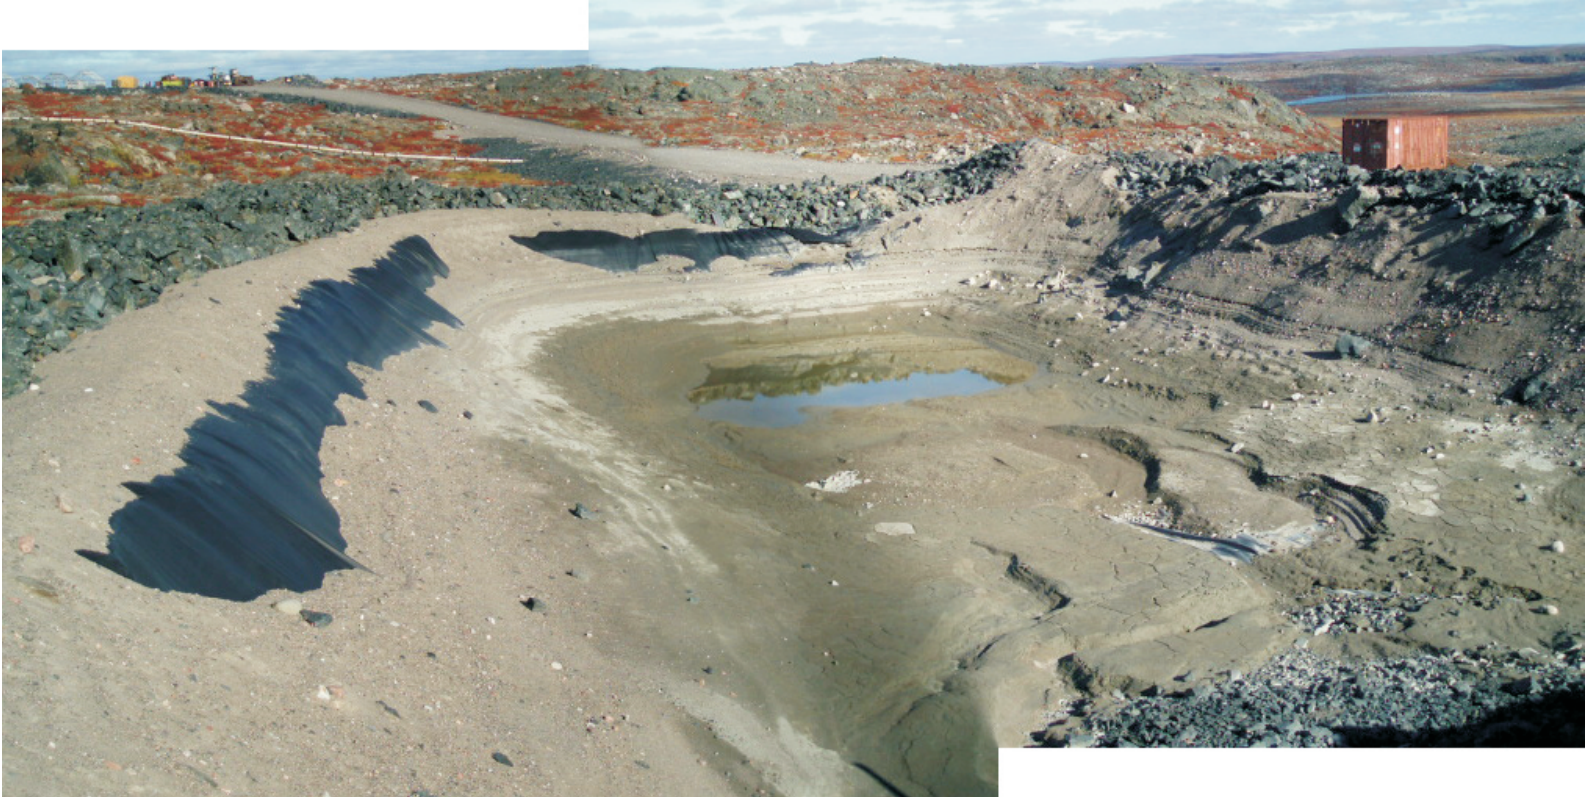
LOCATION:	Directly outside the portal, uphill from both a local access road and the portal laydown pad.
FUNCTION:	Provides containment for settling and sediment retention of mine water pumped from the decline ramp.
SIZE:	~20 m wide by ~30 m long.
BERM HEIGHT:	~1.5 to 2 m above adjacent grade.
CREST ELEVATION:	No detailed survey information provided.
BERM CONDITION:	<p>Berm is constructed from rockfill (waste rock) and esker sand and gravel, as shown on Figure 7. Geomembrane liner within berm is exposed at several locations. The liner at north end of the pond has become free.</p> <p>Access road and portal laydown pad located on the downhill side of the sump.</p>
SEEPAGE:	No evidence of seepage observed at the berm toe.
MAINTENANCE / MONITORING	
RECOMMENDATIONS:	The folded free flap of liner at the north end could be held down with some fill to prevent it from becoming loose. Anecdotal information from site indicates no leakage is occurred from the sump when previously used. As such, it appears that no leakage is occurring around the noted rock fragments.

Shows the interior of the mine sump where we see the exposures of the liner and the loose flap at the far north end.

CONCLUSIONS:	Outside of the noted minor maintenance required to fix the liner, the sump appears in satisfactory condition.

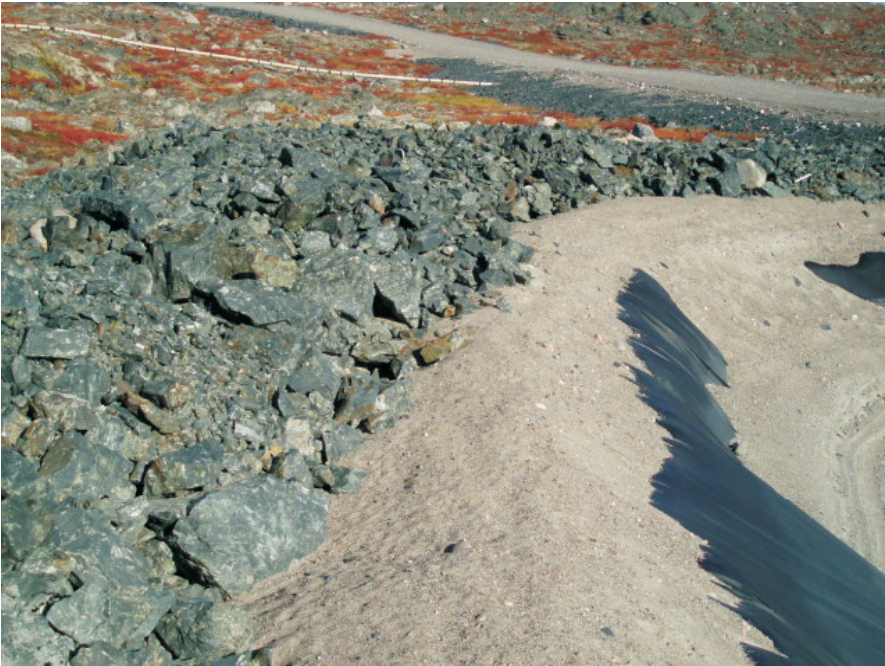
Shows a view of the pond edge taken along the west side of the pond.

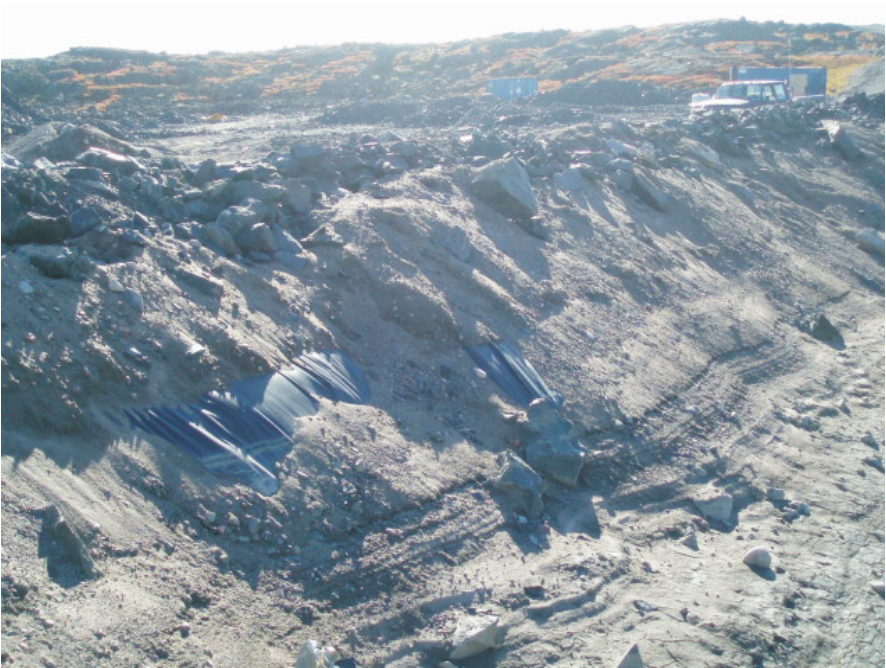
Shows the inside view of the east berm. There are exposures of the liner in approximately three places where the sand cover is fairly thin.

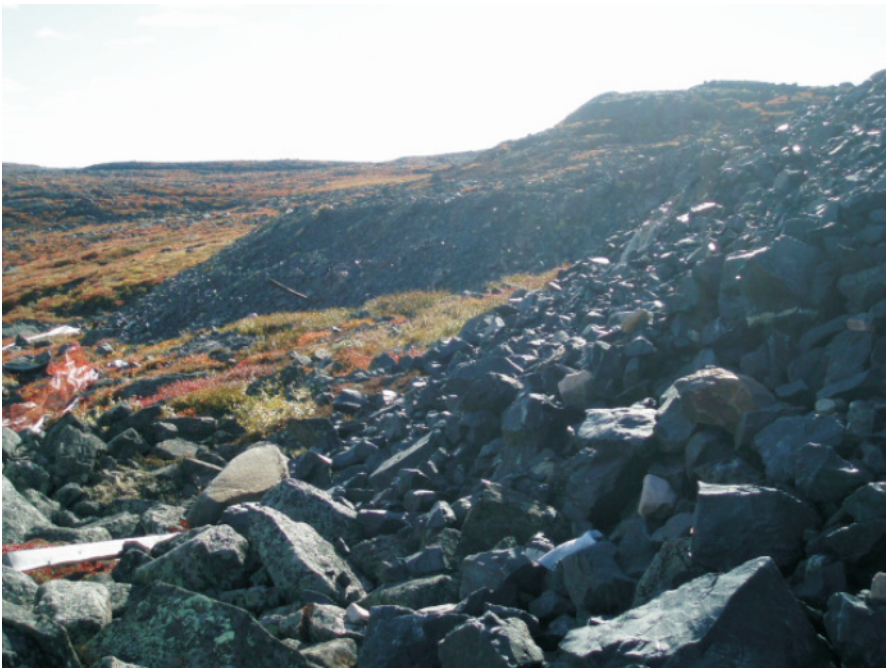
Shows a view along the toe of the Waste Dump looking towards the south to southwest.

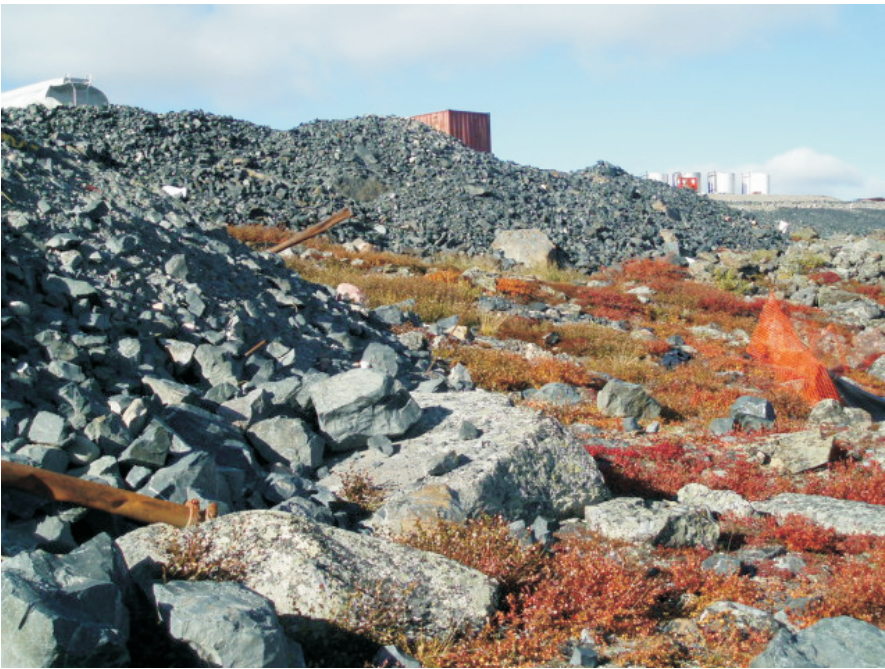
View taken back along the toe looking back towards the Tank Farm. To this distance along the toe, I have not heard or seen any indications of seepage discharging from the toe area.

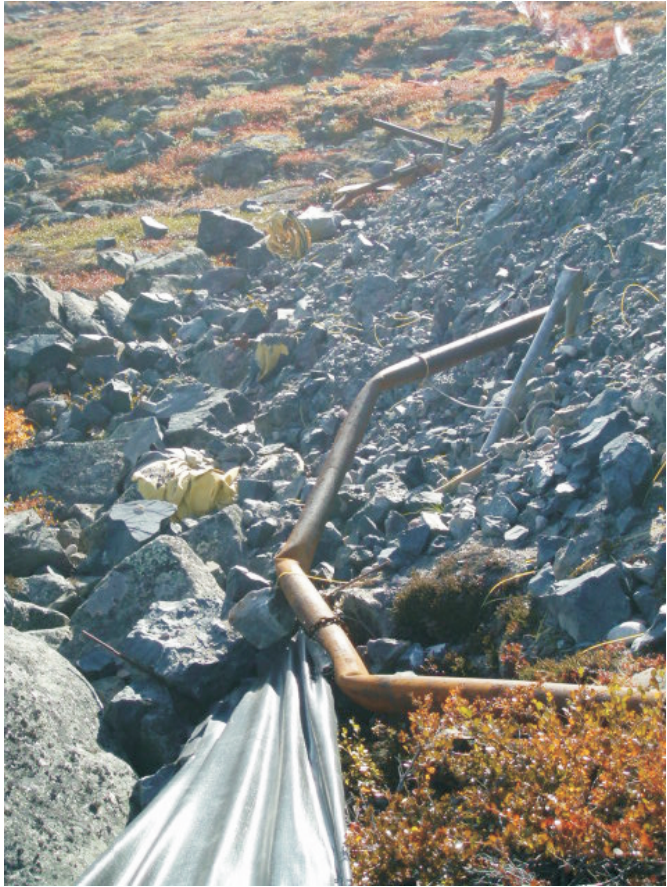
Shows where the fill has overridden the top of the sediment control fence.

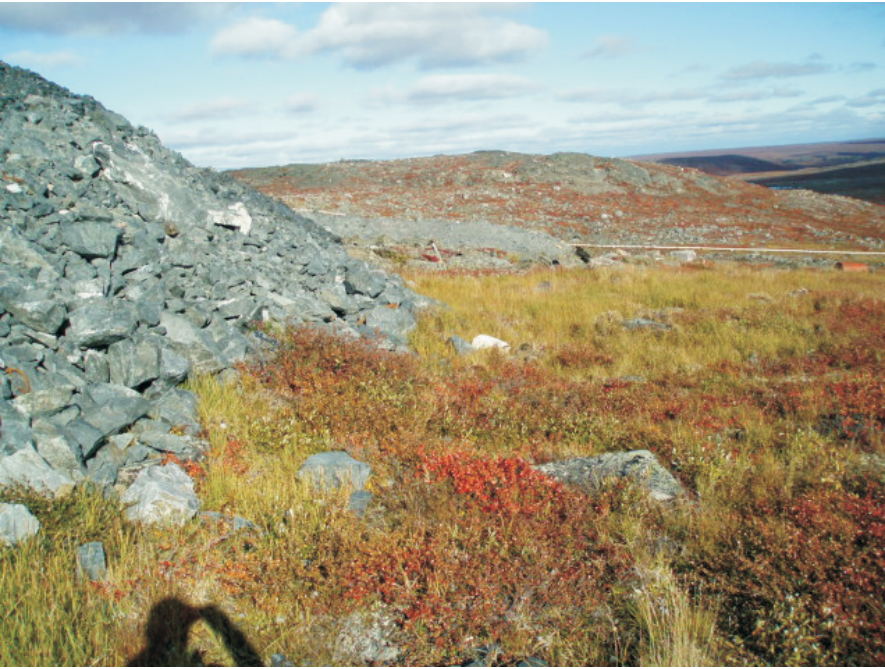
Shows a grassy area located right at the toe of the dump. In this area there is a minor amount of standing water, but no signs of seeping water.

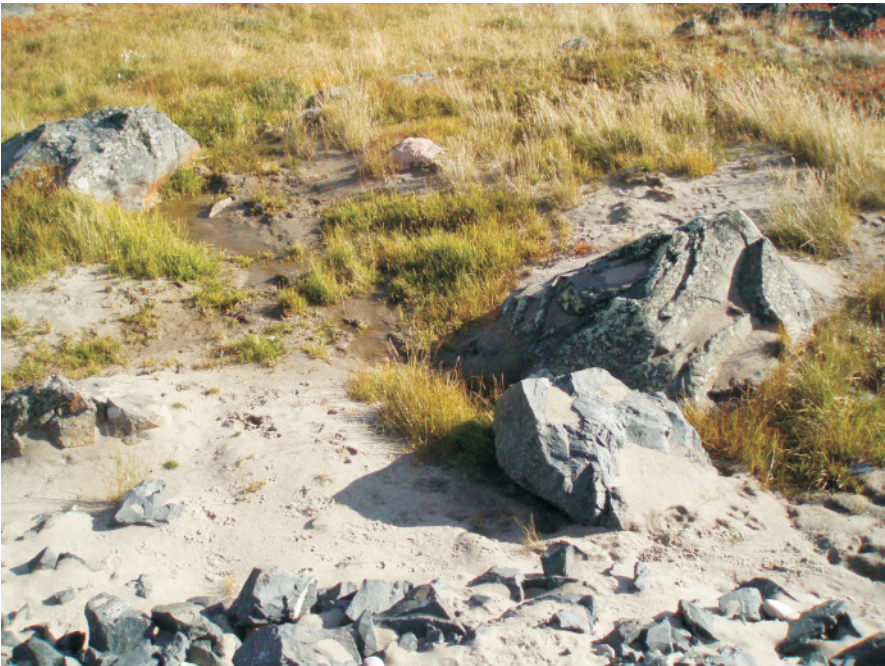
Shows a very small channel of water located at the toe. It does not appear to be currently running.

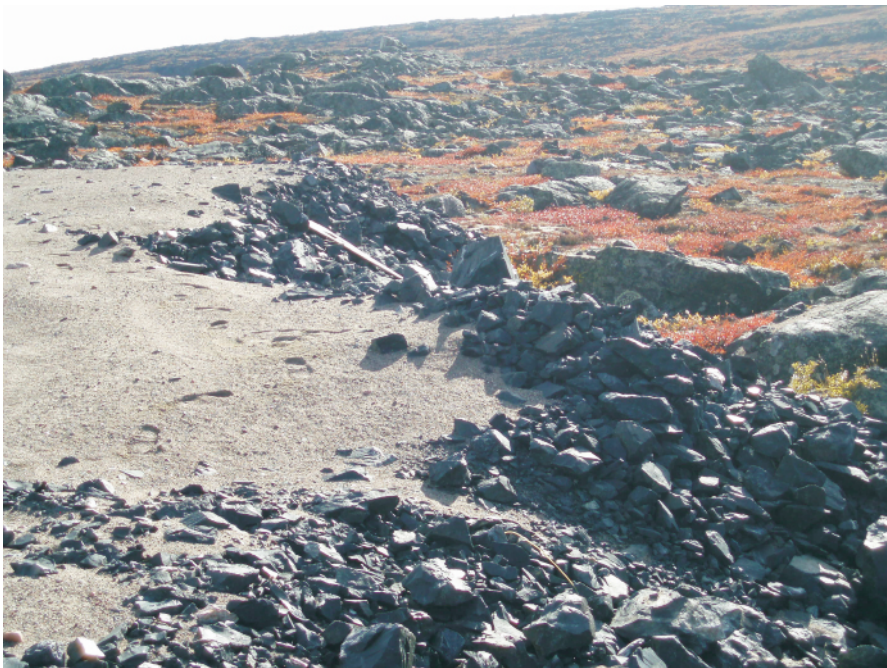
View taken along the southwest corner of the storage pad. No signs of seepage are noted along this edge.

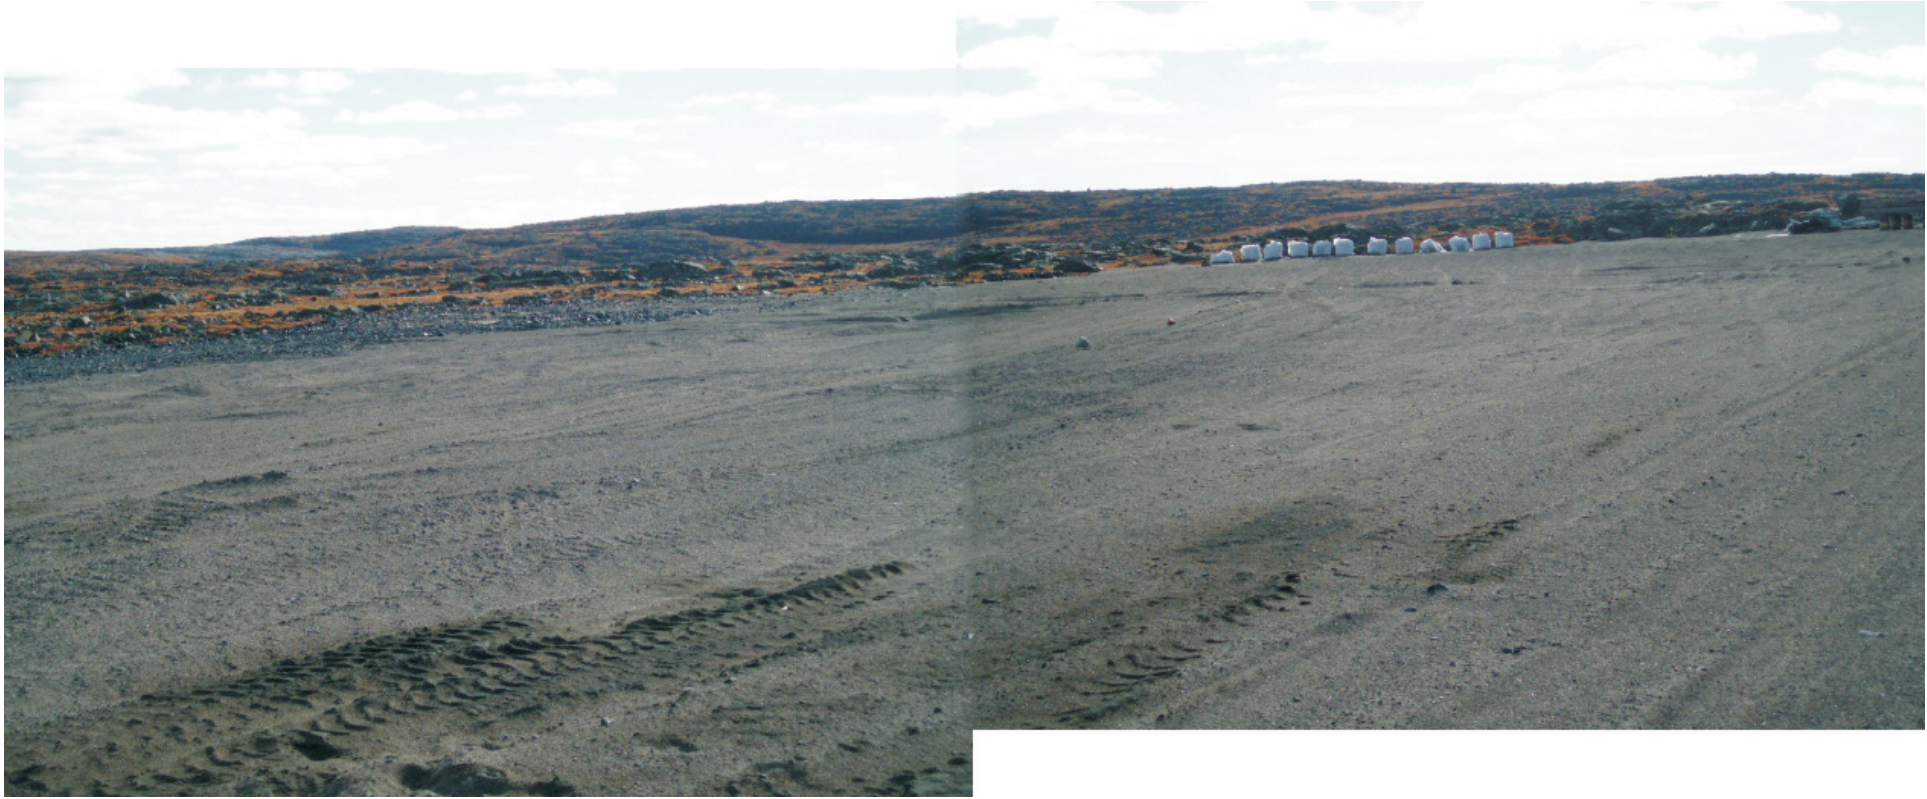
MAINTENANCE / MONITORING	
RECOMMENDATIONS:	No current concerns.
CONCLUSIONS:	The pad appears stable with no signs of erosion or instability. Runoff from the pad is collected within East Lake that passes through a wetland before entering Ulu Lake.

Shows a panoramic of the top of the storage pad.
