2009 Annual Geotechnical Inspection Various Earth Structures Ulu, Nunavut

Prepared For:
MMG Resources Inc.
200-1159 Alloy Drive
Thunder Bay, On
P7B 6M8

Ref. No. 09-161

**Re: 2009 Annual Geotechnical Inspection
Various Earth Structures
ULU Mine, Nunavut**

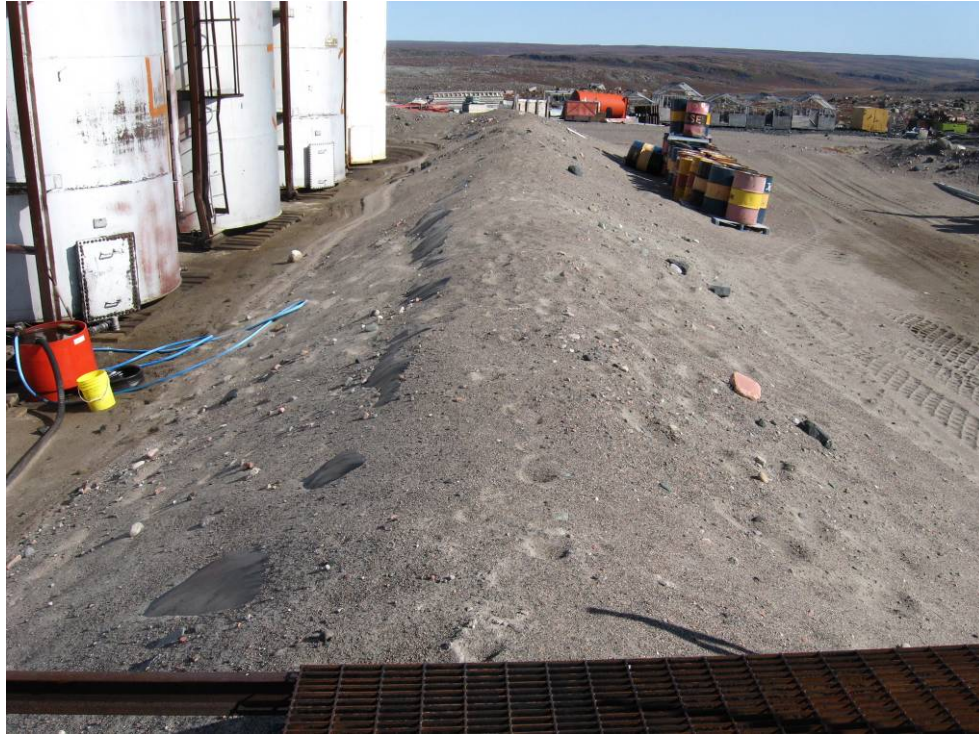
Exterior Berm

LOCATION:	Northeast corner of the Ulu camp pad.
FUNCTION:	Provides secondary containment for five large fuel tanks and numerous barrels of fuel.
SIZE:	~20 m wide by ~50 m long.
BERM HEIGHT:	~1.5 to 2 m above adjacent grade.
CREST ELEVATION:	No survey information available
BERM CONDITION:	Berm is constructed from esker sand and gravel and appears in good condition. Numerous animal burrows observed on the outside slope of the berm. The liner is exposed in several areas. No tears noted.
SEEPAGE:	No evidence of seepage observed at the exterior berm toe. Small amounts of water are being retained within the storage area.
MAINTENANCE/MONITORING RECOMMENDATIONS:	The areas of exposed liner should be recovered with granular fill to prevent deterioration.
CONCLUSIONS:	The berm appears in generally satisfactory condition. See above maintenance item.

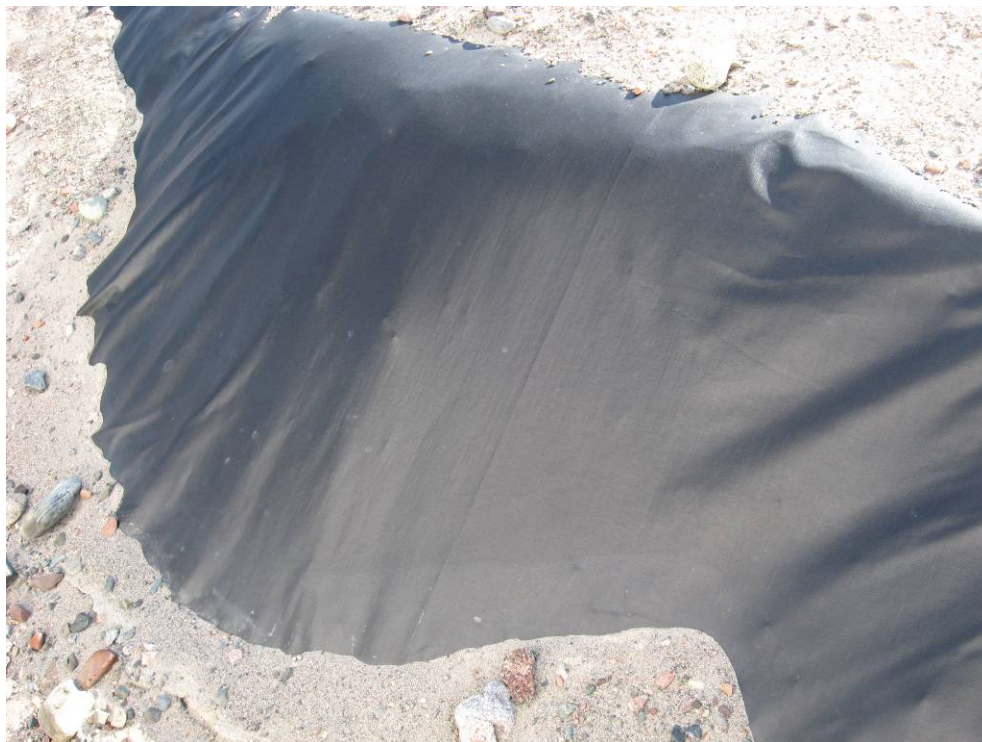
Exposed Liner

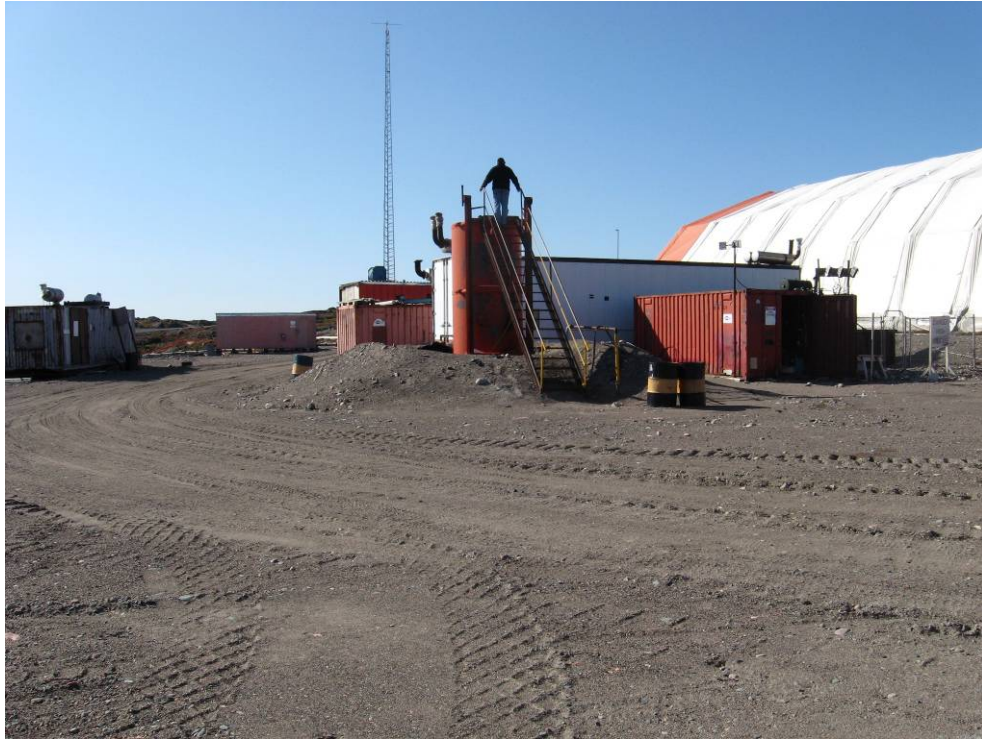
Day Tank Berms

LOCATION:	Adjacent to powerhouse area.
FUNCTION:	Provides secondary containment for one fuel tank.
SIZE:	~5 m wide by ~5 m long.
BERM HEIGHT:	~1 to 1.2 m above adjacent grade.
CREST ELEVATION:	No survey information available.
BERM CONDITION:	Berm is constructed from esker sand and gravel and appears in overall good condition. Liner exposed in two locations (loose in one).
SEEPAGE:	No evidence of seepage observed at the berm toe.
MAINTENANCE/MONITORING RECOMMENDATIONS:	The areas of exposed liner should be recovered with granular fill to prevent deterioration.
CONCLUSIONS:	The berm appears in generally satisfactory condition. See above maintenance item.

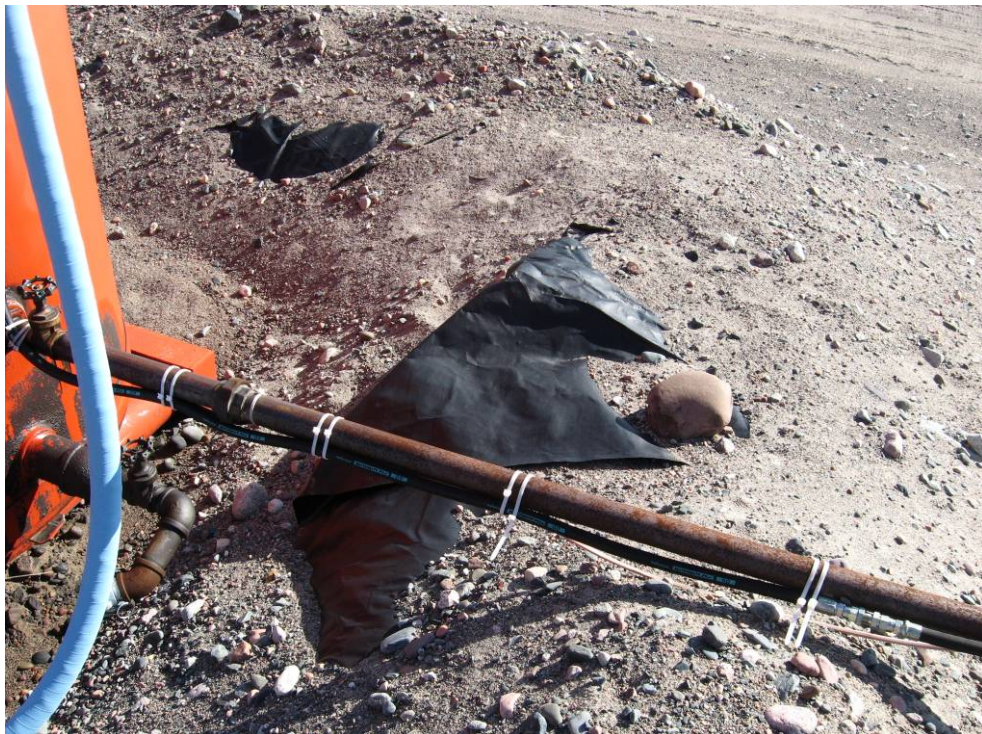
Exposed Liner

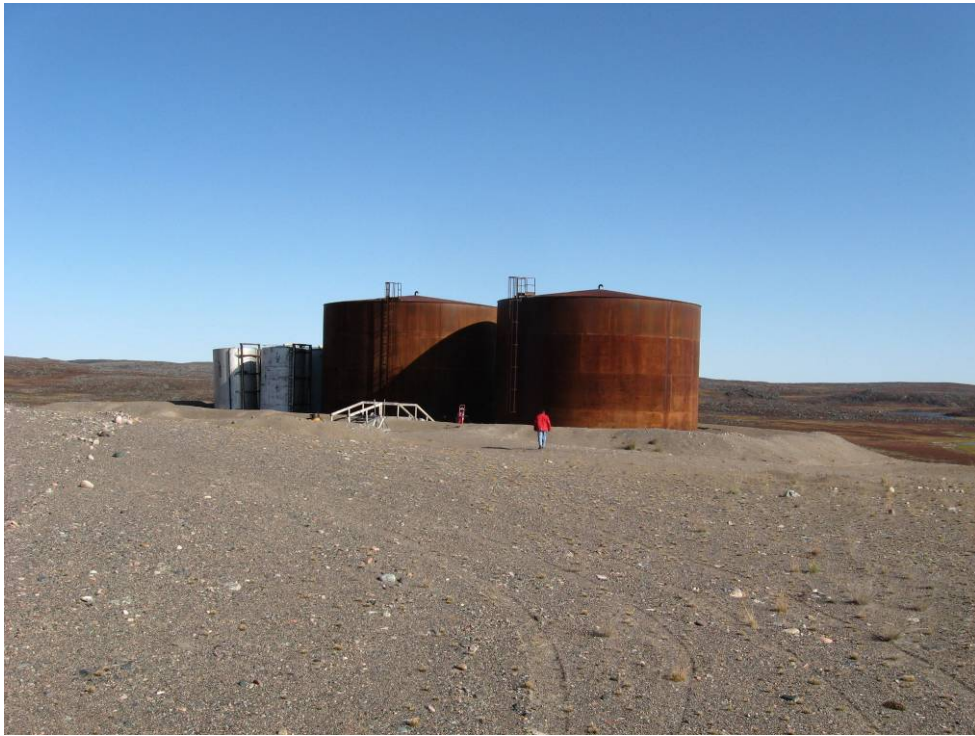
Camp 3 Tank Farm

LOCATION:	Far southern end of the esker, west of Reno Lake North.
FUNCTION:	Provides secondary containment for two large fuel tanks and six smaller skid-mounted tanks.
SIZE:	~30 m wide by ~60 m long.
BERM HEIGHT:	~1.5 to 2 m above adjacent grade on one side and ~1 to 1.2 m on the other.
CREST ELEVATION:	No survey information available
BERM CONDITION:	Berm is constructed from esker sand and gravel and appears in good condition. Liner exposed in several locations. Small tears are beginning to develop.
SEEPAGE:	No evidence of seepage observed at the berm toe.
MAINTENANCE/MONITORING RECOMMENDATIONS:	The areas of exposed liner should be recovered with granular fill to prevent deterioration. Any tears should be repaired to ensure watertight conditions.
CONCLUSIONS:	The berm appears in generally satisfactory condition. See above maintenance item.

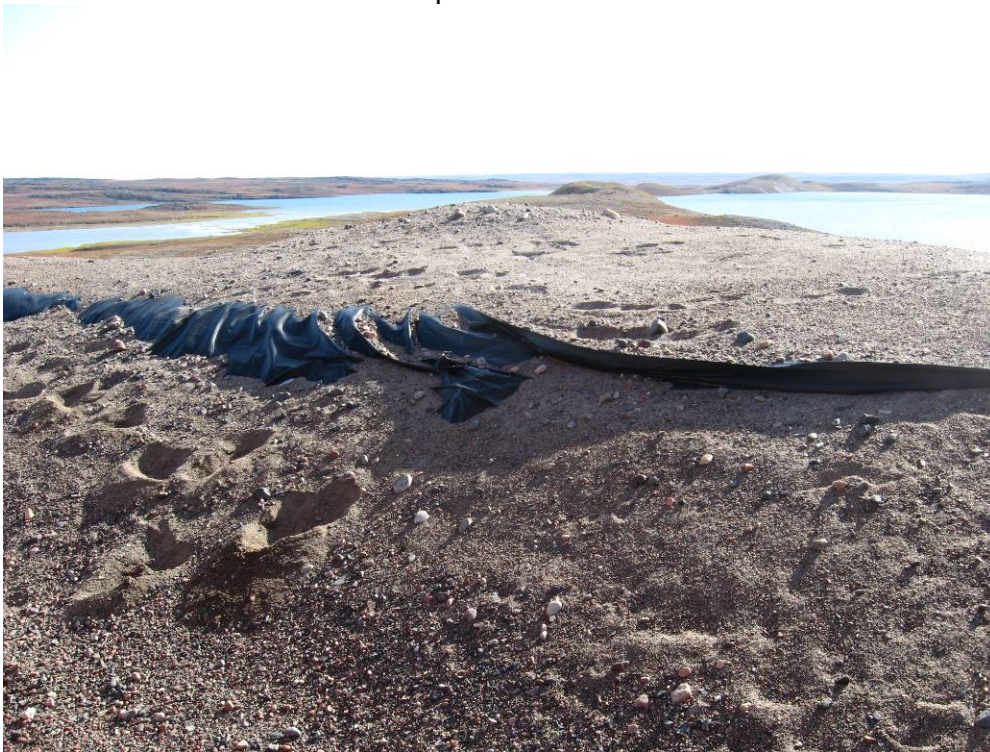
Exposed Liner

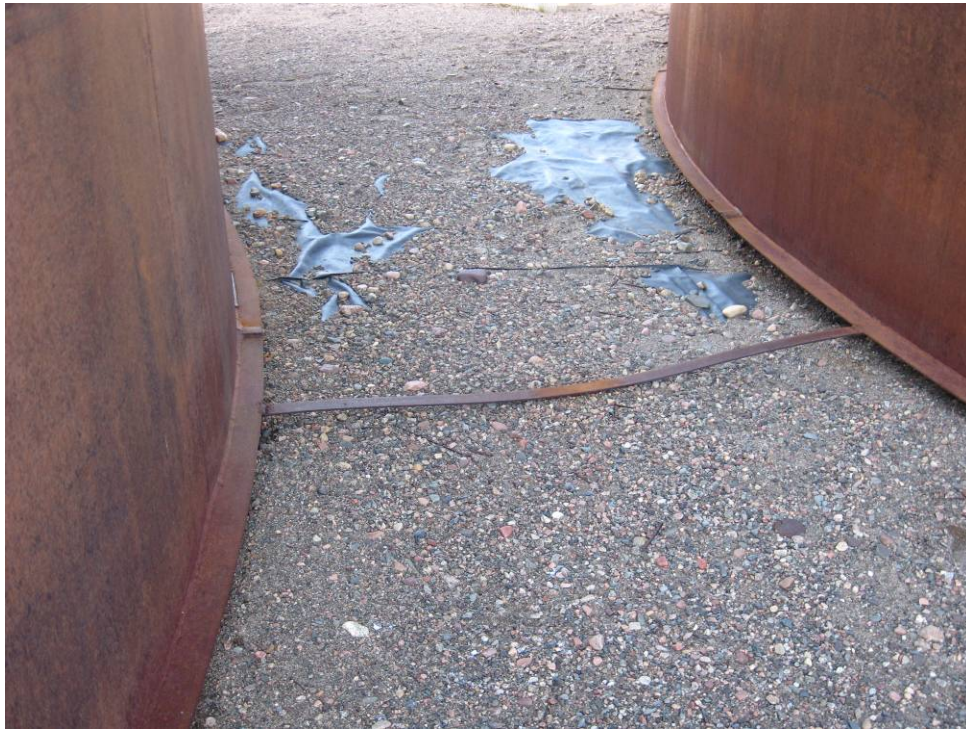
Exposed Liner

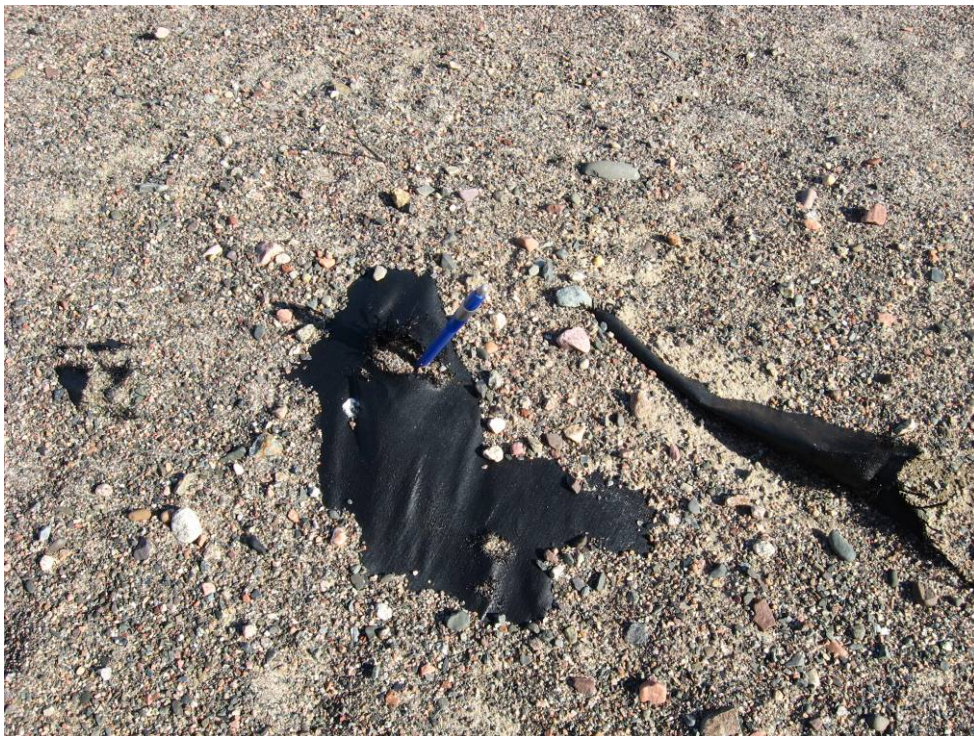
Torn Liner

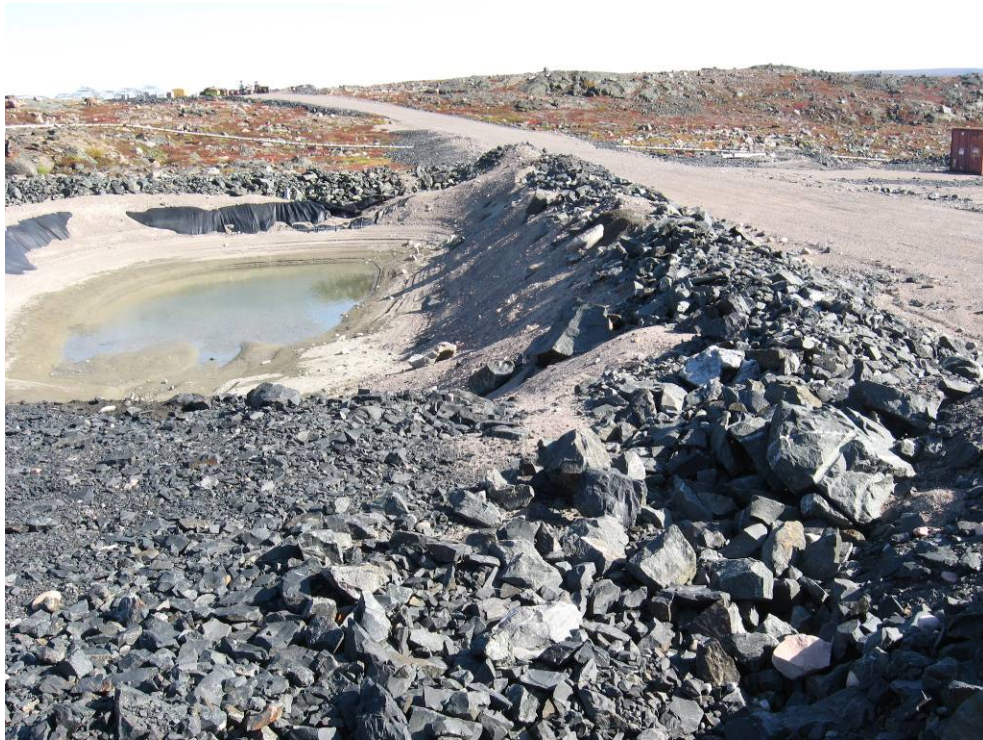
Mine Sump Pit

LOCATION:	Directly outside the portal, uphill from both a local access road and the portal laydown pad.
FUNCTION:	Provides containment for settling and sediment retention of mine water pumped from the decline ramp.
SIZE:	~20 m wide by ~30 m long.
BERM HEIGHT:	~1.5 to 2 m above adjacent grade.
CREST ELEVATION:	No survey information available.
BERM CONDITION:	<p>Berm is constructed from rockfill (waste rock) and esker sand and gravel, The banks are oversteepened.</p> <p>Geomembrane liner within berm is exposed at several locations. The liner at north end of the pond is loose. Small tears are developing in the liner.</p>
SEEPAGE:	No evidence of seepage observed at the berm toe.
MAINTENANCE/MONTORING RECOMMENDATIONS:	Before the sump is put back into service the liner and side slopes should be repaired/restored.
CONCLUSIONS:	The berms are suitable for the interim. Before the sup is put back into use, the liner and slopes should be repaired.

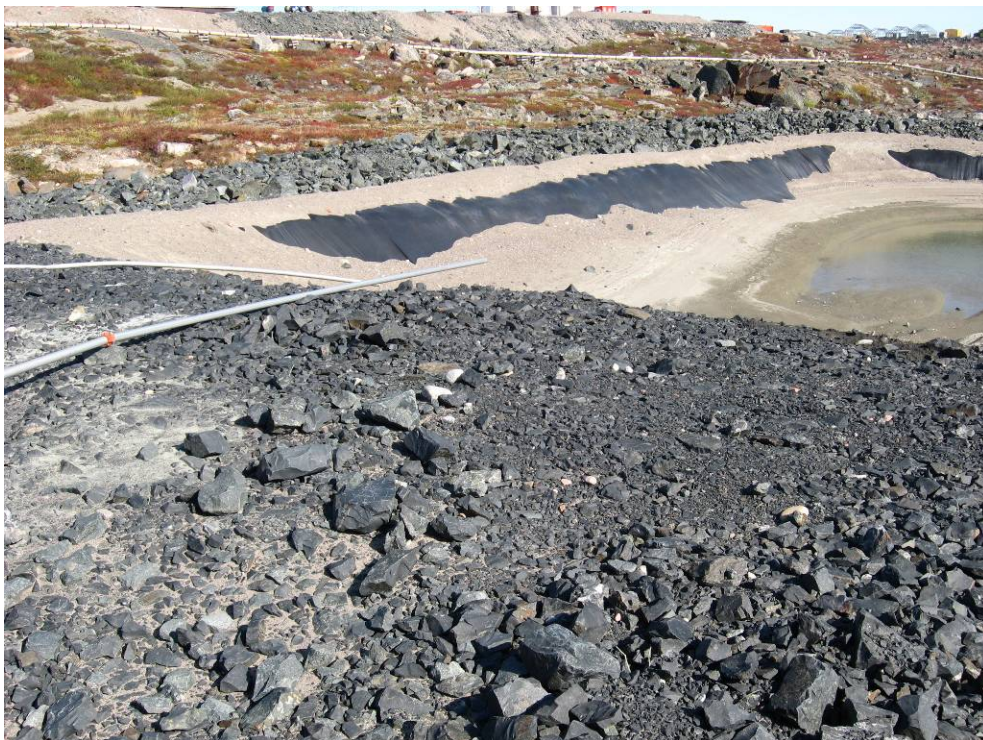
Exposed Liner

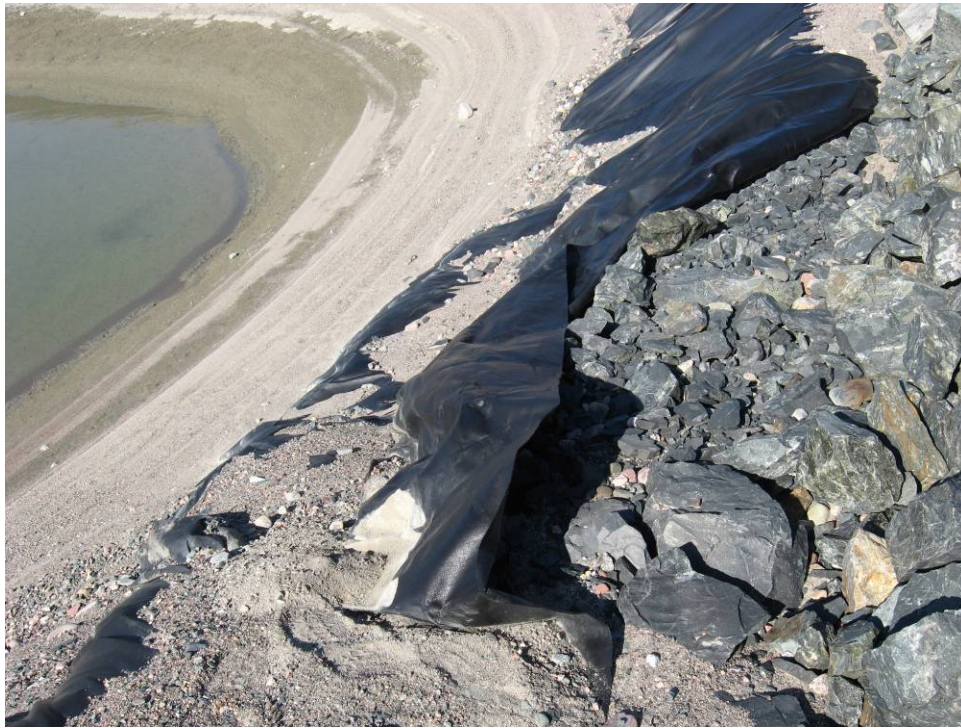
Exposed Liner

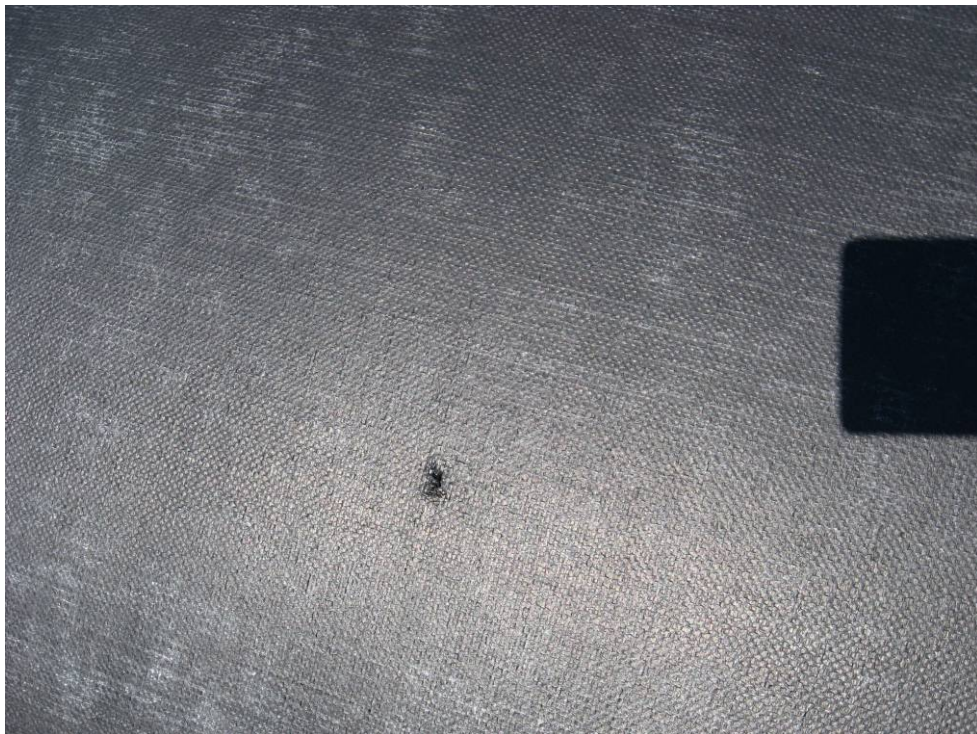
Typical Small Tear in Liner

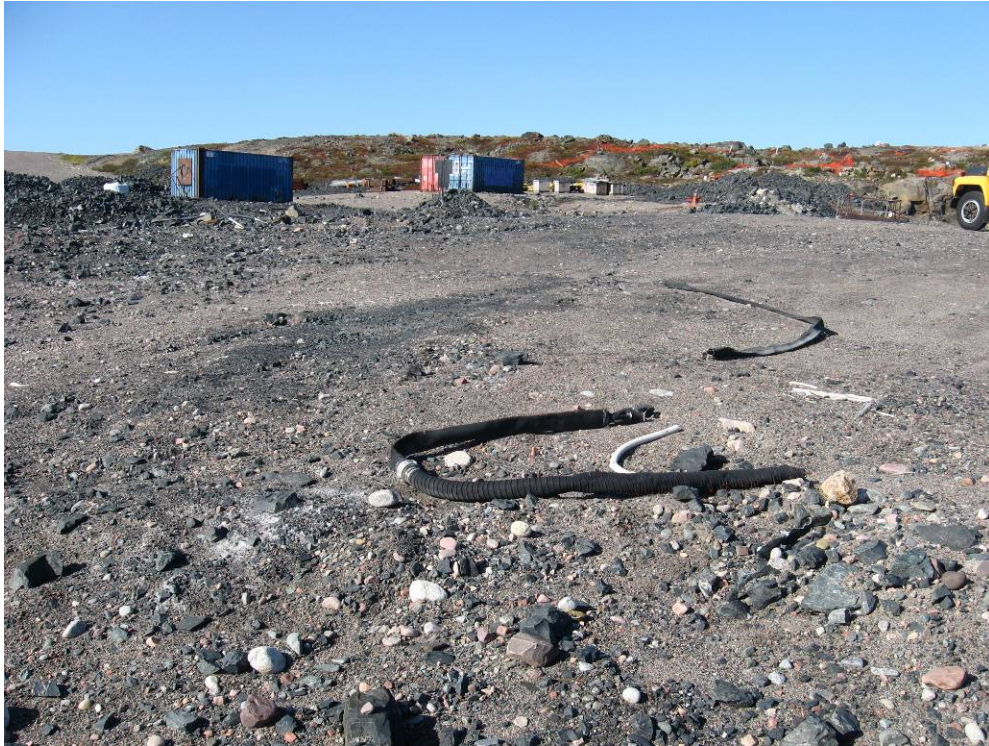
Portal Laydown Pad

LOCATION:	Pad is located just downhill from the portal and local access road, approximately 150 m from East Lake.
FUNCTION:	Initially constructed from waste rock from the decline ramp development. Mine muck material was placed on the pad covers a portion of the silt control fence.
SIZE:	~50 m wide by ~200 m long.
PAD THICKNESS:	Ranges from 1 to 5 m above original topography.
CREST ELEVATION:	No survey information available.
PAD CONDITION:	Pad is constructed from rockfill (waste rock), as shown on Figure 9. Toe of the pad sits at the angle of repose for rockfill. Scarps and cracks have developed on downhill toe due to sloughing of loose fill.
TOE DISCHARGE:	No seepage observed or heard of at the toe of the pad. Any potential pad drainage heads downhill into East Lake.
MAINTENANCE/MONITORING RECOMMENDATIONS:	No current requirements
CONCLUSIONS:	The pad appears shows signs of instability and erosion on the downstream side. Re-grading and shaping will be required before the pad is put into use. Runoff from the pad is collected within East Lake that passes through a wetland before entering Ulu Lake. The existing down slope silt curtain has been covered by the toe of the pad. The silt curtain should be restored prior to use of the pad.

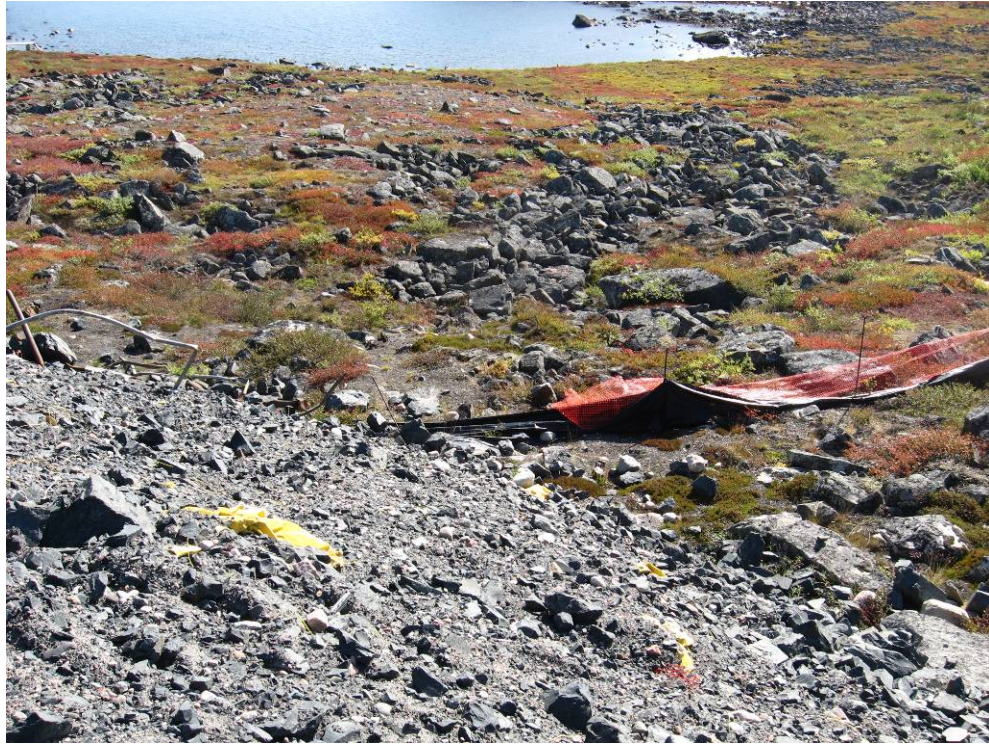
Silt Fence

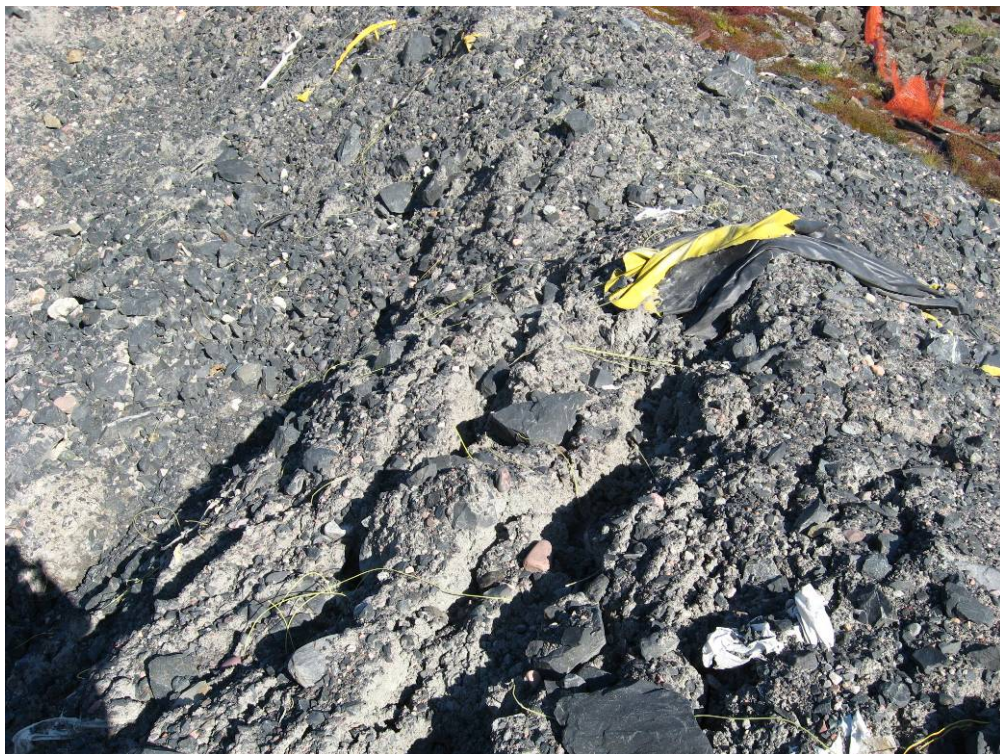
Slump Cracking Downhill Side

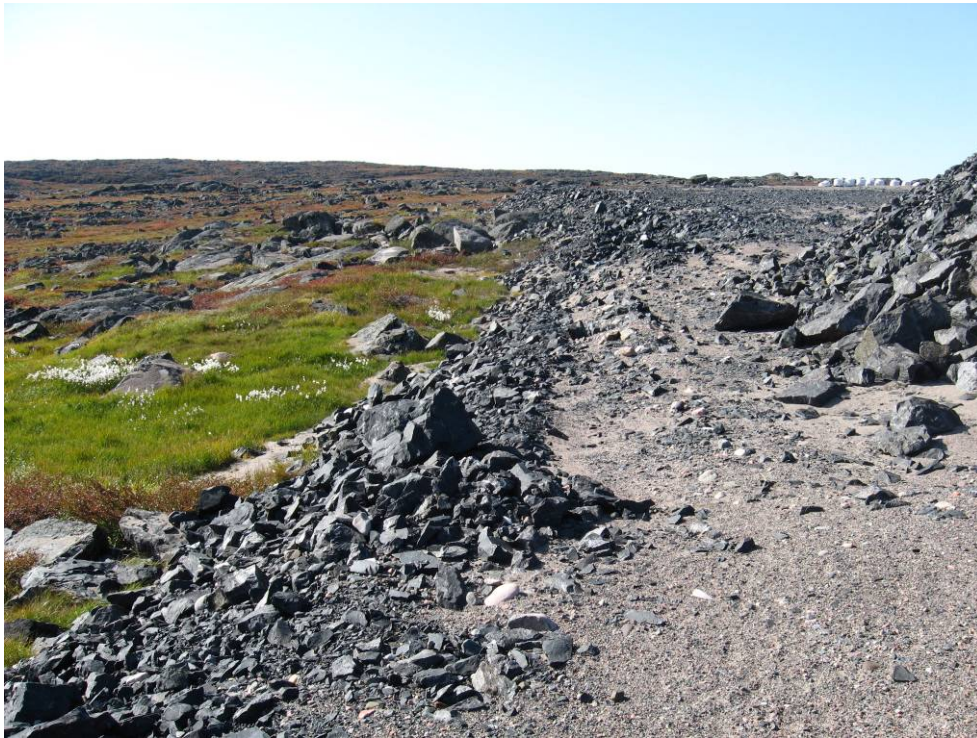
Storage Pad Outside Edge

LOCATION:	Pad is located southwest of the Portal Laydown Pad, approximately 325 m from East Lake.
FUNCTION:	Constructed from waste rock and then partially covered with esker sand and gravel. The pad was originally constructed for temporary storage of ore before its proposed shipment. Two small ore stockpiles are currently located on the pad.
SIZE:	~100 m wide by ~200 m long.
PAD THICKNESS:	Ranges from 1 to 3 m above original topography.
CREST ELEVATION:	No survey information available.
PAD CONDITION:	Pad is constructed from rockfill (waste rock) and esker sand and gravel, as shown on Figure 10. Two ore stockpiles located on the east corner of the pad. Toe of the pad sits at the angle of repose for rockfill.
TOE DISCHARGE:	None noted. Surficial pad drainage would head west from the southwest corner of the pad. No drainage was observed in this direction.
MAINTENANCE/MONITORING RECOMMENDATIONS:	No current concerns.

CONCLUSIONS:	The pad appears stable with no signs of erosion or instability.
