2010 Annual Geotechnical Inspection Various Earth Structures Ulu, Nunavut

Prepared For:
MMG Resources Inc.

Prepared By:
TBT Engineering Consulting Group

November 3, 2010

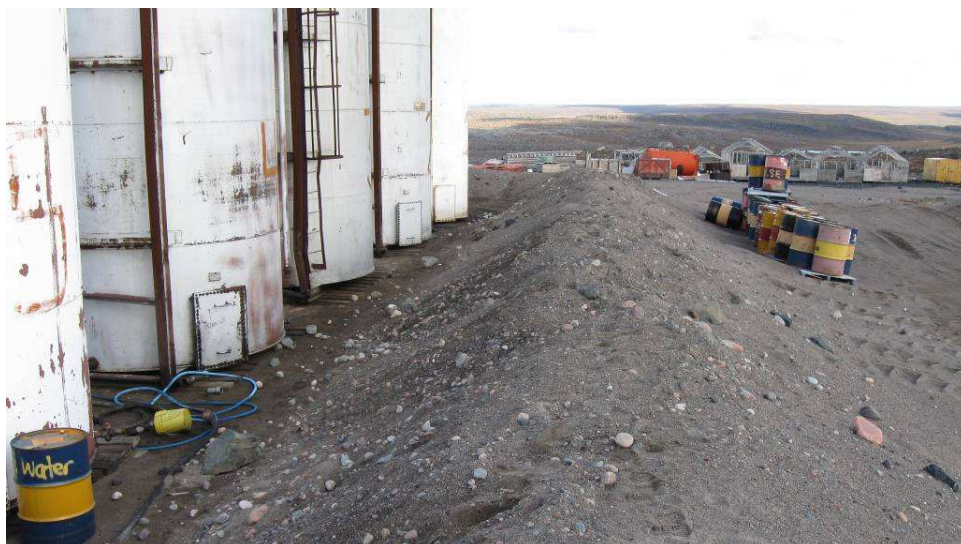
Exterior Berm

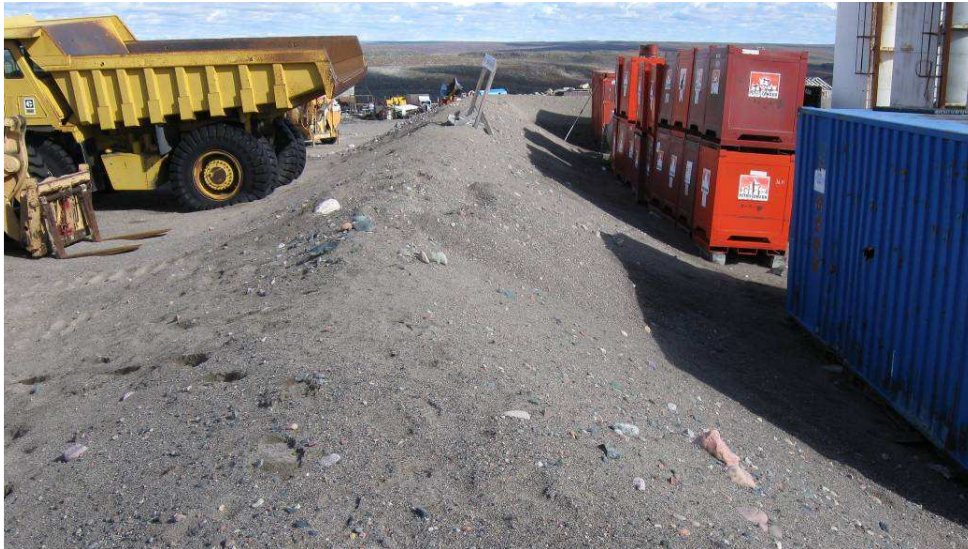
Exterior Berm

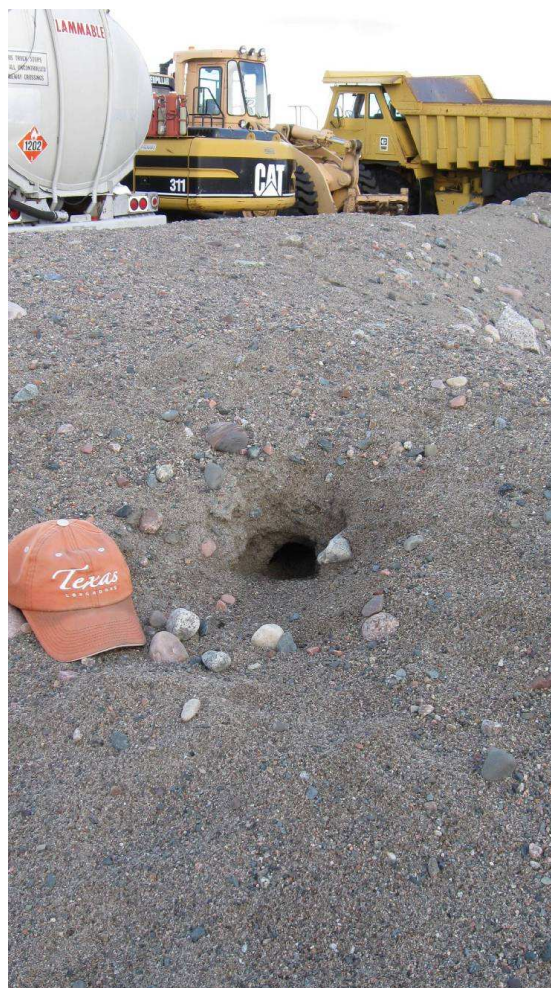
Animal Burrow

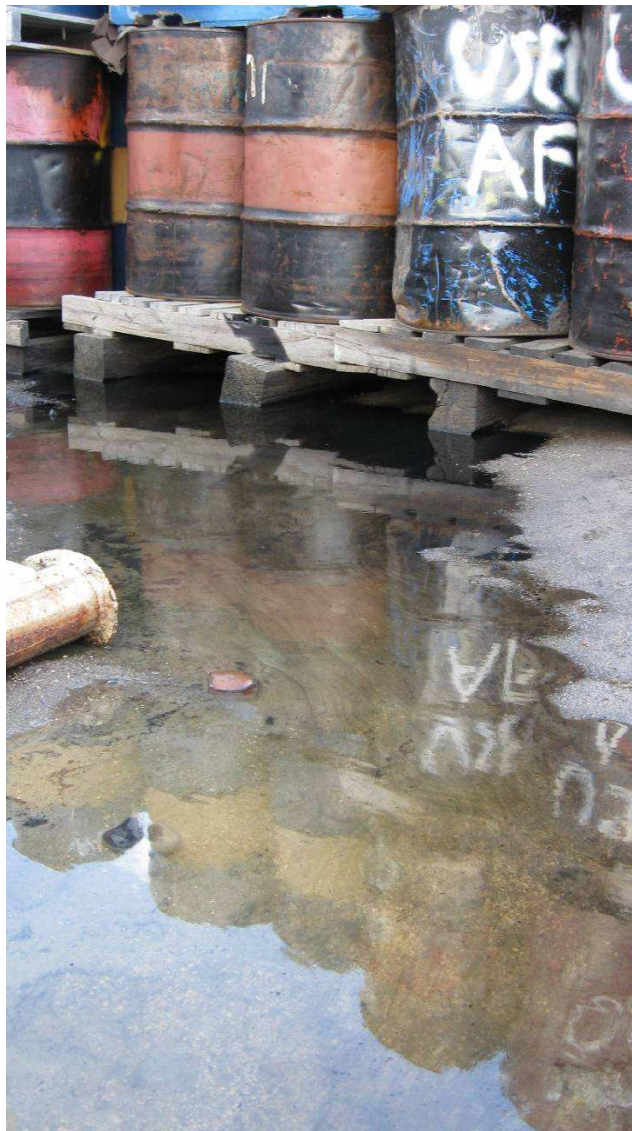
Small amount of water with oily sheen

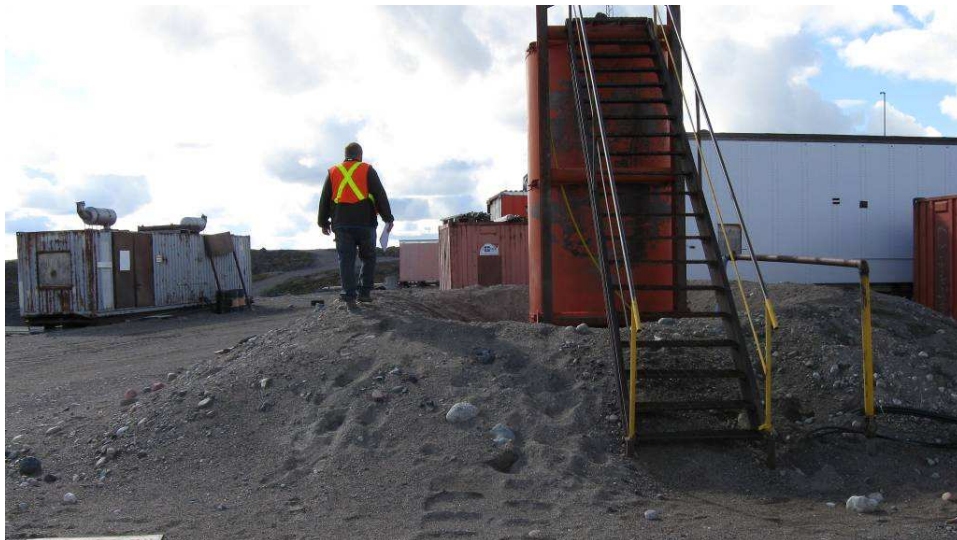
Day Tank Berm

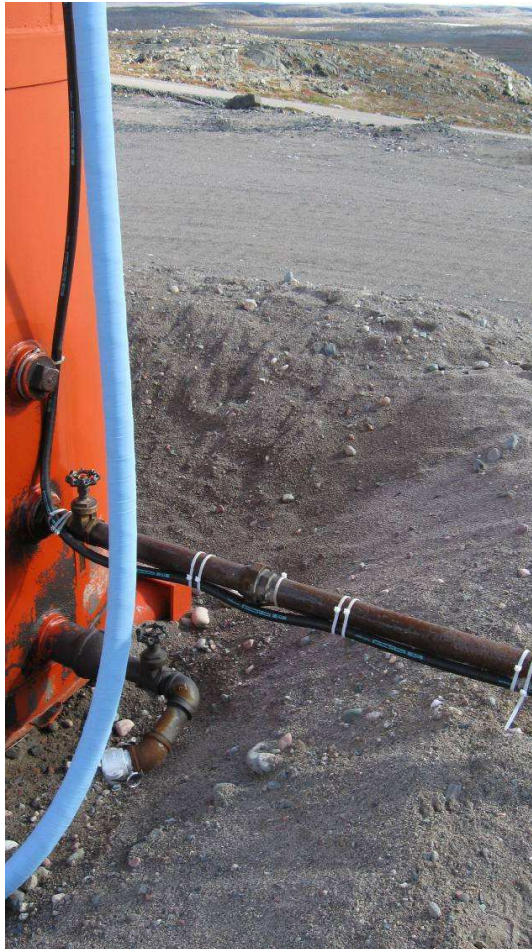
Area Exposed Liner Last Year - Now Covered

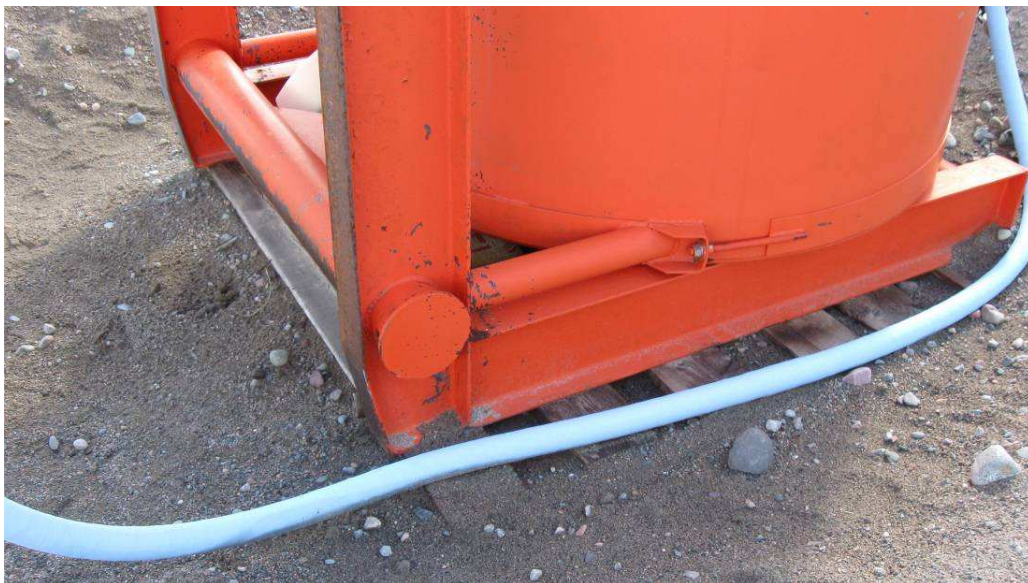
Inside of Berm Dry

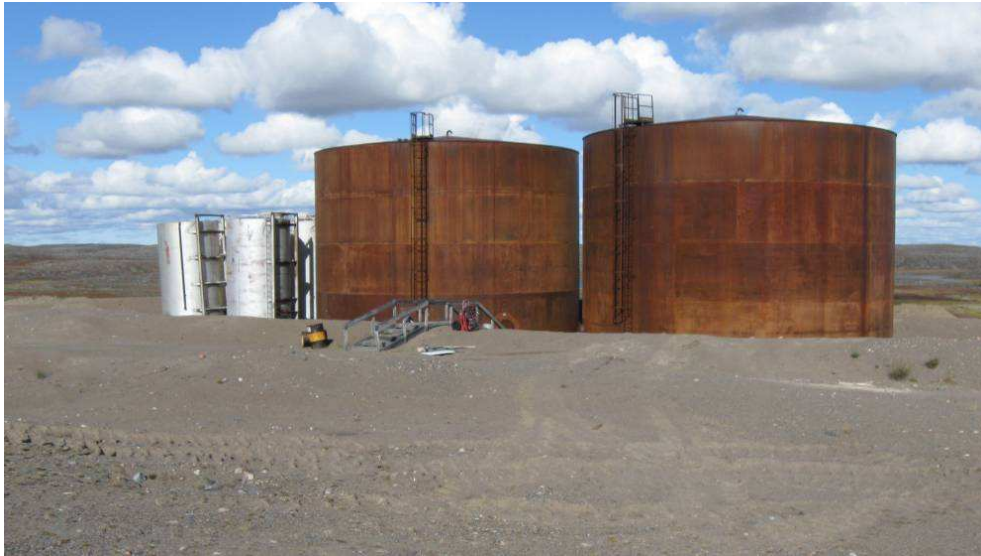
Camp 3 Tank Farm

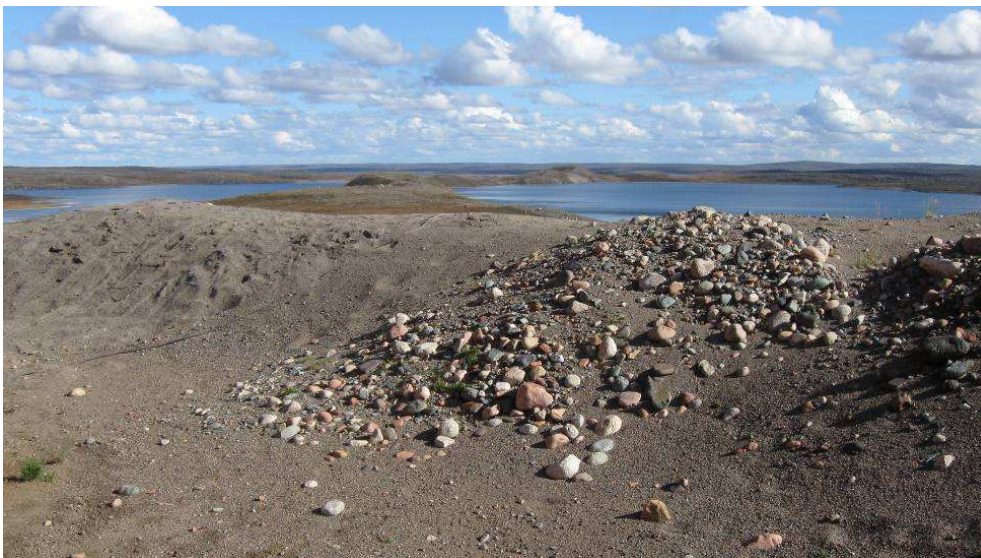
Last Year Exposed Liner – Now Covered

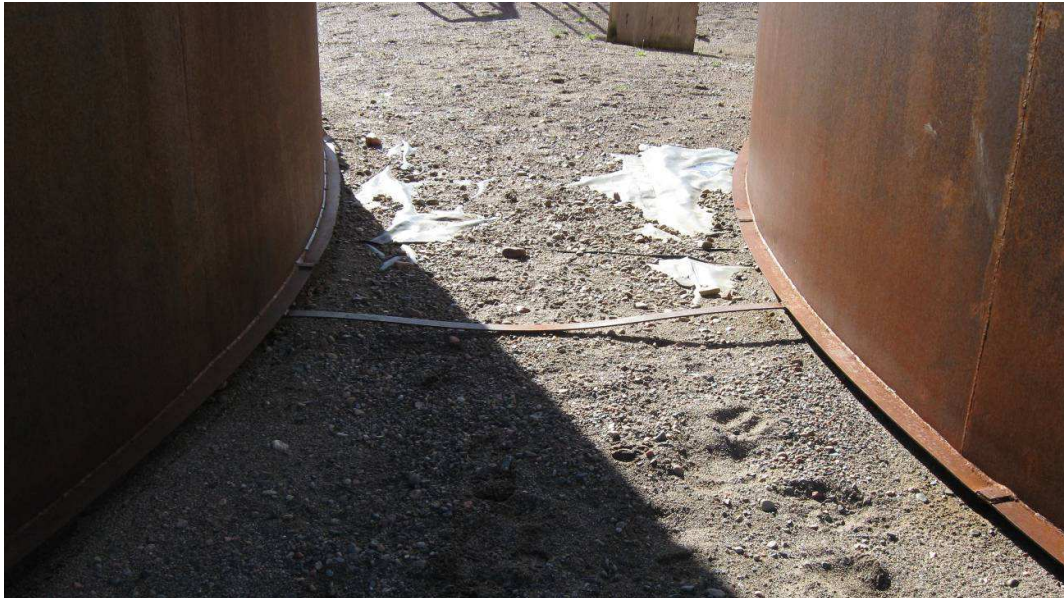
Exposed Liner Between Tanks

SEEPAGE:	No evidence of seepage observes at the berm toe.
MAINTENANCE/MONTORING RECOMMENDATIONS:	Two areas of exposed liner should be recovered with granular fill. The one area of cut slope near the toe and the one erosion gully should be repaired.
CONCLUSIONS:	The berm appears in generally satisfactory condition. See above maintenance items. The leaning tank should be repaired

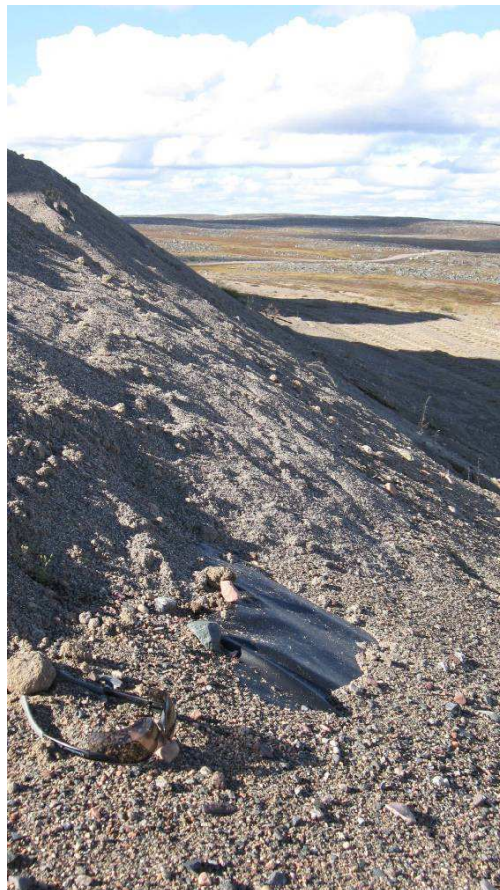
One Area of Exposed Liner on Downstream Slope

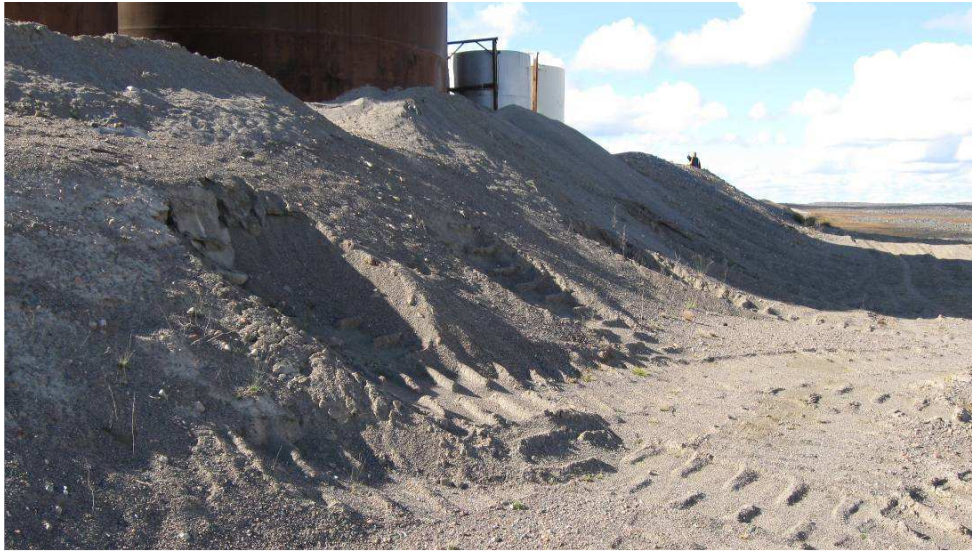
Area of Cut Into Downstream Slope

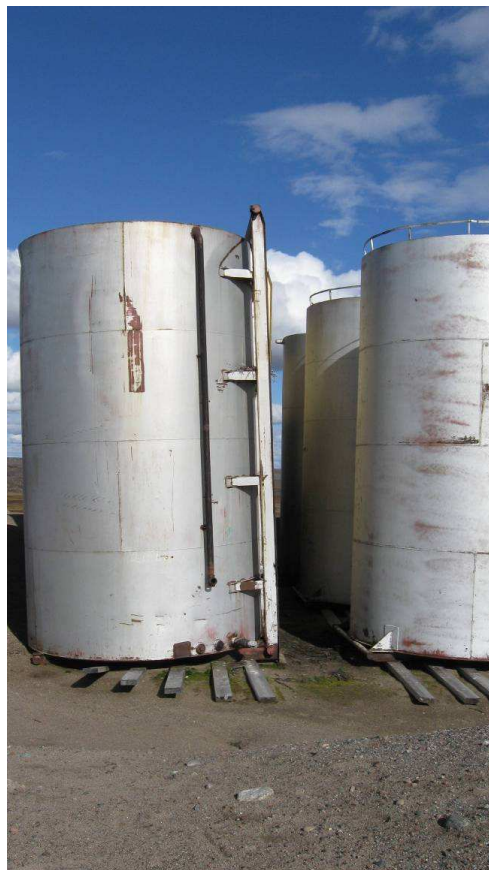
Leaning Tank

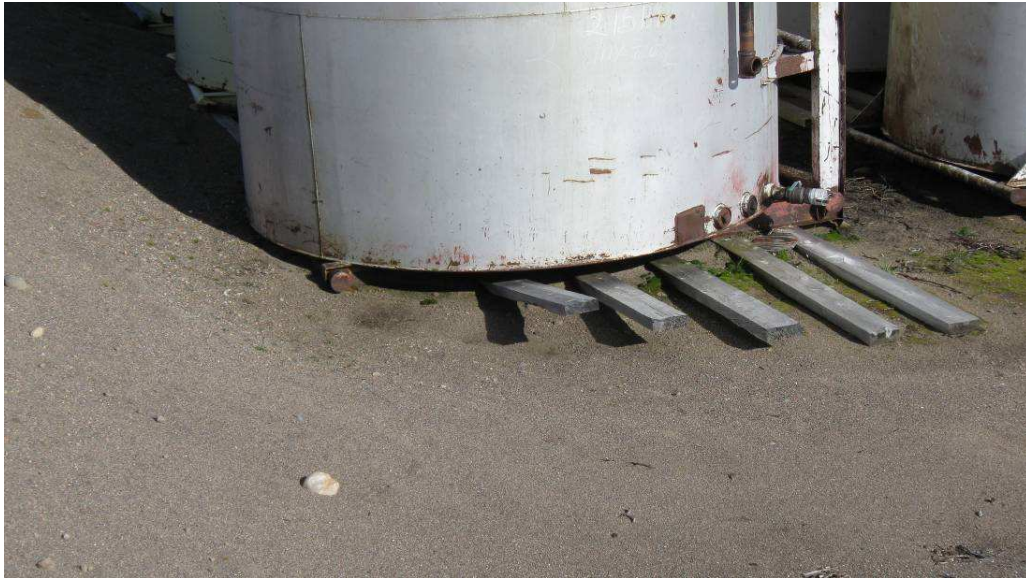
Broken Timber Support

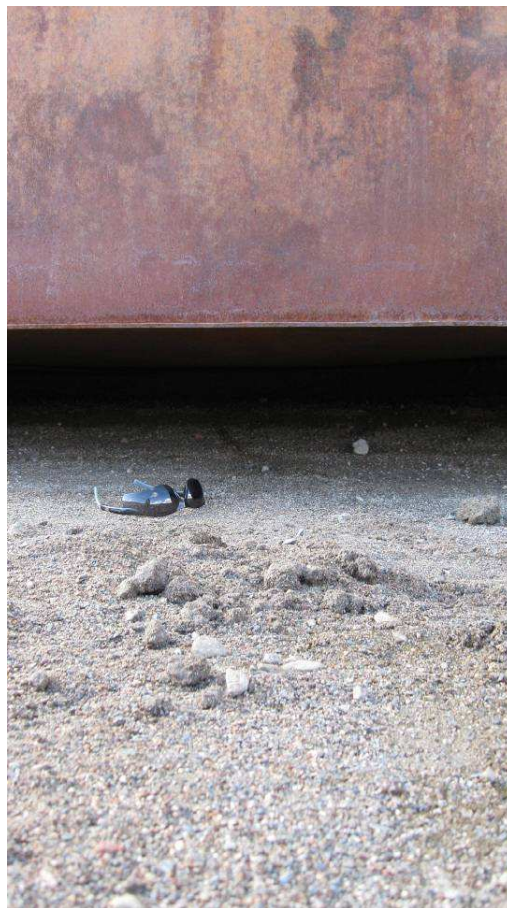
Gap below tank

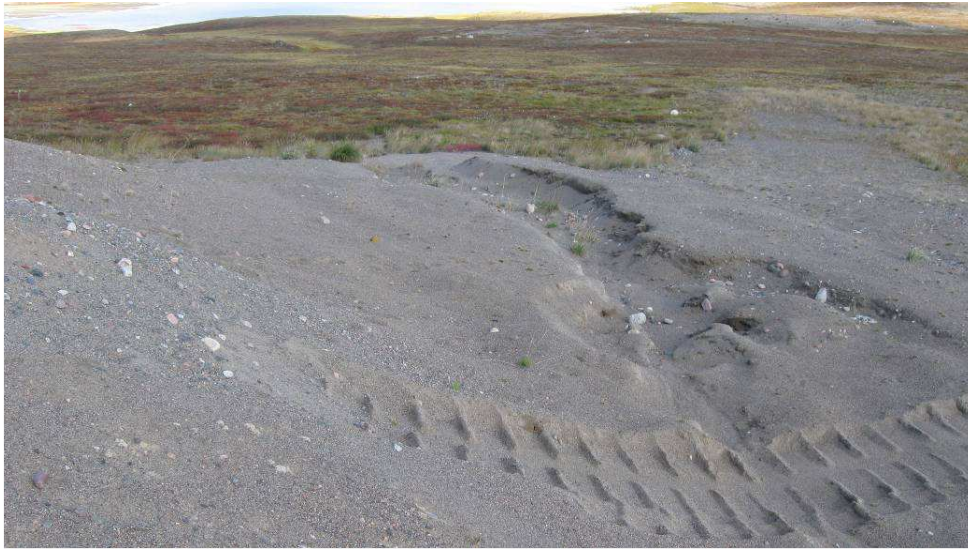
Erosion Gully Near Toe of Embankment S/E Corner

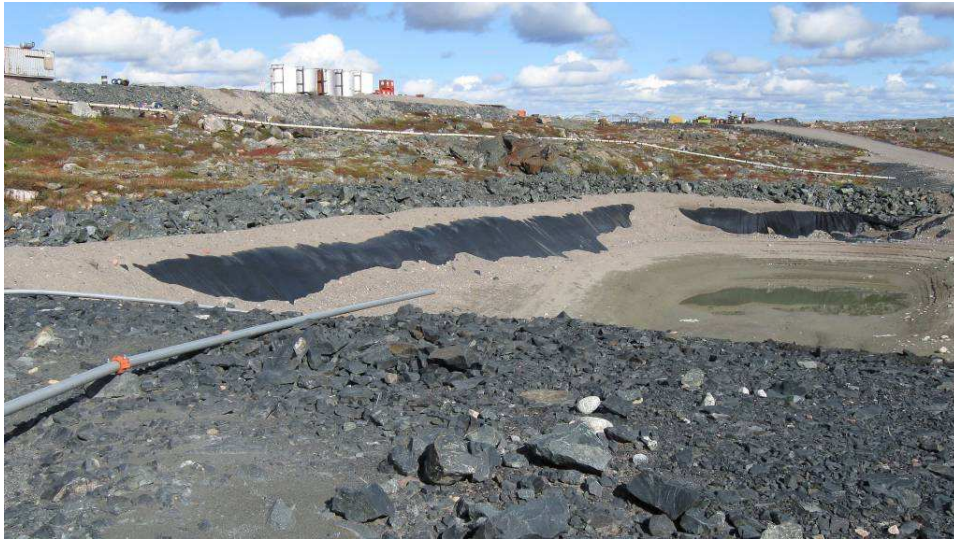
Mine Sump Pit – Exposed Liner

LOCATION:	Directly outside the portal, uphill from both a local access road and the portal laydown pad.
FUNCTION:	Provides containment for settling and sediment retention of mine water pumped from the decline ramp.
SIZE:	~20 m wide by ~30 m long.
BERM HEIGHT:	~1.5 to 2 m above adjacent grade.
CREST ELEVATION:	No survey information available.
BERM CONDITION:	<p>Berm is constructed from rockfill (waste rock) and esker sand and gravel. The banks are over-steepened.</p> <p>Geomembrane liner within berm is exposed at numerous locations along the north, east and west sides. The liner at north end of the pond is loose. Small tears are developing in the liner.</p>
SEEPAGE:	No evidence of seepage observed at the berm toe. Current water depth inside sump is about 150 mm.
MAINTENANCE/MONTORING RECOMMENDATIONS:	Before the sump is put back into service the liner and side slopes should be repaired/restored.
CONCLUSIONS:	The berms are suitable for the interim. Before the sump is put back into use, the liner and slopes must be repaired.

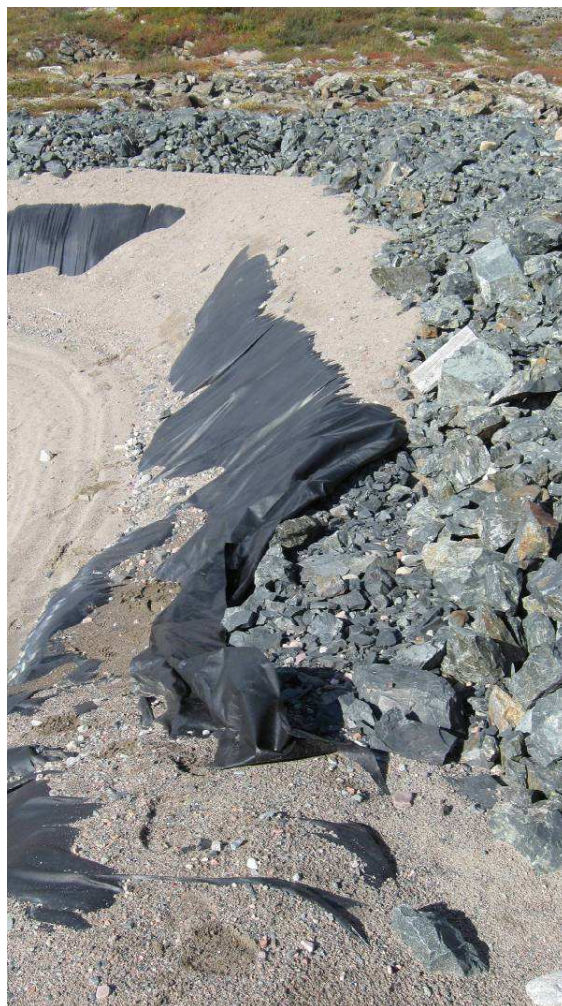
Exposed and Loose End of Liner

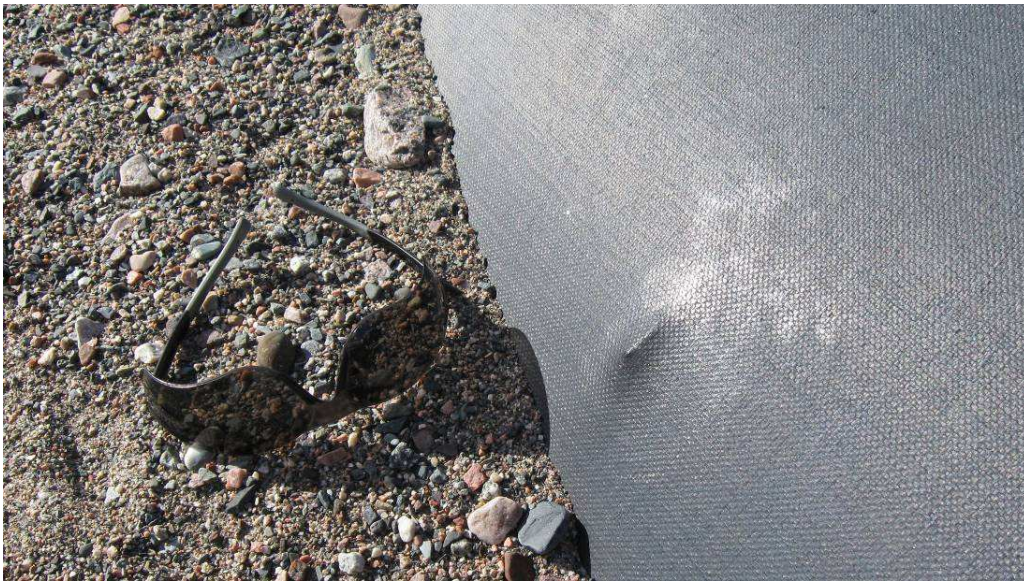
Typical Small Tear in Liner

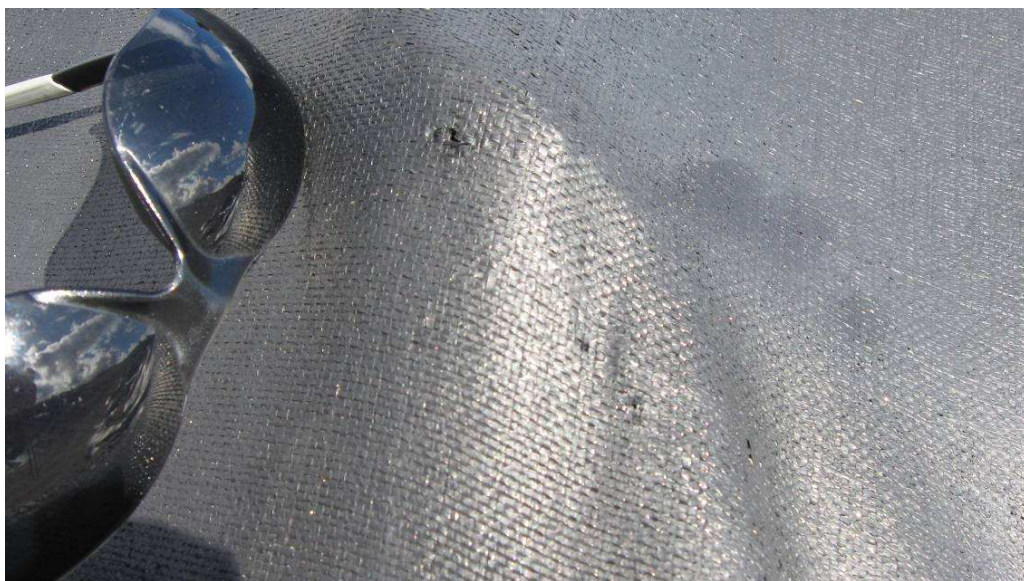
Typical Small Tear in Liner

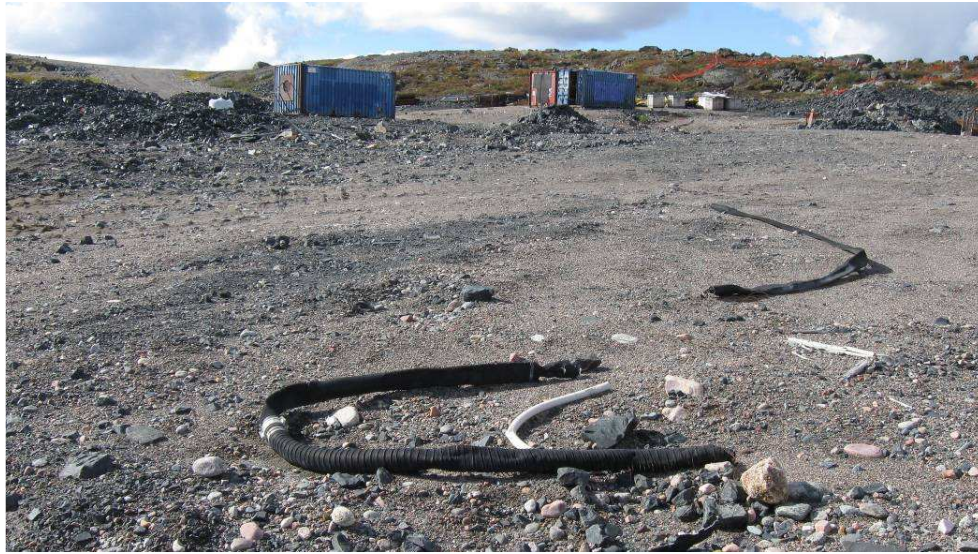
Portal Laydown Pad

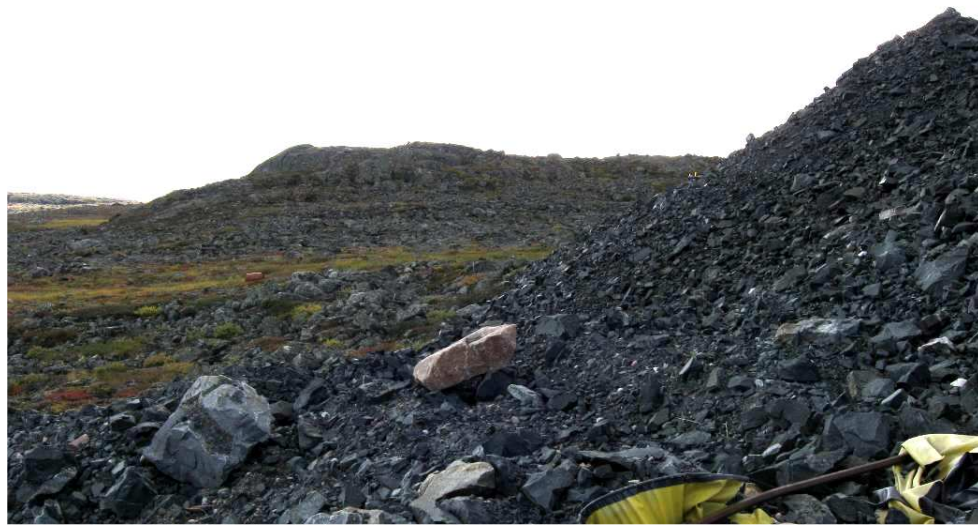
Downhill Face of Pad

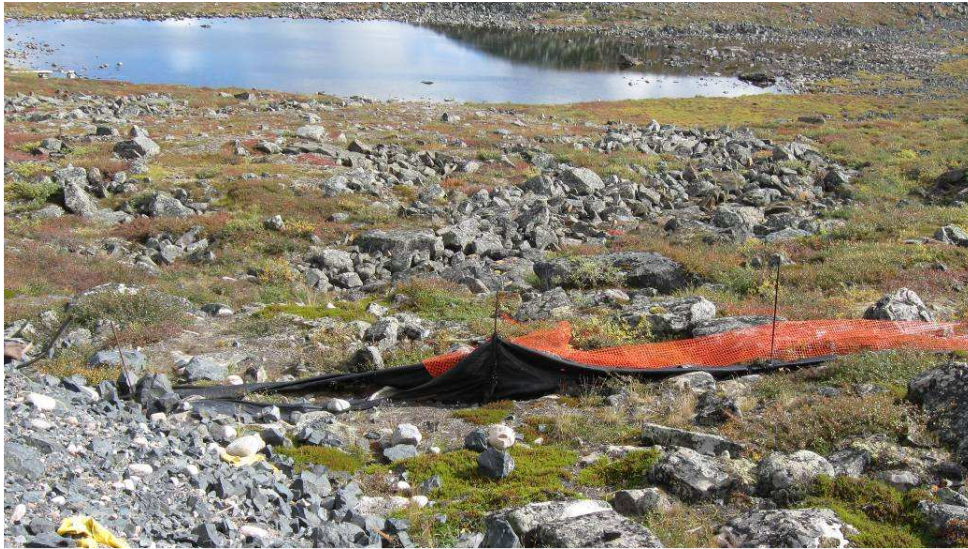
Silt Fence

LOCATION:	Pad is located just downhill from the portal and local access road, approximately 150 m from East Lake.
FUNCTION:	Initially constructed from waste rock from the decline ramp development. Mine muck material was placed on the pad covers a portion of the silt control fence.
SIZE:	~50 m wide by ~200 m long.
PAD THICKNESS:	Ranges from 1 to 5 m above original topography.
CREST ELEVATION:	No survey information available.
PAD CONDITION:	Pad is constructed from rockfill (waste rock). Toe of the pad sits at the angle of repose for rockfill. Scarps and cracks have developed on downhill toe due to sloughing and erosion of loose fill.
TOE DISCHARGE:	No seepage observed at the toe of the pad. Any potential pad drainage heads downhill into East Lake.
MAINTENANCE/MONTORING RECOMMENDATIONS:	Existing downstream stream silt fencing is in need of repair.
CONCLUSIONS:	The pad appears to shows signs of instability and erosion on the downstream side. Re-grading and shaping will be required before the pad is put into use. Runoff from the pad is collected within East Lake that passes through a wetland before entering Ulu Lake. The existing down slope silt curtain is in need of repair and has been covered by the toe of the pad at some locations. The silt curtain should be restored.

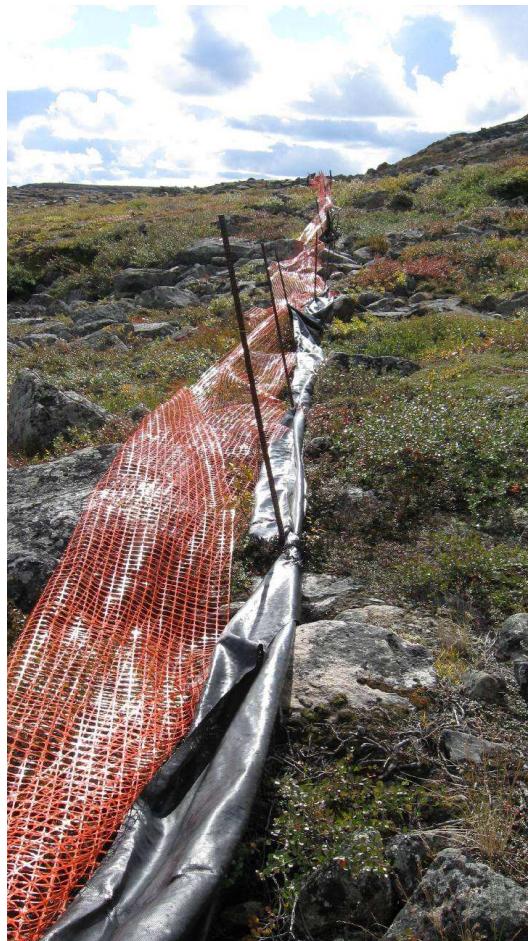
Silt Fence

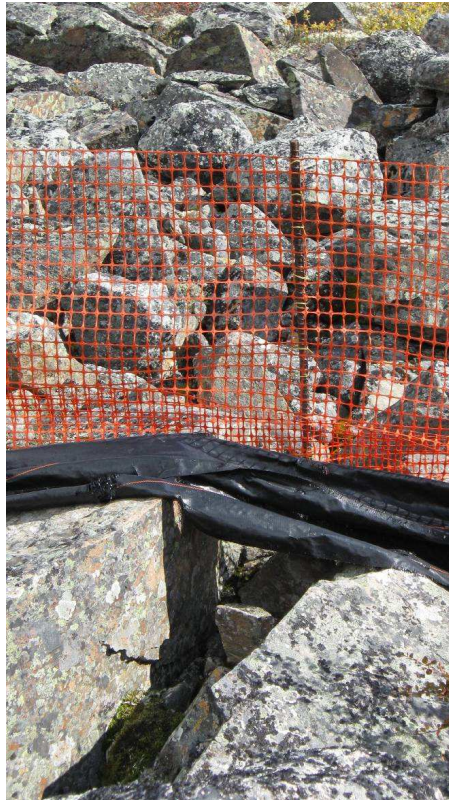
Silt Fence

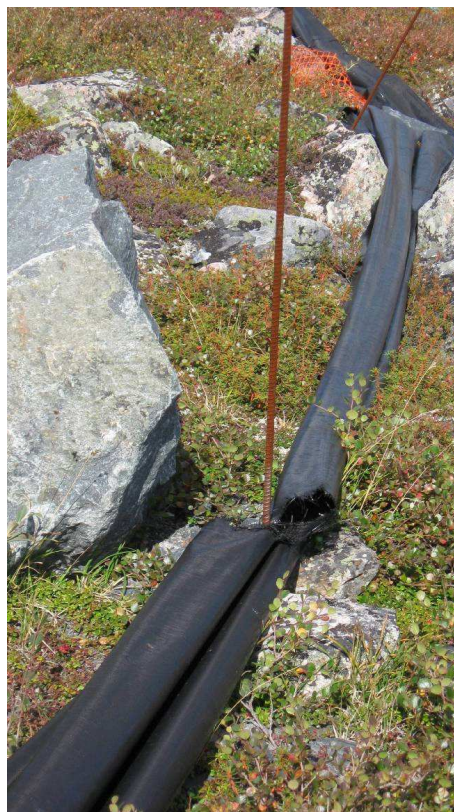
Silt Fence

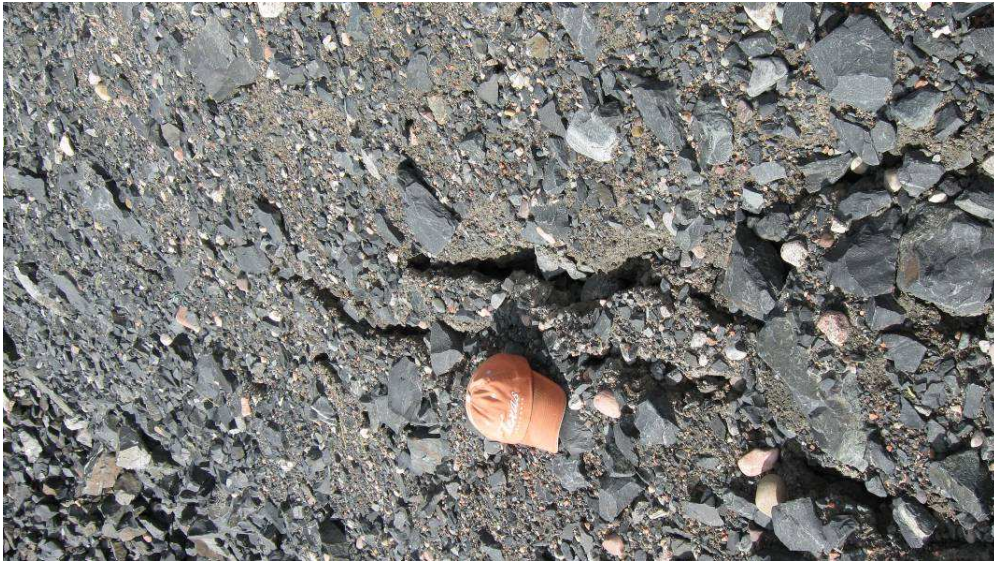
Slump Cracking Downhill Side

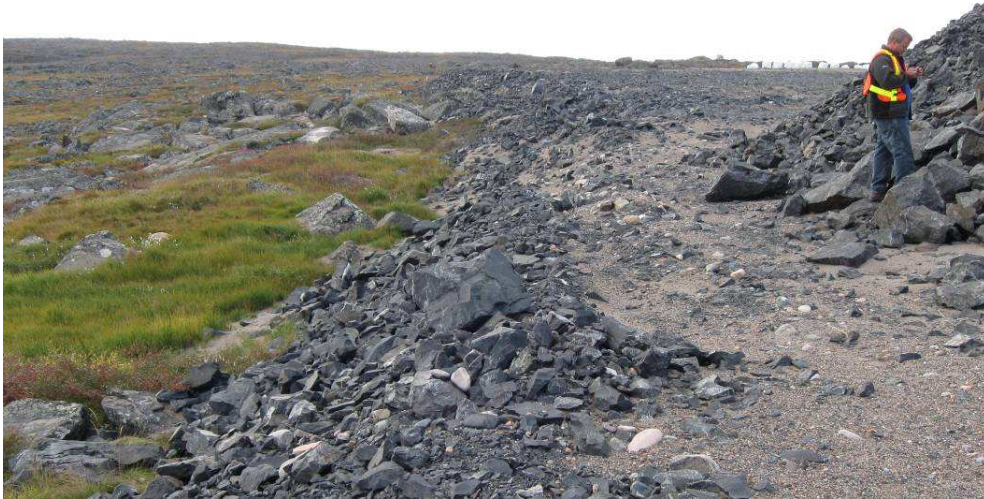
Storage Pad Outside Edge

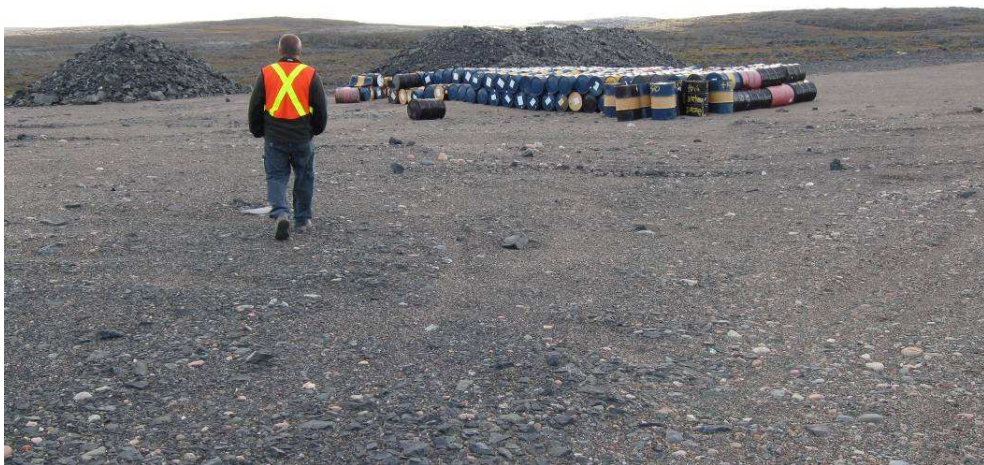
Storage Pad Area
