2011 Annual Geotechnical Inspection Various Earth Structures Ulu, Nunavut

November 24, 2011

Ref. No. 11-293

**2011 Annual Geotechnical Inspection
Various Earth Structures
Ulu Gold Project, Nunavut**

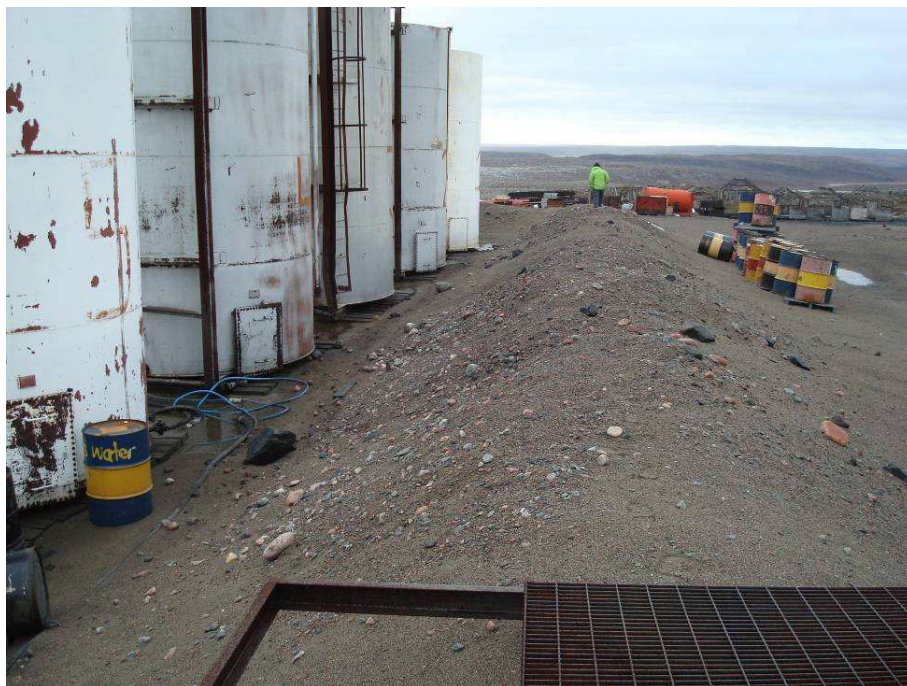
| BERM CONDITION: | Berm is constructed from esker sand and gravel and appears in good condition. Numerous animal burrows observed on the outside slope of the berm. Several areas of exposed liner along interior of berm. Exposed liner appears to be in good shape (no visible holes). |

Exterior Berm – 2011

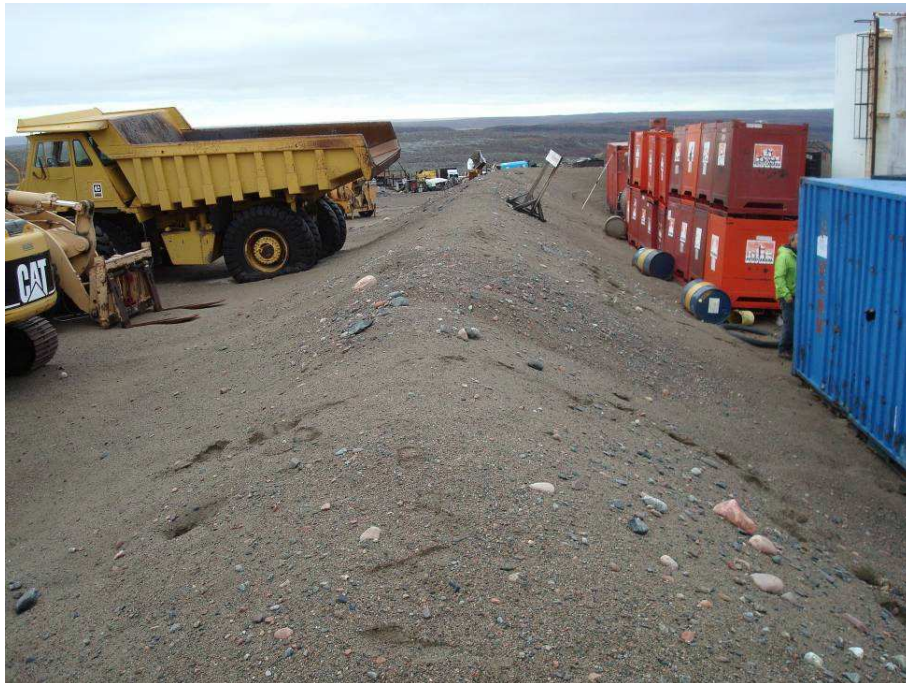
Exterior Berm – 2011

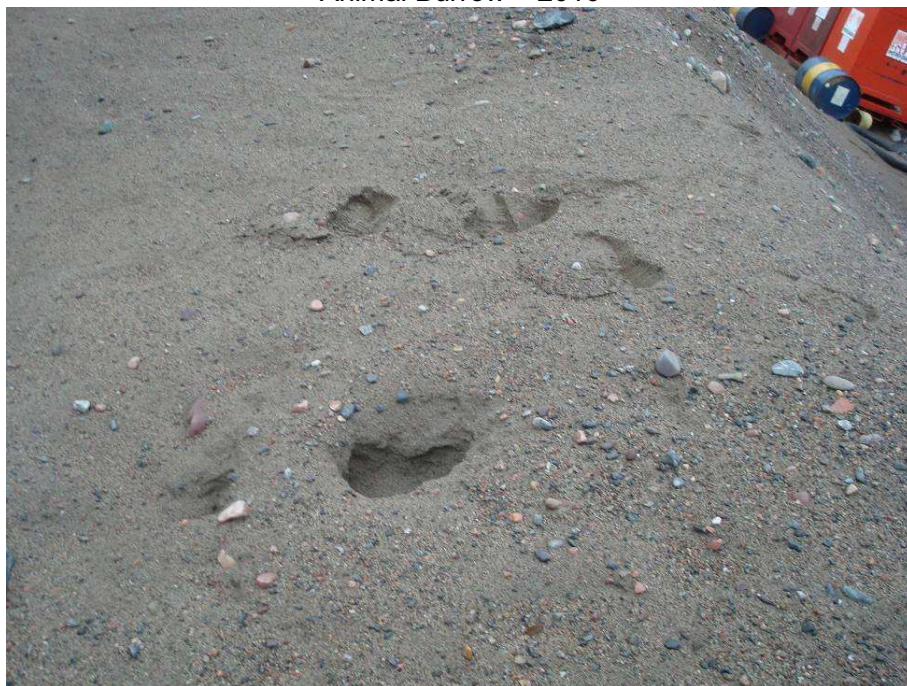
Animal Burrow – 2011

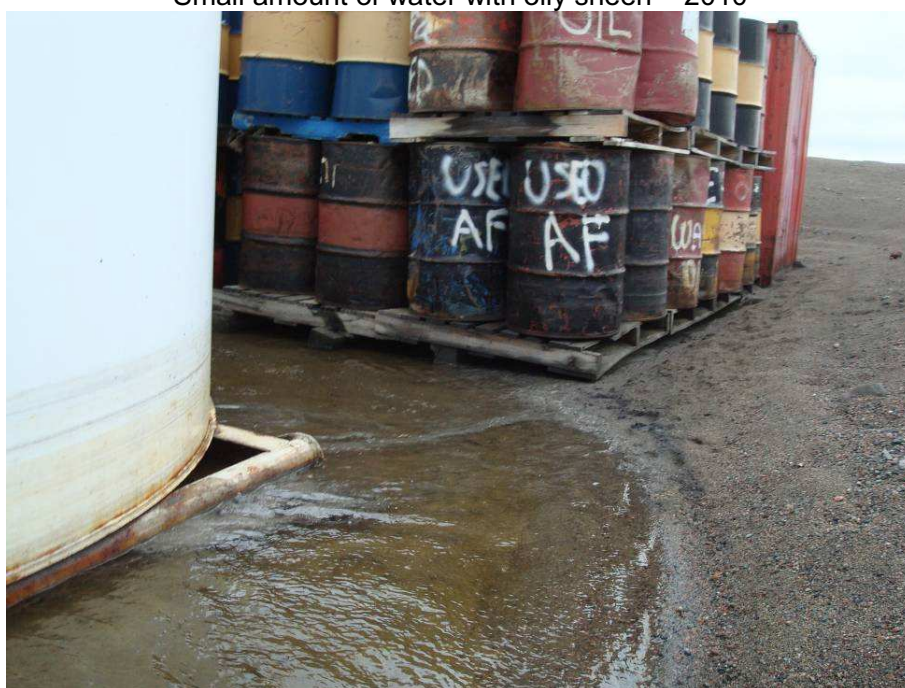
| SEEPAGE: | No evidence of seepage observed at the exterior berm toe. Small amounts of water with oil sheen are being retained within the storage area. Slightly more water being retained this year as compared to last year. |

Small amount of water with oily sheen – 2011

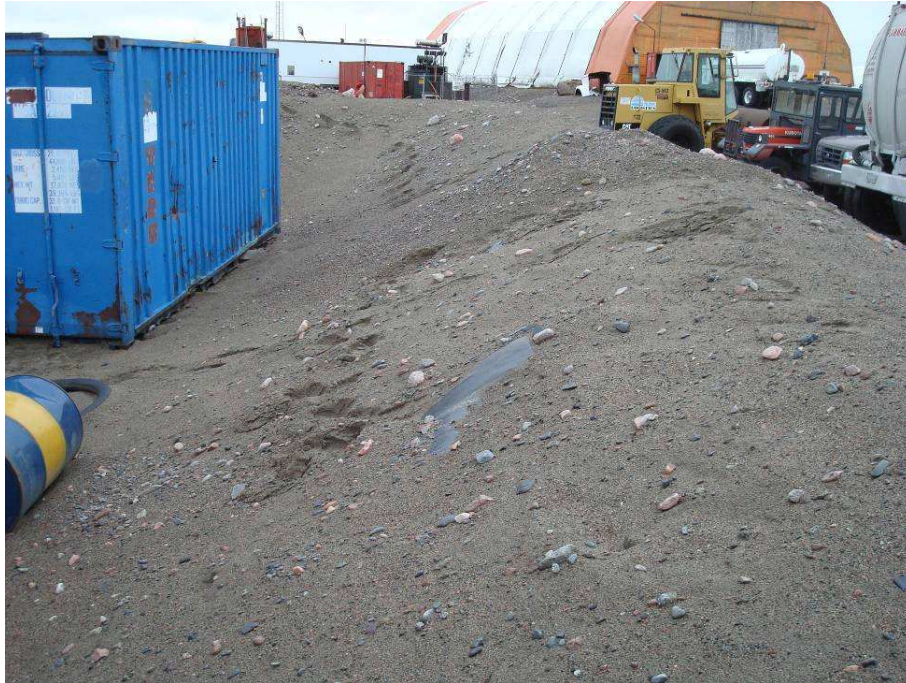
One Area of Exposed Liner – 2011

| RECOMMENDATIONS: | Cover areas of exposed liner. |

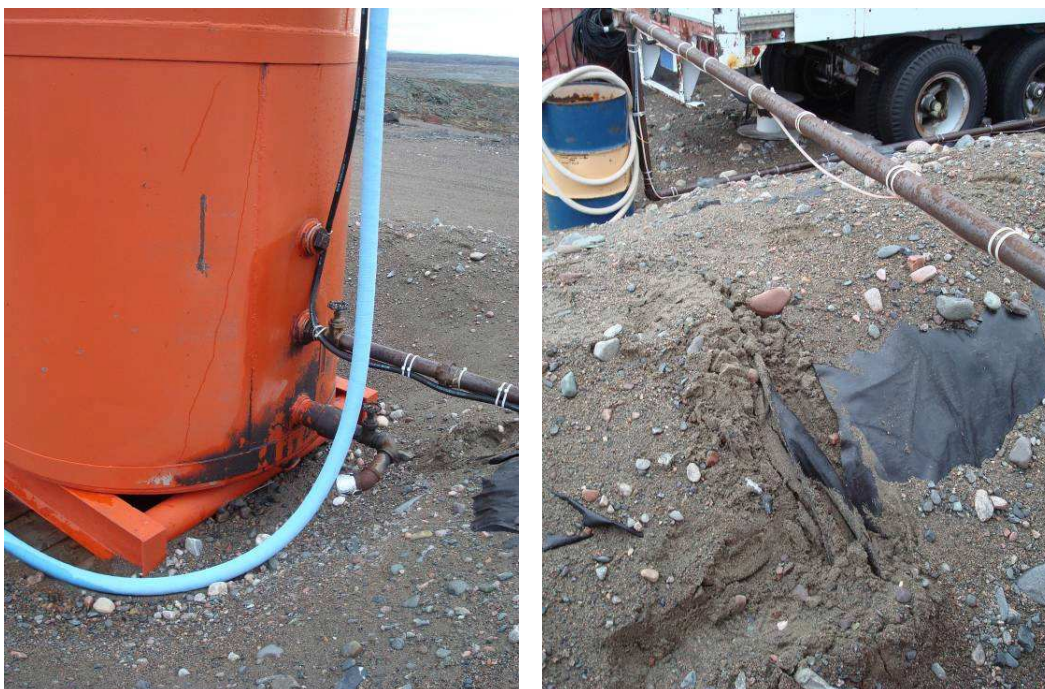
| BERM CONDITION: | Berm is constructed from esker sand and gravel and appears in overall good condition. Liner is exposed at one location along the interior of the berm. Where the liner is exposed, it is also separated at a seam. |

Inside of Berm, West Side with Exposed and Separated Liner – 2011

| MAINTENANCE/MONTORING RECOMMENDATIONS: | Repair and cover exposed section of separated liner. |

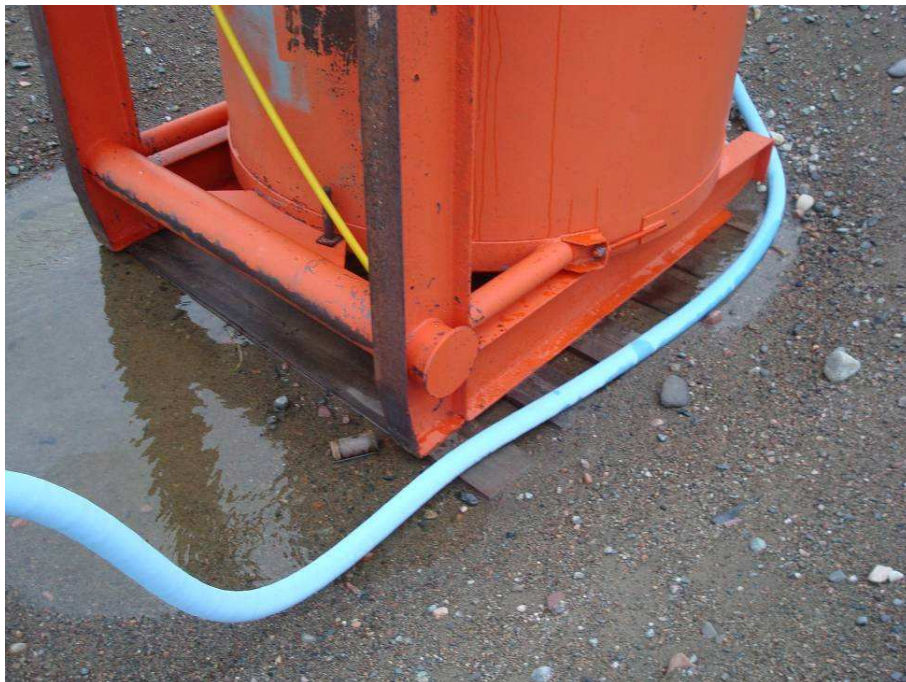
| SEEPAGE: | No evidence of seepage observed at the berm toe. Approximately 50 mm of water has accumulated in bottom of containment area. |

Inside of Berm, Up To 50 mm of Water – 2011

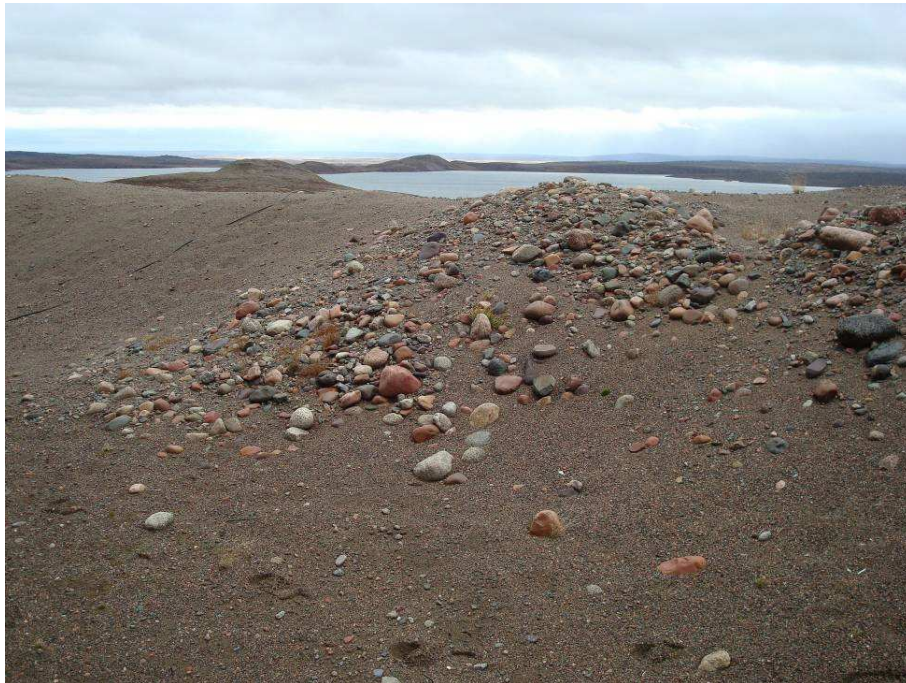
Area of Exposed Liner Covered in 2010 – 2011

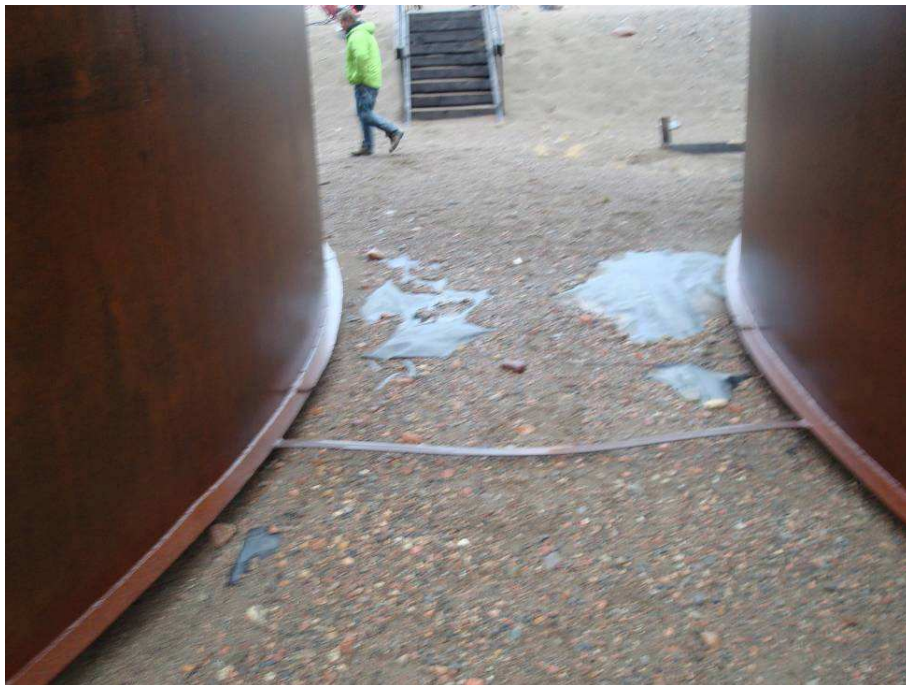
Exposed Liner Between Tanks – 2011

| MAINTENANCE/MONITORING RECOMMENDATIONS: | Areas of exposed liner should be covered with granular fill. |

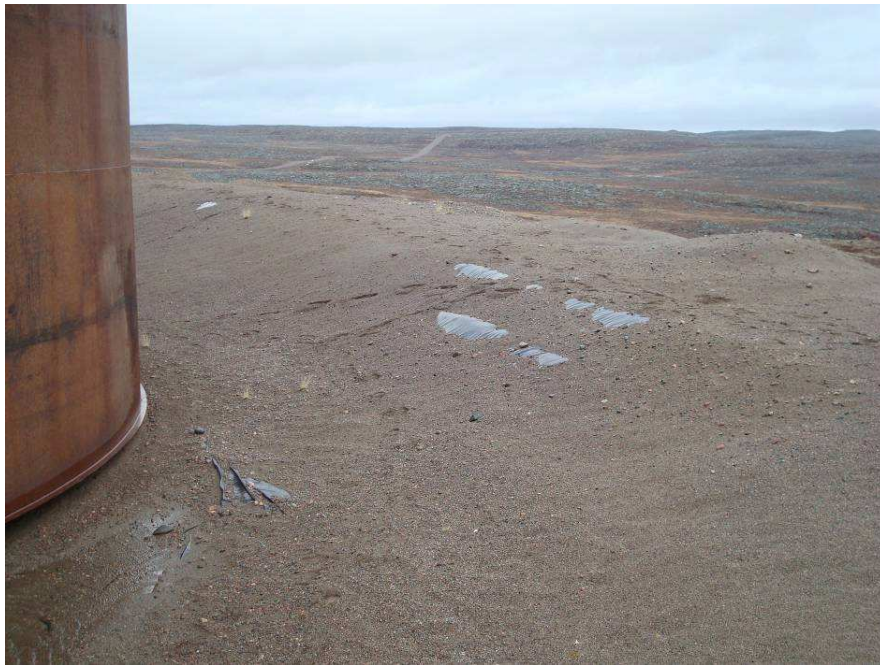
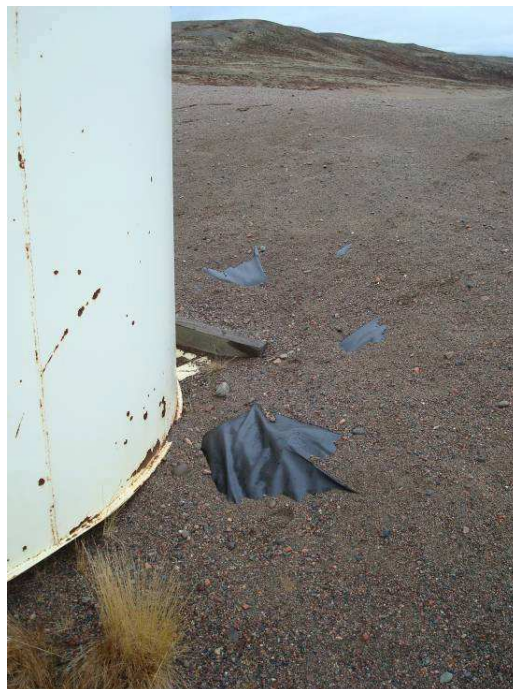
| BERM CONDITION: | Berm is constructed from esker sand and gravel and appears in good condition. Some new areas of liner are exposed, but no holes were observed at the interior locations. Several animal burrows were noted along the exterior of the berm. Some of the smaller tanks have broken timber foundation supports causing the tanks to lean. This should be repaired. |

New Area of Exposed Liner – 2011

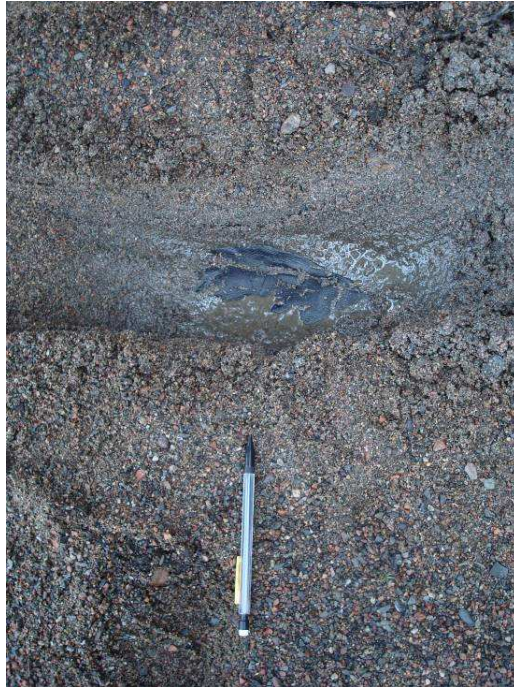
Liner Uncovered At One Location of Containment Area Floor – Appears in Good Shape – 2011

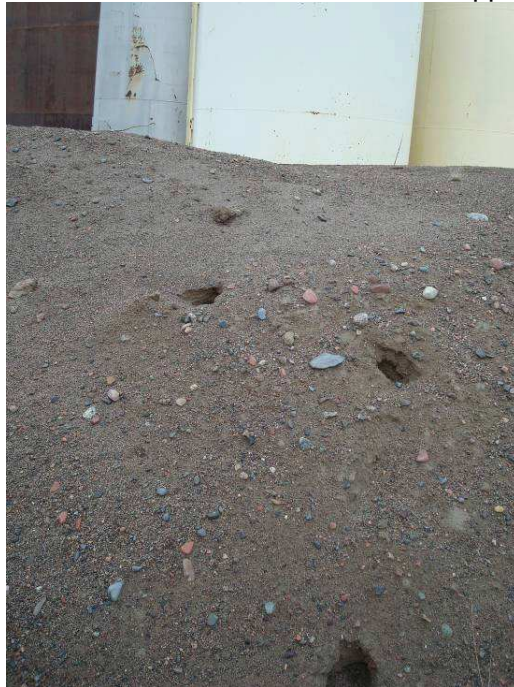
Animal Burrows Exterior of Berm – 2011

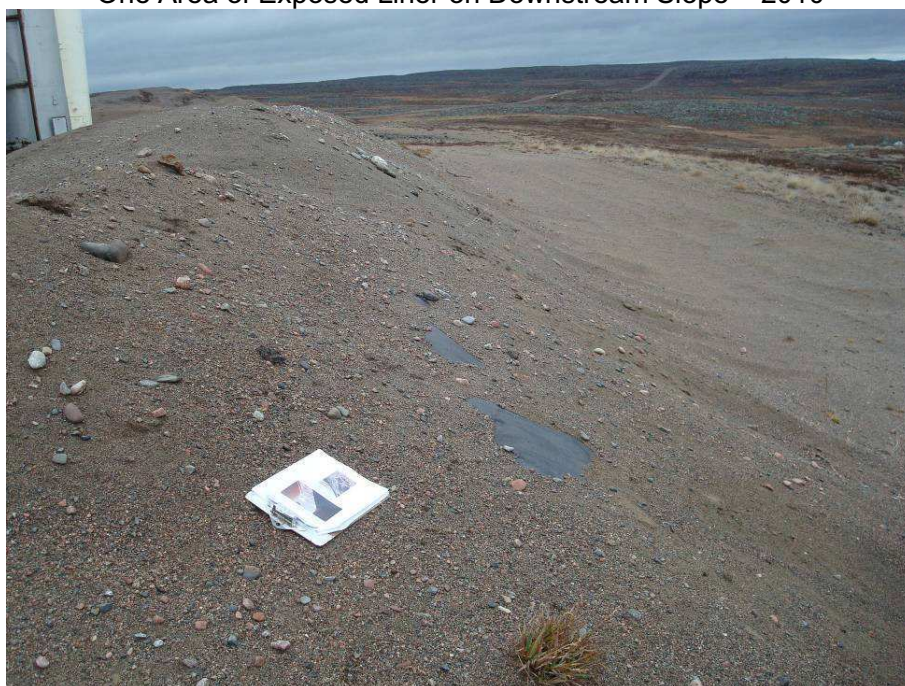
One Area of Exposed Liner on Downstream Slope – 2011

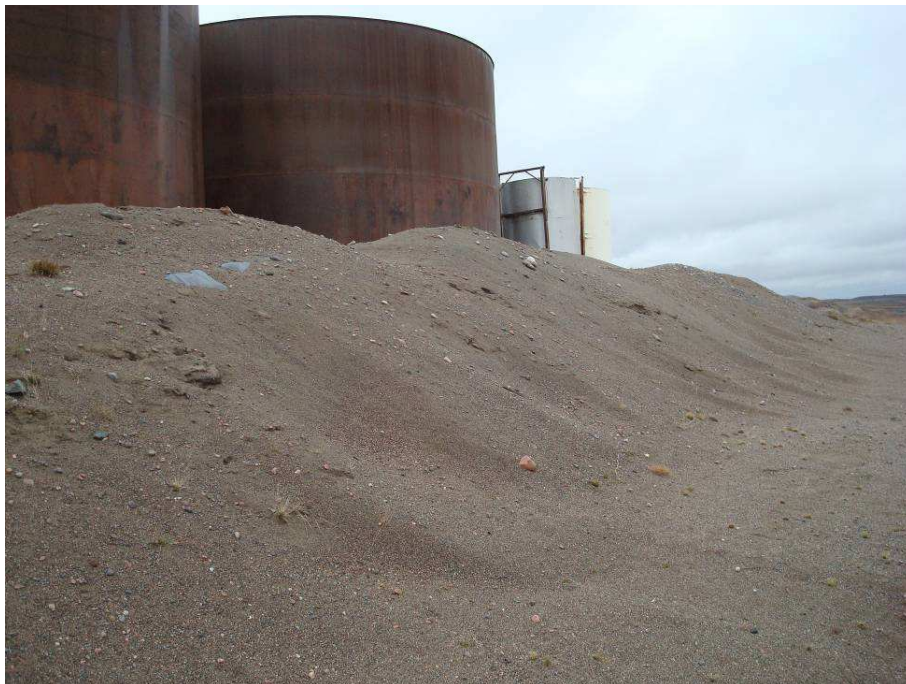
Area of Cut Into Downstream Slope – 2011

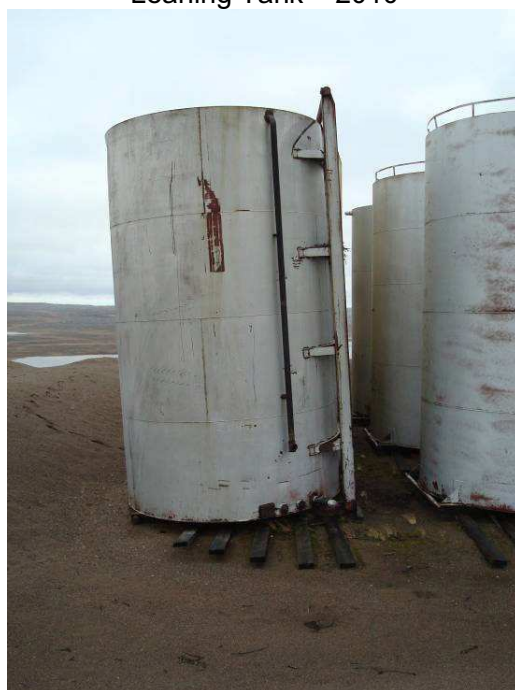
Several of the smaller tanks are leaning due to broken timber foundations supports. This should be assessed and repaired if deemed necessary.

Leaning Tank – 2011

| CONCLUSIONS: | The berm appears in generally satisfactory condition. See above maintenance items. The leaning tanks should be assessed/repared |

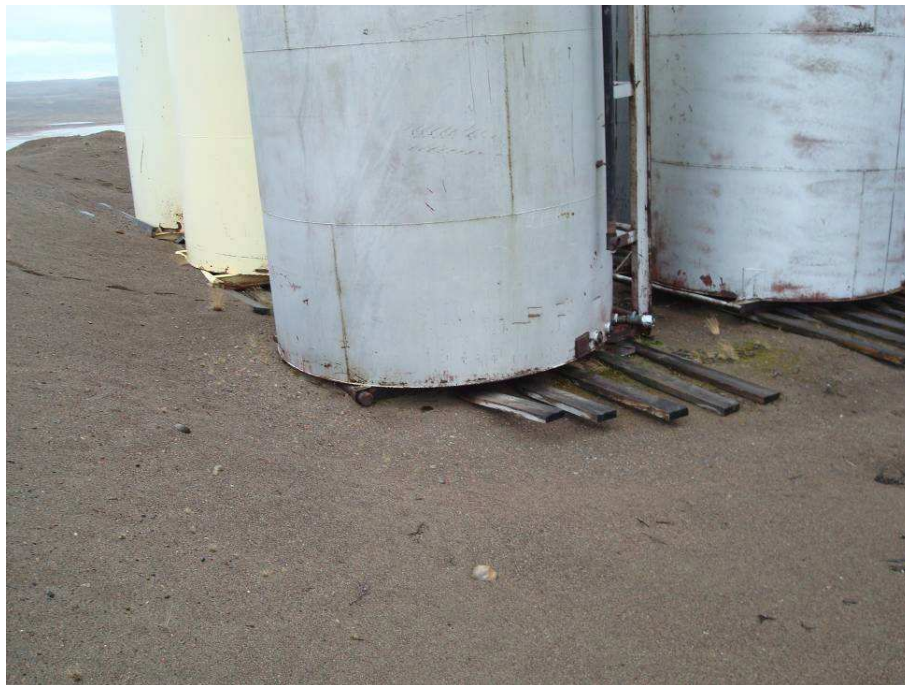
Broken Timber Support – 2011
Another Leaning Tank – 2011

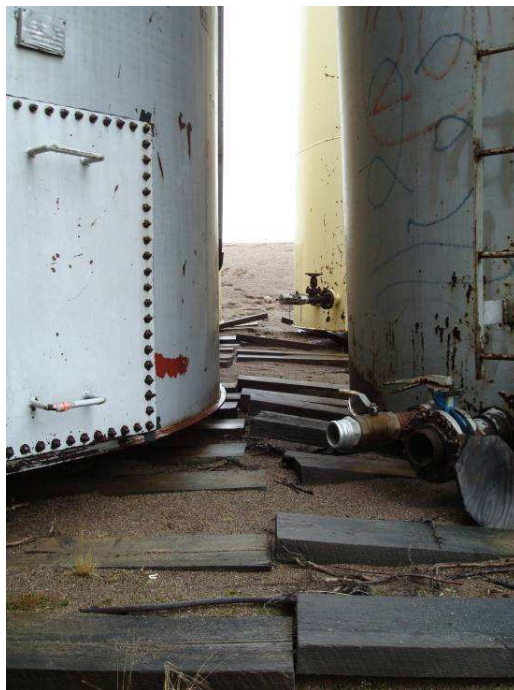
More Broken Timber Tank Supports – 2011

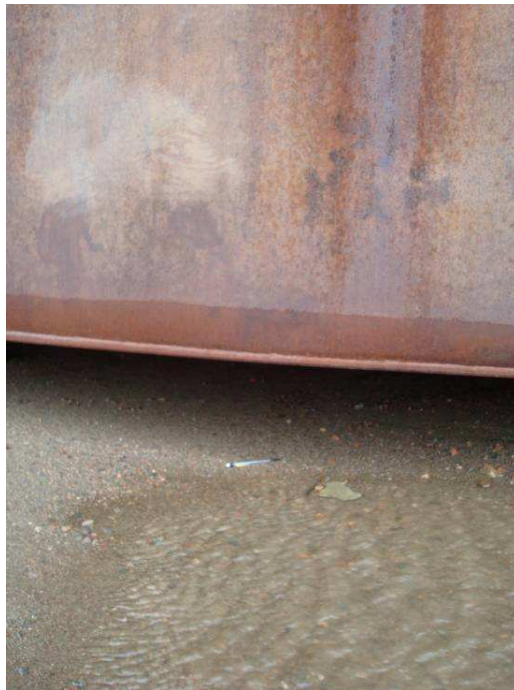
Gap below tank (some contained water) – 2011

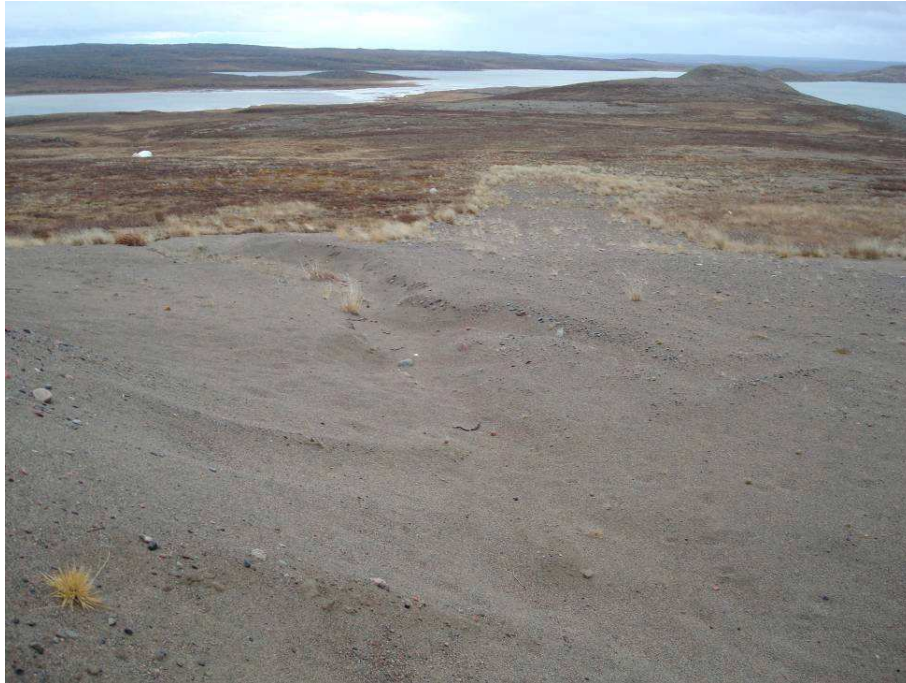
Erosion Gully Near Toe of Berm S/E Corner – 2011

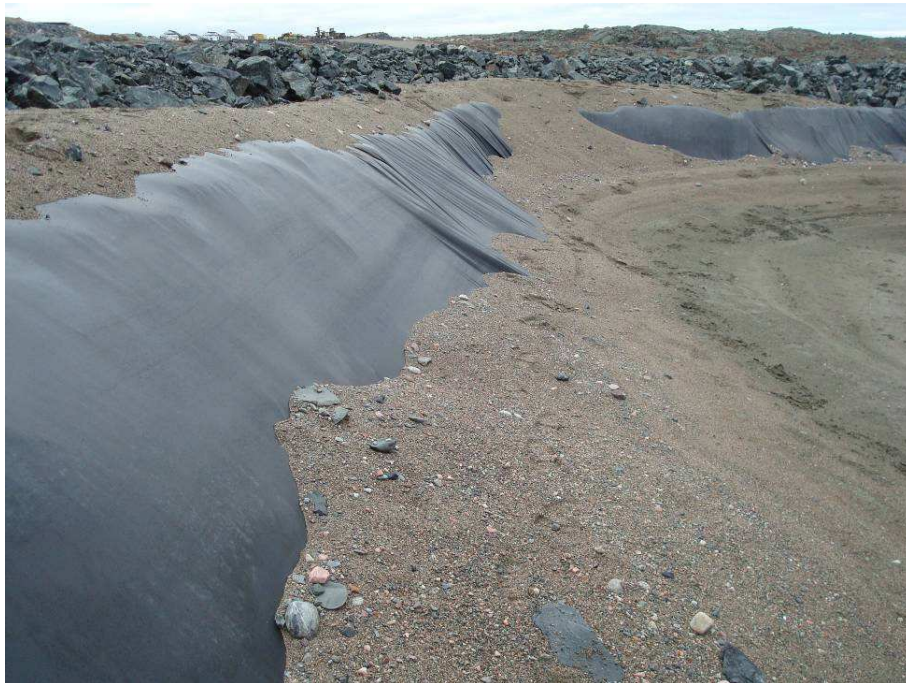
| BERM CONDITION: | <p>Berm is constructed from rockfill (waste rock) and esker sand and gravel. The banks are over-steepened.</p> <p>Geomembrane liner within berm is exposed at numerous locations along the north, east and west sides. The liner at north end of the pond is loose. Small tears are developing in the liner.</p> |

Mine Sump Pit – Exposed Liner – 2011

| MAINTENANCE/MONTORING RECOMMENDATIONS: | Before the sump is put back into service the liner and side slopes should be repaired/restored. |

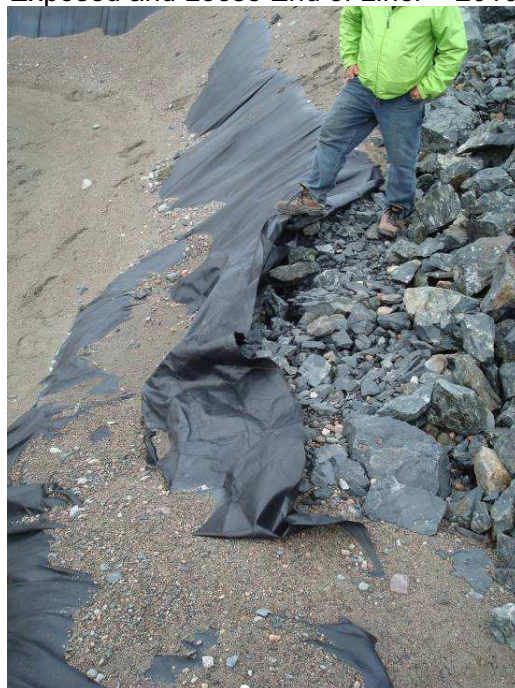
Exposed and Loose End of Liner – 2011

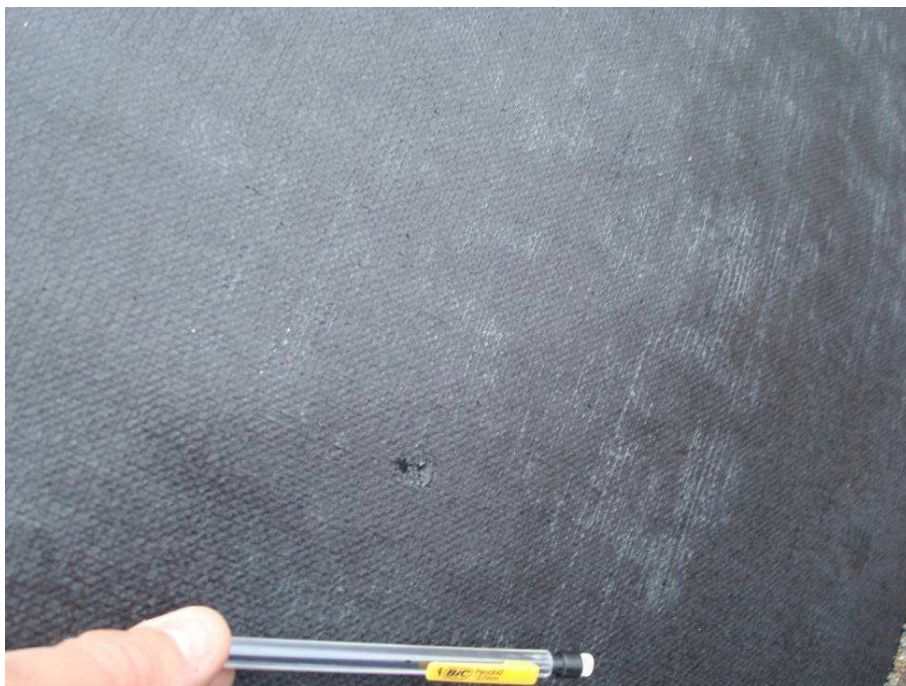
Typical Small Tear in Liner – 2011

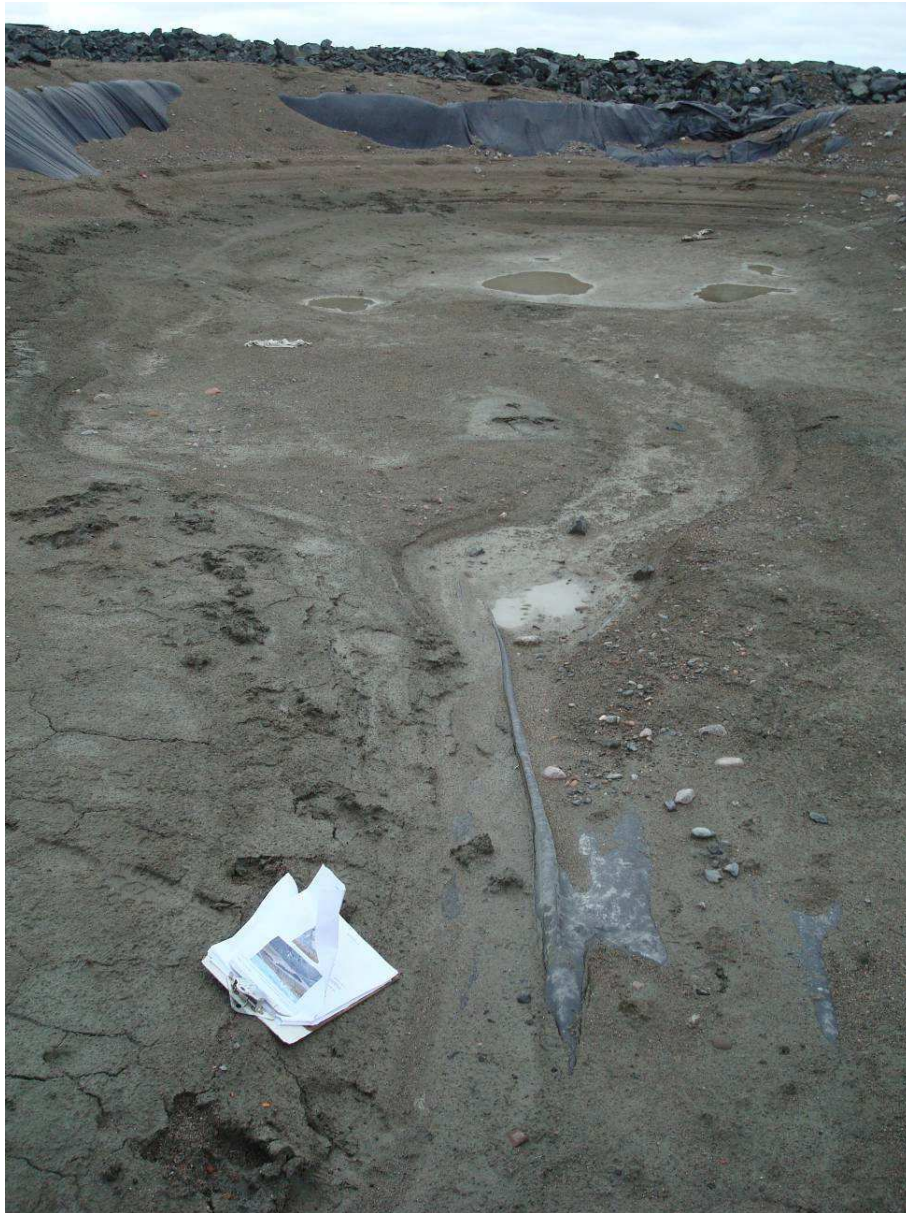
| SEEPAGE: | No evidence of seepage observed at the berm toe. Small amount of ponded water. |

Small Amout of Poned Water – 2011

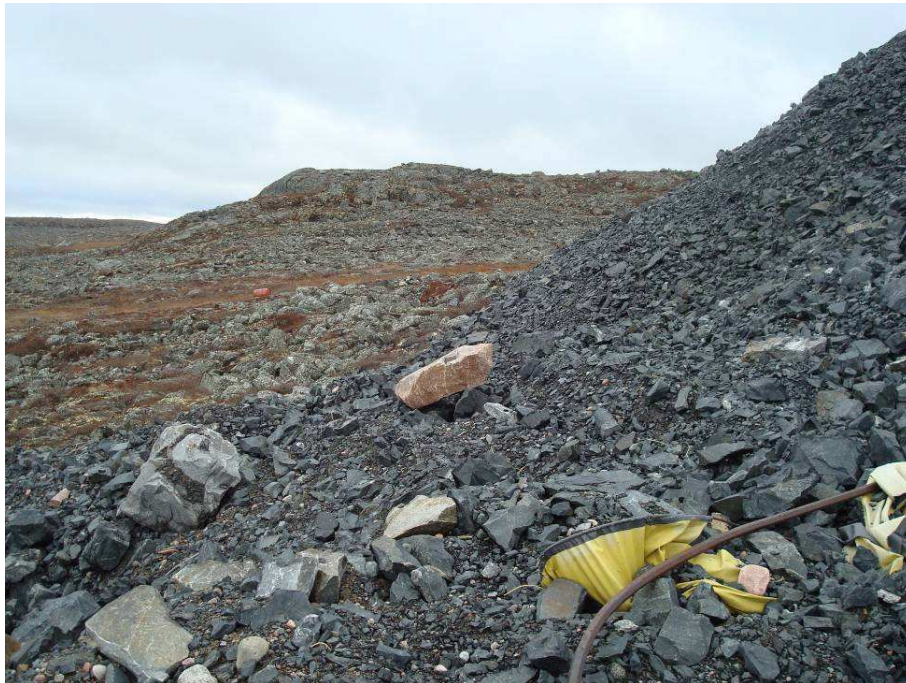
| PAD CONDITION: | Pad is constructed from rockfill (waste rock). Toe of the pad sits at the angle of repose for rockfill. Scarps and cracks have developed on downhill toe due to sloughing and erosion of loose fill. |

Downhill Face of Pad – 2011

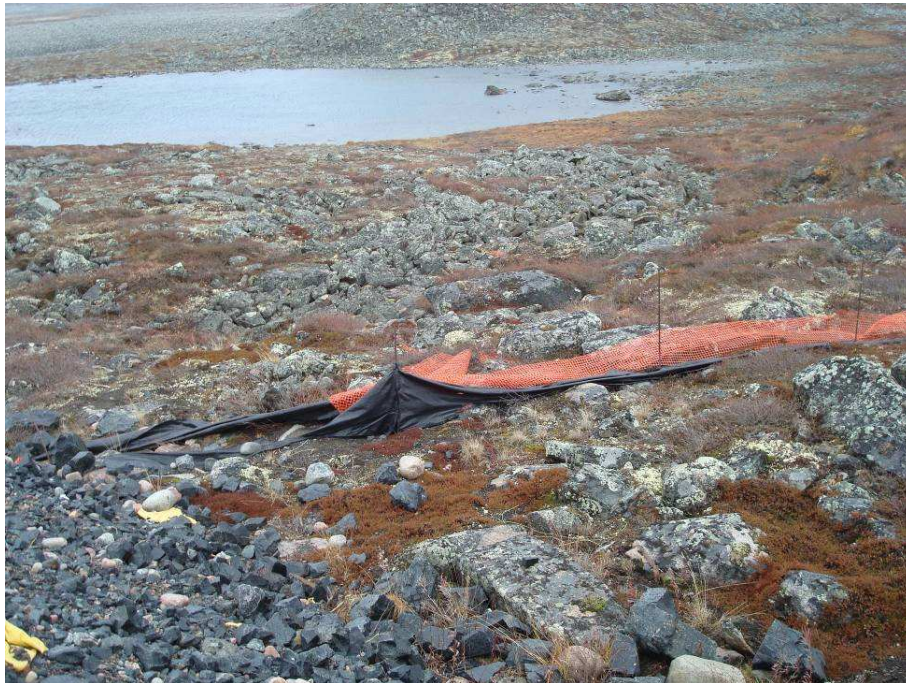
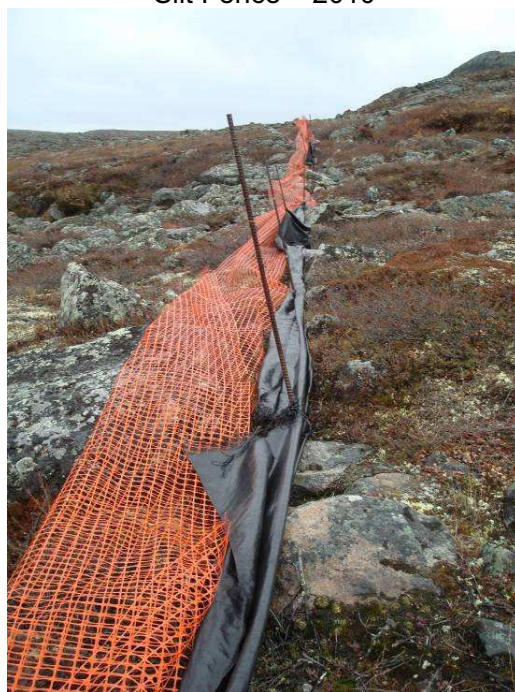
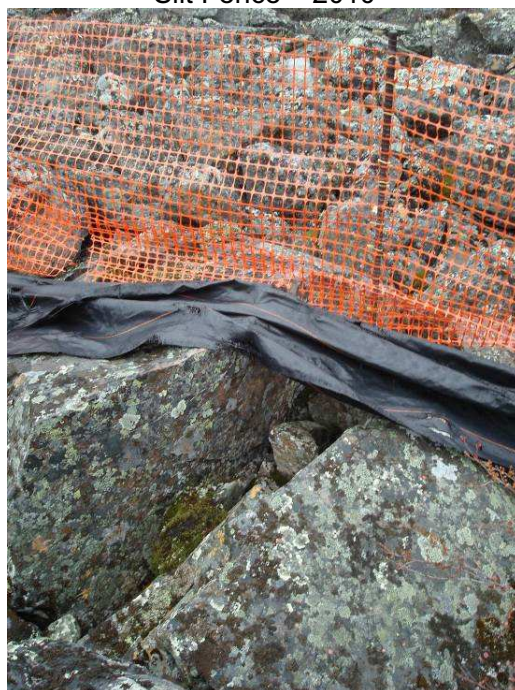
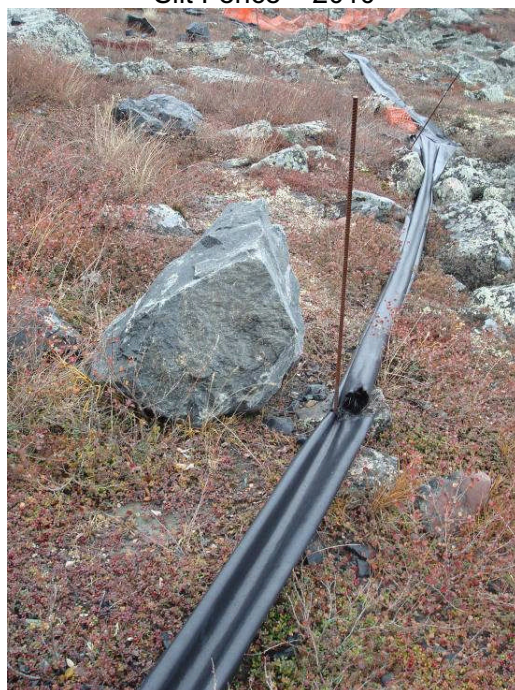
Silt Fence – 2011

| MAINTENANCE/MONTORING RECOMMENDATIONS: | Existing downstream stream silt fencing is in need of repair. |

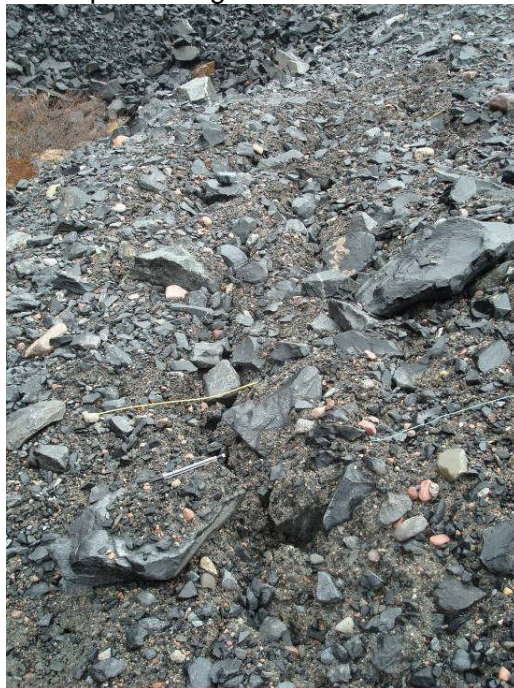
Slump Cracking Downhill Side – 2011

| CONCLUSIONS: | The pad appears to shows signs of instability and erosion on the downstream side. Re-grading and shaping will be required before the pad is put into use. A sample of seepage identified at the toe of the pad was collected. Pending the results of analytical testing, additional measures to address the seepage may be required. Runoff from the pad is collected within East Lake that passes through a wetland before entering Ulu Lake. The existing down slope silt curtain is in need of repair and has been covered by the toe of the pad at some locations. The silt curtain should be restored. |

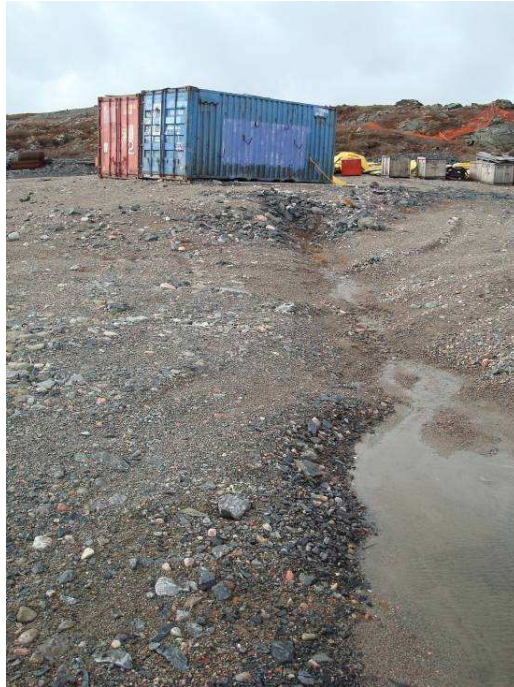
| TOE DISCHARGE: | Near the uphill portion of the pad (on top of the pad), surfacewater was observed flowing in a small drainage channel which flows towards the waste rock pile (on the pad). The source of this surfacewater is unknown, but appeared to be groundwater entering the small channel. At one location at the toe of the pad, seepage outflow was observed (estimated at 1L/min). It is likely the the source of the toe seepage is the observed surface water observed near the uphill side of the pad. A sample of the toe seepage was collected by a representative for Elgin Mining. Any potential pad drainage leads downhill into East Lake. |

Flowing Surface Water in Small Channel Near Uphill Side of Pad (source of water unknown) – 2011

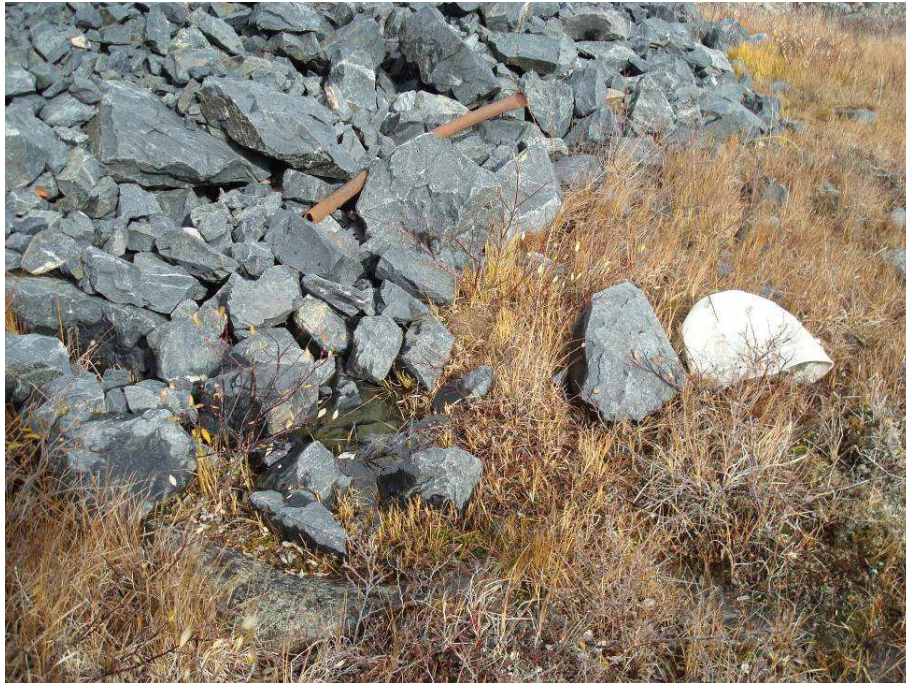
The existing silt curtain downstream of the Portal Laydown Pad is in need of repair / maintenance. Toe seepage was observed and sampled by a representative of Elgin Mining Inc. Pending the results of analytical testing, additional measures may be required address the seepage.

Seepage Noted At One Location, Toe of Pad (est. 1 l/min.) – 2011

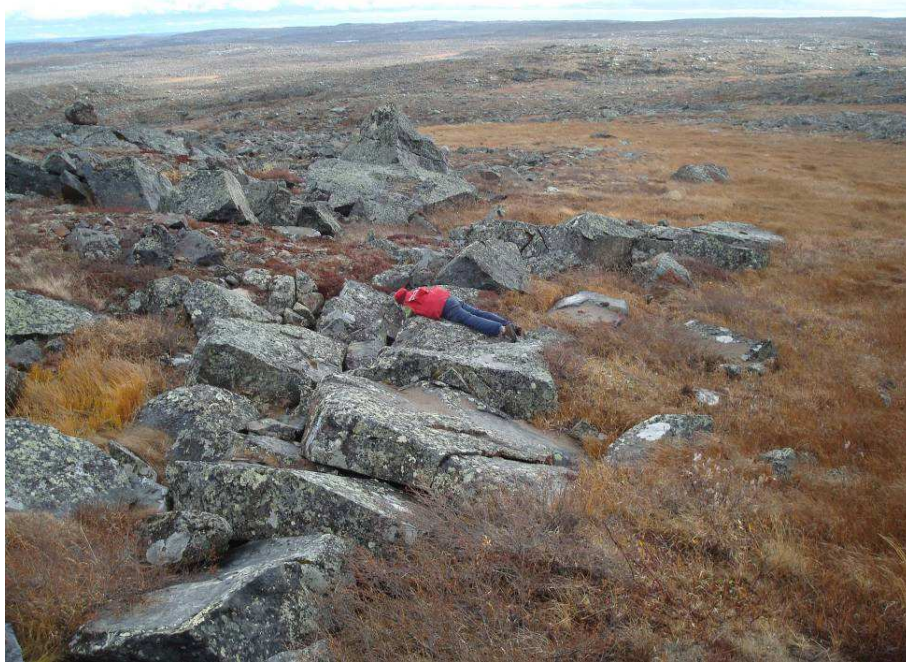
| TOE DISCHARGE: | No seepage was observed along the toe of the pad. However an area of seepage located to the south of the pad (approximately 15 m from the toe of pad) was observed and sampled by a representative of Elgin Mining Inc. The seepage was reported to be at an estimated rate of 1 L/min. |

Seepage Sampling - South of Pad - 2011

| CONCLUSIONS: | The pad appears stable with no signs of erosion or instability. A sample of seepage identified outside the toe of the pad was collected. Pending the results of analytical testing, additional measures to address the seepage may be required. |
