2012 Annual Geotechnical Inspection of Selected Structures – Ulu Gold Project, Nunavut

Bonito Capital Corporation

SRK Consulting (Canada) Inc.
1CB027.000
November 2012

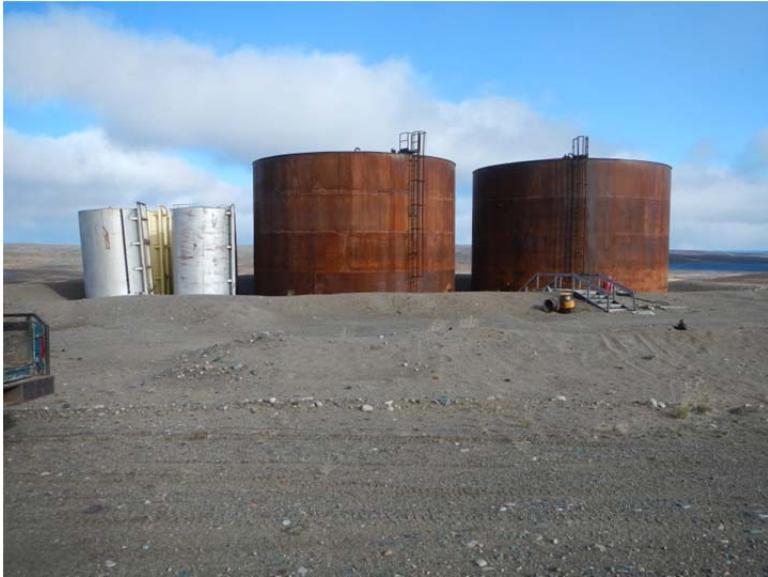
The main concern observed during the Camp 3 inspection is that one fuel tank is leaning because of broken cribbing at its base. It is recommended that the cribbing be repaired. The tank should be set upright and level to prevent toppling and damage to the tanks and containment berm. Alternatively, the leaning tank should be decommissioned and removed from the containment berm. The fuel tank

Camp 3 Tank Farm and the leaning empty fuel tank

- Cover all exposed liners and leading edges with granular fill for overliner protection;
- Repair all damaged liners;
- Replace the broken cribbing at Camp 3 and re-level the fuel tank or decommission the tank;
- Repairs and perform maintenance on the liner in the mine sump shall be completed prior to utilizing it.
- BCC may wish to submit a request to the Nunavut Water Board for an amendment to the inspection schedule as consisting of bi-weekly inspections during May and June, monthly inspections from July to October of the fuel containments and mine sump, and an annual inspection of the storage pad when the site is in care and maintenance. The inspection schedule stated in the Part D. Item 8.e of Water Licence is:

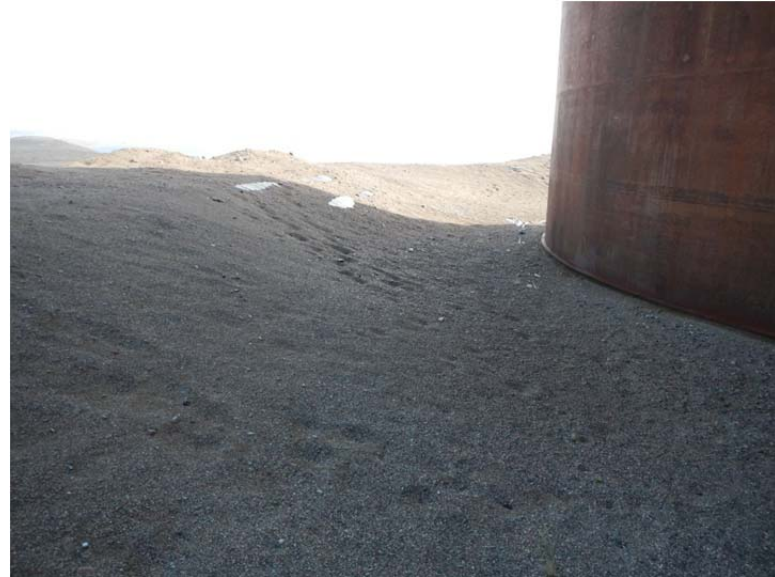
farm containment berm was in generally good condition. The parts of the liner that are exposed should be repaired.

Camp 3 Tank Farm Exposed Liner

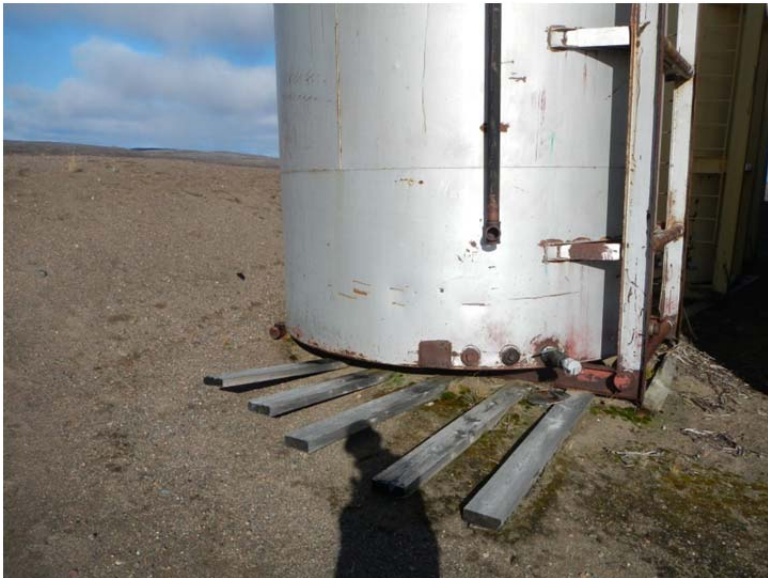
Camp 3 Tank Farm Broken Cribbing

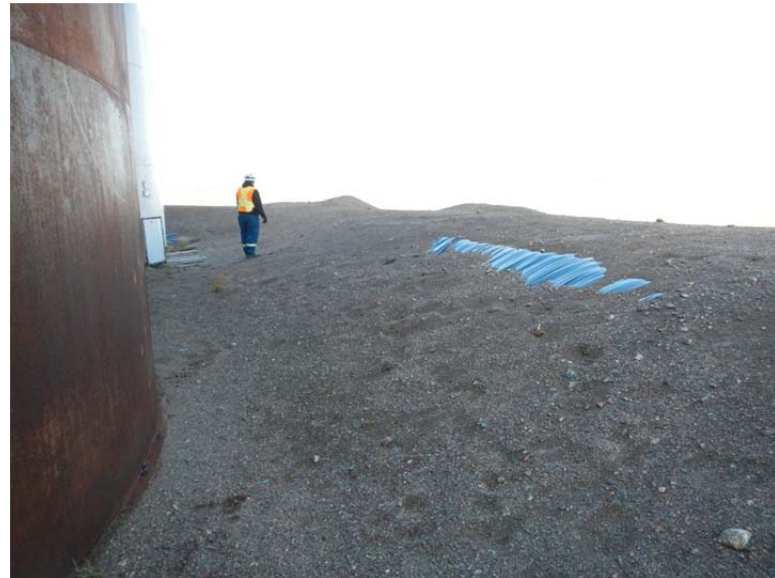
Camp 3 Tank Farm Exposed Liner

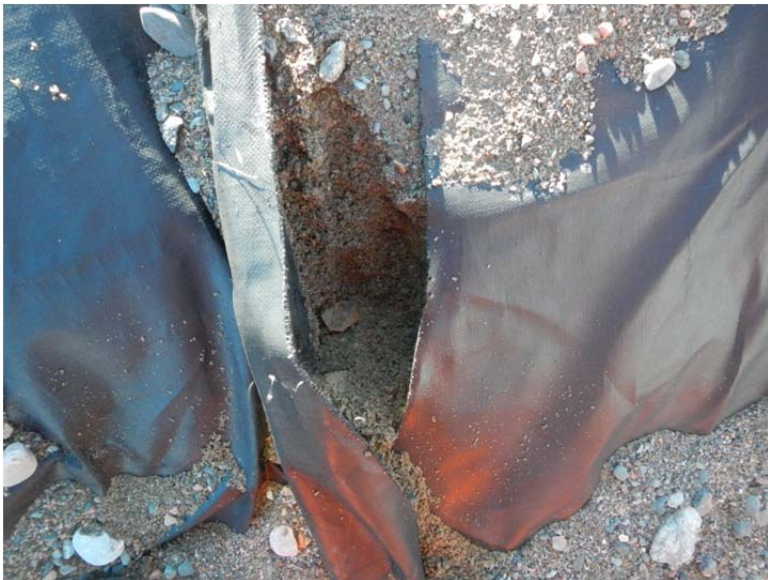
There are minor erosion issues near each crest of the fuel containment berms where liners are exposed and damaged. Furthermore, small animal burrows were observed in the fuel containment overliner. The erosions and burrows should be repaired to prevent further damage to the liner, as well as to prevent leakage during periods of high water levels. Both the ore storage and portal laydown pads are in satisfactory geotechnical condition.

Ulu Day Tank exposed and damaged liner (closer view)

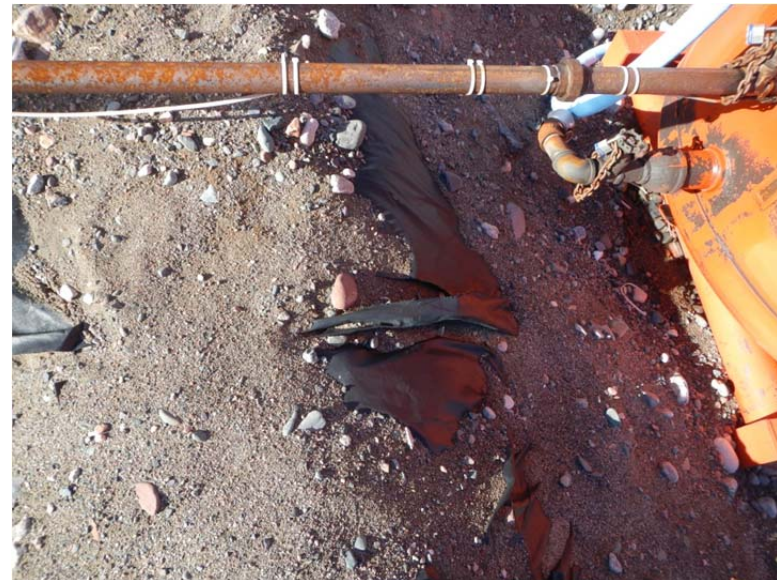
Ulu Day Tank Damaged Liner

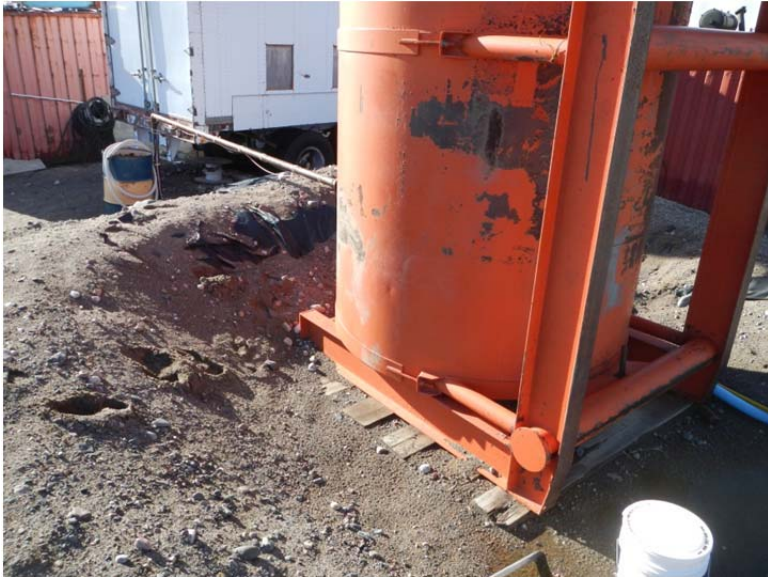
Ulu Day Tank Exposed Liner

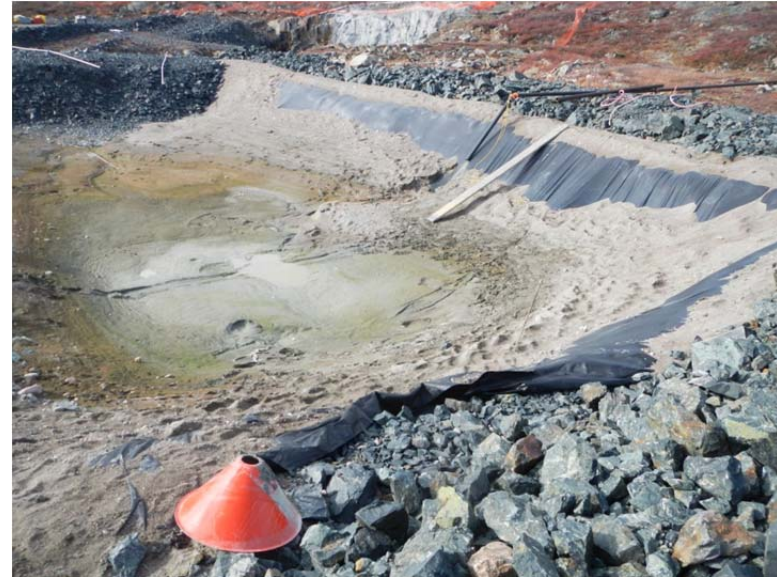
During the inspection, part of the leading edge and the slopes of the liner in the mine sump were found to be exposed and should be covered at the first opportunity to protect the liner. Damages to the sump liner were also observed and should be repaired. Repairs to and maintenances should be performed prior to utilizing the sump.

Ulu Mine Sump Exposed Liner and leading edge

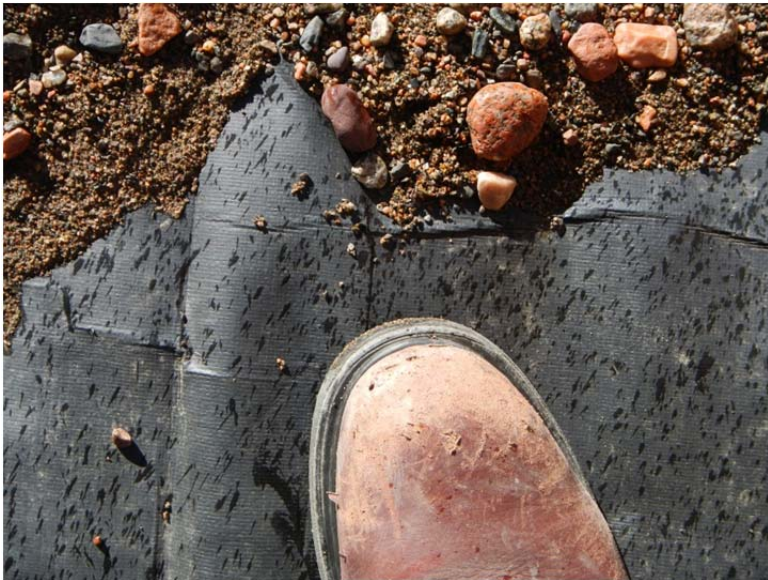
Ulu Tank Farm Exposed Liner

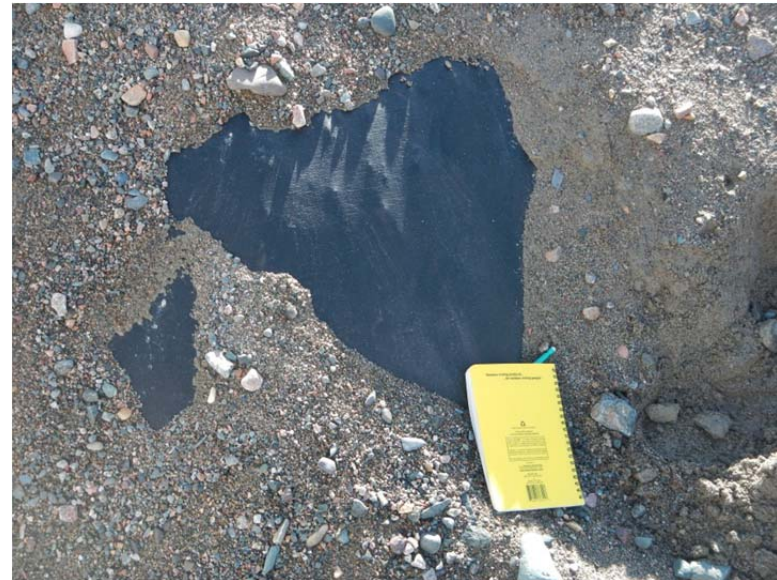
Ulu Tank Farm Exposed Liner

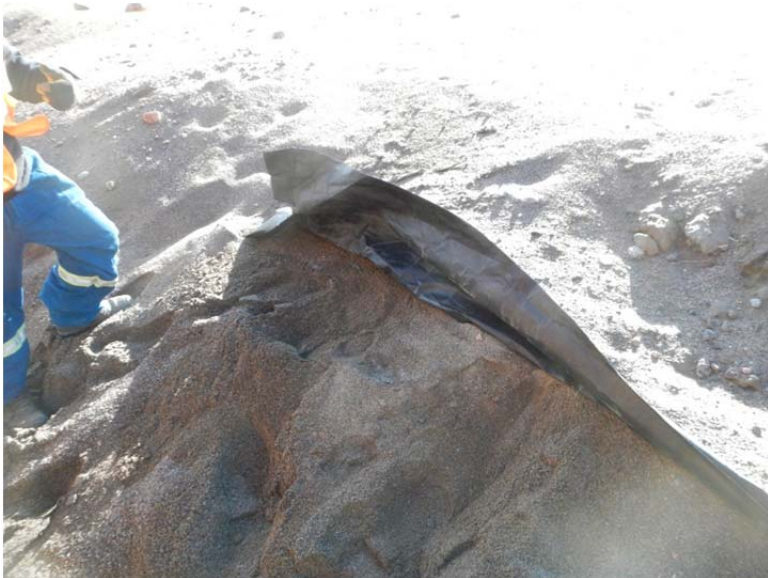
Ulu Tank Farm Exposed Liner

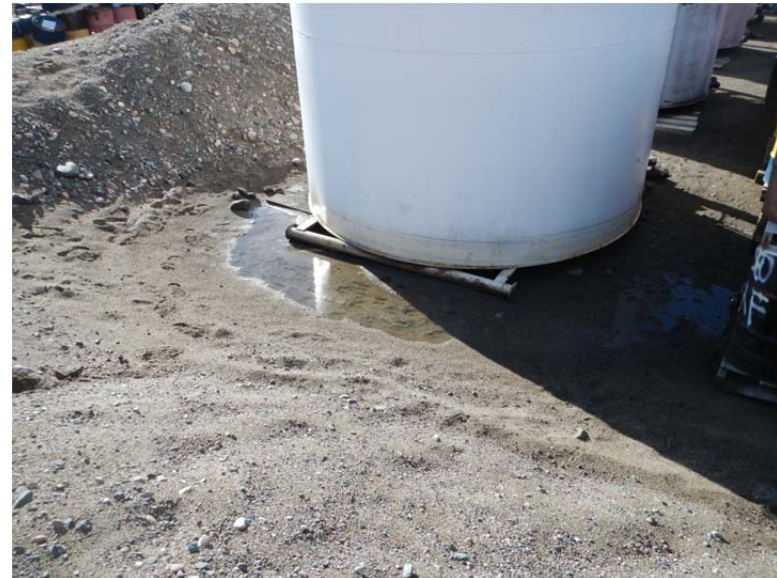
Ulu Tank Farm Ponding Water

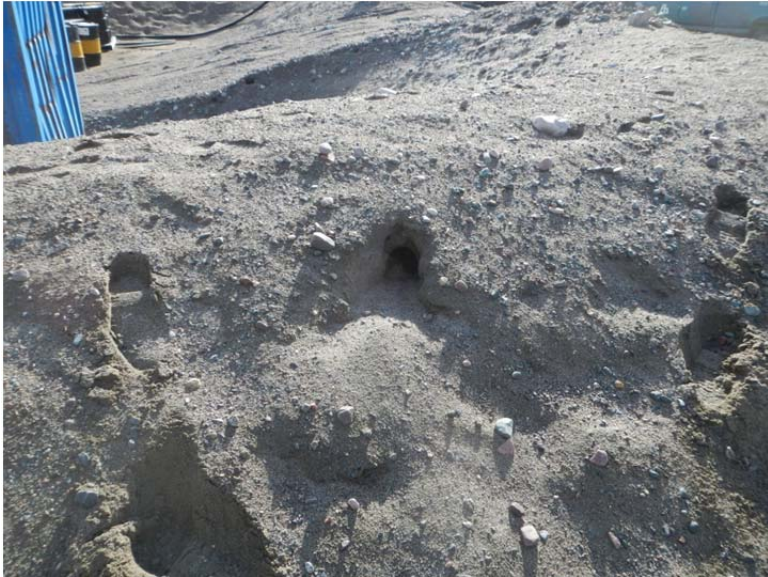
Ulu Tank Farm Potential Animal Burrow
