2013 Annual Geotechnical Inspection of Selected Structures – Ulu Gold Project, Nunavut

Bonito Capital Corporation

SRK Consulting (Canada) Inc.
1CB027.001
October 2013

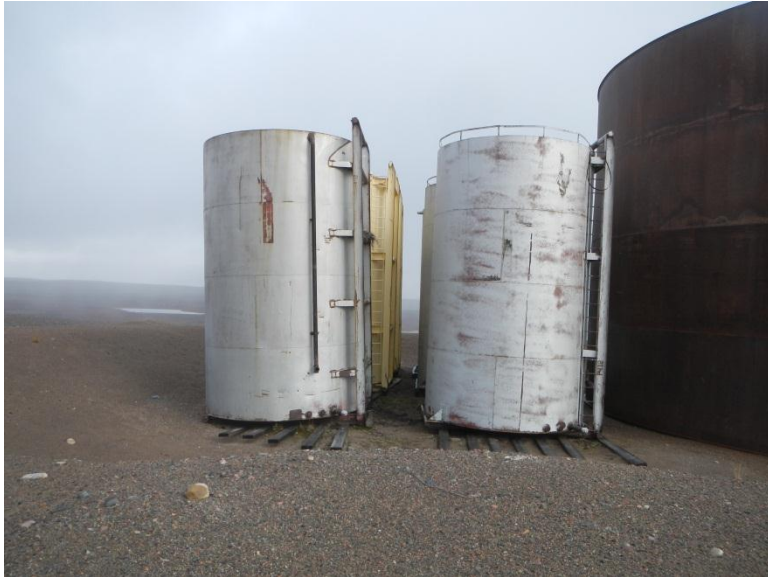
The main concern observed during the Camp 3 inspection is that one fuel tank is leaning because of broken cribbing at its base. It is recommended that the cribbing be repaired. The tank should be set upright and level to prevent toppling and damage to the tanks and containment berm. Alternatively, the leaning tank should be decommissioned and removed from the containment berm. The fuel tank farm containment berm was in generally good condition. The parts of the liner that are exposed should be repaired.

Ulu Camp 3 tank farm, view of leaning fuel tank

- Cover all exposed liners and leading edges with granular fill for overliner protection;
- Repair all damaged liners;
- Replace the broken cribbing at Camp 3 and re-level the fuel tank or decommission the tank;
- Repairs and perform maintenance on the liner in the mine sump shall be completed prior to utilizing it.
- BCC may wish to submit a request to the Nunavut Water Board for an amendment to the inspection schedule as there is no mining or exploration activity. The proposed inspection schedule would consist of bi-weekly inspections during May and June freshet, monthly inspections from July to October of the fuel containments and mine sump, and an annual inspection of the storage pad when the site is in care and maintenance status. The inspection schedule stated in the Part D. Item 8.e of Water Licence is:

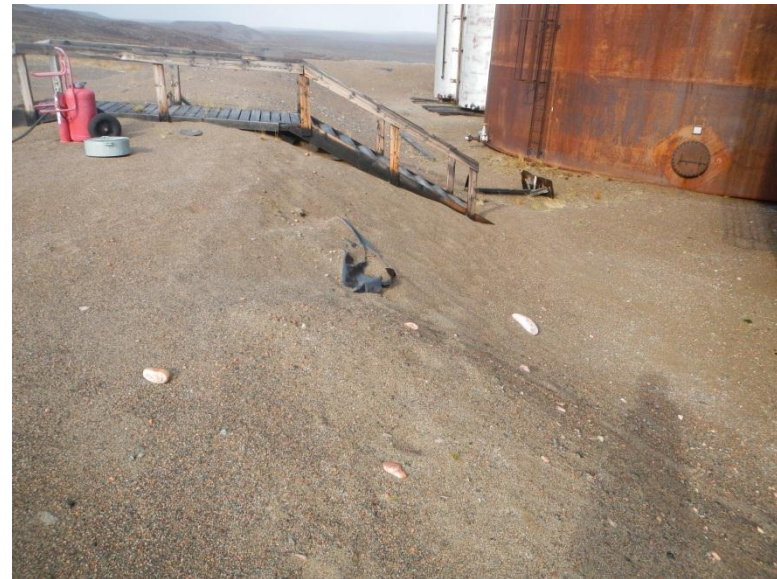
There are minor erosion issues near each crest of the fuel containment berms where liners are exposed and damaged. The erosion should be repaired to prevent further damage to the liner, as well as to prevent leakage during periods of high water levels. Both the ore storage and portal laydown pads are in satisfactory geotechnical condition.

Ulu Camp 2 tank farm, view of exposed liner

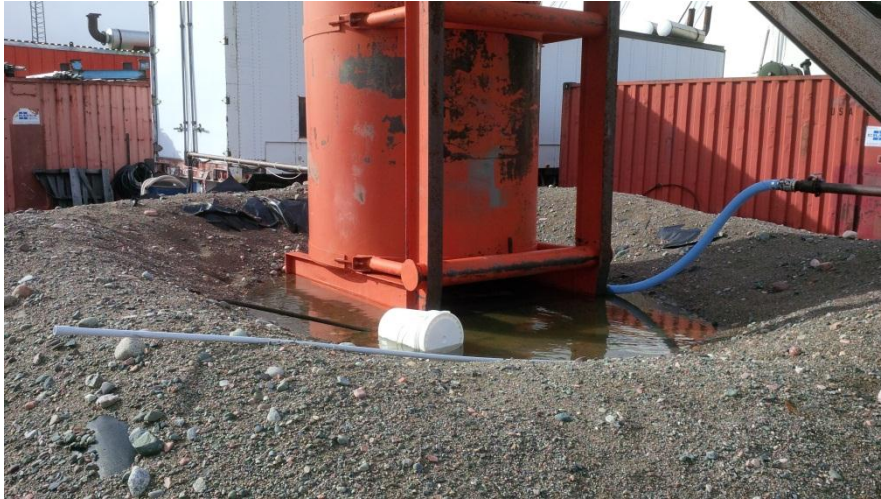
Ulu day use tank, view of exposed liner

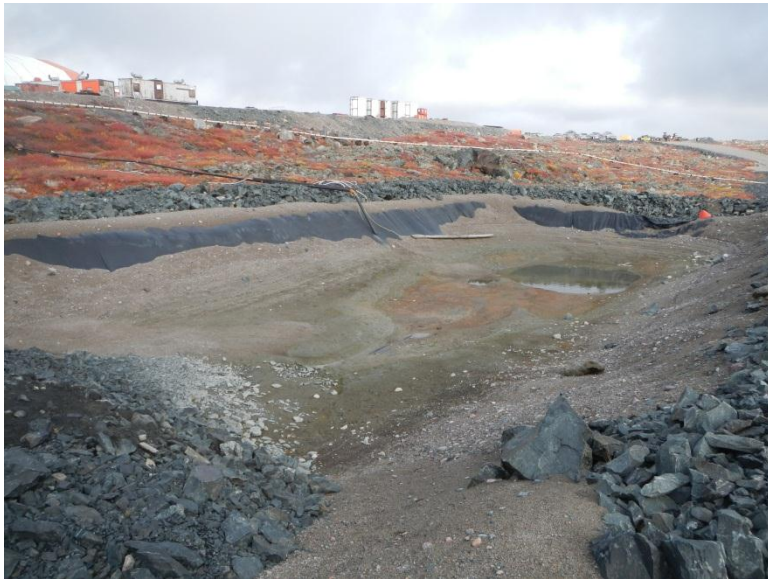
During the inspection, part of the leading edge and the slopes of the liner in the mine sump were found to be exposed and should be covered at the first opportunity to protect the liner. Damage to the sump liner was also observed and should be repaired. These repairs and maintenance should be performed prior to utilizing the sump.

Ulu mine sump, view of exposed liner
