2014 Annual Geotechnical Inspection of Selected Structures – Ulu Gold Project, Nunavut

Bonito Capital Corporation

SRK Consulting (Canada) Inc.
1CB027.001
October 2014

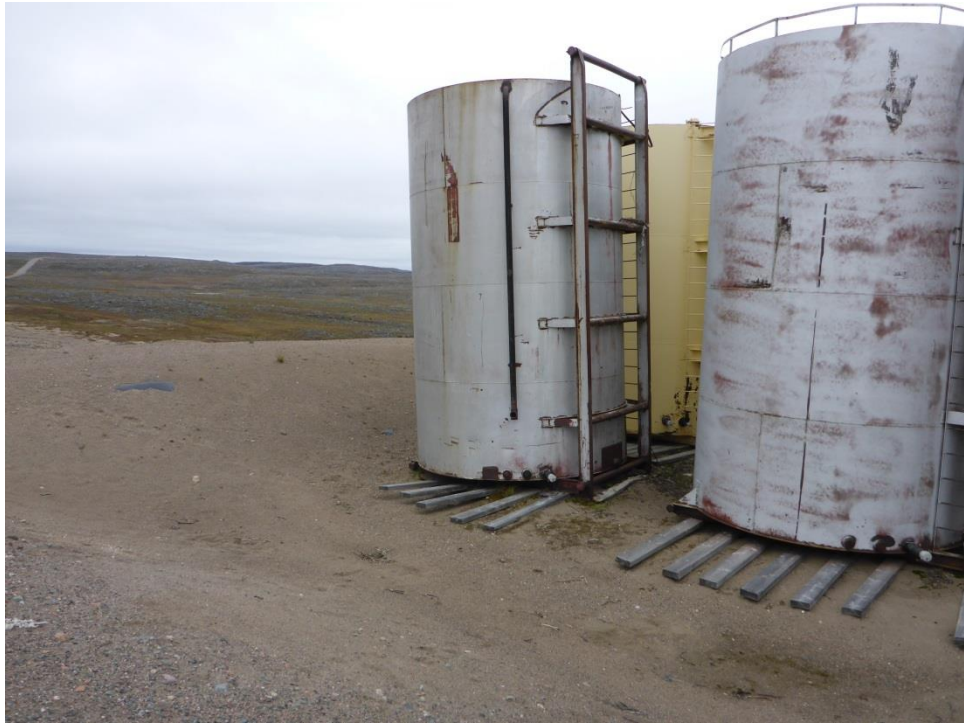
Similar to facilities at Ulu, minor damage was noted in the liner and left exposed from erosion. The main concern observed during the Camp 3 inspection is that three fuel tanks are leaning because of broken cribbing at their base. It is recommended that the cribbing be repaired. The tanks should be set upright and leveled to prevent toppling and damage to the tanks and containment berm. Alternatively, the leaning tanks could be decommissioned and removed from the containment berm. The fuel tank farm containment berm was generally in good condition with no visual stability concerns. The parts of the liner that are damaged should be repaired and covered with appropriate backfill.

Photo 1: Looking north at one of the leaning tanks in the front of the Camp 3 fuel tank farm.

- Cover all exposed liners and leading edges with granular fill for overliner protection.
- Repair all damaged liners in the fuel storage.
- Replace the broken cribbing at Camp 3 and re-level the fuel tank or decommission the tank.
- Repairs and perform maintenance on the liner in the mine sump shall be completed prior to utilizing it.
- BCC may wish to submit a request to the Nunavut Water Board for an amendment to the inspection schedule as there is no mining or exploration activity. The proposed inspection schedule would consist of bi-weekly inspections during May and June freshet, monthly inspections from July to October of the fuel containments and mine sump, and an annual inspection of the storage pad when the site is in care and maintenance status. The inspection schedule stated in the Part D. Item 8.e of Water Licence is:

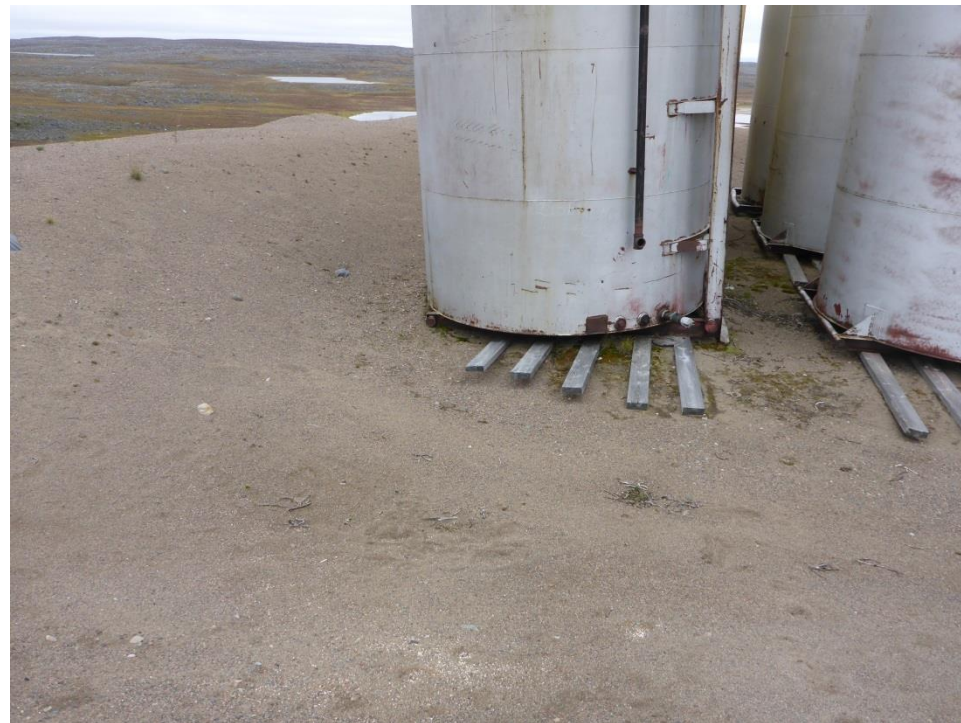
Photo 2: Close up view of the broken cribbing underneath the tank.

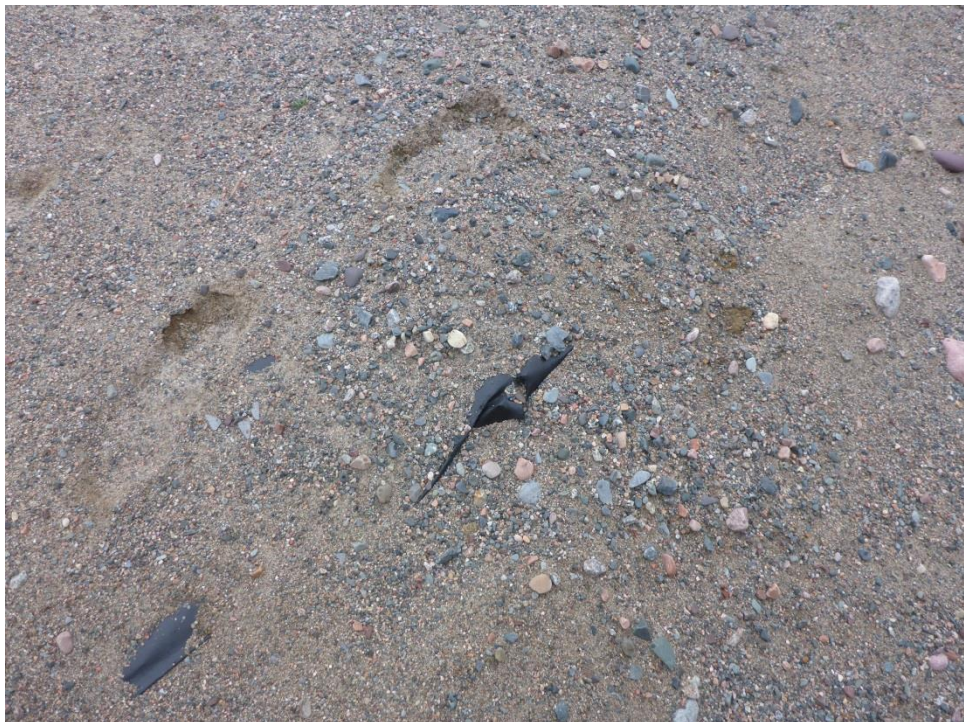
Photo 4: Close up view of the damaged liner in the southern bank of the Camp 3 fuel tank farm.

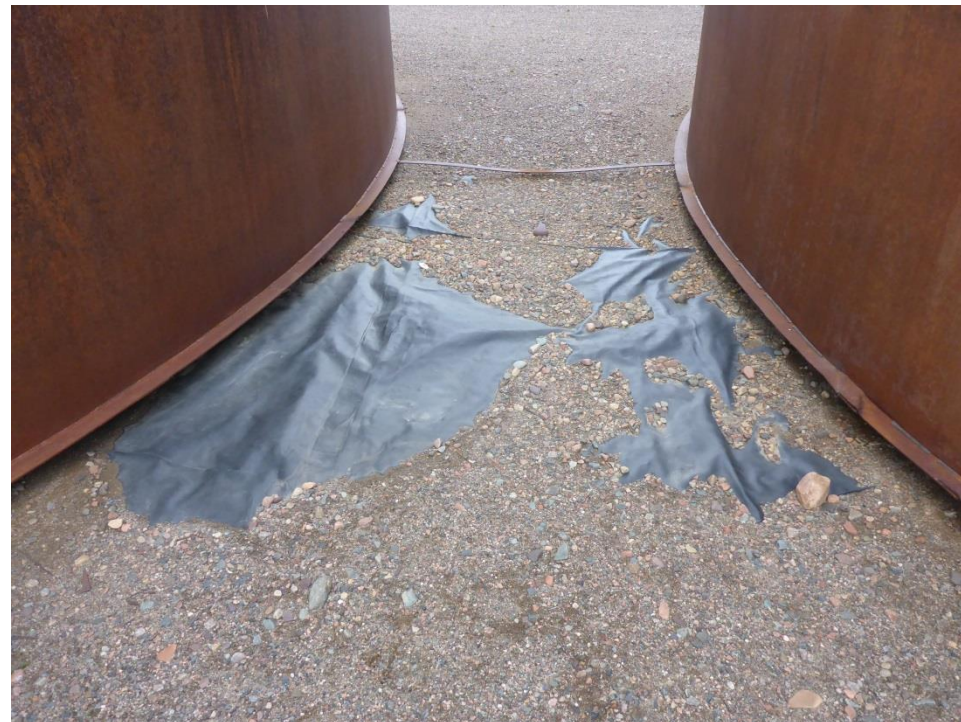
Photo 5: Close up view of the exposed liner between the 2 large tanks in Camp 3 fuel tank farm.

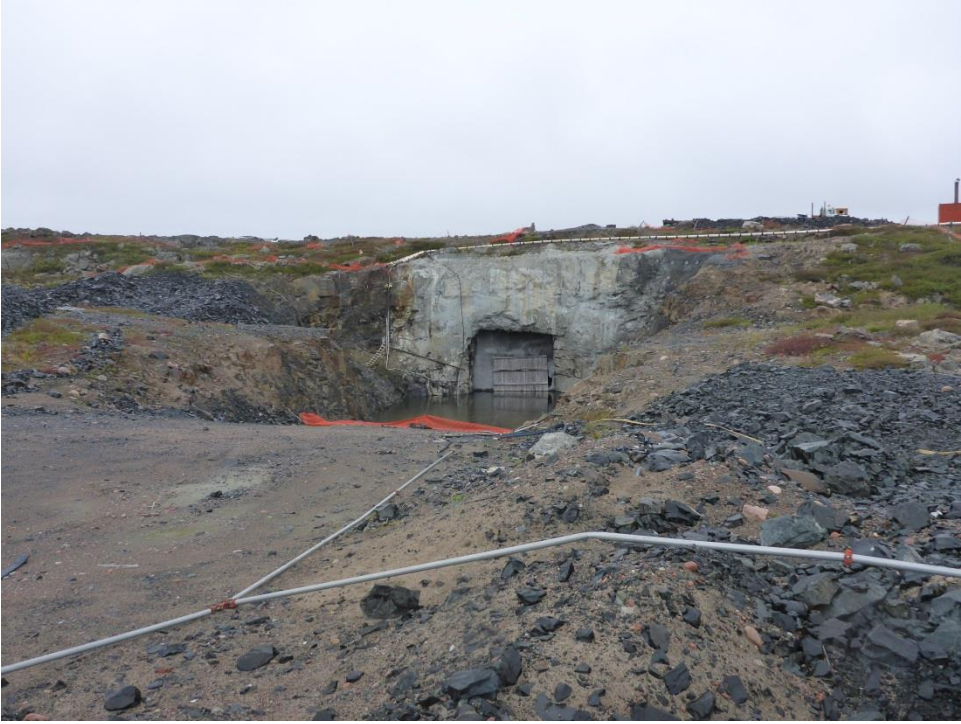
Photo 15: View of the portal and south slope of the mine sump.
