2015 Annual Geotechnical Inspection of Selected Structures – Ulu Gold Project, Nunavut

Bonito Capital Corporation

SRK Consulting (Canada) Inc.
1CB027.003
October 2015

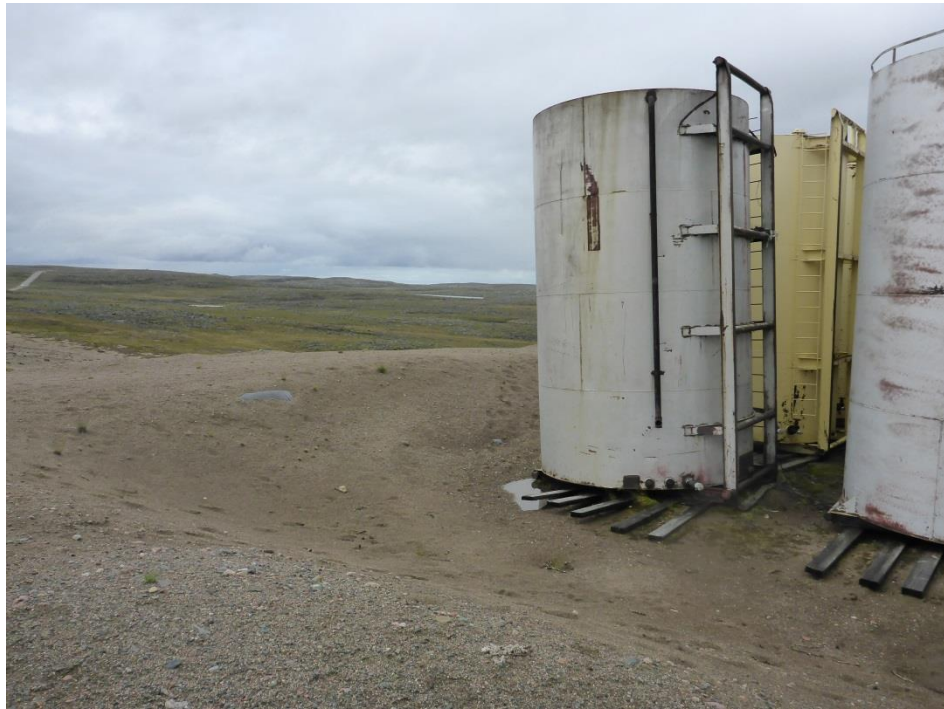
Similar to facilities at Ulu, minor damage was noted in the liner and left exposed from erosion. The main concern observed during the Camp 3 inspection is that three fuel tanks are leaning because of broken cribbing at their base. It is recommended that the cribbing be repaired. The tanks should be set upright and leveled so as to prevent toppling and damage to the tanks and containment berm. Alternatively, the leaning tanks could be decommissioned and removed from the containment berm. The fuel tank farm containment berm was generally in good condition with no visual stability concerns. The parts of the liner that are damaged should be repaired and covered with appropriate backfill.

Photo 1: Looking north at one of the leaning tanks in the front of the Camp 3 fuel tank farm.

- Cover all exposed liners and leading edges with granular fill for overliner protection.
- Repair all damaged liners in the fuel storage.
- Replace the broken cribbing at Camp 3 and re-level the fuel tank or decommission the tank.
- Repairs and perform maintenance on the liner in the mine sump shall be completed prior to utilizing it.
- Monitor the animal burrows in the fuel containment area for increased activities, damaged liner and fragments.

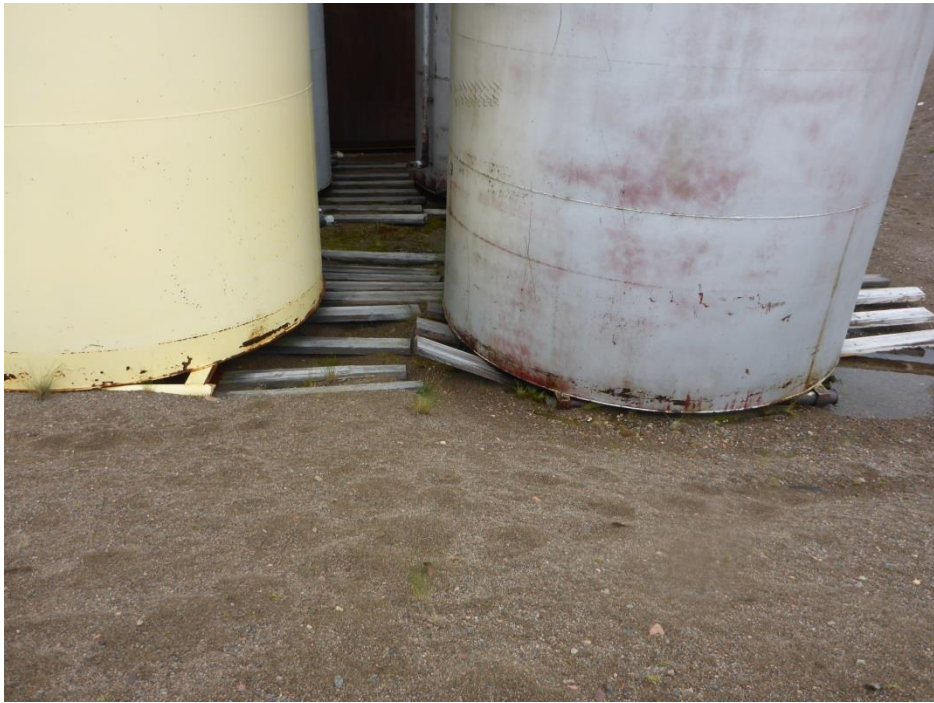
Photo 2: Close up view of the broken cribbing underneath the tank.

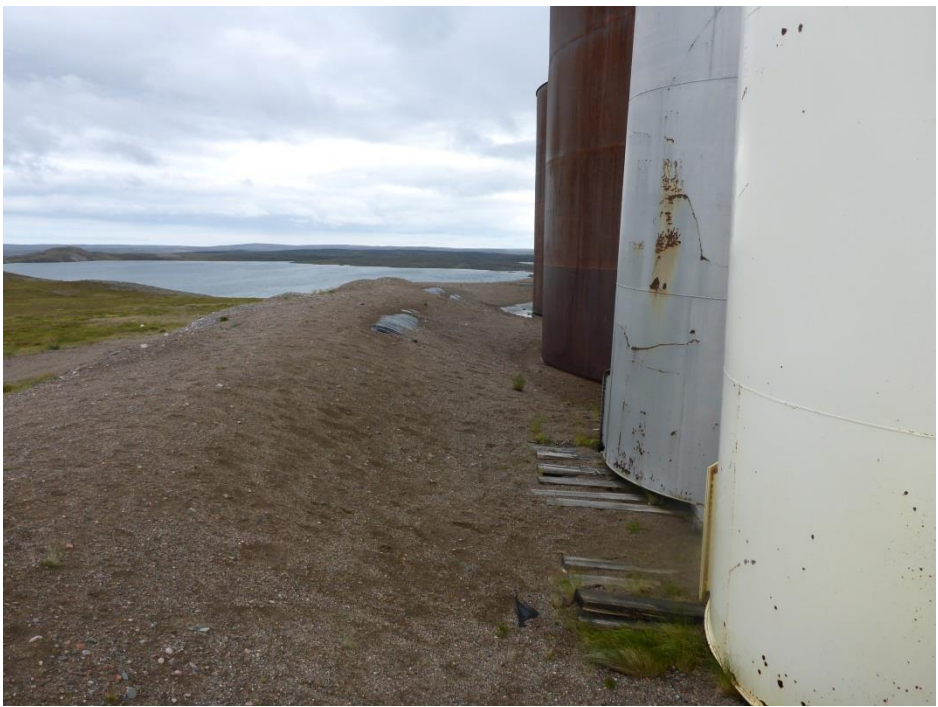
Photo 3: Looking east at the Camp 3 fuel tank farm.

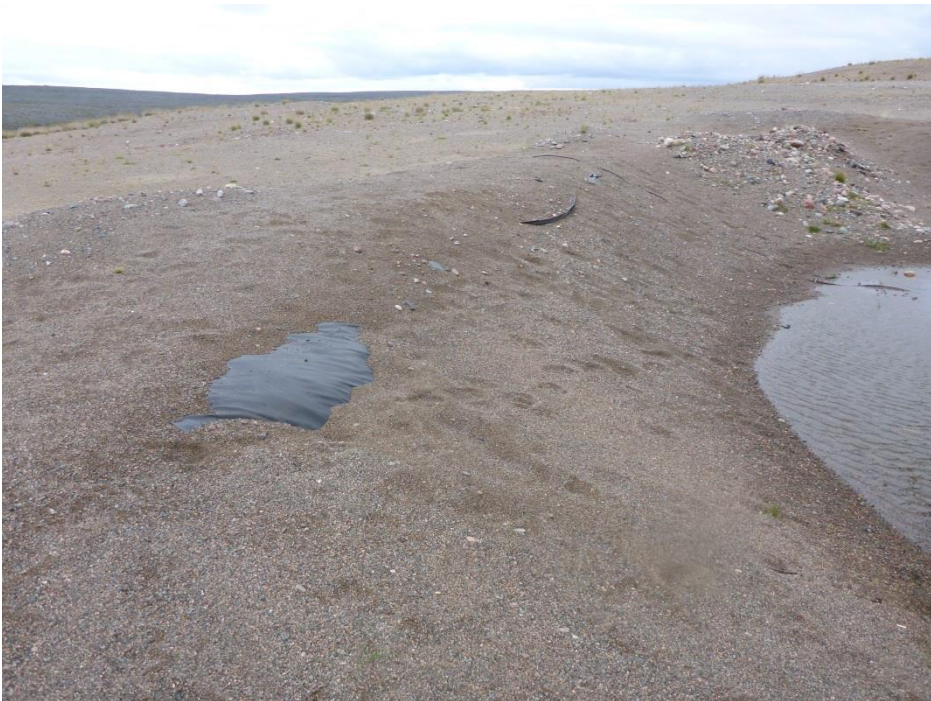
Photo 4: Close up view of the damaged liner in the southern bank of the Camp 3 fuel tank farm.

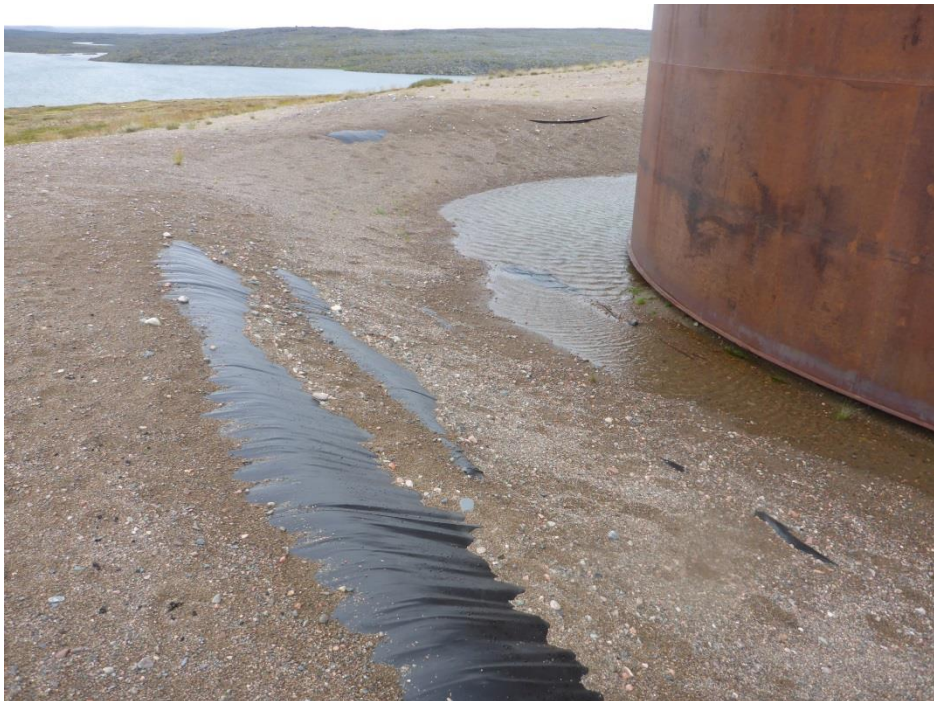
Photo 5: Close up view of the exposed liner and water ponding underneath the large tanks in Camp 3 fuel tank farm.

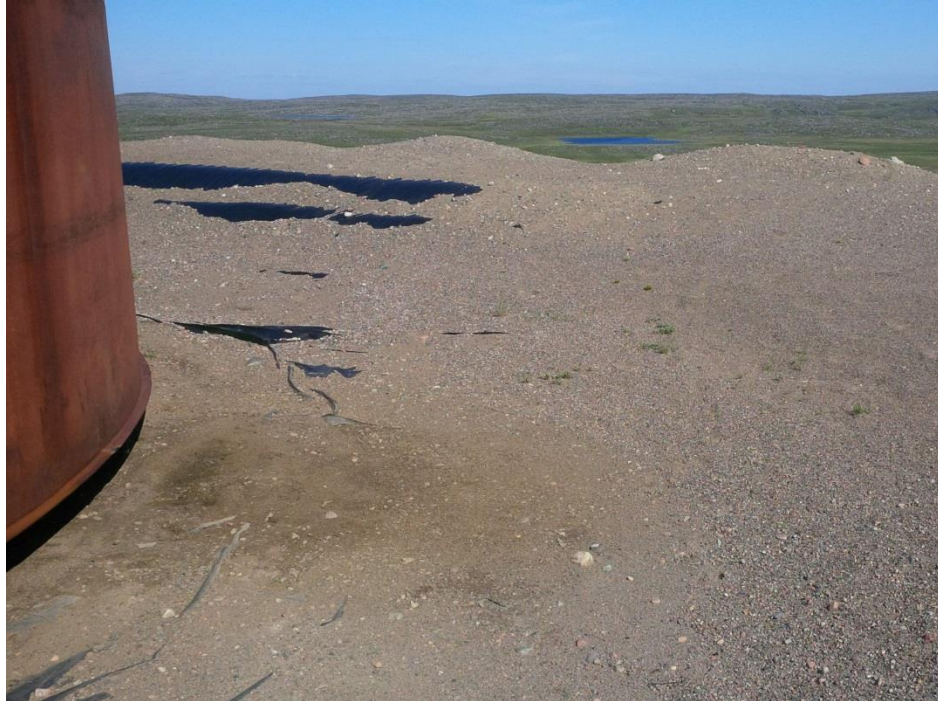
Photo 6: Looking at the exposed liner in the north bank of the Camp 3 fuel tank farm.

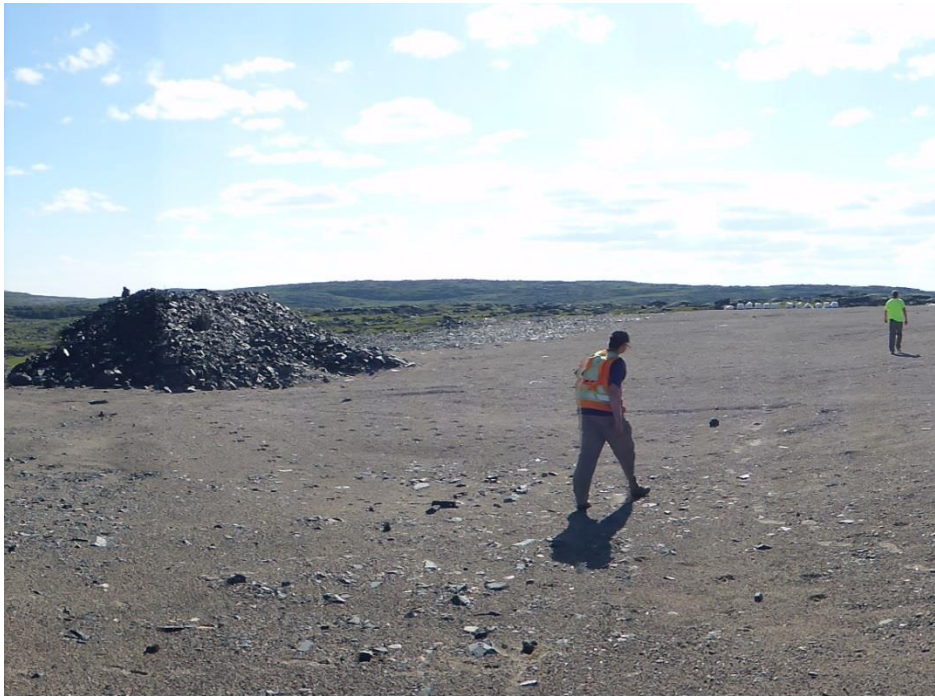
Both the ore storage and portal laydown pads are in satisfactory geotechnical condition.

Photo 7: Looking South at the Ore Pad.

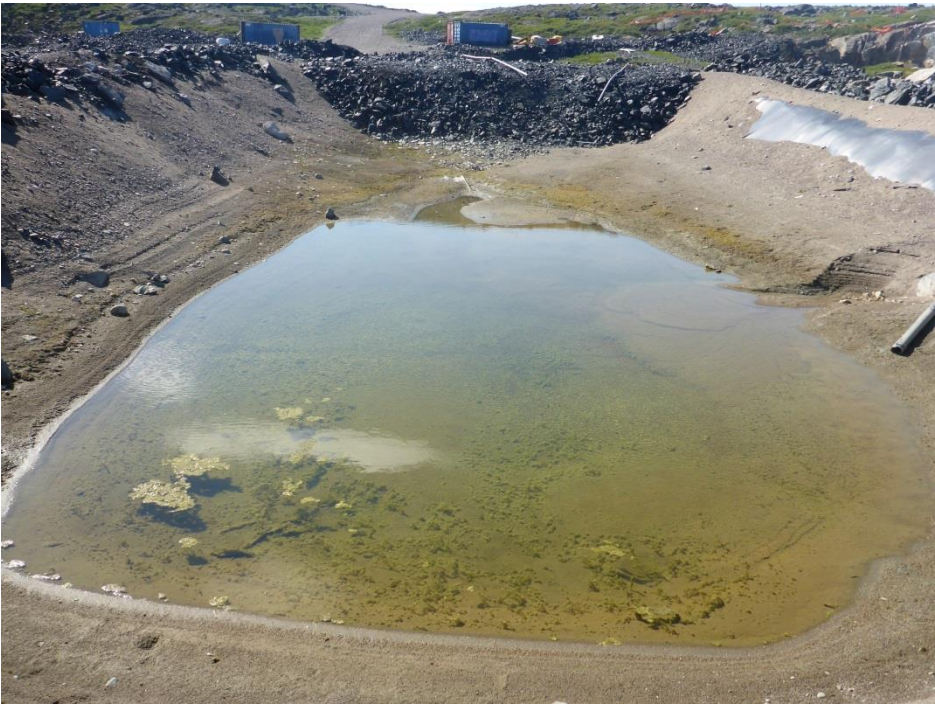
During the inspection, part of the leading edge and the slopes of the liner in the mine sump were found to be exposed and should be covered at the first opportunity to protect the liner. Damage to the sump liner was also observed and should be repaired. These repairs and maintenance should be performed prior to utilizing the sump.

Photo 8: Looking west at the mine sump. Note the exposed liner on the north bank.

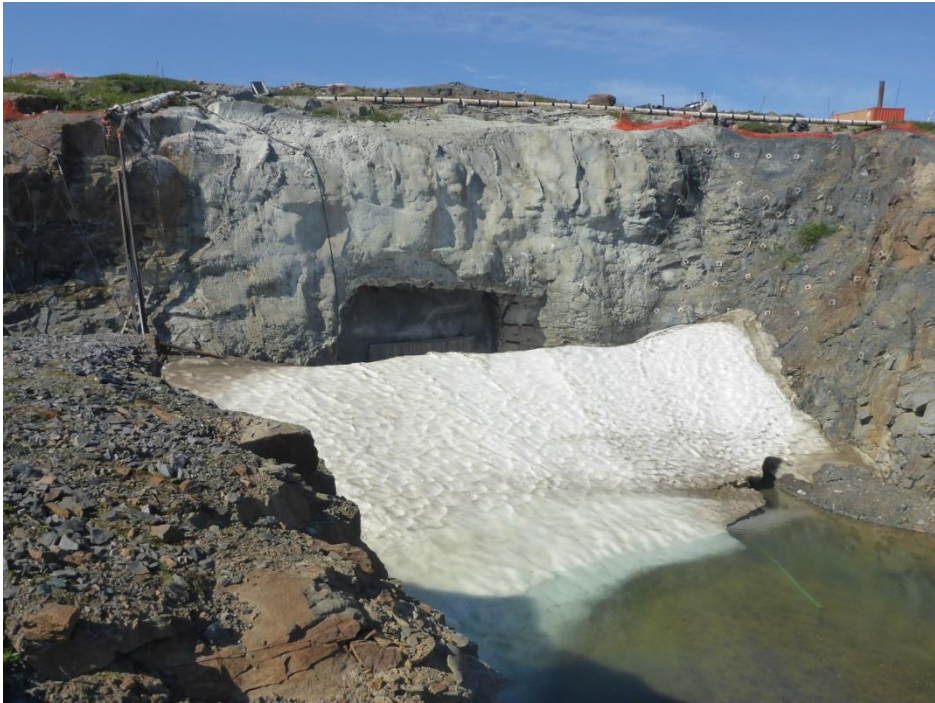
Photo 9: View of the portal.

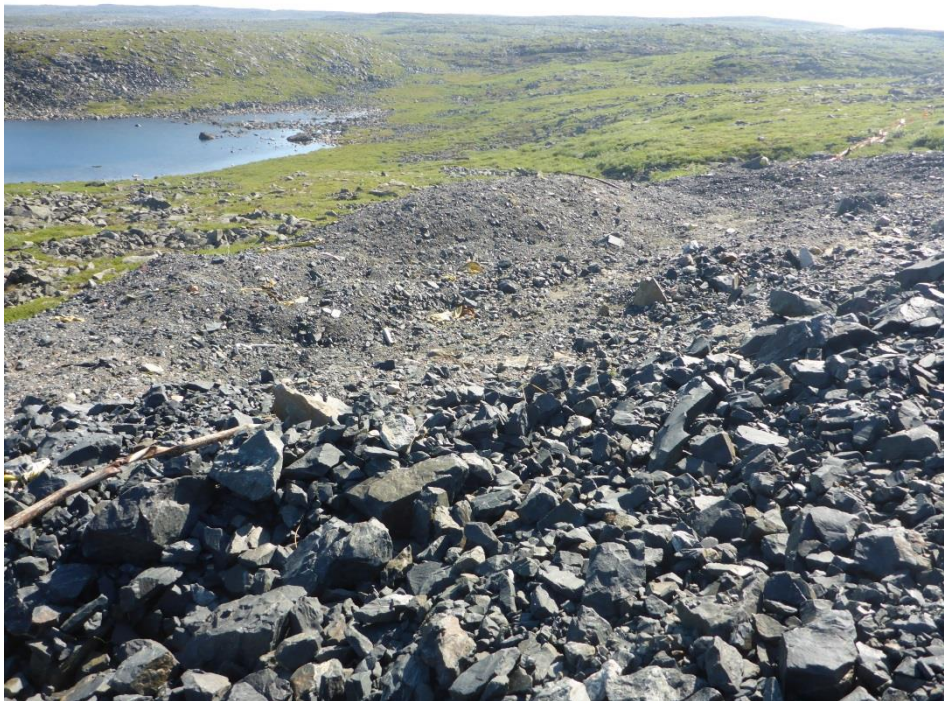
Photo 10: Looking southwest at the south slope of the Portal Laydown Pad.

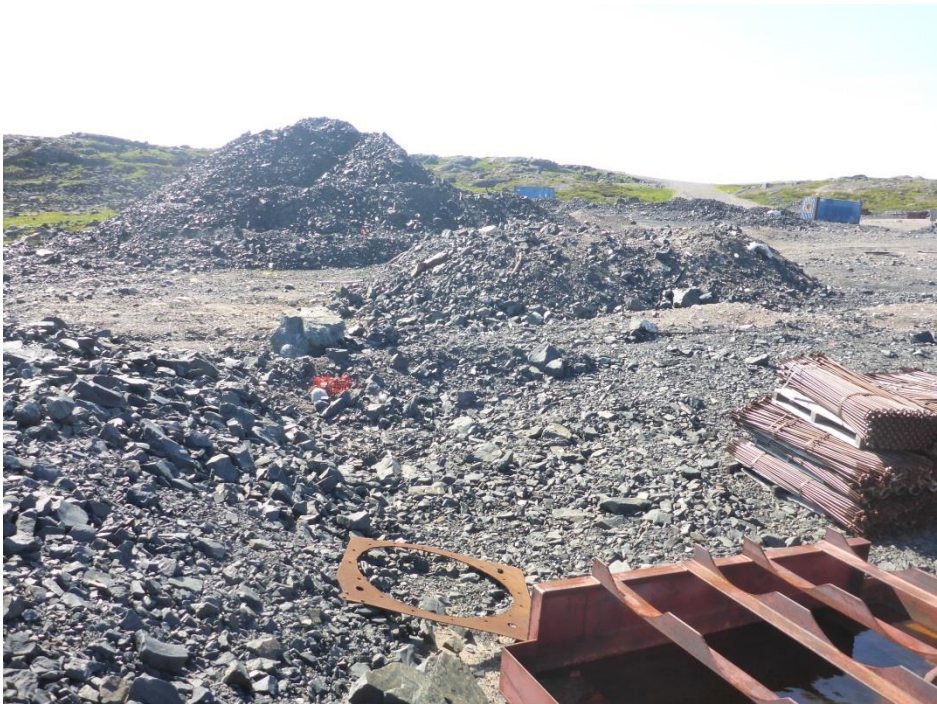
Photo 11: Looking southeast at the south slope of the Portal Laydown Pad.

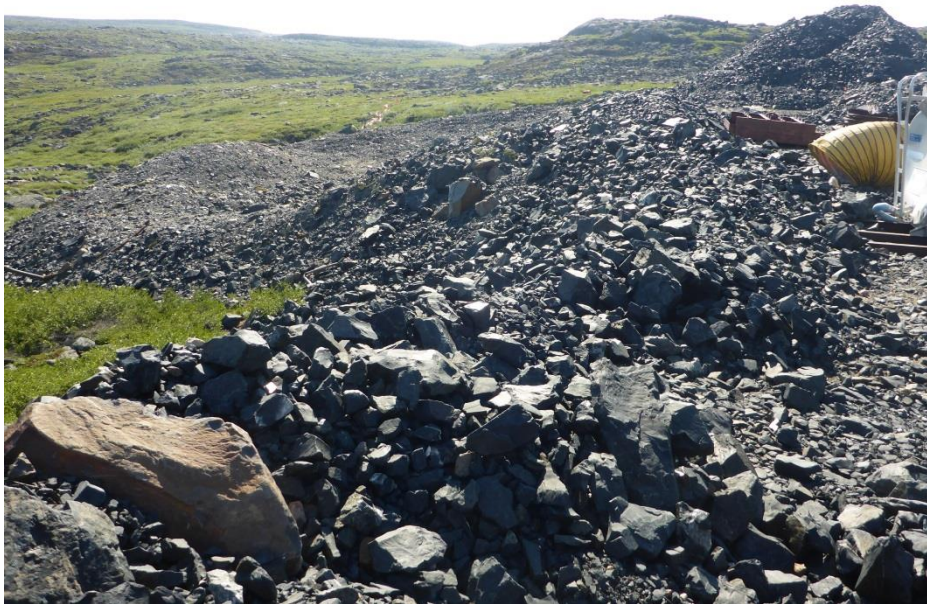
Photo 12: Looking north at the Portal Laydown Pad.

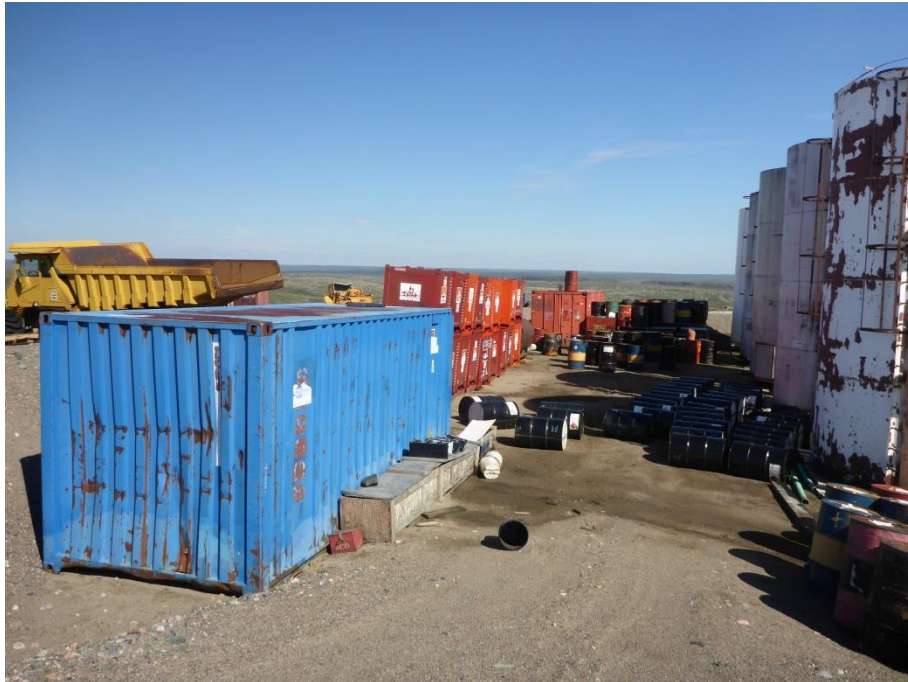
Photo 13: Looking northeast at the Ulu Main Tank Farm.

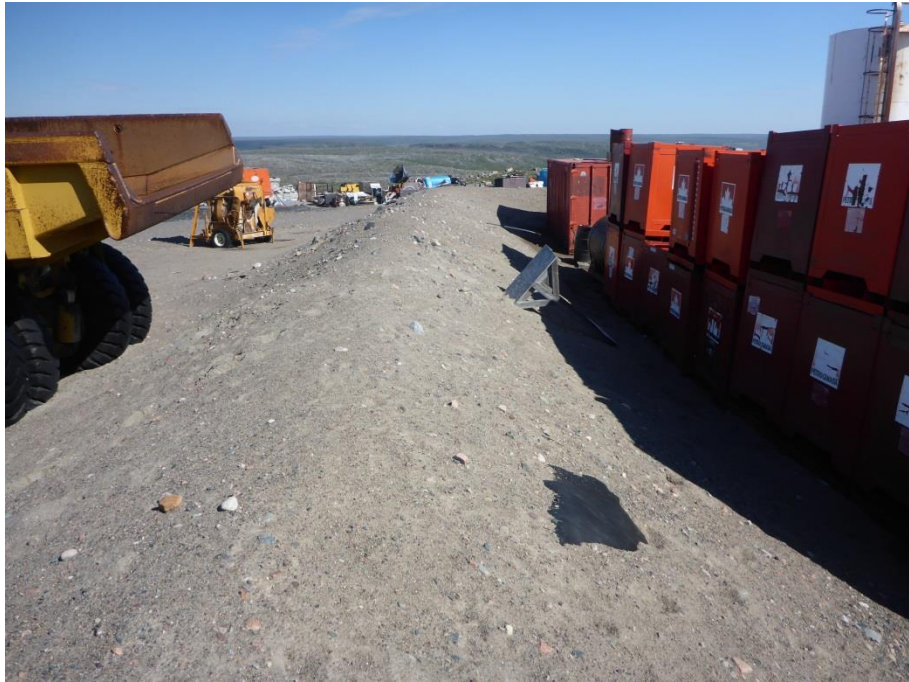
There are minor erosion issues near each crest of the fuel containment berms where liners are exposed and damaged. The erosion should be repaired to prevent further damage to the liner, as well as to prevent leakage during periods of high water levels. Burrows are observed in the main tank farm containment berm. It is undetermined what ground animal made these burrows. Liner fragments were not observed in 2015 around the burrows to indicate the animal had damaged the liner. While it is unlikely that the animal would damage the geosynthetic liner, periodic monitoring is recommended during the summer season to ensure the number of burrows does not increase and liner fragments are not observed.

Photo 14: Looking at the north banks and exposed liner at the Ulu Main Tank Farm.

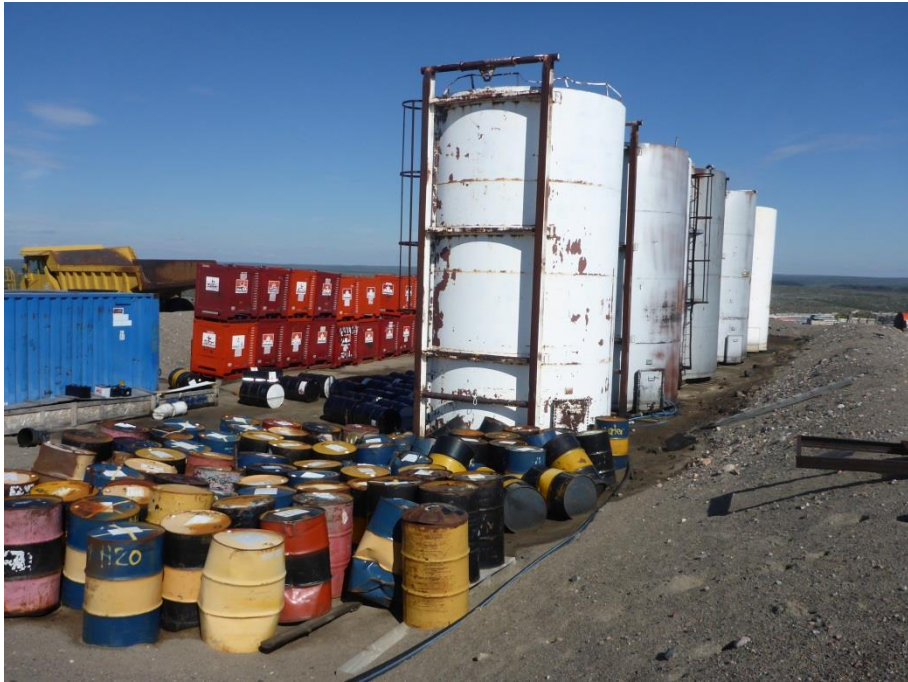
Photo 15: Looking at the south banks of the Ulu Main Tank Farm

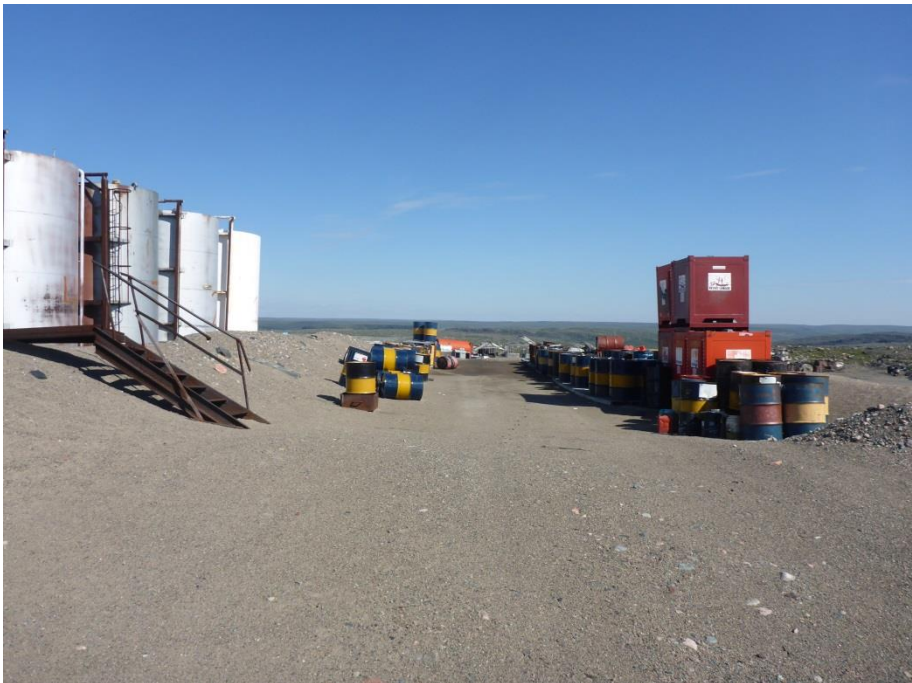
Photo 16: Looking northeast at the waste oil storage, just south of the Ulu main tank farm

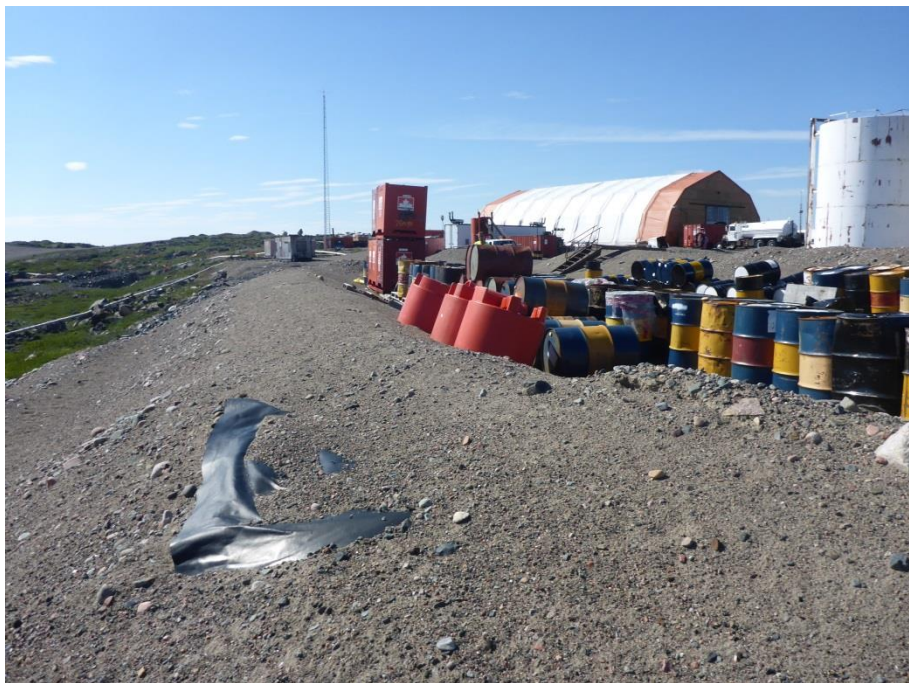
Photo 17: Looking west at the exposed liner in the south banks of the waste oil storage.

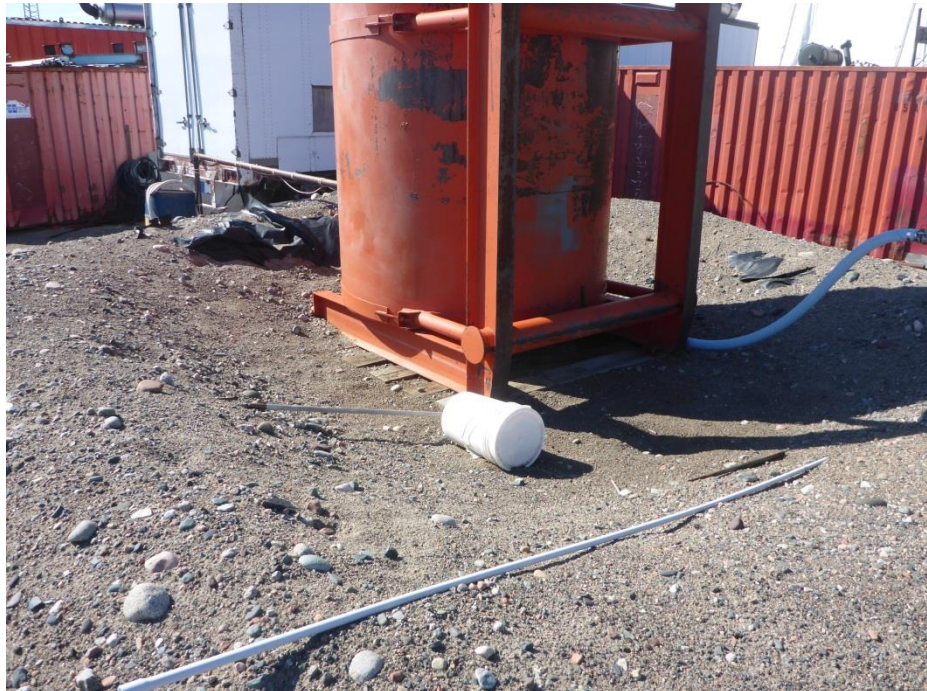
Photo 18: Looking west at the day use tank at Ulu. Note the exposed liner in the west bank.
