## **2016 Ulu Project Geotechnical Inspection**

Submitted to:  
**Bonito Capital Corp.**

Project Number: 948-1

Date:  
October 2016

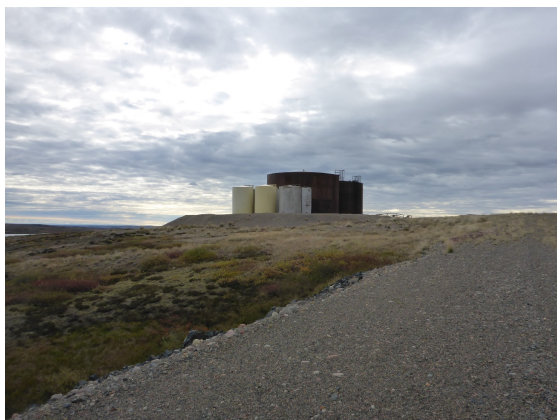
Similar over liner erosion and liner damage are found in the Ulu main tank farm containment, where liners are exposed with minor damages near upper slope and the crest. The damaged liner should be patched and tested, and the over liner should be replaced prior to refueling the tanks (Photos 4 and 5). In addition, the wooden cribbing underneath three of the fuel tanks is broken and causing the tanks to lean (Photos 2 and 3). It is recommended that the cribbing be replaced and the tank to be levelled. Alternatively, the tanks could be decommissioned and removed from the containment to eliminate the risk of falling over and damage other parts of the facility.

Photo 1: Looking southeast at the Camp 3 fuel tank farm.

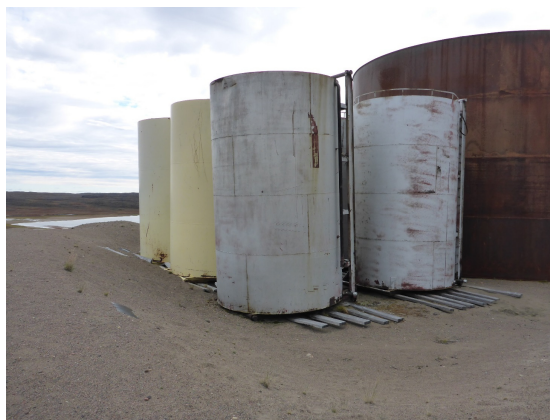
Photo 2: Looking southeast at one of the leaning 53 thousand litres tank.

- Repair all damaged liner and test the repairs
- After the tests, cover all exposed liner and any exposed edges with protective over liner
- Replace the broken wooden cribbing in the Camp 3 fuel tank farm and re-level the tanks or decommission and remove the tanks from the containment.
- Continue to monitor the animal burrow activities on site.
- Repair the access roads between the camps for safe vehicle access.

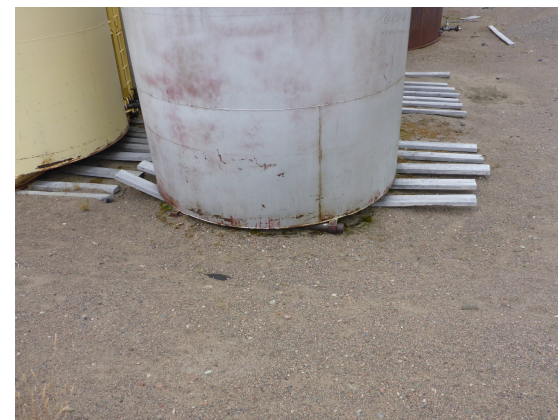
Photo 3: At the broken wooden cribbing at the base of the leaning tank.

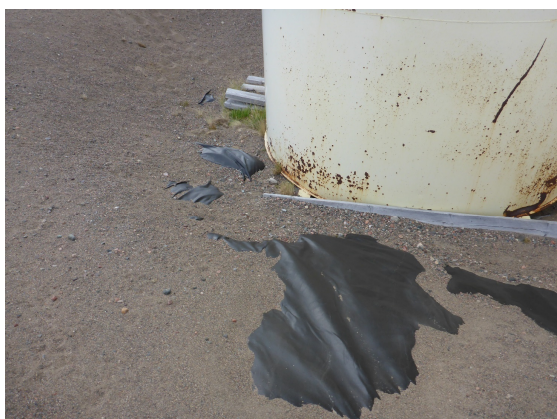
Photo 4: Looking at the exposed and damaged liner at the northeast corner of the tank farm.

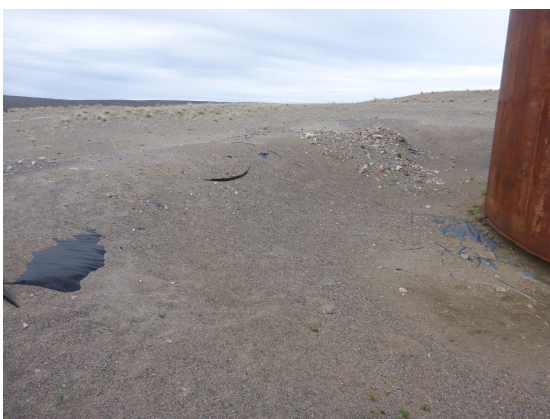
Photo 5: Looking at the exposed and damaged liner at the southeast corner of the tank farm.

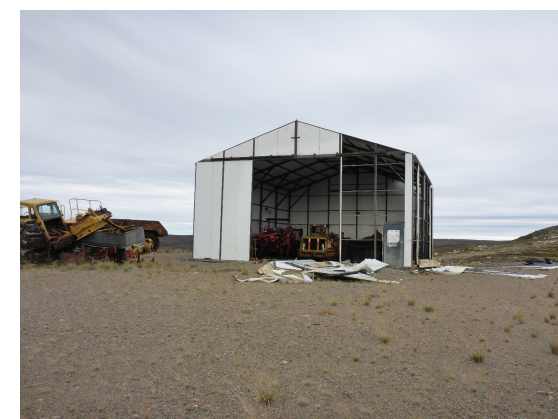
The vehicle repair shop was observed to have some structural damage but the foundation pad is in stable geotechnical condition (Photo 6). A structural engineer should inspect the structure as necessary prior to operation of the shop.

Photo 6: Looking west at the vehicle shop at Camp 3 area.

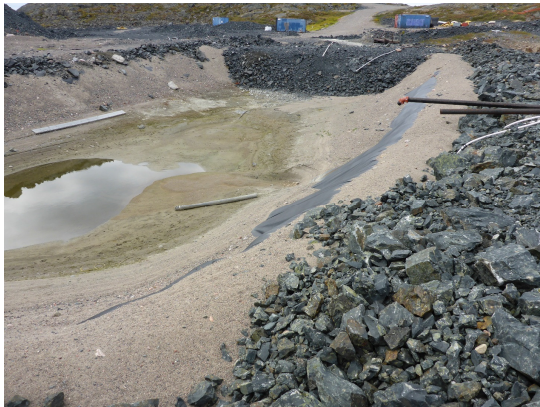
The edges and the slopes of the geosynthetics liner at the mine sump were found to be exposed, where the protective over liner was sloughed off (Photo 7 and 8). Minor yielded deformations were found on the exposed liner. These deformations should be tested and repaired as necessary, and the over liner replaced for protection prior to utilization of the sump.

Photo 7: Looking southwest at the exposed liner in the mine sump

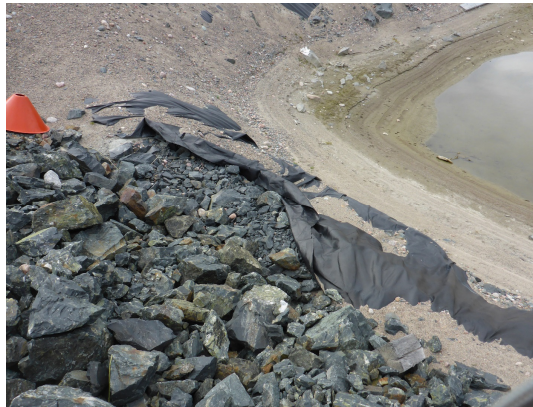
Photo 8: Looking at the northern edge of the exposed liner in the mine sump.

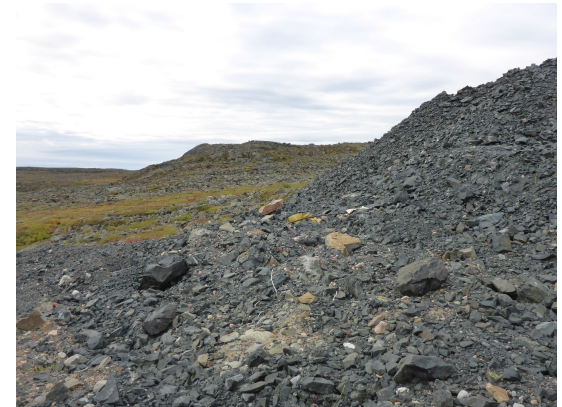
The waste rock storage pad (Photos 18 and 19) and portal laydown pad (Photos 9 to 11) were found to be in similar satisfactory geotechnical condition. No large deformations such as cracks, sloughs, settlements or erosions were found.

Photo 9: Looking southwest at the leading edge of the portal laydown area.

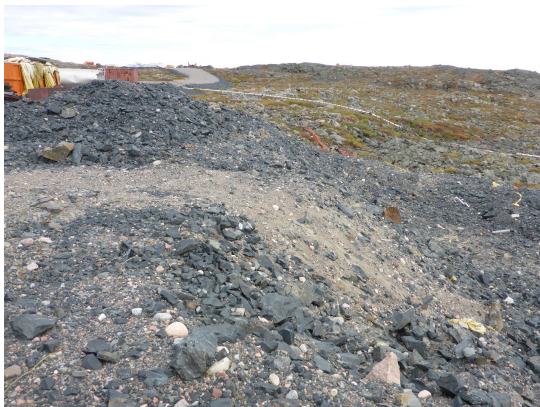
Photo 10: Looking northeast at the leading edge of the portal laydown area.

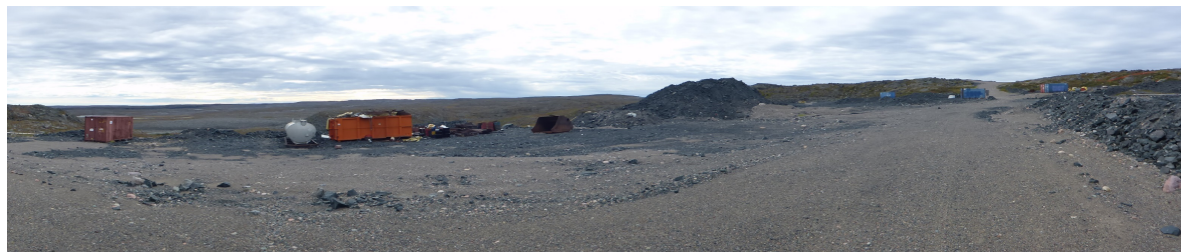
Photo 11: Looking south at the panoramic view at the top of the portal laydown area.

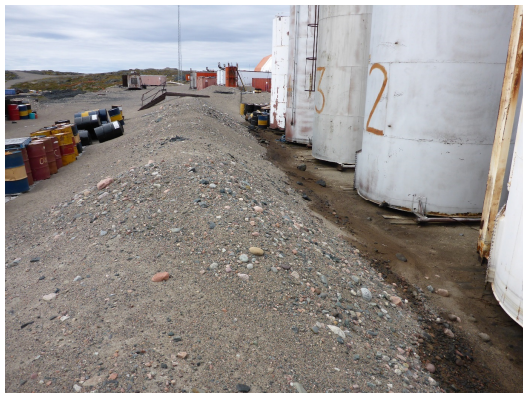
Similar over liner erosion and liner damage are found in the main tank farm and day use fuel containment, where liners are exposed with minor damage near the crest (Photo 12 to 17). The liner needs be patch up and tested as necessary, covered with protective over liner to prevent effluent leakage at extreme high water. Animal burrows were observed last year but were not observed this year. The ponding water left over in the containment berm suggests the liner at the bottom is still intact.

Photo 12: Looking northwest at the east side of the Ulu Main Tank Farm containment berm.

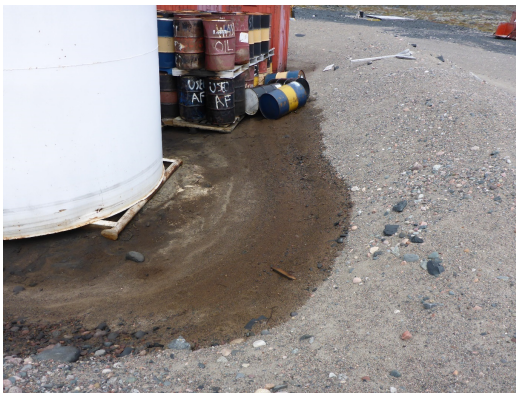
Photo 13: Looking at the south side of the containment berm. Note the high water mark.

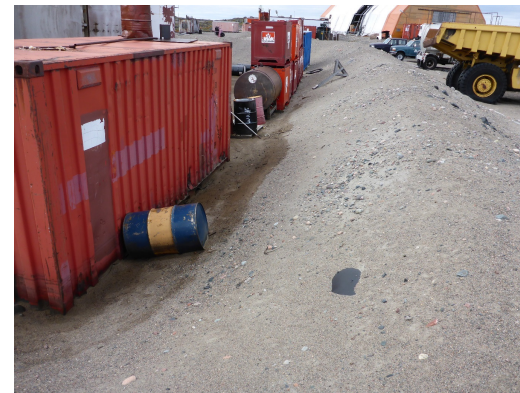
Photo 14: Looking at the west side of the containment berm with the exposed liner.

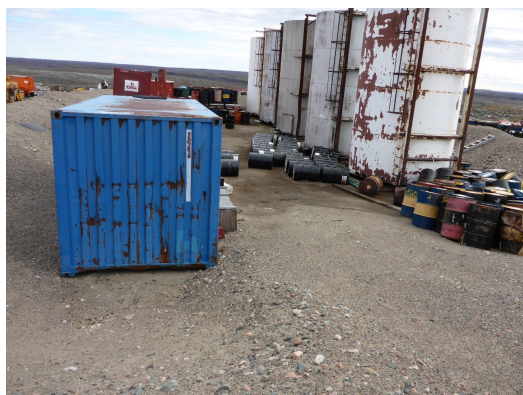
Photo 15: Looking south into the main tank farm from the access ramp.

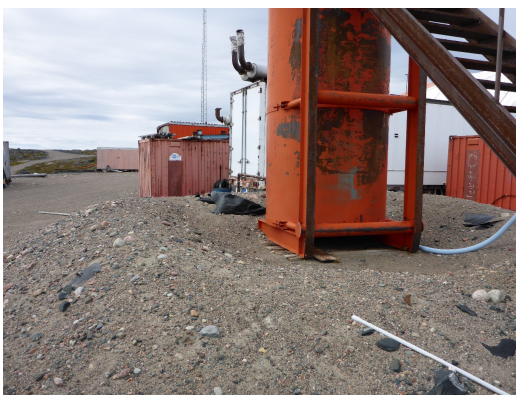
Photo 16: Looking northwest at the Ulu day use tank containment berm.

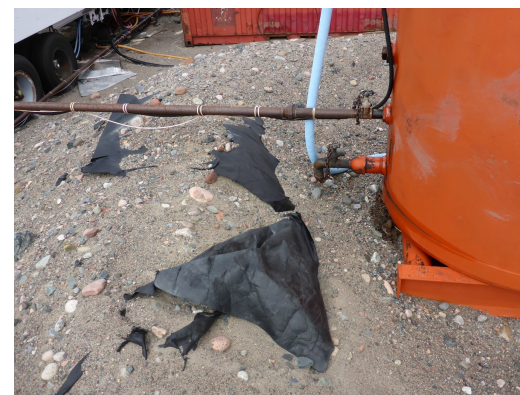
Photo 17: Looking at the exposed and damaged liner at the south side of the day use tank containment berm.

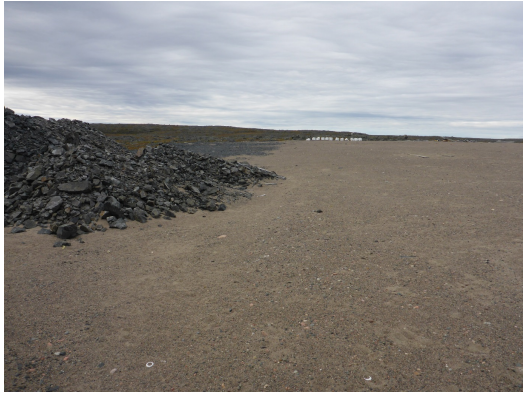
Photo 18: Looking southwest at the top of the waste rock storage pad.

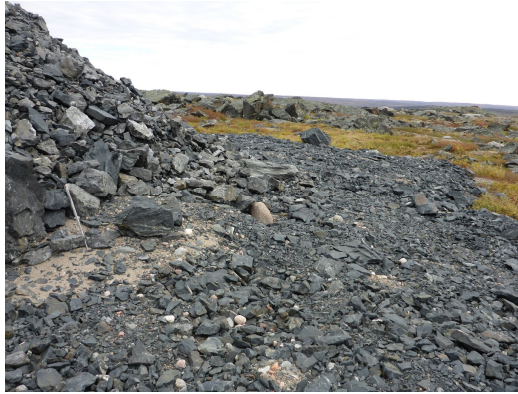
Photo 19: Looking at the northeast corner of the waste rock storage pad.

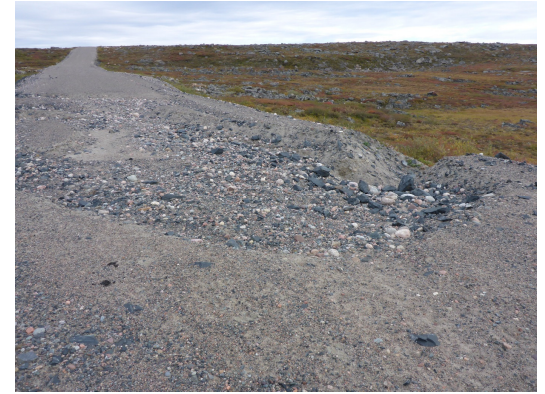
Although it is not a facility that requires official inspection, the road connecting Camp 3 to the airstrip was damaged by a number of large erosion gullies. These erosion gullies impede large vehicles, thus limiting access for equipment to complete the maintenance work at Camp 3. It is recommended that the road be repaired to allow regular vehicle access.

Photo 20: Looking at one of the large erosion gullies across the access road between the airstrip and Camp 3.

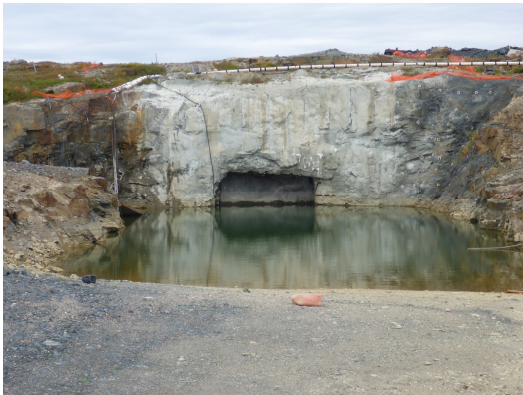
Photo 21: Looking at the submerged bulkhead of the mine portal.
