2017 Ulu Project Geotechnical Inspection

Submitted to:
Bonito Capital Inc.

Project Number: 948-2

Date:
September 29, 2017

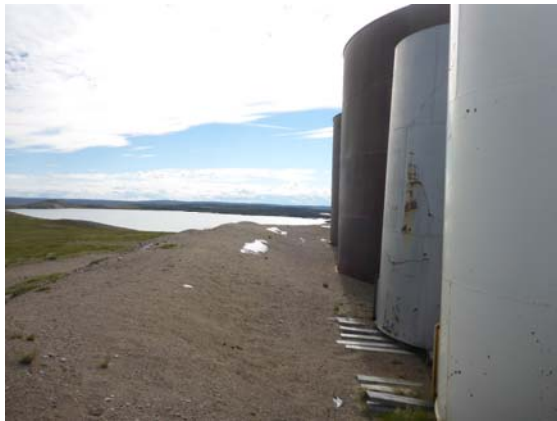
Photo 1: Looking southeast at the Camp 3 fuel tank farm.

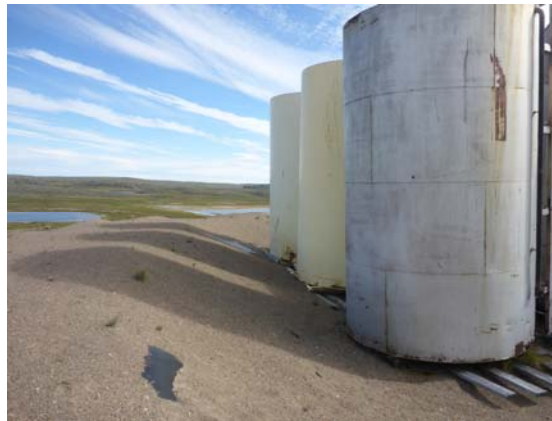
Erosion of the liner cover and liner damage were found in the Ulu main tank farm containment, where liners are exposed with minor damage near upper slope and the crest. The damaged liner should be patched and tested, and the over-liner should be replaced prior to refueling the tanks (Photos 4 and 5). In addition, the wooden cribbing underneath three of the fuel tanks is broken and causing the tanks to lean (Photos 2 and 3). It is recommended that the cribbing be replaced and the tanks levelled. Alternatively, the tanks could be decommissioned and removed from the containment to eliminate the risk of falling over and damaging other parts of the facility.

Photo 2: Looking southeast at one of the leaning 53 thousand litres tank.

- Repair and test all the damaged liner, including the areas that were covered during maintenance work;
- Cover all exposed liner and any exposed edges with protective over-liner (sandy material);
- Replace the broken wooden cribbing in the Camp 3 fuel tank farm and re-level the tanks or decommission and remove the tanks from the containment; and,
- Document the as-built and mitigation work done at the fuel transfer area.

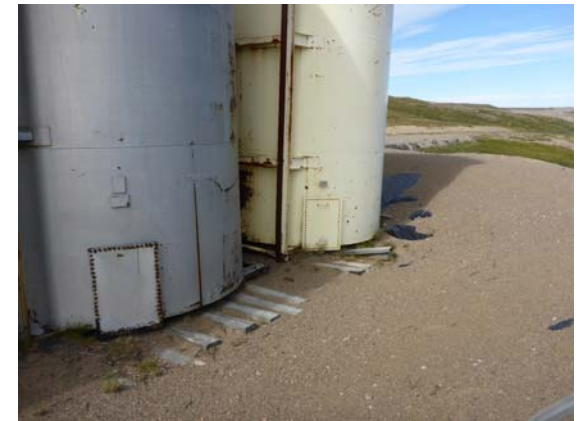
Photo 3: At the broken wooden cribbing at the base of the leaning tank.

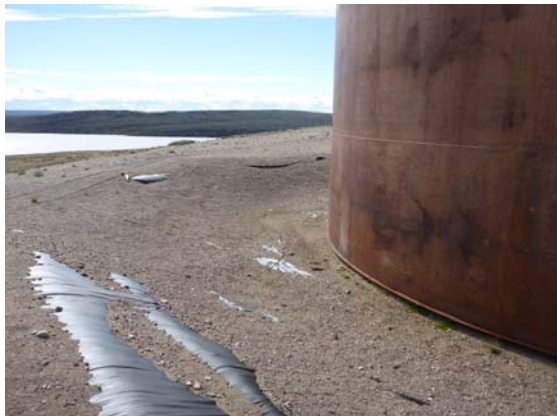
Photo 4: Looking at the exposed and damaged liner at the northeast corner of the tank farm.

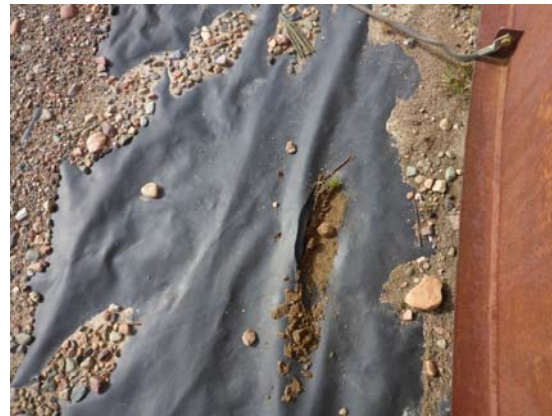
Photo 5: Looking at the exposed and damaged liner between the tanks.

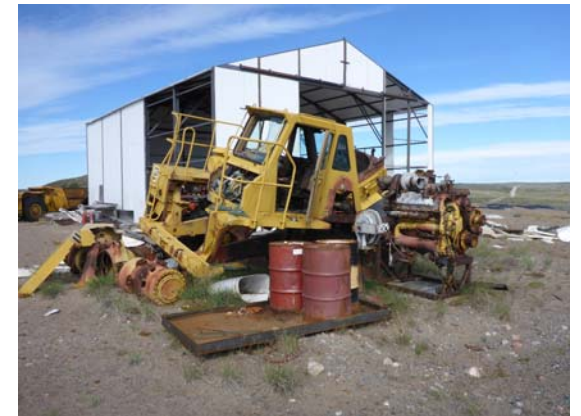
The vehicle repair shop building was observed to have some structural damage but the foundation pad is in stable geotechnical condition (Photo 6). A structural engineer should inspect the building as necessary prior to operation of the shop.

Photo 6: Looking west at the vehicle shop at Camp 3 area.

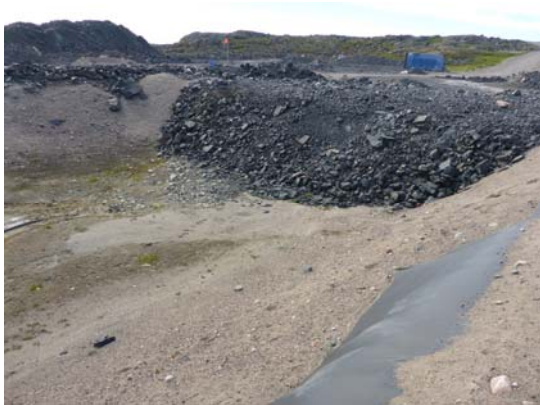
The edges and the slopes of the geosynthetics liner at the mine sump were exposed, where the protective over-liner had sloughed off (Photo 7 and 8). Minor deformations were also found on the exposed liner. These deformations should be repaired and tested as necessary, and the over-liner replaced for protection prior to utilization of the sump.

Photo 7: Looking southwest at the exposed liner in the mine sump

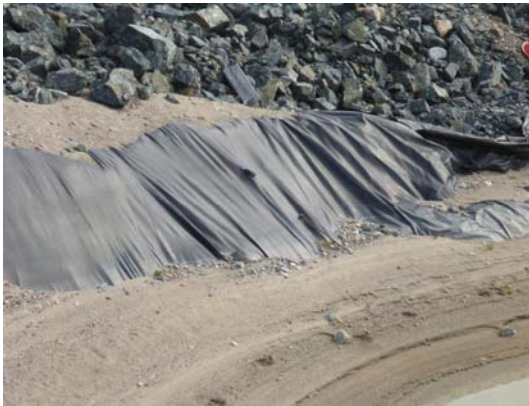
Photo 8: Looking at the northern edge of the exposed liner in the mine sump.

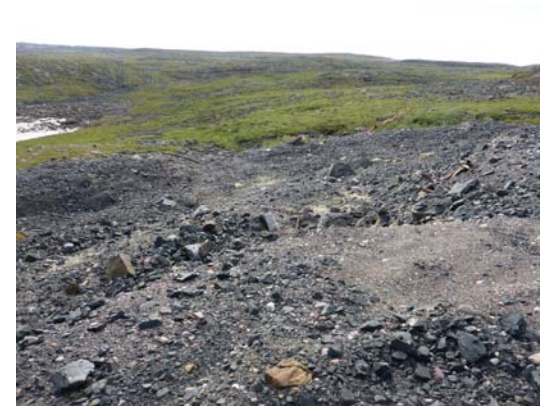
Photo 9: Looking southwest at the leading edge of the portal laydown area.

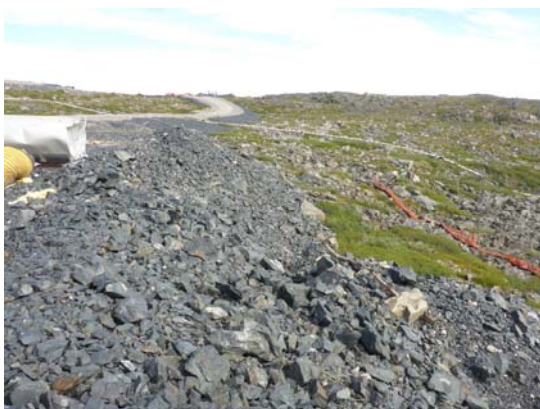
Photo 10: Looking northeast at the leading edge of the portal laydown area.

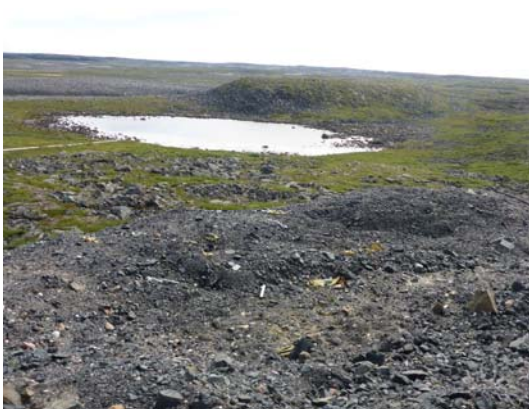
Photo 11: Looking south at the at the leading edge of the laydown area with East Lake in the background.

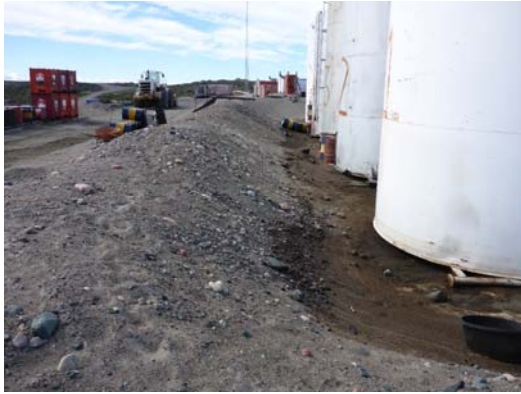
The previously noted exposed liner in the main tank farm and day use fuel containment is now covered with sandy material (Photo 12 to 17). It is not known if the damaged liner noted from previous year was repaired prior to cover placement. The animal burrow noted from the previous year was not observed. The waste rock storage pad (Photos 18 and 19) and portal laydown pad (Photos 9 to 11) were found to be in similar satisfactory geotechnical condition. No large deformations such as cracks, sloughs, settlements or erosion were found.

Photo 12: Looking northwest at the east side of the Ulu Main Tank Farm containment berm.

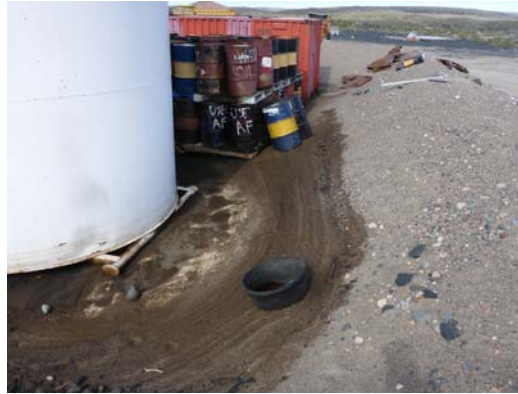
Photo 13: Looking at the south side of the containment berm. Note the high water mark.

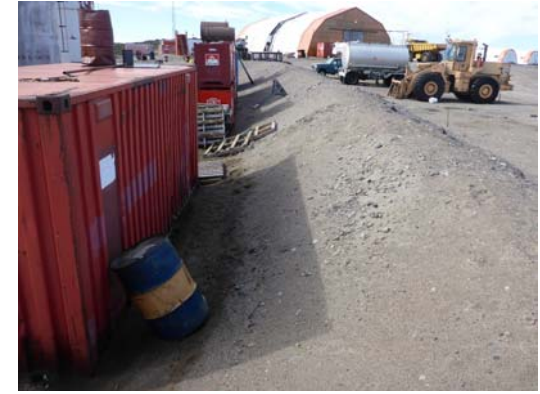
Photo 14: Looking at the west side of the containment berm with the exposed liner.

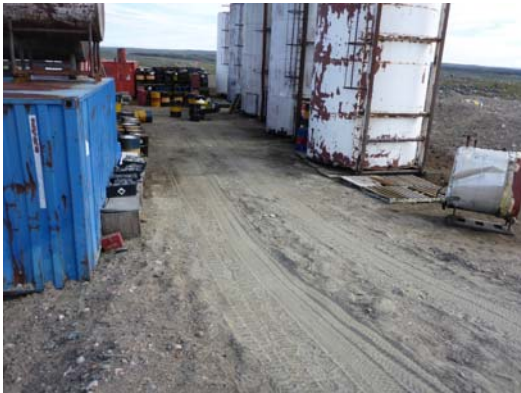
Photo 15: Looking south into the main tank form from the access ramp.

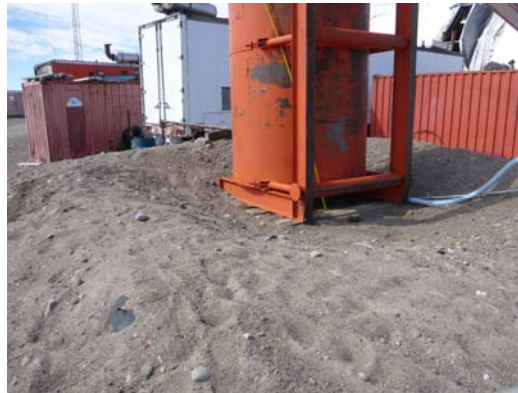
Photo 16: Looking northwest at the Ulu day use tank containment berm.

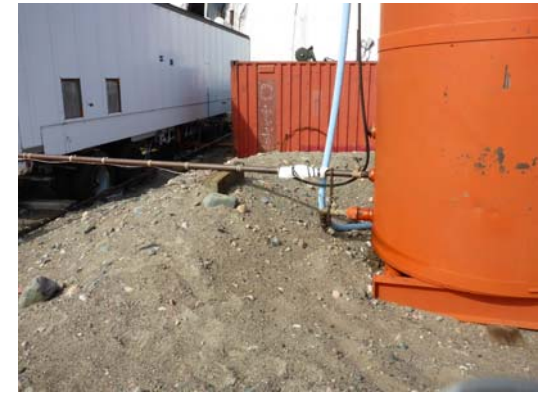
Photo 17: Looking at the covered liner at the south side of the day use tank containment berm.

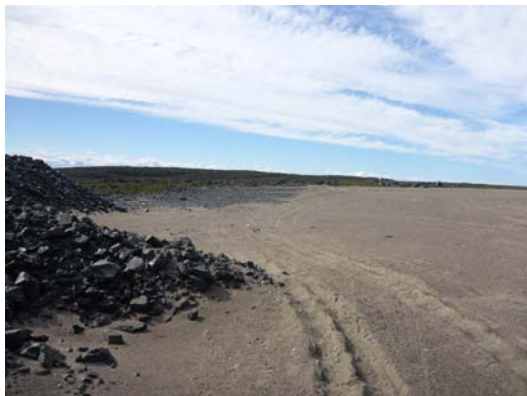
Photo 18: Looking southwest at the top of the waste rock storage pad.

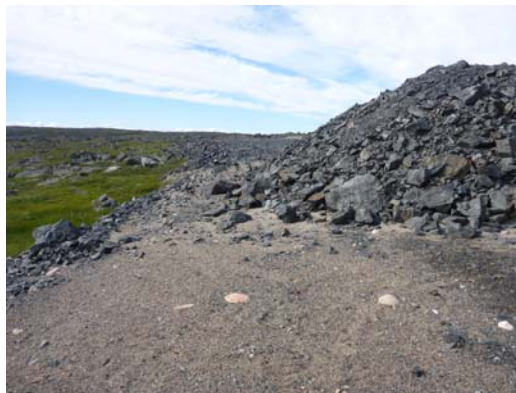
Photo 19: Looking at the southeast corner of the waste rock storage pad.

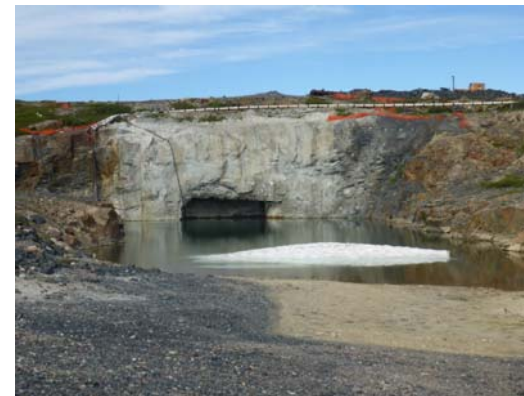
Photo 20: Looking at the submerged bulkhead of the mine portal.

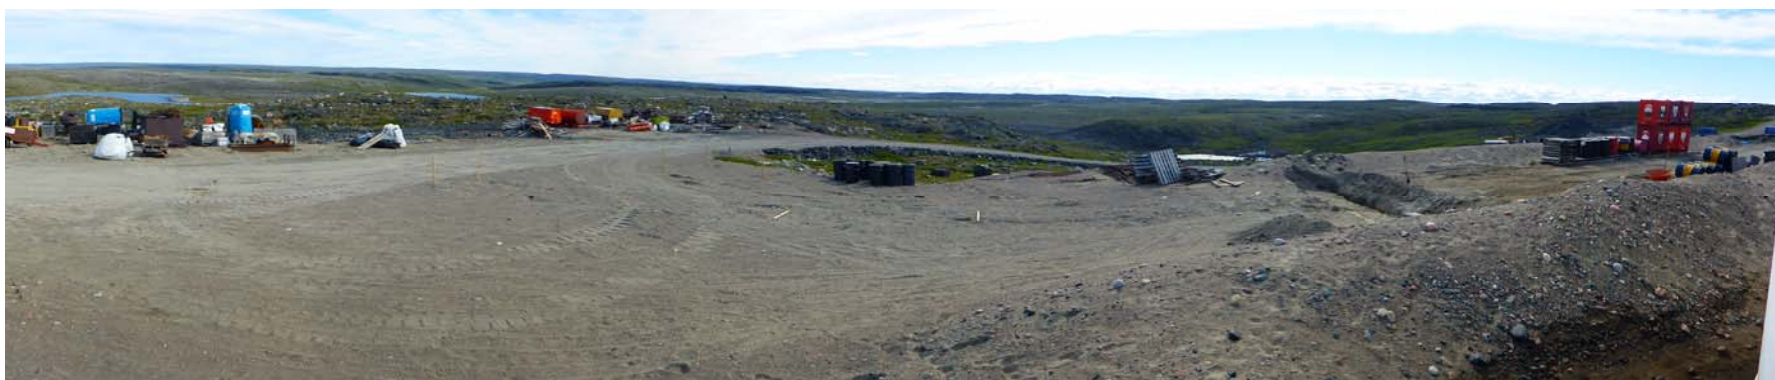
Although it is not a facility that is part of the official geotechnical inspection, there some maintenance and mitigative works being carried out on the fuel transfer area, downstream of the tank farm. Previous inspections noted a minor hydrocarbon spill. To alleviate the impact of the spill, all hydrocarbon containers were being relocated to the main tank farm for storage and

mitigative work is done to build a large berm to contain any residual hydrocarbon (Photo 21). Preliminary soil sampling is being done to evaluate extent of the spill to guide future delineation studies and remediation efforts.

Photo 21: Panoramic south looking view at the fuel transfer area mitigative work, including exposing the edge of the underlaying liner and start of berm construction.
