Indian and Northern Affairs Canada Affaires indiennes et du Nord Canada

**Nunavut District Office**

Hamlet of Arviat

Re: Water Licence Inspection August 12, 2003

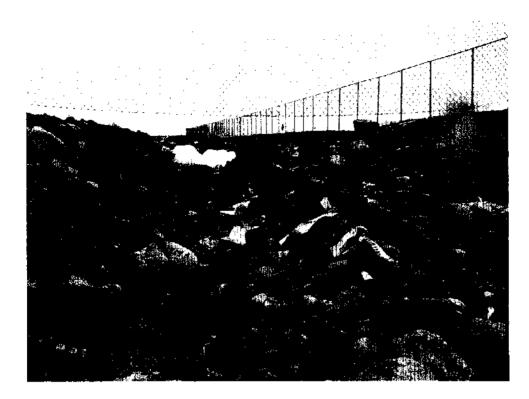
Materials in the landfill are not well segregated as metal waste and 12-volt lead acid batteries are visible in the landfill. There is also a considerable amount of ponding (figure 2) on the perimeter of the landfill with a ditch for leachate to flow out of the landfill (figure 3) into a pond on the Northwest side of the landfill. I advised the SAO that this should be remedied. All precipitation and runoff entering the landfill should be contained and sampled before it can be pumped out of the landfill. This will help prevent the release of contaminants. Samples of the pond water receiving runoff from the Arviat landfill were all within the Guidelines for the Discharge of Treated Municipal Wastewater in the Northwest Territories as well as the Canadian Water Quality Guidelines for the Protection of Aquatic Life 2002 (see attached lab results). Mr Van Horn suggested pumping the water into the sewage lagoon on the Southeast side of the landfill. It would be better to simply contain the accumulated water until it can be determined how contaminated it is. If the water is within the Guidelines for the Discharge of Treated Municipal Wastewater in the Northwest Territories as well as the Canadian Water Quality Guidelines for the Protection of Aquatic Life 2002 it can be discharged. Combining seepage from the solid waste disposal site with sewage effluent could have unpredictable effects on the toxicity of the final effluent.

Figure 3. Drainage ditch on the Northwest corner of the Hamlet of Arviat landfill.

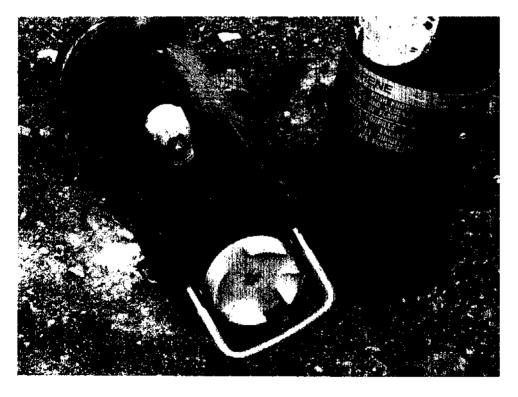
Some segregation of materials was evident at the metal dump, however there was no containment of hazardous materials. A number of Pyrene fire extinguishers (figure 4) were observed scattered around the site. Mr Van Horn has said that he will have the fire extinguishers collected and stored in a Sea Lift container until they can be disposed of properly.

Figure 4. Improperly disposed fire extinguishers in Arviat metal dump.

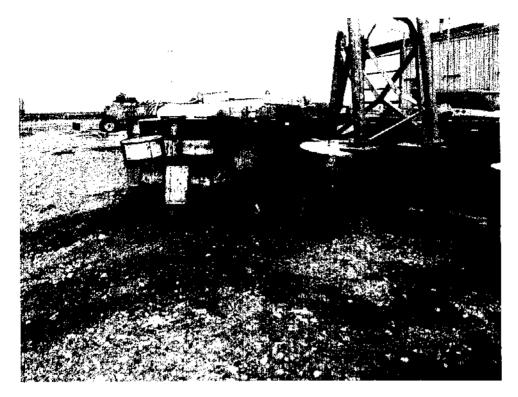
The waste oil for the hamlet is designated to be burned in a waste oil burner which is the property of the Hamlet. The burner has not been used for some time and there is an accumulation of more than 50 drums of waste oil at the site. Mr Van Horn said that there was not currently anything wrong with the burner and it is unclear why the accumulation had occurred. The drums were generally in a dilapidated state with significant rust visible and a large amount of hydrocarbon

contamination visible at the site (figure 5). No structures are in place to contain spills of waste oil. The spills should be cleaned up and the waste oil should be burned on a more regular basis to prevent accumulation that leads to spillage. Construction of a lined and bermed area would prevent further soil contamination from waste oil spills.

Figure 5. Hamlet of Arviat waste oil storage with hydrocarbon contamination visible.
