WATER LICENCE INSPECTION FORM

Licensee	Licensee Representative
Hamlet of Chesterfield Inlet	Douglas Aggark, Megan Lusty (CGS)
Licence No. / Expiry	Representative's Title
3BM-CHE1013 (30/09/13)	Senior Administrative Officer
Date of Inspection	Inspector
07/07/2014	WRO C. Wilson

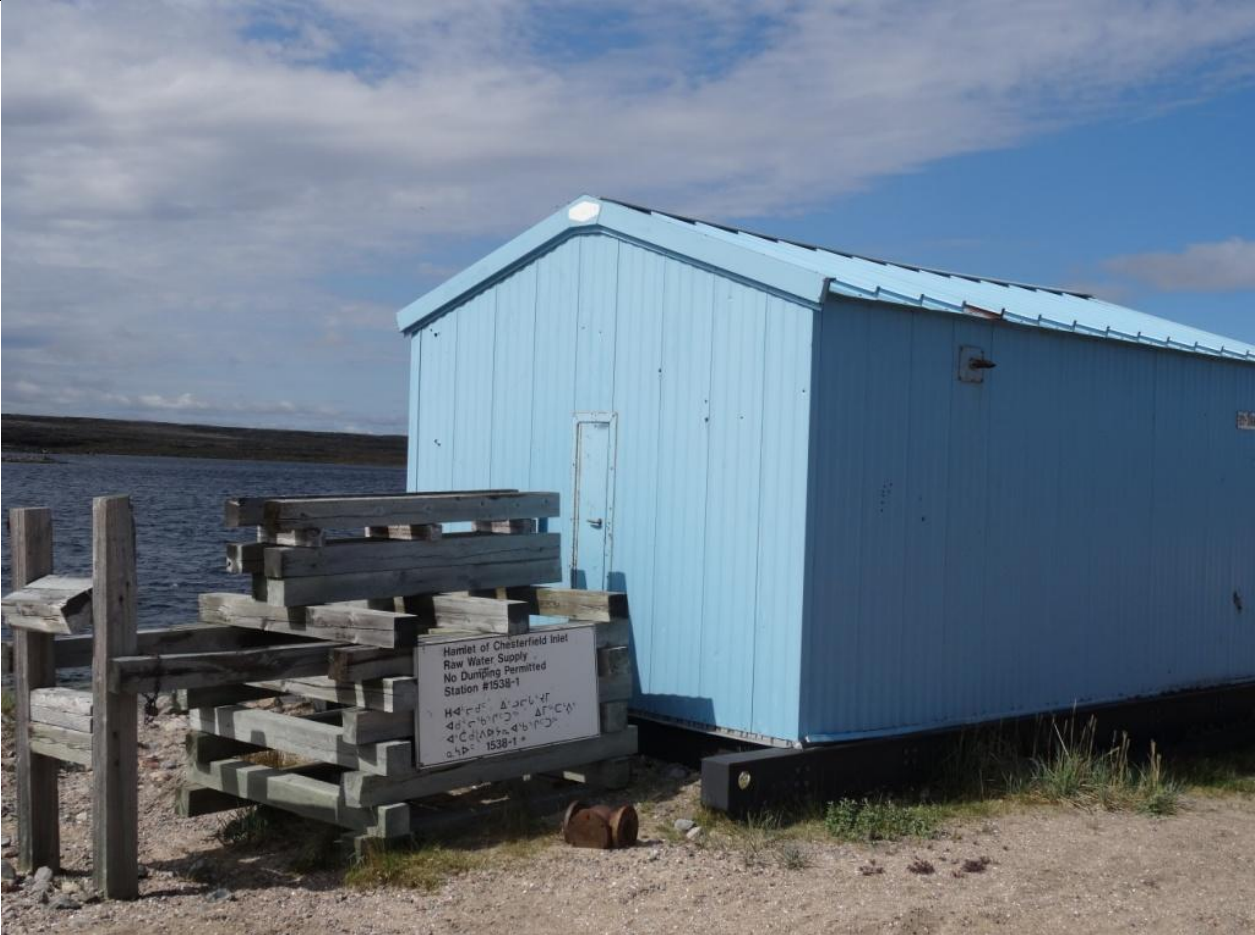
Locations name:	Lat/Long (DD.MM.SS.SS, NAD83)
PHOTO 1	N 63° 19' 48.4", W90° 46' 18.4"

Descirption:
Raw water intake location at fish lake. This is where the water meter must be installed to count for the raw water drawn to the reservior.

- The Hamlet will install at the intake pump at First Lake and record the meter volume daily while filling the reservoir. A picture of the meter will be provided to the inspector before September 30th, 2014.

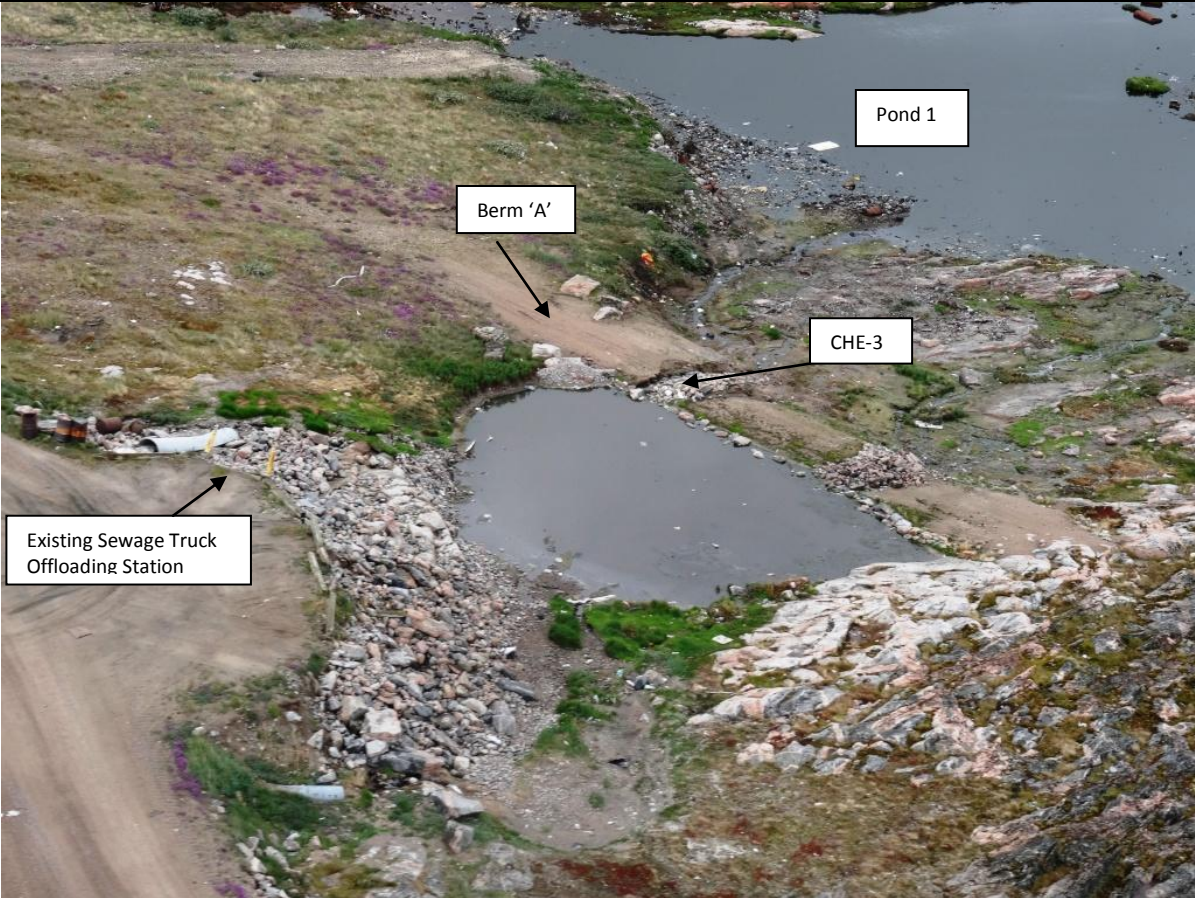
Locations name:	Lat/Long (DD.MM.SS.SS, NAD83)
PHOTO 2	N63 20' 40.499", W 90 45' 4.601"

Description:
From left to right- Current utilized sewage truck offloading location; Berm 'A' wash out; CHE-3 sampling location; Location of Pond 1.
