# **Water Licence Inspection Report**

Orginization	Representative			
Hamlet of Chesterfield Inlet	Paul Bosetti			
Authorization No. / Expiry	Representative's Title			
3AM-CHE2333/ December 19 <sup>th</sup> 2033	Senior Administrative officer			
Inspection Date	Inspector			
July 17 <sup>th</sup> 2024	Atuat Shouldice			
Other Authorization/s				
Activities Inspected				
☐ Camp, Commercial ☐ Drilling ☐ Mining ☐ Construction ☐ Reclamation ☐ Fuel Storage ☐ Roads/Hauling ☐ Winter Hauling				
☐ Camp, Private ☑ Other Municipal

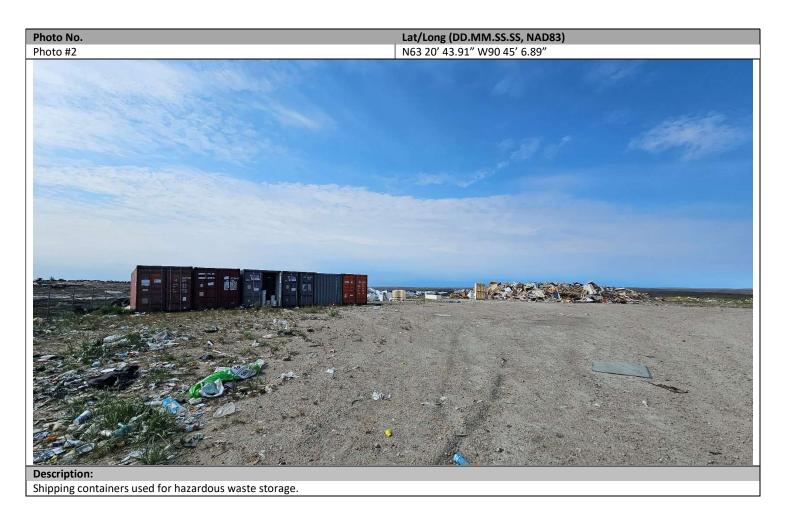
Landfill photo of segragated locations for opening burning, demestic waste, and hazardous waste storage.
