Subject: Chesterfield Inlet Overland Water Re-supply Pipeline (Contract 18310-0544) - Certificate of

Substantial Completion

DAILY INSPECTION REPORT

Project: Water Transmission Line Replacement – Chesterfield Inlet, NU

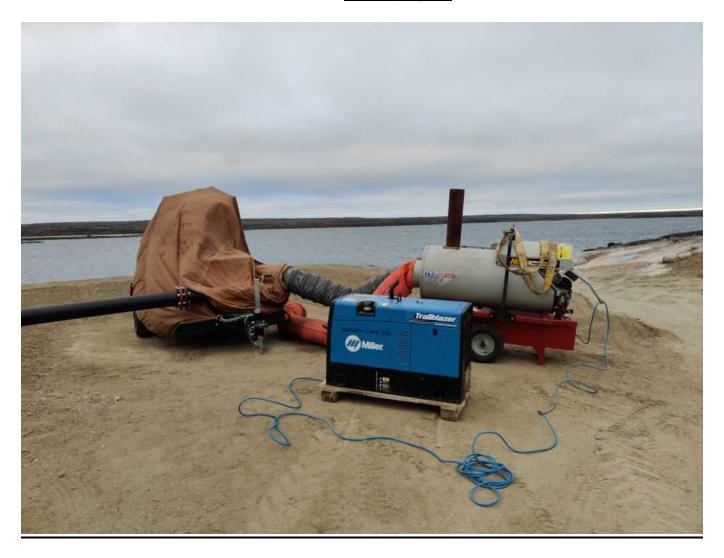
Photo 1: 08:30 am – Heater was installed to ensure pump is ice-free for this afternoon's pump commissioning.

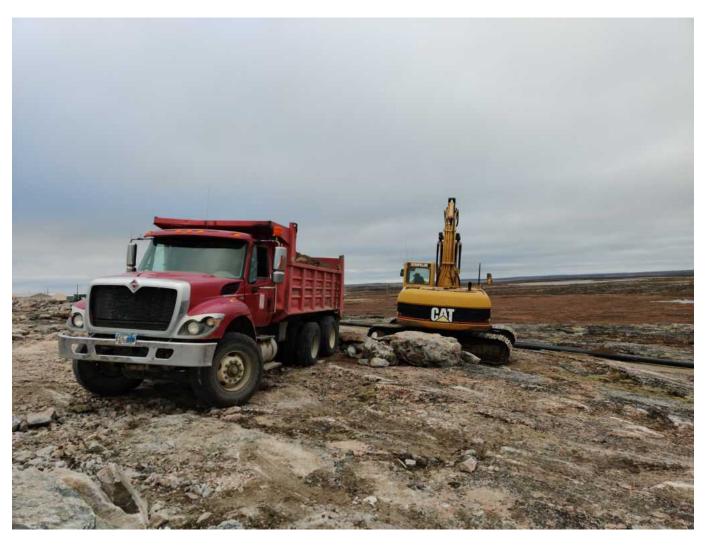
Photo 2: 10:00 am – Photo taken at station 3+000, facing southeast. Berm placement and anchor installation continues from station 3+000. Progress rate slower here due to extra precaution taken to maneuver excavator and dump truck around rocky terrain. By end of day, berm placement and anchor installation reaches station 3+220, with 1 drain valve box installed at station 3+110.

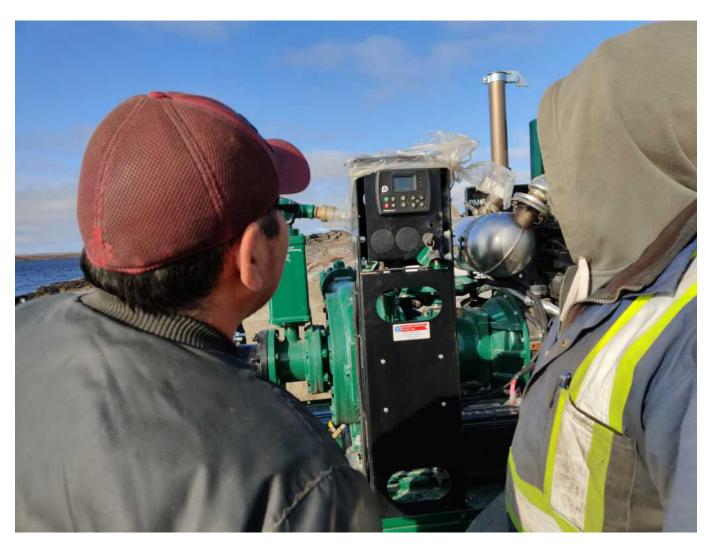
Photo 1:10 pm – Photo taken at pump at station 0+0000. Walkthrough of pump startup procedures with Don, Hamlet Foreman takes place with ICL's mechanic. Factory-optimized operating speed and flow rate were discussed, along with prestartup procedures, and troubleshooting for common errors. Pumping began at 1:11 pm.

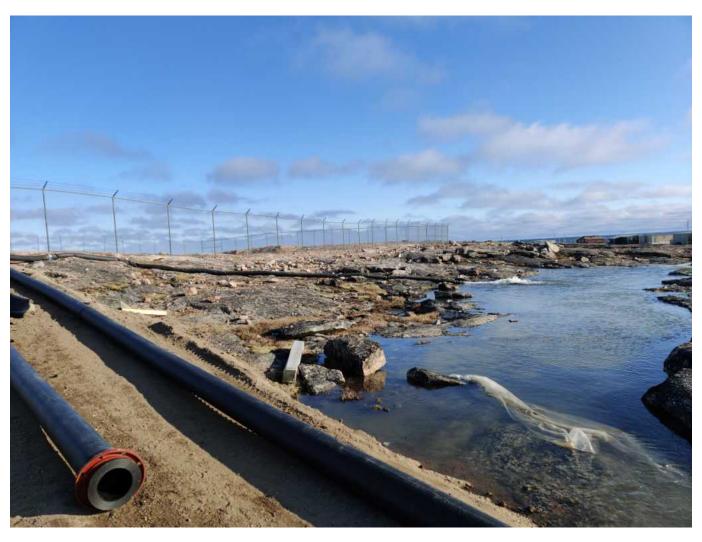
Some minor erosion was noted during the flushing phase of the pump commissioning between station 3+220 to 3+250. This was due to the length of flexible Camlock hose not being able to extend past the local rocky depression containing the gravel pad. Thus, water draining to the low-lying area to the south caused some sloughing of the pad embankment. ICL was instructed to repair the eroded section at a later date.

Photo 4: 2:15 pm – Photo taken a station 3+200, facing east. Water first reaches the reservoir-end of pipeline at approximately 1:35 pm. Camlock hose installed on pipe end before reservoir for pipeline flushing was not long enough to extend past the local rocky depression containing the gravel pipe base. Some sloughing of the embankment was noted, and ICL was instructed to repair embankment at a later date.

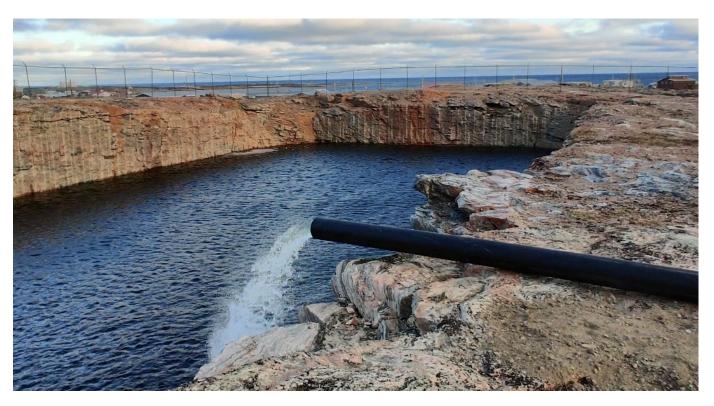
Photo 5: 05:00 pm – Photo taken at reservoir-end pipe outlet. After 1 hour of flushing, crew connected final section of HDPE pipe to the reservoir, and at the request of the Hamlet, pumping proceeded until 7:00 pm to top up the reservoir level. By end of day, 759,859 liters of water were added to the reservoir.
