WATER LICENCE INSPECTION FORM

Licensee		Licensee Representative	
Hamlet of Igloolik		Joasai Kublu	
Licence No. / Expiry		Representative's Title	
3BM-IGL1520		Director of Public Works	
Land / Other Authorizations			
None			
Date of Inspection		Inspector	
August 9 , 2016		Justin HACK	
Activities Inspected			
<input checked="" type="checkbox"/> Camp/Municipality	<input type="checkbox"/> Drilling	<input type="checkbox"/> Mining	<input type="checkbox"/> Construction
<input type="checkbox"/> Roads/Hauling	<input type="checkbox"/> Other:	<input type="checkbox"/> Reclamation	<input type="checkbox"/> Fuel Storage

On August 9 2016, a water licence inspection was conducted at the Hamlet of Igloolik, Qikiqtani Region, Nunavut. Sites inspected included the freshwater lake (South Lake), potential secondary water source (Fish Lake), water storage reservoir, sewage lagoon, hazardous materials storage area.

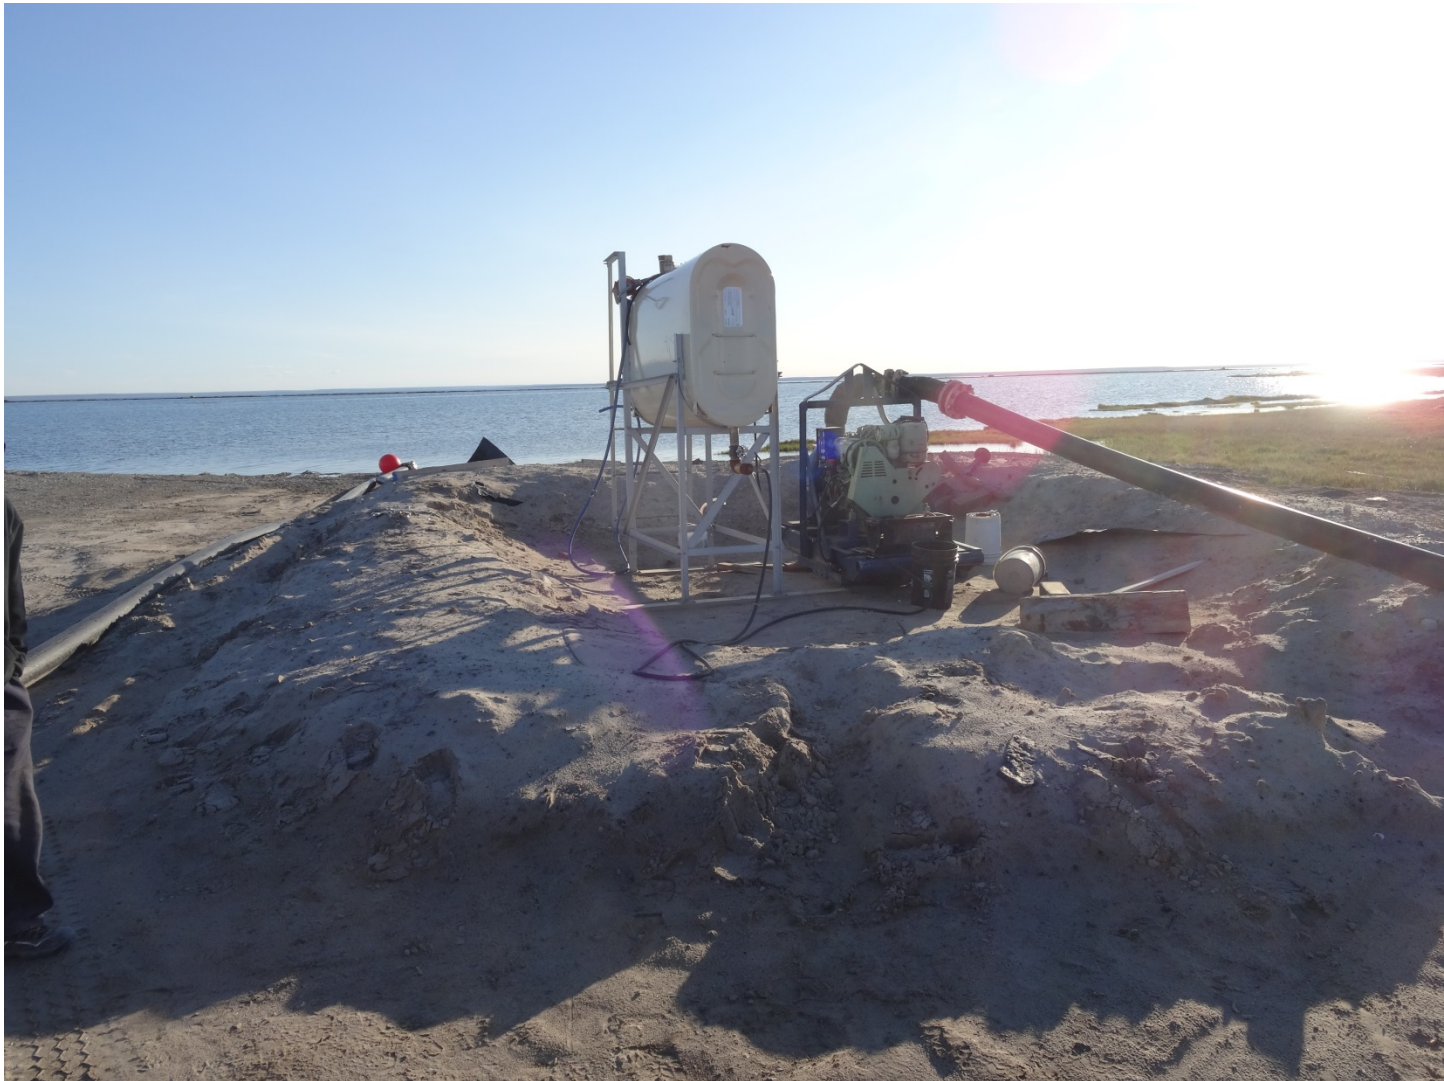
The pump and diesel tank were located approximately 20m within secondary containment from the South Lake. See figure 1

Figure 1 (South Lake water pump)

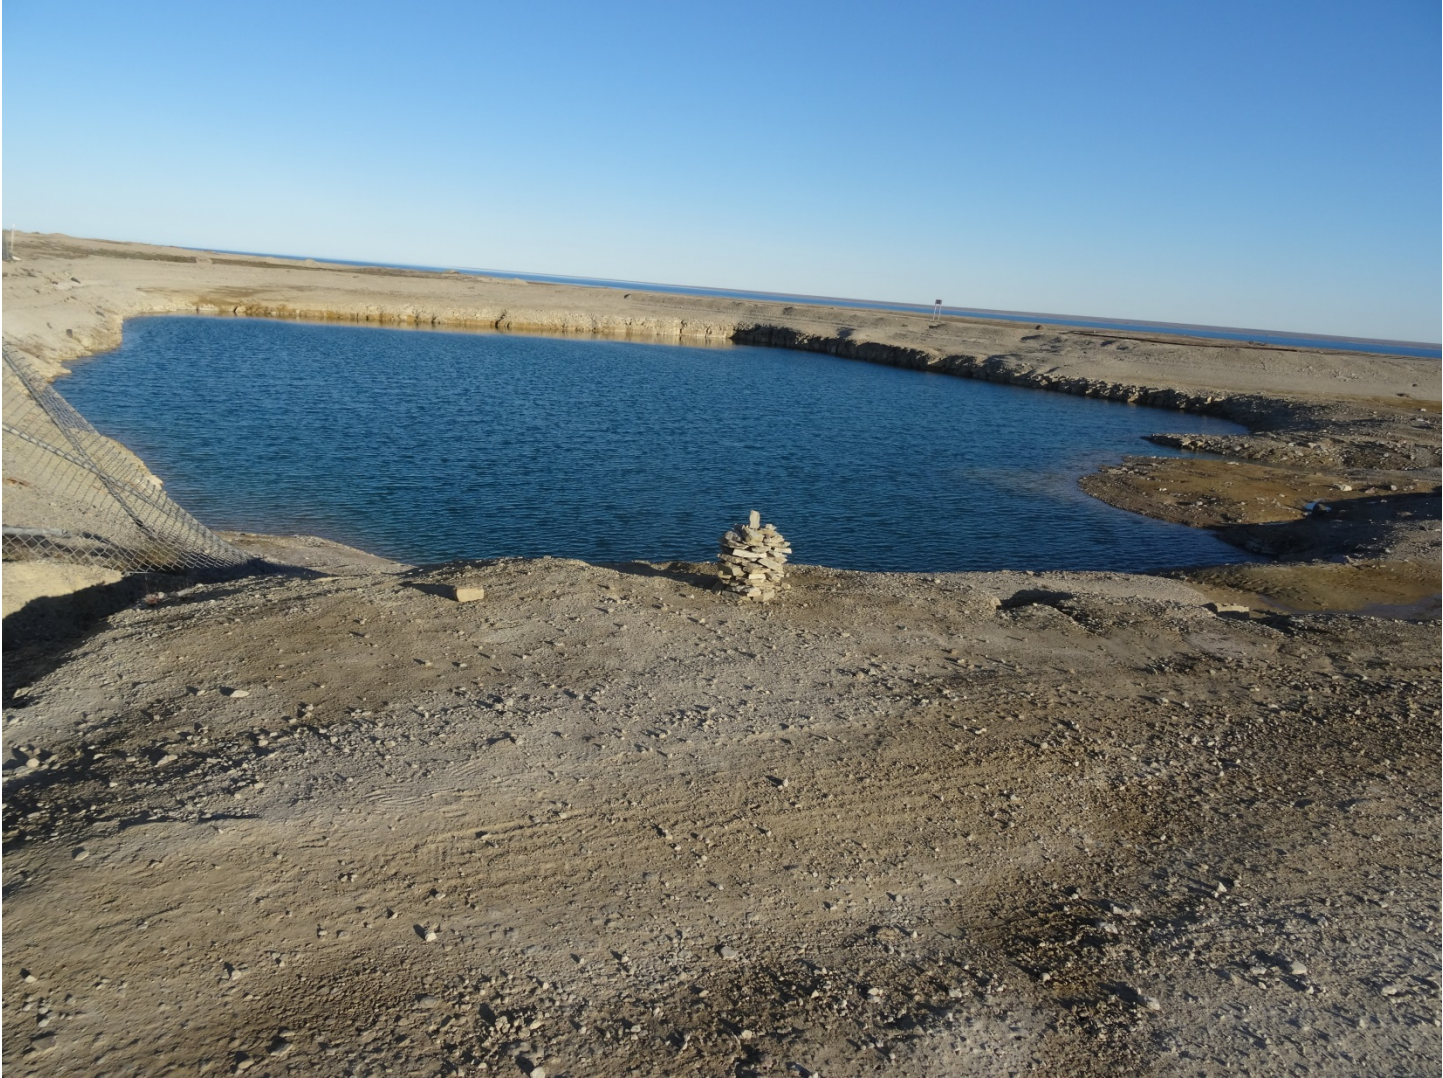
Figure2 (water reservoir)

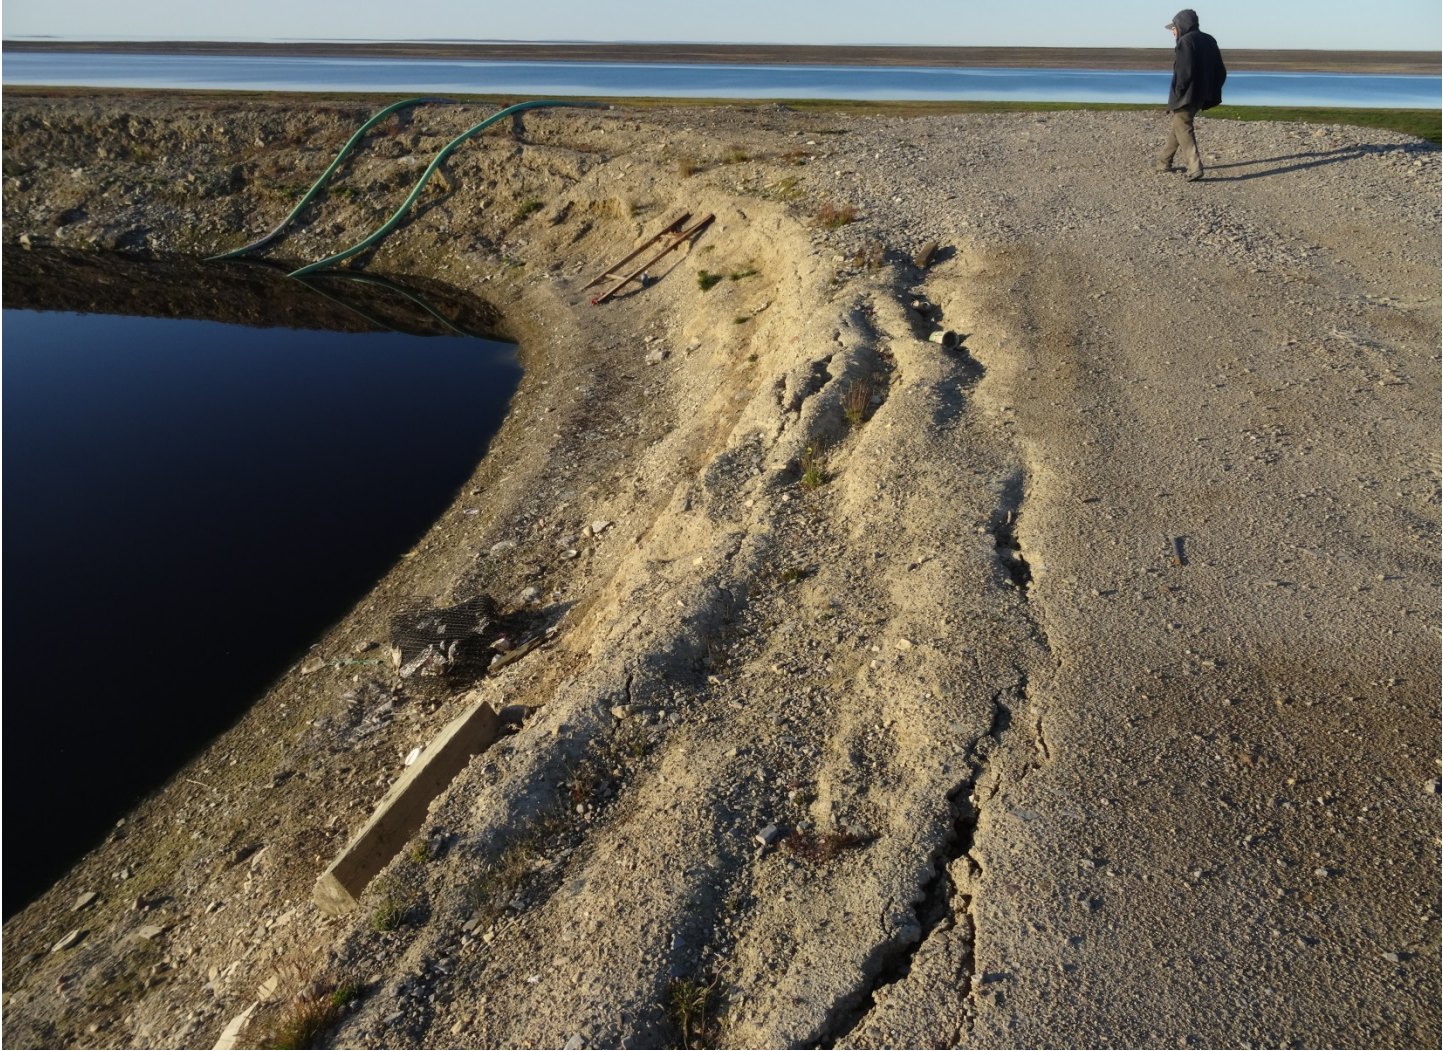
Berm walls surrounding the facility were starting to show signs of minor slumping or cracking; however, this facility is going to be repaired 2016/2017. See figure 3 and 4

Figure 3 (Sewage lagoon)

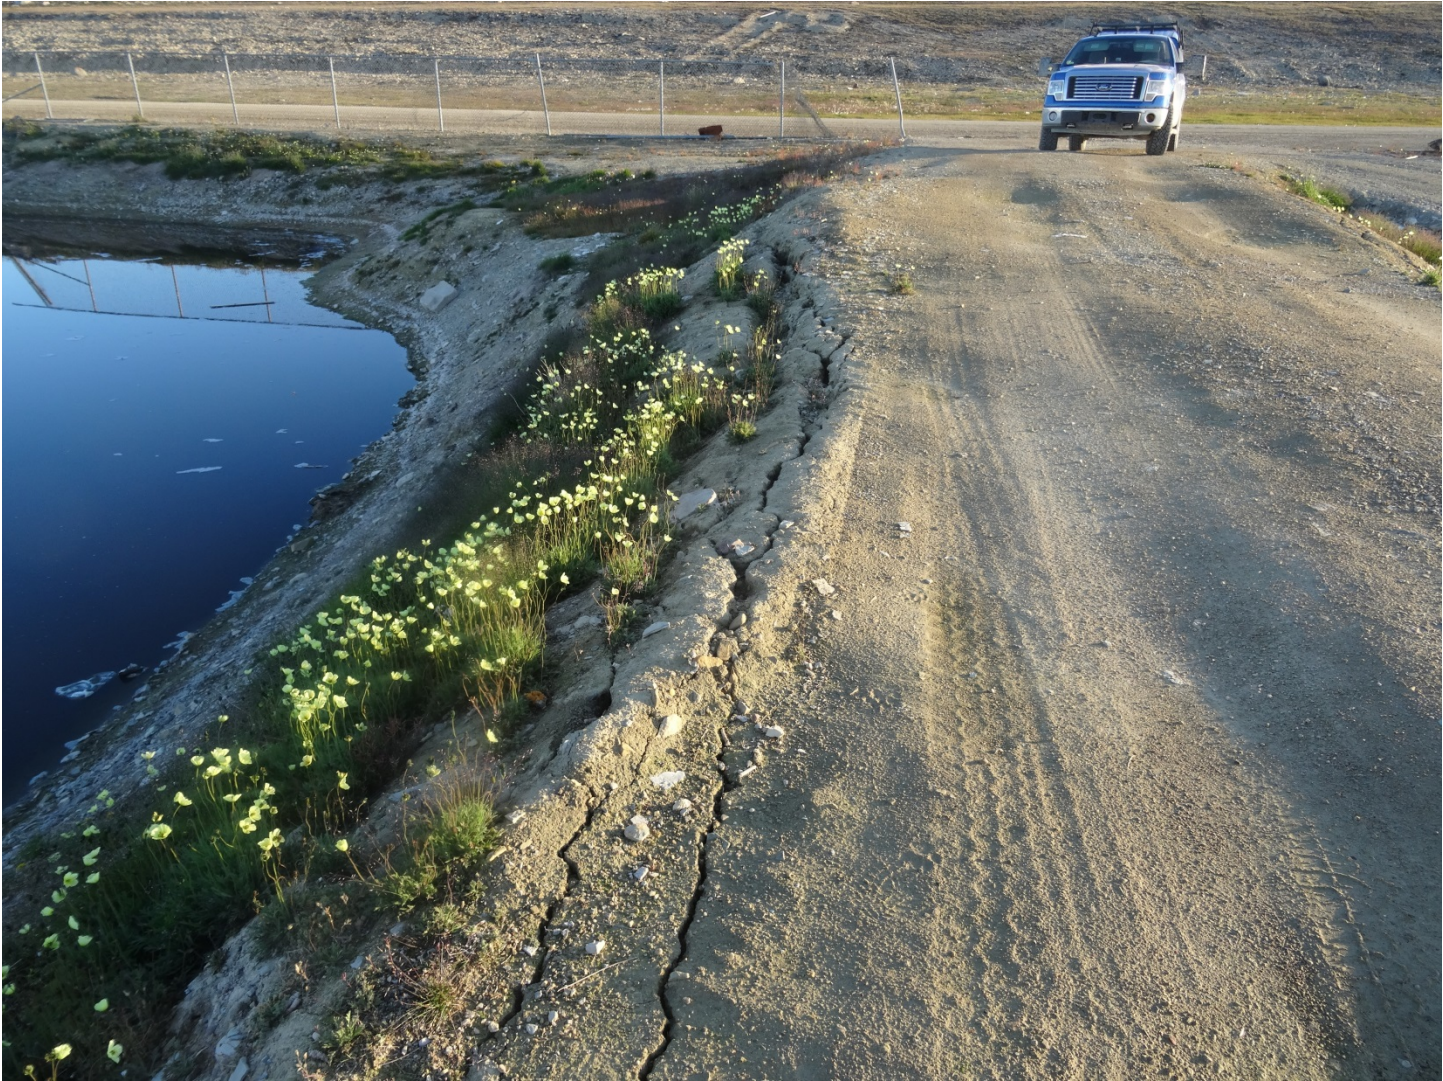
Figure 4 (sewage lagoon)
