WATER LICENCE INSPECTION FORM

Licensee	Licensee Representative
Hamlet of Igloolik	Bhabesh Roy
Licence No. / Expiry	Representative's Title
3BM-ILG1520	Municipal Engineer
Land / Other Authorizations	Land / Other Authorizations
Date of Inspection	Inspector
July 10, 2018	Joseph Monteith & Jonathan Mesher
Activities Inspected	
<input type="checkbox"/> Camp	<input type="checkbox"/> Drilling
<input type="checkbox"/> Roads/Hauling	<input type="checkbox"/> Mining
	<input checked="" type="checkbox"/> Other: Potable Water Source, Solid Waste Facility, Sewage Disposal Facility
	<input type="checkbox"/> Construction
	<input type="checkbox"/> Reclamation
	<input type="checkbox"/> Fuel Storage
	<input type="checkbox"/> Other:

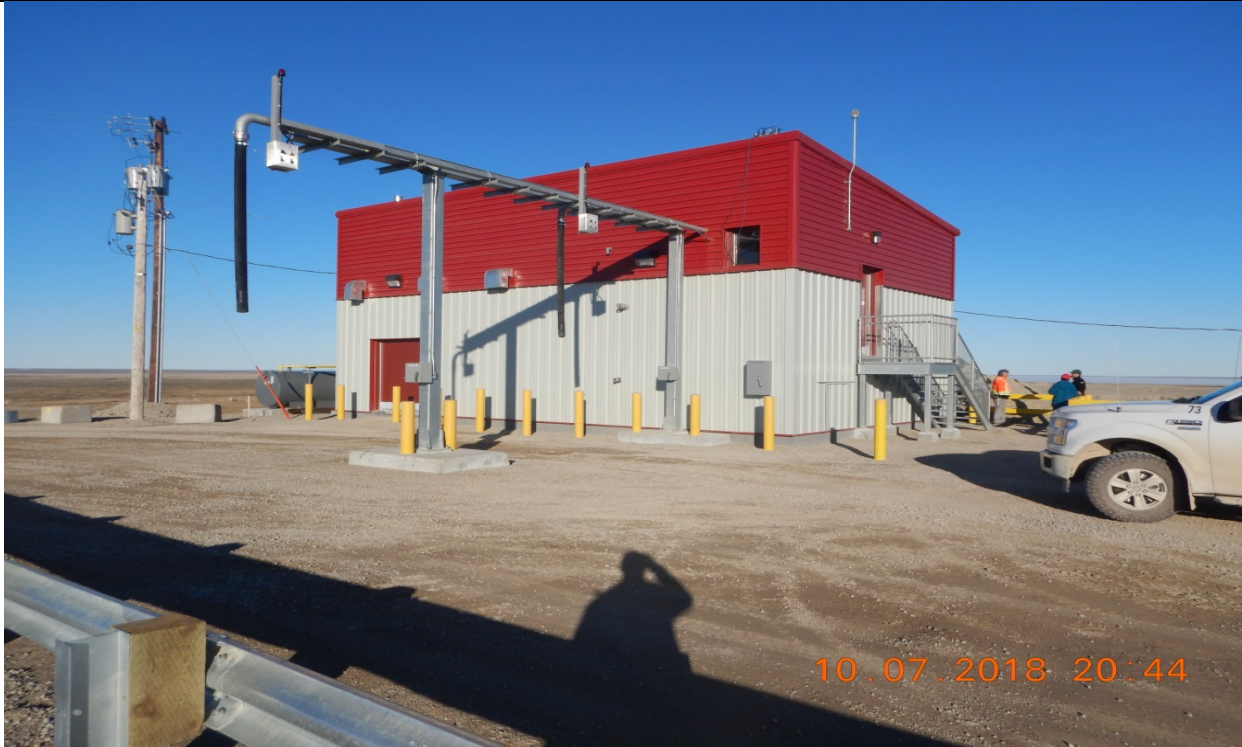
Photo 8

5. At the time of the inspection, the Water Treatment Facility was locked. No observation of a water metre. (Photo 8).
6. The Water Treatment Facility has two intake pipes that extend 9 metres into the Water Storage Reservoir.
7. The Water Treatment Facility has an auto-chlorine injector, and 3 types of filters.
8. Water is dispersed to the public by trucked service from the Water Treatment Facility (Photo 9).
9. The chlorine injection requires 20 minutes in the truck to properly treat the water, as per Health Regulations
10. The old Water Treatment Facility has auto-chlorine injectors. (Photo 10).
11. The Water Storage Reservoir goes to a depth of 10 metres, and can contain a total of 100,000 cubic metres of freshwater (See photo 11).
12. The fencing appears to have collapsed on one side. (Photo 12).
13. Pipe enters Water Storage Reservoir (Photo 13).

Description: Water Truck Pump and water treatment Facility

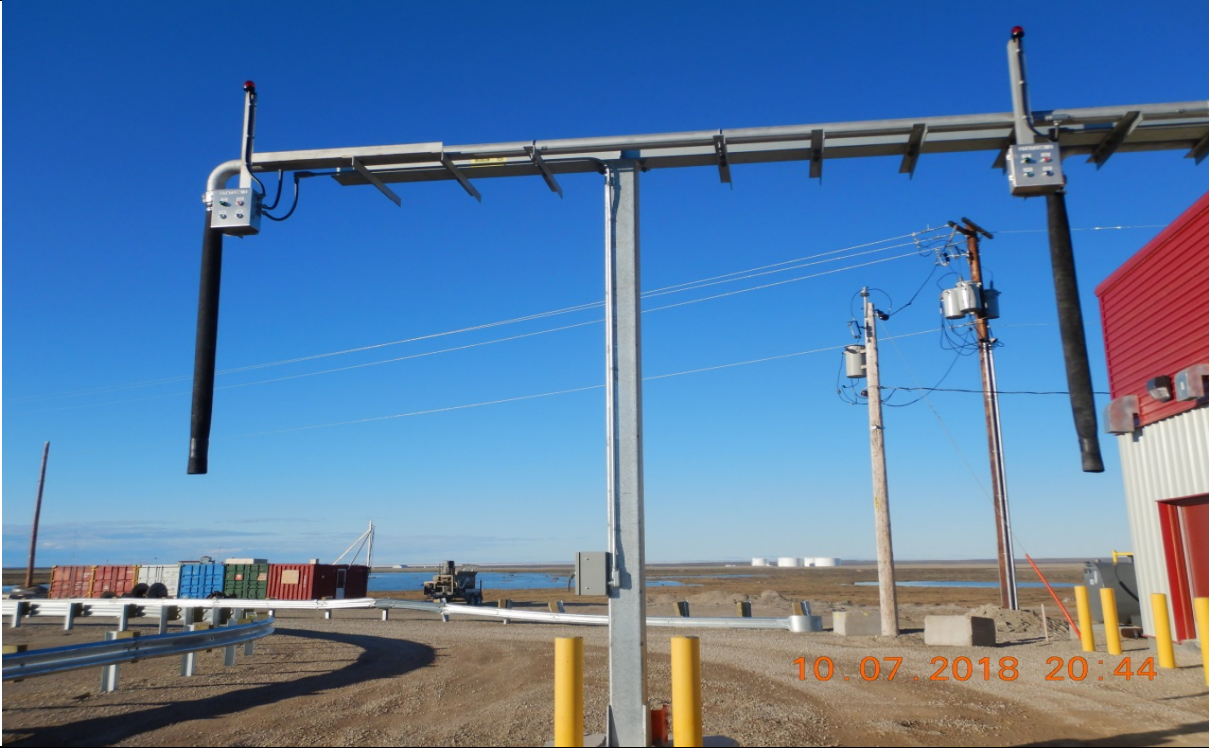
Photo 9

Description: Water Truck Pumping Hose at Water Treatment Facility

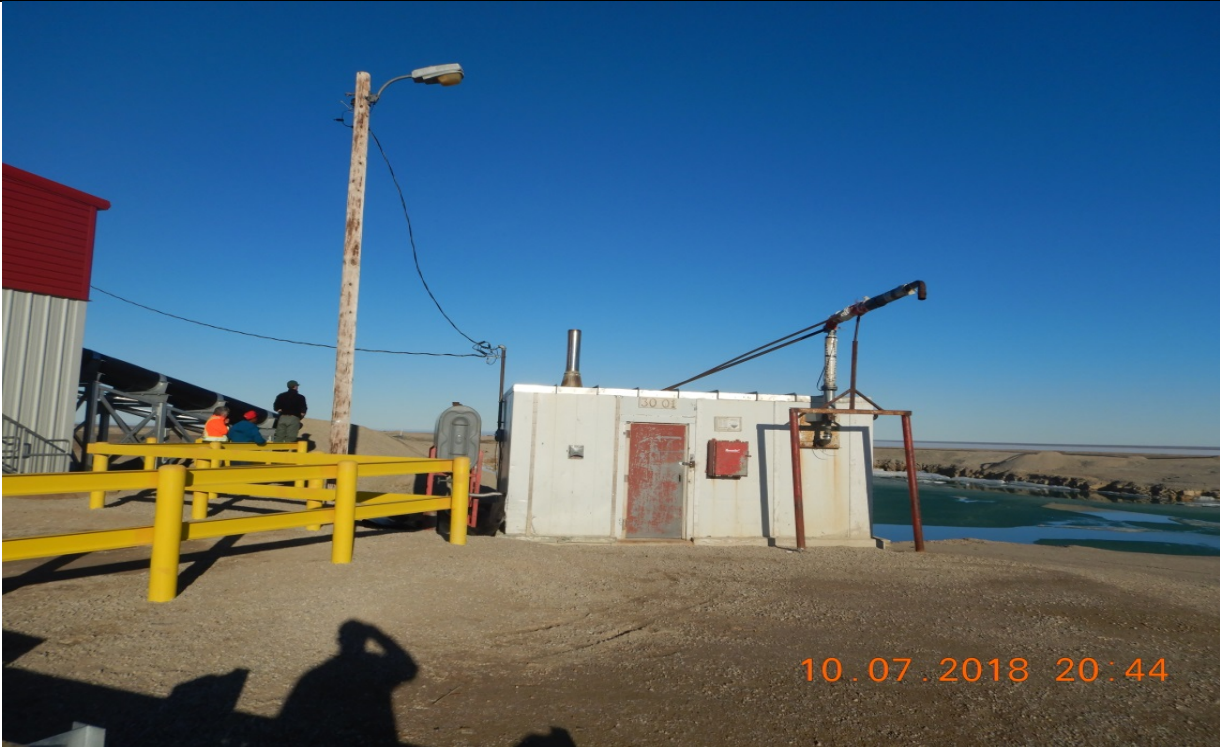
Photo 10

Description: Old Water Treatment Facility

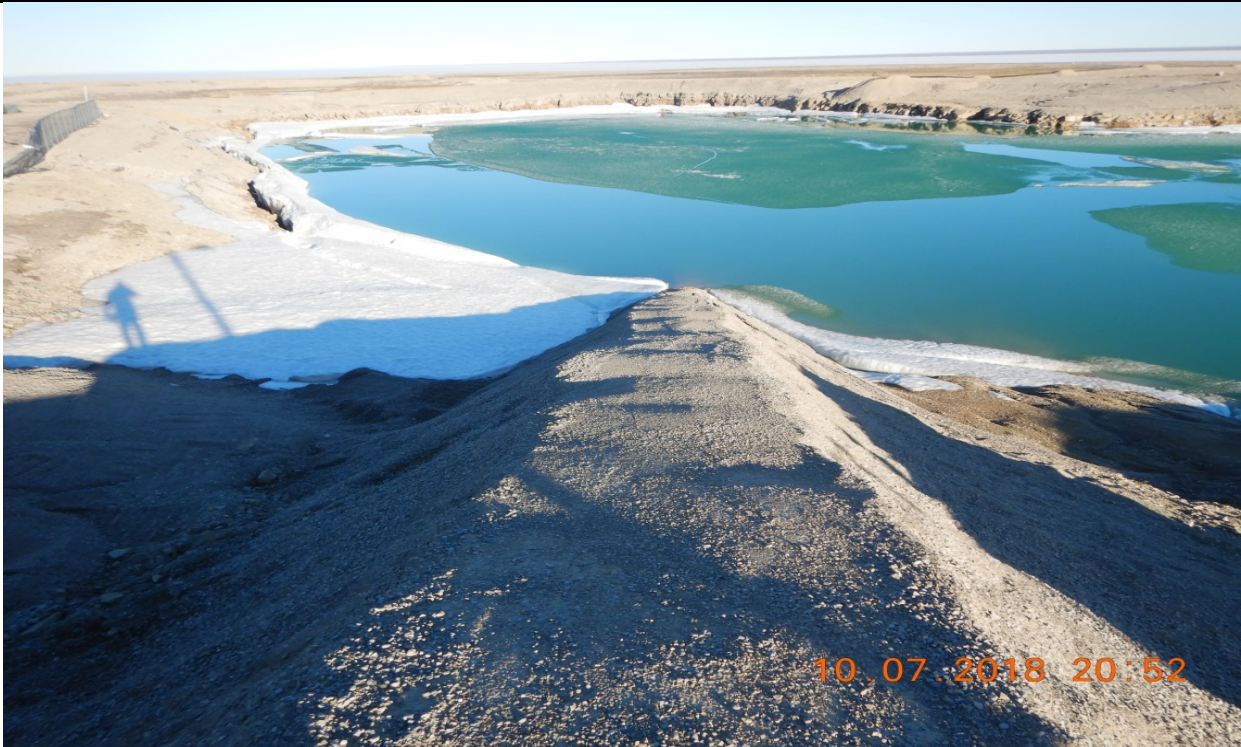
Photo 11

Description: Water Storage Reservoir

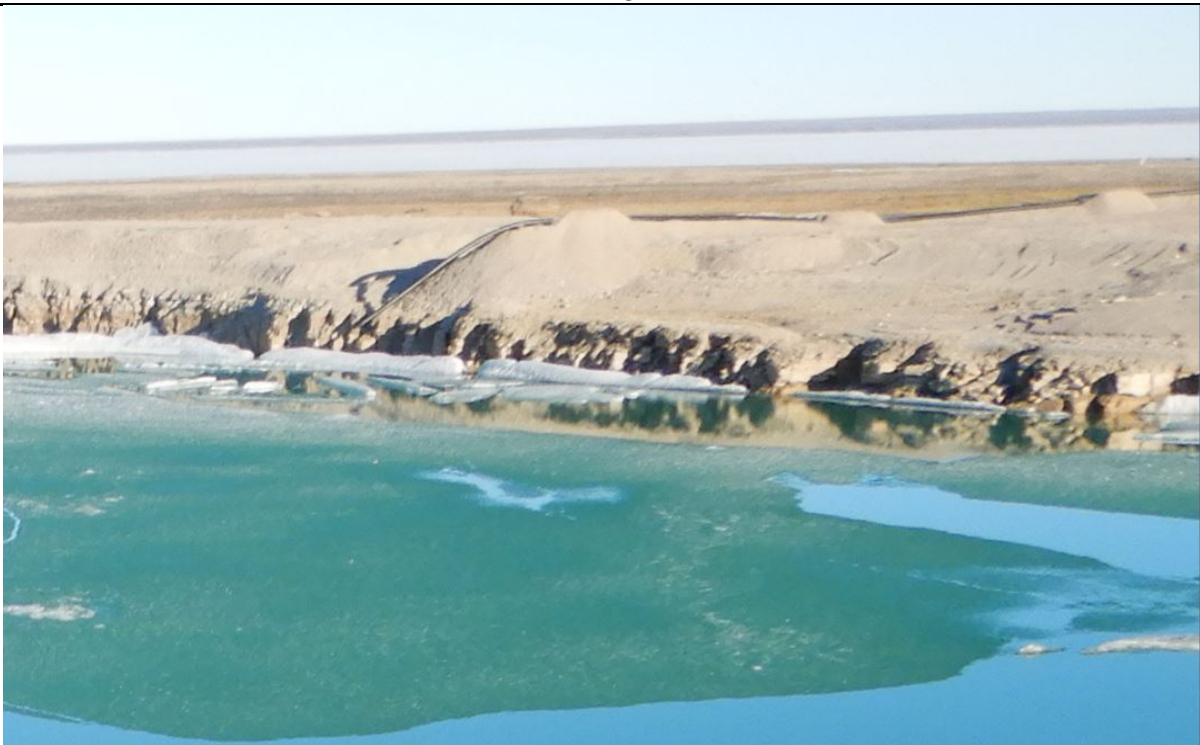
Photo Log #	Location
Photo 13	Igloolik

Description: Water Storage Reservoir

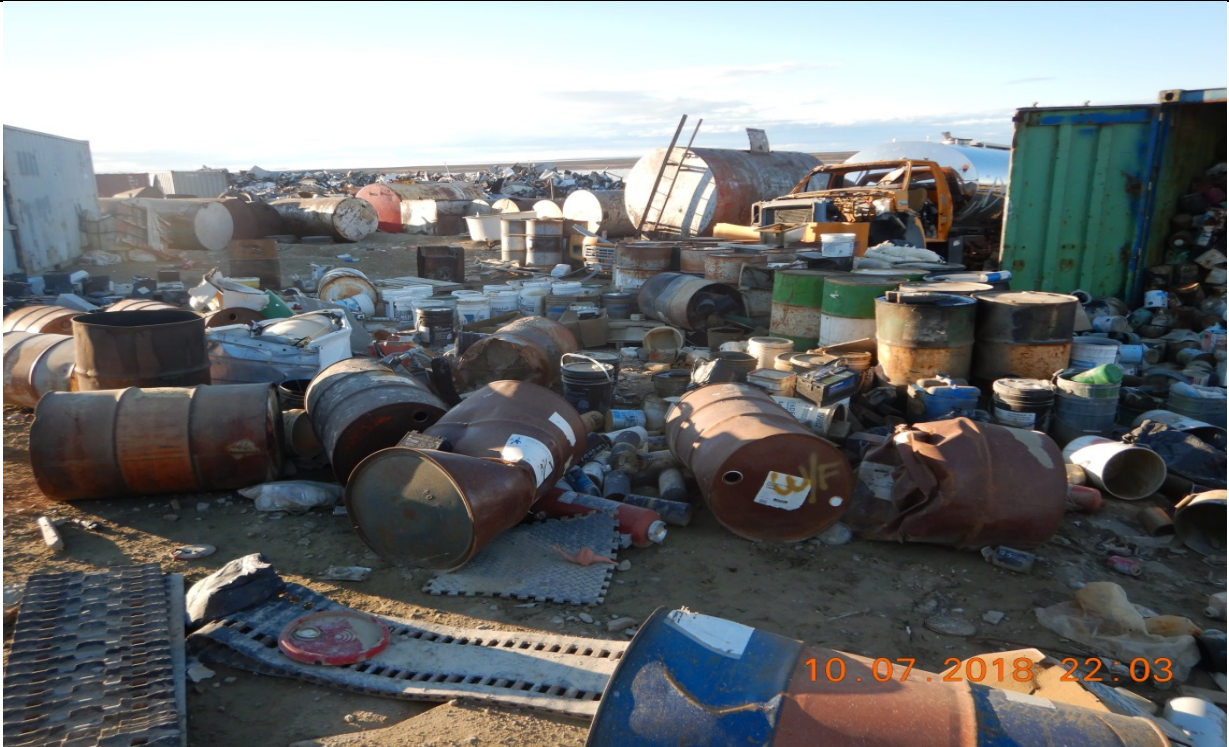
Photo 18

Description: Hazardous Waste Sea Can is full, and spilling out, waste oil drums, batteries, and paint lay out in the elements

-Consolidate all Hazardous Waste and store in such a way as to protect water from mixing with the hazardous waste.

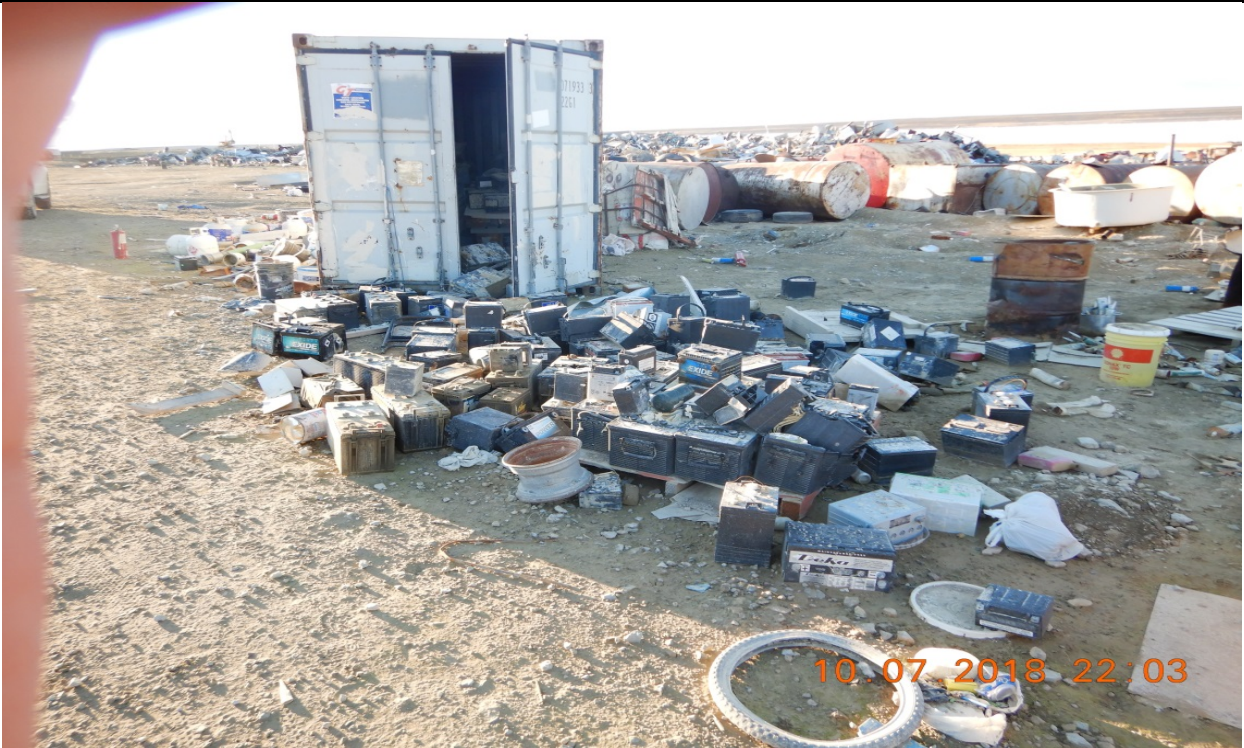
Photo 19

Description: Batteries lay outside exposed to the elements.

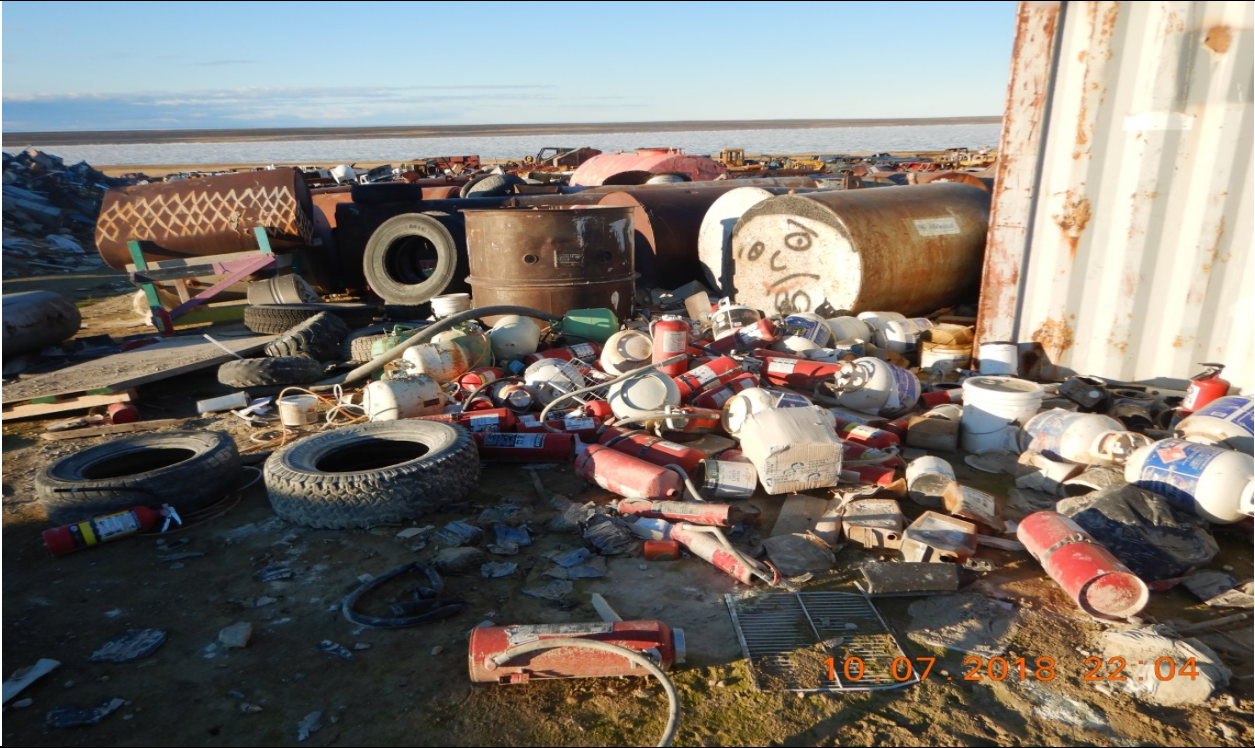
Photo 20

14. The Solid Waste Facility manages their waste by segregating the Bulk Metals, Woods, Open Pit Burning and Capping, and Hazardous Waste. The site doesn't have any fencing. One section of the Bulk Metal and Hazardous Waste section are merged together and not segregated.
15. Open Pit Burning at the Solid Waste Facility has no fencing. Does not appear to do any capping of the ash, but has created a berm using a mix of gravel and the ash from the burning of garbage. (Photo's 15 &16).
16. Hazardous Waste Facility has a couple of sea cans, full, open, and numerous amounts of hazardous waste such as batteries, paint cans, waste oil drums exposed to the elements laying across the landscape outside. (Photo's 17, 18, & 19). Bulk Metal Storage Facility (Photo's 20 &21).
17. Bulk Wood Storage (Photo 22).
18. Hazardous Waste and contaminated soil in contact with Fresh Water (Photo 23).

Description: Bulk Metal Waste merged with Hazardous Waste. The sea can provides separation.

-Segregate the Bulk Metals, and Hazardous Waste.

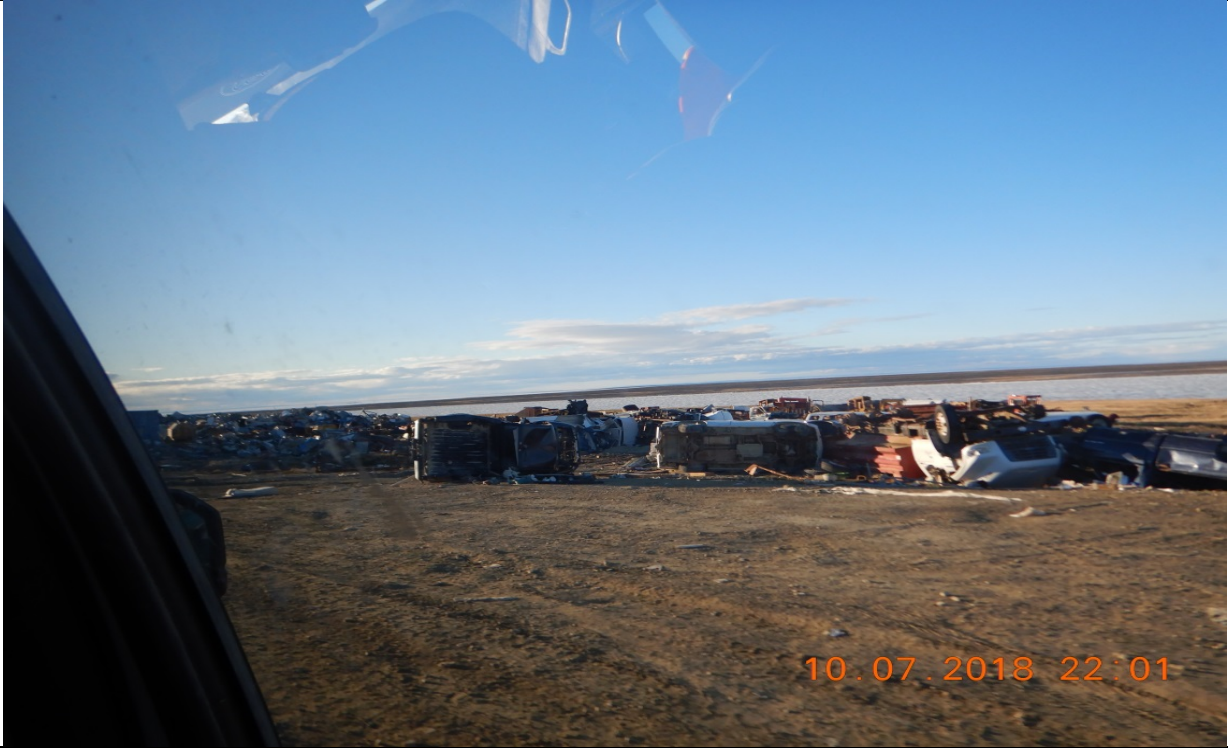
Photo 21

Description: Bulk Metal Waste merged with Hazardous Waste. Hazardous Waste observed throughout the area.

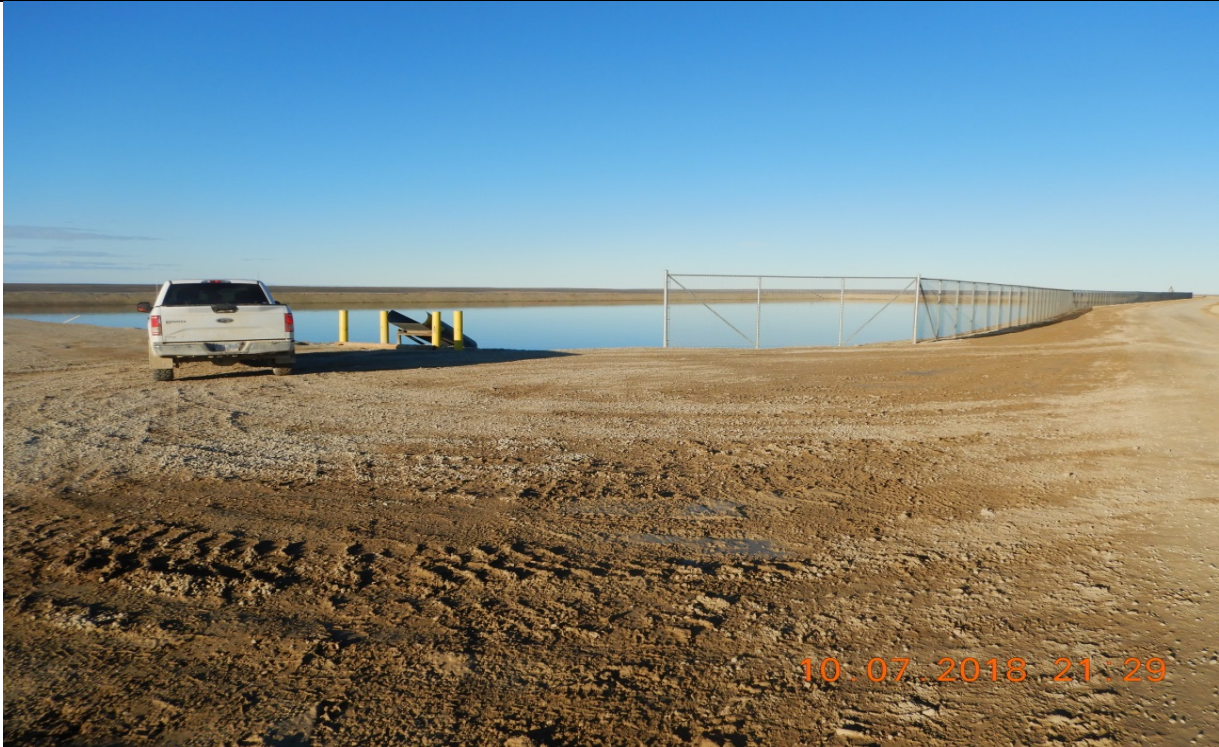
Photo 25

19. The Sewage Disposal Facility is a 4 cell facility, Cells 1, 2, & 3 each have an HDPE Liner. Fencing appears to be in good condition (Photo 25).
20. Freeboard 3-4 metres, spill way, and fencing appear to be in good condition (Photo 25).
21. Newly built sewage lagoon (Photo 26).
22. On October 3, a telephone notification from the Igloolik foreman of a decant that would be occurring over the long weekend. WRO Monteith requested that in future all decant notification be notified by way of email. 10 days in advance of decant as required by the license.
23. On October 25, 2018 William Toonoo, Municipal Technical Clerk, GN-CGS emailed WRO Monteith a copy of Igloolik's "Delivery Summary by Month and Year". Showing a total of 40,810,960 Litres delivered between the

Description: Fencing newly installed, discharge point at West side of Sewage Lagoon cells.

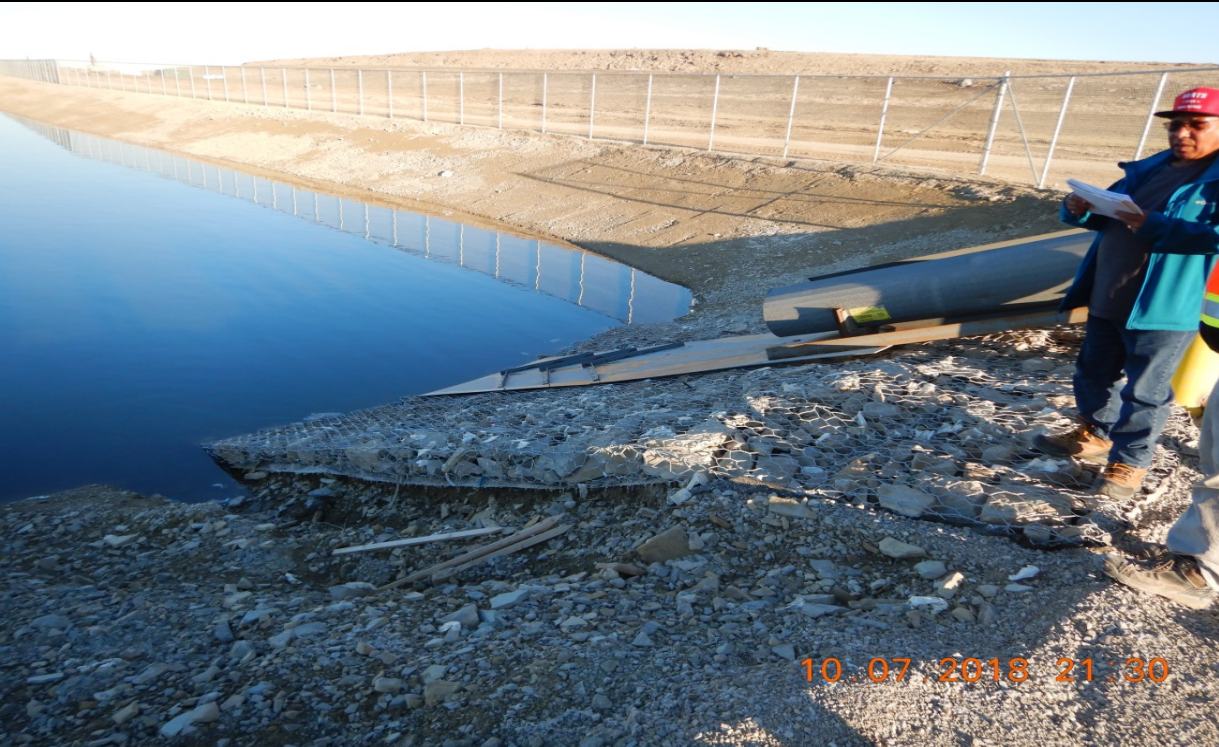
Description: Spill way into lagoon, free board is more than 1 metre.

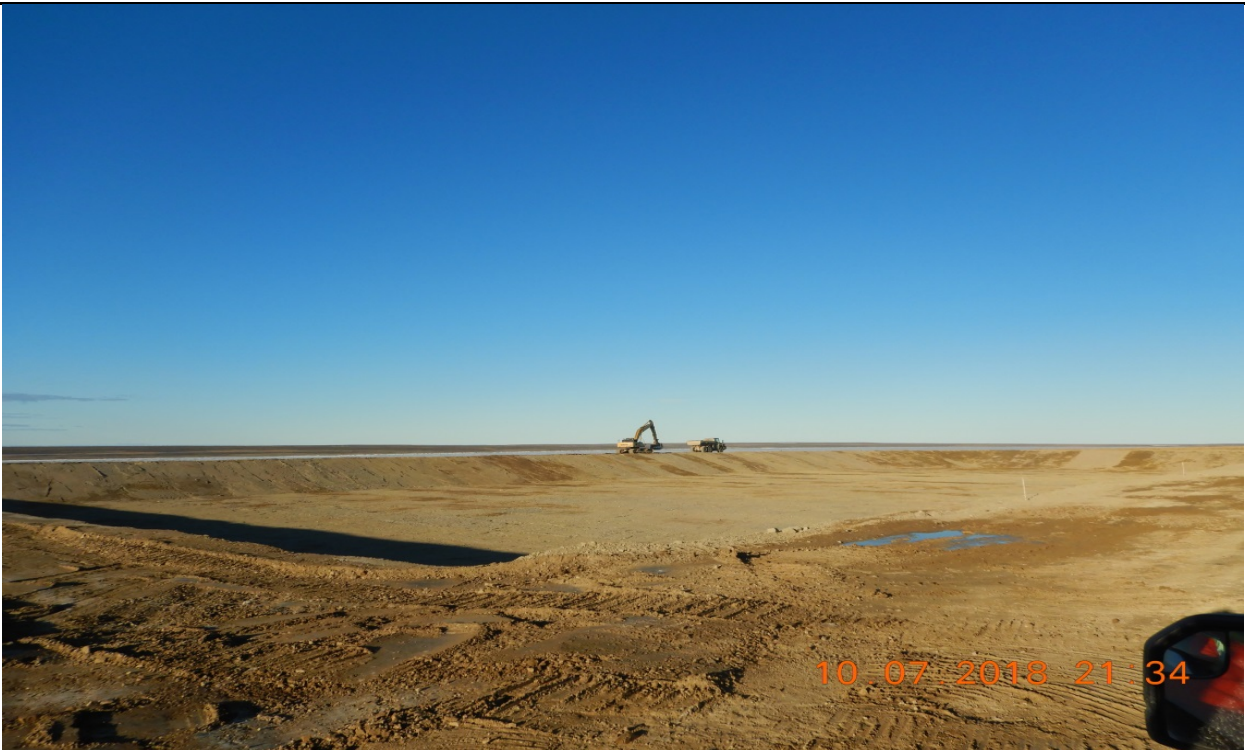
Photo 26

Description: Newly constructed sewage lagoon

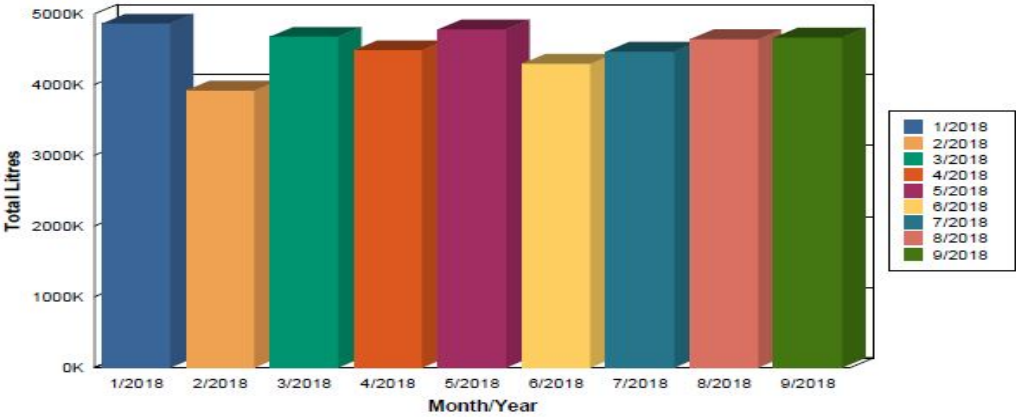
Photo 27

months of January to September 2018. This figure should represent the amount discharged into the Sewage Disposal Facility (see photo 26). The document in photo 27, also details out how the water consumption rates is also what is discharged. (Photo 27).

Description: Water Consumption Report Titled Delivery Summary By Month and Year. 40810960.00 Litres between January and September 2018.

-Articulate how you calculate water consumption
