WATER LICENCE INSPECTION FORM

Licensee	Licensee Representative
Hamlet of Igloolik	Bhabesh Roy
Licence No. / Expiry	Representative's Title
3BM-ILG1520	Municipal Engineer
Land / Other Authorizations	Land / Other Authorizations
Date of Inspection	Inspector
September 16, 2019	Joseph Monteith
Activities Inspected	
<div><input type="checkbox"/> Camp<input type="checkbox"/> Drilling<input type="checkbox"/> Mining<input type="checkbox"/> Construction<input type="checkbox"/> Reclamation<input type="checkbox"/> Fuel Storage</div> <div><input type="checkbox"/> Roads/Hauling<input checked="" type="checkbox"/> Other: Potable Water Source, Solid Waste Facility, Sewage Disposal Facility<input type="checkbox"/> Other:</div>

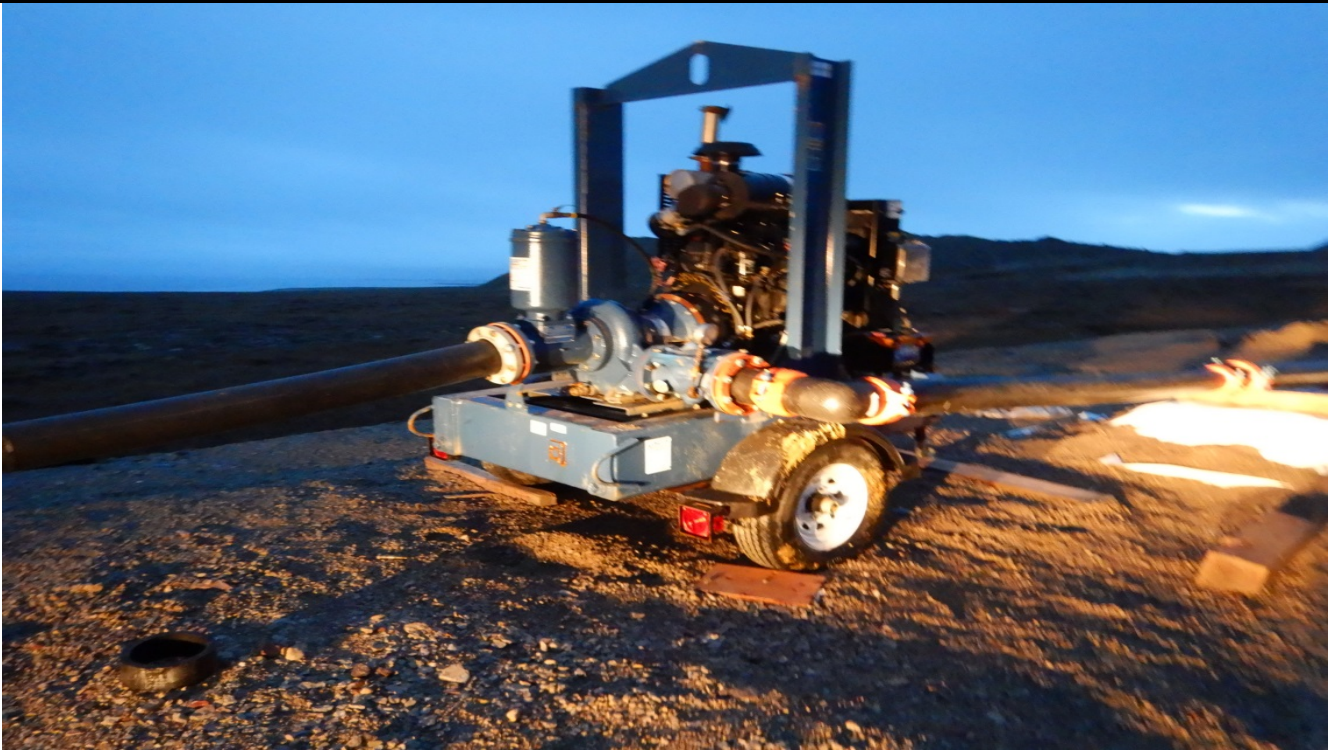
Photo Log #	Location
Photo 3	Igloolik

Description: mobile water pump, connects half way from water source to water reservoir to aid in the recharging of the water reservoir. A berm was installed to house the fuel tank when operating.

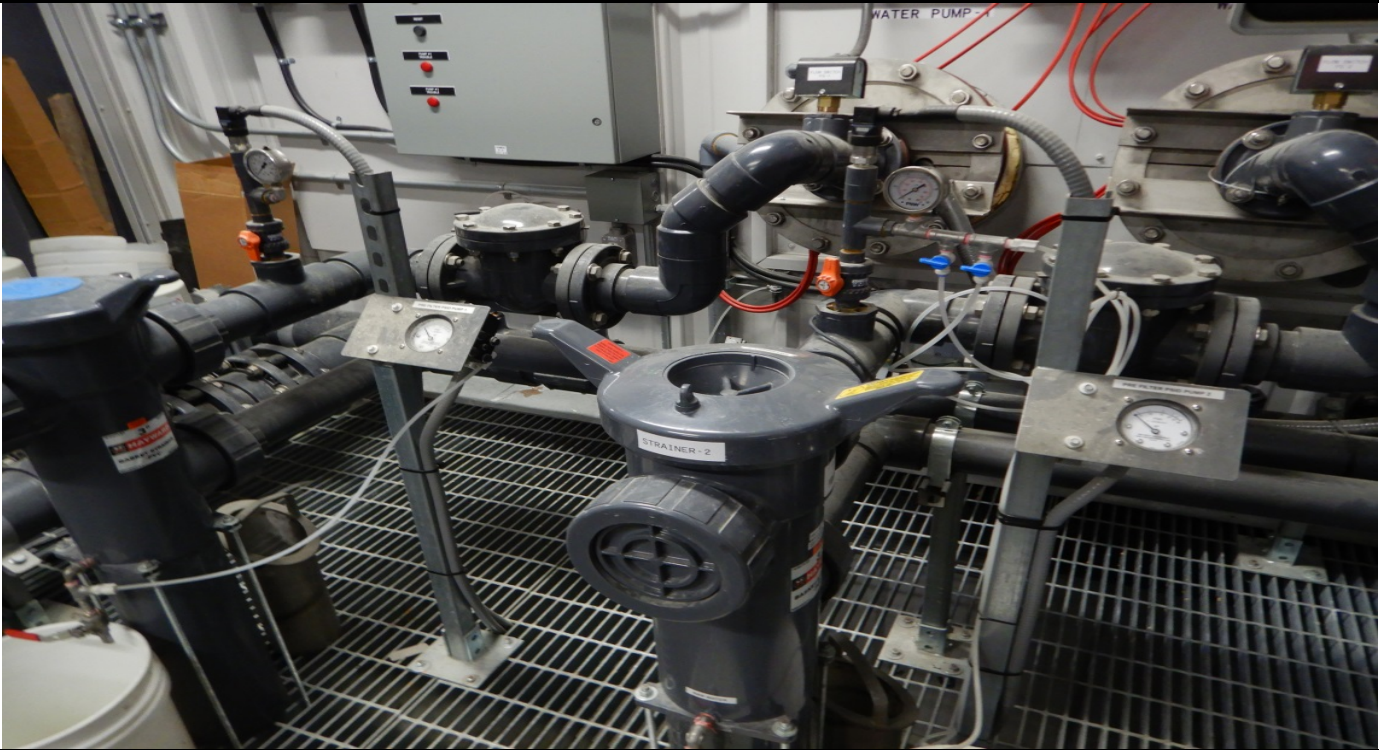
Photo 7

Description: 2x intake pipes entry into water treatment facility. 2 x Pre filter strainer

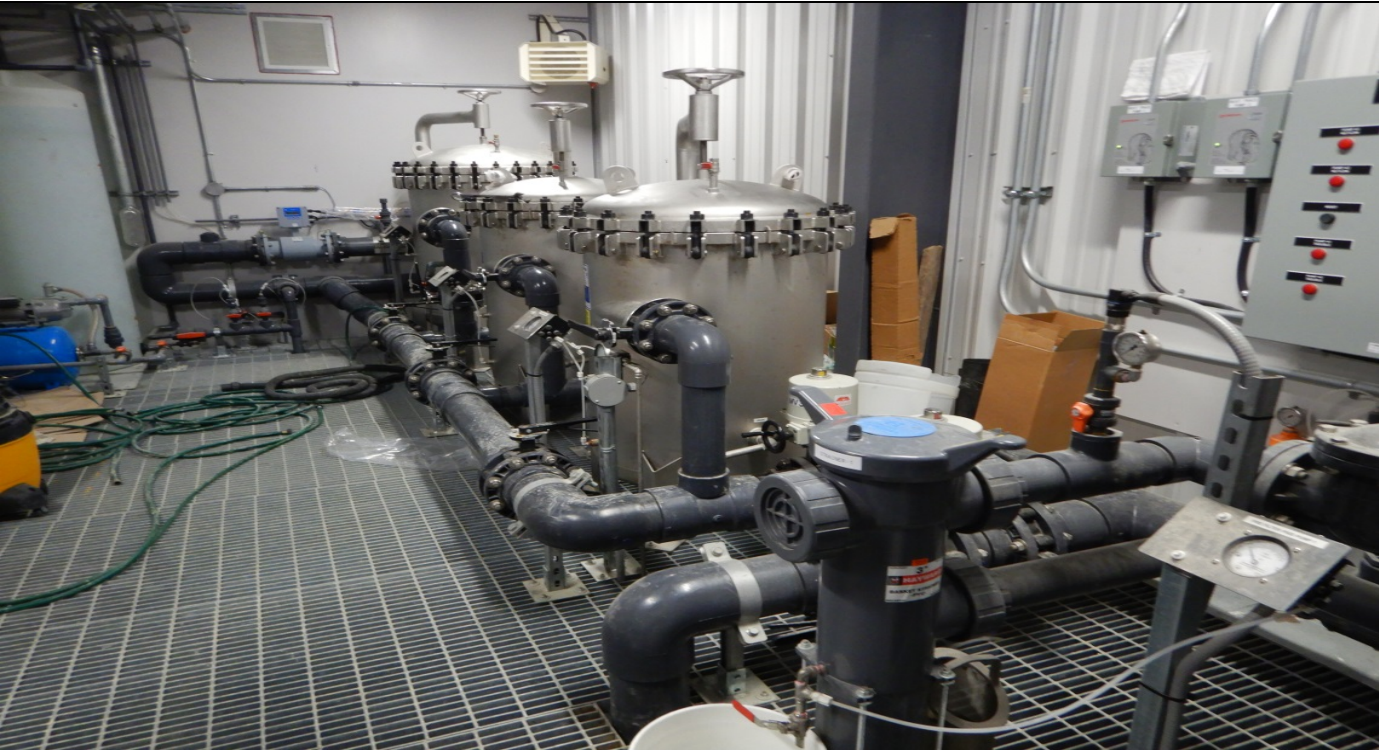
Photo 8

Description: 3 x water filters

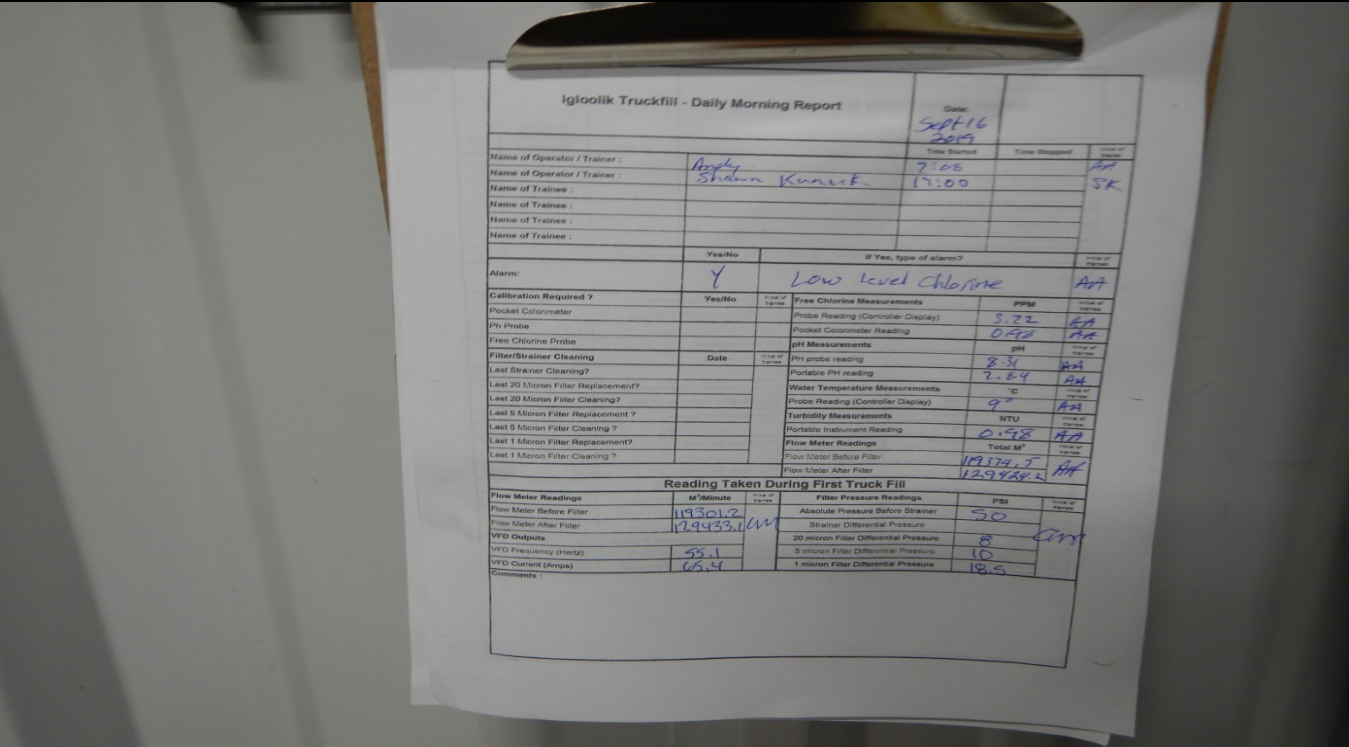
Photo Log #	Location
Photo 9	Igloolik

Description: Water meter recording listed in Igloolik – Daily Morning Report. Reads Before Filter: 119301.2m³ and 129433.1m³ after filter during first truck fill. Another set of flow meter readings shows before filter reading of 119374.5m³ before filter and 129424.2m³.

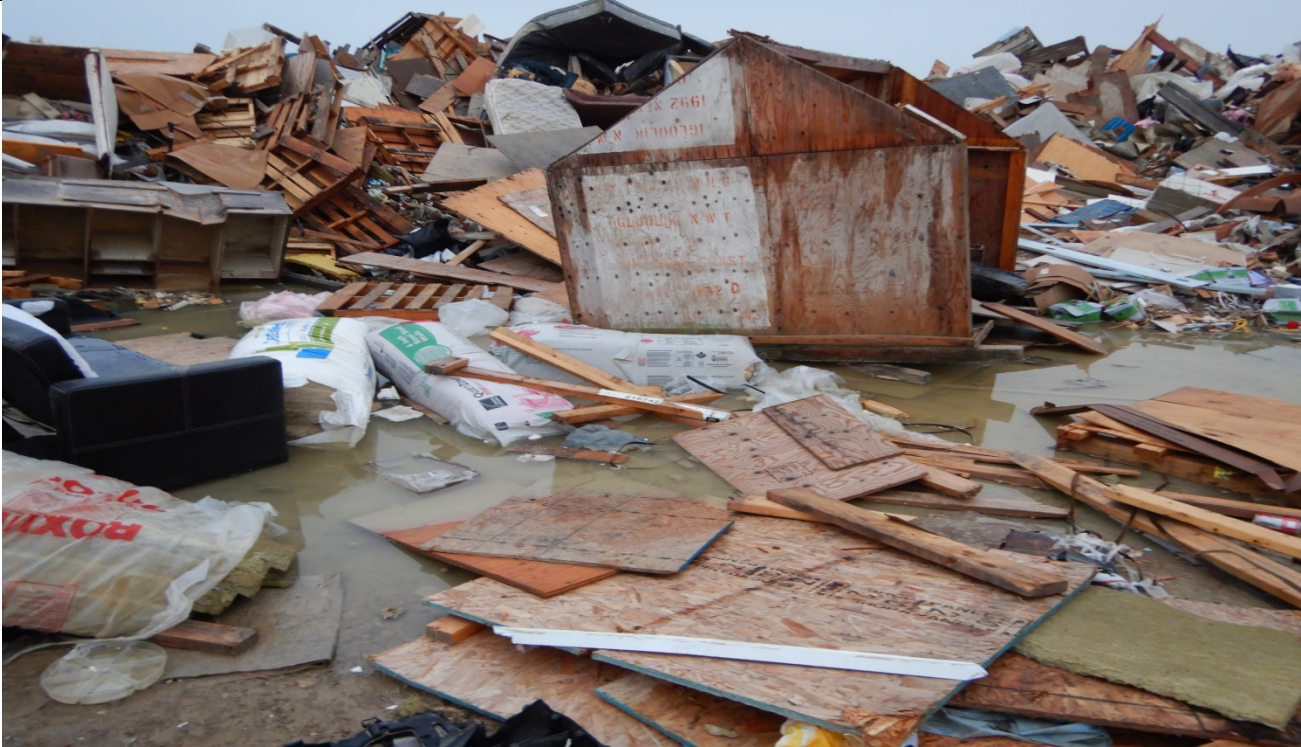
Photo Log #	Location
Photo 17	Igloolik

Description: Mixing of solid waste and accumulated water within the solid waste facility.

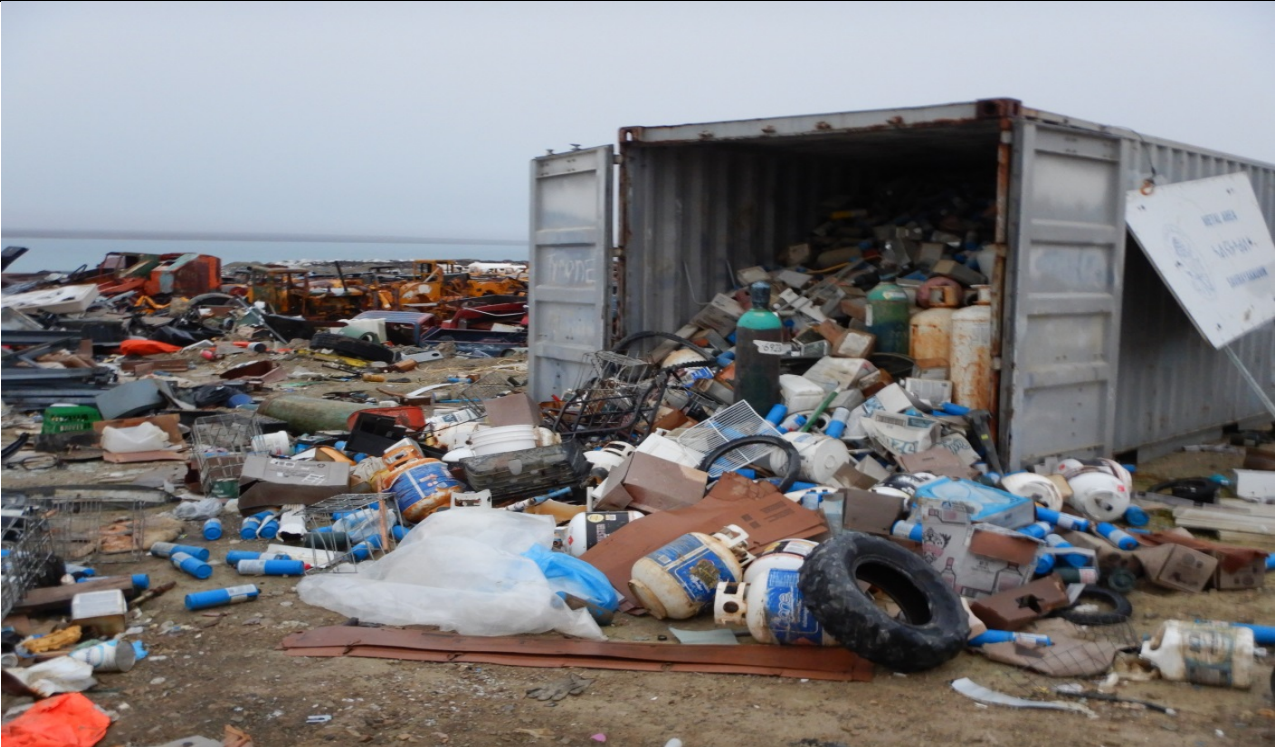
Photo Log #	Location
Photo 22	Igloolik

Description: Bulk Metal Seacan #4: with empty propane tanks overflowing. This seacan starts the merge from hazardous waste to bulk metal.

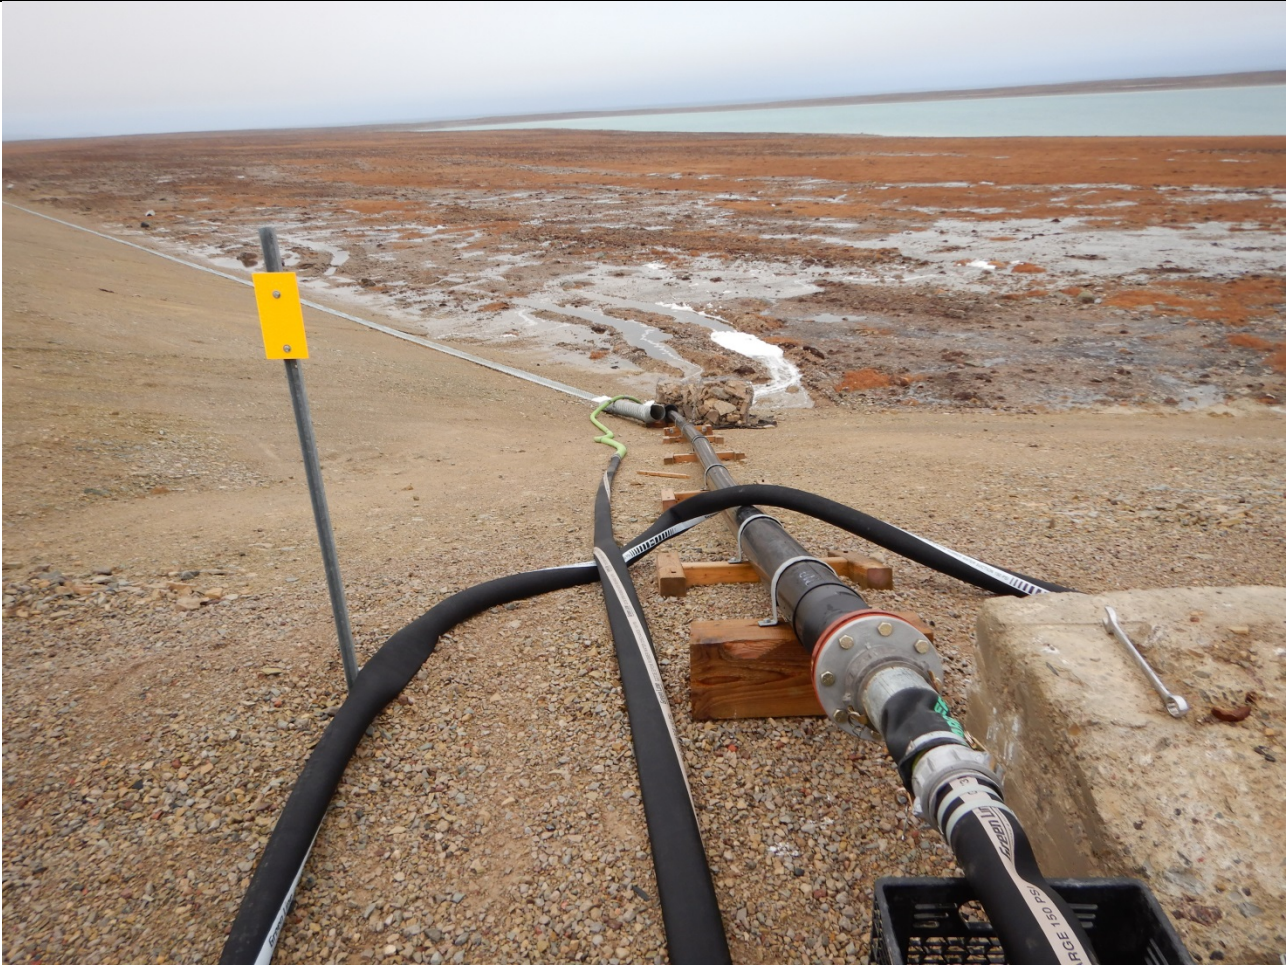
Photo 27

Discharge Location. Half culvert diverting some of the discharge along the intended route. Most of the discharge goes directly to the receiving environment. What goes along the half culvert also leaks out and washes out the base of the sewage reservoir.

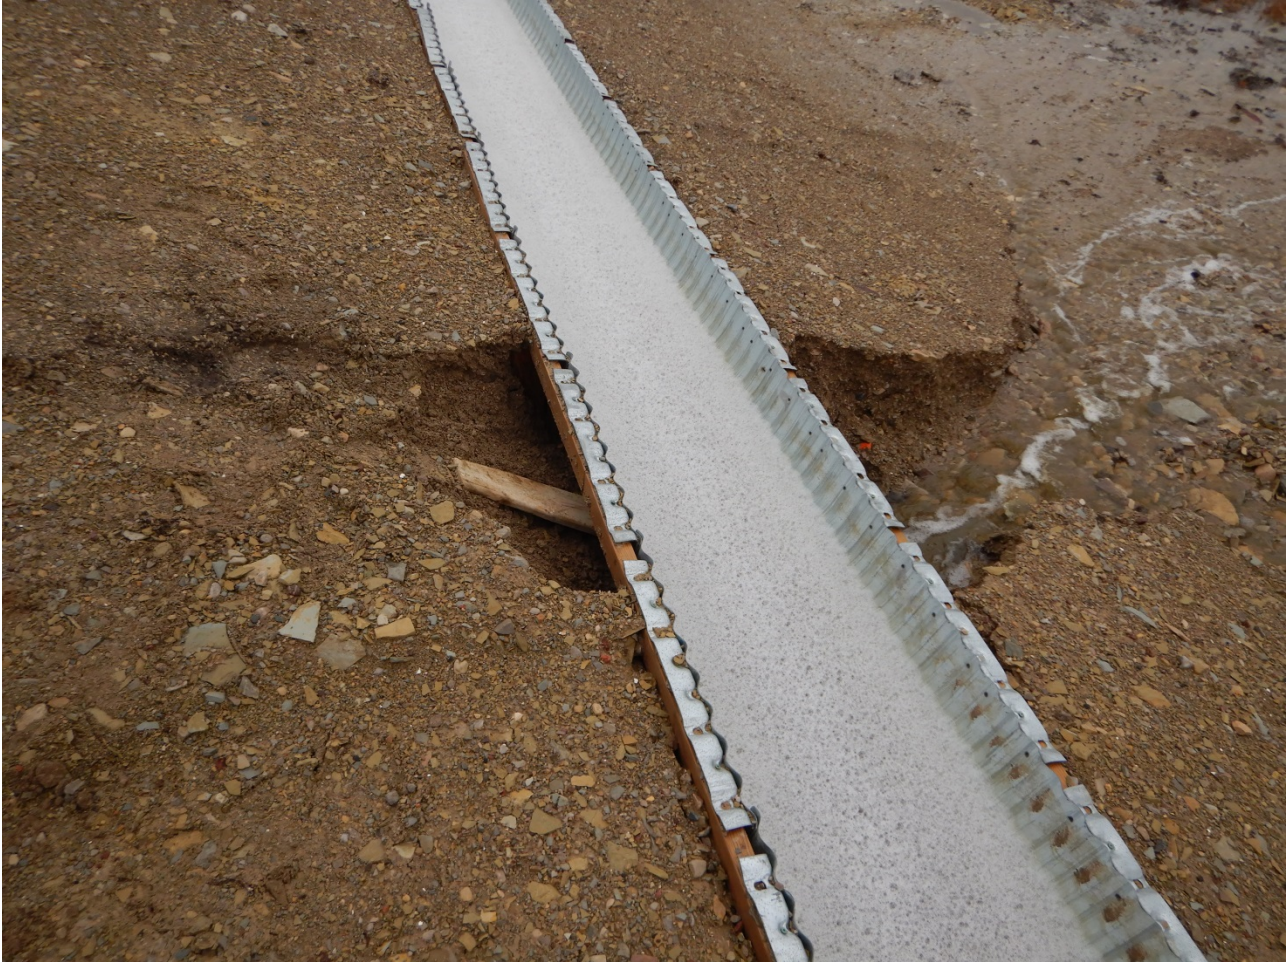
Photo 28

Discharge Location. Half culvert diverting some of the discharge along the intended route. What goes along the half culvert also leaks out and washes out the base of the sewage reservoir.

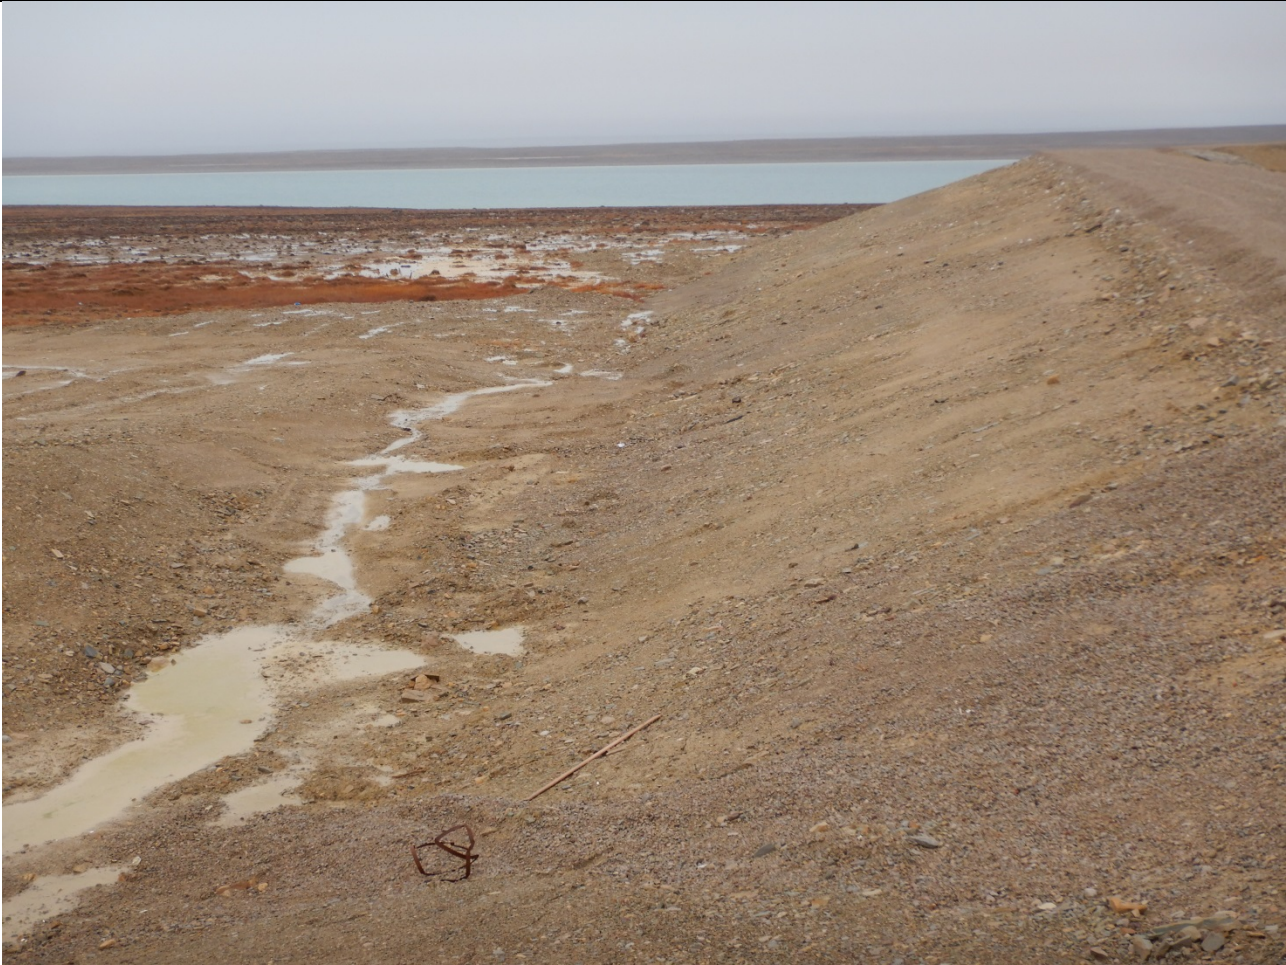
Photo 29

Cell #1 Outer wall of Cell 1 appears to have some minor wheeping.

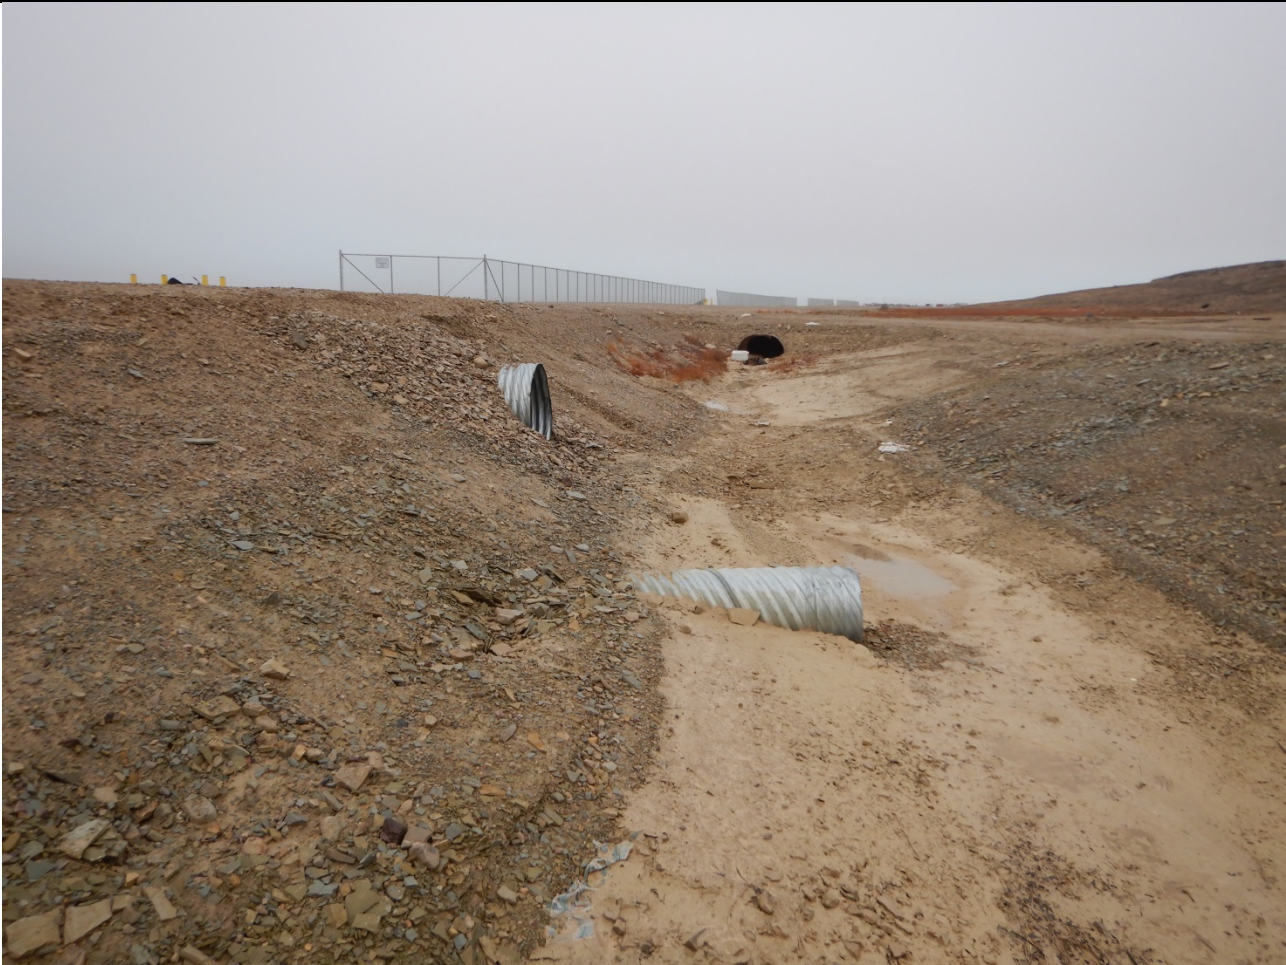
Photo 30

A new Culvert installed to stop the build up of water due to a frozen culvert. Installed spring 2019. The drainage basin appears to be operating as intended.
