WATER LICENCE INSPECTION FORM

Licensee	Licensee Representative
Hamlet of Igloolik	Bhabesh Roy
Licence No. / Expiry	Representative's Title
3BM-ILG1520	Municipal Engineer
Land / Other Authorizations	Land / Other Authorizations
Date of Inspection	Inspector
August 12, 2020	Joseph Monteith
Activities Inspected	
<div><input type="checkbox"/> Camp<input type="checkbox"/> Drilling<input type="checkbox"/> Mining<input type="checkbox"/> Construction<input type="checkbox"/> Reclamation<input type="checkbox"/> Fuel Storage</div> <div><input type="checkbox"/> Roads/Hauling<input checked="" type="checkbox"/> Other: Potable Water Source, Solid Waste Facility, Sewage Disposal Facility<input type="checkbox"/> Other:</div>

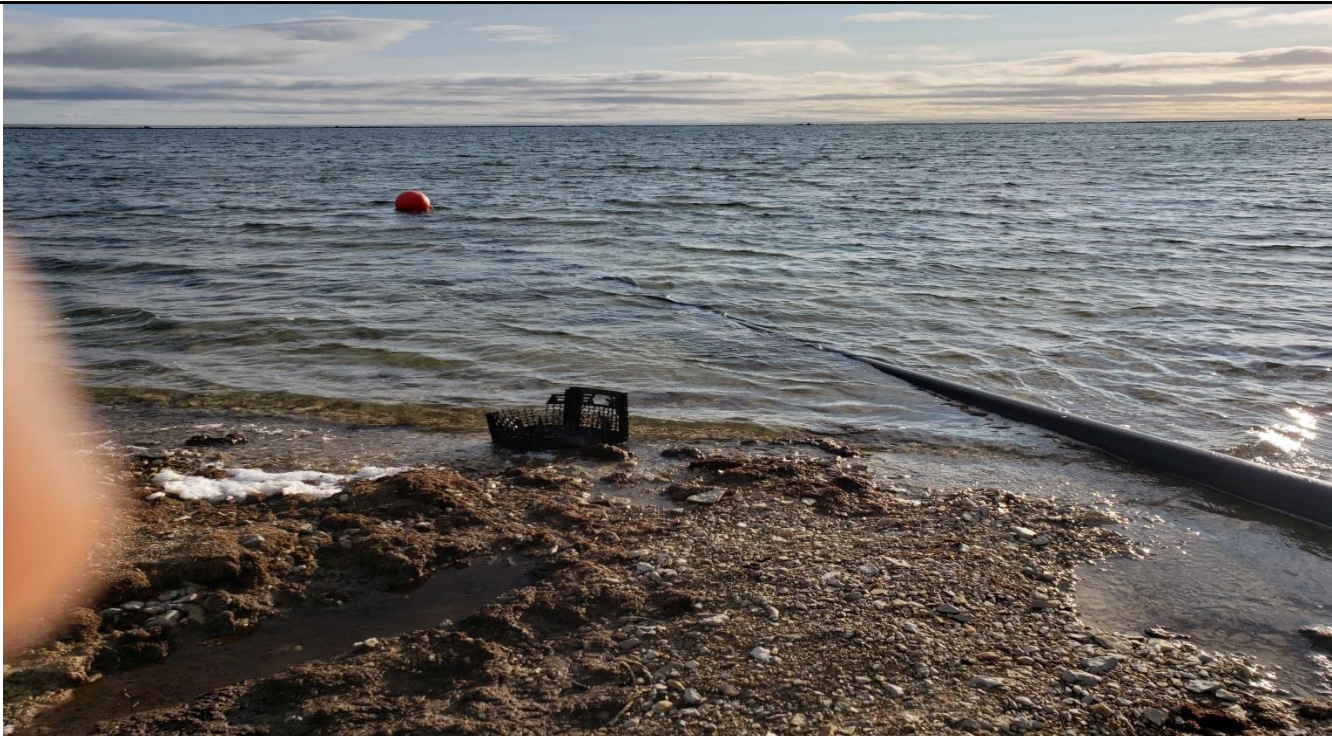
Photo 2

Description: South Lake Water Source. Water pump pipe end submerged held up by buoy. No indication of fish mesh screen.

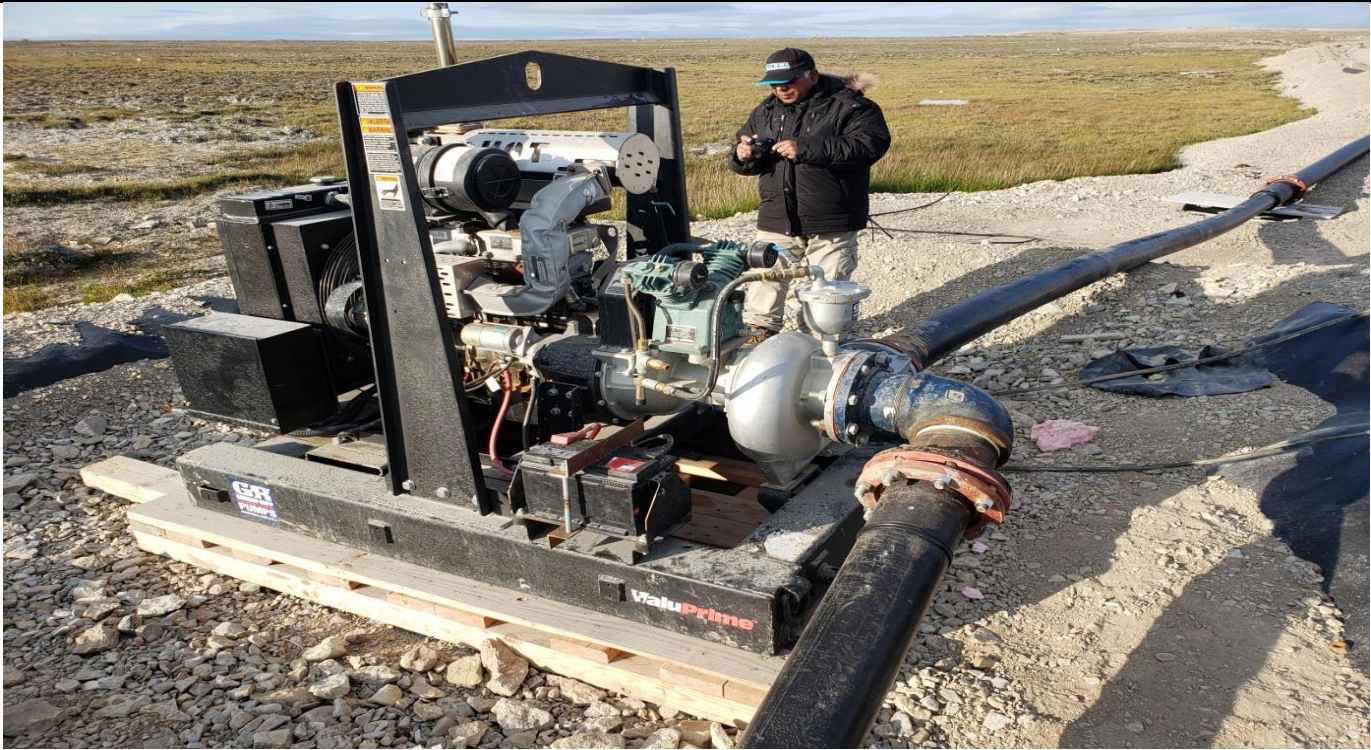
Description: Water pump connected to recharge intake pipe, and pushes water uphill to a second water pump(mobile which pushes the water to the reservoir.

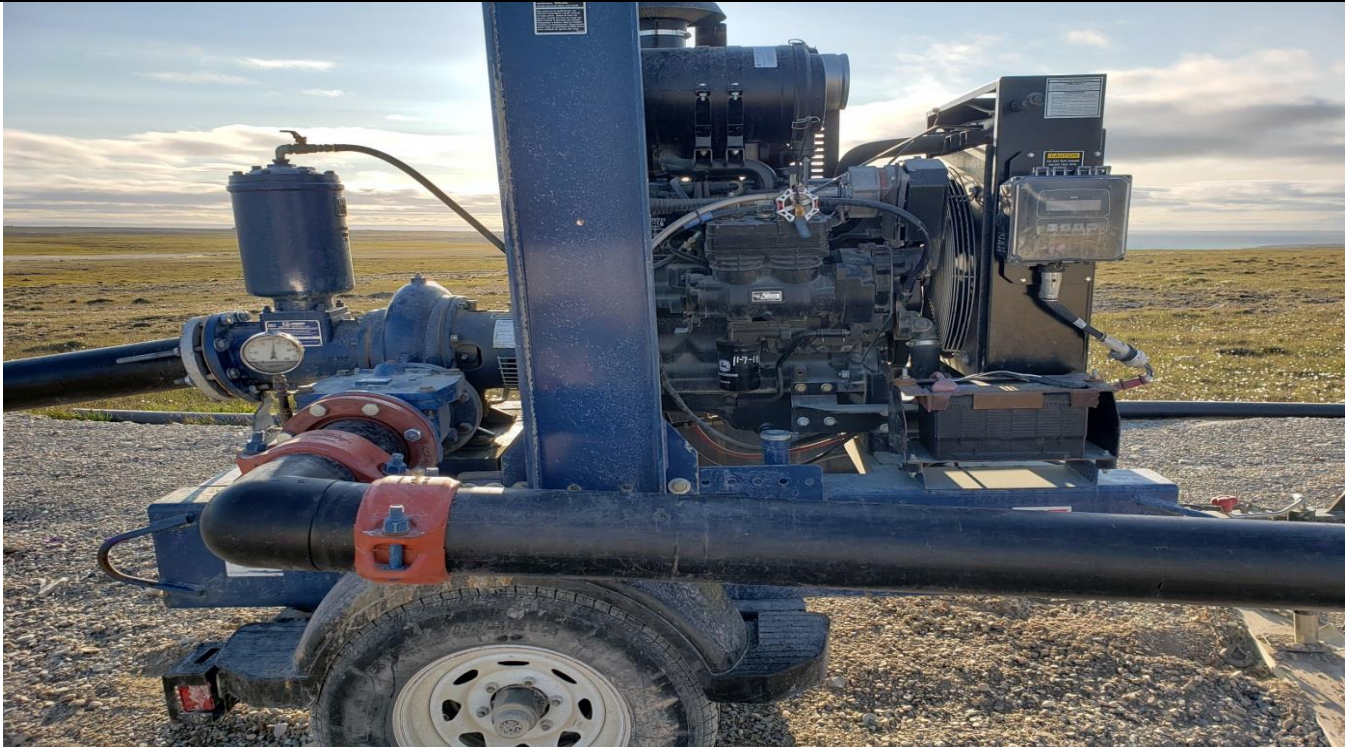
Photo 3

Description: Second water pump (mobile), connects half way from water source to water reservoir to aid in the recharging of the water reservoir. A berm was installed to house the fuel tank when operating.

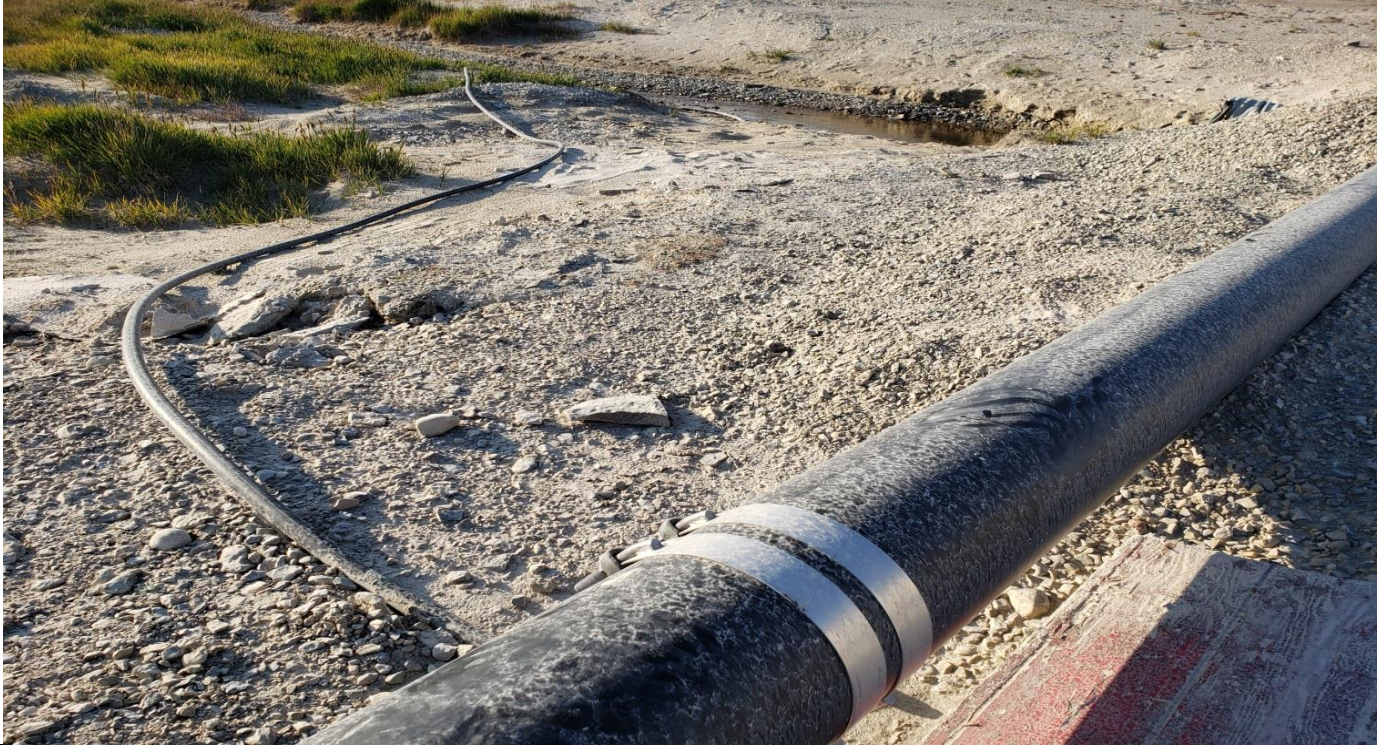
Photo 4

Description: The bypass hose installed at the low point, to bleed out any still water from freezing when not in use. GPS Coordinates: Latitude 69° 21.248'N, Longitude 81° 50.439'W.

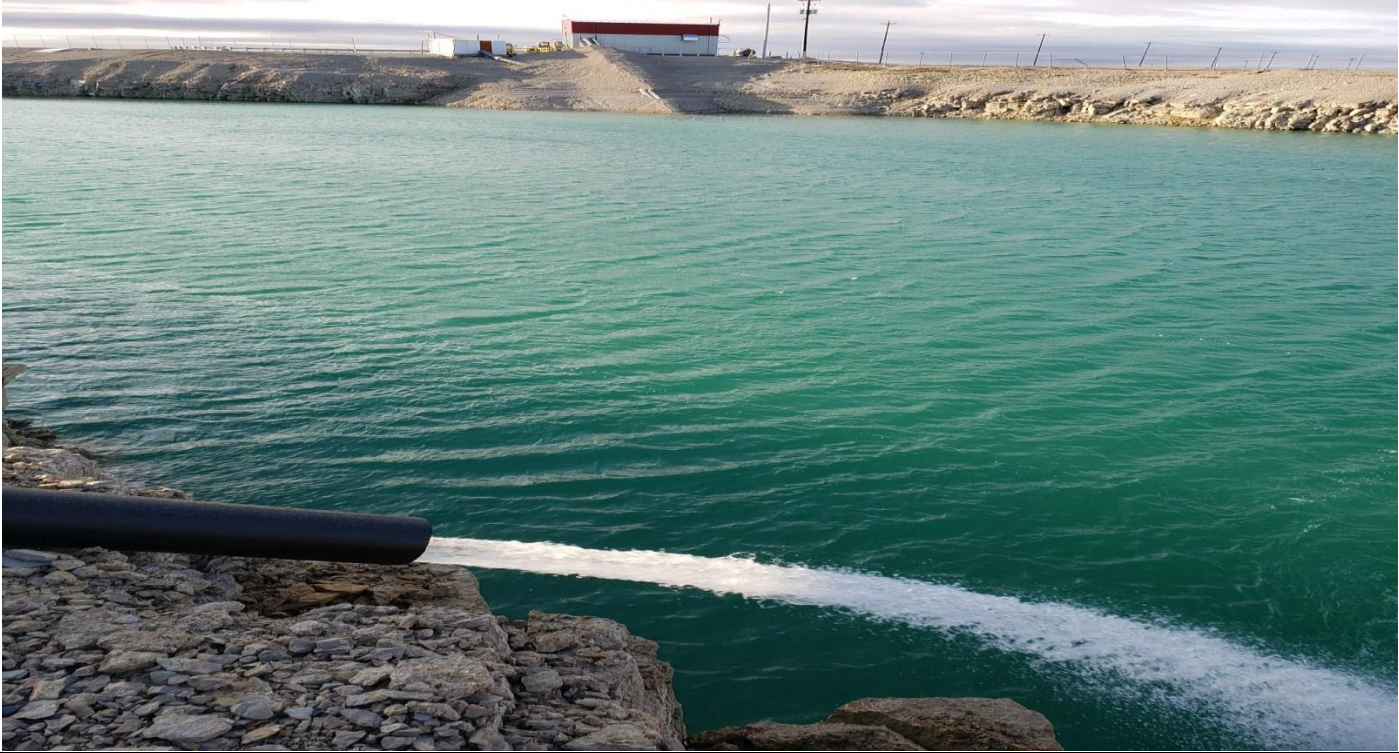
Photo Log #	Location
Photo 5	Igloolik Water Reservoir , Qikiqtani Region, Nunavut

Description: Water Reservoir, recharge pipe in the foreground. Old pump house (left) in the background, decommissioned, but still operational in case of emergency. New Water Treatment/Pump Station/(right).

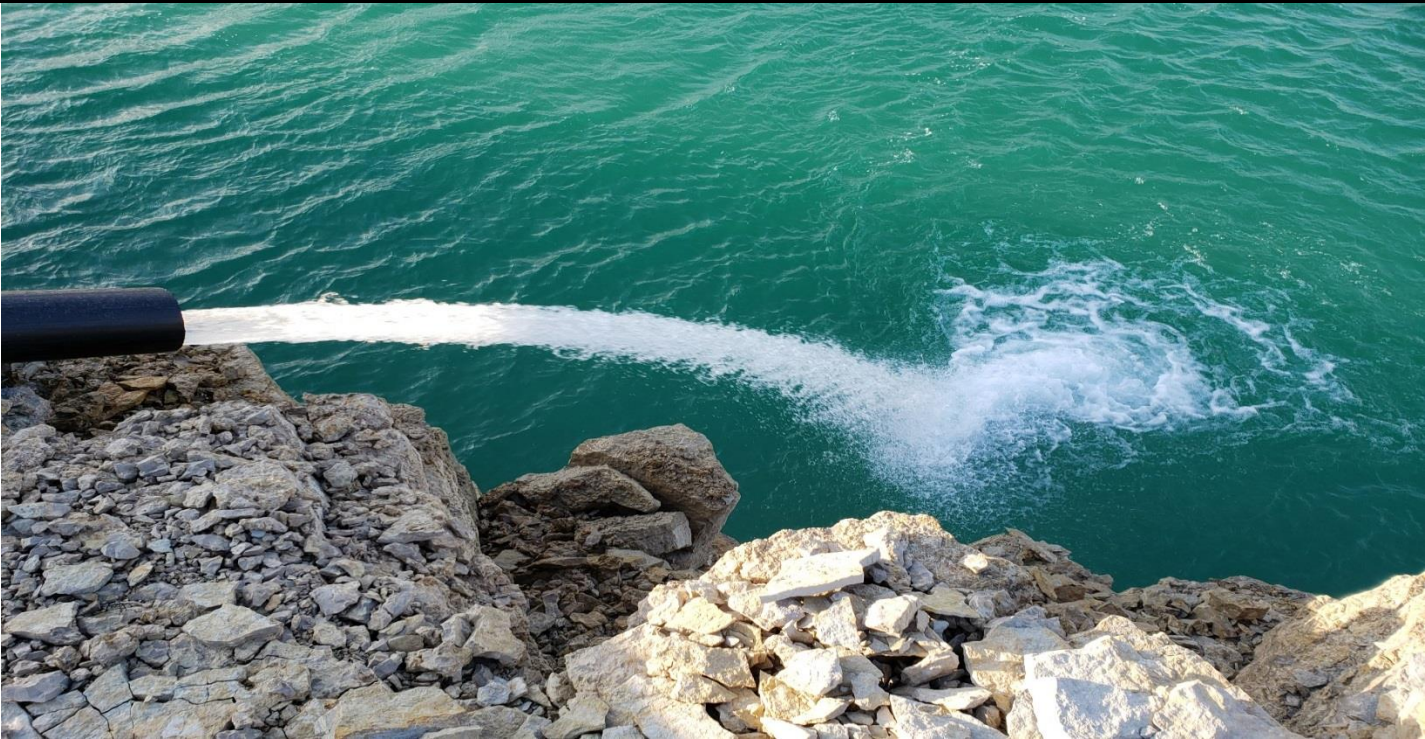
Photo Log #	Location
Photo 6	Igloolik Water Reservoir , Qikiqtani Region, Nunavut

- 11. The Water Storage Reservoir goes to a depth of 10 metres, and can contain a total of 100,000 cubic metres of freshwater (See photo 11). Concerns have been raised by the hamlet council in regards to the water quality. They suspect that the high turbidity is a result of high water pressure, and high drop from the pipes.

Description: High Water Pressure during the recharge of the Igloolik Water Reservoir is suspected by the hamlet of causing high turbidity.

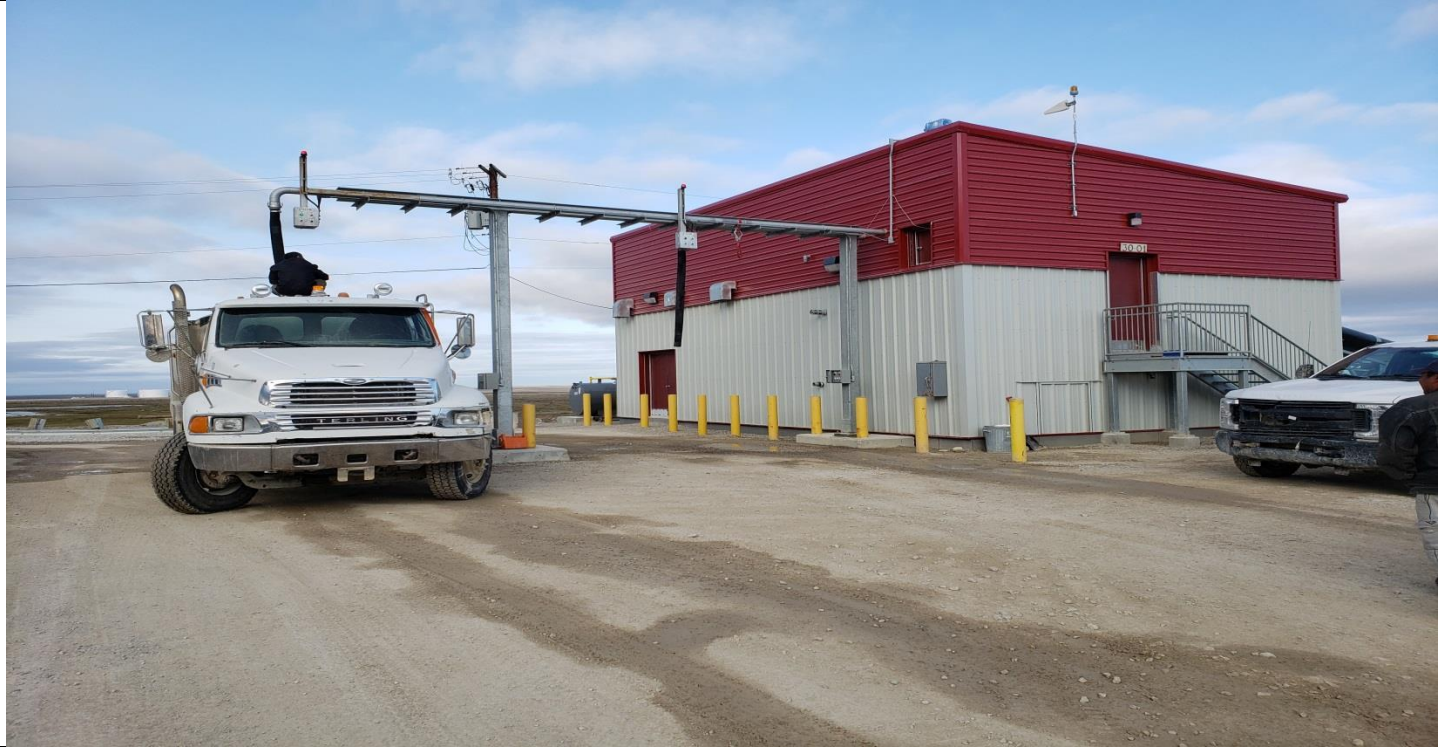
Photo 7

Description: Truck Refill station, and Water Treatment Facility. Truck being refilled at the time of inspection.

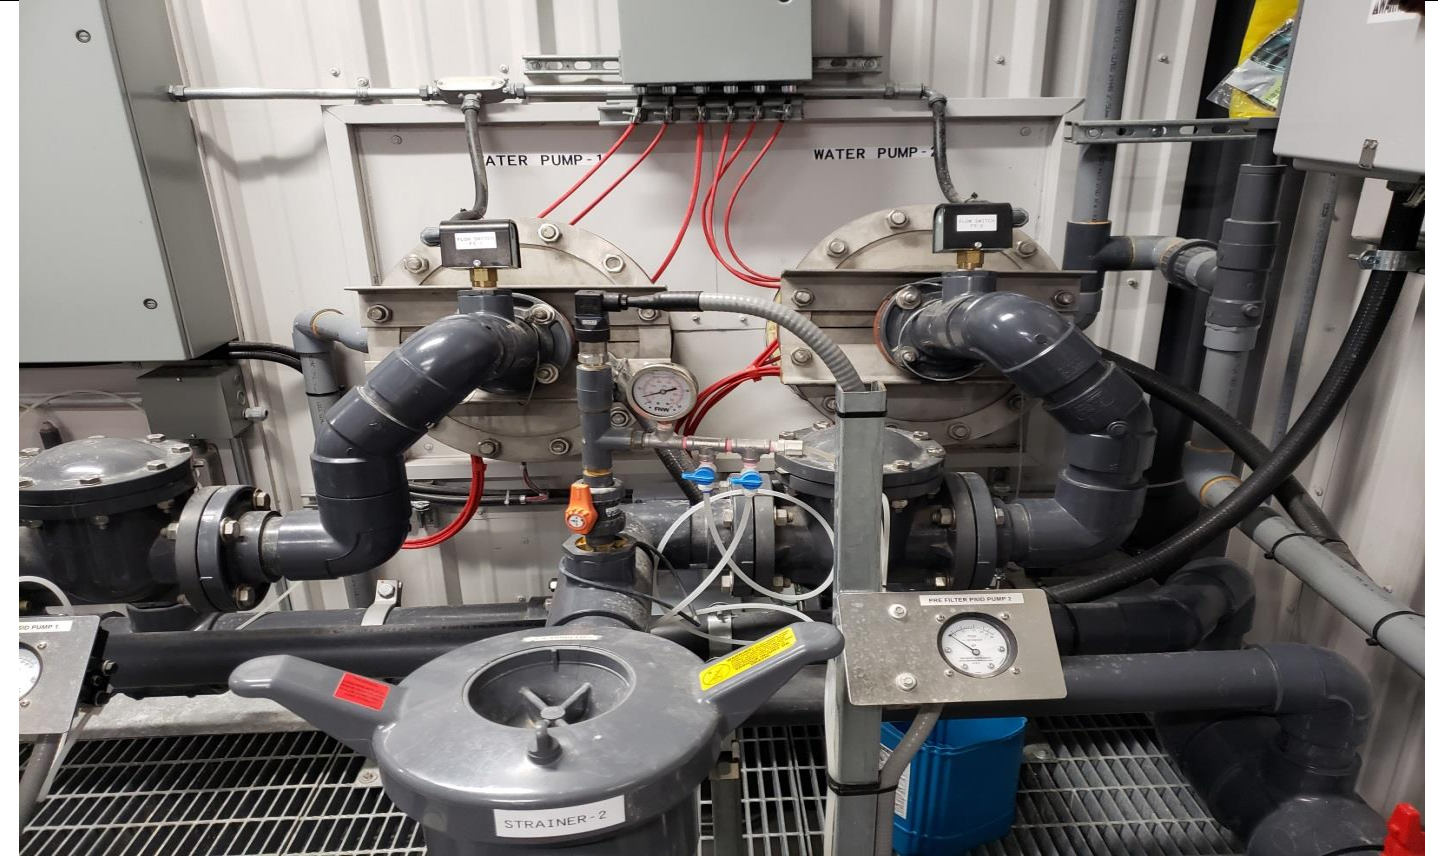
Photo 8

Description: 2x intake pipes entry into water treatment facility. 2 x Pre filter strainer

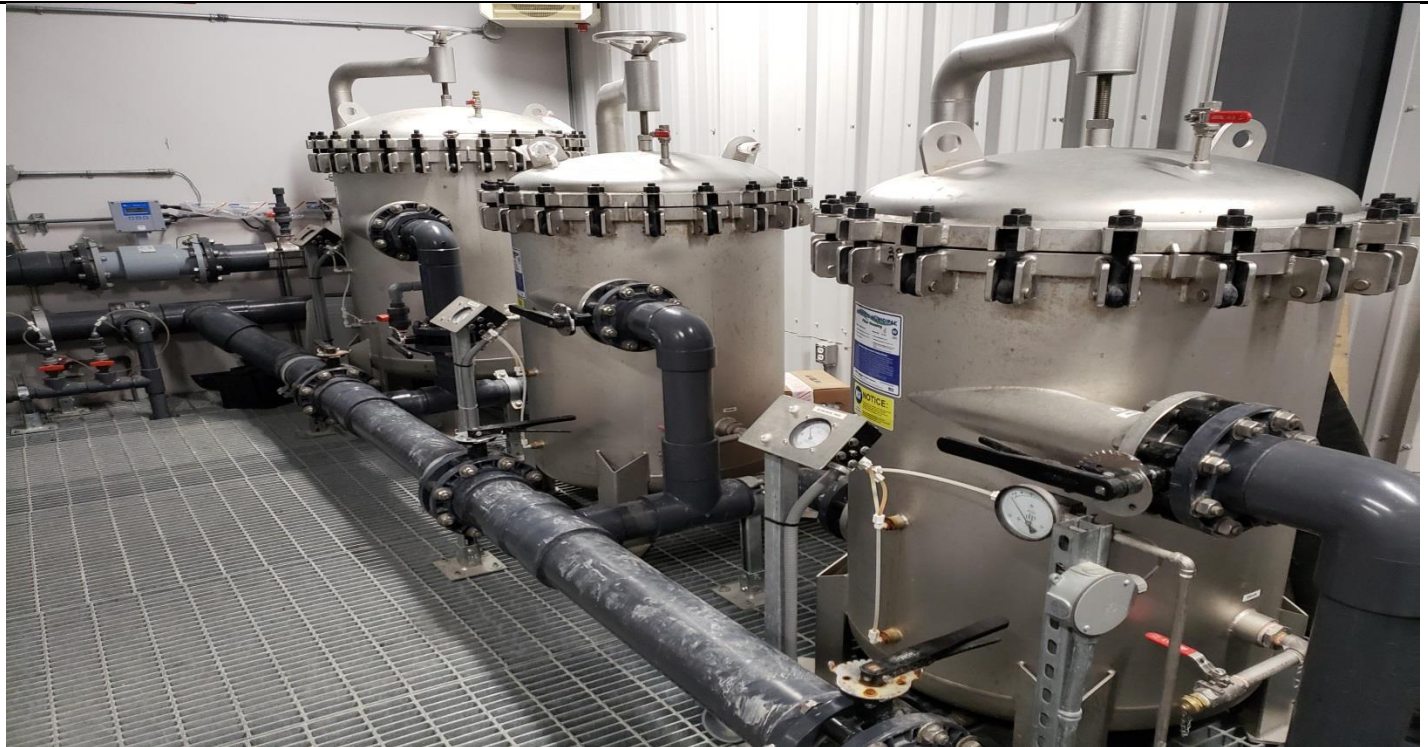
Description: 3 x water filters. Liquid Chlorine injector after the filtration. Water Meter in the background against the wall pipe.

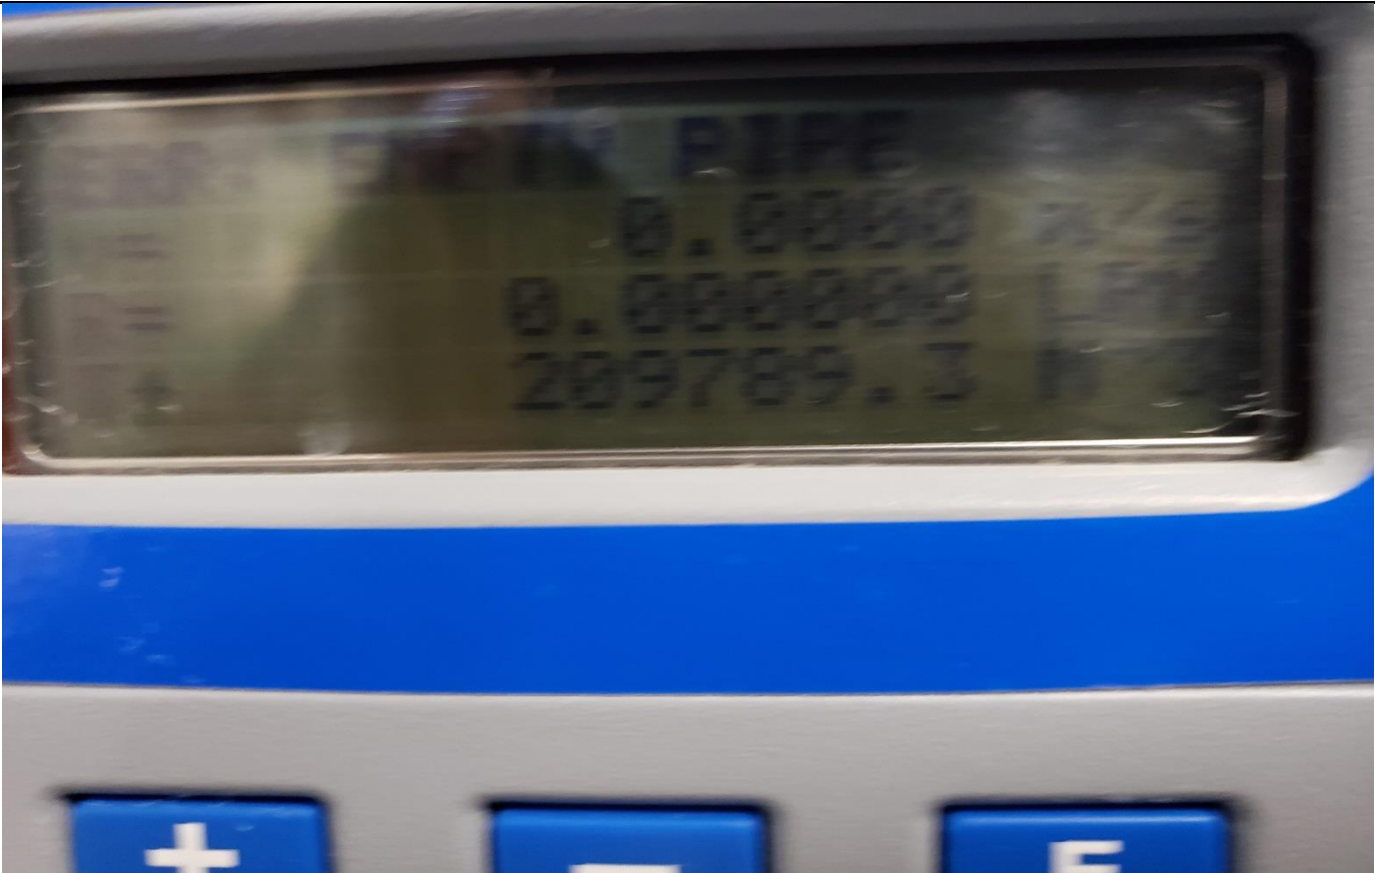
Photo Log #	Location
Photo 11	Igloolik , Qikiqtani Region, Nunavut

Description: Digital Water Meter Reads 209789.3m³

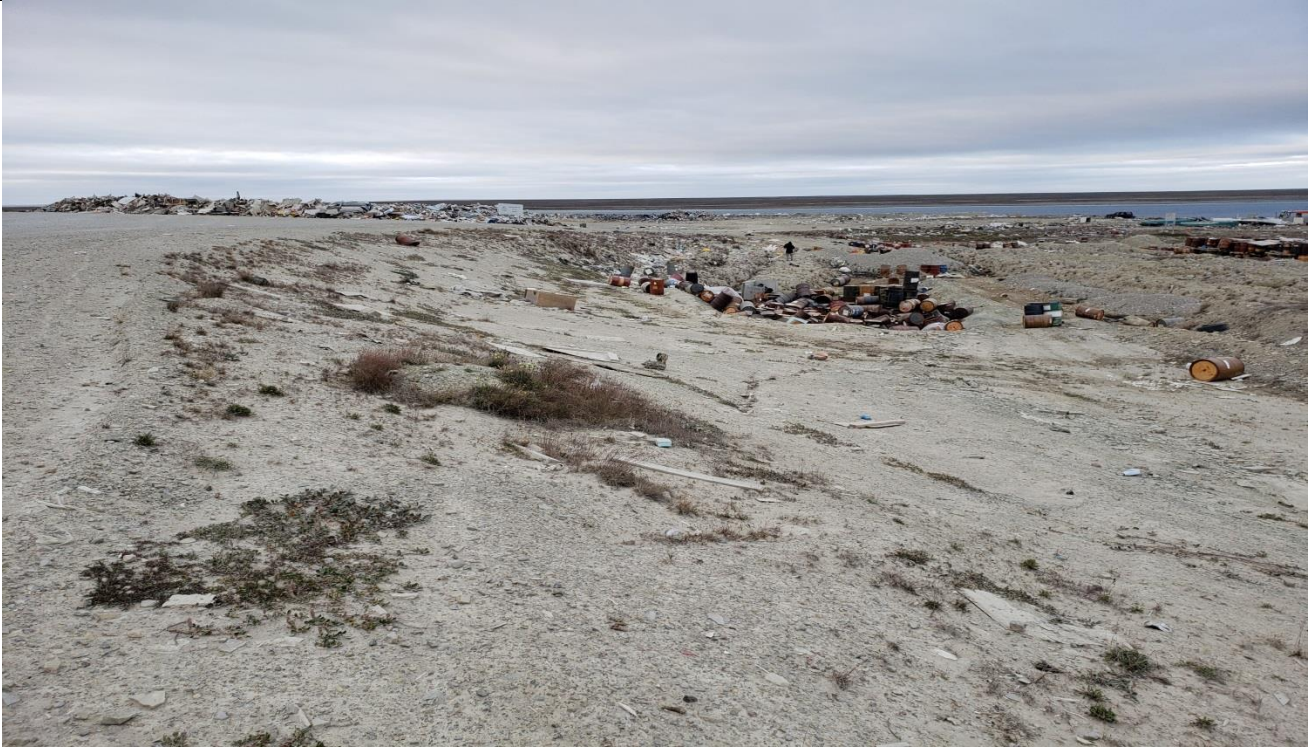
Photo Log #	Location
Photo 15	Igloolik , Qikiqtani Region, Nunavut

<p>Description: Hazardous Waste Area #1, Old Waste Oil Drums within a bermed area – berm is full. Wall was taken down to allow for access. Drums being deposited there are being deposited further and further away from the bermed area. Water puddles litter the area, and the natural contours of the areas allow for migration into the hazardous waste area, then drains to a small lake downgrade of this site.</p>

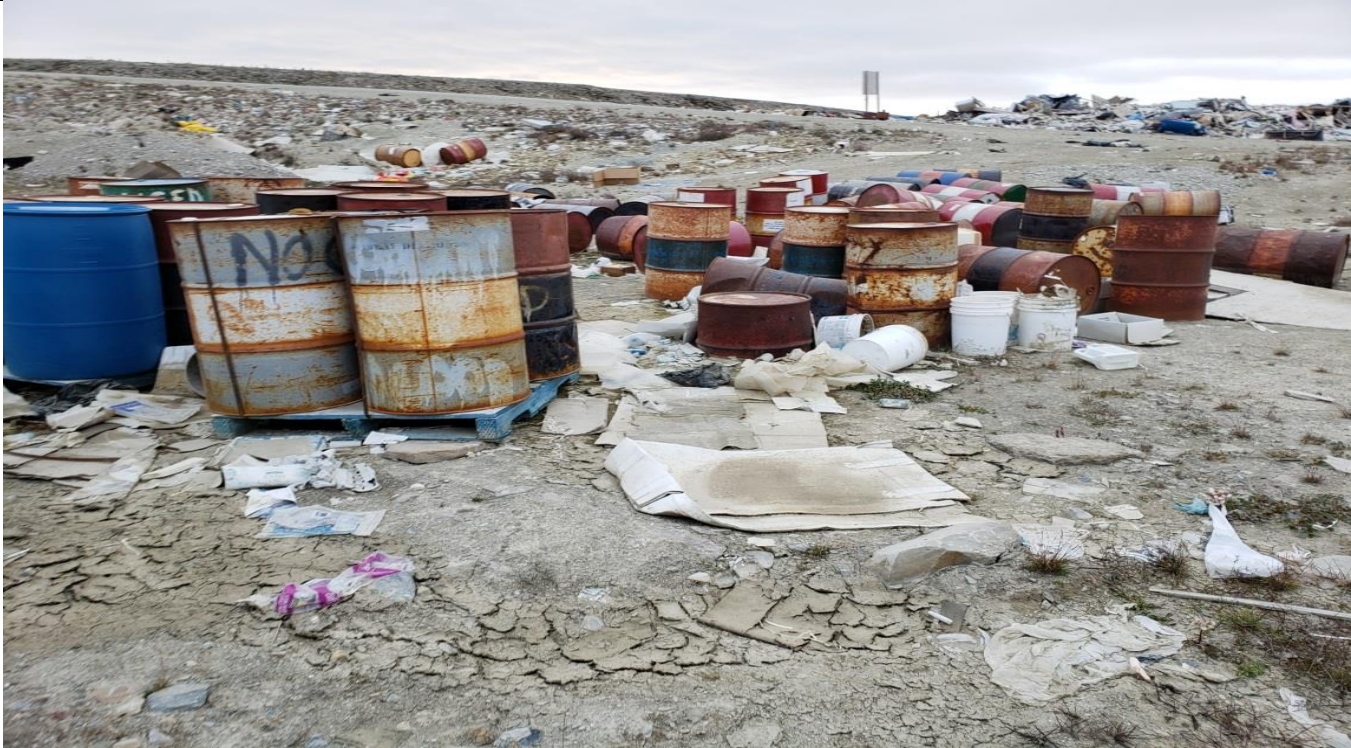
Photo Log #	Location
Photo 16	Igloolik , Qikiqtani Region, Nunavut

<p>Description: signs of Water around the hazardous waste disposal area. Surface water migrates from background of photo to within hazardous waste storage facility.</p>

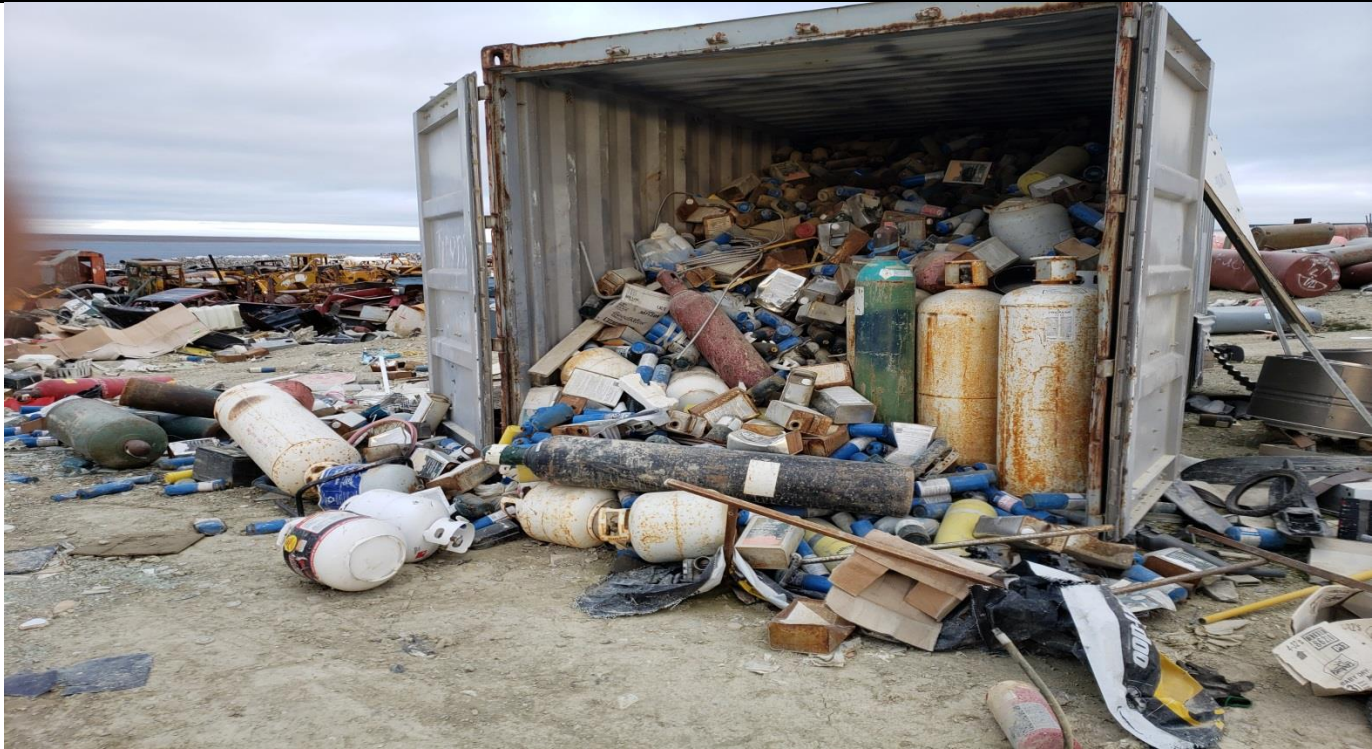
Photo Log #
Photo 23

Description: Bulk Metal Seacan #4: with empty propane tanks overflowing. This seacan starts the merge from hazardous waste to bulk metal.

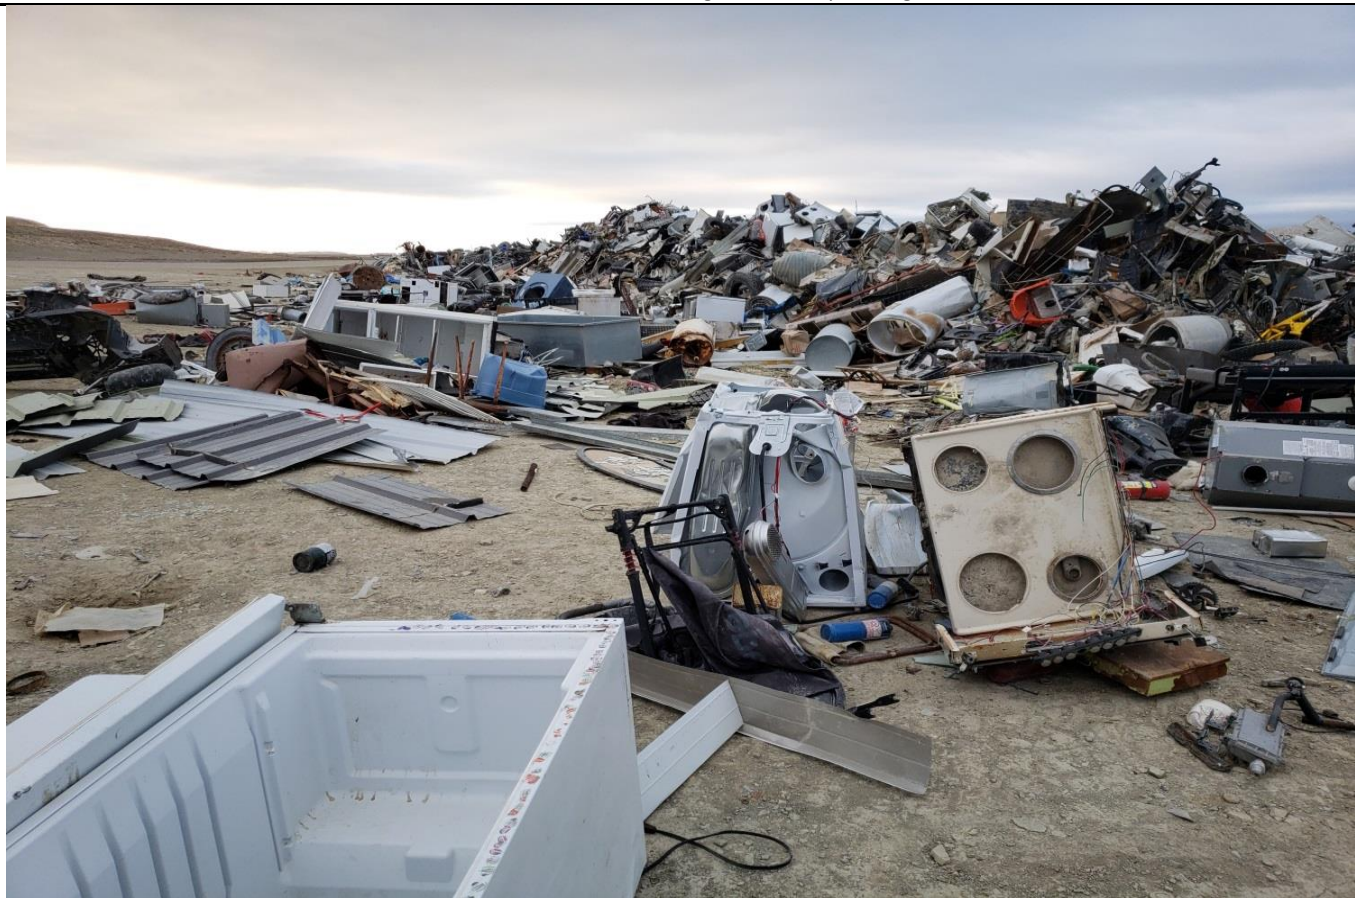
Photo Log #
Photo 24

Description: Some empty camping fuel tins, and standing water in the bulk metals section of the Solid Waste Facility

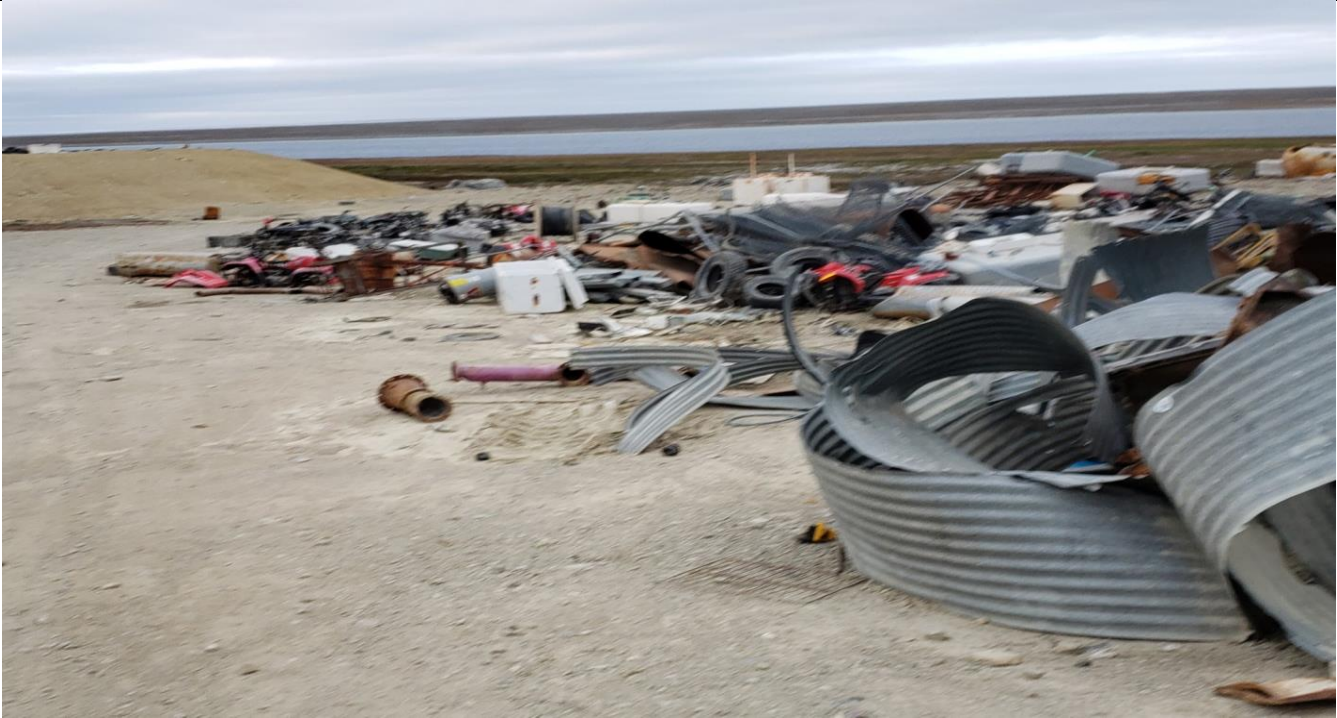
Photo Log #	Location
Photo 25	Igloolik , Qikiqtani Region, Nunavut

Description: End of Bulk Metals. Sewage lagoon starts on left hand side of photo.

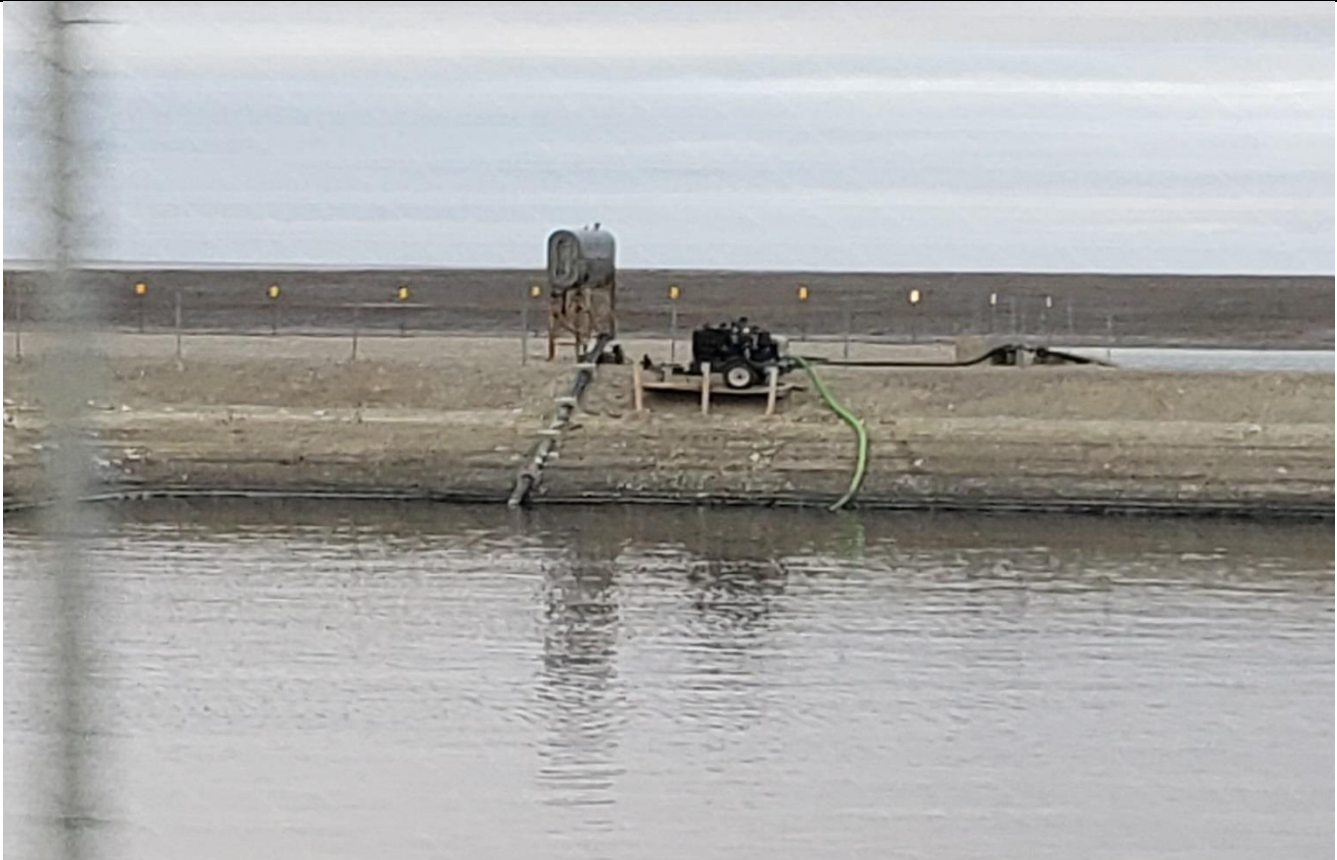
Photo Log #	Location
Photo 26	Igloolik , Qikiqtani Region, Nunavut

Description: Decanting at the Cell#1 Lagoon. Structural Integrity possibly compromised. Doubled walled storage tank to fuel a high intensity water pump.

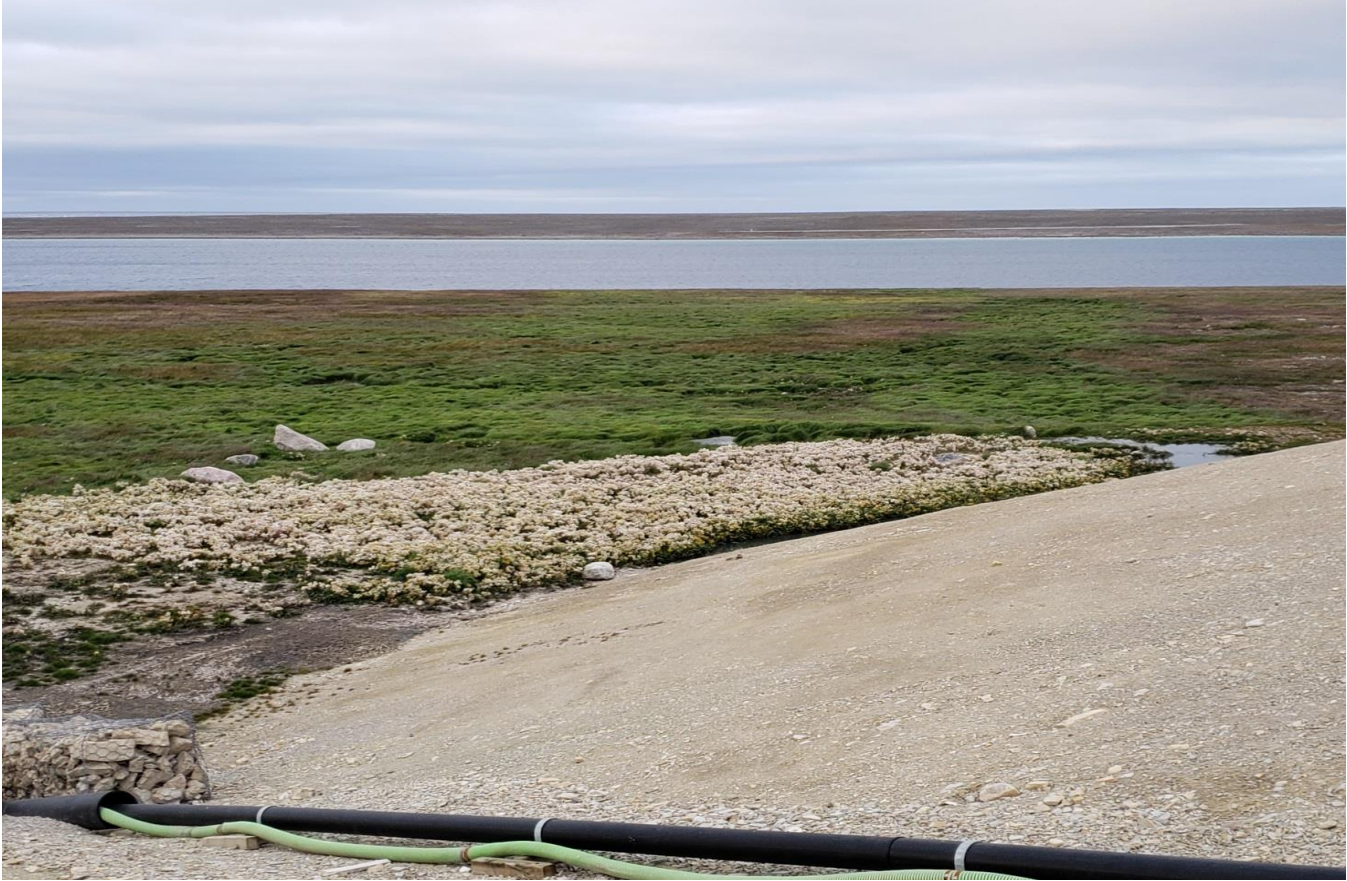
Photo Log #1	Location
Photo 28	Igloolik , Qikiqtani Region, Nunavut

Discharge Location. Half culvert diverting some of the discharge along the intended route. Most of the discharge goes directly to the receiving environment. What goes along the half culvert also leaks out and washes out the base of the sewage reservoir. Dicharge Location for Cell #2

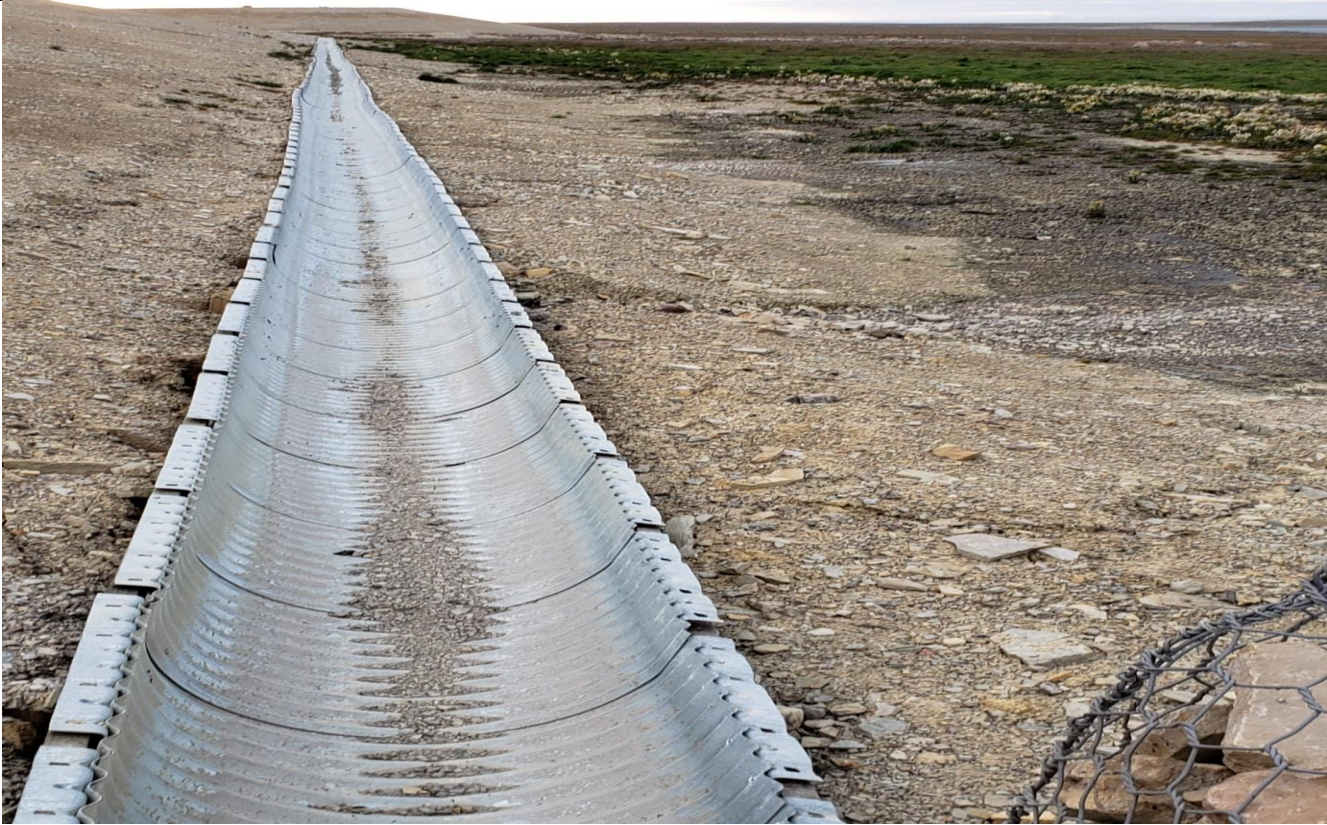
Photo 30

Discharge Location. Half culvert diverting some of the discharge along the intended route. What goes along the half culvert also leaks out and washes out the base of the sewage reservoir.

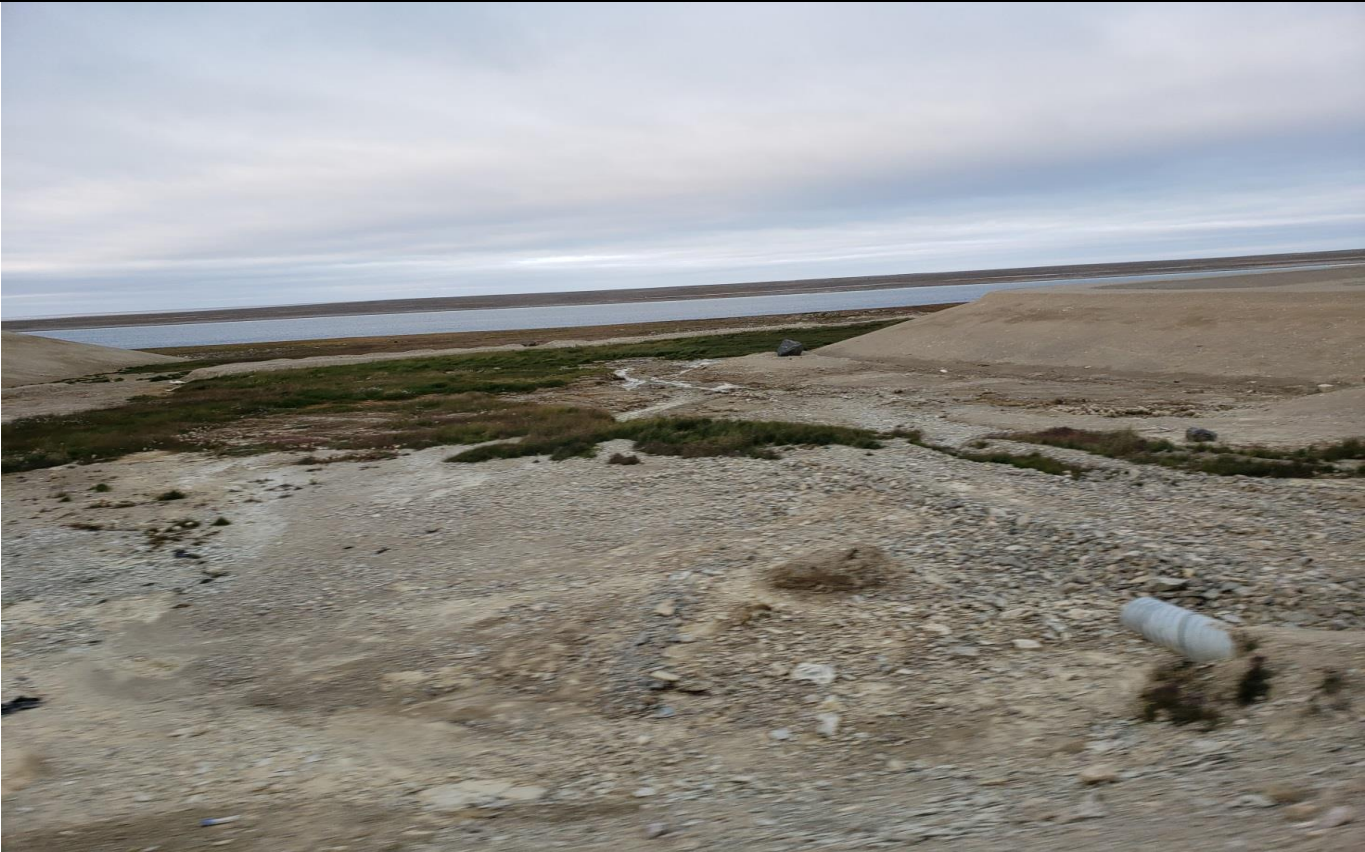
Photo 31

Cell #1 Outer wall of Cell 1 appears to have some minor wheeping.

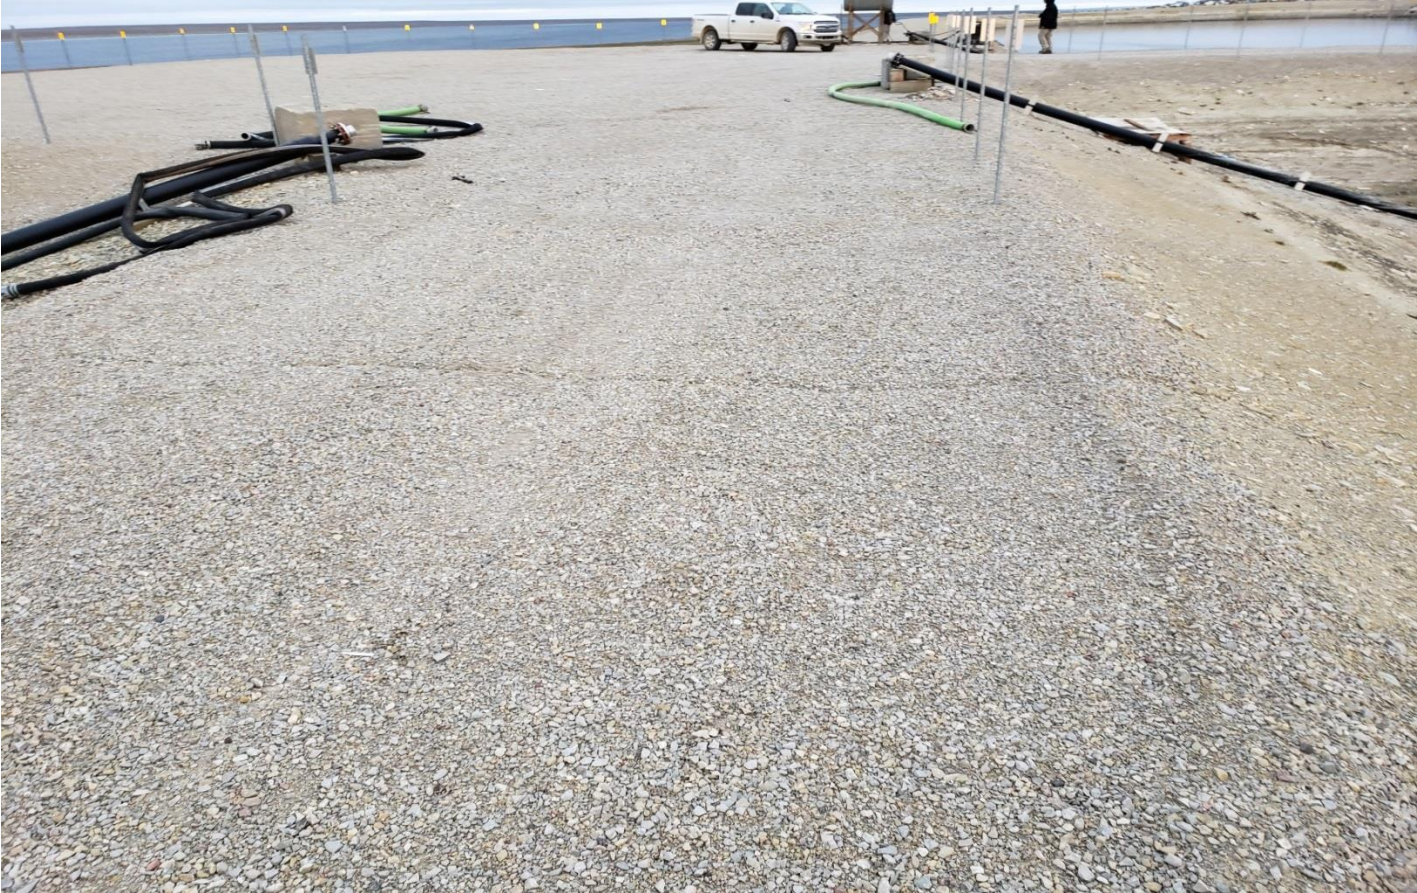
Photo 32

A crack in the walls appears on the outside, top, and inside of sewage lagoon walls.
