WATER LICENCE INSPECTION FORM

Licensee	Licensee Representative
Hamlet of Igloolik	Bhabesh Roy
Licence No. / Expiry	Representative's Title
3BM-ILG1520	Municipal Engineer
Land / Other Authorizations	Land / Other Authorizations
Date of Inspection	Inspector
August 12, 2020	Joseph Monteith
Activities Inspected	
<div><input type="checkbox"/> Camp<input type="checkbox"/> Drilling<input type="checkbox"/> Mining<input type="checkbox"/> Construction<input type="checkbox"/> Reclamation<input type="checkbox"/> Fuel Storage</div> <div><input type="checkbox"/> Roads/Hauling<input checked="" type="checkbox"/> Other: Potable Water Source, Solid Waste Facility, Sewage Disposal Facility<input type="checkbox"/> Other:</div>

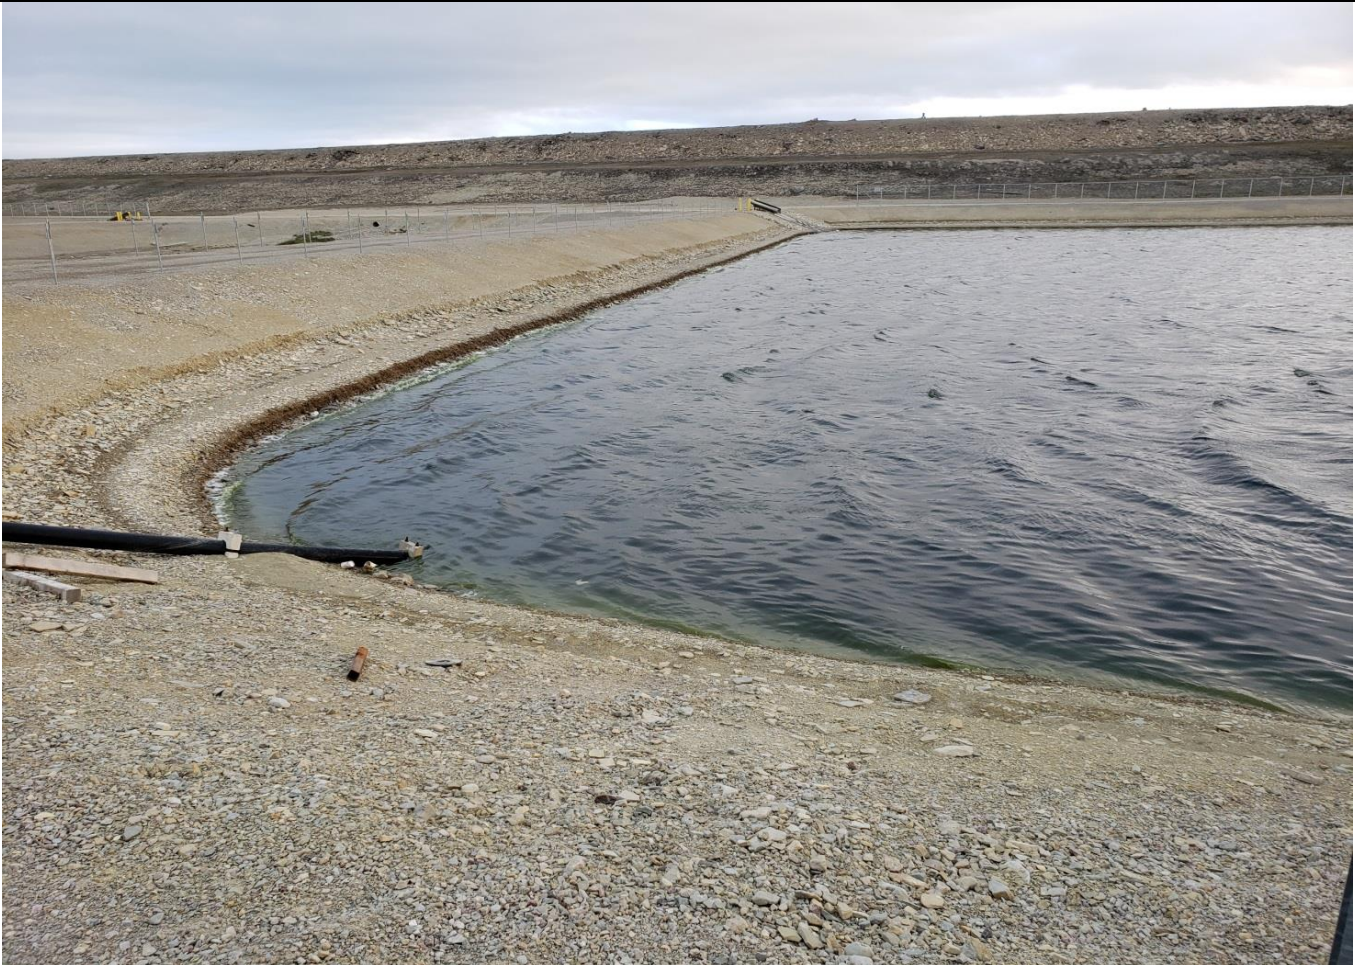
Photo Log #1	Location
Photo 33	Igloolik , Qikiqtani Region, Nunavut

Cell # 2. Freeboard is good. No observable sludge. Freeboard appears to have dropped.

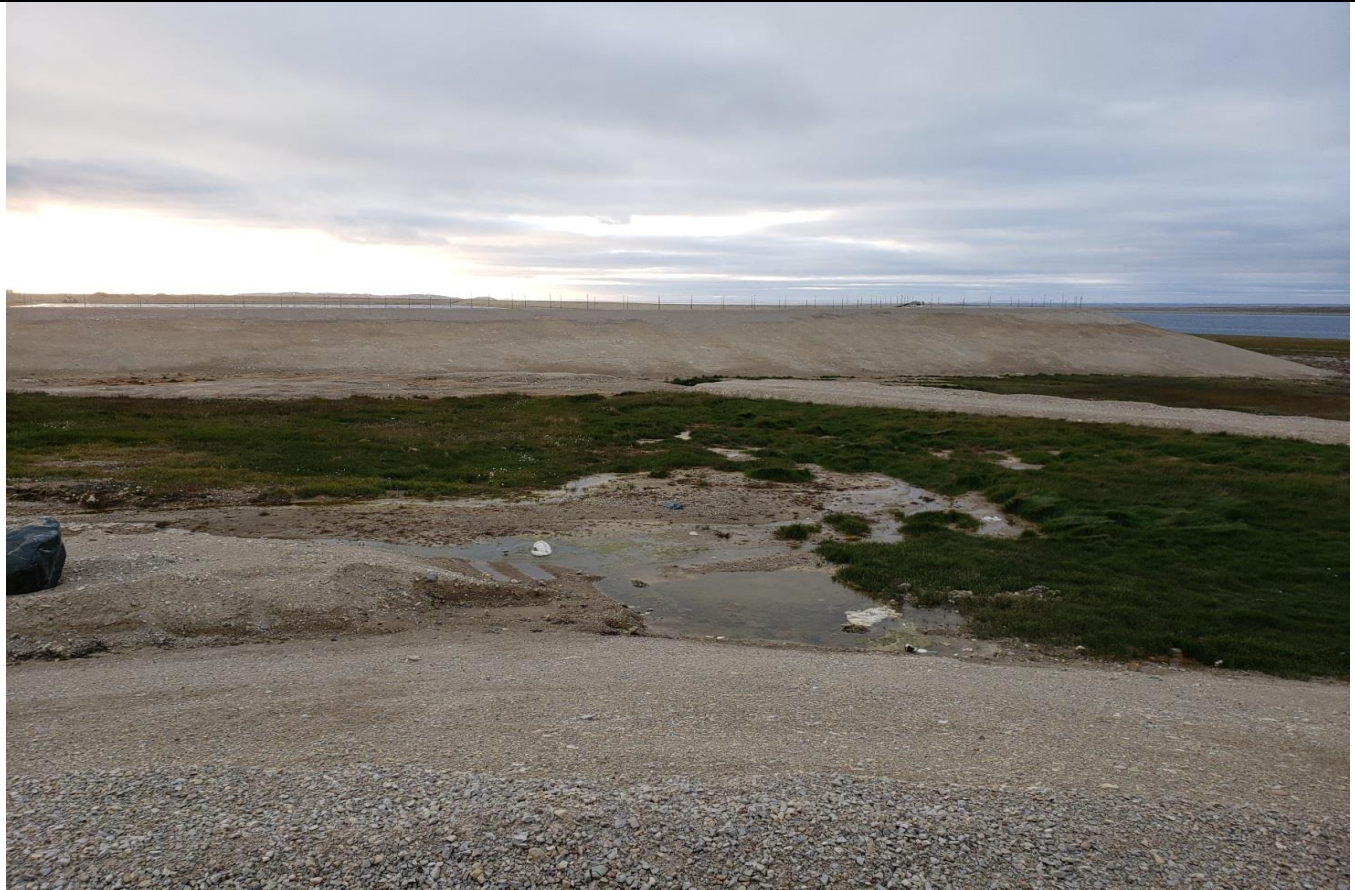
Cell # 2. 2019 signs of slumping may be a leak. Engineer Inspection on walls requested.
