WATER LICENCE INSPECTION FORM

Licensee	Licensee Representative
Hamlet of Igloolik	Bhabesh Roy
Licence No. / Expiry	Representative's Title
3AM-ILG2131	Regional Engineer
Land / Other Authorizations	Land / Other Authorizations
Date of Inspection	Inspector
October 26, 2021	Joseph Monteith
Activities Inspected

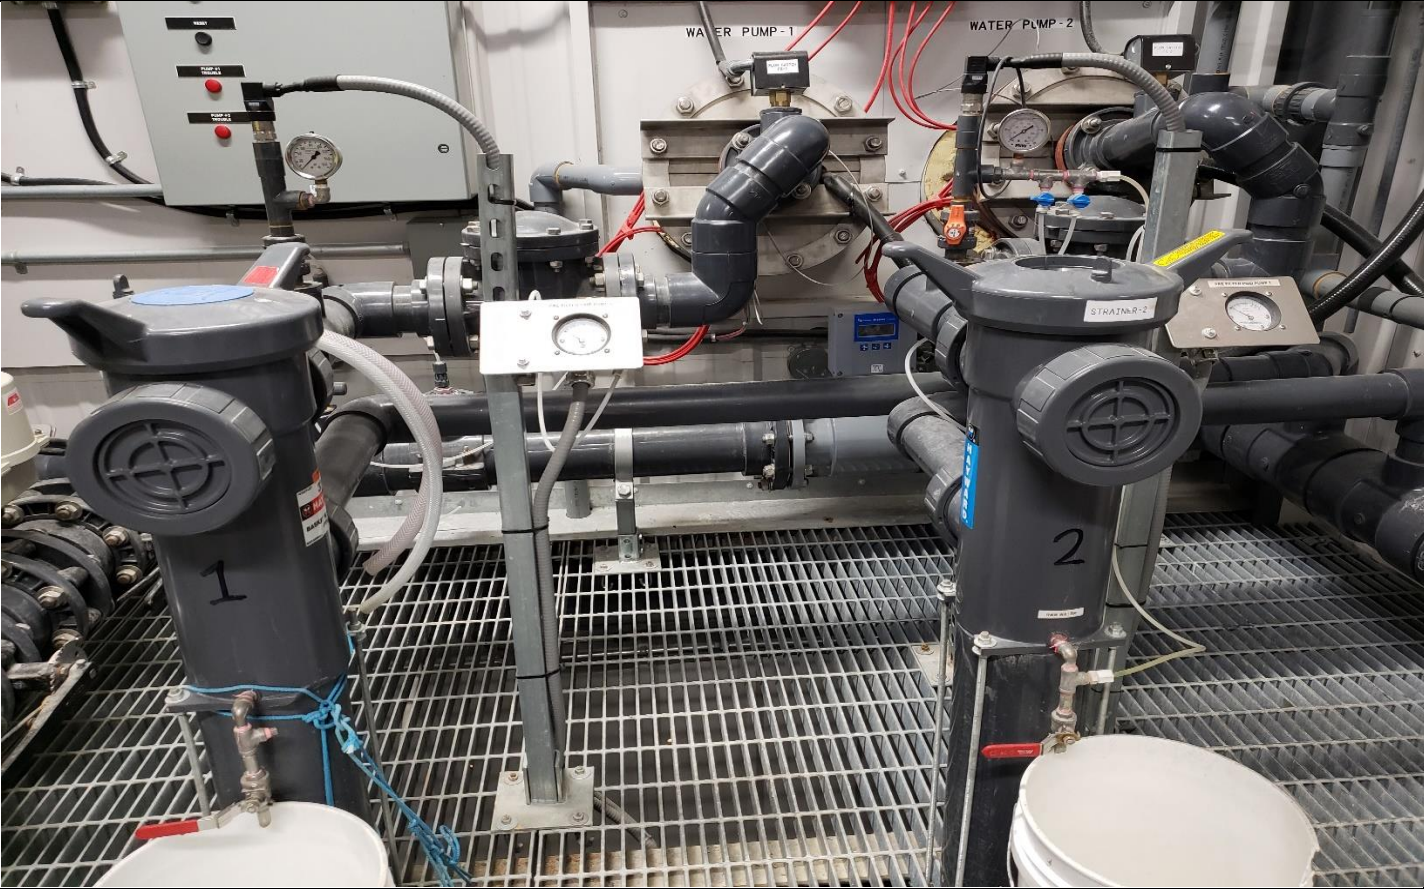
Photo 7

7. The Water Treatment Facility has an auto-chlorine injector, and 3 types of filters of various sizes(photo 8), and a strainer (photo 7). The filters tend to clog up and cost the hamlet a lot of money to replace. (photo 9).

Description: 2x intake pipes entry into water treatment facility. 2 x Pre filter strainer

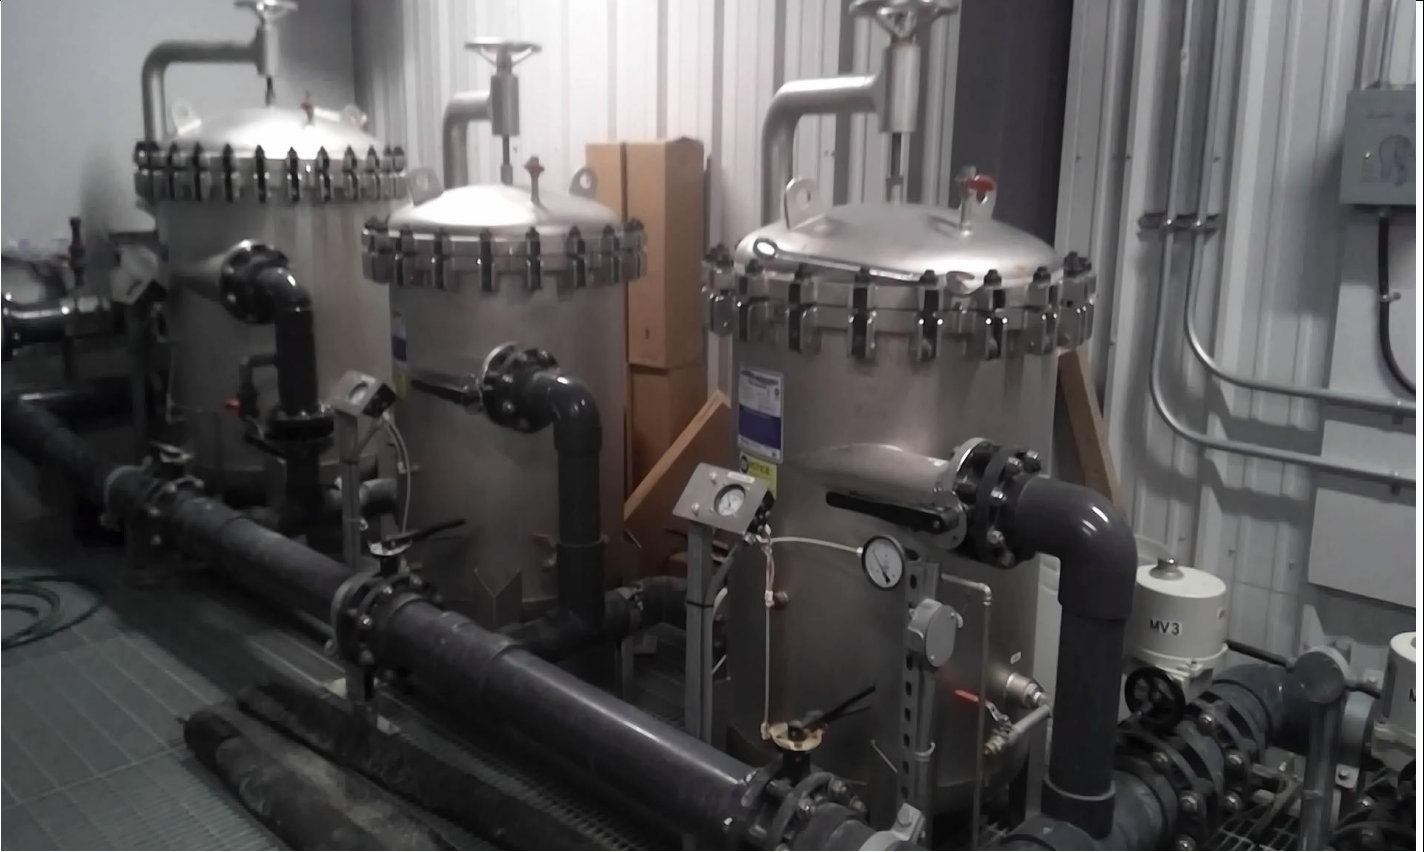
Photo 8

Description: 3 x water filters. Liquid Chlorine injector after the filtration. Water Meter in the background against the wall pipe.

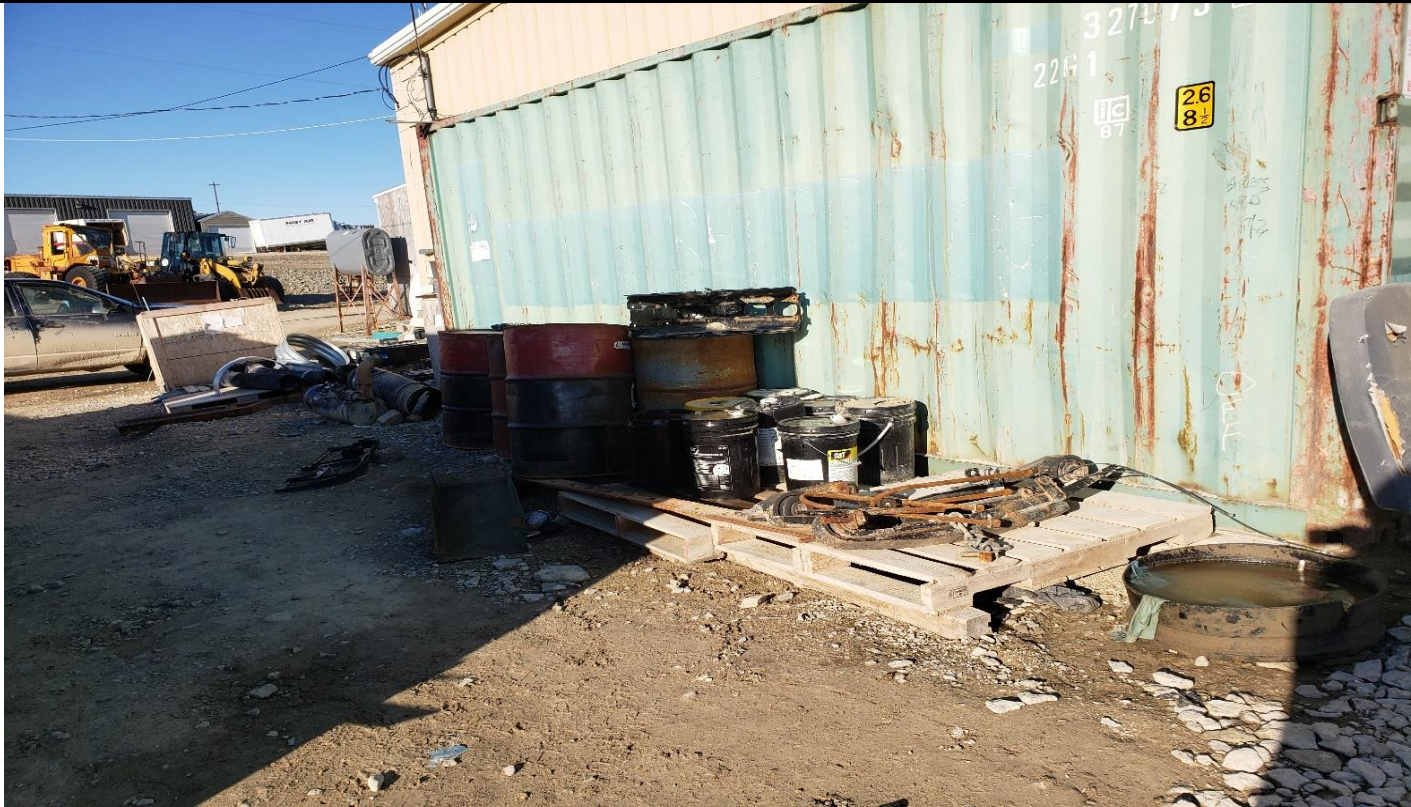
Photo Log #	Location
Photo 20	Igloolik

Description: Bulk Metal Seacan #4: with empty propane tanks overflowing. This seacan starts the merge from hazardous waste to bulk metal.

- Maintain fencing at Water Storage Reservoir;
- Segregate the Bulk Metals, and Hazardous Waste;
- Consolidate all Hazardous Waste and store in such a way as to protect water from mixing with the hazardous waste;
- Provide the inspector with a copy of or the location(s) of the modified Solid Waste Disposal Facility.
- Submit an update to the spill line as per Part H:5(c). on spill report 2021-372.

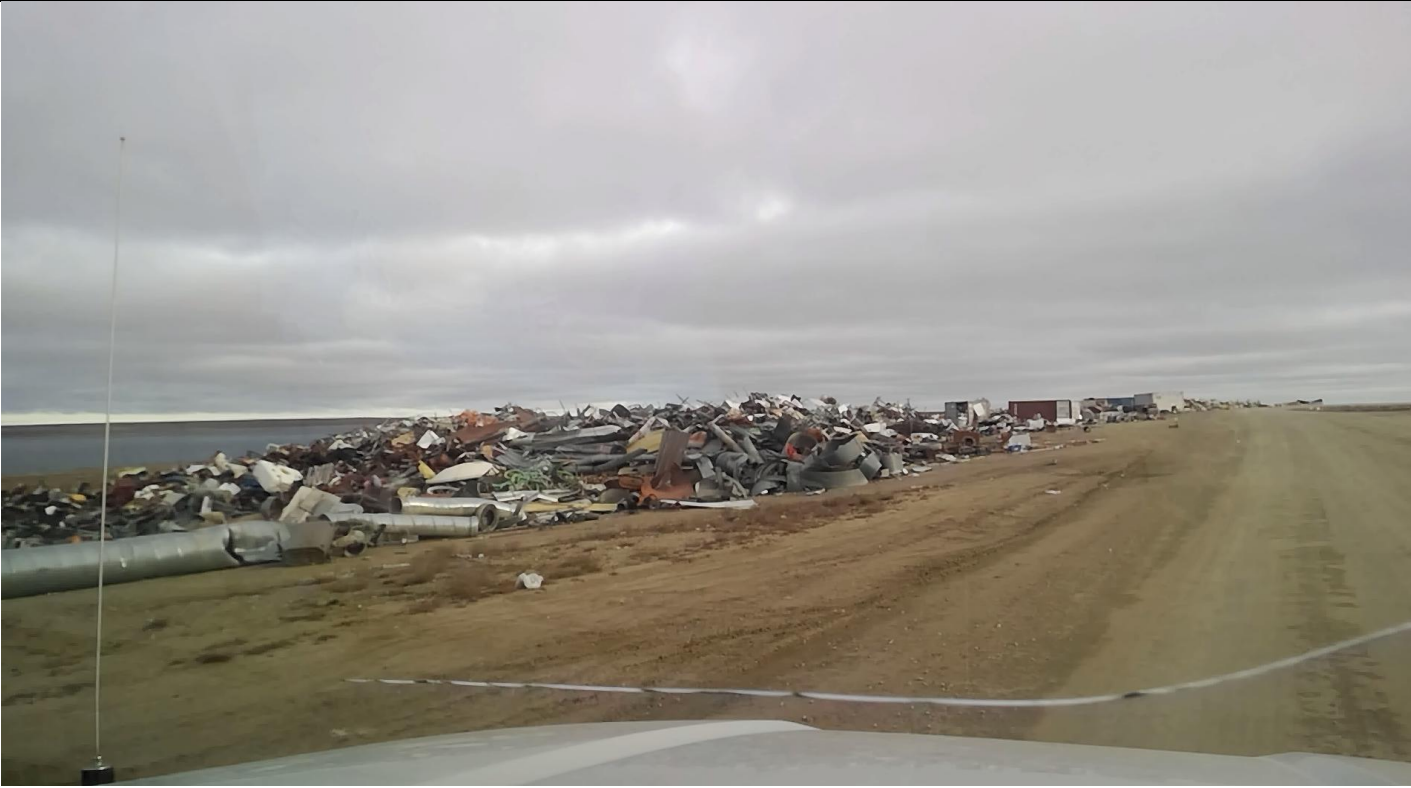
Photo Log #	Location
Photo 22	Igloolik

Description: End of Bulk Metals. Sewage lagoon starts on left hand side of photo.
