**ANNUAL REPORT
FOR THE HAMLET OF IGLOOLIK, 2021**

YEAR BEING REPORTED: 2021

The following information is compiled pursuant to the requirements of Part A, Item 1 of Water Licence # 3AM–IGL2131 issued to the Hamlet of Igloolik.

WATER LICENCE INSPECTION FORM

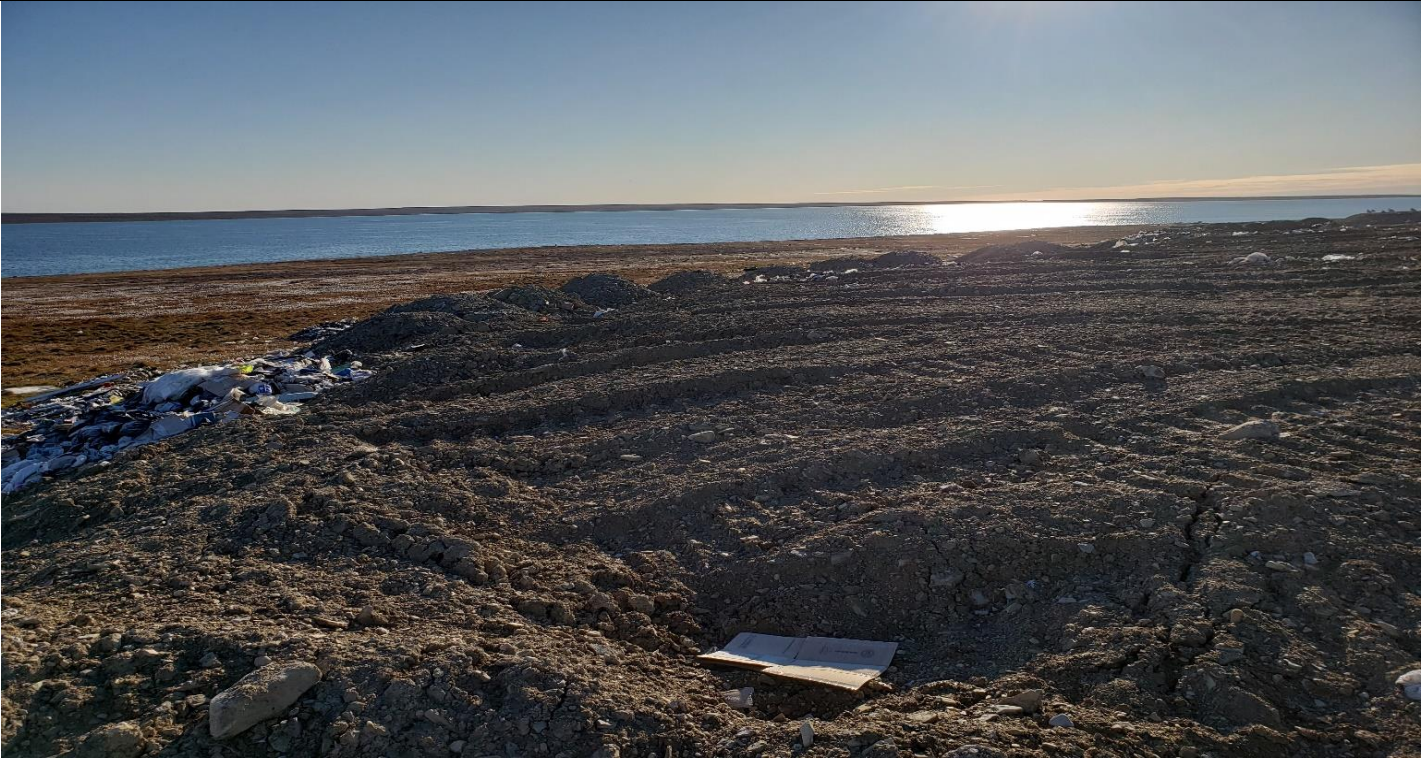
Photo Log #	Location
Photo 11	Igloolik

14. Open Pit Burning at the Solid Waste Facility has no fencing. Does not appear to do any capping of the ash, but has created a berm using a mix of gravel and the ash from the burning of garbage. (Photo's 11 &12).

Description: The back side of the open pit burning. Non engineered walls. Fresh Gravel laid over migrating sludge first observed in 2020 inspection report.

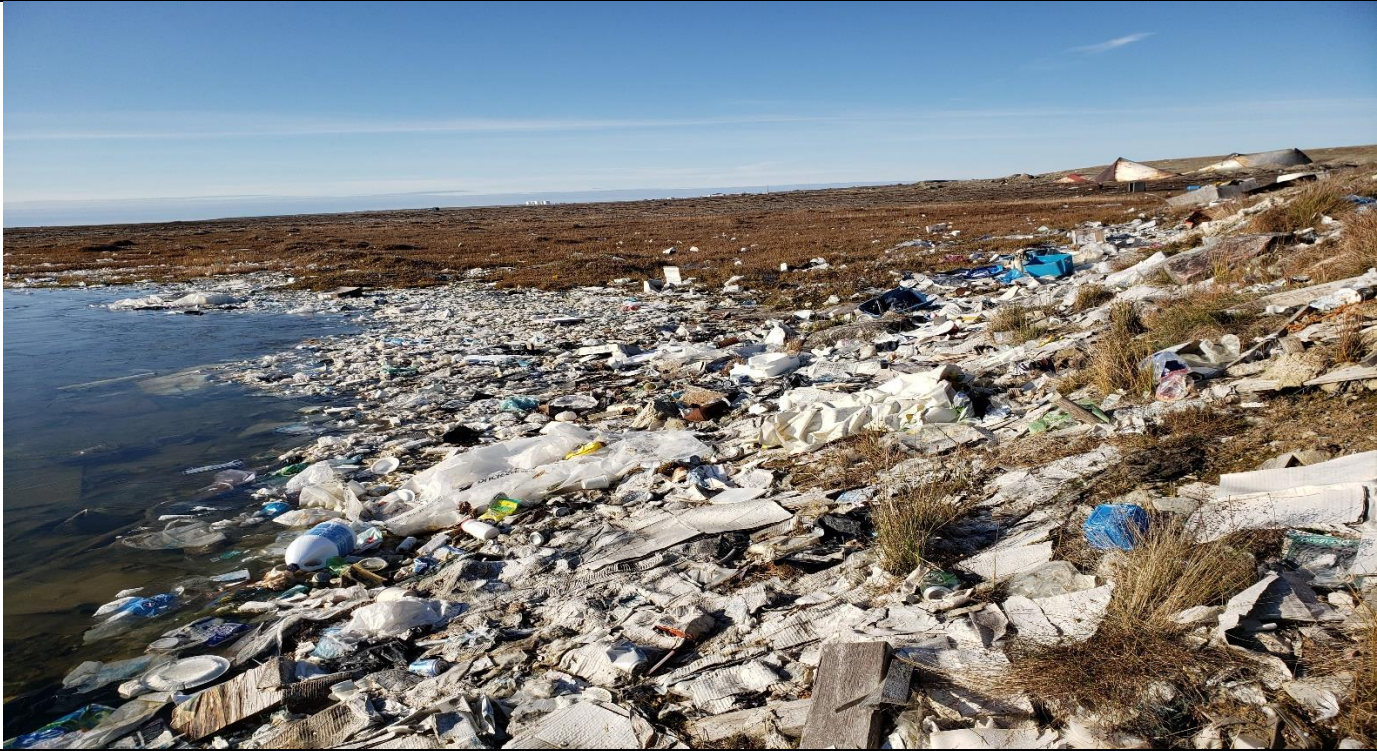
Photo Log #1	Location
Photo 15	Igloolik

16. Hazardous Waste and contaminated soils path of migration downgrade of historic Hazardous Waste Storage Facility (Photo 15).
17. Windblown garbage has migrated off site into a fresh water pond. (photo).

Description: Fresh Water pond downgrade of Historic Hazardous Waste Disposal Facility. Wind Blown Garbage also litter the pond.

- Maintain fencing at Water Storage Reservoir;
- Segregate the Bulk Metals, and Hazardous Waste;
- Consolidate all Hazardous Waste and store in such a way as to protect water from mixing with the hazardous waste;
- Provide the inspector with a copy of or the location(s) of the modified Solid Waste Disposal Facility.
- Submit an update to the spill line as per Part H:5(c). on spill report 2021-372.

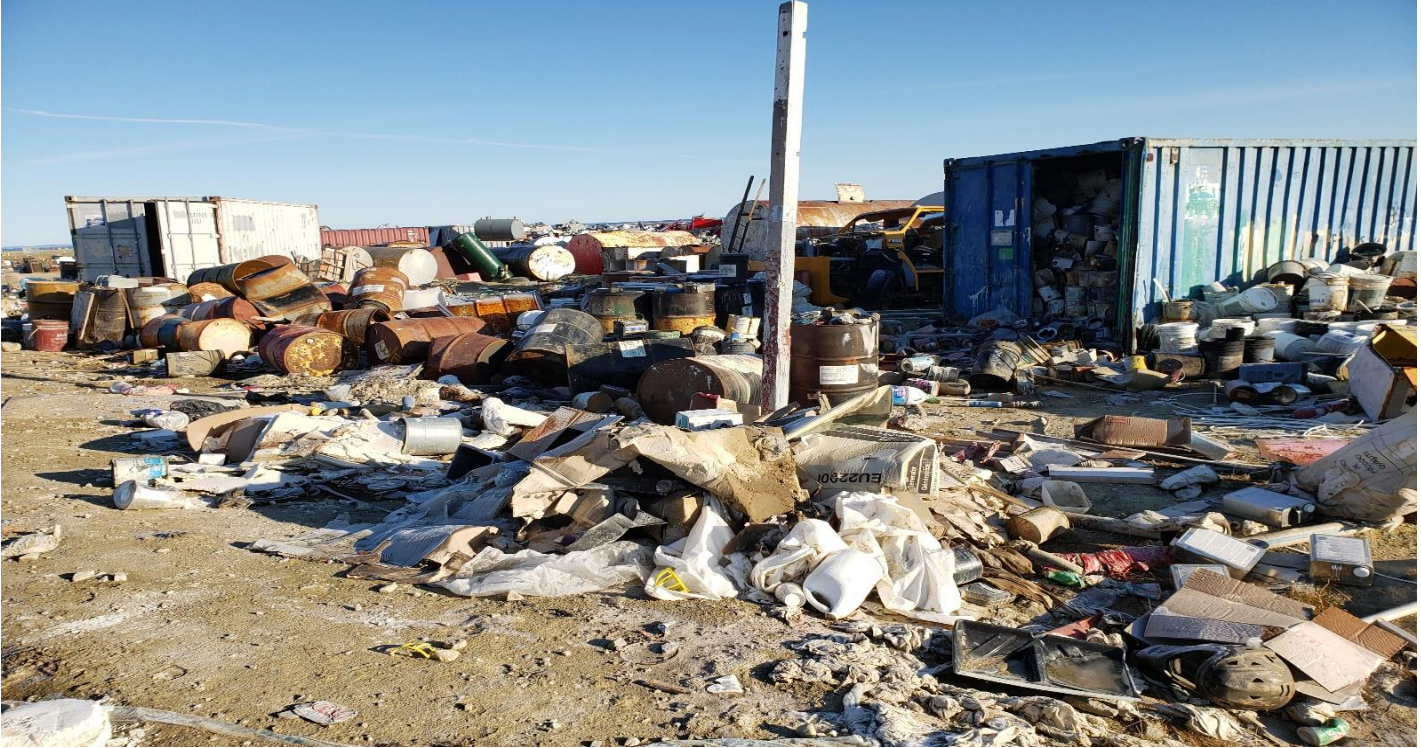
Photo Log #	Location
Photo 17

Description: Hazardous Waste Seacan # 1 – Overfilled Paint Cans exposed to the outside elements

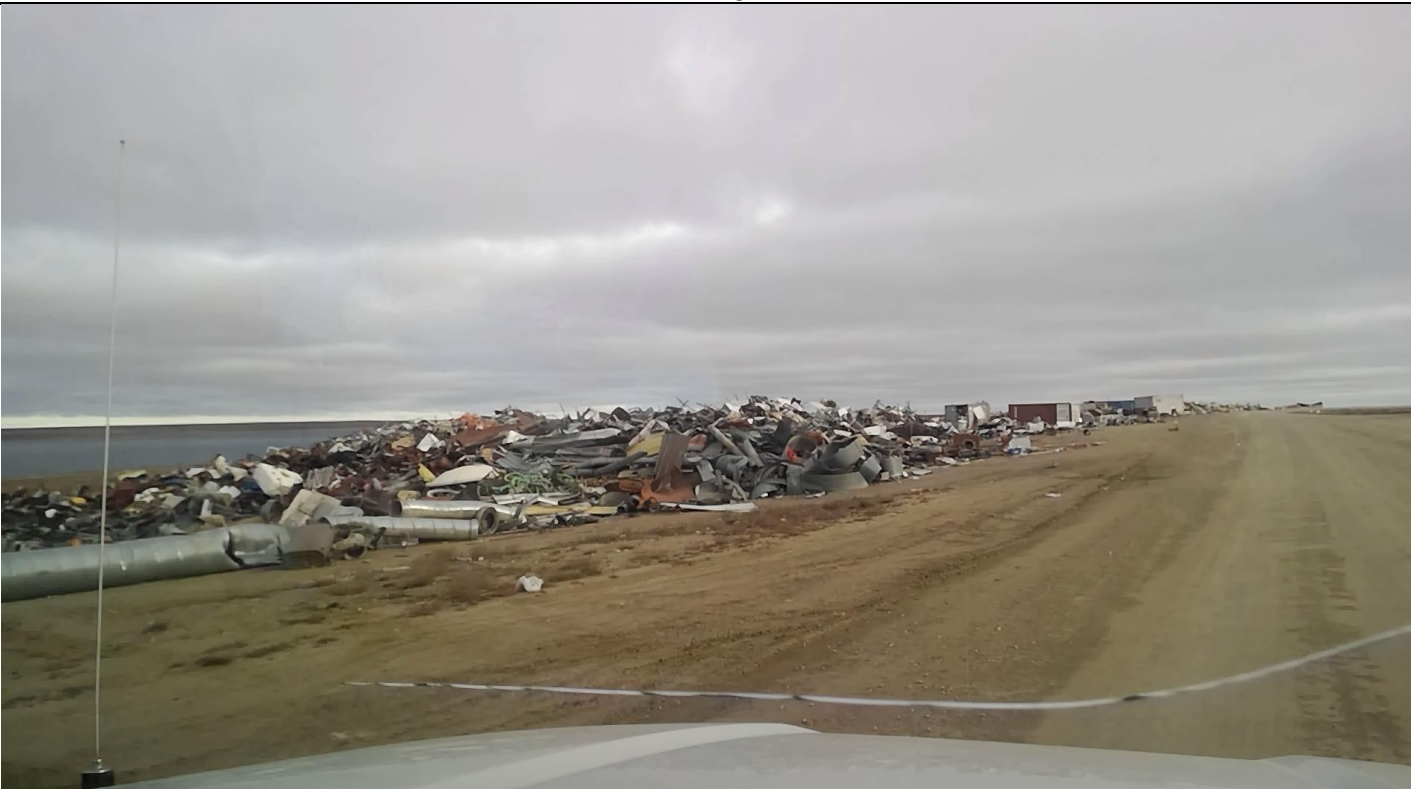
Photo Log #	Location
Photo 22	Igloolik

Description: End of Bulk Metals. Sewage lagoon starts on left hand side of photo.

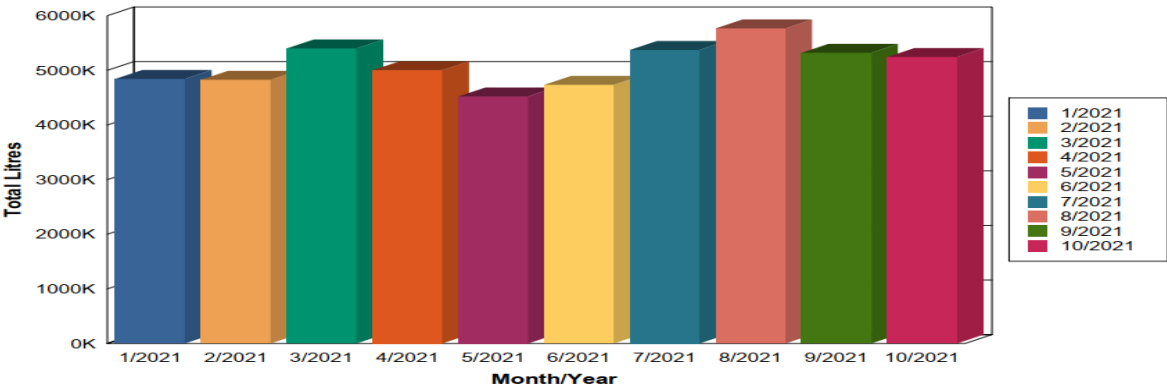
24. On August 8, 2021 Phillip Avingaq, Accounts Receivable, Hamlet of Igloolik, NU emailed the inspector a copy of January 1, to October 31, 2021 Quantity of Water Obtained from all sources in litres, Annual Total is 51, 053, 4427.00 Litres withdrawn equals 510534.43 m³ (photo 31)

Quantity of Water Obtained from all sources in litres, Annual Total is 51, 053, 4427.00 Litres withdrawn and delivered
