# IGLOOLIK WASTEWATER TREATMENT FACILITY

## SEWAGE LAGOON BERM 2022 DAM SAFETY INSPECTION, IGLOOLIK, NUNAVUT

PROJECT NO.: TE0223017  
DATE: OCTOBER 2022

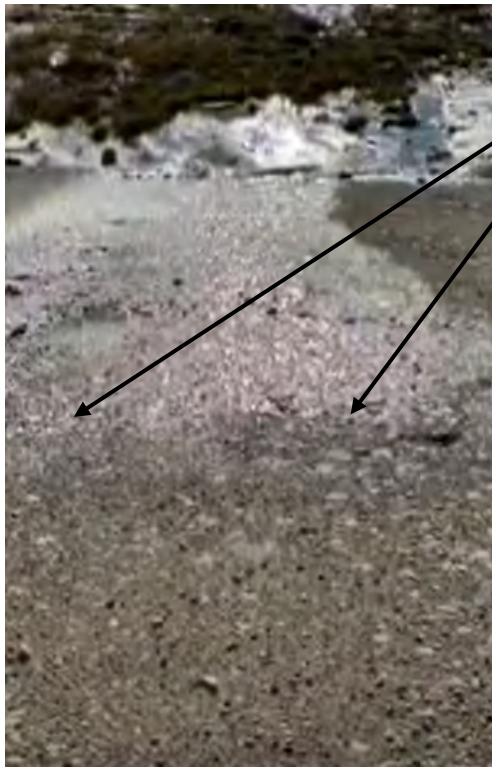
FIGURE  
A6

Signs of seepage, i.e., a discolored zone, were observed along the east berm, over an area approximately 5 m wide, as shown in Figure A6 in Appendix A. Figure A7 presents a photo showing active seepage on August 29, 2021, which was taken and provided by Mr. Steve Weedmark. The following is a summary of communication with Mr. Steve Weedmark regarding this seepage issue:

- The seepage occurred when the water level reached the maximum operation level.
- The seepage reduced and stopped when the water level dropped by about 150 mm below the maximum operation level.
- No seepage in this area was observed/reported in the past from the completion of construction up until 2021.

Active seepage zone observed when Cell A had high water level.

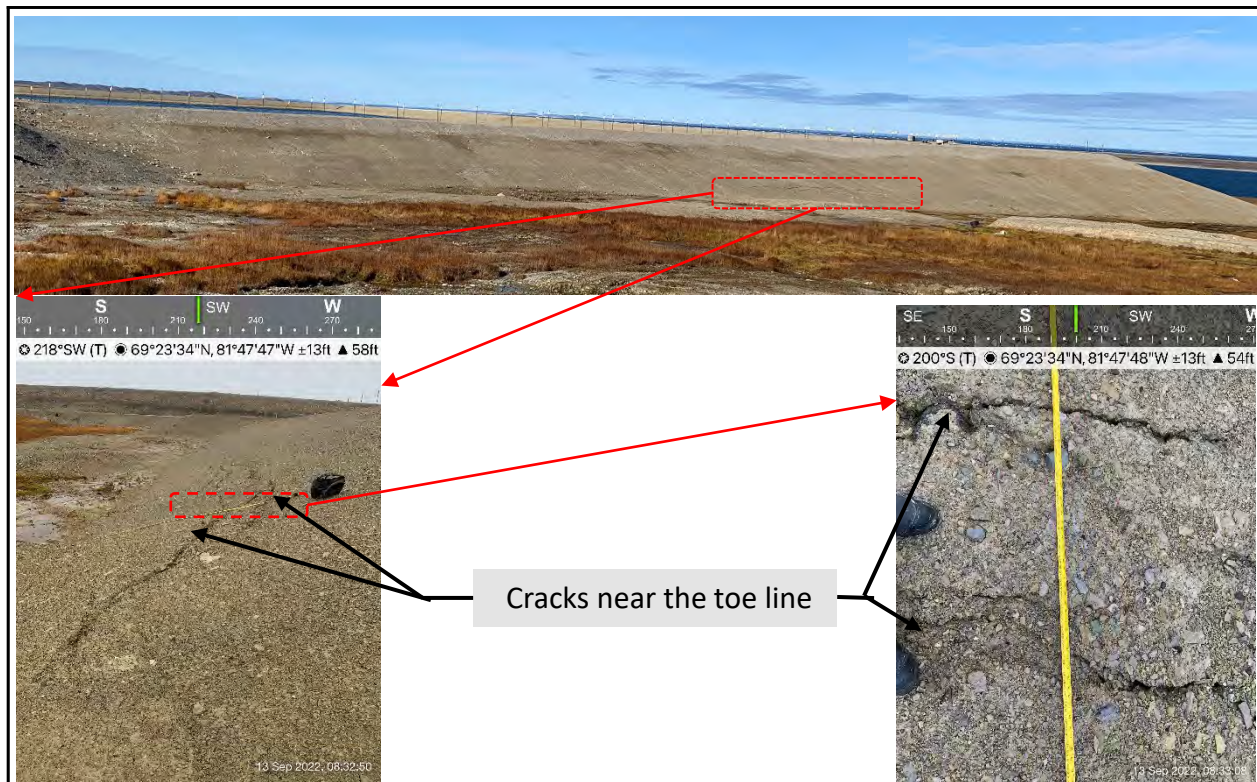
FIGURE  
A7

Significant cracks were observed on the downstream slope about 60 to 80 m south from the north end of the east berm, as shown in the top photo in Figure A8. They were located within a zone approximately 20 m wide and about 3.5 m away from the toe. The cracks were typically about 50 mm wide, up to 200 mm wide.

There was some localized areas of water ponding at the downstream toe; the water was clear and showed no sign of active seepage or sink holes during inspection. The cracks are possibly due to (1) frost action (freeze/thaw), (2) settlement due to the potential thawing of a local ice rich soil deposit in the foundation after operation of Cell A over time, or (3) soil movement due to insufficient compaction within the identified zone.

| Attributes | |
|---|---|
| Photograph | A – DS – East Berm |

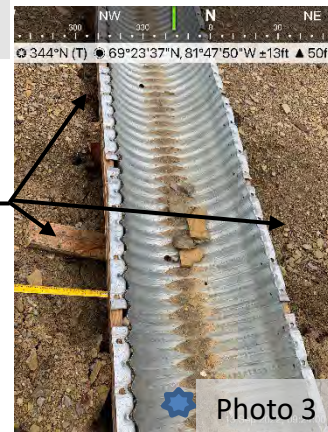
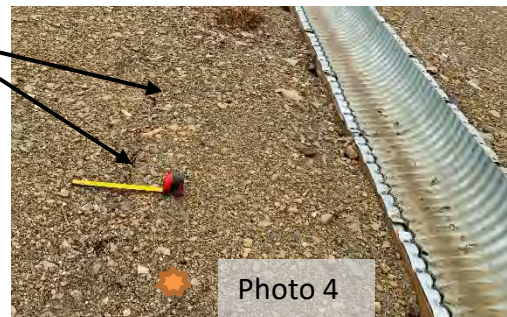
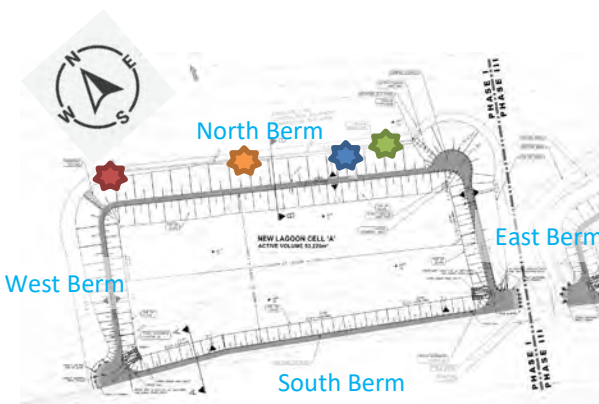
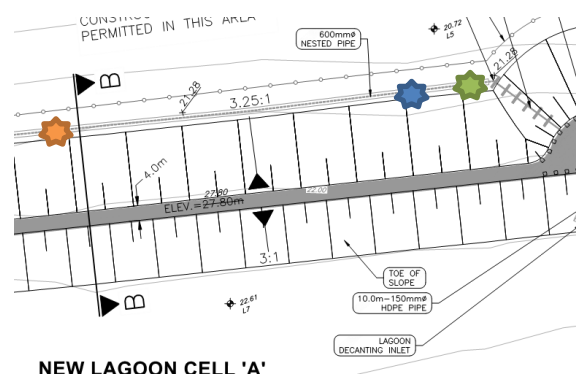
- Significant erosion (wash-out) was observed below and near the trough (see Photo 3 in Figure A12). The erosion scars below the trough were up to 400 mm deep and 200 mm to 400 mm wide at both upstream and downstream sides. This is possibly due to the localized water flow through the perforations during decanting. Runoff from the downstream slope may also contribute to the erosion at a certain level.

- Some cracks were encountered downstream of the drainage trough within approximately 3 m of the trough (see Photo 4 in Figure A12).

Erosion below trough

Cracks at downstream slope near the trough

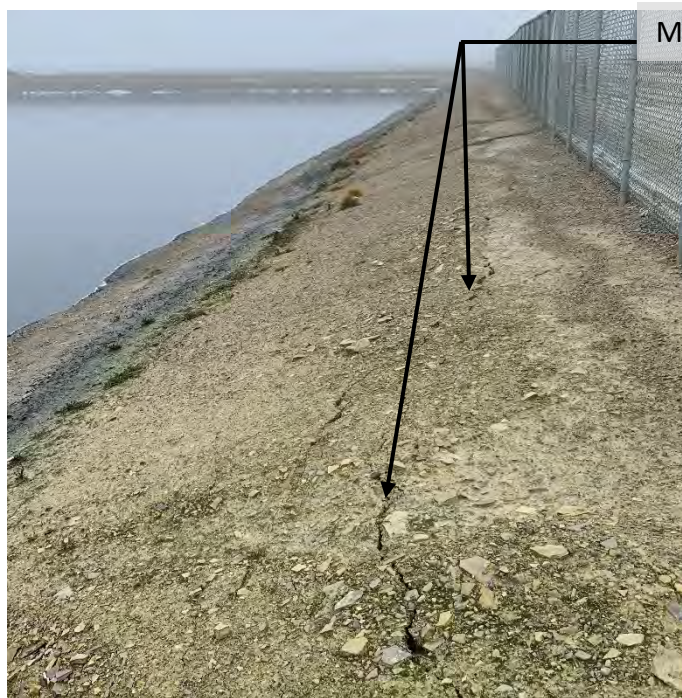
FIGURE  
A19

Minor cracks

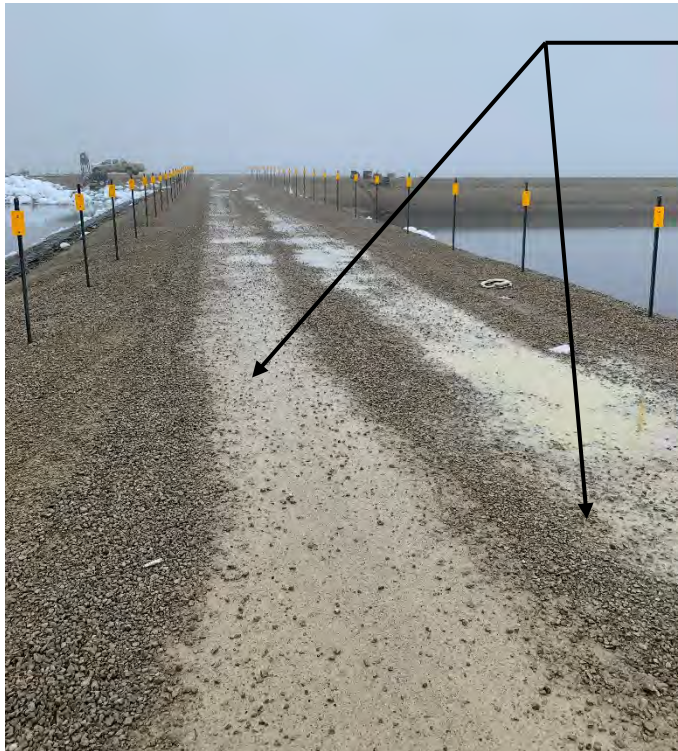
FIGURE  
A22

Crest generally in a good condition.

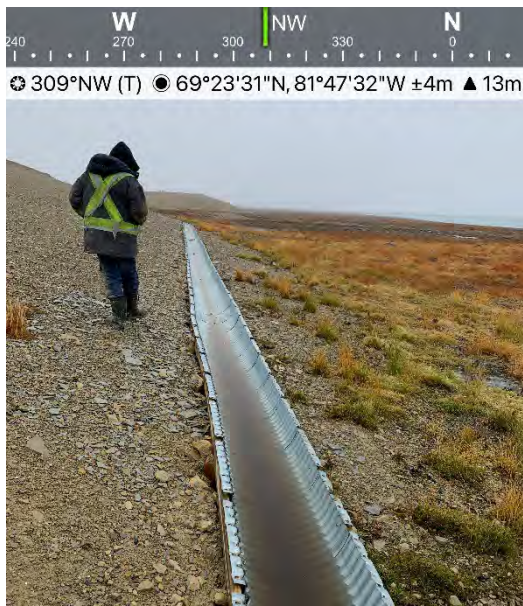
FIGURE  
A28

Water level in trough reduced to a dry condition at about 1/3 of the trough

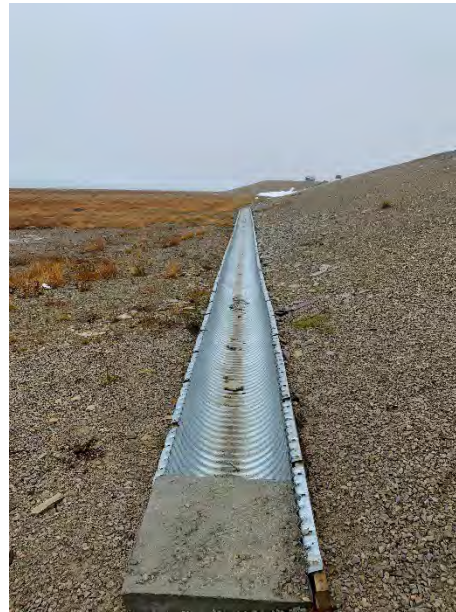
Dry condition at the end of the drainage trough.

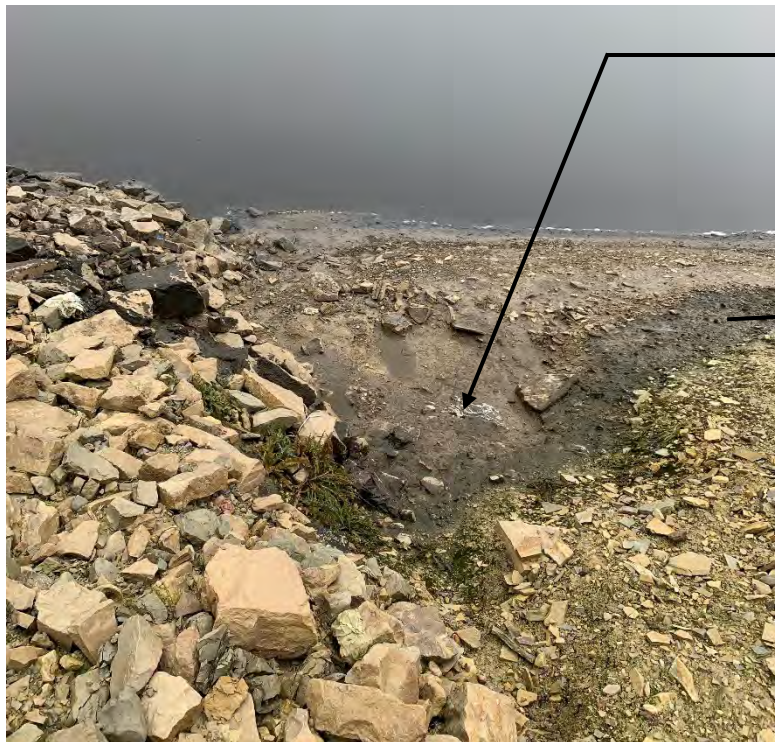
FIGURE  
A29

Local riprap damage

| Attributes | |
|---|---|
| Photograph | B – US –East Truck Discharge Facility (#4) - Local Riprap Damage |

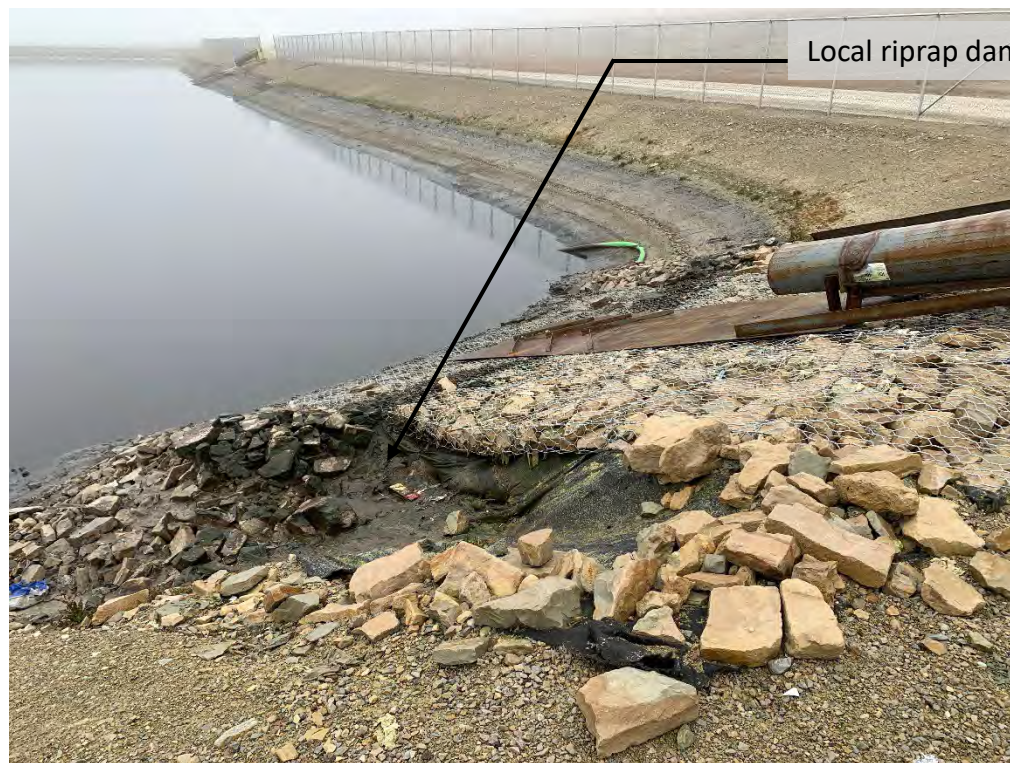
FIGURE  
A30

Local riprap damage

| Attributes | |
|---|---|
| Photograph | B – US –West Truck Discharge Facility (#3) -Local Riprap Damage |

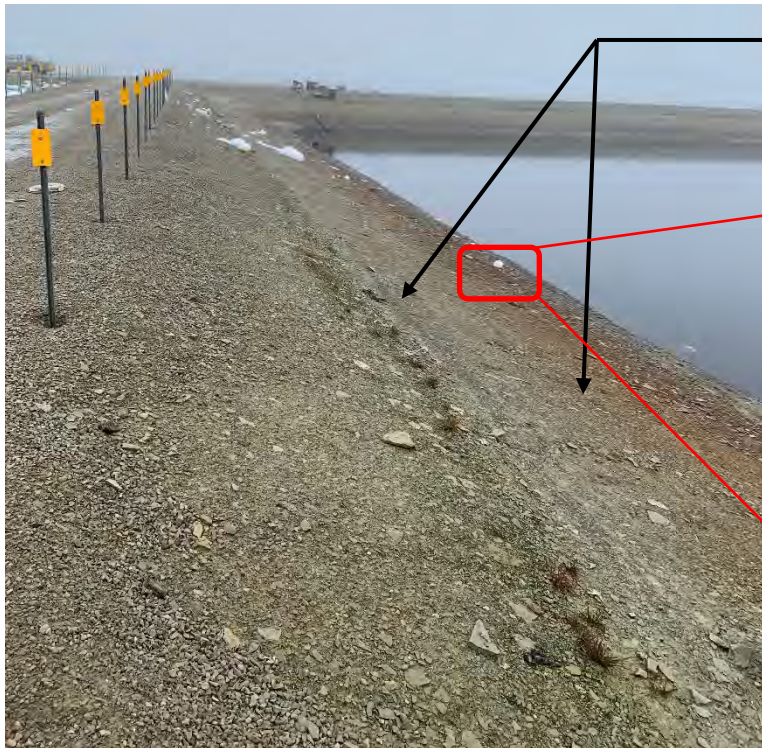
FIGURE  
A34

Generally good condition.

Sign of minor washout, noting the coarser particles

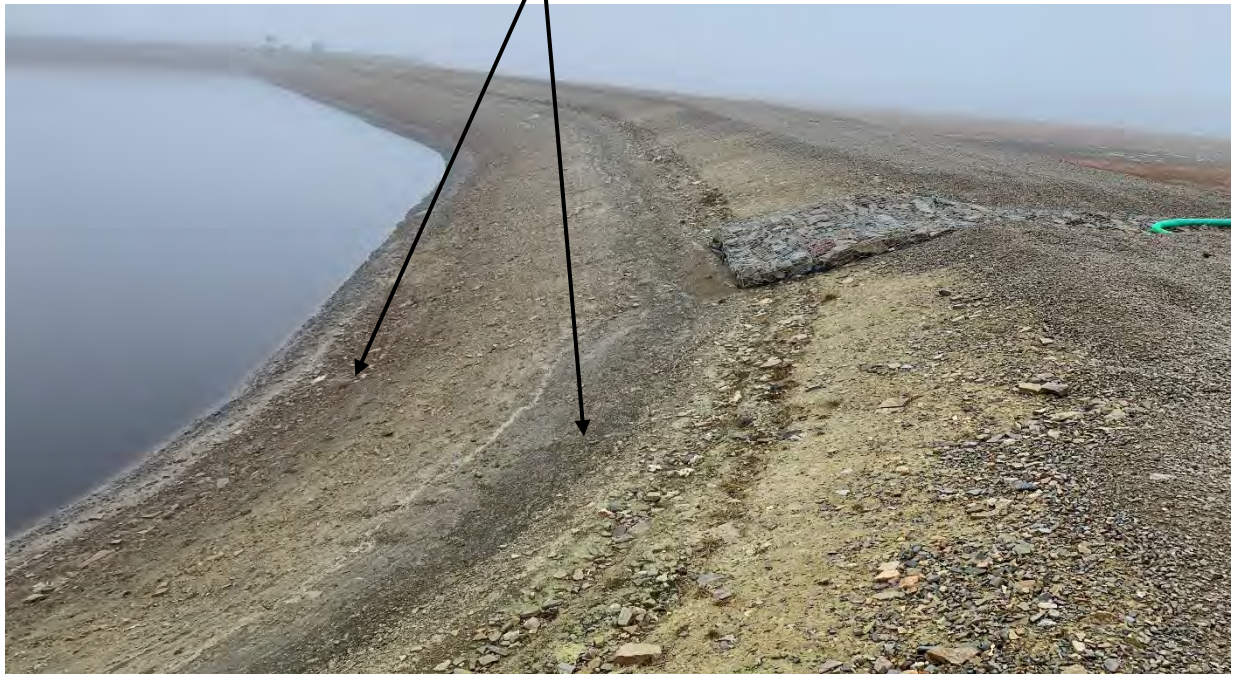
FIGURE  
A35

Generally good condition.

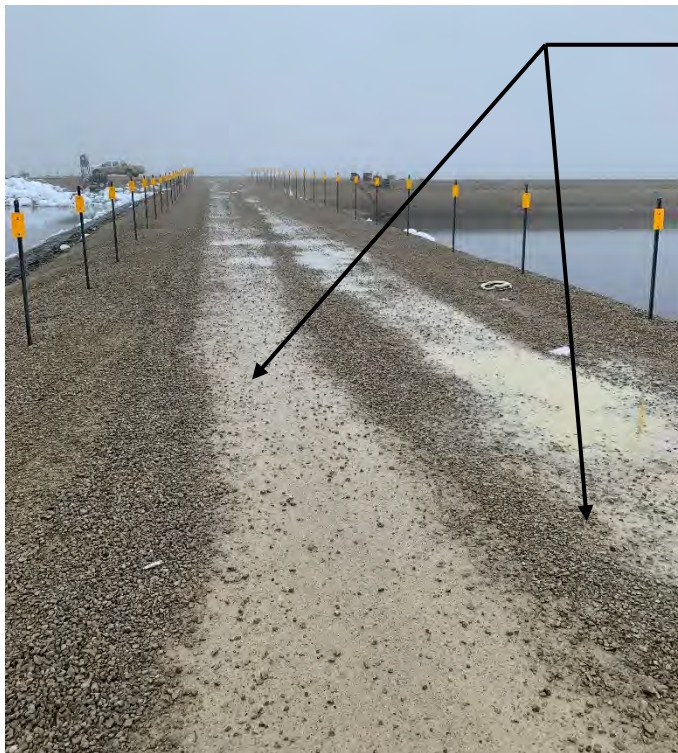
FIGURE  
A36

Crest generally in a good condition.

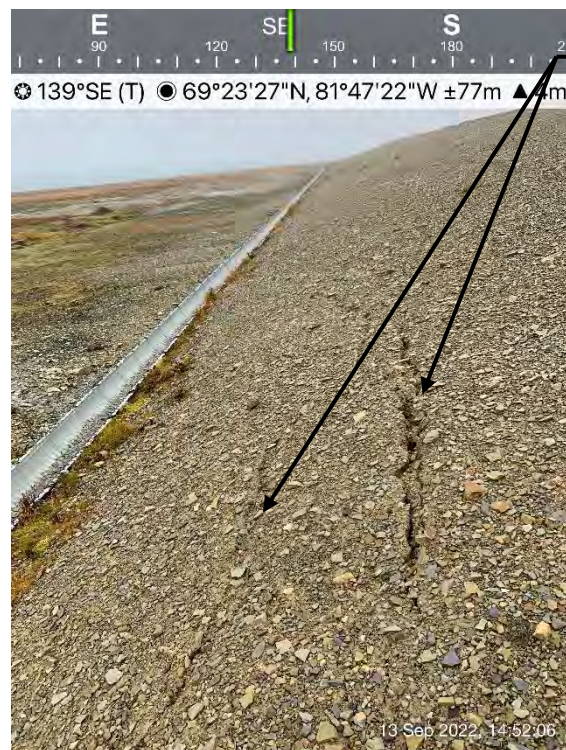
FIGURE  
A39

Minor cracks near the toe line

Signs of erosions (e.g. erosion below trough, gullies)

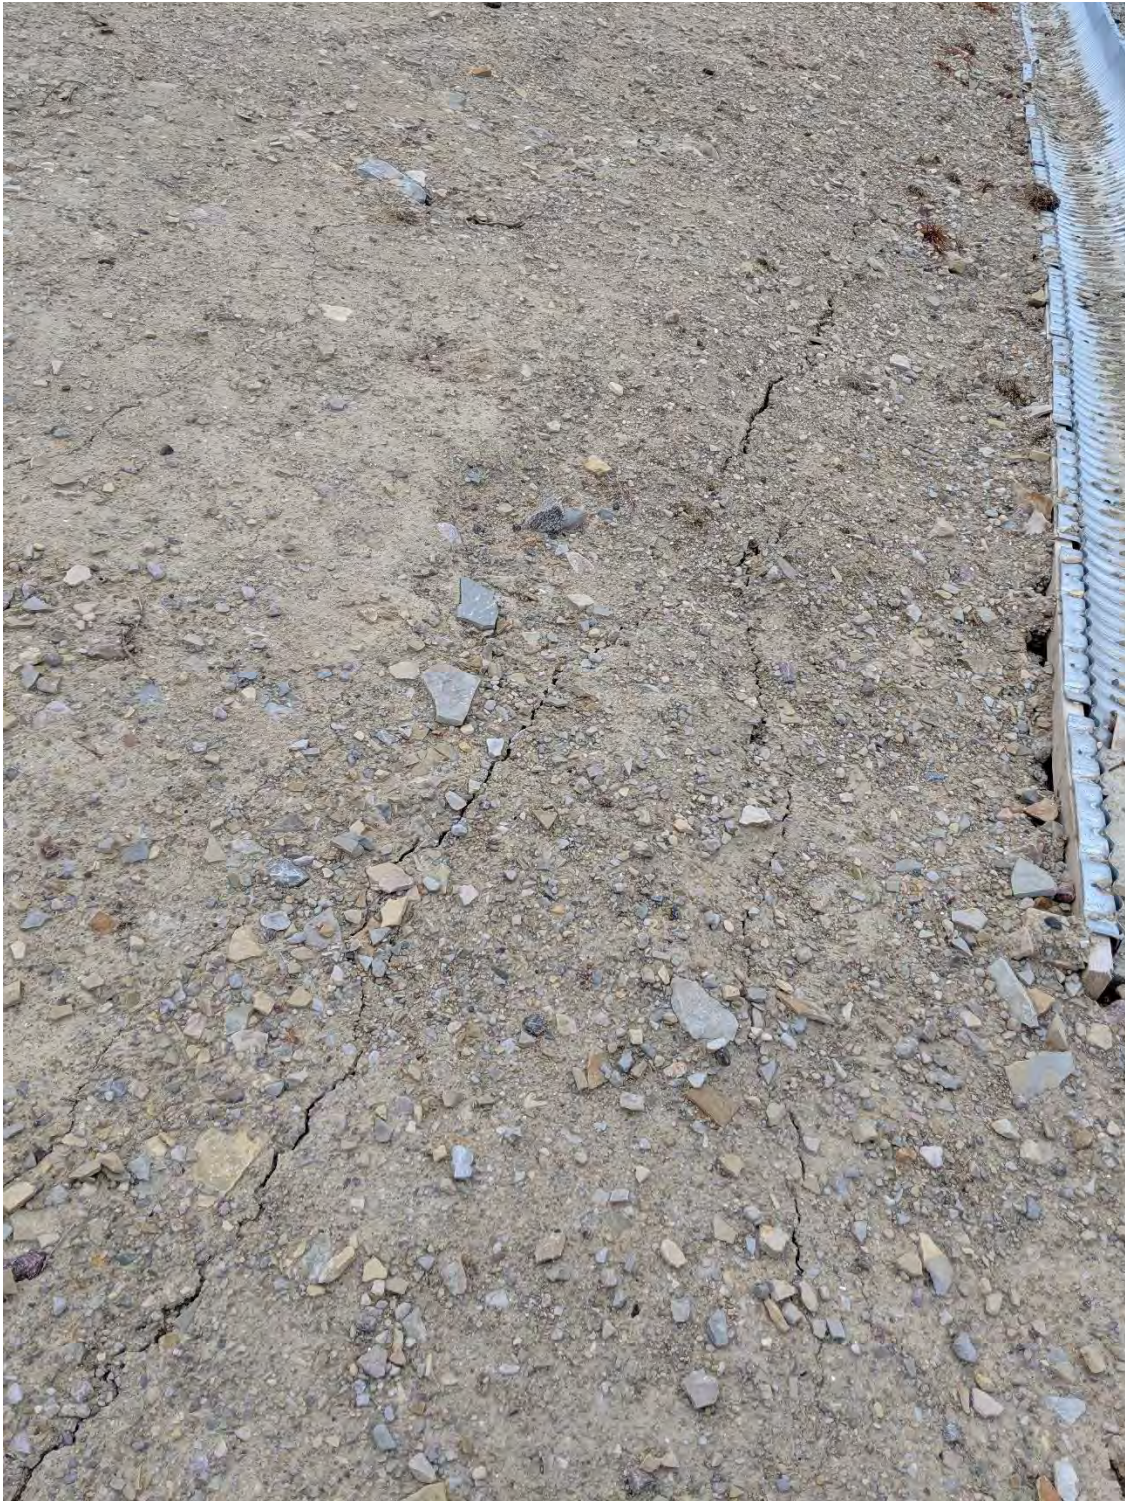
**Photograph #1: Settlement Cracking of the soil around the lagoon.**

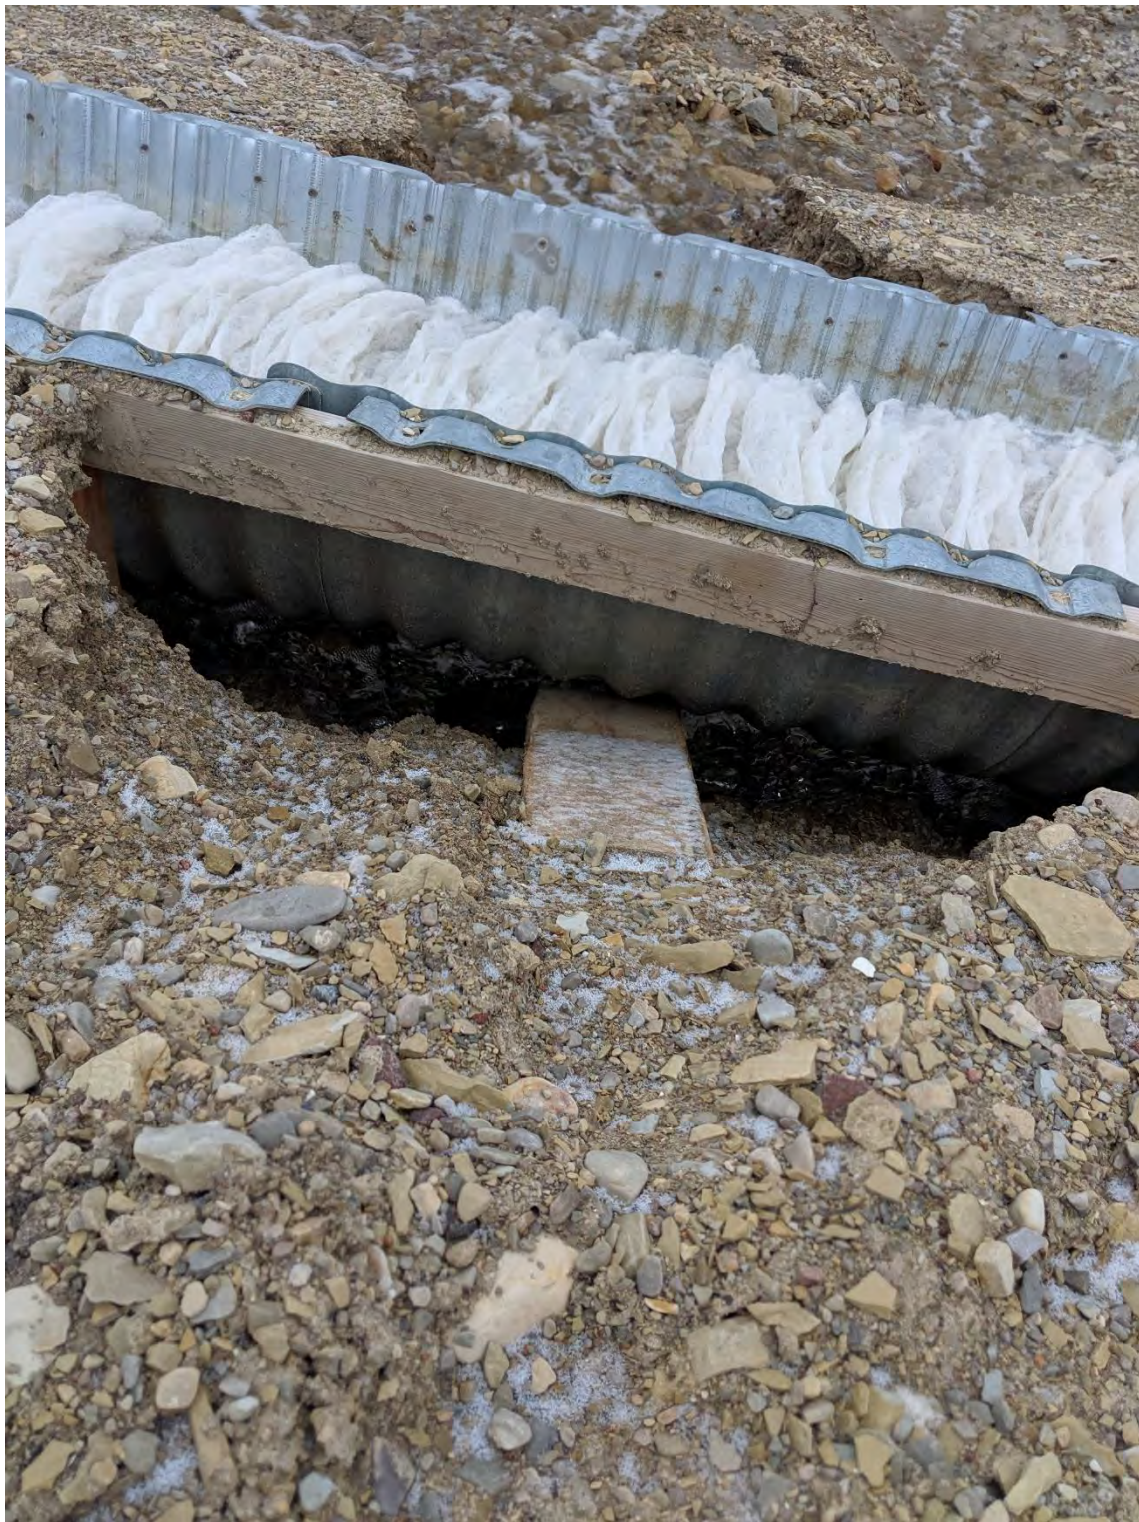
Figure 4: One of several washouts along the drainage trough.

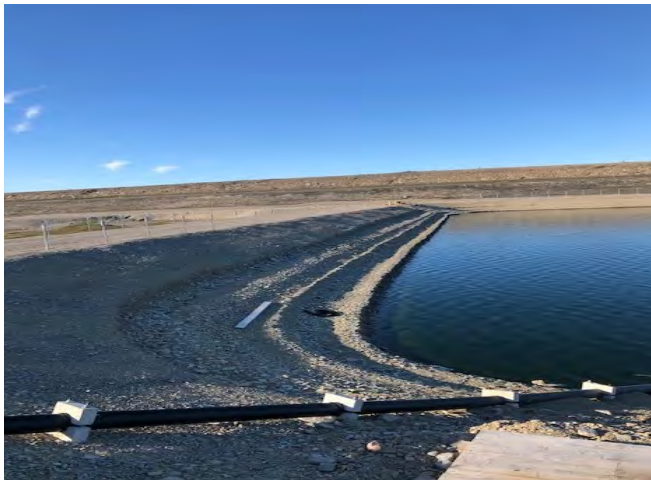
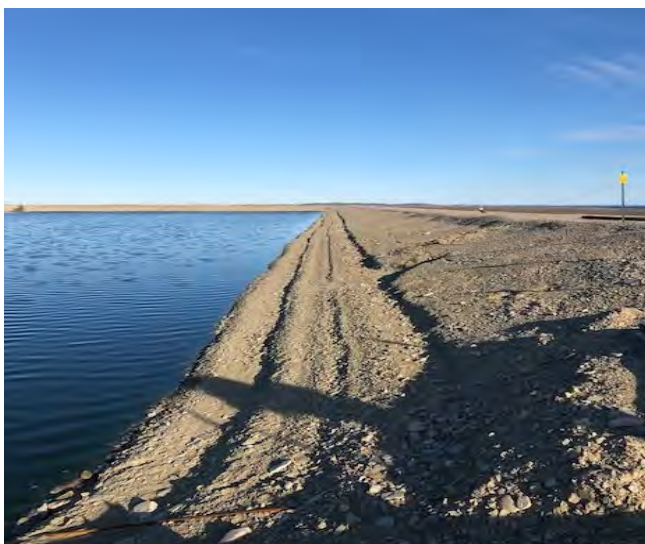
- Inspection of Interior berms in cell “A” has identified concerning process of soil breaking off in a visible three step process and collapsing into the sewage. As per IFT documents interior berms in contact with sewage should be lined. As per pictures attached, there is no visible sign of the installed liner. Interior berms within Cells B and C had no visible interior berm damages/washouts

Collapsing interior berm soil within cell “A”

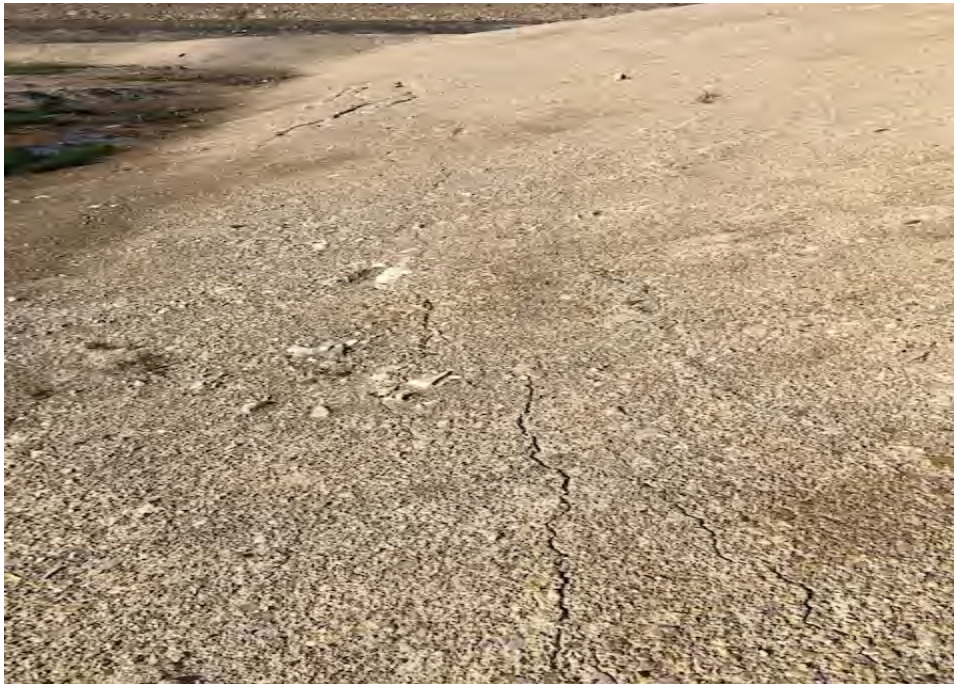
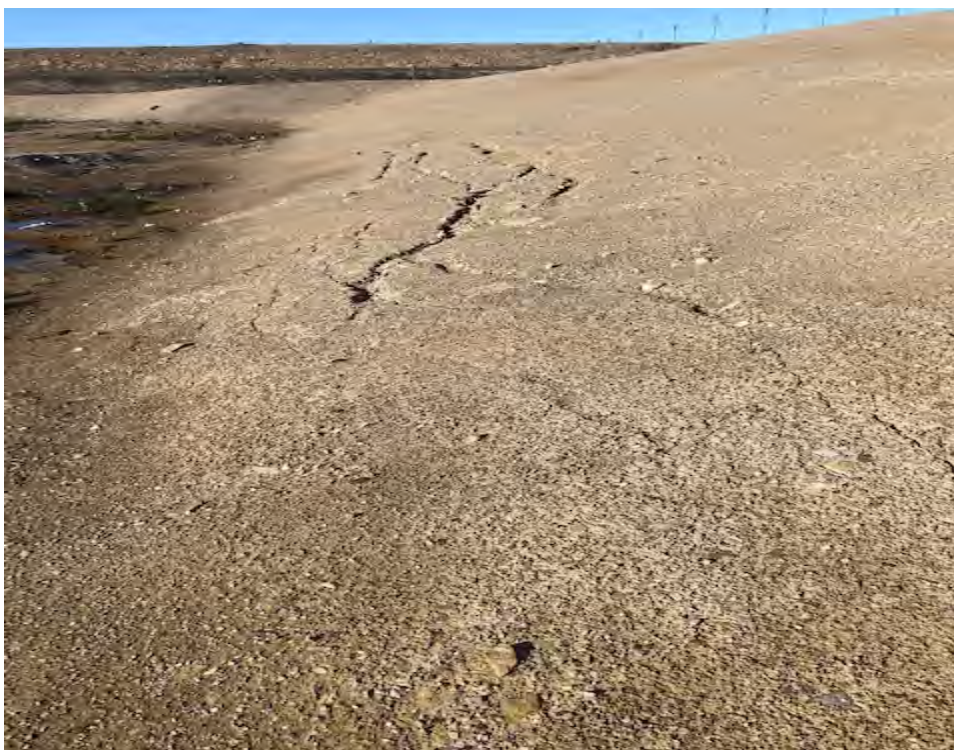
- Soil on all three exterior cells berms is experiencing some cracking. Possible causes of soil cracking might be caused by the settlement during freeze-thaw cycles, or improper compaction during the construction.
- **Concerning are observed significant signs of cracked soil and signs of exfiltration in the soil of the lagoon cell “A” facing cell “B”** (Pls see 2 pictures bellow)

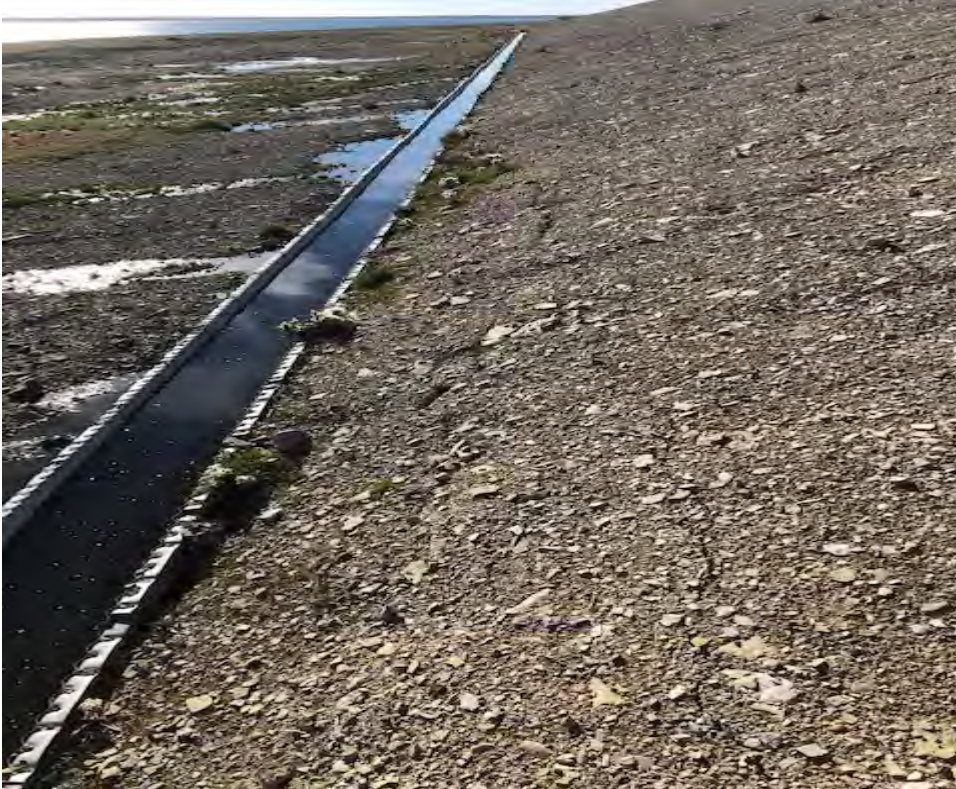
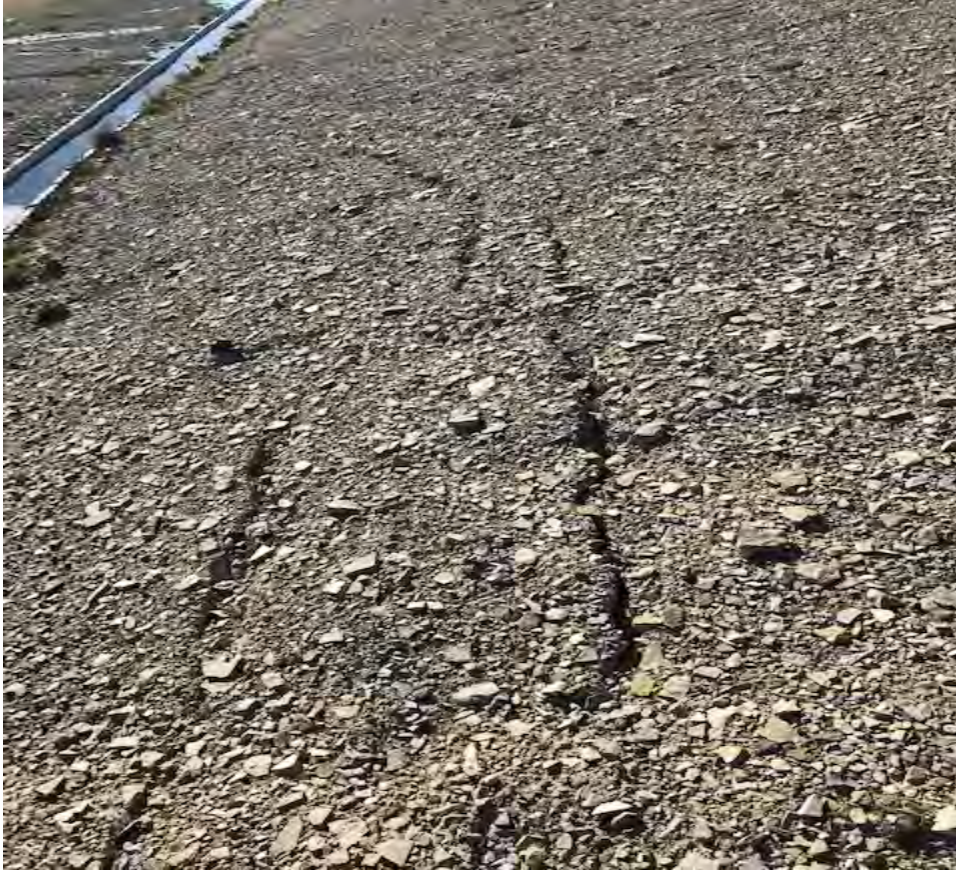
- There was no visible creeping or sliding soil movement noticed in any of 4 berms
- During the walkthrough, sewage pumping was performed on cell “B”. It was observed that the wastewater pumped out of the lagoon was causing erosion along the trough located on the North side of the lagoon (facing wetland and ocean). Observed are **significant washouts** along the troughs.

- Since there are no as-built records saved for this project, further involvement of the professional geotechnical engineering firm will be required to assess safety and structural integrity of the berms.
- **CGS has secured the funds and has commenced with a hiring process of a professional Geotech firm that will conduct thorough facility inspection during 2022 Summer/Fall construction season. Inspection Findings will define deficiencies and provide Scope of work along with a cost estimate for all construction activates to follow**
