IGLOOLIK WASTEWATER TREATMENT FACILITY

SEWAGE LAGOON BERM 2022 DAM SAFETY INSPECTION, IGLOOLIK, NUNAVUT

PROJECT NO.: TE0223017
DATE: OCTOBER 2022

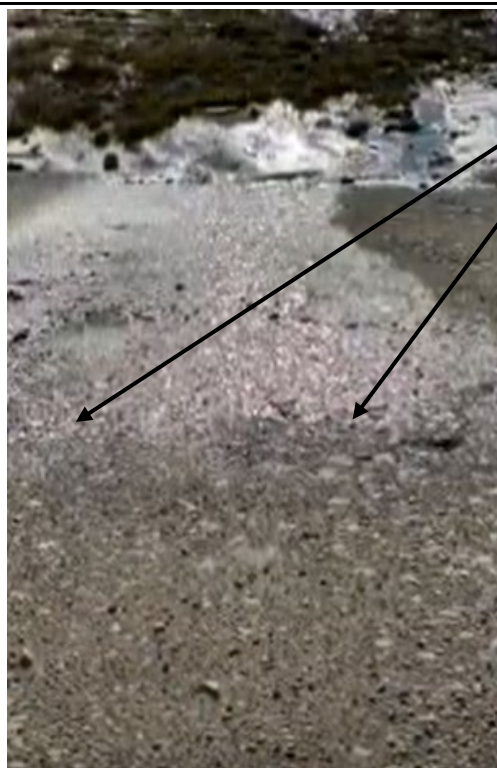
FIGURE
A6

Signs of seepage, i.e., a discolored zone, were observed along the east berm, over an area approximately 5 m wide, as shown in Figure A6 in Appendix A. Figure A7 presents a photo showing active seepage on August 29, 2021, which was taken and provided by Mr. Steve Weedmark. The following is a summary of communication with Mr. Steve Weedmark regarding this seepage issue:

- The seepage occurred when the water level reached the maximum operation level.
- The seepage reduced and stopped when the water level dropped by about 150 mm below the maximum operation level.
- No seepage in this area was observed/reported in the past from the completion of construction up until 2021.

Active seepage zone observed when Cell A had high water level.

Note: Photo was taken by Mr. Steve Weedmark on August 29 2021.

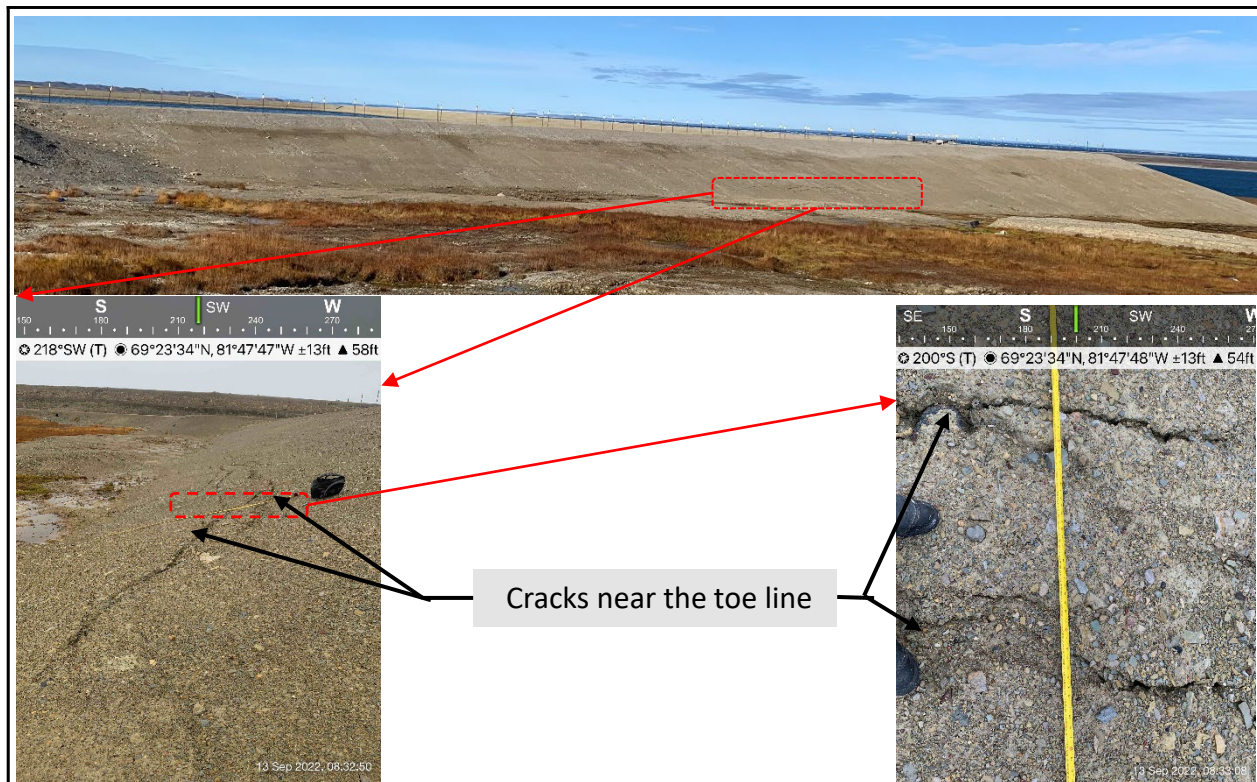
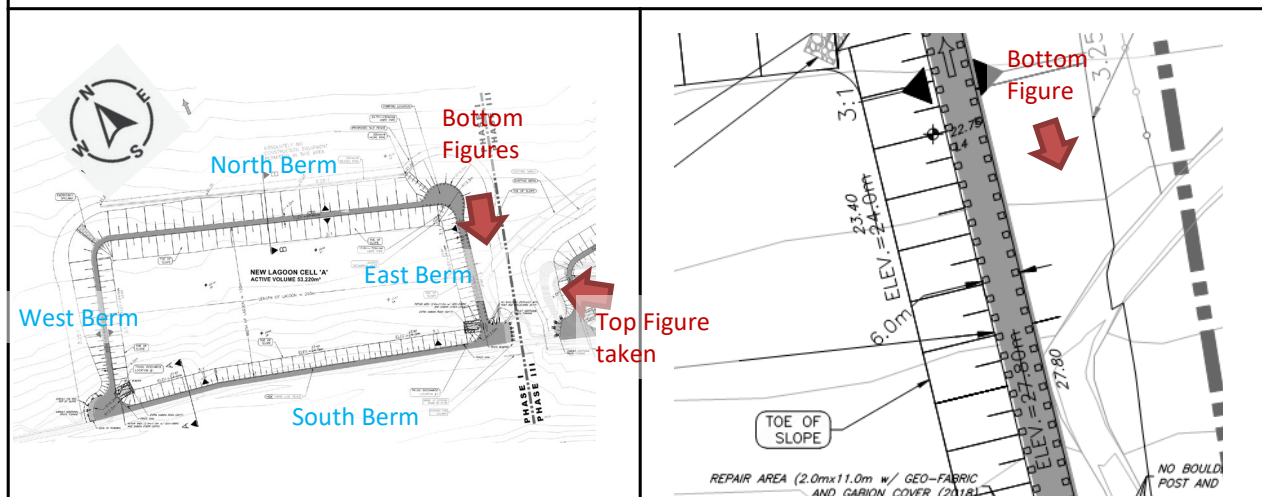
FIGURE
A7

Significant cracks were observed on the downstream slope about 60 to 80 m south from the north end of the east berm, as shown in the top photo in Figure A8. They were located within a zone approximately 20 m wide and about 3.5 m away from the toe. The cracks were typically about 50 mm wide, up to 200 mm wide.

There was some localized areas of water ponding at the downstream toe; the water was clear and showed no sign of active seepage or sink holes during inspection. The cracks are possibly due to (1) frost action (freeze/thaw), (2) settlement due to the potential thawing of a local ice rich soil deposit in the foundation after operation of Cell A over time, or (3) soil movement due to insufficient compaction within the identified zone.

Attributes	
Photograph	A – DS – East Berm
Description	View of cracks at downstream slope
Observations	<ul style="list-style-type: none"> - Cracks at downstream slope, about 3.5 m away from the toe line. Crack widths about 50 mm, upto 0.2 m. - Water ponding near the toe line are clear. No sign of active seepage / sink holes during inspection.
Remarks	There are a set of cracks near the toe line, possibly due to thermal stabilization at toe or local slope slough.

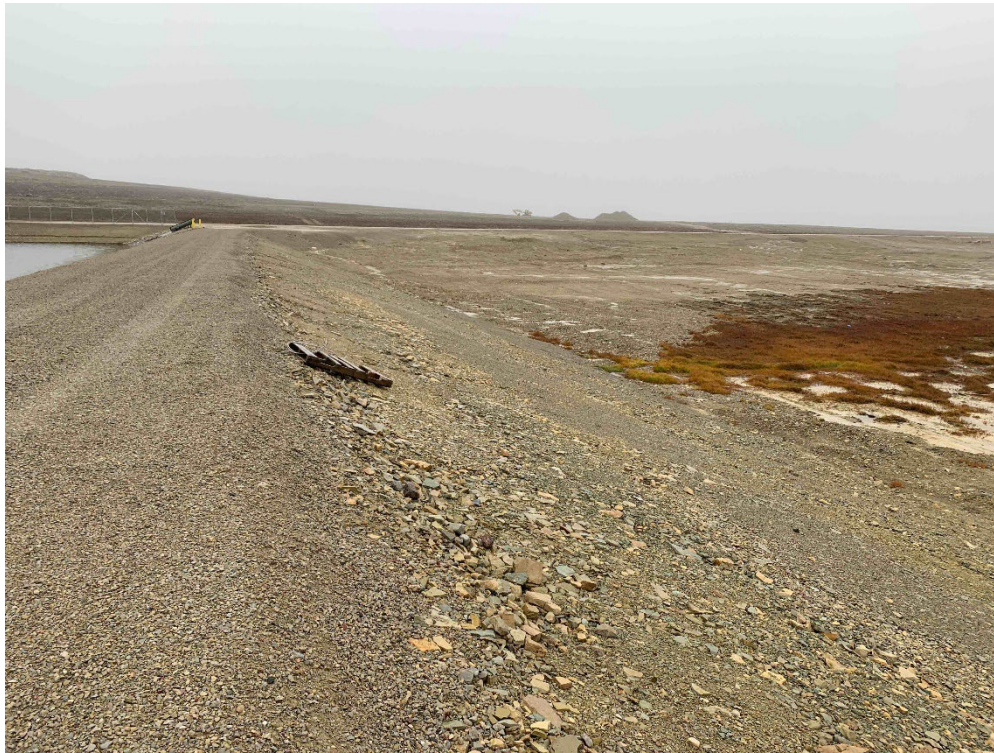
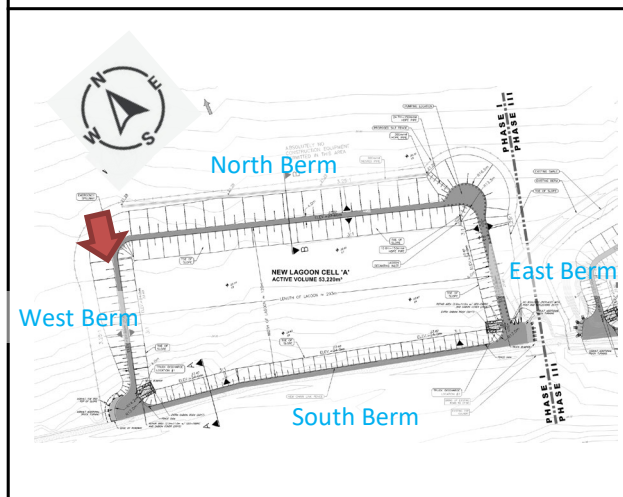
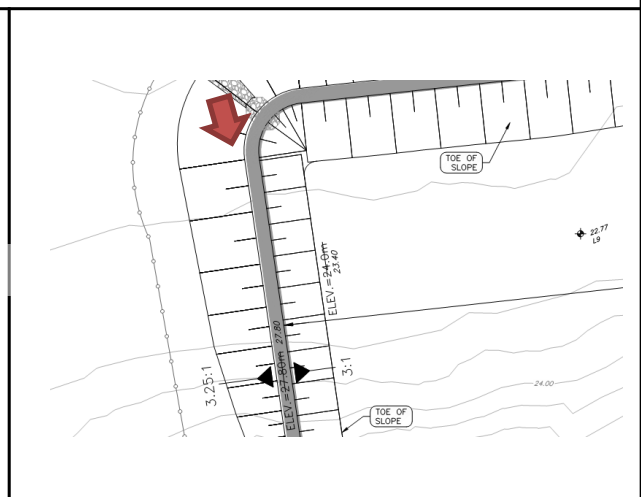
FIGURE
A8

Attributes	
Photograph	A – DS- West Berm
Description	View of downstream slope
Observations	No sign of cracks, active seepage, or sink holes. No sign of erosion.
Remarks	The downstream slope is in a good condition.

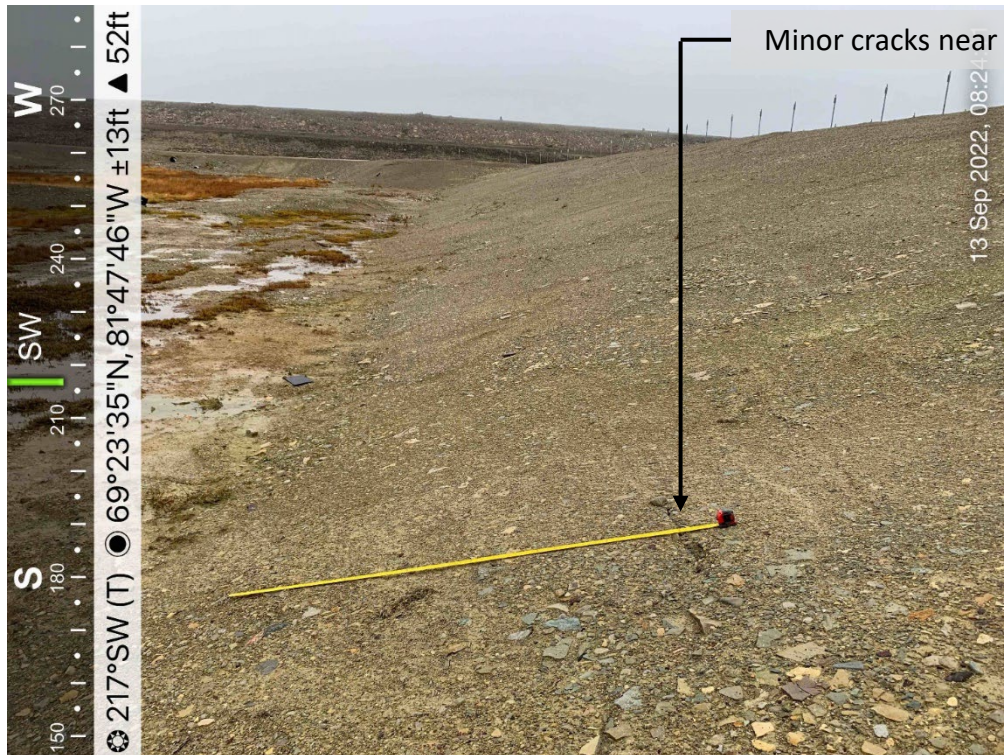
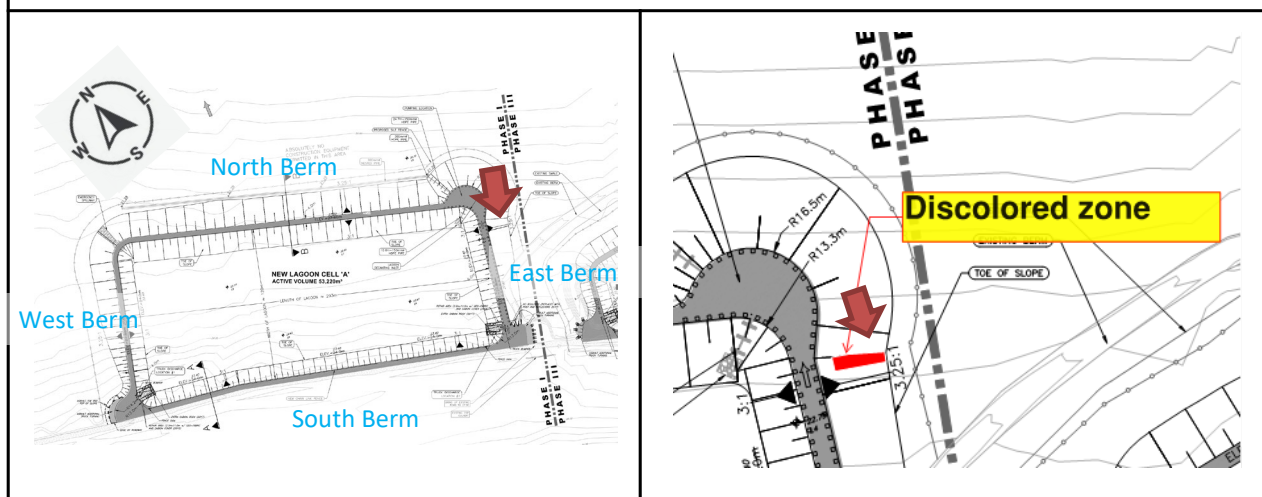
FIGURE
A9

Attributes	
Photograph	A – DS – East Berm
Description	View of minor cracks at downstream slope
Observations	-Minor cracks at downstream slope
Remarks	Cracks are minor and isolated.

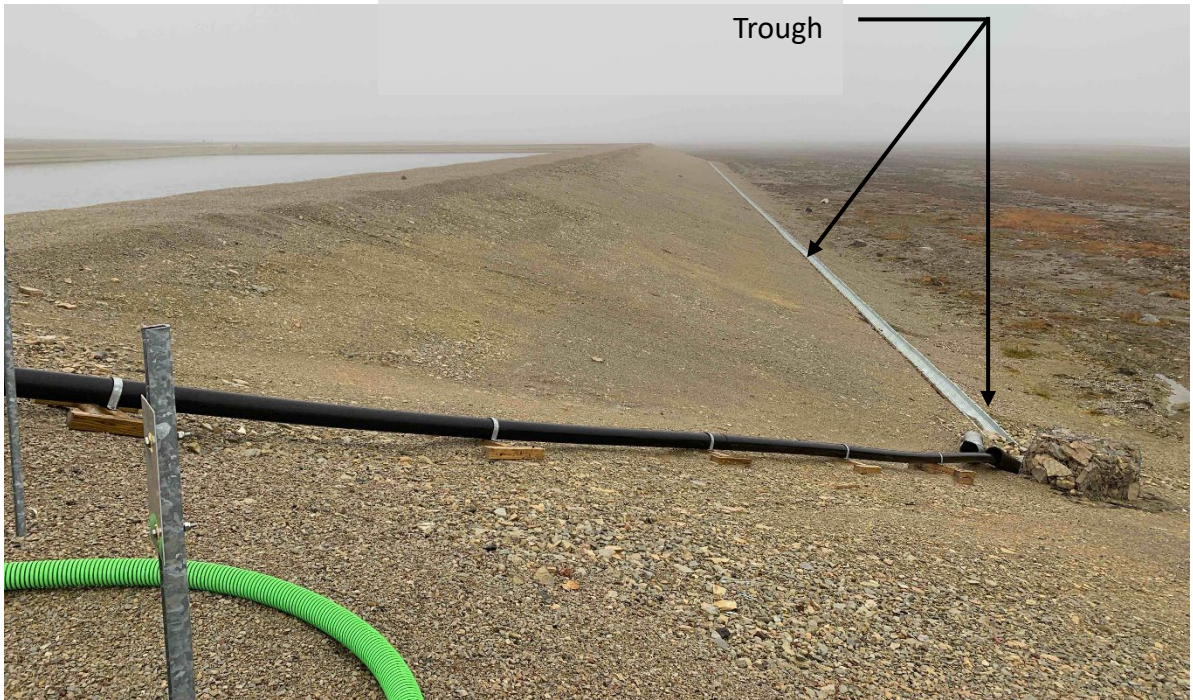
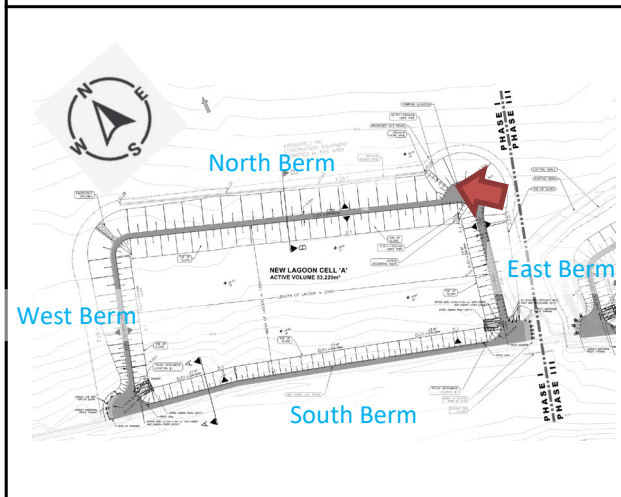
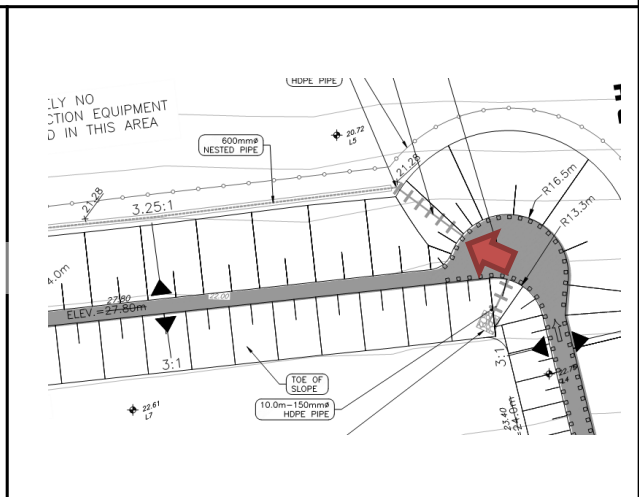
FIGURE
A10

Attributes	
Photograph	A – Trough
Description	View of decant pump outlet pipe and trough
Observations	The downstream slope is in a good condition. The outlet pipe is in a good condition
Remarks	N/A

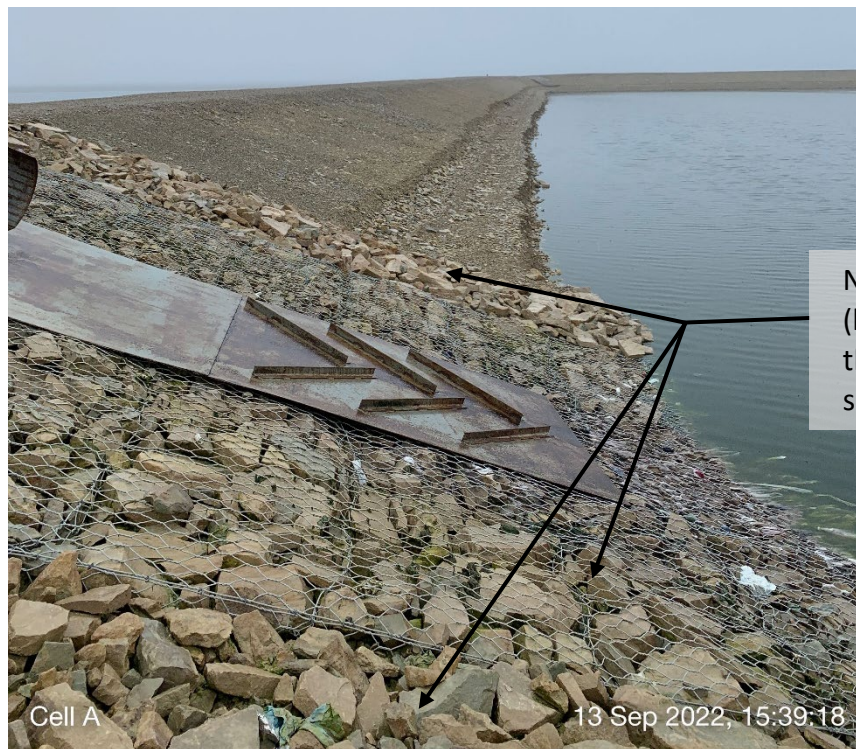
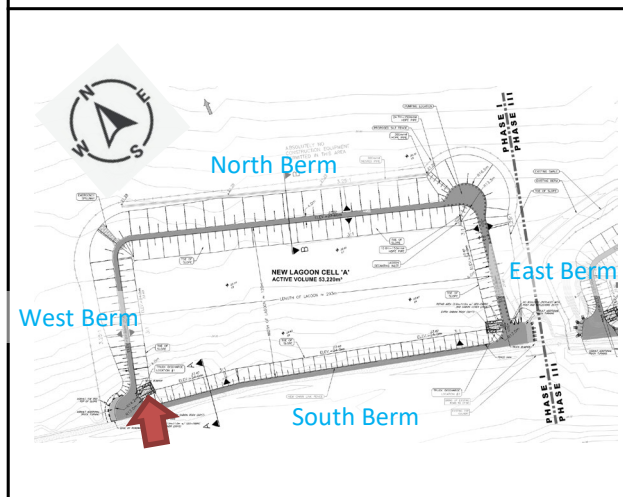
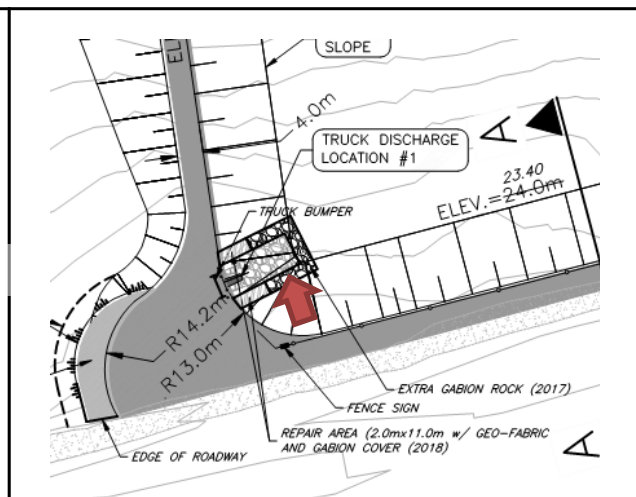
FIGURE
A12

Attributes	
Photograph	A – US – West Truck Discharge Facility (#1)
Description	View of upstream slope of West Truck Discharge Facility
Observations	-No visible issue (benches, wave erosion) for the riprap protected slope section, regardless of the presence of gabion box. -Truck Discharge Facility equipment in a good condition.
Remarks	West truck discharge area is in a good condition.

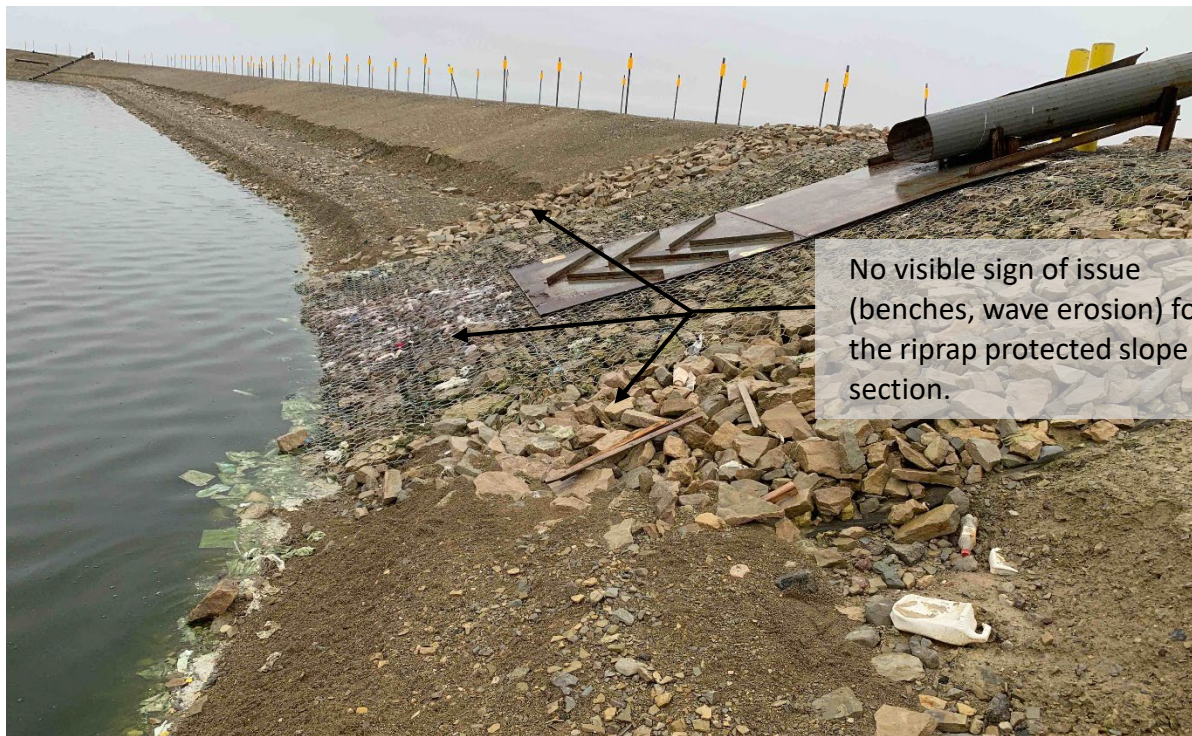
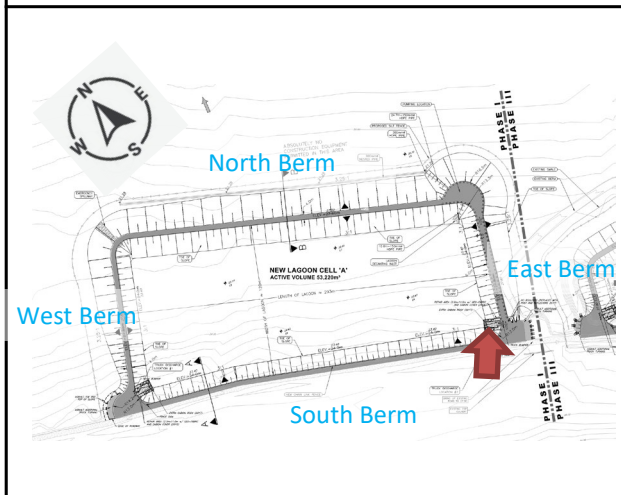
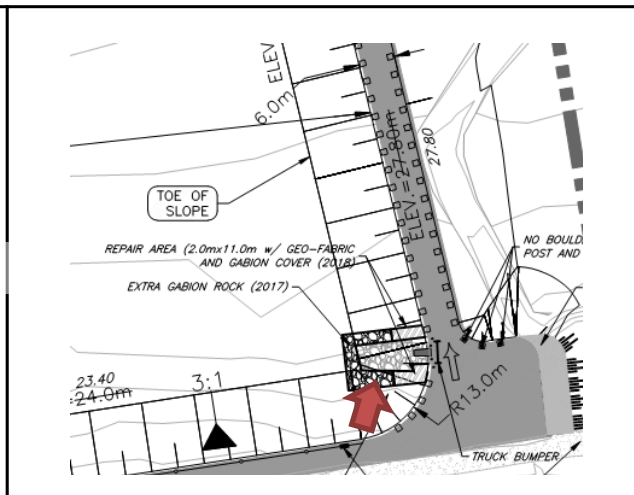
FIGURE
A13

The slope sections with riprap protection were in a good condition, as shown in the photographs taken near the truck discharge #1 and #2 in Figures A13 and A14 (Appendix A). No benches/steps, washout or other erosion was observed at the upstream slope protected by riprap, with or without gabion.

Attributes	
Photograph	A – US – East Truck Discharge Facility (#2)
Description	View of upstream slope of East Truck Discharge Facility
Observations	-No visible sign of issue (benches, wave erosion) for the riprap protected slope section, regardless the presence of gabion box. -Truck Discharge Facility equipment in a good condition.
Remarks	East truck discharge area is in a good condition.

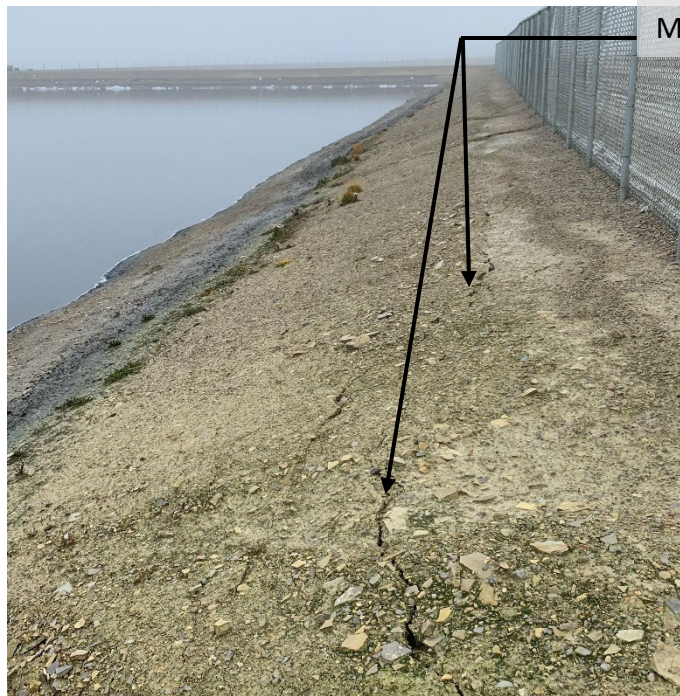
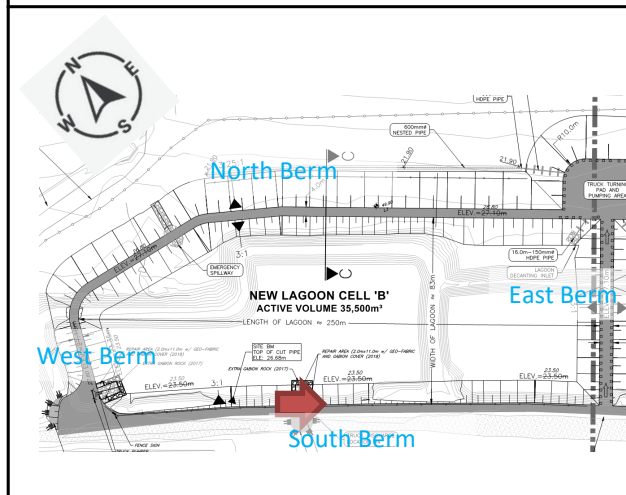
FIGURE
A19

Minor cracks

Attributes	
Photograph	B – Upstream Slope – South Berm
Description	View of upstream slope
Observations	Minor cracks were observed near crest, parallel with the longitudinal direction.
Remarks

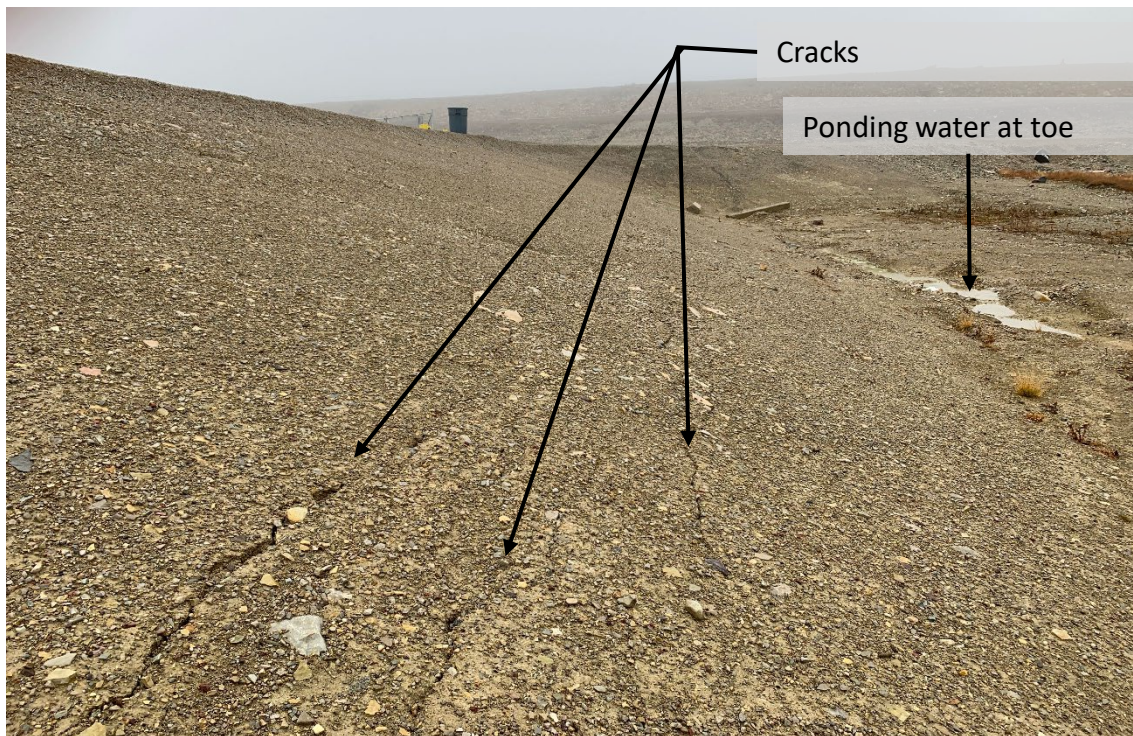
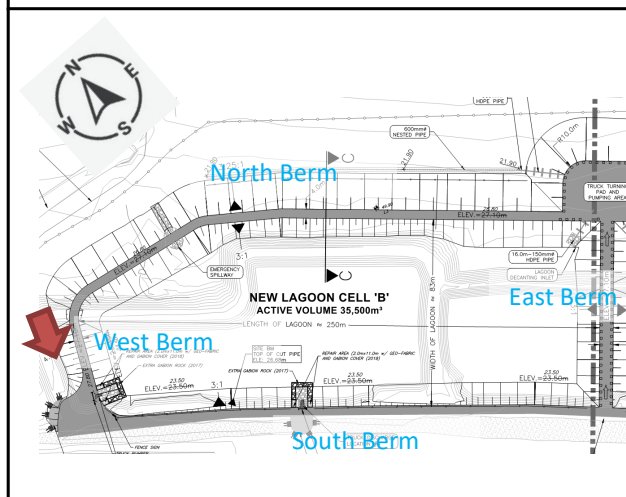
FIGURE
A23

Attributes	
Photograph	B – DS Slope – West Berm
Description	View of downstream slope
Observations	Minor cracks at downstream slope. The cracks are generally parallel with the longitudinal direction.
Remarks	Ponding water at toe. The water is clear and there was no sign of active seepage. The downstream slope is in a generally good condition. Some cracks were encountered and are likely due to frost action and/or thermal stabilization after construction.

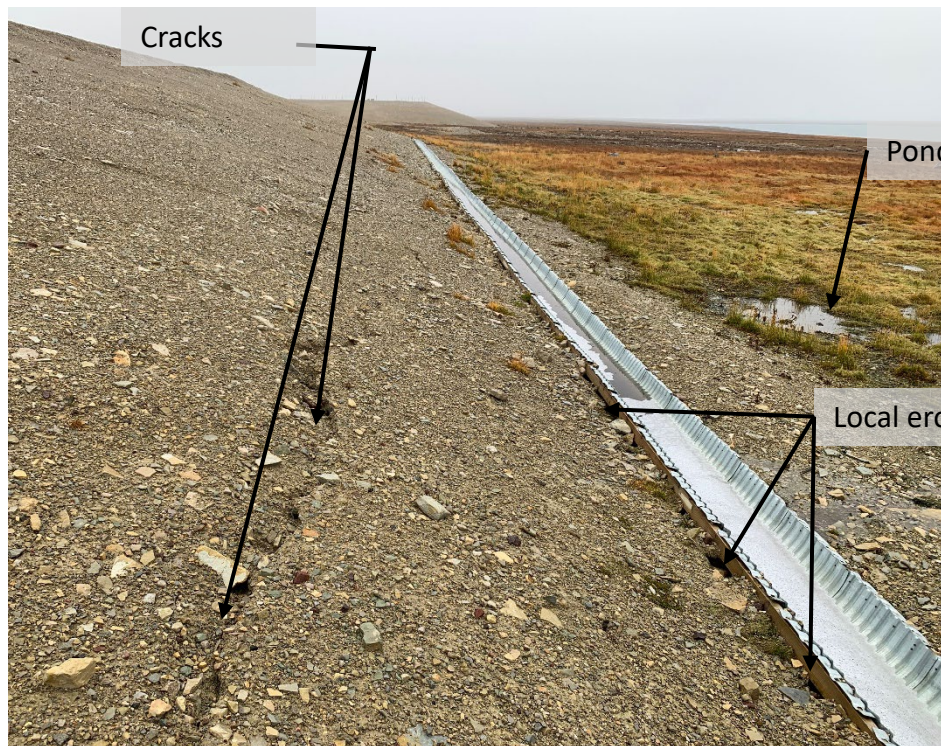
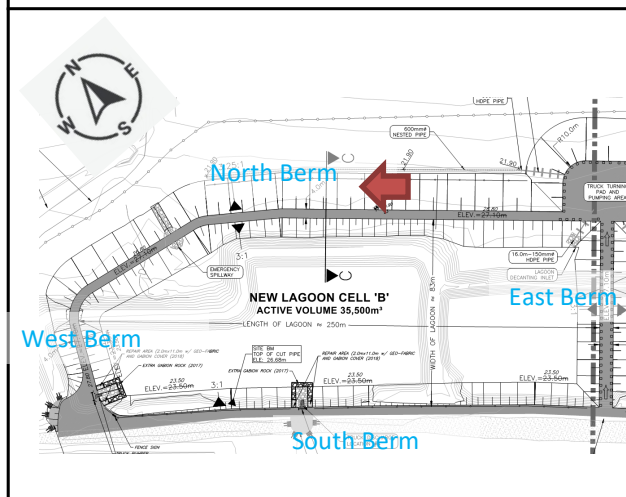
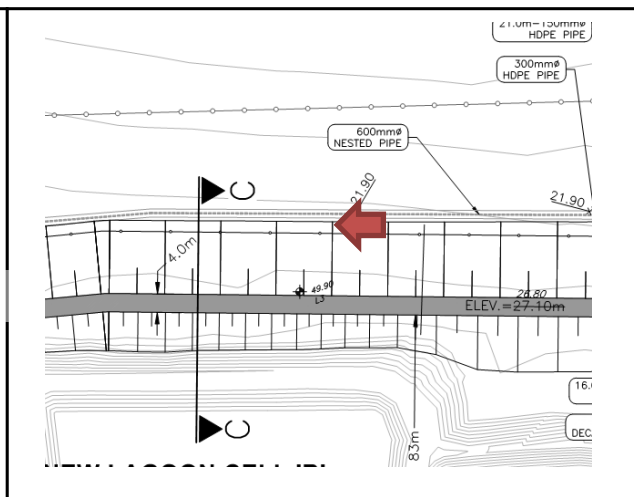
FIGURE
A27

Attributes	
Photograph	B –Trough - North Berm
Description	View of cracks and erosion at downstream slope and trough
Observations	Cracks at d/s slope near the tow trough. Some erosions near the trough. Ponding water near the toe, water is clear and there is no sign of active seepage.
Remarks	Water level in trough is well below the side wall. Signs of erosion near the trough. Cracks observed at d/s slope near the trough.

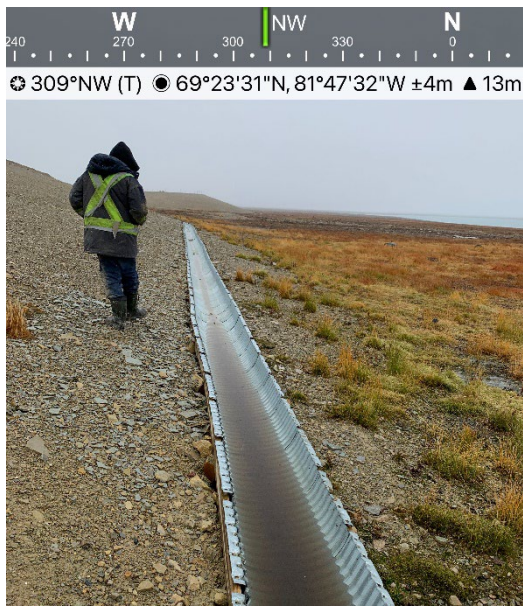
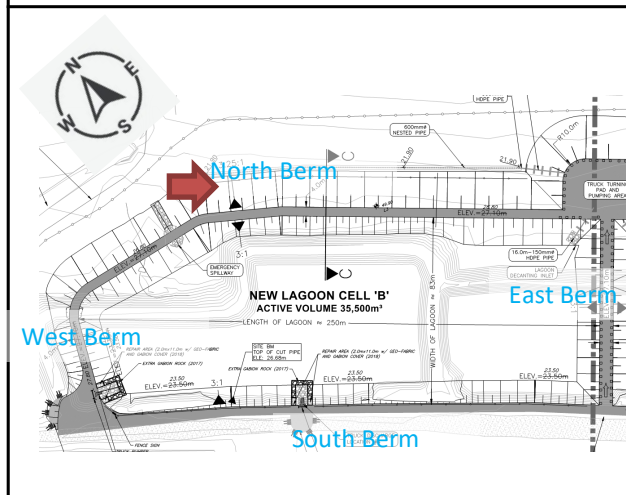
FIGURE
A28

Water level in trough reduced to a dry condition at about 1/3 of the trough

Dry condition at the end of the drainage trough.

Photograph	B –Trough - North Berm
Description	View of trough
Observations	Dry condition was encountered along the westerly one third of the trough.
Remarks	The site grading may cause the dry condition of the trough during decanting.

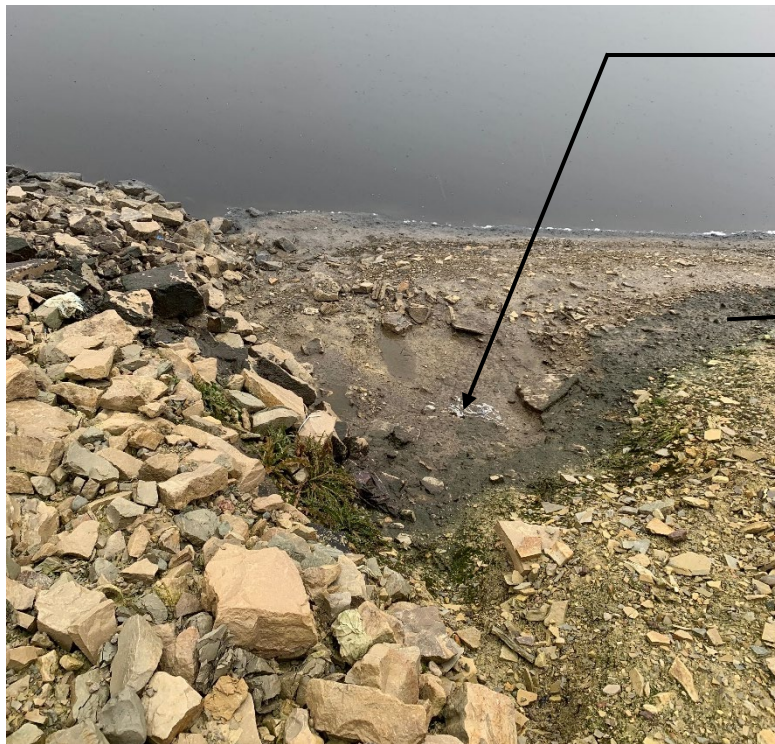
FIGURE
 A29

Local riprap damage

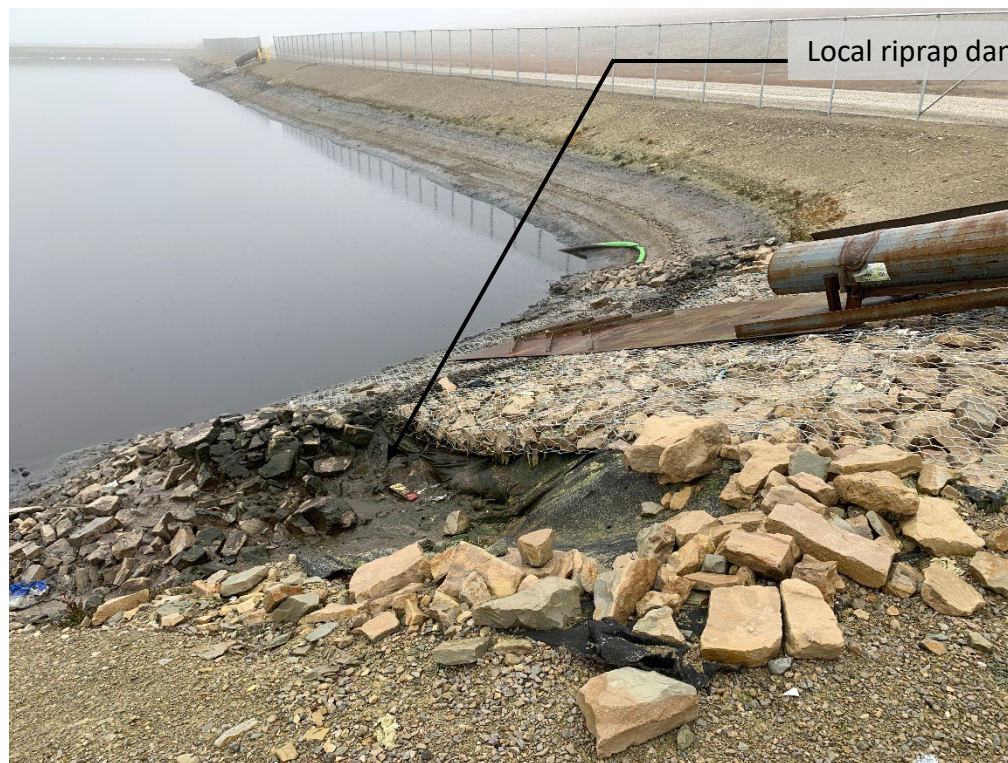
FIGURE
A30

Attributes	
Photograph	B – US –West Truck Discharge Facility (#3) -Local Riprap Damage
Description	View of local riprap damage at upstream slope
Observations	Sign of riprap damage from waste-water dumping. The operation staff indicated that the riprap damage was due to the truck dumping away from the designed location.
Remarks	There are signs of local riprap damage from truck dumping slightly off the designed discharge location.

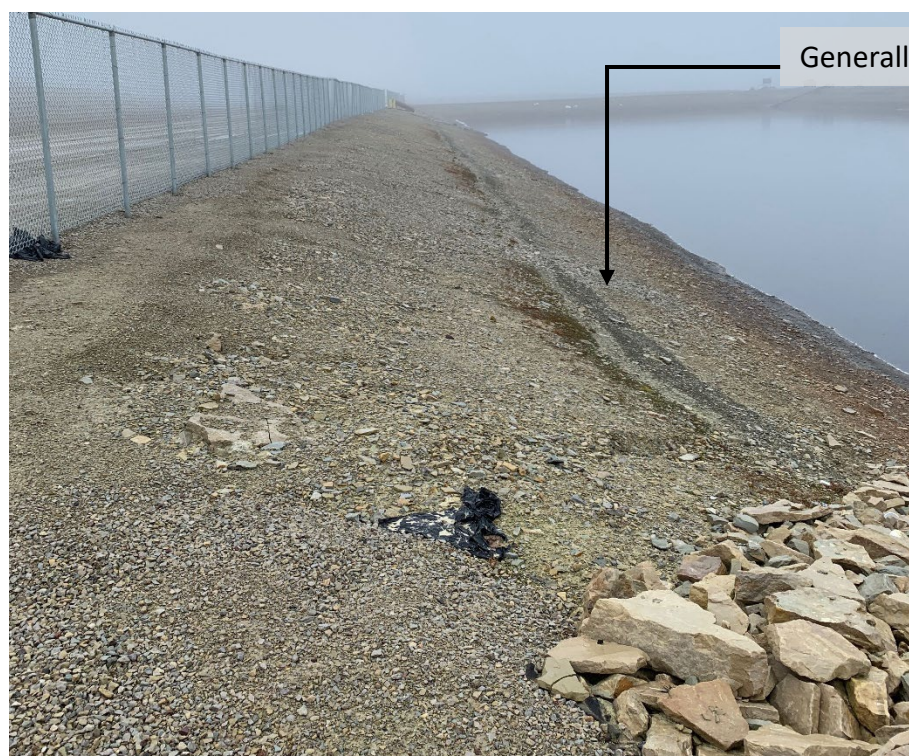
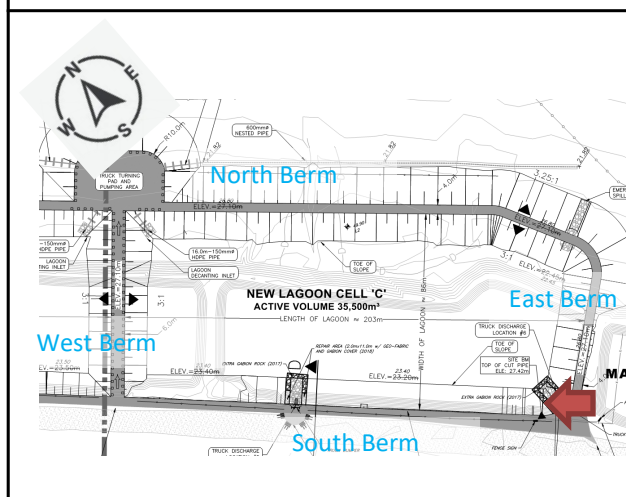
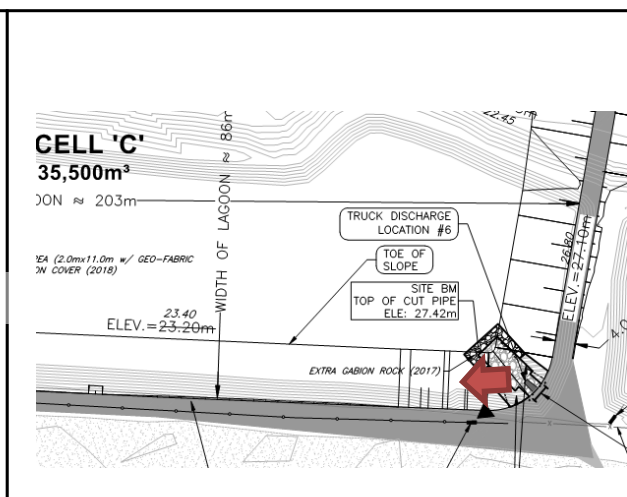
FIGURE
A32

Attributes	
Photograph	C – US –South Berm
Description	View of upstream slope
Observations	No visible signs of erosion such as soil steps or benches.
Remarks	The slope is in a good condition

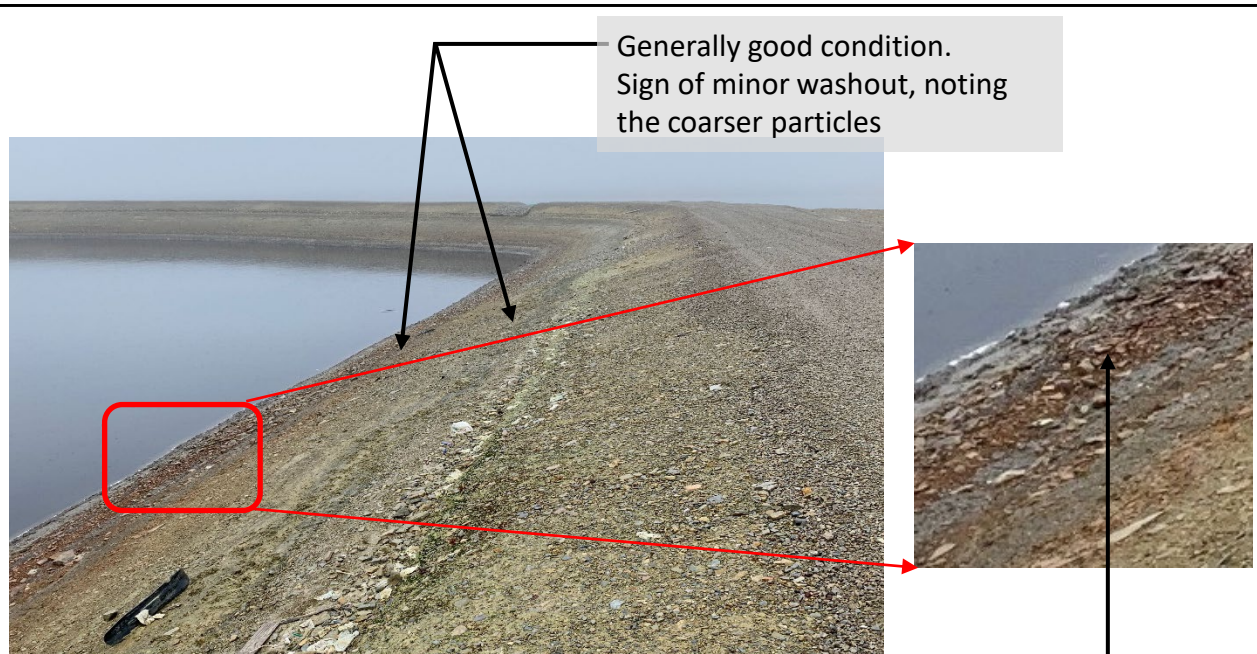
FIGURE
A33

Generally good condition.
Sign of minor washout, noting
the coarser particles

Sign of minor washout,
noting the coarser particles

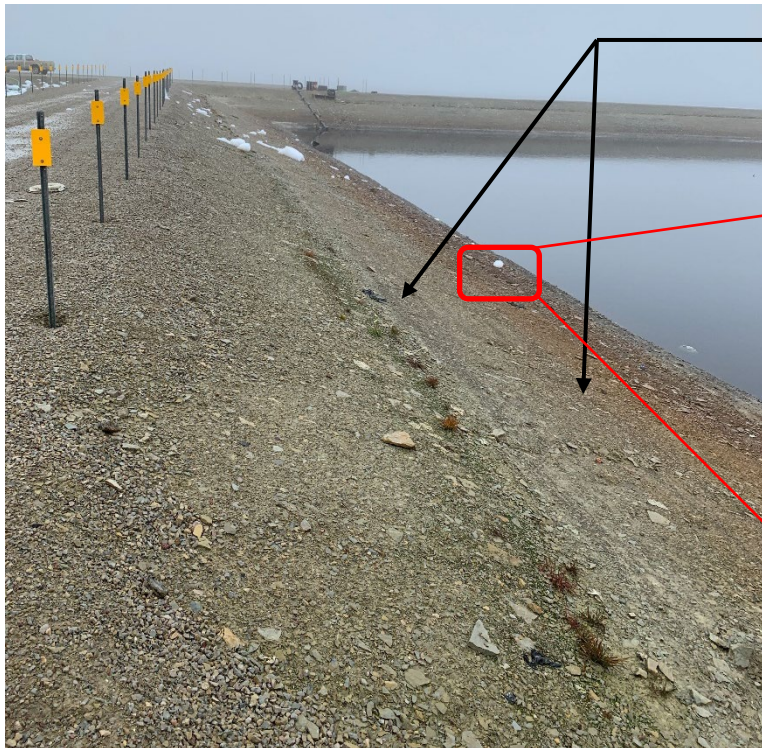
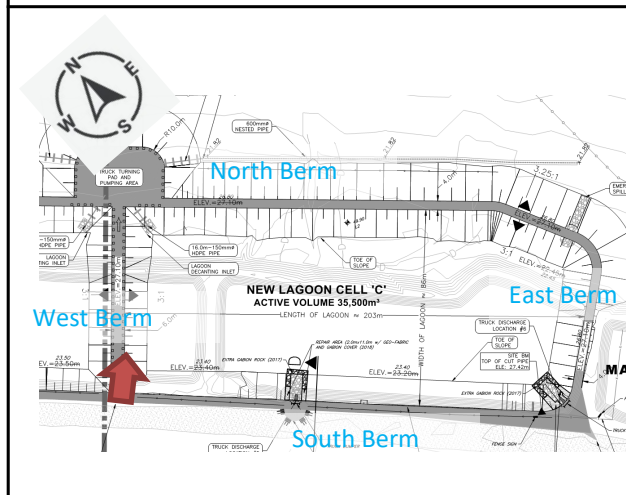
FIGURE
A34

Generally good condition.

Sign of minor washout, noting the coarser particles

Photograph	C – US – West Berm
Description	View of upstream slope
Observations	No visible signs of significant erosion such as soil steps or benches. Sign of minor washout, noting the coarser particles.
Remarks	The slope is in a good condition

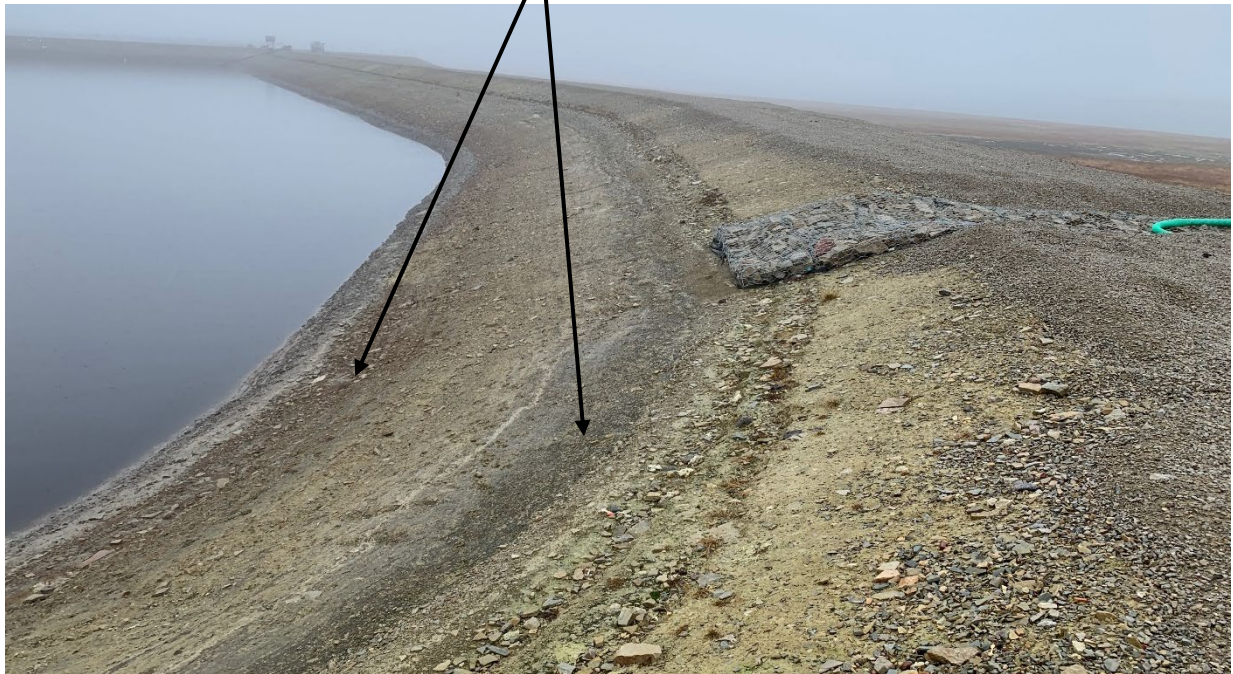
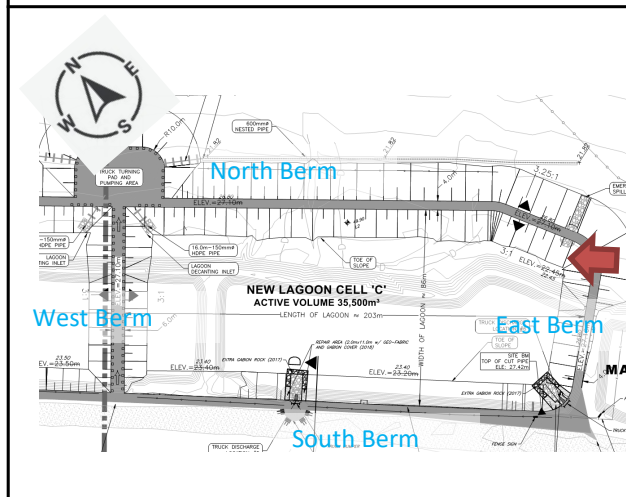
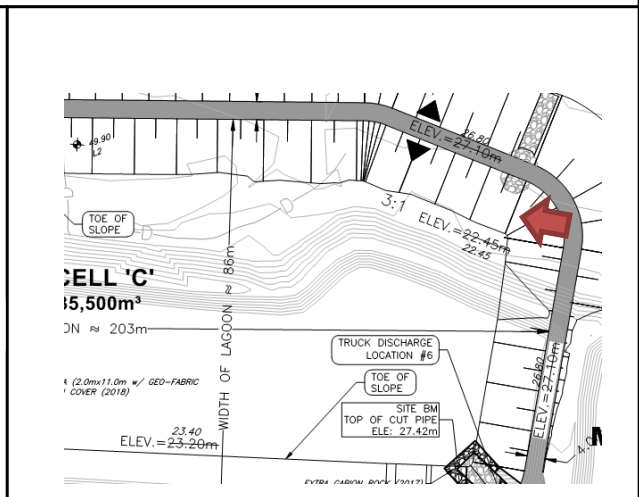
FIGURE
A35

Attributes	
Photograph	C – US – North Berm
Description	View of upstream slope
Observations	No visible signs of erosion.
Remarks	The slope is in a good condition

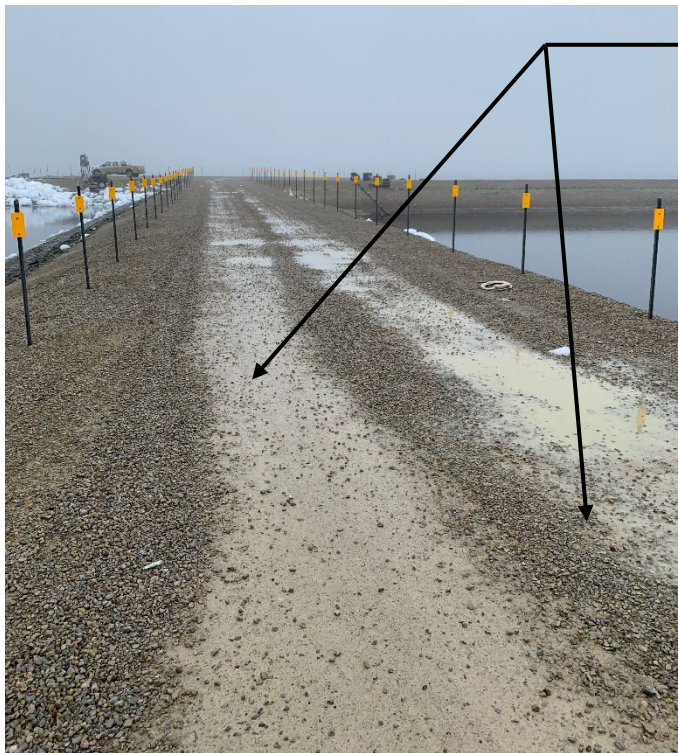
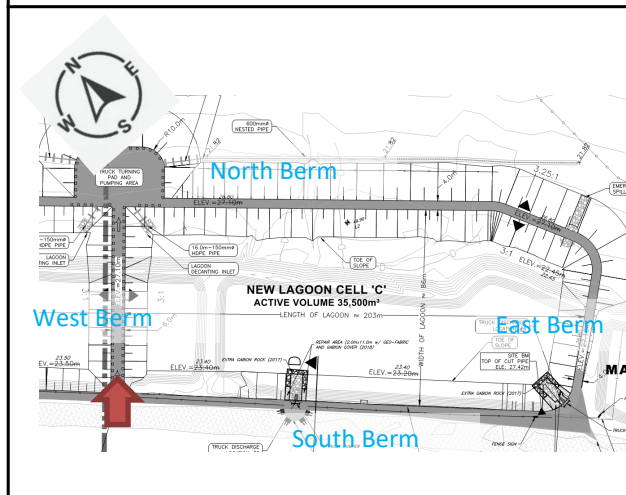
FIGURE
A36

Crest generally in a good condition.

Photograph	C – Crest – West Berm
Description	View of crest
Observations	No signs of settlement, erosion, cracks.
Remarks	The crest is in a good condition.

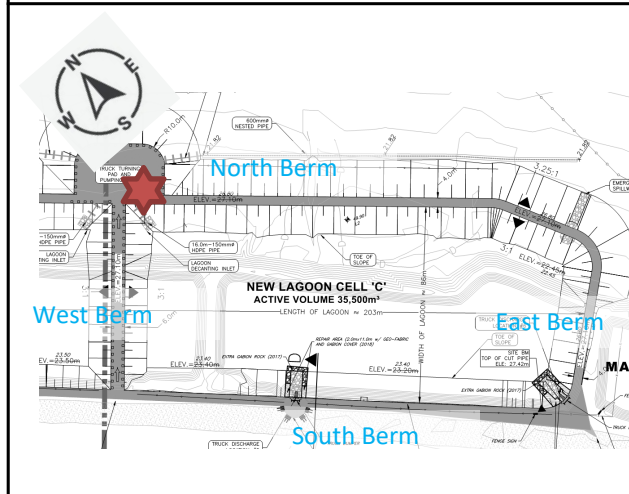
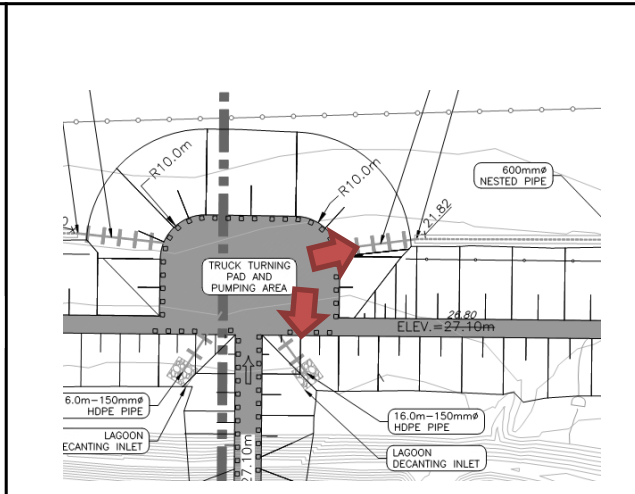
Photograph	C – Pump – Inlet and outlet at North Berm
Description	View of Inlet and outlet
Observations	Equipment not in operation. Sign of drainage towards west side.
Remarks	The pump equipment appears in a good condition. It indicates that some drainage may flow to west instead following the trough as designed.
