IGLOOLIK WASTEWATER TREATMENT FACILITY

SEWAGE LAGOON BERM 2022 DAM SAFETY INSPECTION, IGLOOLIK, NUNAVUT

PROJECT NO.: TE0223017
DATE: OCTOBER 2022

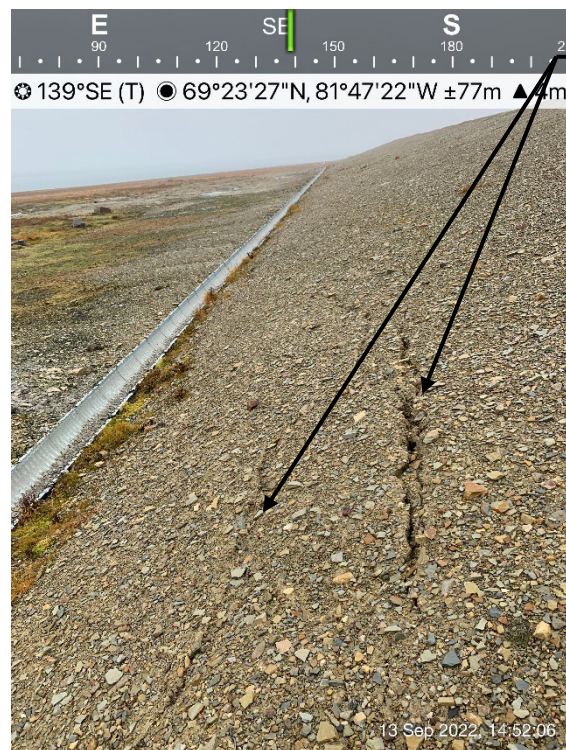
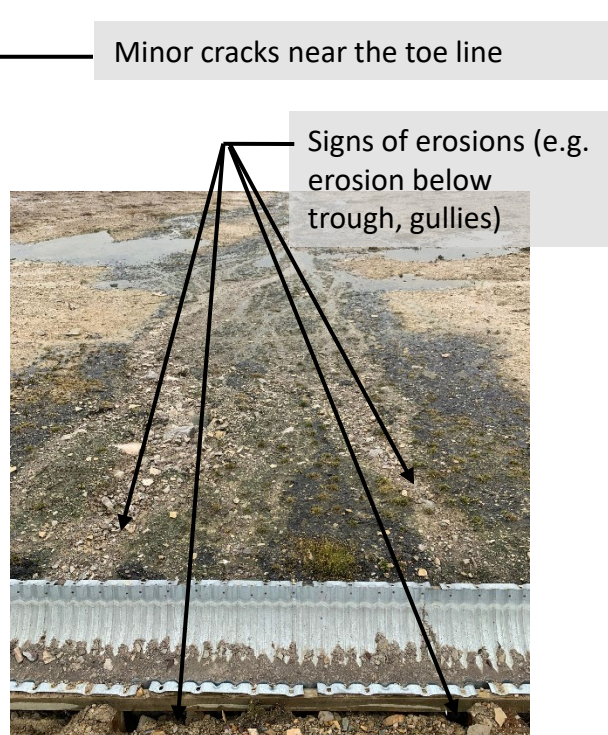
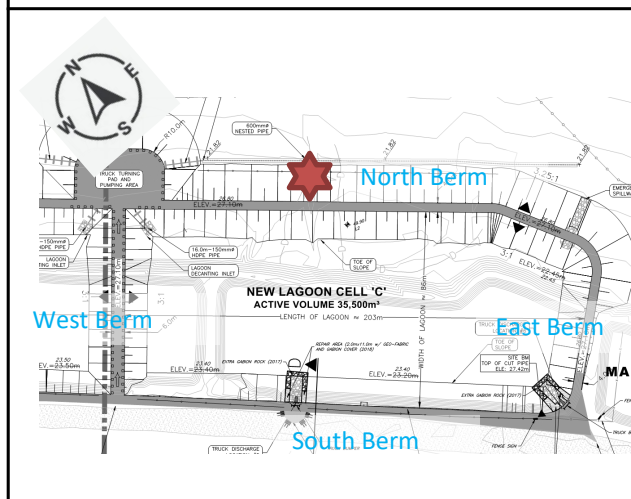
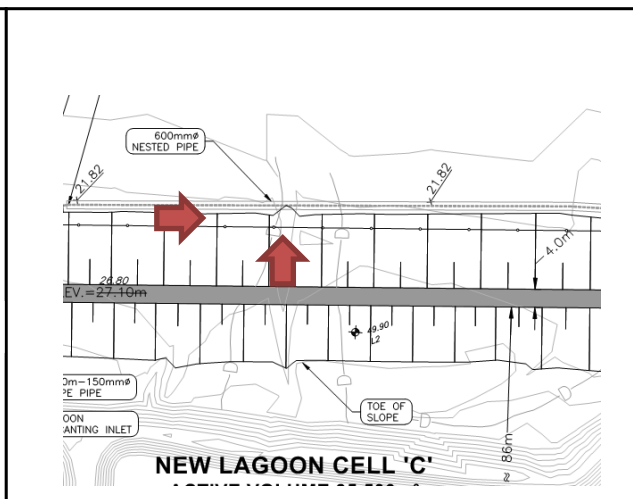
FIGURE
A39

Attributes	
Photograph	C – DS – North Berm
Description	View of downstream slope
Observations	Downstream slope generally in a fair condition. Minor cracks at downstream slope near the toe line. Signs of erosion near the trough.
Remarks	Downstream slope generally in a fair condition. Signs of erosion and soil cracks near the trough.

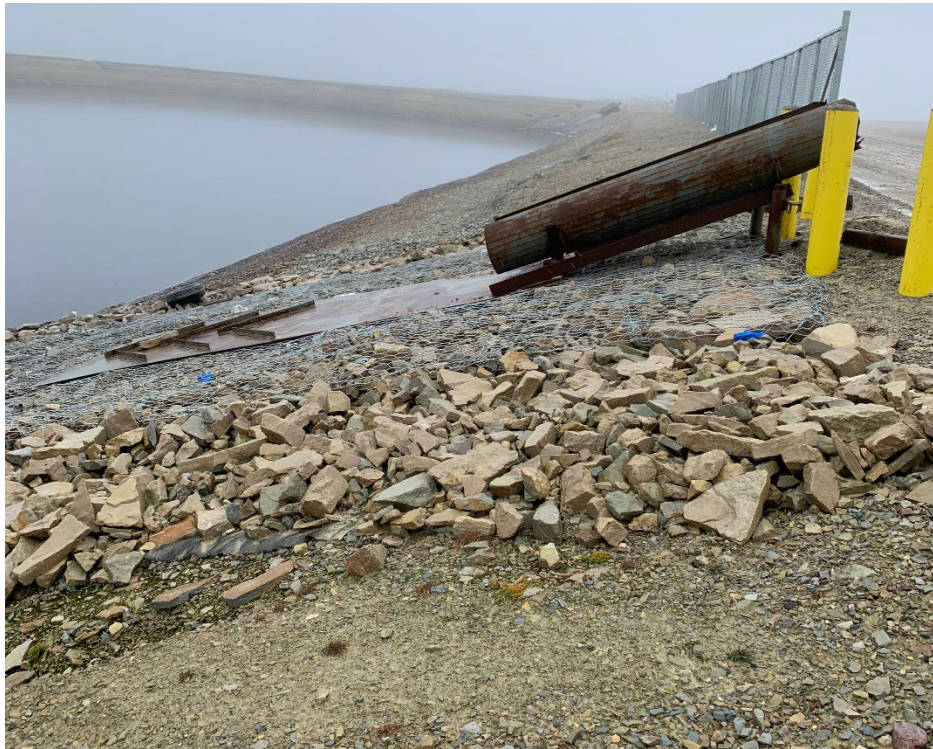
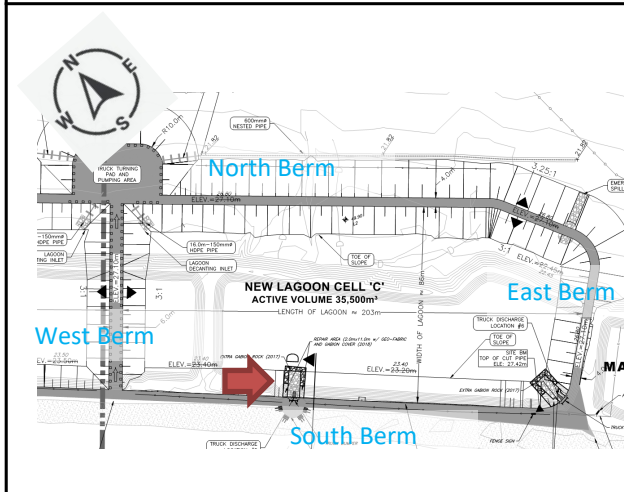
FIGURE
A40

Photograph	C – Truck Discharge Facility (#5)
Description	View of truck discharge area
Observations	Riprap in a good condition. Discharge equipment in a good condition.
Remarks	The area is in a good condition

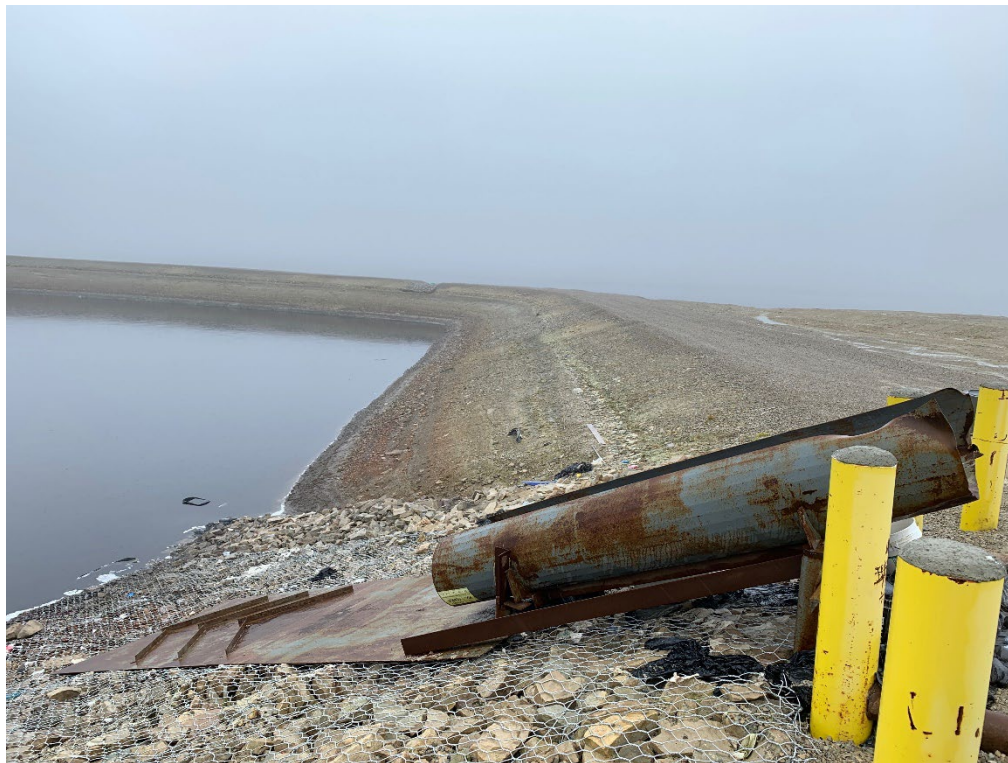
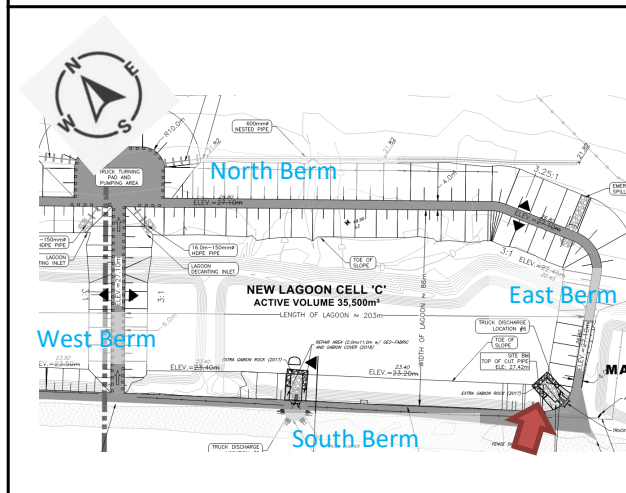
FIGURE
A41

Photograph	C – Truck Discharge Facility (#6)
Description	View of truck discharge area
Observations	Riprap in a good condition. Discharge equipment in a good condition.
Remarks	The area is in a good condition

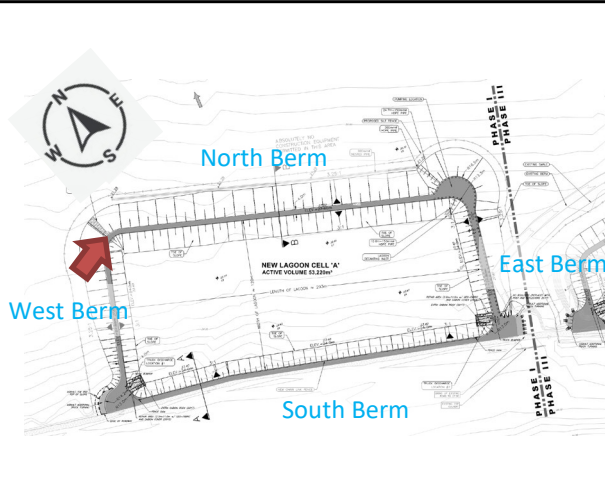
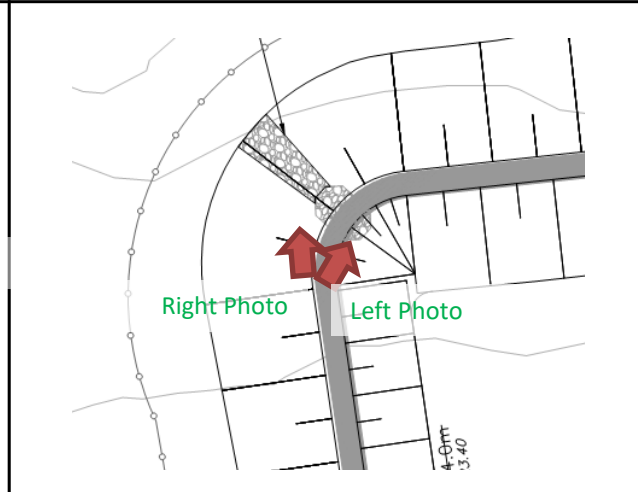
Photograph	A – Spillway
Description	View of spillway
Observations	Riprap at spillway is in good condition. No sign of riprap damage. Riprap baskets are likely placed above the slope. The thickness of riprap is about 200 to 250 mm.
Remarks	The riprap was placed above the slope surface at both upstream and downstream. In this way, the riprap may not prevent soil erosion during emergent use of spillway. Similar configuration of spillway with Cell B and Cell C.

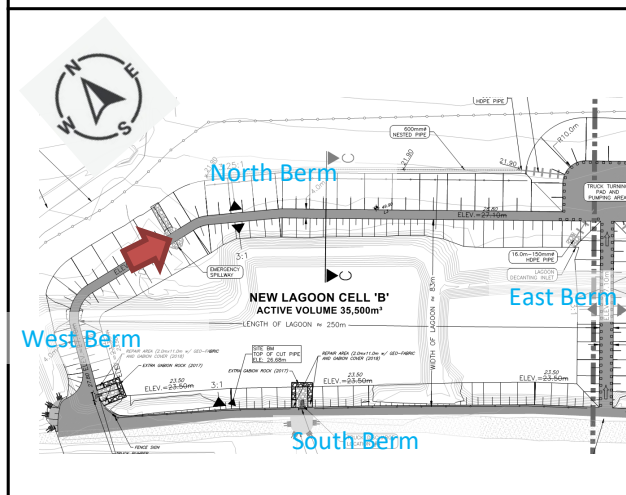
Photograph	B – Spillway
Description	View of spillway – riprap
Observations	Riprap at spillway is in good condition. No sign of riprap damage. Riprap baskets were placed <u>above</u> the slope. Riprap at downstream slope does not extend to the toe.
Remarks	Similar configuration of spillway with Cell A and Cell C.

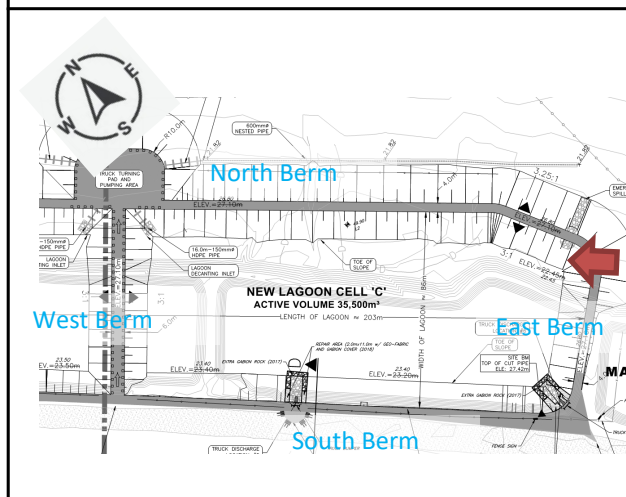
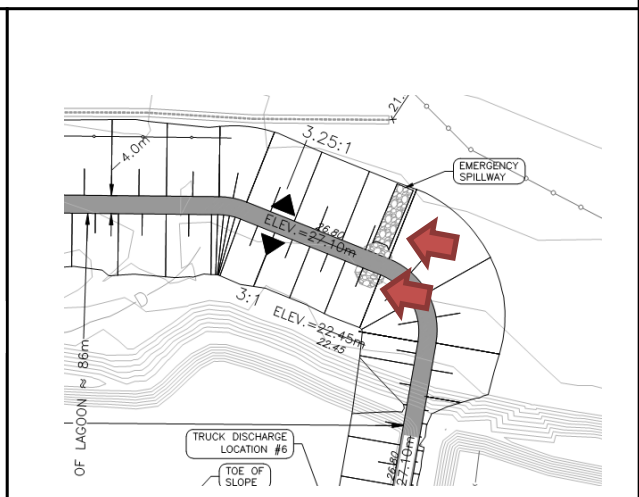
Photograph	C – Spillway
Description	View of spillway
Observations	Riprap at spillway is in good condition. No sign of riprap damage. Riprap baskets are likely placed <u>above</u> the slope.
Remarks	Similar configuration of spillway with Cell A and Cell B.

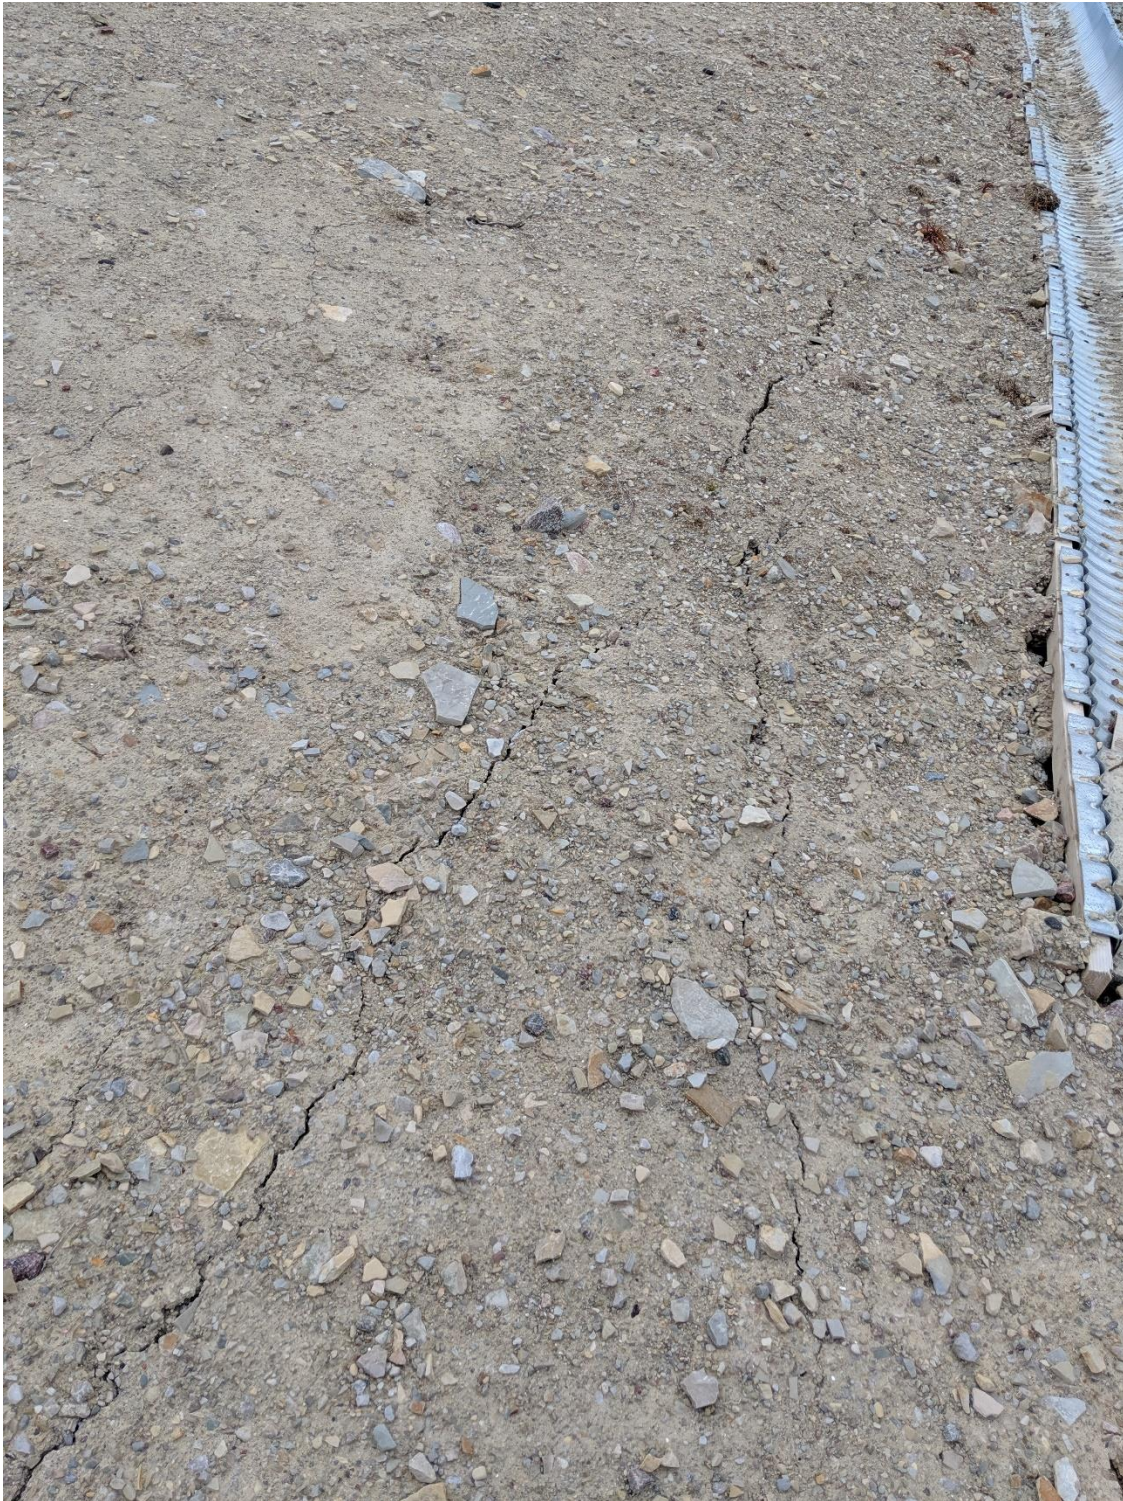
- Some cracking in the soil around the lagoon cells, suggesting settlement during freeze-thaw cycles. Photo No.1 in Appendix D shows the cracks near the downstream drainage trough.
- Some erosion near the downstream drainage trough caused by water pumped out of the lagoon. Photo No.3 in Appendix D shows water flows overtopping the trough. The report noted that the pumping setup did not conform to the intended setup and recommended that the operation manual and operation procedures be reviewed. However, no specific recommendations were provided.
- Signs of erosion along the lower portion of the upstream slopes are inferred by WSP, as shown in Photo No.2 from the EXP site review report (2019). It is noted that the issue of upstream slope erosion was not specifically raised in the EXP report.

Photograph #1: Settlement Cracking of the soil around the lagoon.

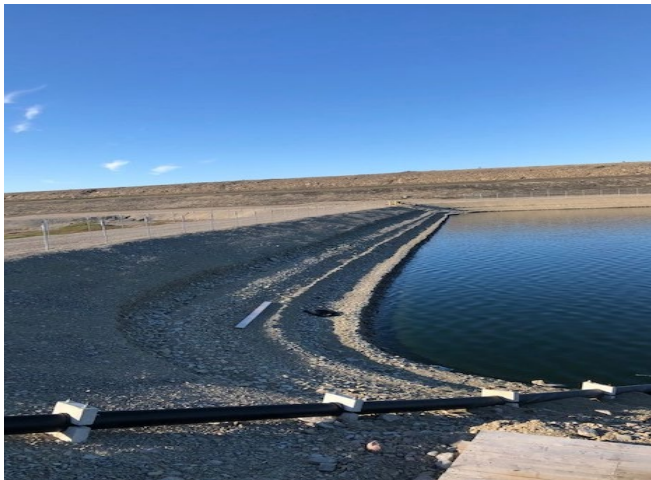
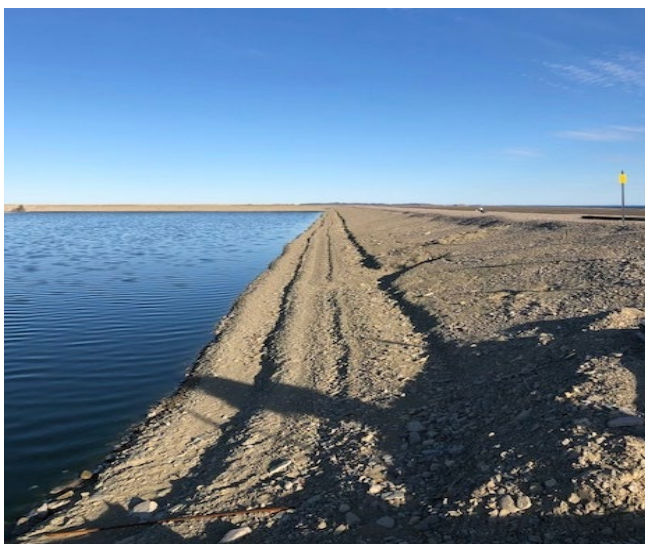
- Inspection of Interior berms in cell “A” has identified concerning process of soil breaking off in a visible three step process and collapsing into the sewage. As per IFT documents interior berms in contact with sewage should be lined. As per pictures attached, there is no visible sign of the installed liner. Interior berms within Cells B and C had no visible interior berm damages/washouts

Collapsing interior berm soil within cell “A”

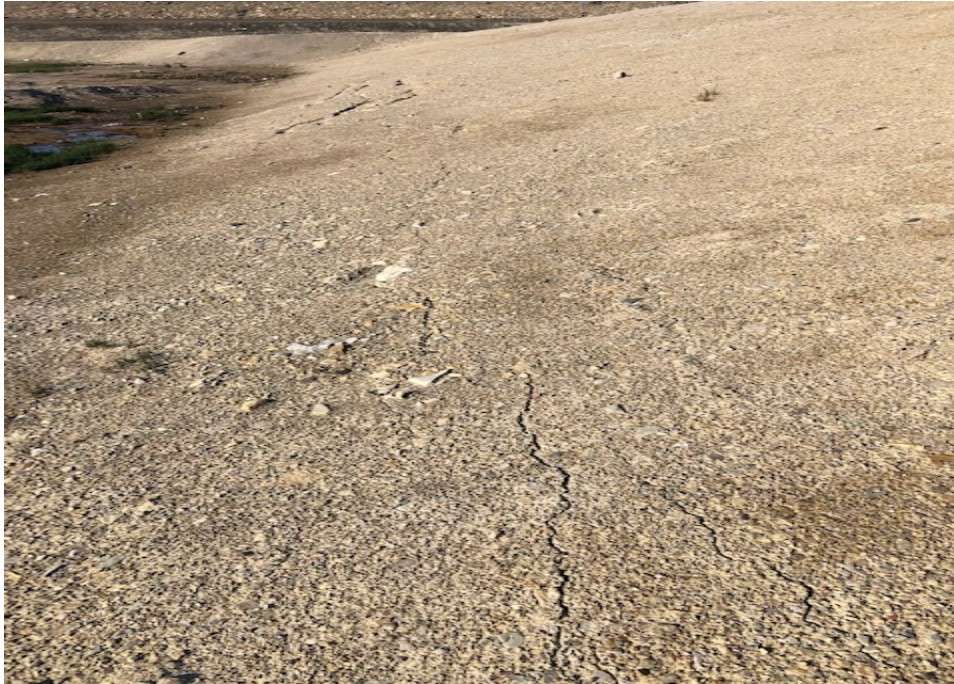
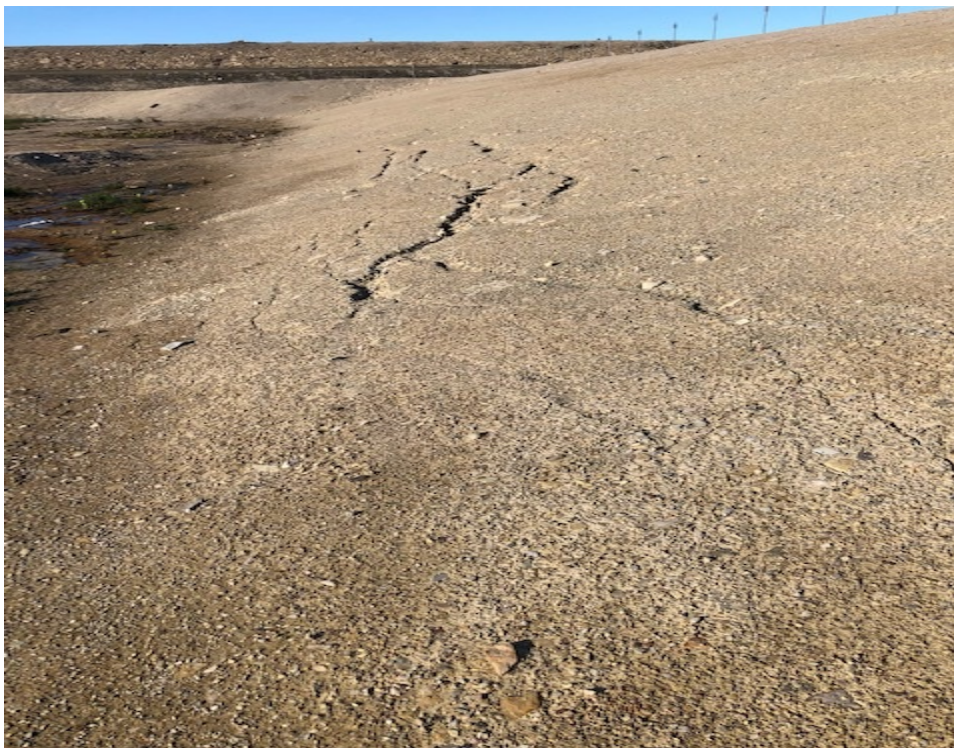
- Soil on all three exterior cells berms is experiencing some cracking. Possible causes of soil cracking might be caused by the settlement during freeze-thaw cycles, or improper compaction during the construction.
- **Concerning are observed significant signs of cracked soil and signs of exfiltration in the soil of the lagoon cell “A” facing cell “B”** (Pls see 2 pictures bellow)

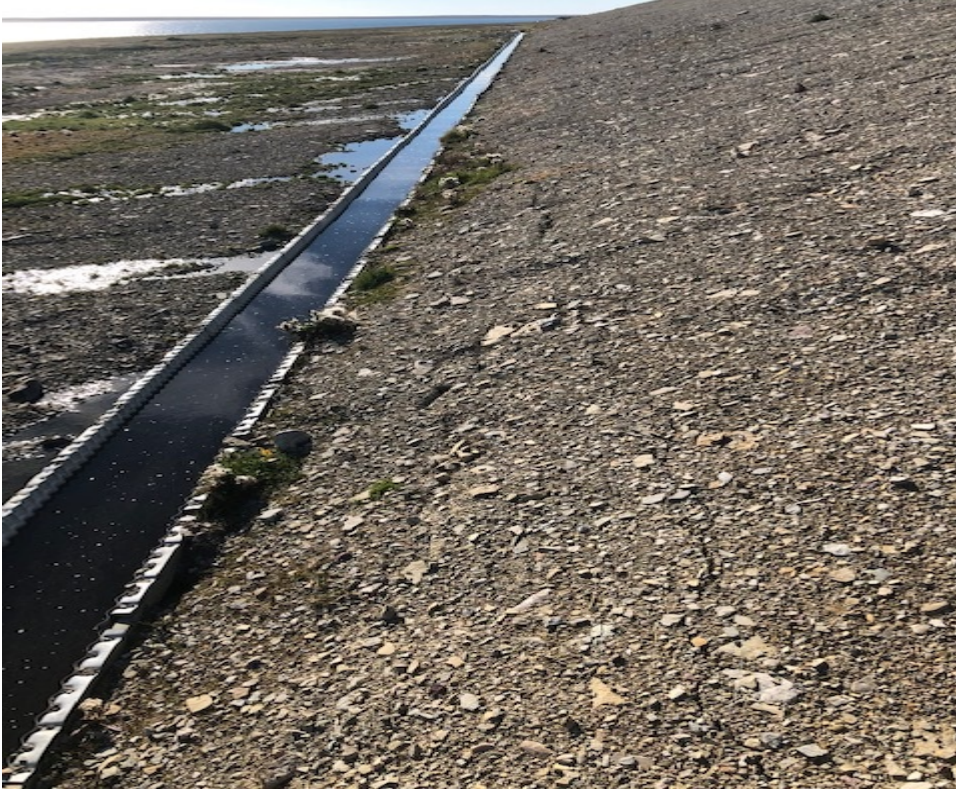
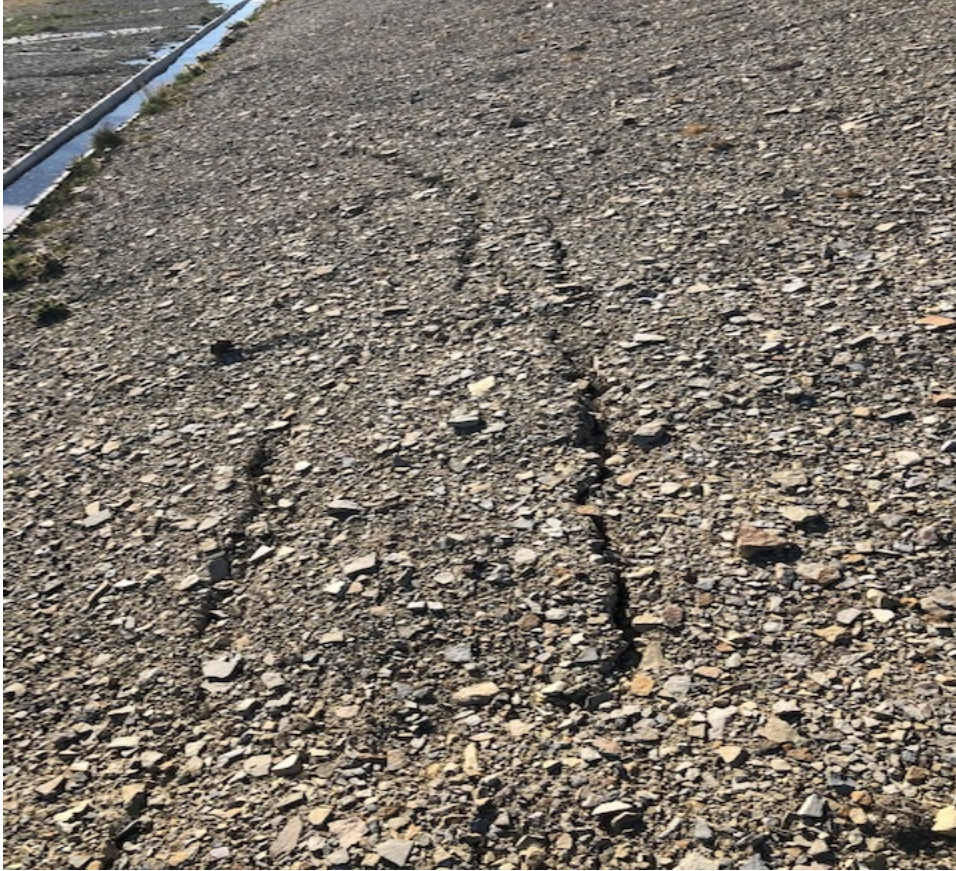
- There was no visible creeping or sliding soil movement noticed in any of 4 berms
- During the walkthrough, sewage pumping was performed on cell “B”. It was observed that the wastewater pumped out of the lagoon was causing erosion along the trough located on the North side of the lagoon (facing wetland and ocean). Observed are **significant washouts** along the troughs.

- Since there are no as-built records saved for this project, further involvement of the professional geotechnical engineering firm will be required to assess safety and structural integrity of the berms.
- **CGS has secured the funds and has commenced with a hiring process of a professional Geotech firm that will conduct thorough facility inspection during 2022 Summer/Fall construction season. Inspection Findings will define deficiencies and provide Scope of work along with a cost estimate for all construction activates to follow**
