2024 ANNUAL REPORT FOR THE MUNICIPALITY OF IGLOOLIK

The following information is compiled pursuant to the requirements of Part B, Item 1 of Water Licence No. 3AM-IGL2131 issued to the **Municipality of Igloolik**.

Appendix A: CIRNAC Inspection Report

Water Licence Inspection Report

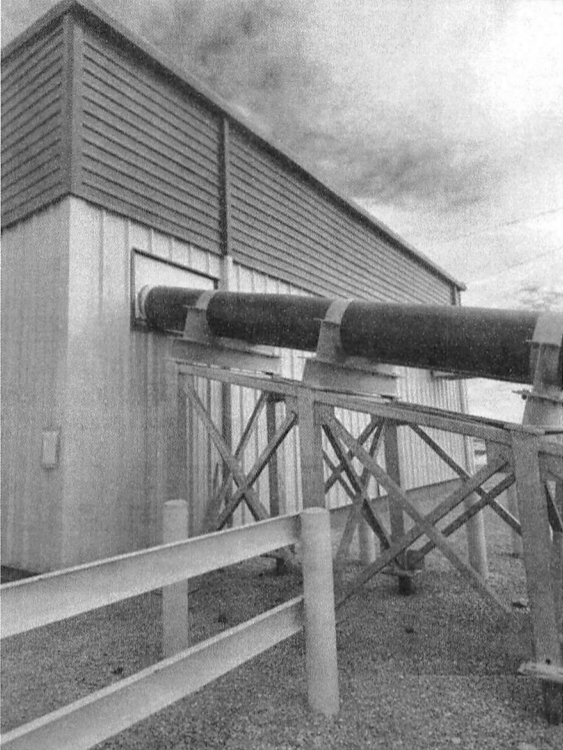
PHOTO LOG			
Date:	Authorization Number:	Camera/Model:	Inspector
Friday, June 28, 2024	3AM-IGL2131	Samsung S23	Sean Noble-Nowdluk
Photo No. 1		Lat/Long (DD.MM.SS.SS, NAD83)	
Photo

Description: View of water intake pipe connecting the reservoir to the water treatment facility.			
Photo No. 2		Lat/Long (DD.MM.SS.SS, NAD83)	
Photo

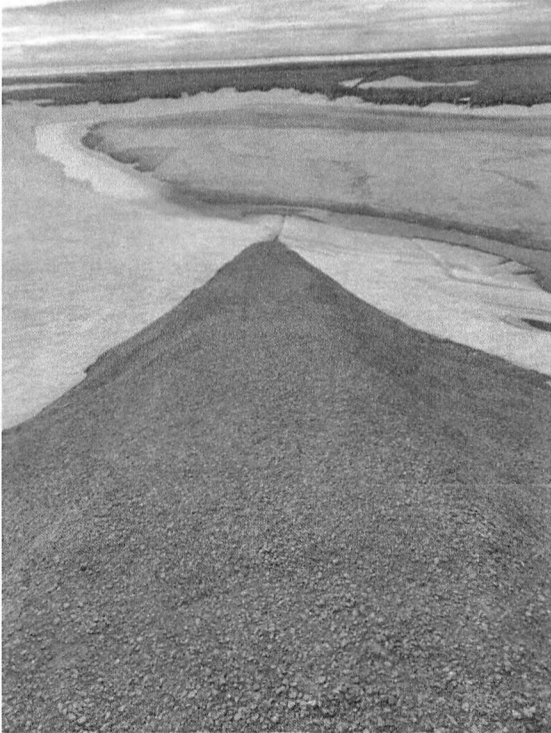
Description: View of water reservoir from water treatment facility.

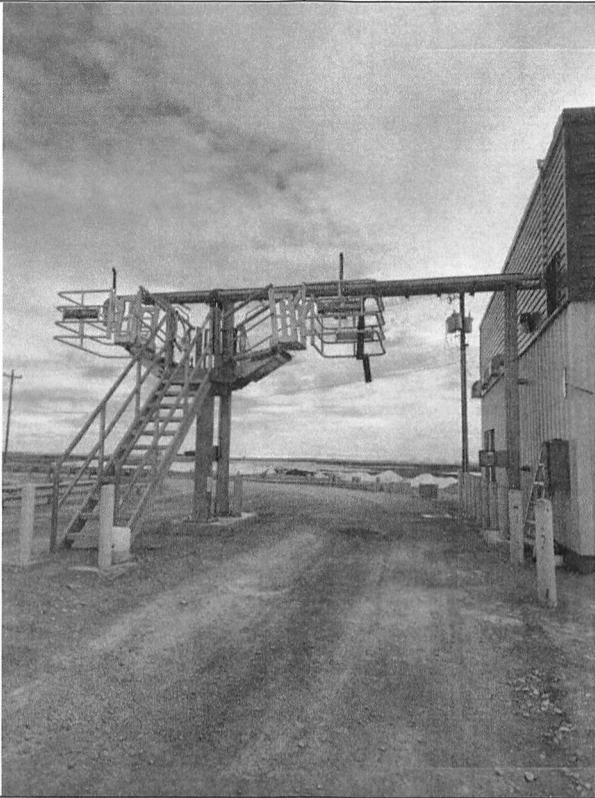
Photo No. 3	Lat/Long (DD.MM.SS.SS, NAD83)
Photo

Description: Water truck fill station.

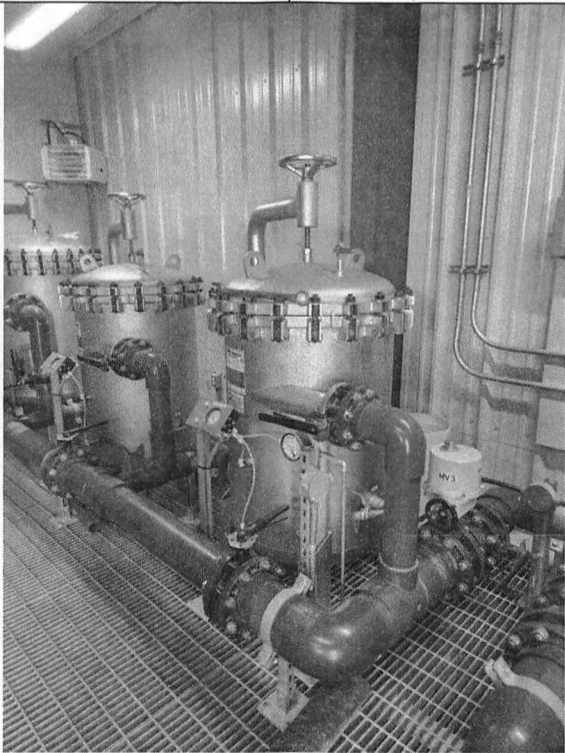
Description: Photo of water treatment system inside the treatment facility.

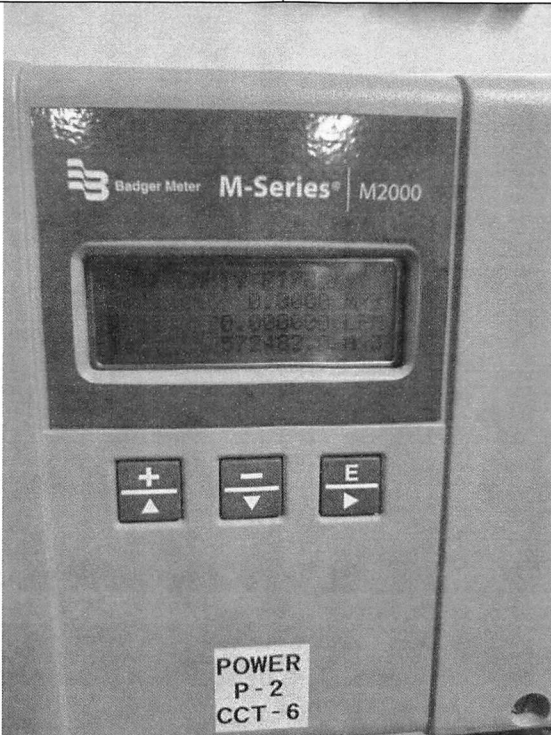
Photo No. 5

Functional water flow meter located in the water treatment facility.

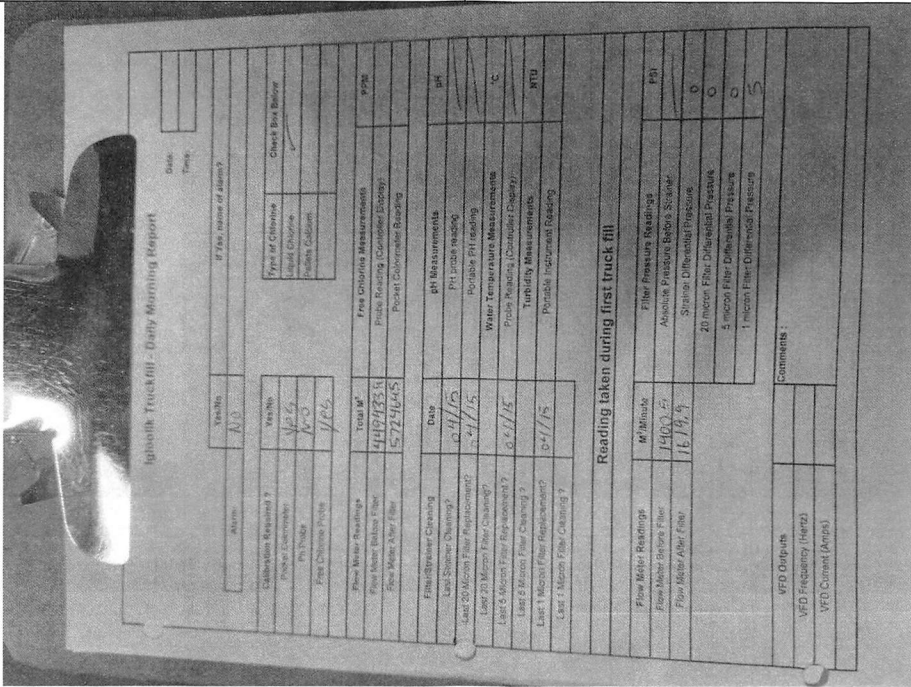
Photo No. 6

Water usage logs filled out by hamlet employees.

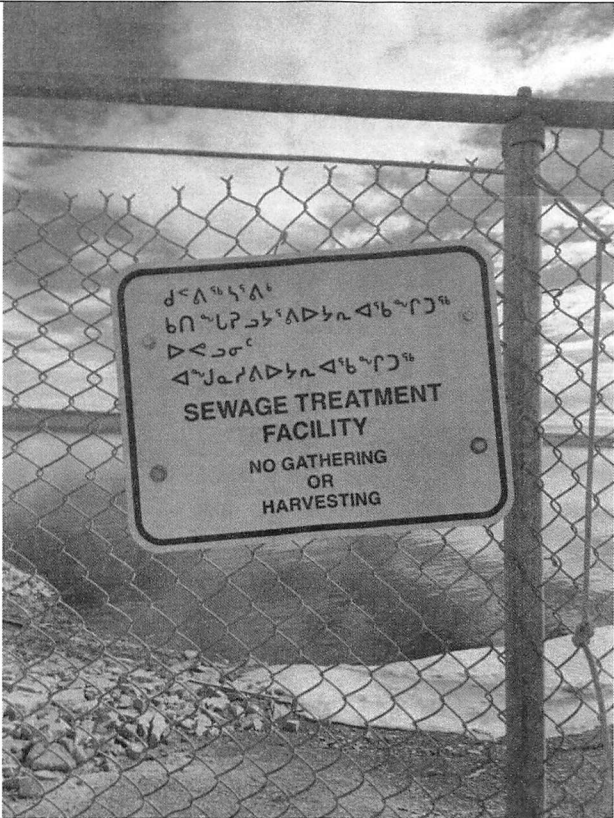
Photo No. 7

Signage observed at the sewage treatment facility.

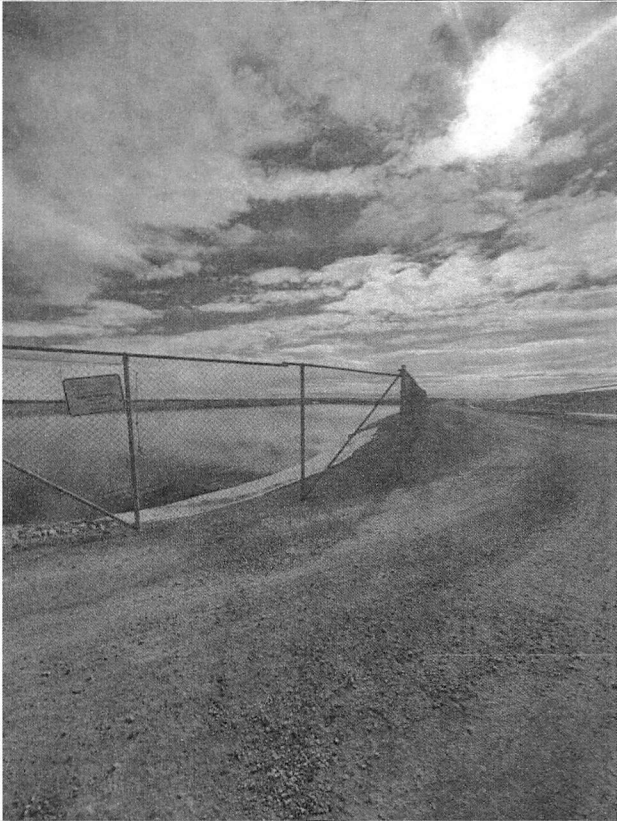
Photo No. 8

Fencing was observed outside the sewage treatment facility.

Section 3 Action Required
<ol style="list-style-type: none">1. Fencing along the perimeter of the Solid Waste Facility must be repaired or replaced to ensure waste and debris are contained within the facility.2. Monitoring station signs must be posted at the designated sites. Please refer to Schedule 1: Table 2 of the License.3. All waste located outside the Solid Waste Facility must be removed and placed within the facility to ensure waste does not enter any body of water.4. The Licensee must submit their 2023 Annual Report to the Nunavut Water Board.

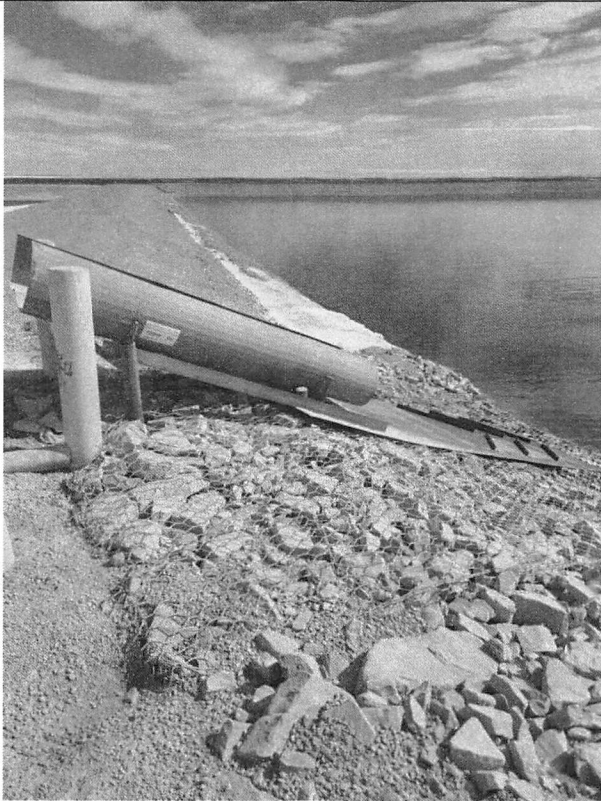
Photo No. 9		Lat/Long (DD.MM.SS.SS, NAD83)
Photo

Description:		
Sewage discharge location at the sewage treatment facility.

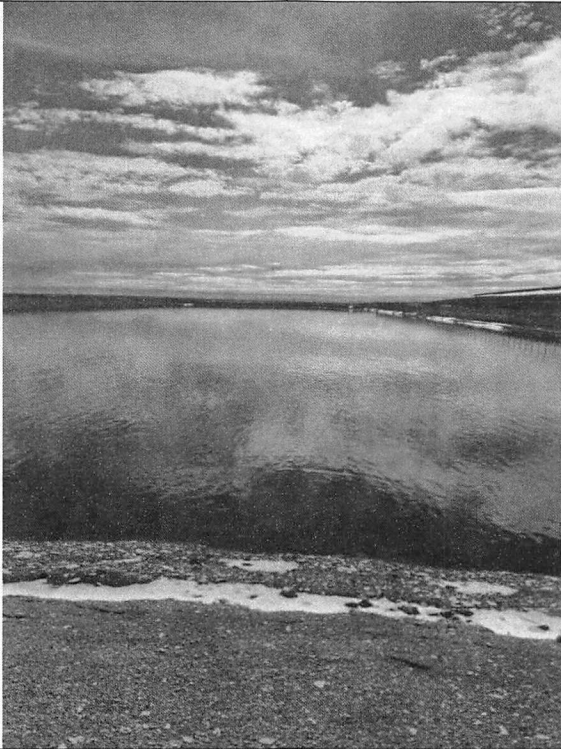
Photo No. 10		Lat/Long (DD.MM.SS.SS, NAD83)
Photo

Description:		
Photo of sewage treatment facility.

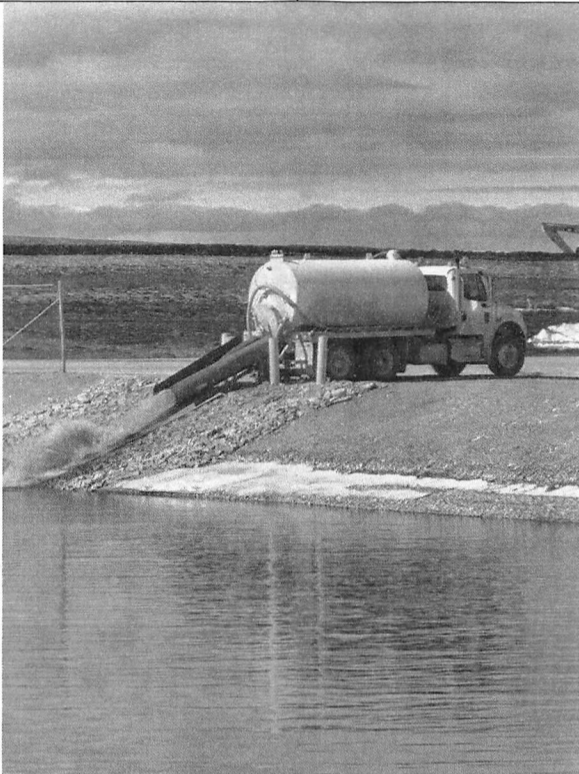
Photo No. 11	Lat/Long (DD.MM.SS.SS, NAD83)
Photo

Description: Active sewage disposal during the inspection.

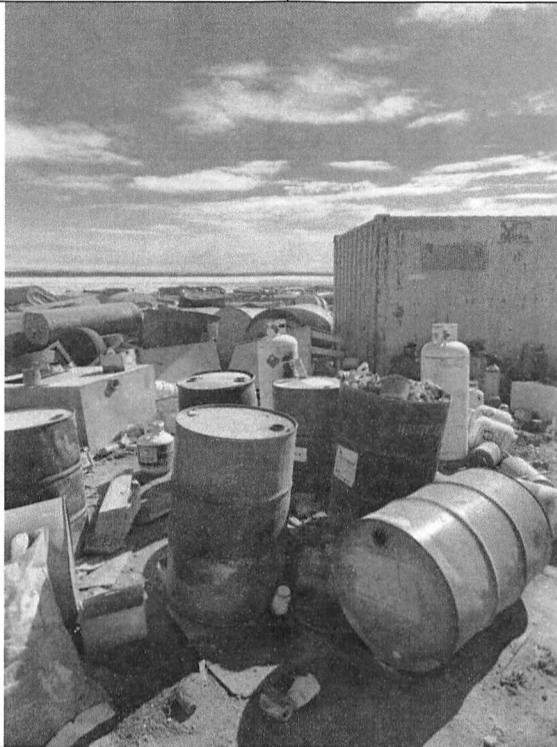
Photo No. 13	Lat/Long (DD.MM.SS.SS, NAD83)
Photo

Description: Hazardous waste was found throughout the solid waste facility.

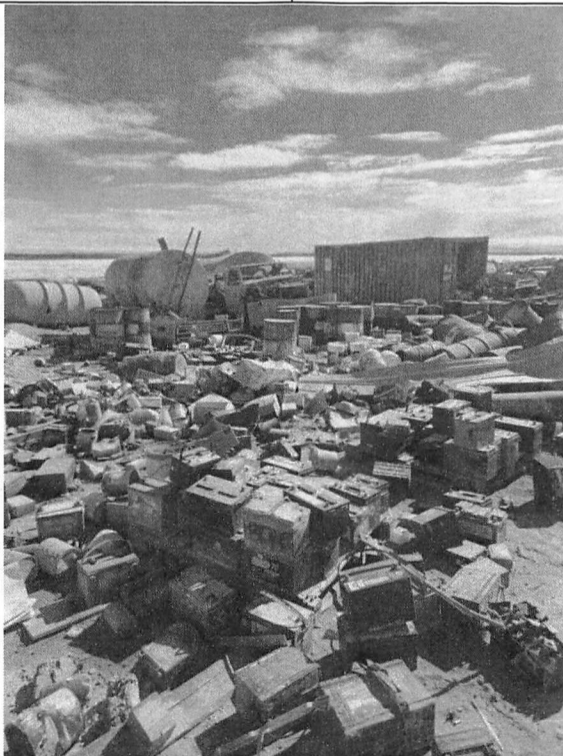
Photo No. 14	Lat/Long (DD.MM.SS.SS, NAD83)
Photo

Description: Hazardous waste was found throughout the solid waste facility.

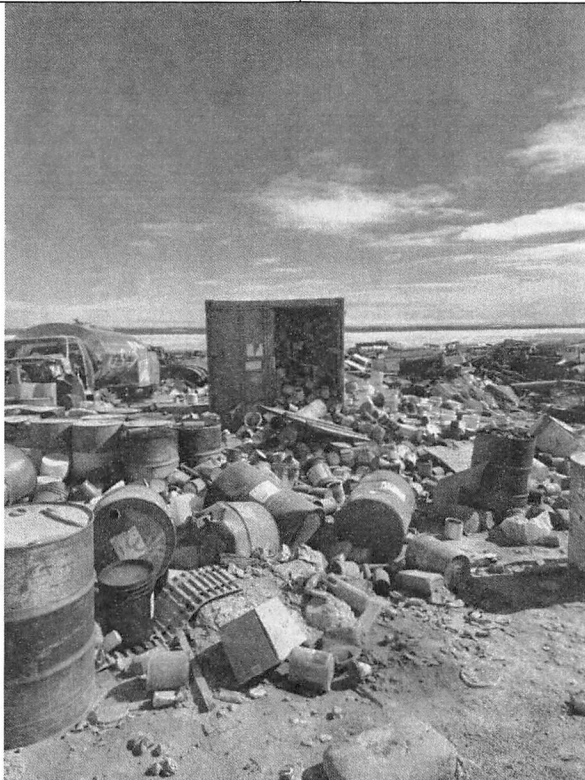
Photo No. 15	Lat/Long (DD.MM.SS.SS, NAD83)
Photo

Description: Hazardous waste without any form of secondary containment.

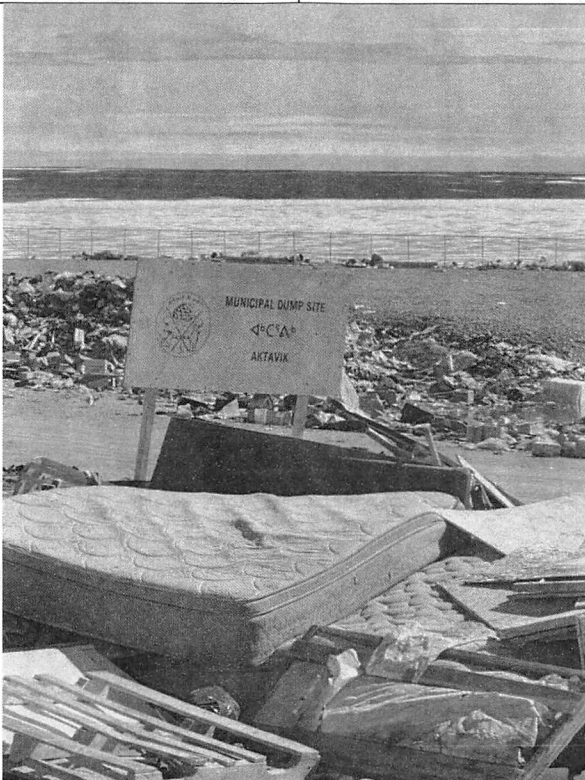
Photo No. 16	Lat/Long (DD.MM.SS.SS, NAD83)
Photo

Description: Municipality dump site signage was present.

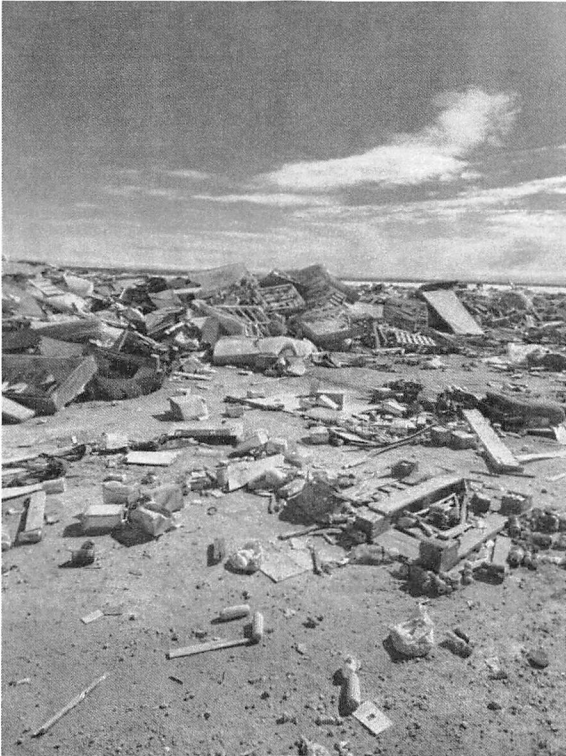
Photo No. 17	Lat/Long (DD.MM.SS.SS, NAD83)
Photo

Description: General photo of solid waste facility.

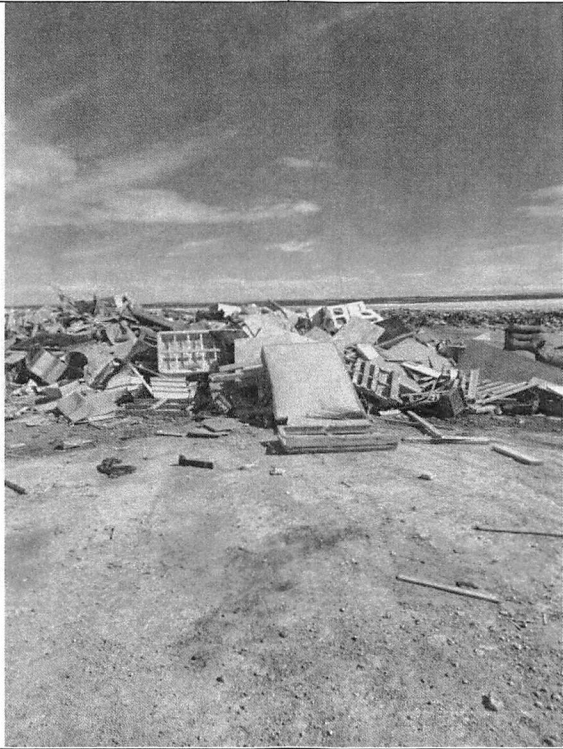
Photo No. 18	Lat/Long (DD.MM.SS.SS, NAD83)
Photo

Description: General photo of solid waste facility.

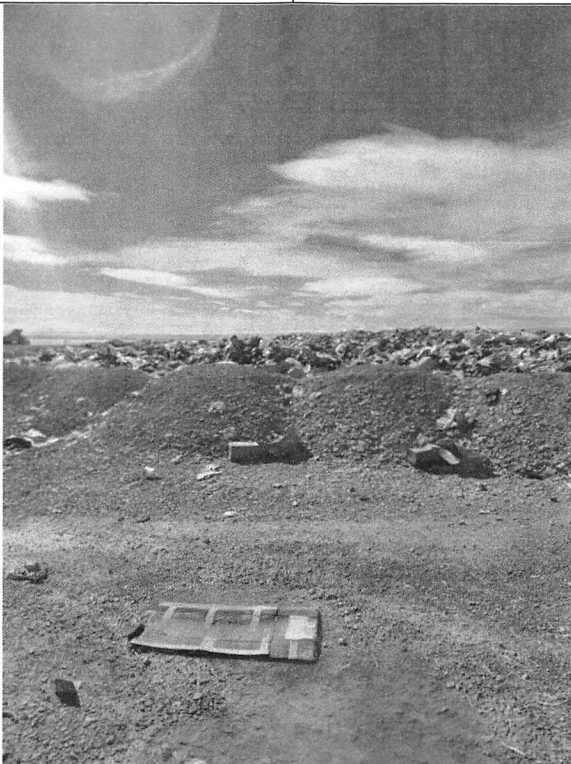
Photo No. 19	Lat/Long (DD.MM.SS.SS, NAD83)
Photo

Description: Photo showing new gravel being laid down to cover the older material at the solid waste facility.

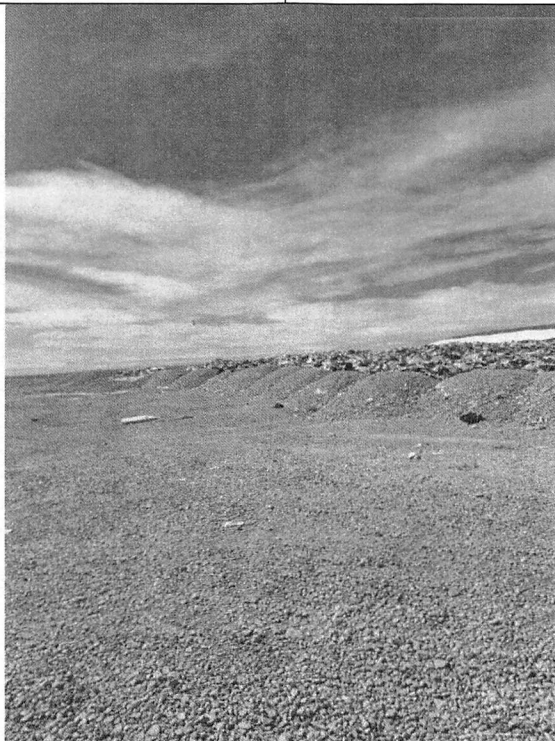
Photo No. 20	Lat/Long (DD.MM.SS.SS, NAD83)
Photo

Description: Photo showing new gravel being laid down to cover the older material at the solid waste facility.

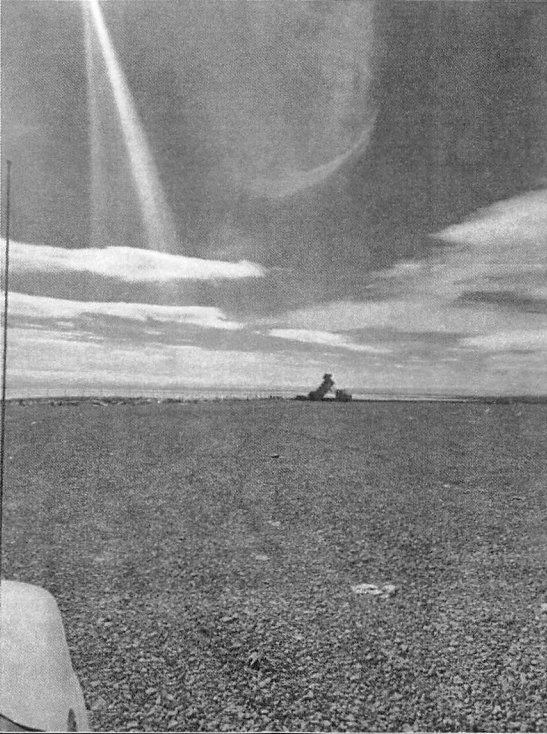
Photo No. 21		Lat/Long (DD.MM.SS.SS, NAD83)
Photo

Description: Photo showing new gravel capping material covering historical dump site. The Hamlet has worked on capping older sites in order to manage new waste coming into the solid waste facility.

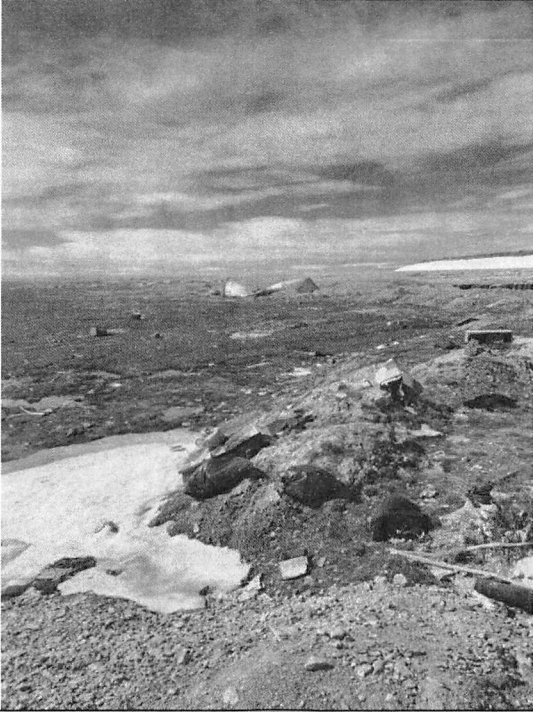
Photo No. 22		Lat/Long (DD.MM.SS.SS, NAD83)
Photo

Description: Leachate runoff flows through this path. This water runs through the solid waste facility and leads into

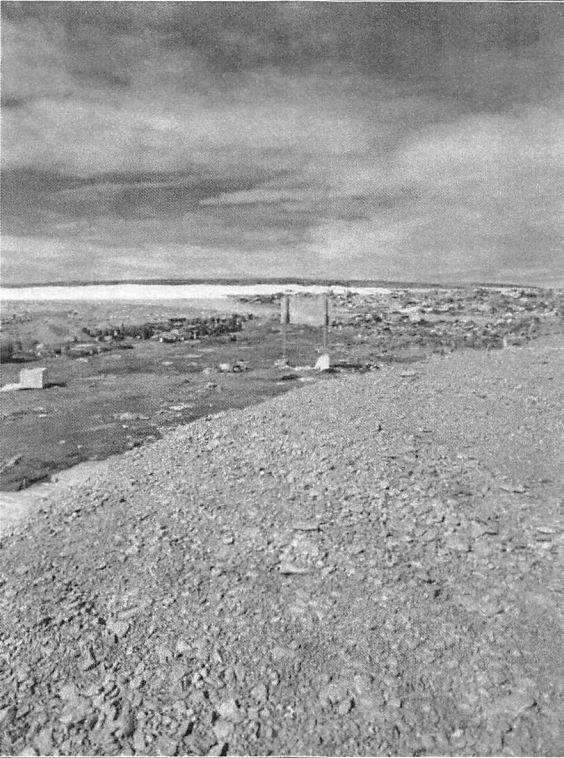
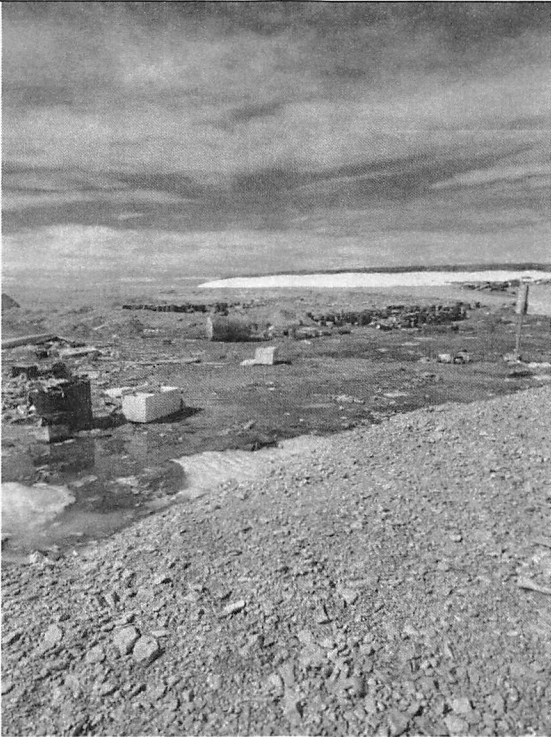
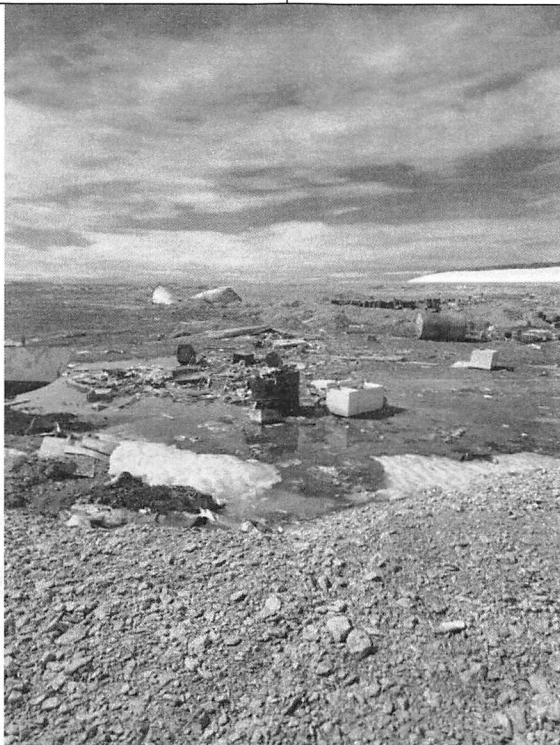
Description:		
Photo of waste located outside the Solid Waste Facility and entering a body of water.

Description: Photo of waste located outside the Solid Waste Facility and entering a body of water.

- Monitoring Station signs will be posted at the designated sites
- Wastes that have escaped the Solid Waste Facility will be picked up and placed back into the Facility
- The 2023 Annual Report will be submitted by May 2025
- Fencing will be repaired as part of the upgrades in the solid waste upgrade project, which the report will be completed in 2025, and the upgrades should take place in 2026.
