**Preliminary Design Report
Expansion of City of Iqaluit
Raw Water Storage,
City of Iqaluit, Nunavut**

Draft Report

Trow Associates Inc.

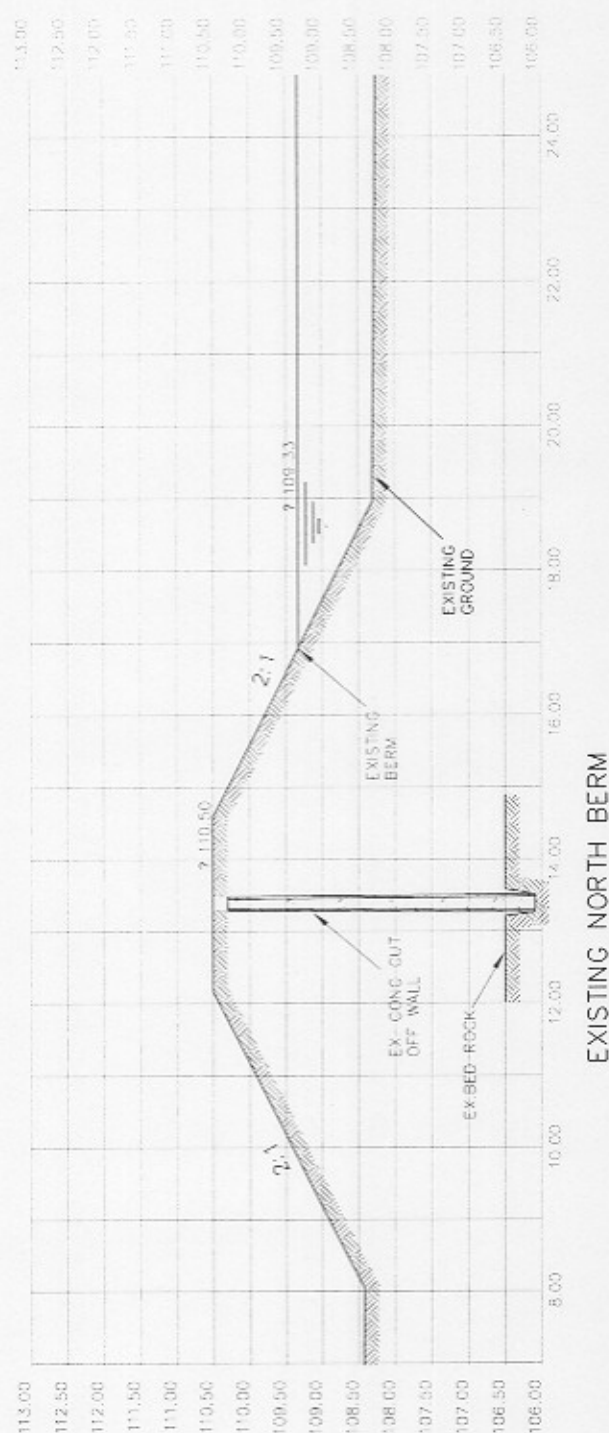
| DATE: MAR 2005 | TITLE: | EXISTING NORTH BERM | SK-3 |

To the north of the existing gravity dam there are sand, gravel and rock embankments with a 200 mm thick concrete cut-off wall reportedly founded on bedrock. A typical section of the existing earth berms are provided in Appendix B of this report. The top of the embankment is at elevation 110.50 metres with the concrete cut-off wall reportedly at elevation 110.30 m. It is therefore our understanding that the elevation of the top of the concrete cut-off wall in the embankment portion of the dam is at least equal to the elevation of the top of the concrete gravity dam portion of the dam, at 110.28 m.

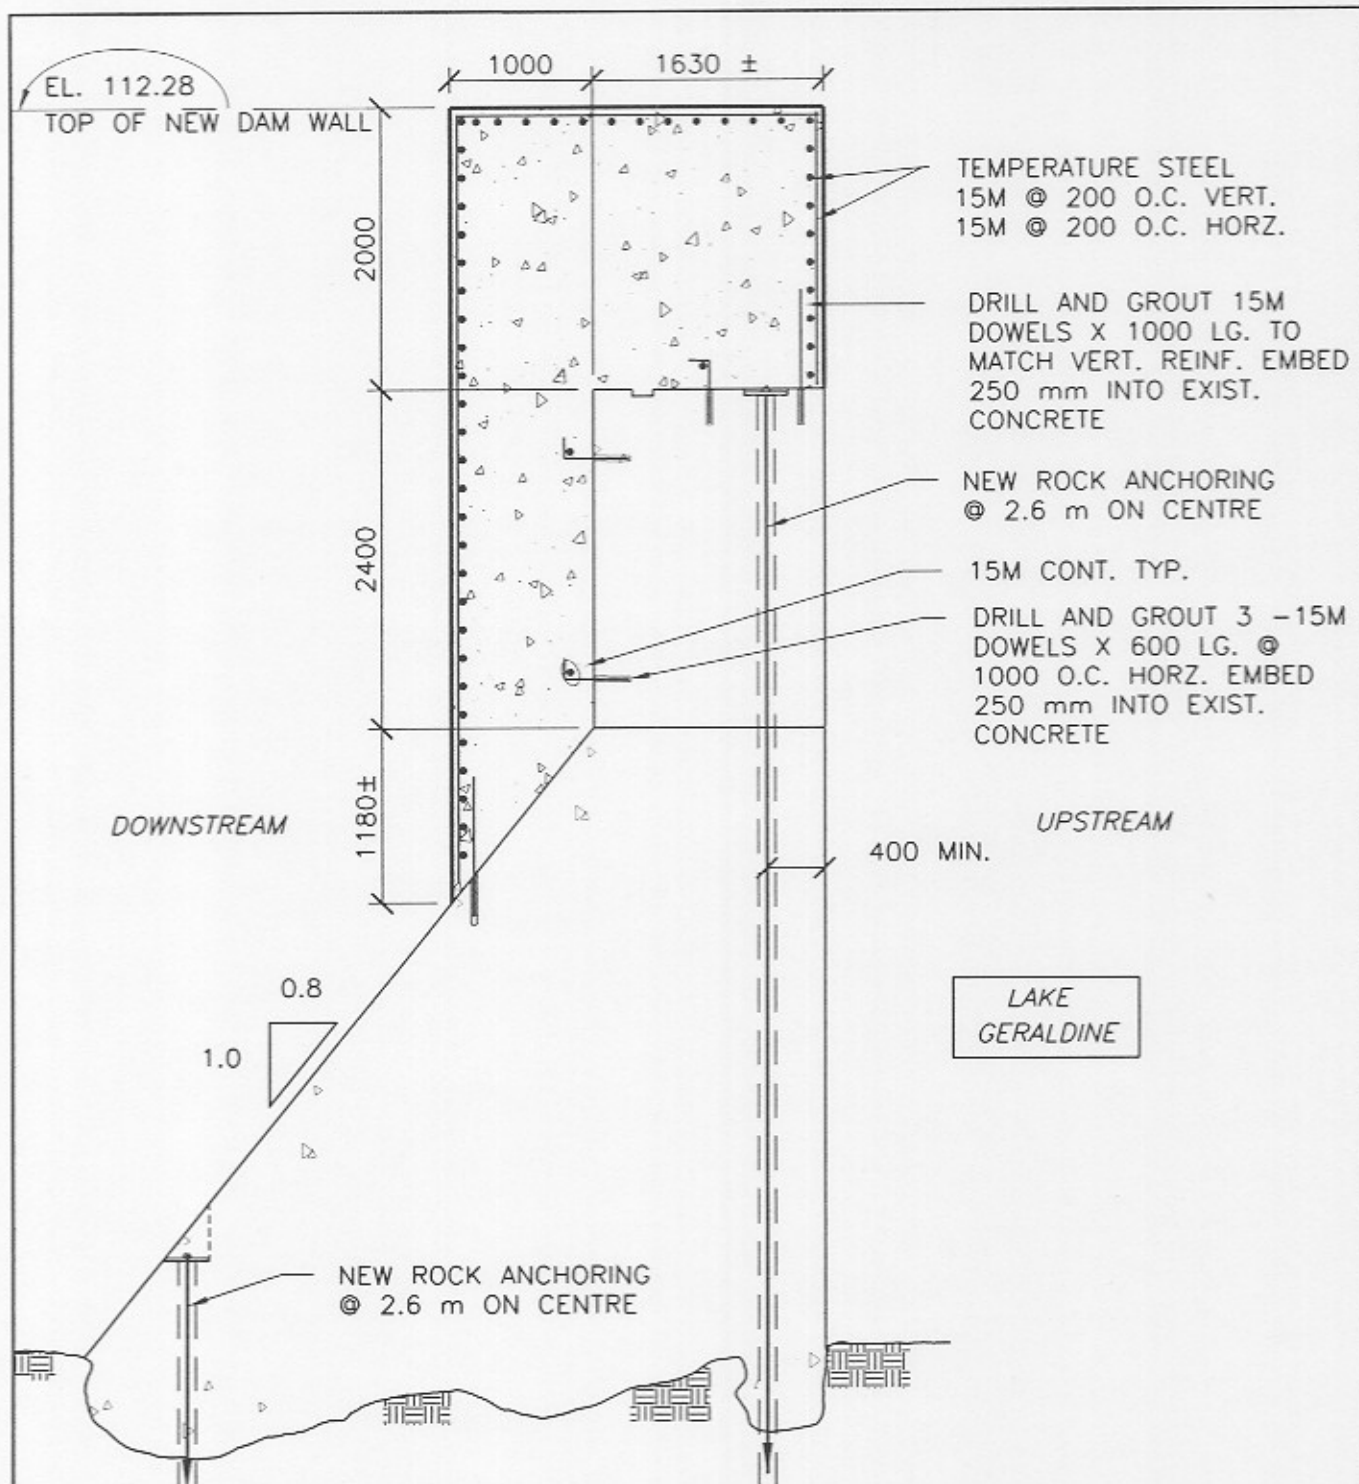
PROPOSED CONCEPT FOR STRUCTURAL MODIFICATIONS TO
THE EXISTING CONCRETE GRAVITY SECTION OF THE DAM

A typical section of the proposed gravity dam is provided in Appendix C of this report. The crest of the 32.7 metre section to the south of the spillway section of the dam and the 13.3 metres long section to the north of the spillway would be established at an elevation of 112.28 metres. The new concrete section would incorporate a new sloped spillway surface and would be dowelled to the existing and reinforced.

The proposed concepts require additional rock anchors for both the spillway and gravity dam sections. A new row of rock anchors would be required in between the existing rock anchors spaced at approximately 2.6 metres on centre, and embedded into the rock a minimum of 9.5 metres. These rock anchors could be either 46 mm diameter grade 835/1030 MPa threadbar in a post-tensioned application or 57 mm diameter grade 517/690 MPa threadbar in a fully grouted passive application. Another row of anchors would be placed near the toe at approximately 2.6 metres on centre, and embedded into the rock a minimum of 2.0 metres to provide shear resistance against the sliding mode of failure. Providing these rock anchors achieves the objective of increasing the stability of the dam to be line with current requirements. Double corrosion protected anchors are recommended for this environment and long service life.

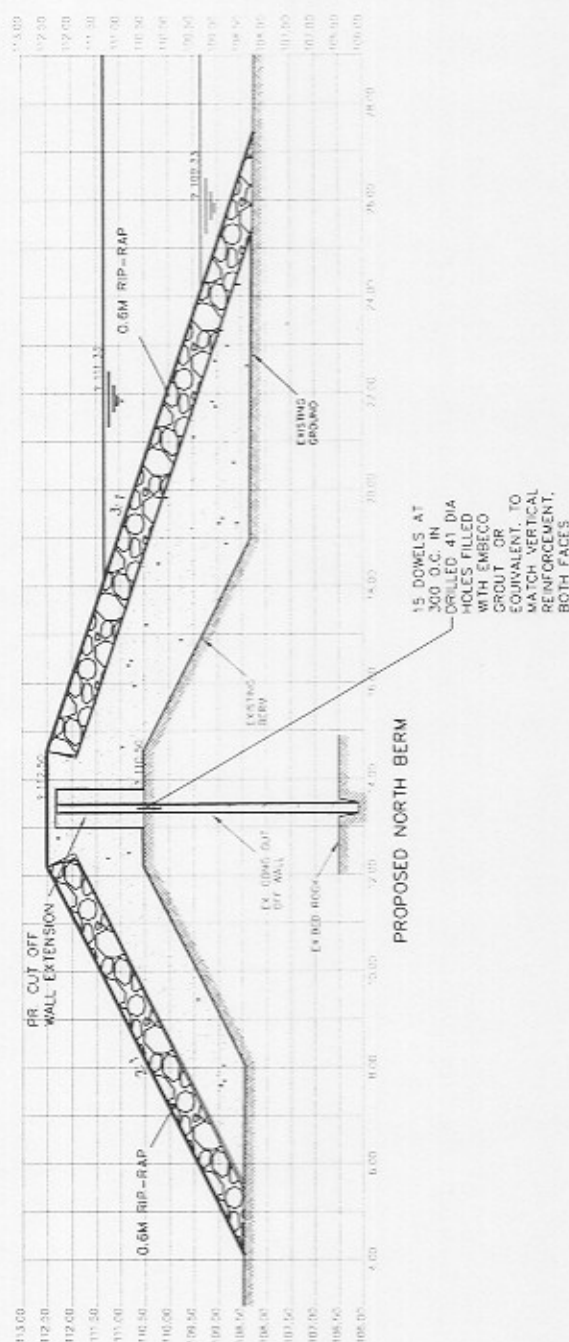
| DATE: MAR 2005 | TITLE: | PROPOSED NORTH BERM | OTCD00017616D |

The top of the northern berm shall be maintained at the current width of 2.4 metres. The berm will have a 3H:1V slope on the upstream side and a 2H:1V slope on the downstream side of the berm. The berm extension will be constructed out of gravel and a layer of riprap will be provided to protect the slopes from erosion. A typical section of the proposed berm extension is provided in Appendix C of this report.
