## **Lake Geraldine Dam Dam Safety Review**

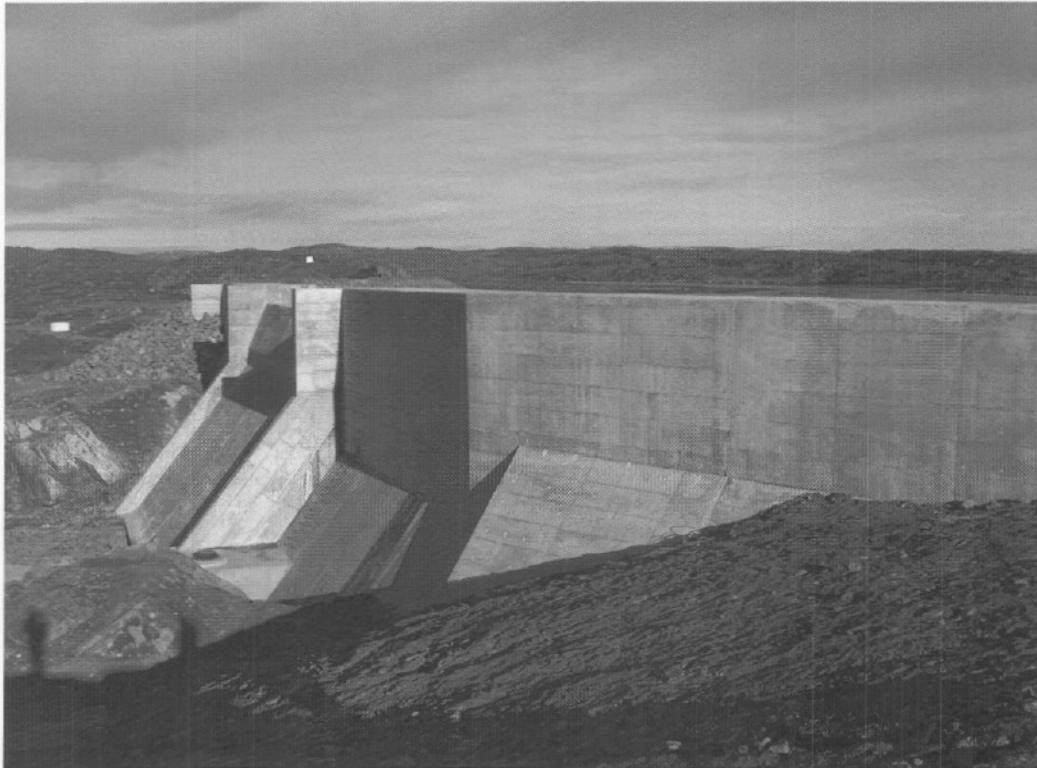
Photograph No. 1: Overview of Dam October 2006 (Post Construction)

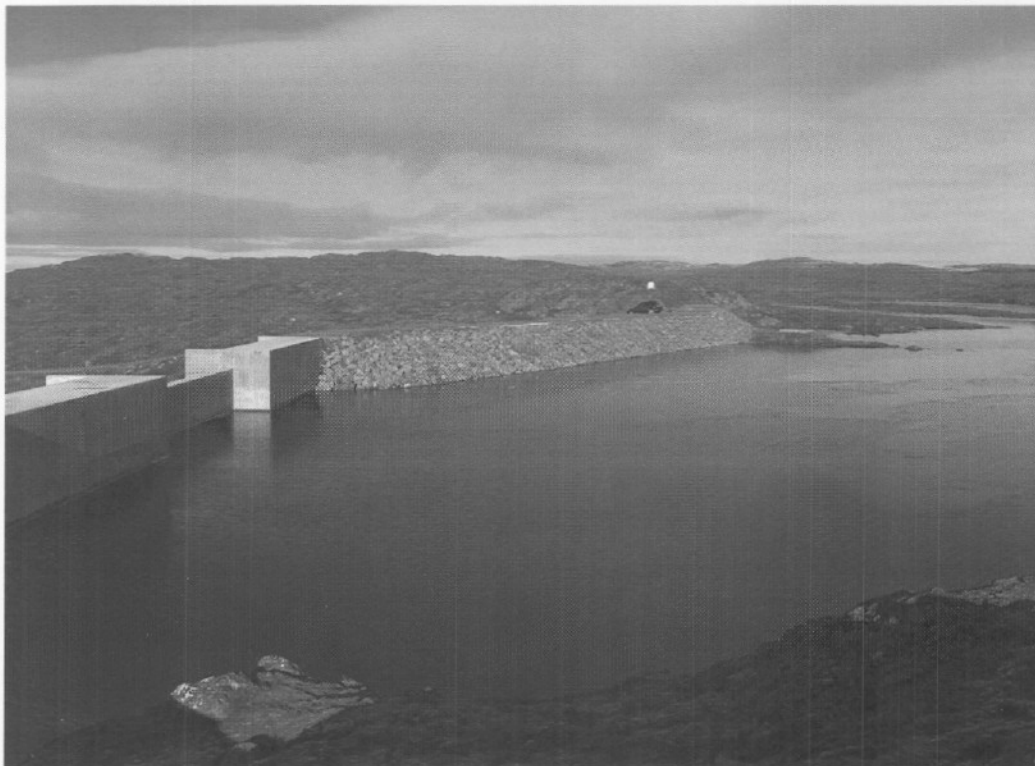
Photograph No. 2: Overview of Upstream Conditions October 2006 (Post Construction)

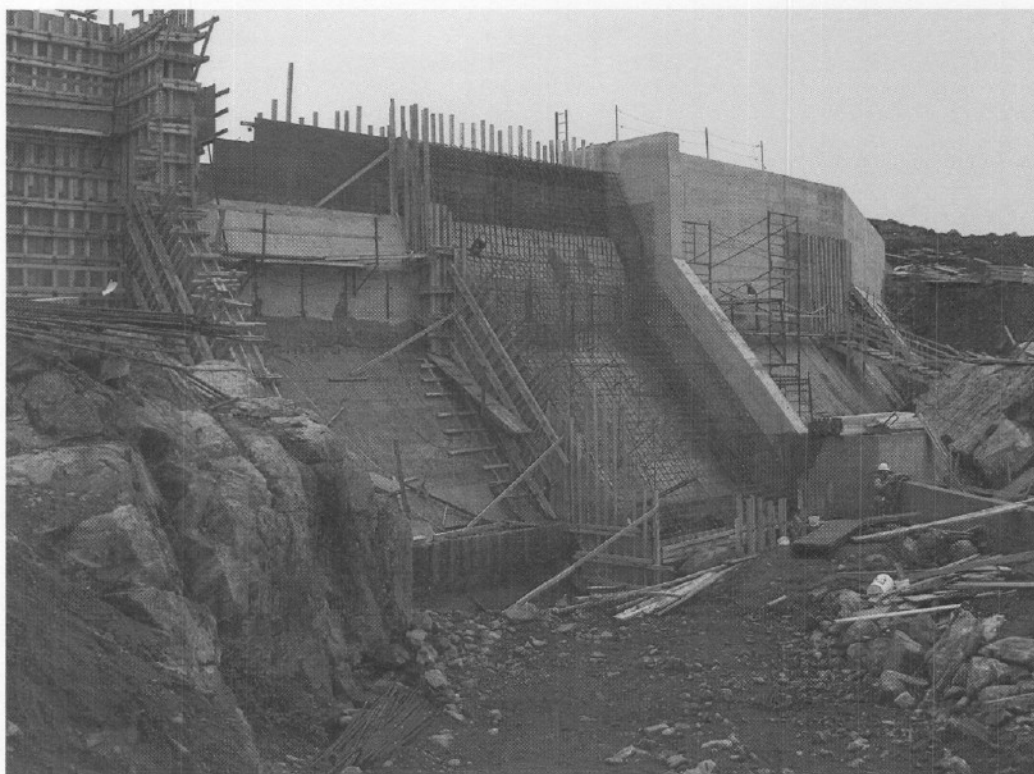
Photograph No. 3: August 2006 Construction Activity

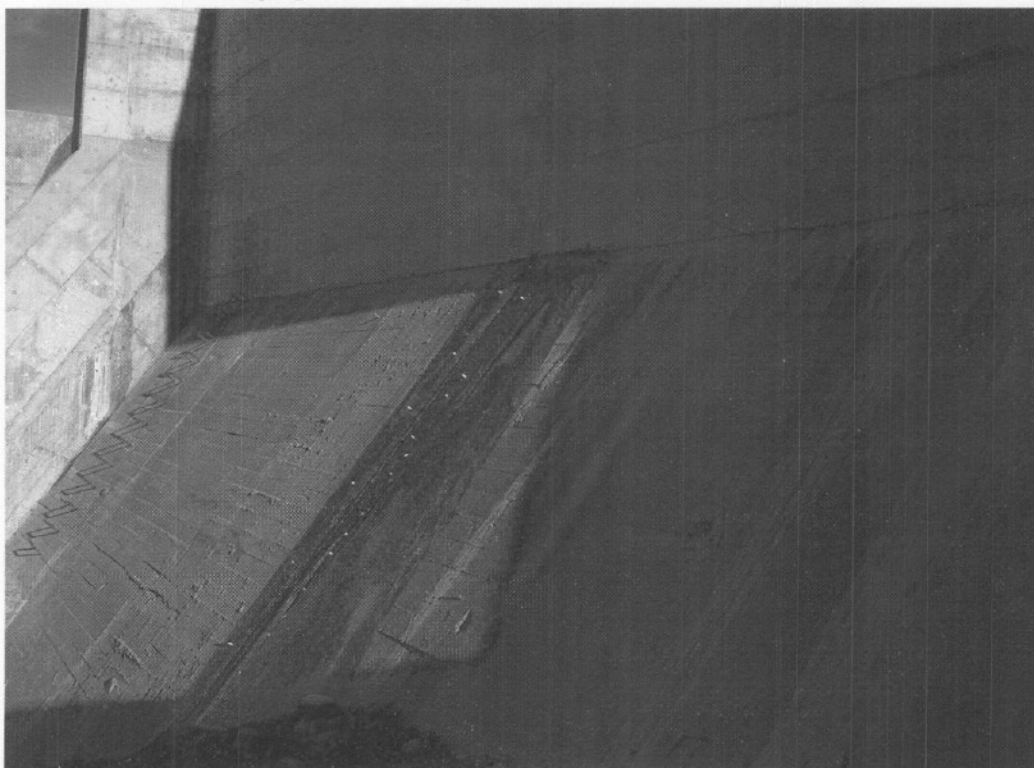
The structure was visually inspected on site. At the time of our visit, we did not observe any conditions that would adversely affect the structural adequacy and/or performance. Leaking cracks were noted and in locations, however, these are presently not deemed to be a structural concern.

Photograph No. 4: Dam Leakage Observed October 2006 (Post Construction)

- Permanent File
  - OMS Manual
  - Logbook
  - Emergency Preparedness Plan
8. A Dam Safety Inspection (DSI) should be conducted in 2007. This is essentially a yearly non-invasive review comprising a visual inspection to identify any changes in condition, or any observed concerns. The 2007 DSI should follow-up on spillway leakage observed in October 2006.
