**Water License Annual Report - Executive Summary**

Water License No. 3AM-IQA0611  
**2009 Annual Report**  
City of Iqaluit

**Lake Geraldine Dam  
Iqaluit, Nunavut  
Dam Safety Inspection**

**City of Iqaluit Sewage Lagoon  
Iqaluit, Nunavut  
Dam Safety Inspection**

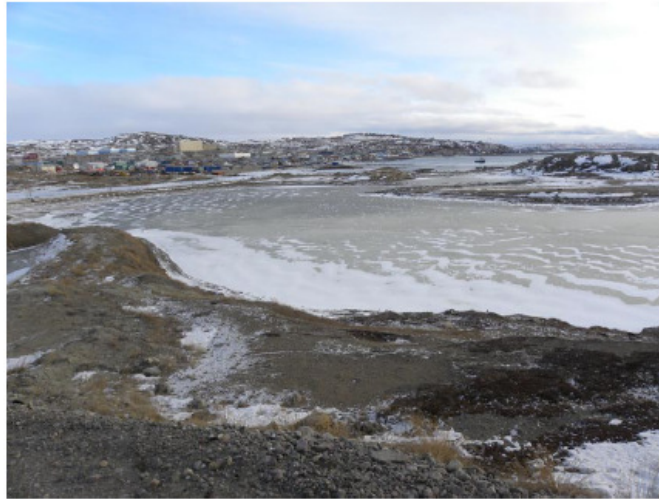
Photograph 1  
Overview looking East.

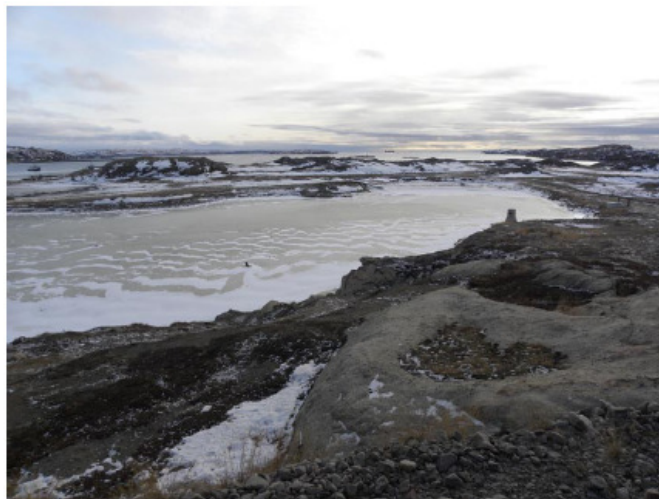
Photograph 2  
Overview looking West

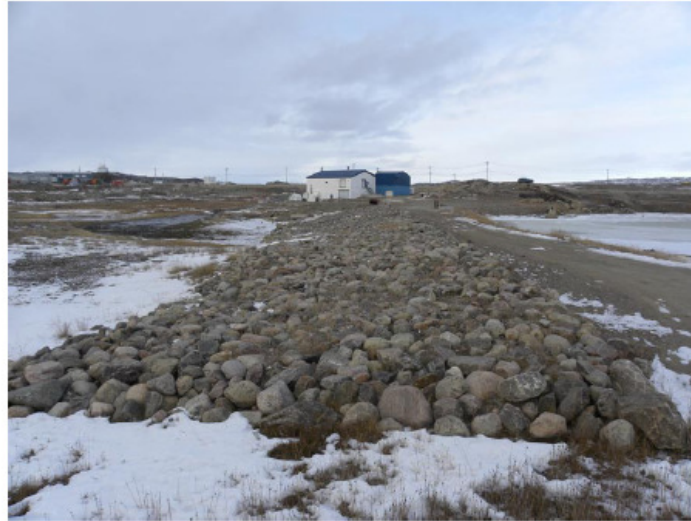
Photograph 5  
West Berm, no change since 2006

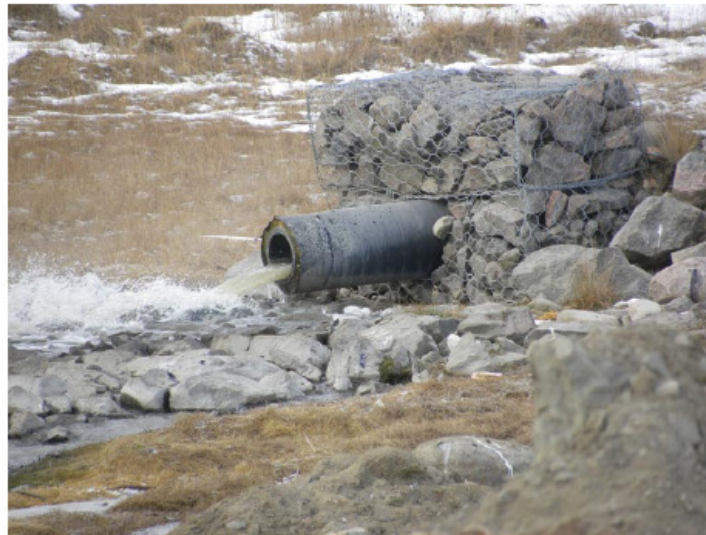
Photograph 6  
Discharge from Sewage Treatment Plant
