Date: Aug. 12, 2010

Client: Concentric Associates International Incorporated

Location: Geraldine Dam, Iqaluit, NU

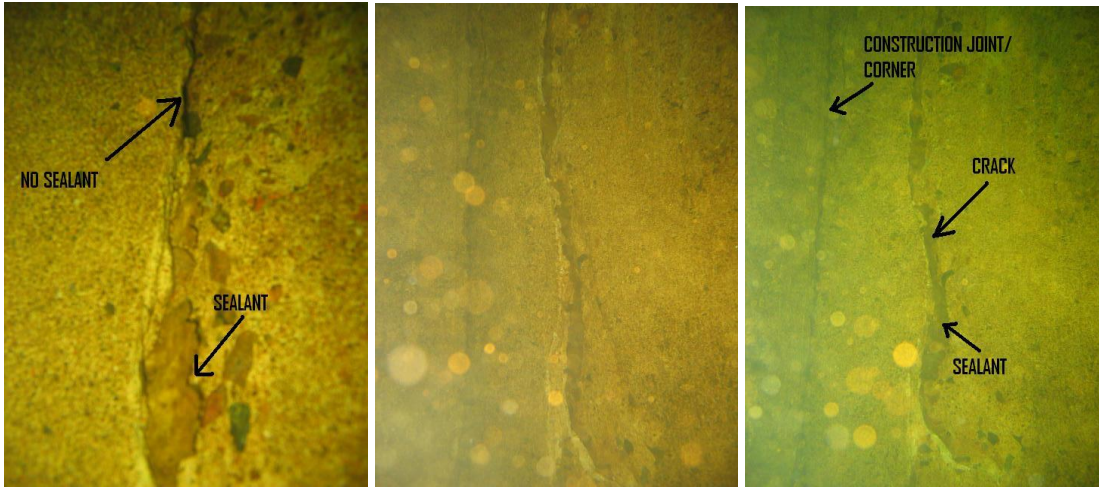
These photos were taken of the crack found about +8050mm from line D, very close to line E, and between elevation 2 and 3 on the drawing.

The crack seems to have had some type of sealant injected into it, and is also in line with one of the leaks found on the downstream side.

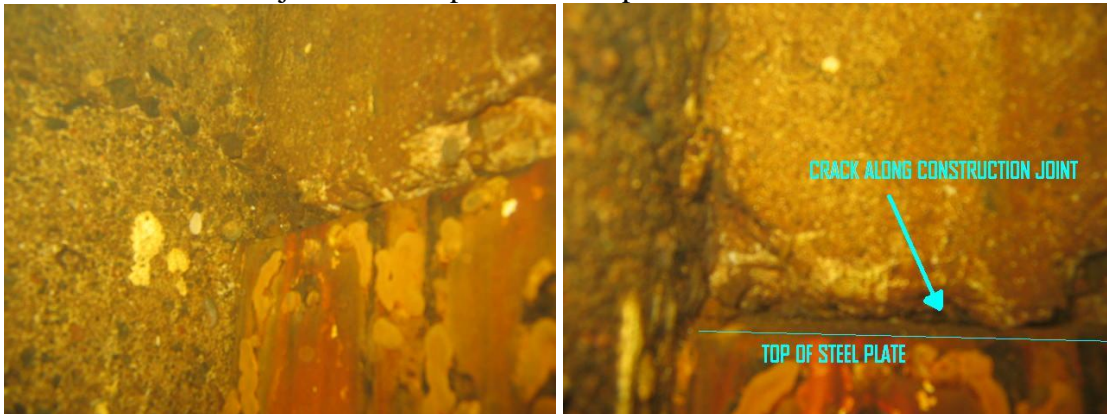
The top of the crack starts at the construction joint between the old concrete and the newer addition. It runs almost parallel with the construction joint in the corner down to the next construction joint at the top of the steel plate.

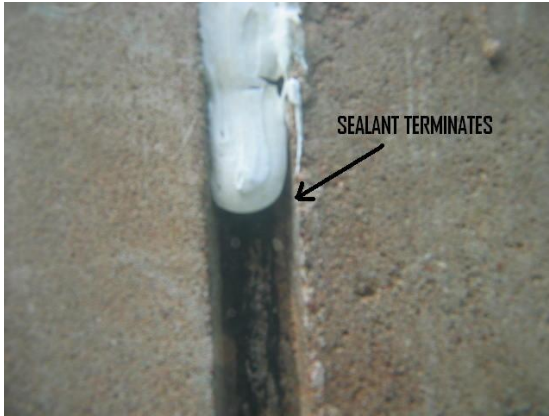
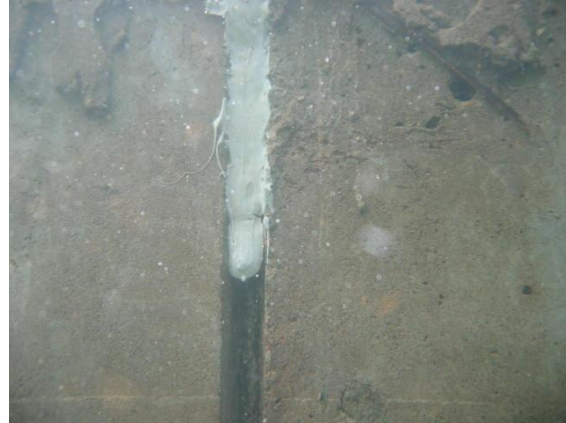
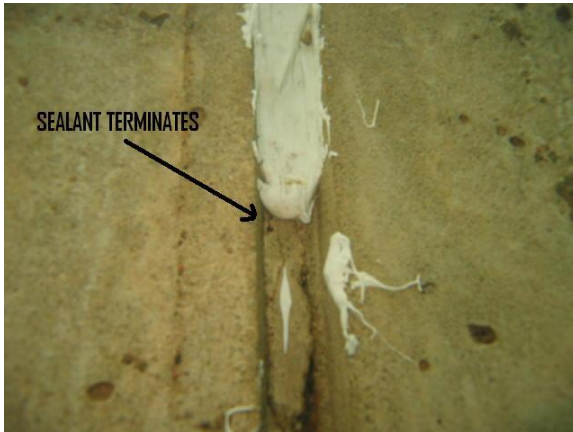
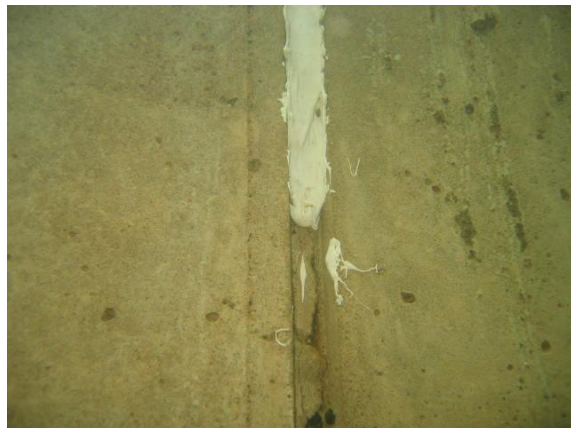
The other leaks are minimal and the water is likely moving through a cold joint or expansion joint, and would be difficult to find due to the lack of flow. The diver did note that the new addition to the dam had sealant in the expansion joints but only at the top. It appears as though the sealant was used when the expansion to the dam was done. There is no evidence of sealant lower on the dam. It is assumed that the workers placed the sealant down to the water at the time, and that was all that could be reached. **Note:** The leaks found on the downstream side are well below the new addition to the dam where there is no sealant in the expansion joints.

The photos below show the sealant in the expansion joints. This sealant does not go beyond the new concrete. The photos clearly show that there was no sealant in the joint previous to the placement of the sealant shown. All of the expansion joints look like this. More visual evidence can be seen in the video that was produced.
