**City of Iqaluit Geraldine Dam
Permanent Record File
Iqaluit, Nunavut**

PRODUCED FOR:
City of Iqaluit

CONCENTRIC ASSOCIATES INTERNATIONAL INCORPORATED

November 4, 2011

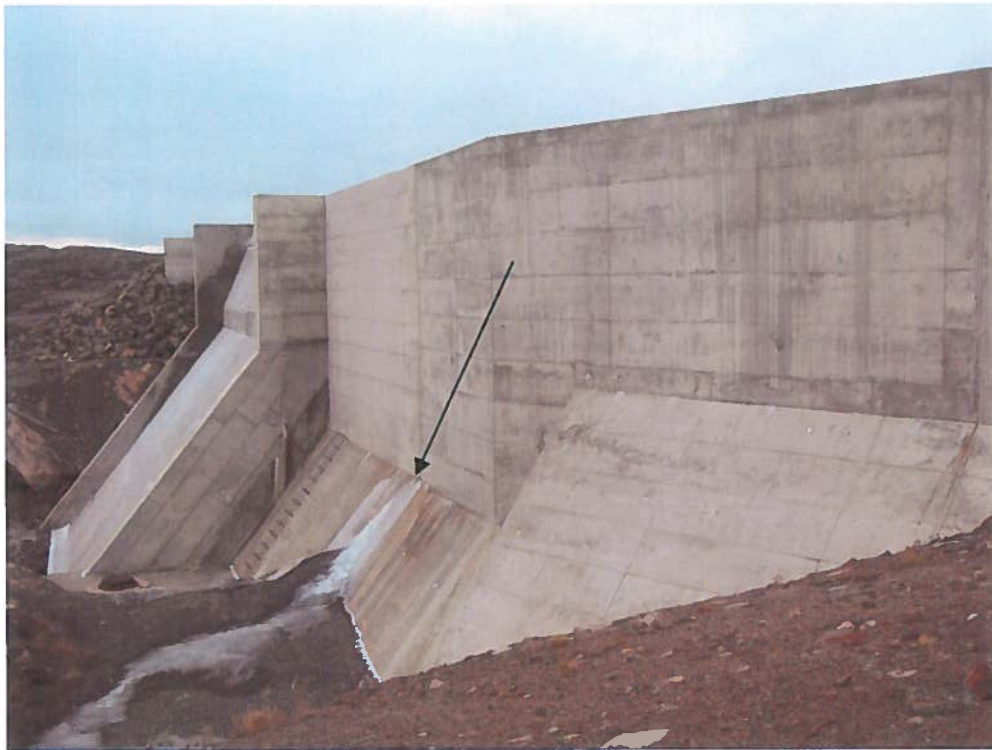
Overview of Downstream Face; 2010; Note Leakage (at arrow)

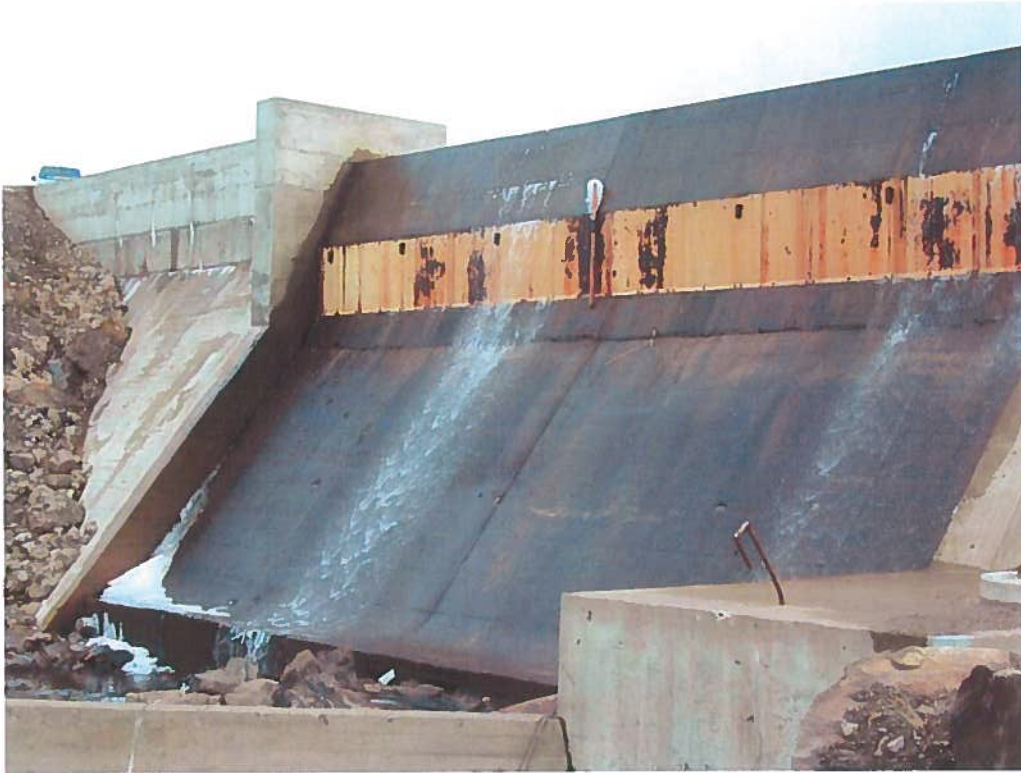
**Photograph No. 7 – Overview of north end of Gravity elevation and Spillway elevation.
Note leaching cracks on Gravity face.**

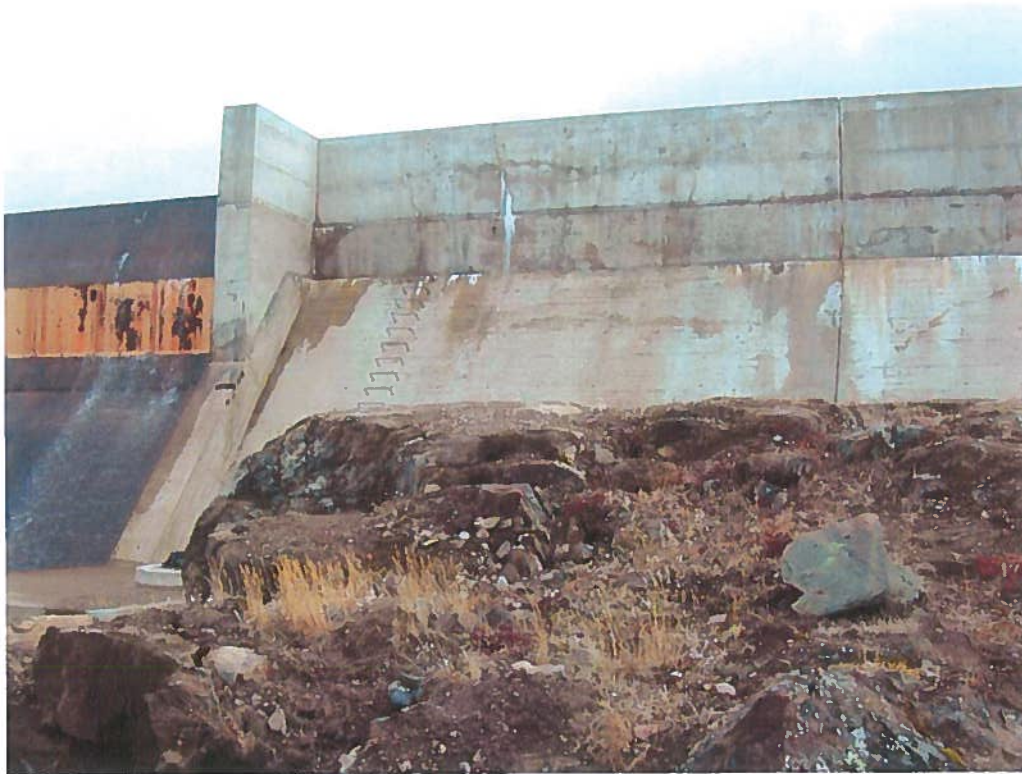
**Photograph No. 8 – Overview of southern portion of Spillway section, and south Gravity
elevation. Note leaching cracks in Gravity face.**

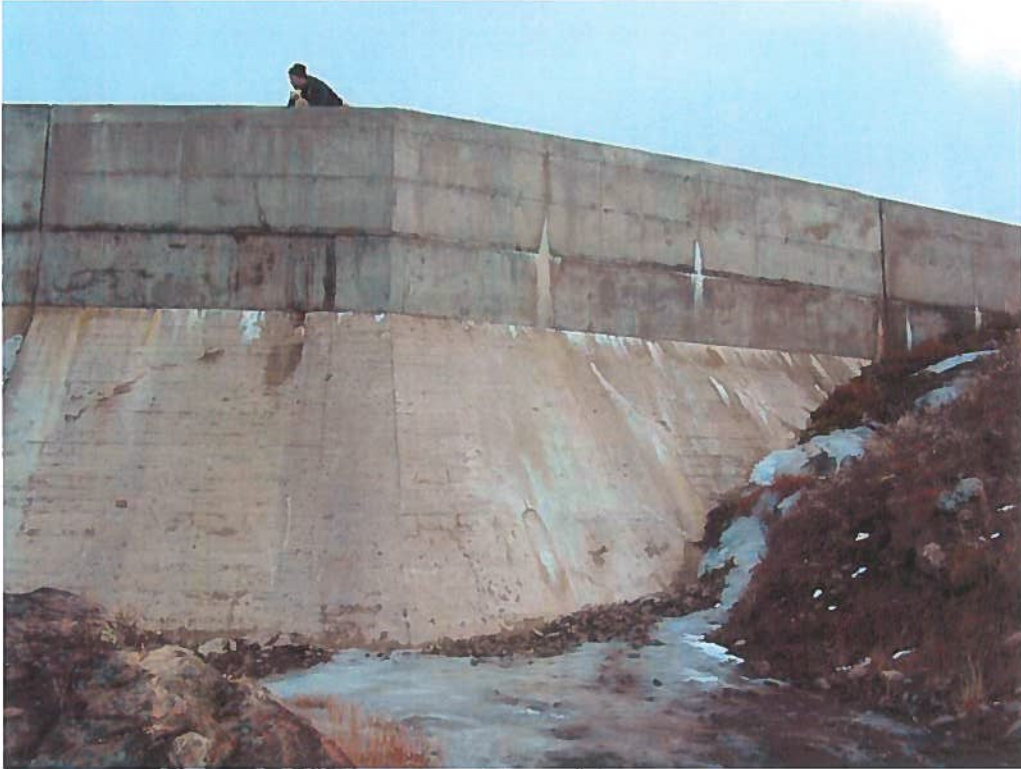
Photograph No. 9 – Overview of south Gravity elevation. Note leaching cracks.

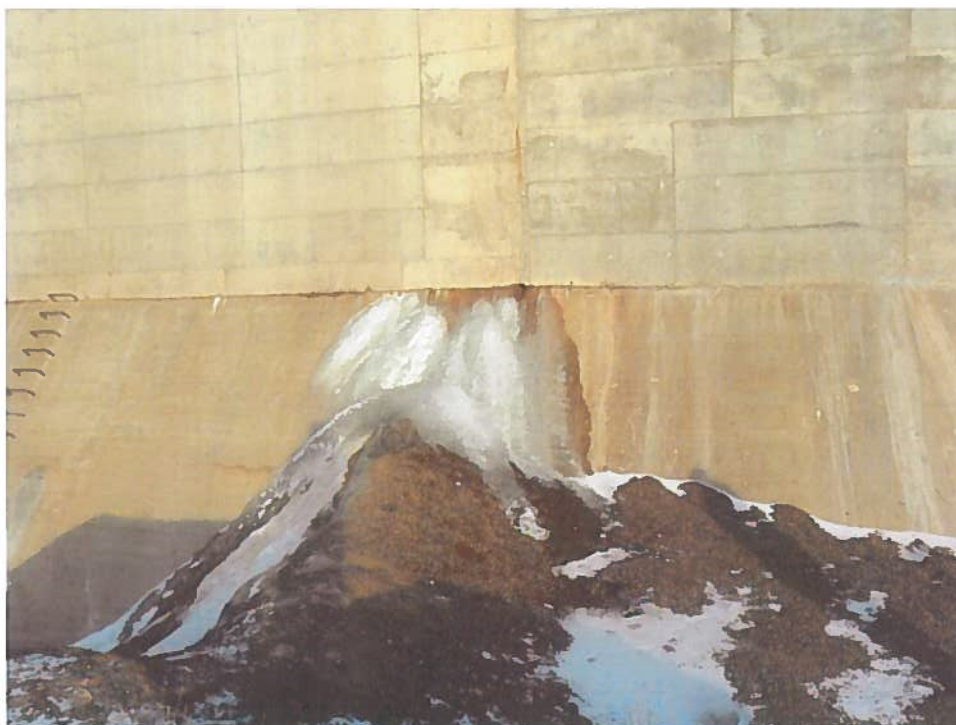
Photograph 5
New leak South of spillway section.

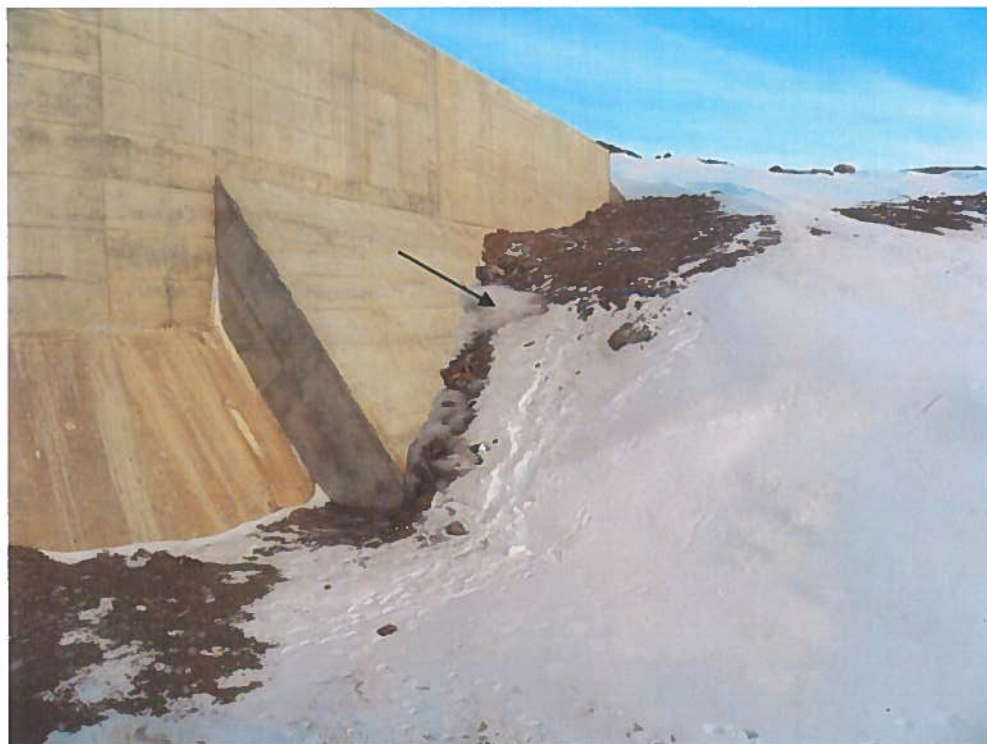
Photograph 6
Upwelling area previously identified in 1997.

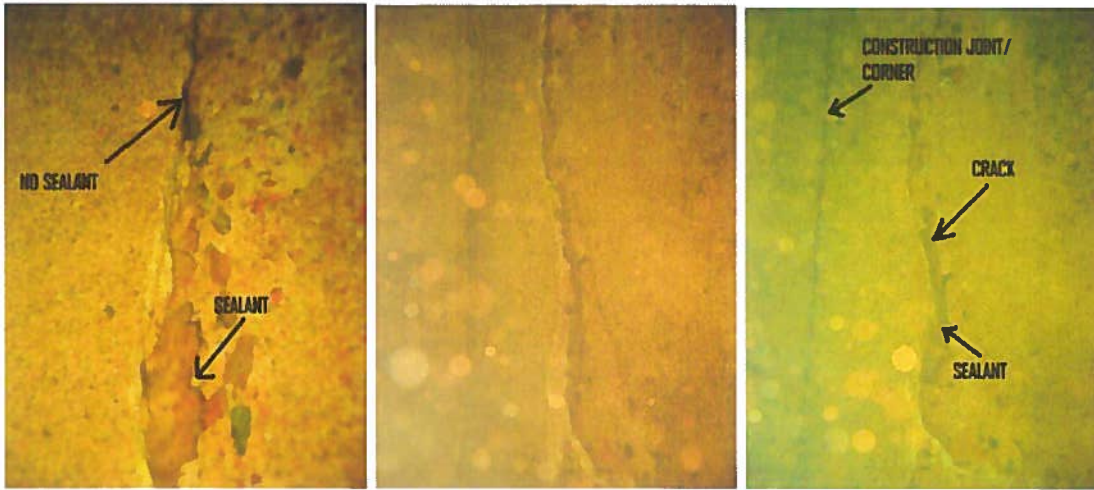
These photos were taken of the crack found about +8050mm from line D, very close to line E, and between elevation 2 and 3 on the drawing.

The crack seems to have had some type of sealant injected into it, and is also in line with one of the leaks found on the downstream side.

The top of the crack starts at the construction joint between the old concrete and the newer addition. It runs almost parallel with the construction joint in the corner down to the next construction joint at the top of the steel plate.

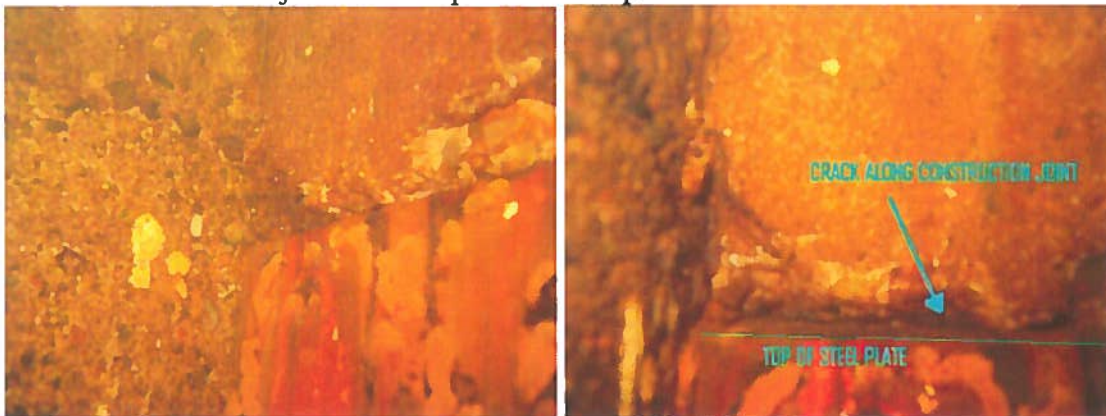
The photos below show the sealant in the expansion joints. This sealant does not go beyond the new concrete. The photos clearly show that there was no sealant in the joint previous to the placement of the sealant shown. All of the expansion joints look like this. More visual evidence can be seen in the video that was produced.

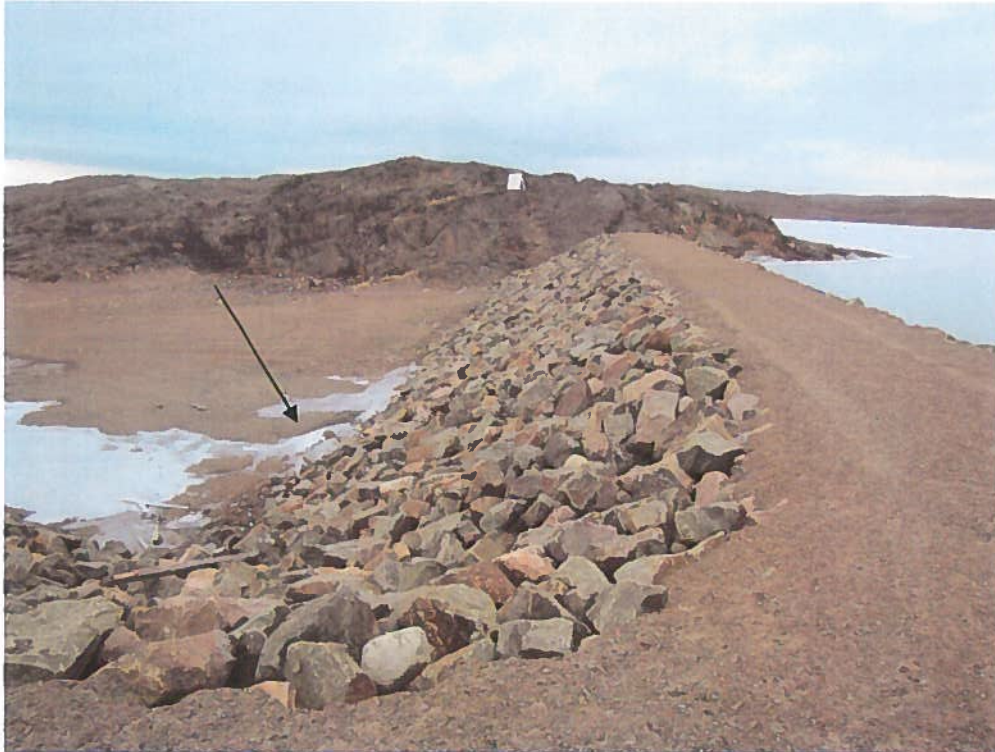
Photograph 2
Overview of North Berm, Downstream Face. Note leakage just north of ramp access.

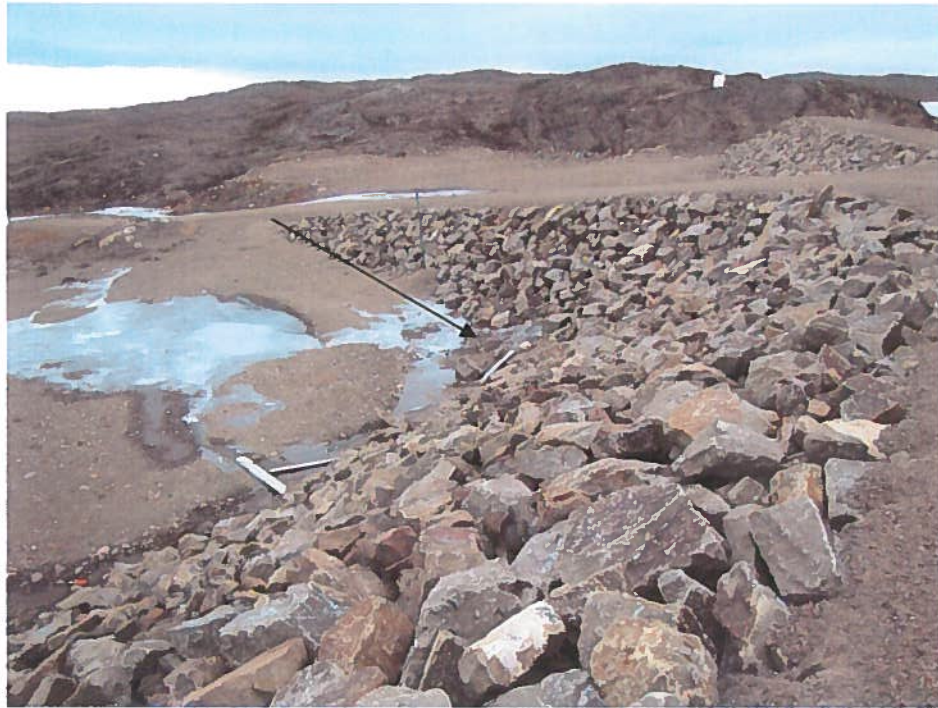
Photograph 3
North Berm at South side of ramp access; note leakage.

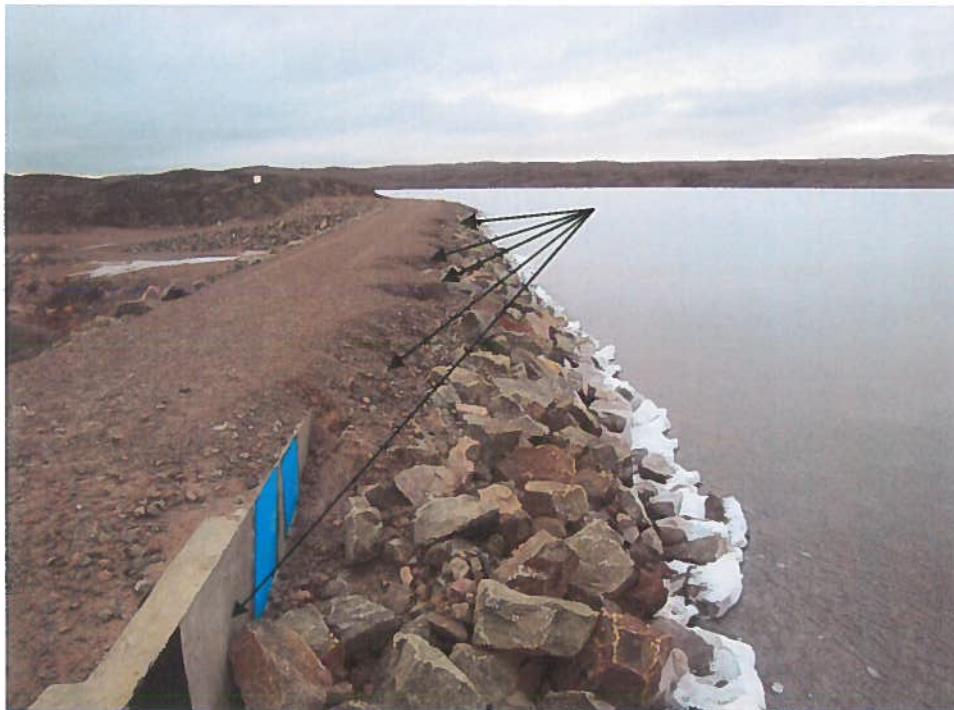
Photograph 4
Southern portion of North Berm, upstream face; note localized washouts due to wave action.

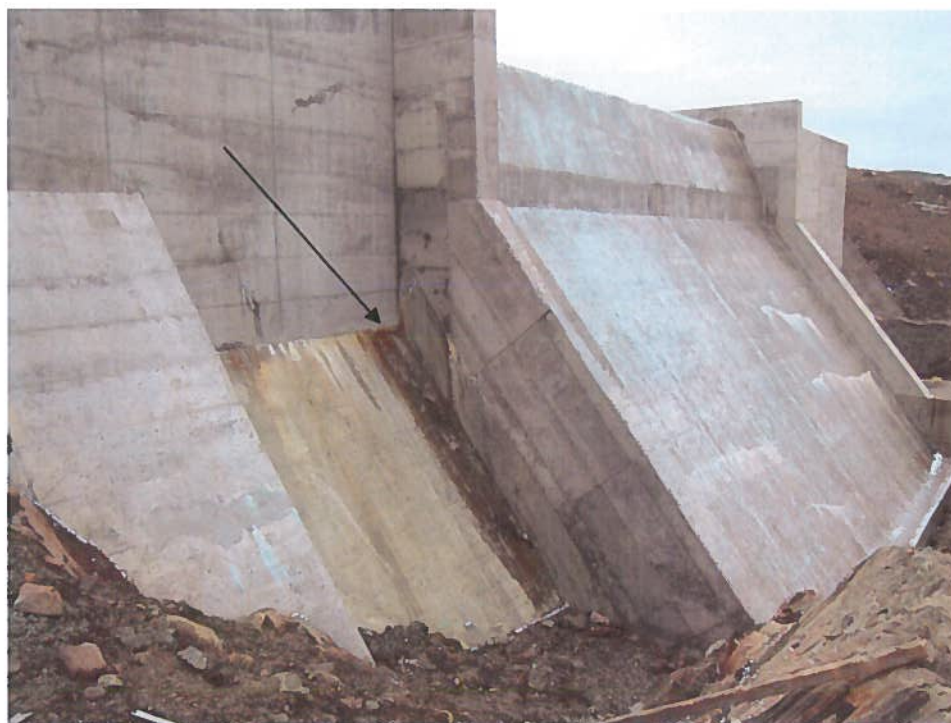
Photograph 6

Leakage at North end of Spillway; similar to 2009 DSI.

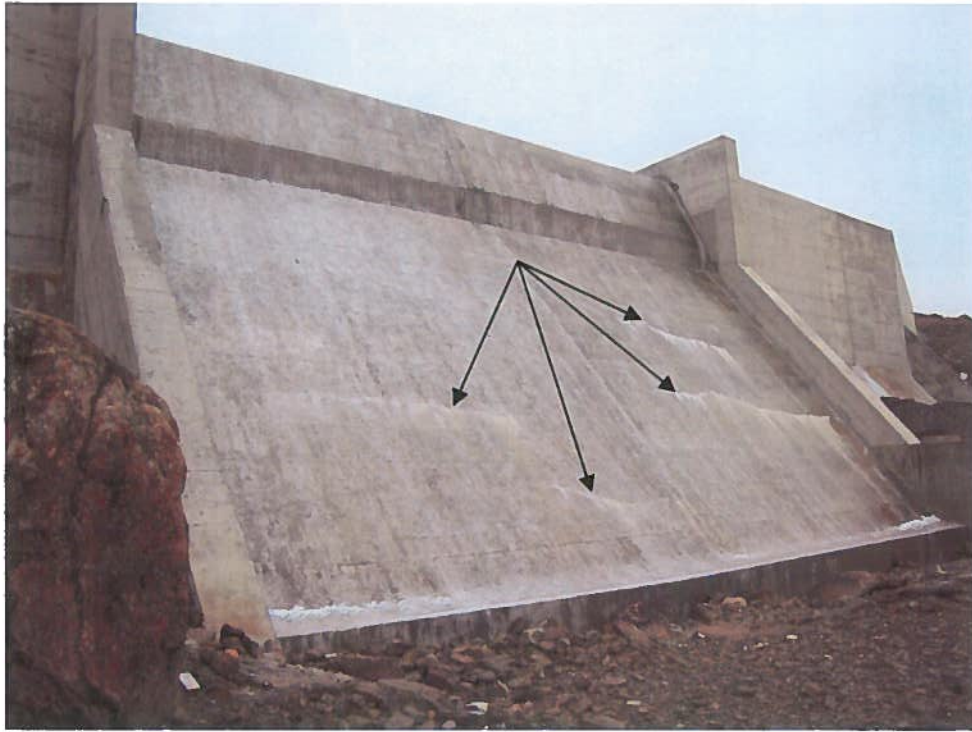
Photograph 7
Leaching cracks in Spillway face; Similar to 2009 DSI.

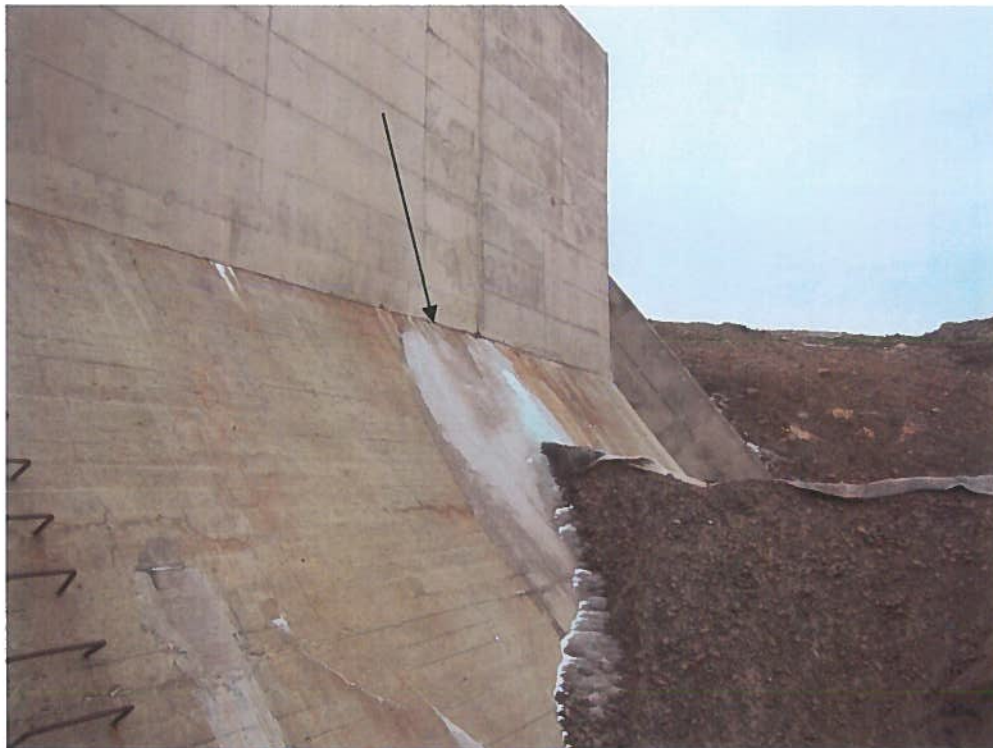
Photograph 8
Leakage at South Gravity section; Similar to 2009 DSI.

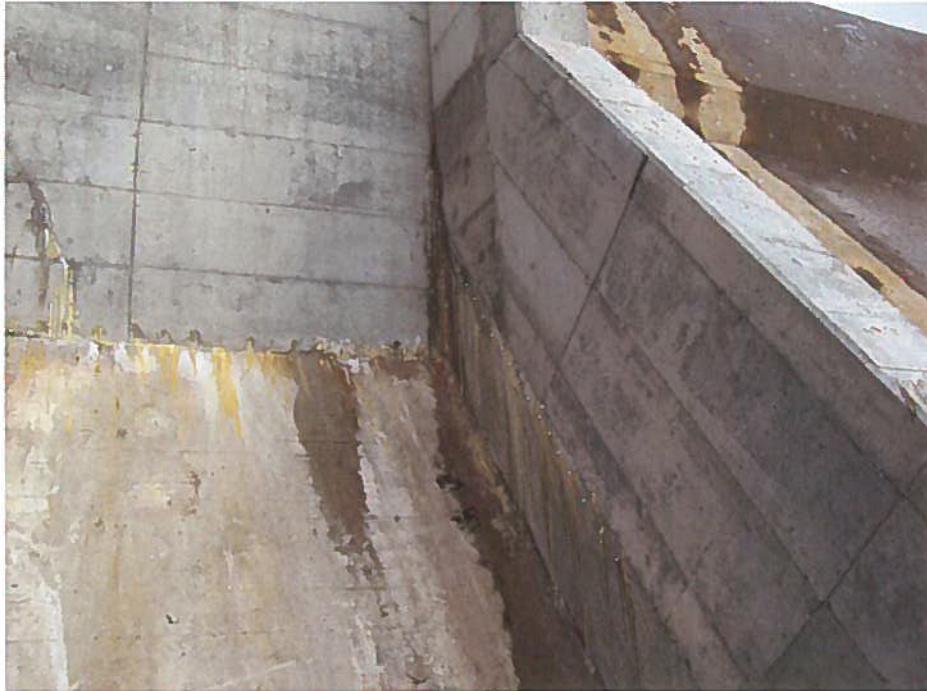
Photograph 3
2011 grouting repair area – concrete is damp only with no running water.

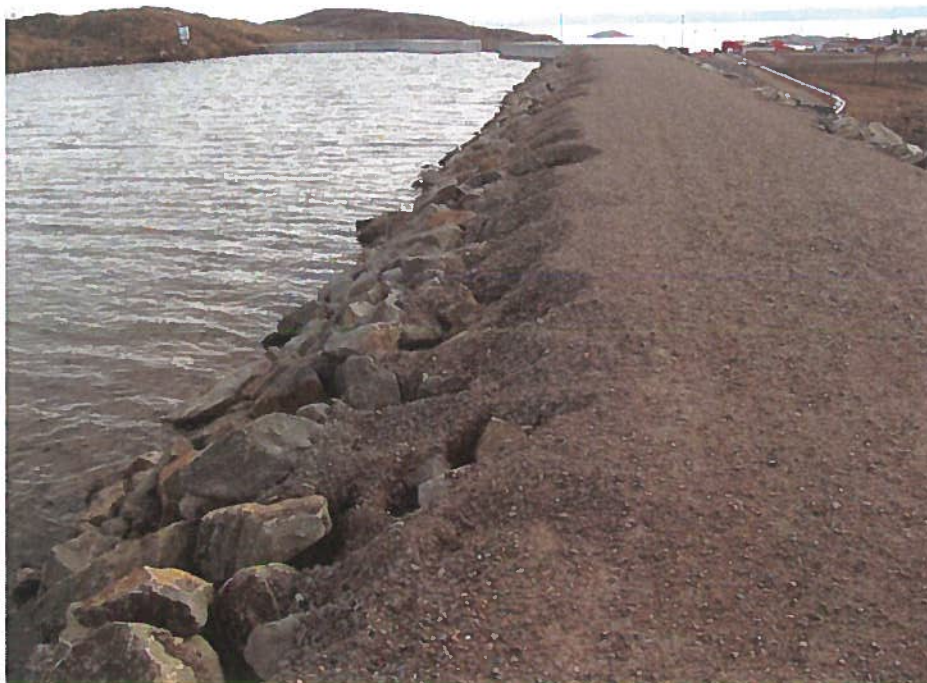
Photograph 4
Overview of North berm – note extensive loss of material from wave action.

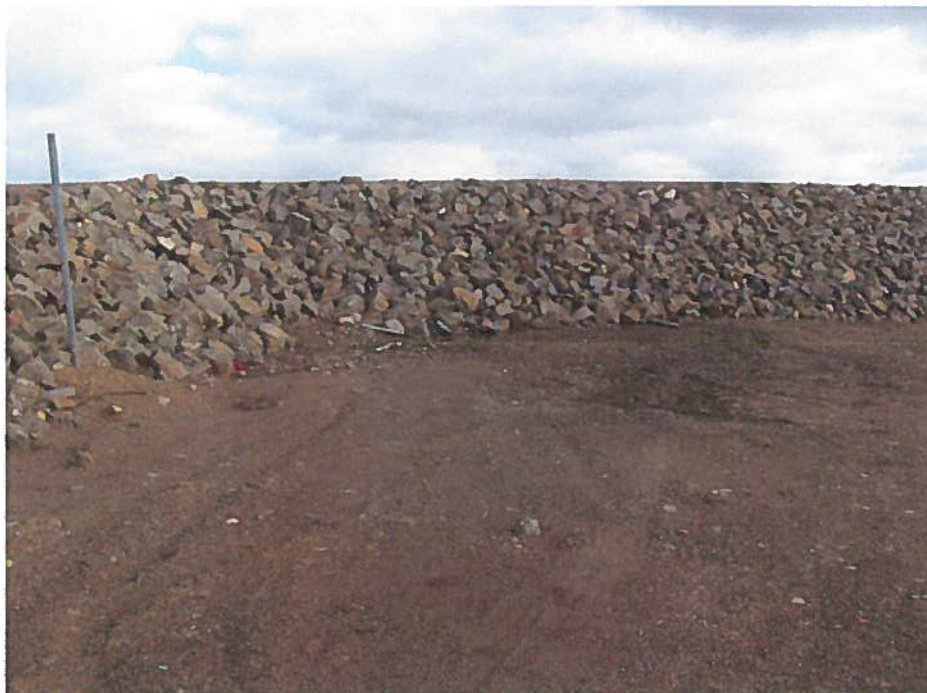
Photograph 6
South side of access ramp – note slight leakage only compared to previously.
