**Lake Geraldine Dam  
Iqaluit, Nunavut  
Dam Safety Inspection**

*November 23, 2010  
REPORT*

**Produced For:**  
THE CITY OF IQALUIT

**Produced By:**  
CONCENTRIC ASSOCIATES INTERNATIONAL INCORPORATED

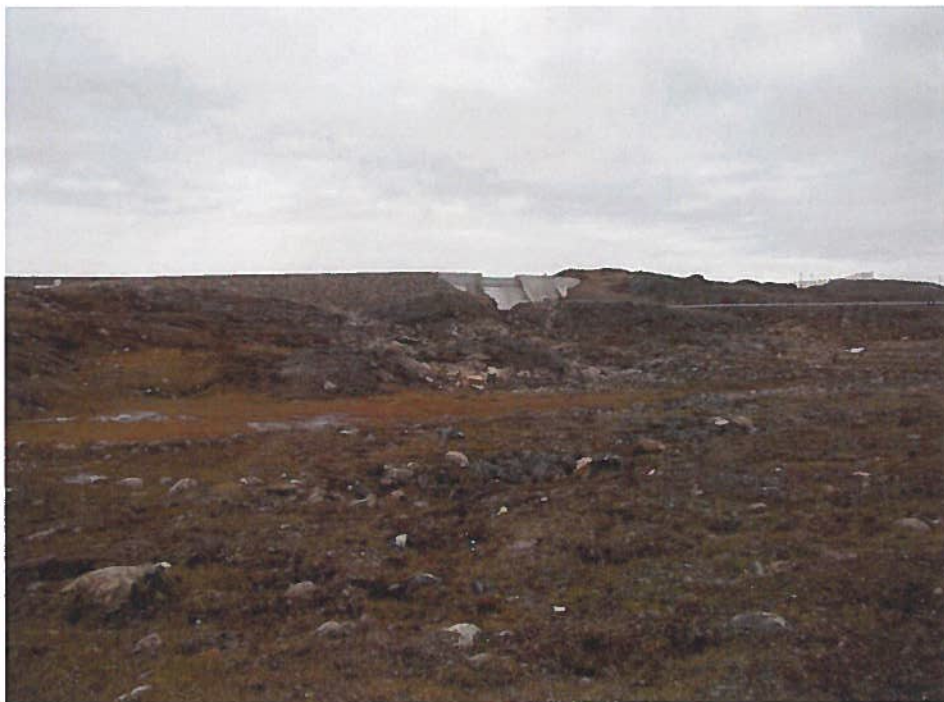
Photograph 1  
Overview of Dam Structure; from the Northwest.

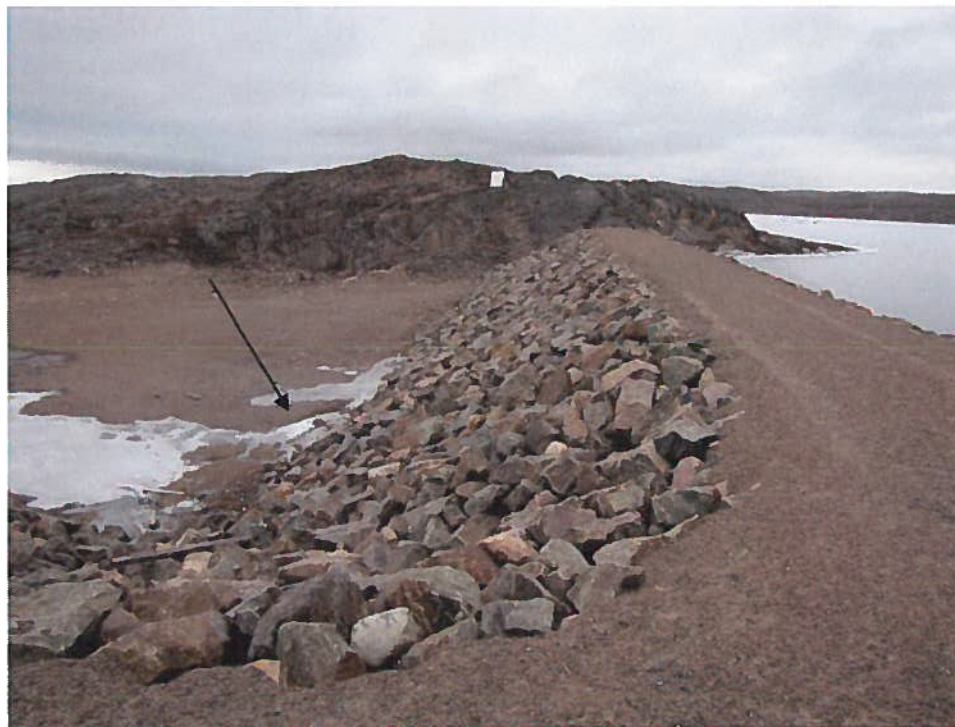
- The berm structures exhibit the following issues:
  - Through leakage has developed in the north berm in the vicinity (both north and south sides) of the vehicular access ramp. The location is coincident with a change in direction of the berm.

Through leakage in the north berm was observed on both the north and south sides of the vehicular access ramp.

A workmanship or durability detail may exist in the cut-off wall in the vicinity; perhaps at the change in direction of the berm, which is coincident with the vehicular access ramp.

Photograph 2  
Overview of North Berm, Downstream Face. Note leakage just north of ramp access.

3. The through leakage in the north berm at the vehicular access ramp requires investigation and repair in 2011. An investigative program will be prepared if requested by the City.

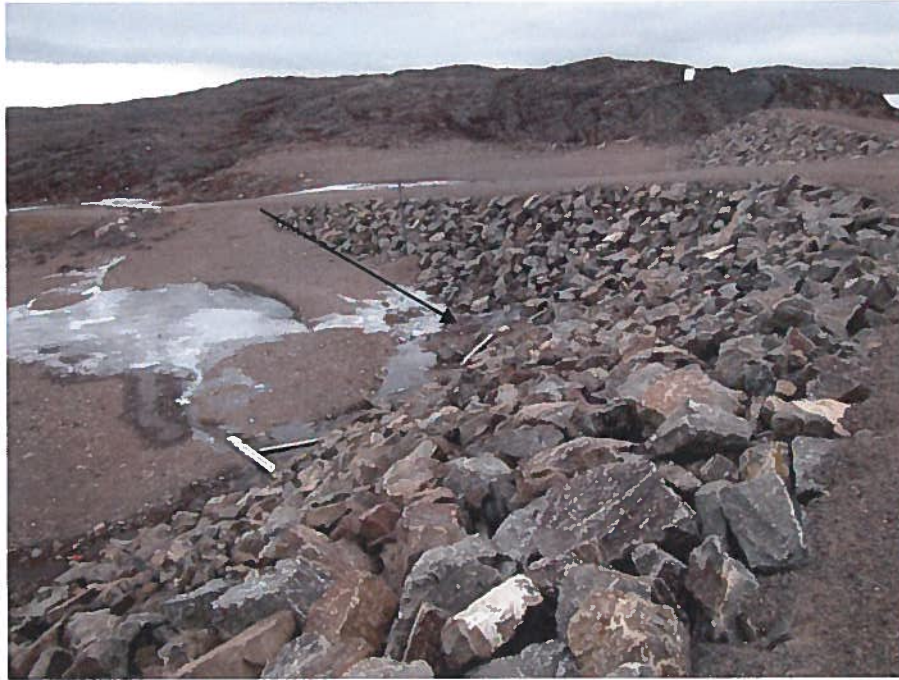
Photograph 3  
North Berm at South side of ramp access; note leakage.

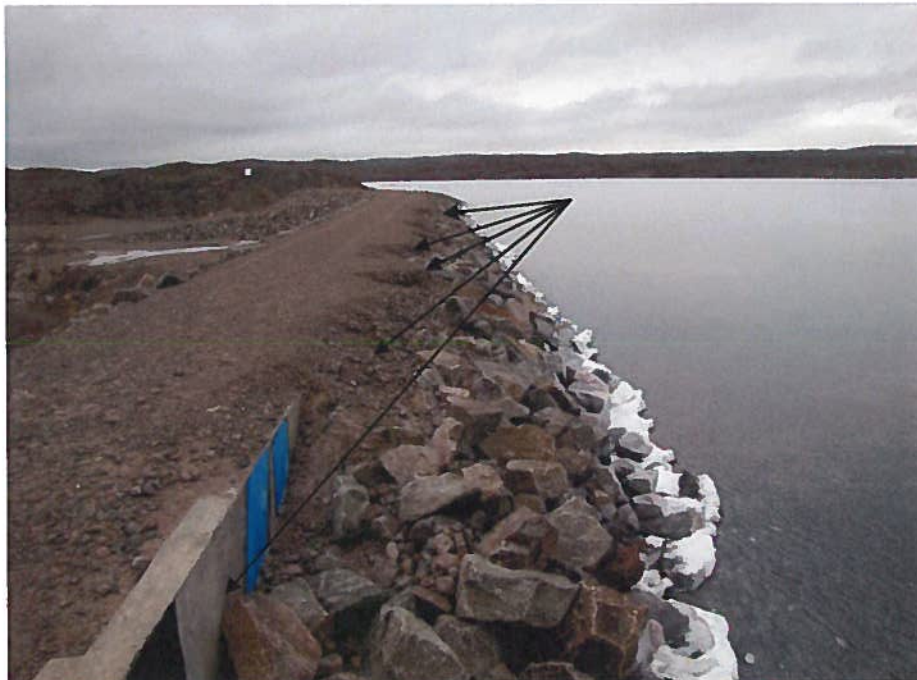
- Localized wash-outs have occurred on the upstream face of the north berm. It was reported that these wash outs developed as a result of wind events during the week of October 18, 2010. The larger armour stone remains however sections of the roadbed have been washed out.

Wave action as a result of high winds caused the erosion of granular material and the exposure of the concrete cutoff wall within the north berm.

As per the design, the vehicular roadbed extends over the cut-off wall on the upstream side of the berm a distance of perhaps 1.2 metres. The roadbed material is a much finer granular than the rip rap, with the visual appearance of pit run gravel. This material was what washed out during the wind events.

Photograph 4  
Southern portion of North Berm, upstream face; note localized washouts due to wave action.

As a short term solution, all areas of erosion should be filled with rock of similar size to the existing rock fill.

In the longer term, we recommend filling the upstream berm with rock up to and slightly above the top of the cutoff wall and thus eliminate a 1.2 metre width of the vehicular roadbed.

2. The localized wash outs from the wind events of 2010 require repair. As a short term interim measure all areas of erosion should be filled with rock of similar size to the existing rock fill. In the longer term, the upstream berm should be filled with rock up to and slightly above the top of the cutoff wall, and thus eliminate a 1.2 metre width of the vehicular roadbed.

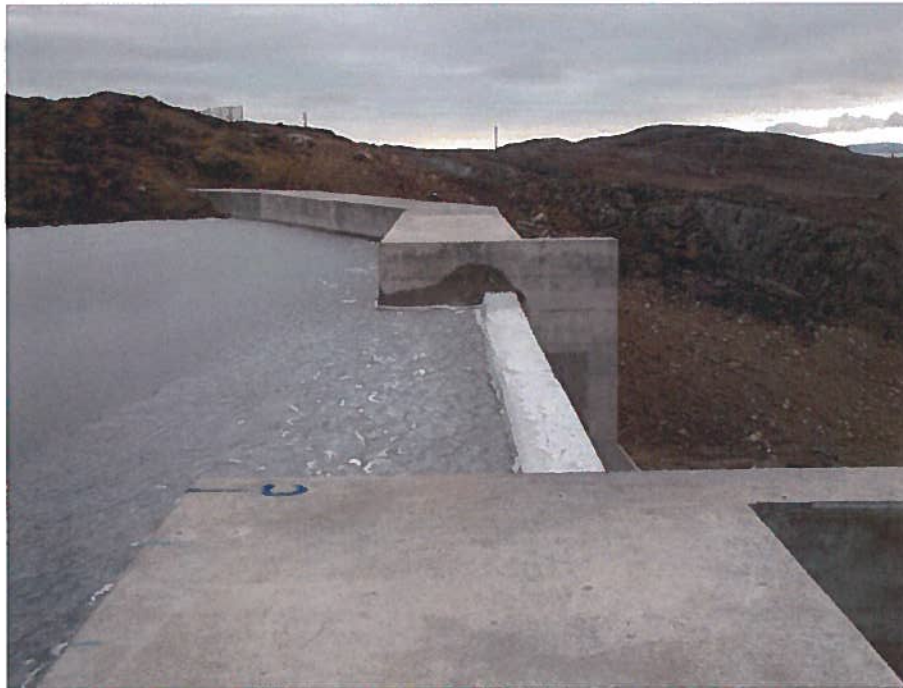
Photograph 5

- The visible concrete portions of the dam structure are in general unchanged from that observed for the 2009 DSI.
- The level of the Lake Geraldine reservoir has increased at least 0.6 metres since October 2009. The water level was within approximately 0.2m of the spillway crest at the time of our recent inspection; i.e. close to capacity.

Overview of spillway; note water level near capacity; approx. 0.6m higher than October 2009.

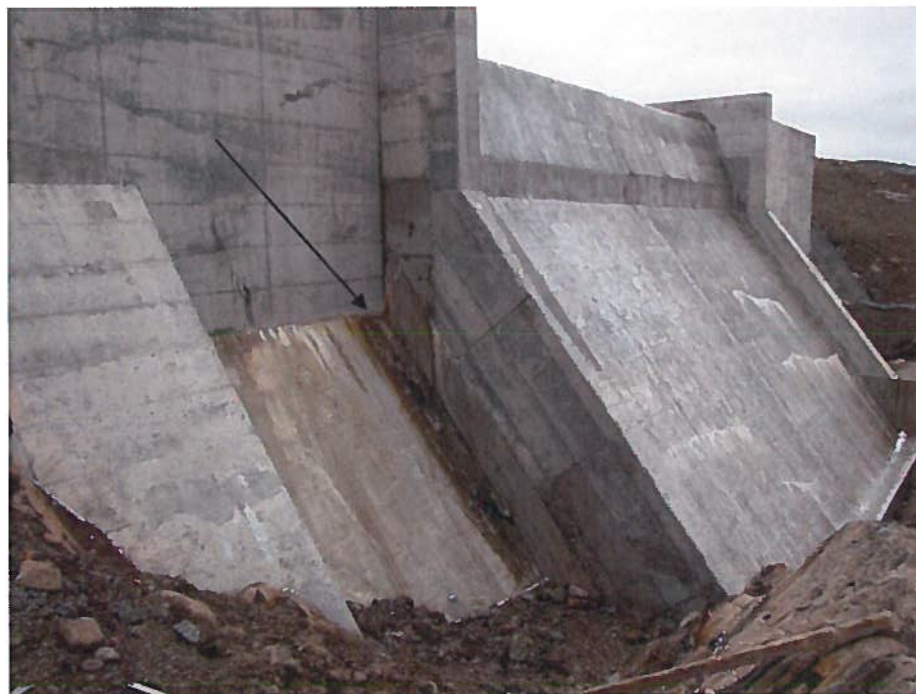
Photograph 6

Leakage at North end of Spillway; similar to 2009 DSI.

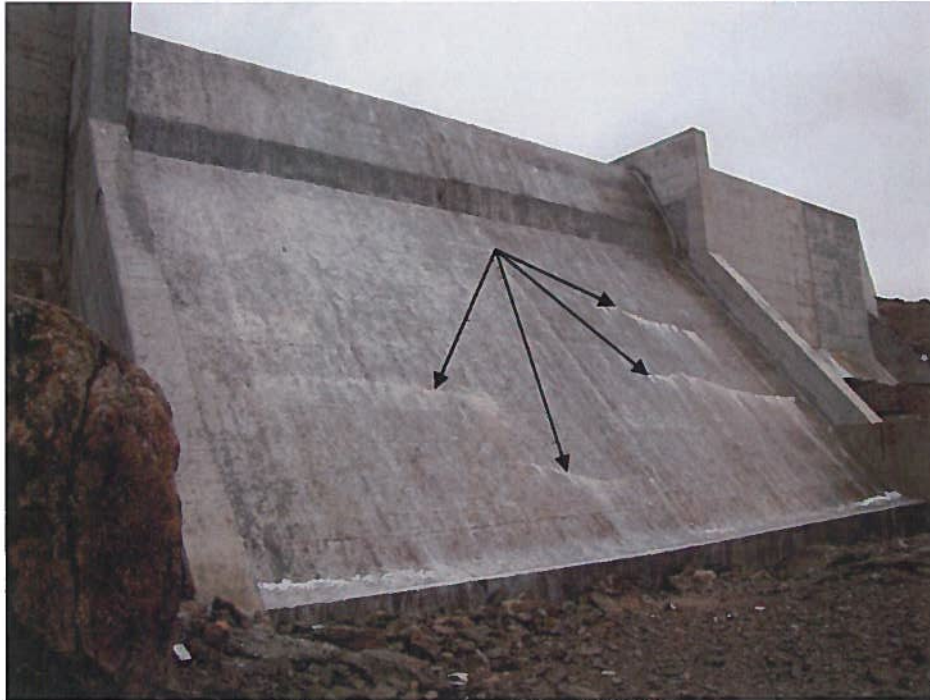
Photograph 7  
Leaching cracks in Spillway face; Similar to 2009 DSI.

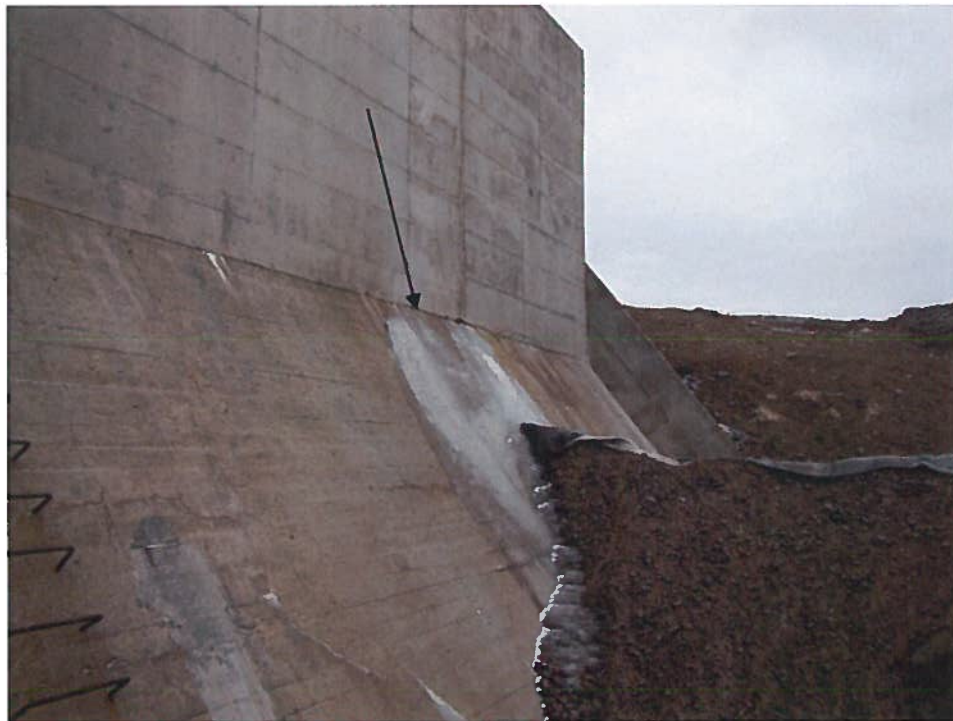
- The leak in the concrete dam structure south of the spillway section that was identified in the 2009 DSI has not changed significantly.
- Upwelling along the south concrete wing wall appears has not changed significantly since the 2009 DSI.

Photograph 8  
Leakage at South Gravity section; Similar to 2009 DSI.

1. The grouting program originally designated for implementation in 2010 was designed in 2010; however, the implementation phase was deferred to 2011 by the City, and after dialogue with Concentric.
