# **Lake Geraldine Dam Iqaluit, Nunavut Dam Safety Inspection**

*September 21, 2011  
REPORT*

**Produced For:**  
THE CITY OF IQALUIT

**Produced By:**  
CONCENTRIC ASSOCIATES INTERNATIONAL INCORPORATED

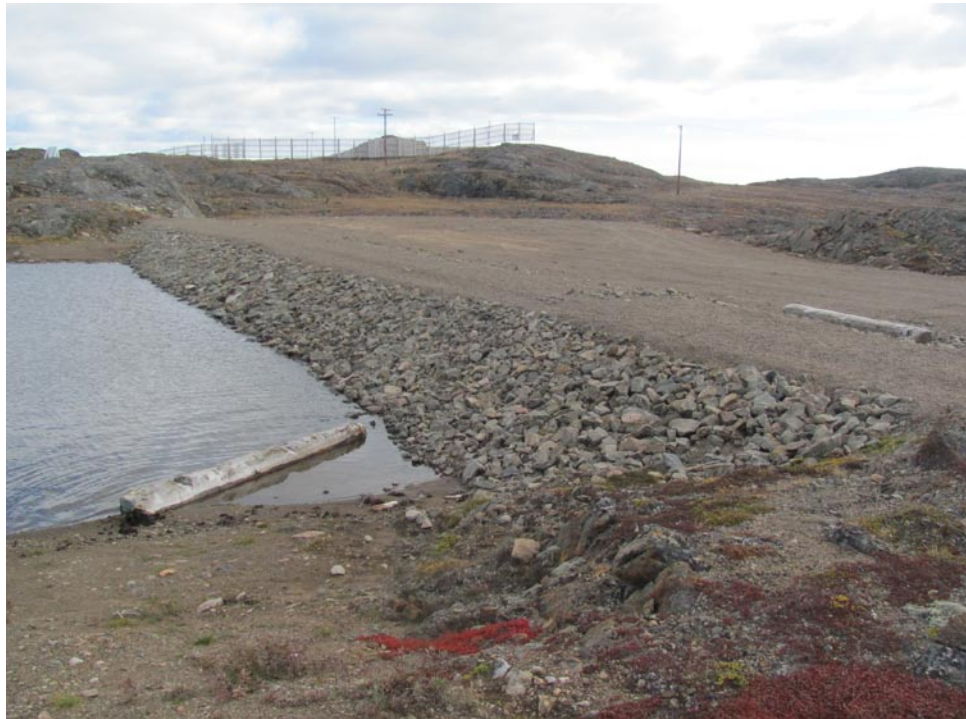
Photograph 1  
Overview of South berm.

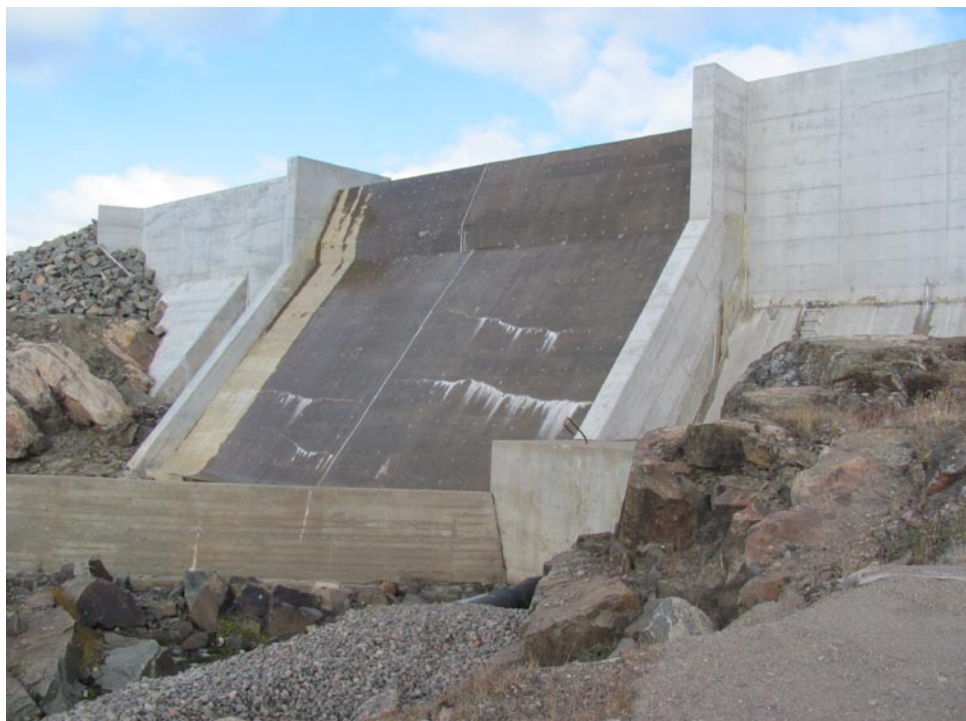
Photograph 2  
Overview of spillway – note overtopping (maximum lake level)

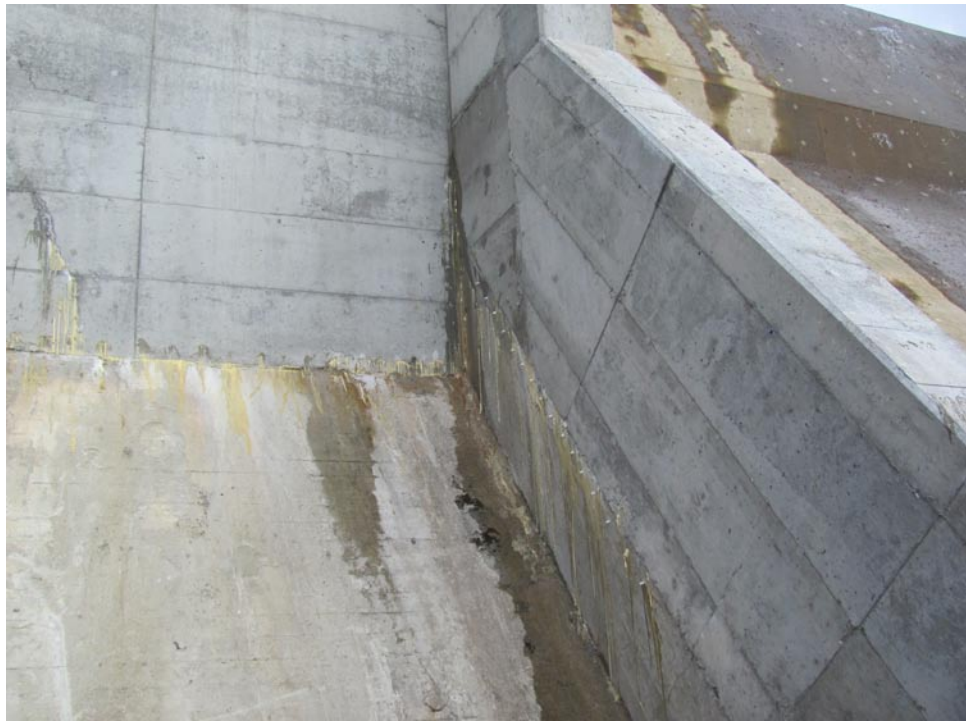
- A grouting program was conducted in 2011 which has addressed the leakage areas identified in the previous DSI.
- Upwelling along the south concrete wing wall appears similar to that observed in 2009.
- North berm repairs are required due to loss of fills on the upstream face.
- Very little leakage was noted at the North berm access ramp where previously observed in 2010.

Photograph 3  
2011 grouting repair area – concrete is damp only with no running water.

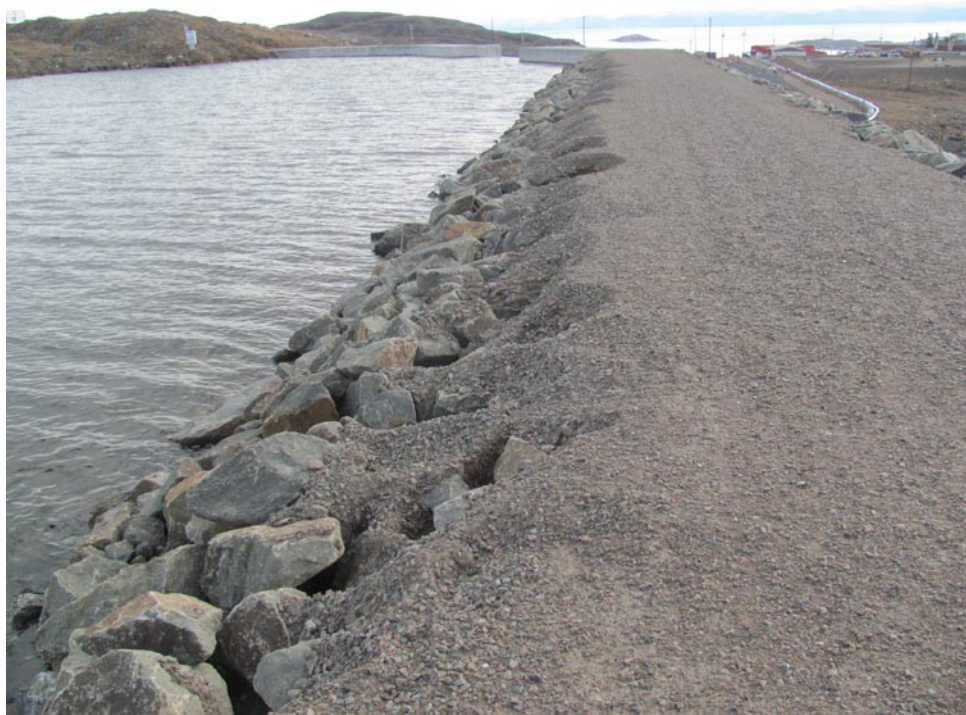
- The concrete portions of the dam structure are in general unchanged from that observed for the 2009 DSI.
- The north berm structure has experienced considerable scour and loss of granular fill due to wave action from wind events; the severity has increased over the last 2 years as the reservoir level has begun to approach maximum.
- A grouting program was completed in August 2011; based in part on the results of an underwater survey commissioned in 2010. The grouting program had been slated for 2010 but was deferred one year to accommodate budgetary constraints. The grouting program appears to have been, in general, effective.
- Upwelling along the south concrete wing wall appears unchanged from the 2009 DSI.
- The (previous) leakage sites on both sides of the vehicle access ramp to the North berm exhibit little or no leakage.

Photograph 4  
Overview of North berm – note extensive loss of material from wave action.

1. A repair of the damage to the North berm is required in 2012. An engineered tender package should be prepared which should include provisions for long term stability of the berm.
2. Continue to monitor the leakage sites on each side of the access ramp to the North berm.
3. Once the Emergency Preparedness Plan is complete, it should be integrated with the dam record documentation and Permanent Record File.
4. Complete the next DSI prior to October 2012.

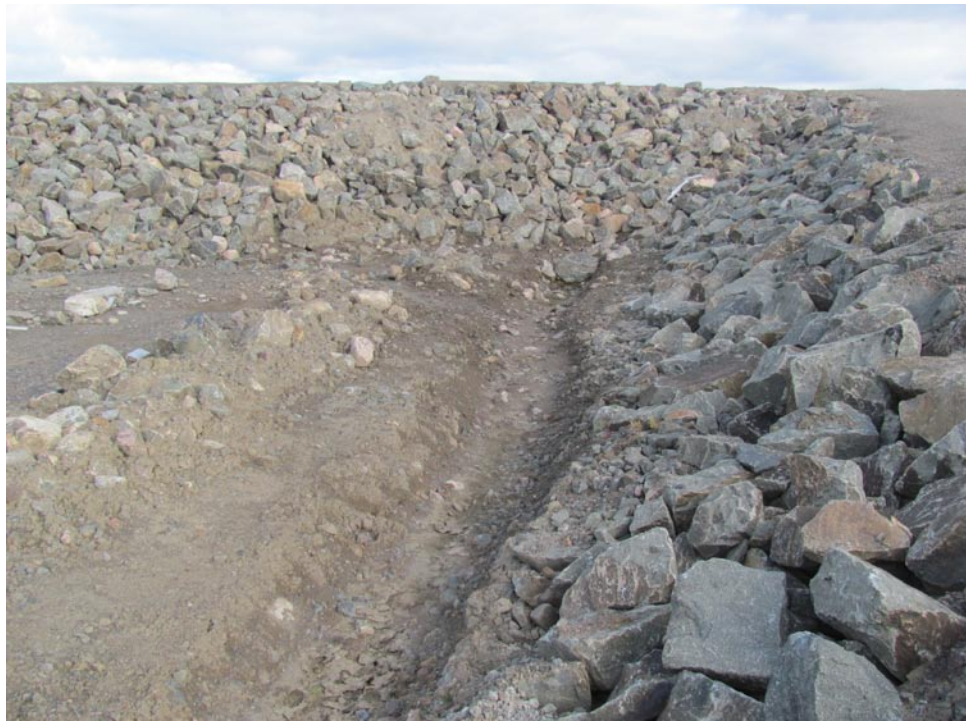
Photograph 5  
North side of access ramp – note previously wet area now dry.

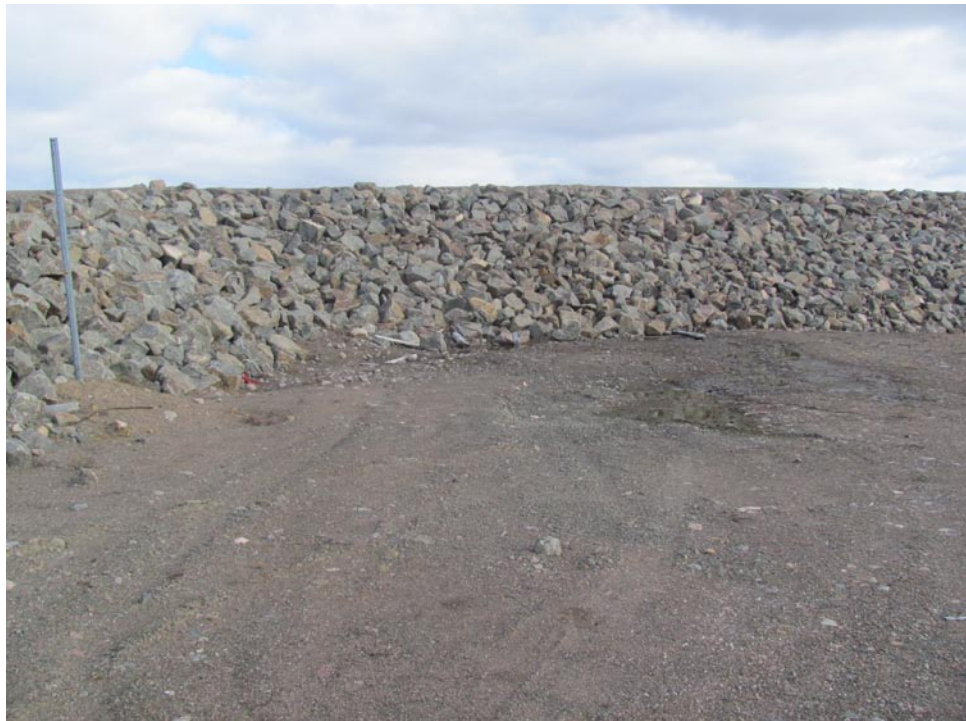
Photograph 6  
South side of access ramp – note slight leakage only compared to previously.
