ATTACHMENT 7

Compliance Assessment

CITY OF IQALUIT
WATER LICENCE 3AM-IQA1626
2024 ANNUAL WATER LICENSE REPORT

May 02, 2025

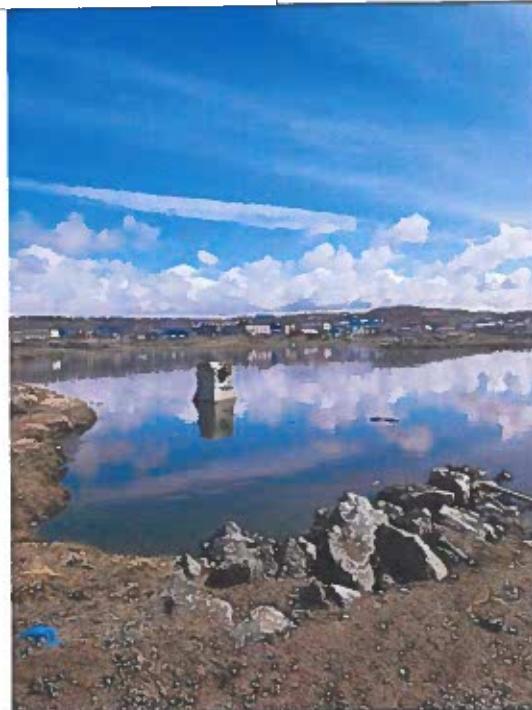
Photo No. 1

Photo of Iqaluit's Sewage Lagoon Facility.

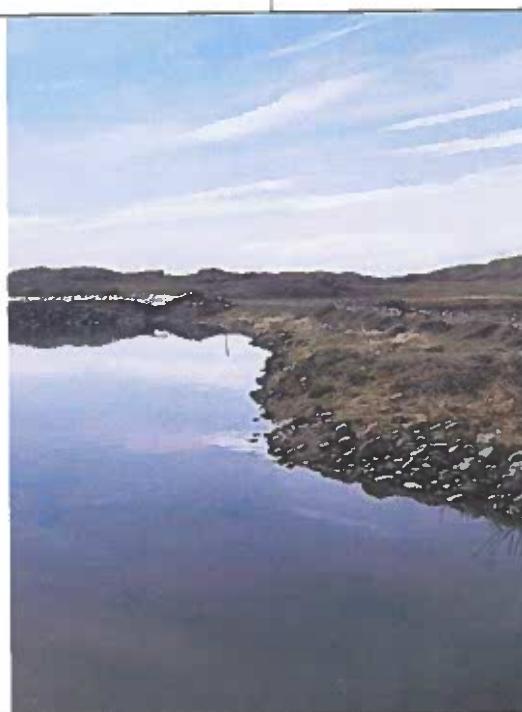
Photo No. 2

Another view of the Sewage Lagoon Facility. No non-compliance issues were observed in this facility during the inspection.

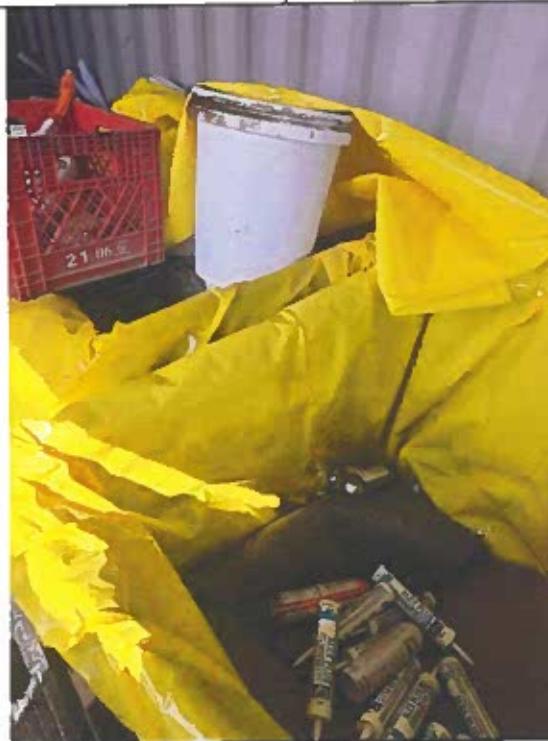
Photo of hazardous waste being contained within a sea can at the landfill.

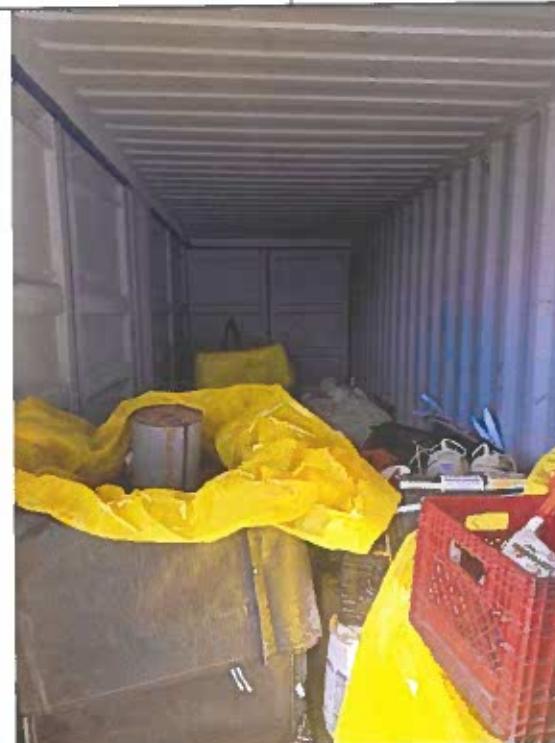
Miscellaneous hazardous waste is being stored within secondary containment at the landfill site.

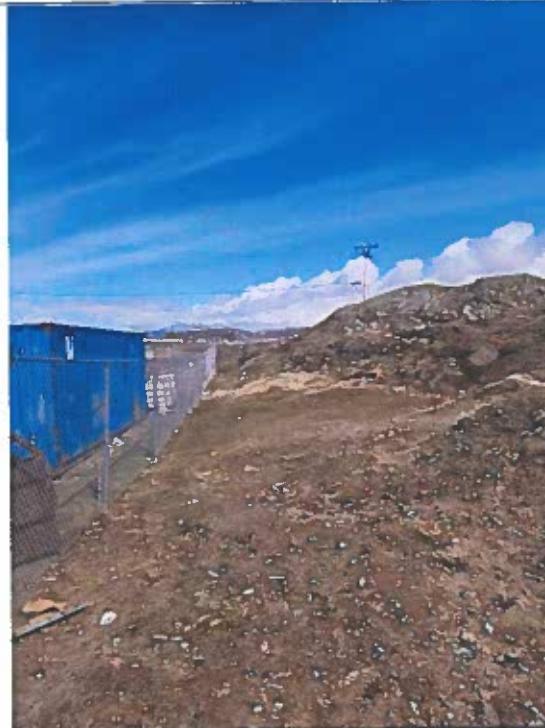
Photo showing improvement of the City's work to clean the surrounding area of the landfill. This area had a variety of metals surrounding the area last year.

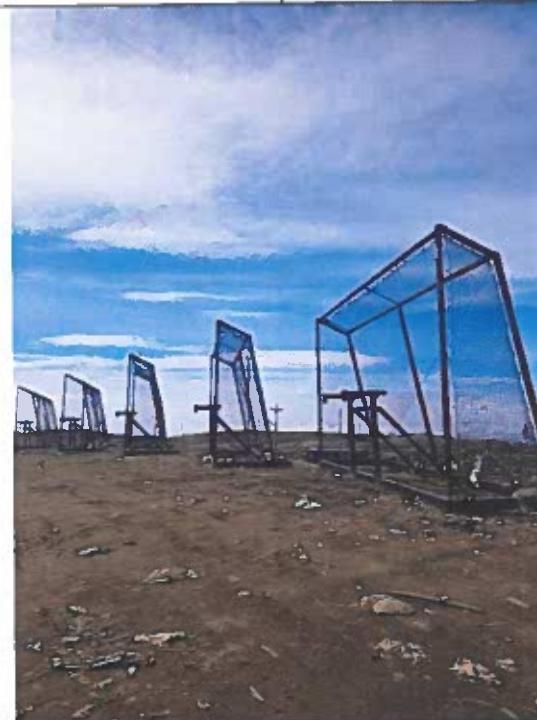
The City had invested in portable fencing in efforts to capture more wind-blown debris from escaping the landfill.

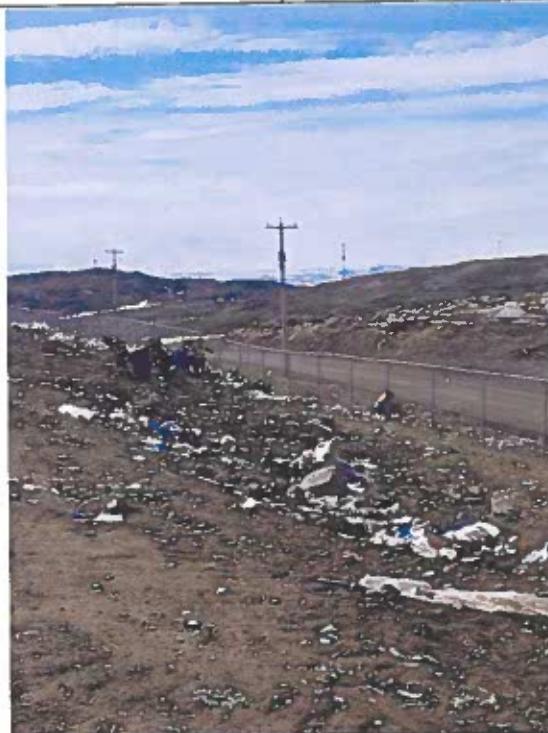
City employees were observed picking up loose trash within the landfill site.

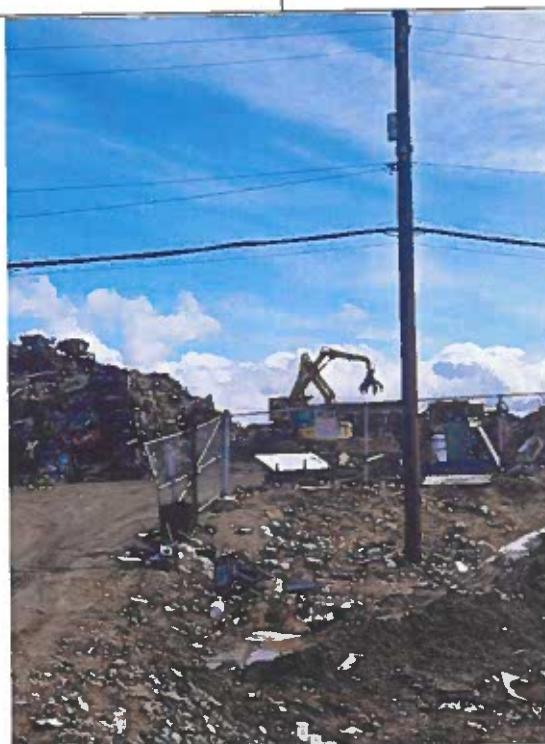
Photo showing metal crushing/organizing on the metal side of the landfill. This metal will be shipped south to a designated facility.

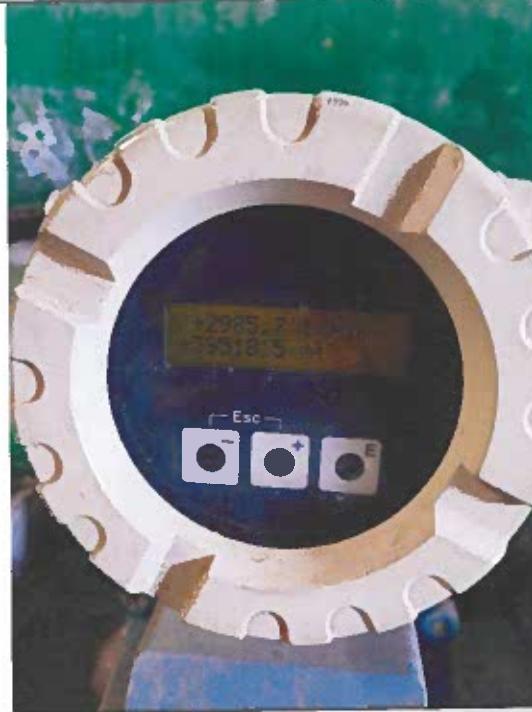
Photo showing raw water intake from Lake Geraldine, the City's water supply.
