### **Lake Geraldine Intake Replacement Conceptual Design**

# LONG-TERM WATER PROJECT OWNERS ENGINEER

LAKE GERALDINE INTAKE ACCESS VAULT  
TECHNICAL REPORT

FINAL REPORT

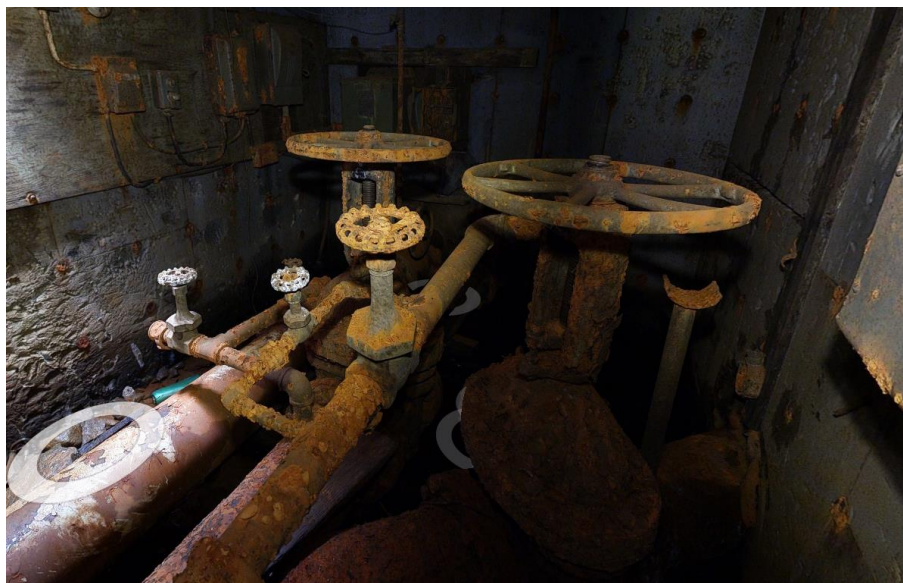
**Figure 9: Example of Heavily Corroded Piping and Valves**

The existing piping within the intake valve chamber is heavily corroded and it appears as though the valves have not been regularly exercised. Redundant piping has been left in place from previous work in the chamber and there is a substantial amount of debris (wood, rocks, garbage) around the chamber.

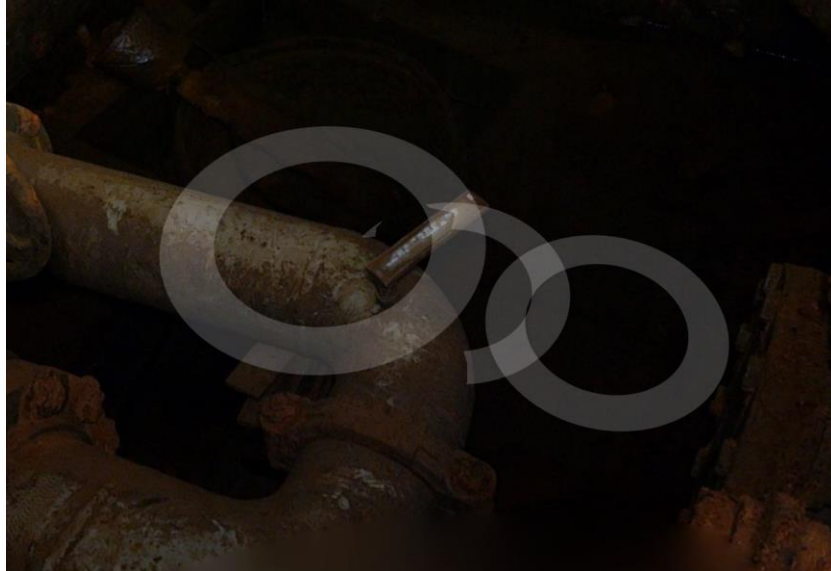
**Figure 10: Corroded Sensor on Heated Water Line**

There is a corroded and unidentifiable sensor installed on the heated water piping prior to its connection to the raw water line (**Figure 10**). Given the condition of the services, it is assumed unlikely to be functioning properly.

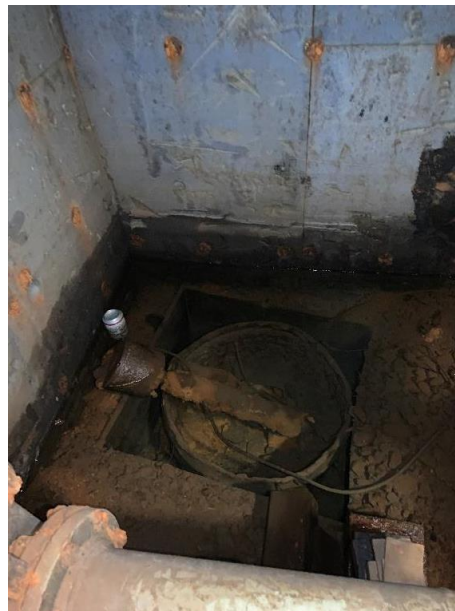
**Figure 11: Sump pump and pit in the southwest corner of the Access Vault (VR Associates Inc., 2023)**

There is a sump pit within the southwest of the intake valve chamber and what appears to be rusted and inoperable components of a pump. The depth of the sump pit is not known.

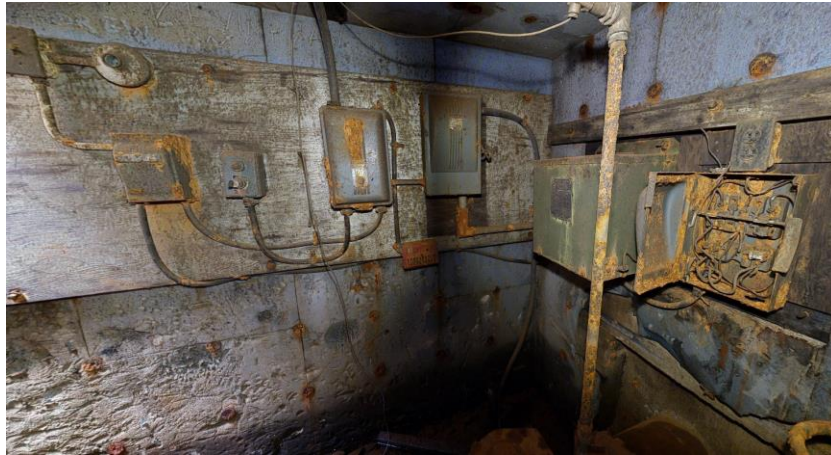
**Figure 12: Electrical System Components Along South and East Walls**

Electrical services, including switches and disconnects are mounted on the south and east wall of the chamber and are heavily damaged by corrosion (Figure 12).

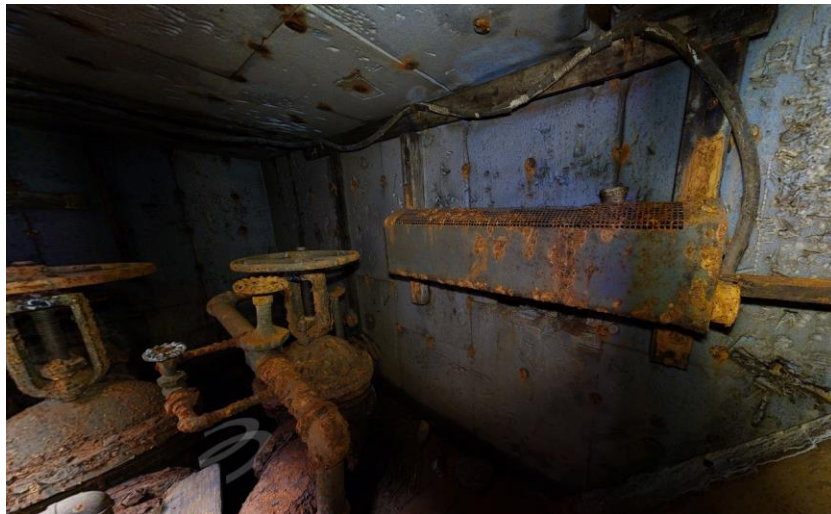
**Figure 13: Existing Electrical Radiant Heater Along West Wall**

There is an electric heater mounted on the west interior wall near the ceiling. It is not known whether this unit still functions.

A new electrical radiant heater could be added to maintain above freezing temperatures within the chamber or for use when an operator is present in the chamber. The radiant heater is not intended as a primary pipe-freeze protection measure, and will have to be evaluated against heat penetration through the structural slab to ensure no impact on permafrost.

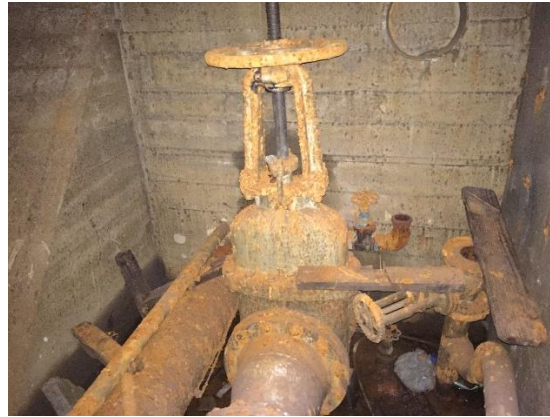
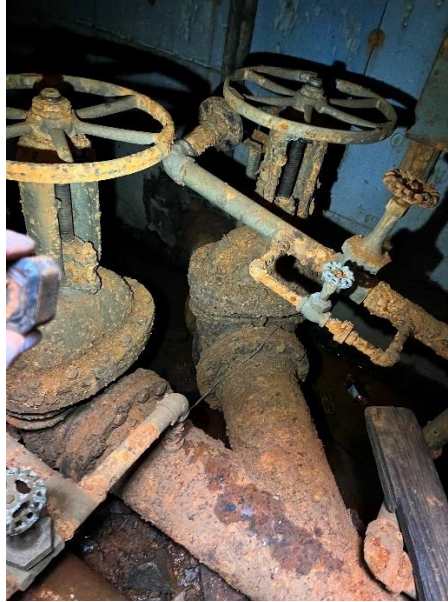
The existing piping within the valve chamber is heavily corroded and it appears as though the valves have not been regularly exercised. Redundant piping has been left in place from previous work in the chamber. There appears to be some sort of sensor, either temperature or flow, installed on the piping prior to it leaving the chamber and heading towards the water treatment plant. Given the condition of the services, it is assumed unlikely to be functioning properly.

Photo 2.1.1: Example of heavily corroded piping and valves.

Photo 2.1.2: Example of heavily corroded piping and valves

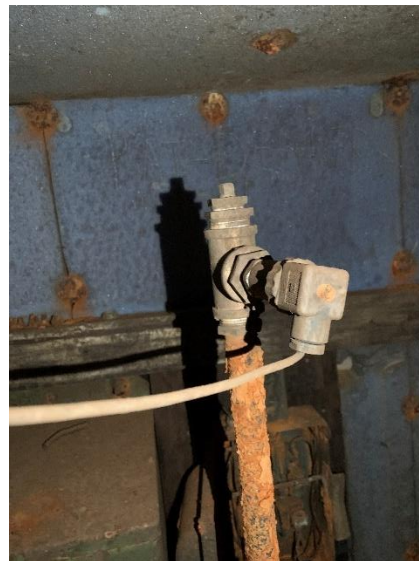
Photo 2.1.3: top stem of sensor

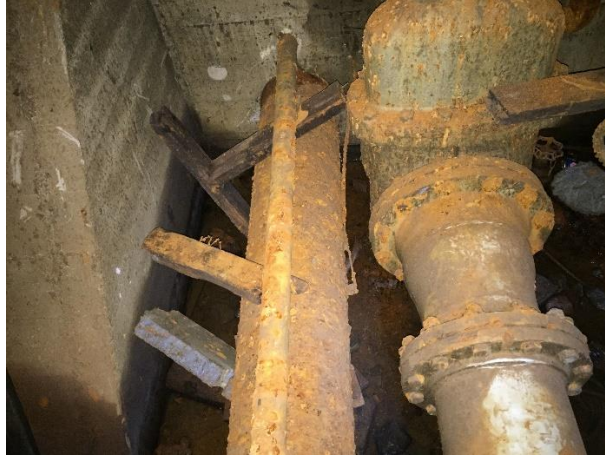
There are pieces of scrap material wedged between piping and the piping is resting on wooden blocks and rocks. No proper pipe supports were used.

Photo 2.1.4: example of scrap metal propping up piping

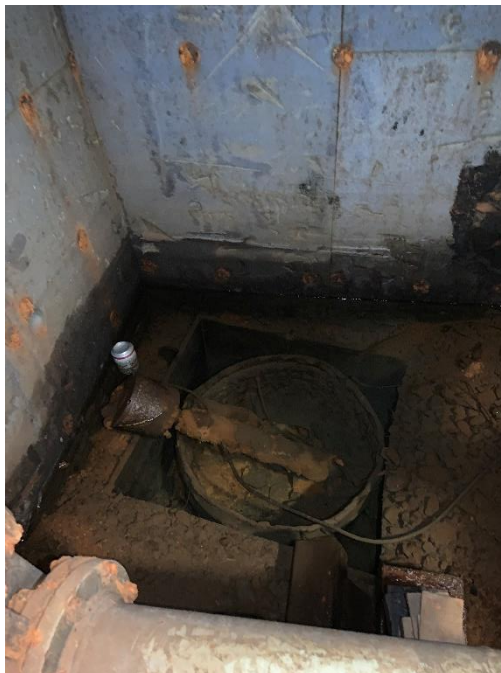
There is a pit within the valve chamber for what appears to be a pump. It is in a state of disrepair and requires replacement. Depth of the pit is unknown.

Photo 2.1.5: Sump pump and pit

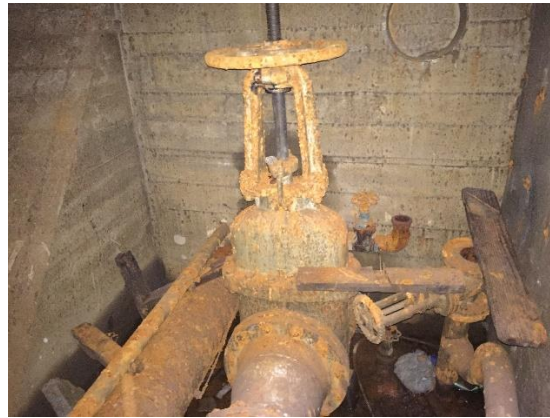
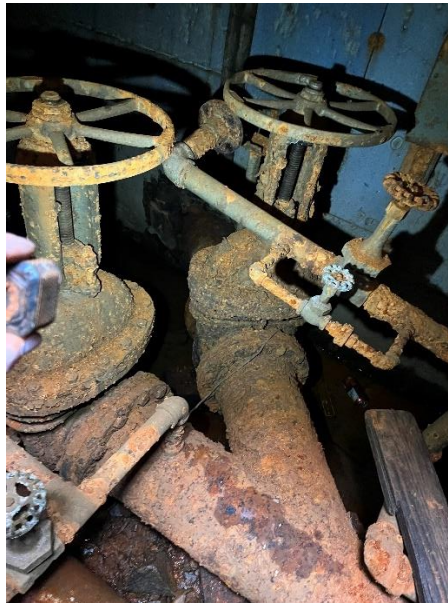
heading towards the water treatment plant. Given the condition of the services, it is assumed unlikely to be functioning properly.

Photo 2.1.1: Example of heavily corroded piping and valves.

Photo 2.1.2: Example of heavily corroded piping and valves

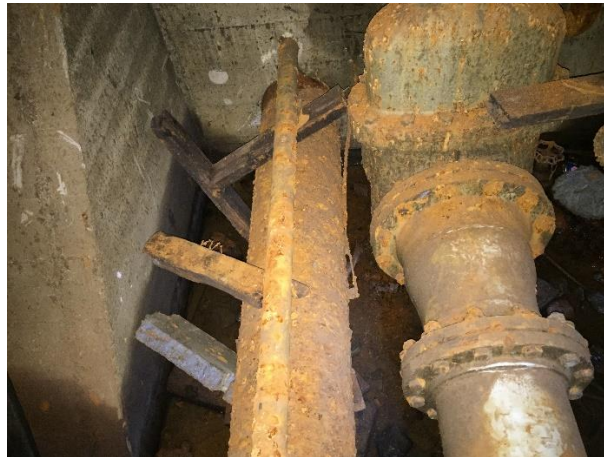
There are pieces of scrap material wedged between piping and the piping is resting on wooden blocks and rocks. No proper pipe supports were used.

Photo 2.1.4: example of scrap metal propping up piping

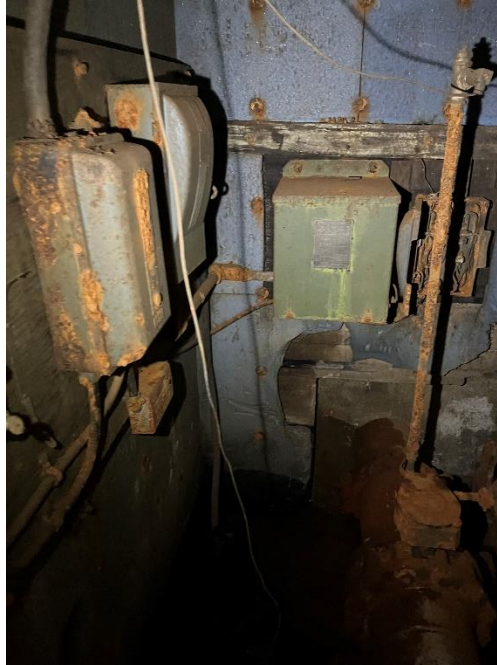
Electrical services, including switches and disconnects are mounted on the wall of the chamber and are also heavily damaged by corrosion. There is an electric heater mounted on the wall. It is not known whether this unit still functions.

Photo 2.2.1: existing electrical radiant heater

Photo 2.1.2: overall view of existing electrical services
