2024 DAM SAFETY REVIEW

Lake Geraldine Dam

Iqaluit, NU

Final | Revision 1 | February 17, 2025

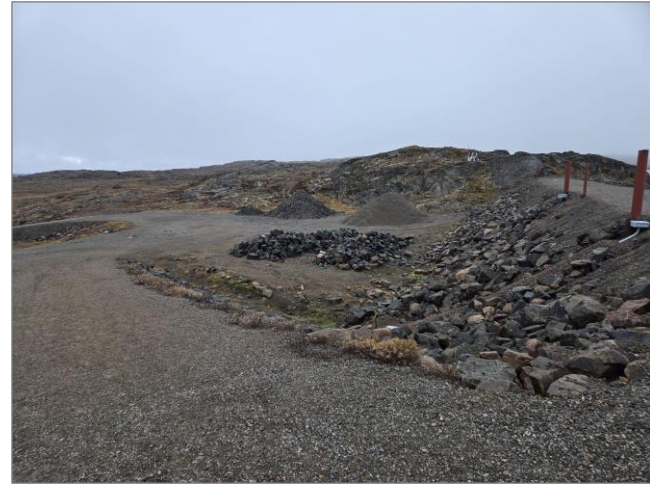
Figure 3 Material Stockpile Below North Berm

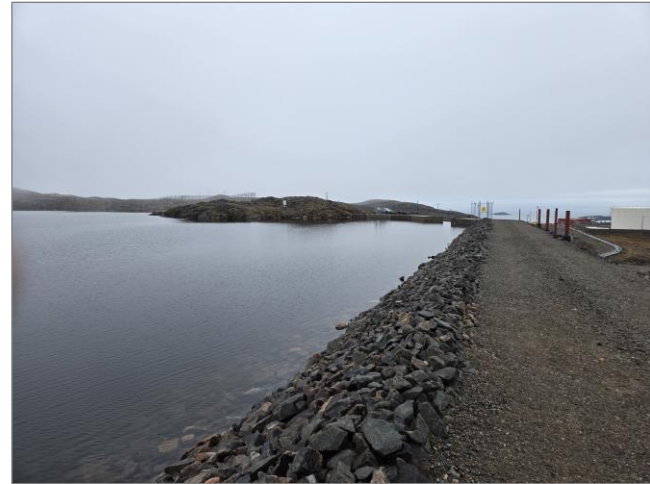
Figure 7 Upstream Limited Riprap Parapet

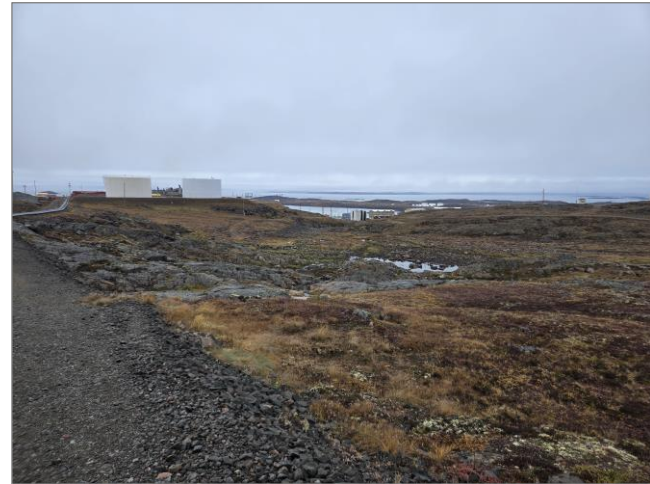
Figure 12 Downstream Pooled Water – Source Unknown

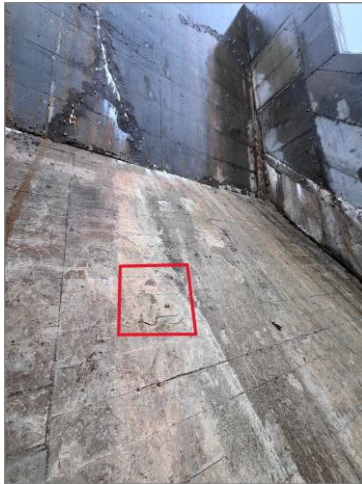
Figure 19 Spillway Spall Location

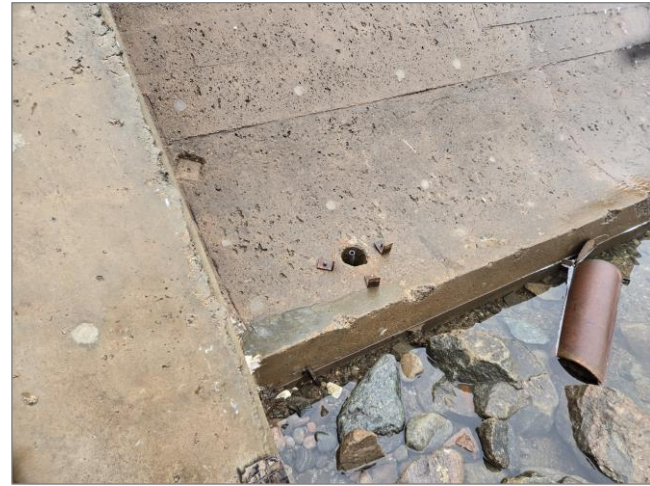
Figure 24 BH112, Piezometer Exposed

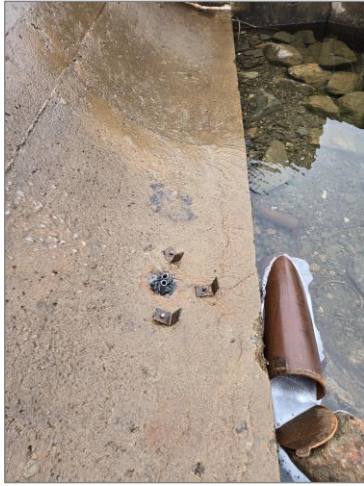
Figure 25 Spillway Apron, BH113 Piezometer Exposed

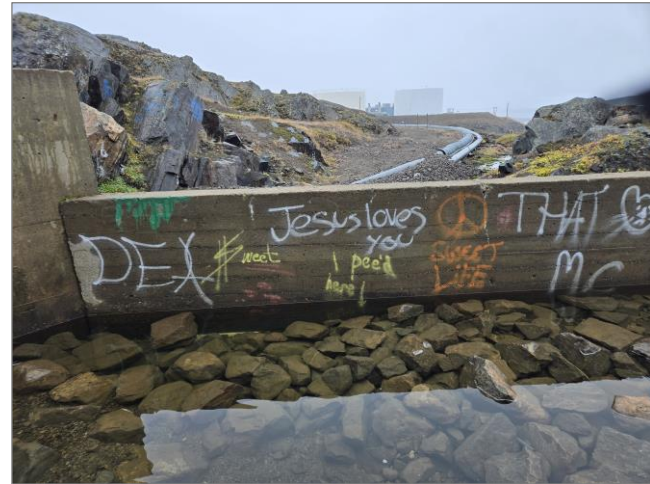
Figure 36 Public Safety Interaction

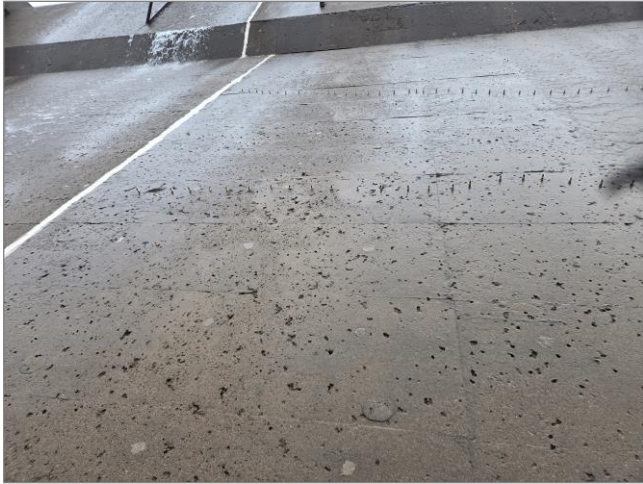
Figure 37 Porosity in Spillway Conveyance Surface

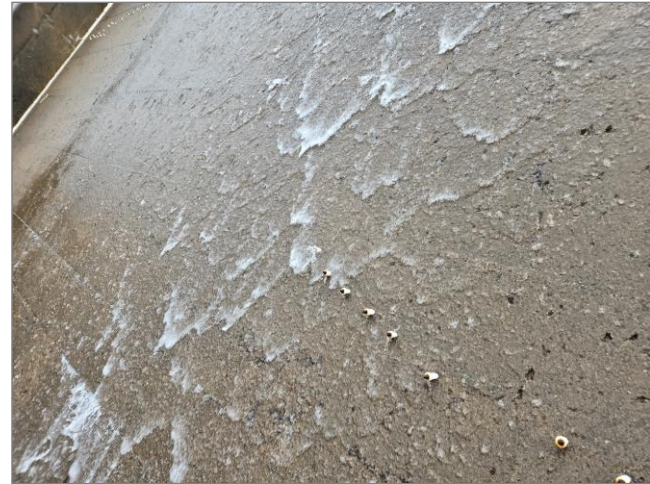
Figure 39 Protruding Caps to be Removed

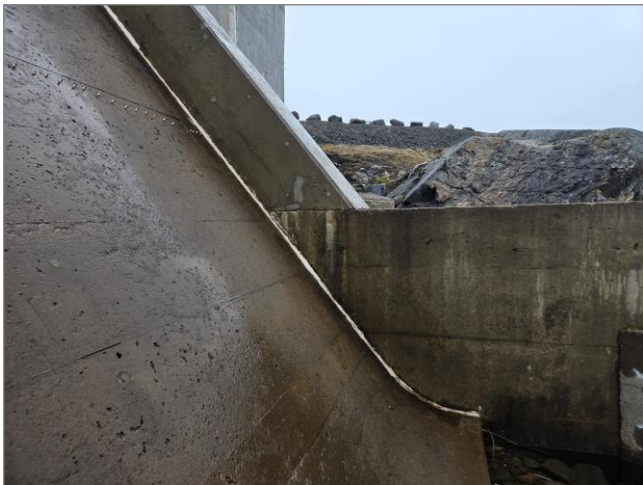
Figure 38 Left Training Wall Sealant Intact

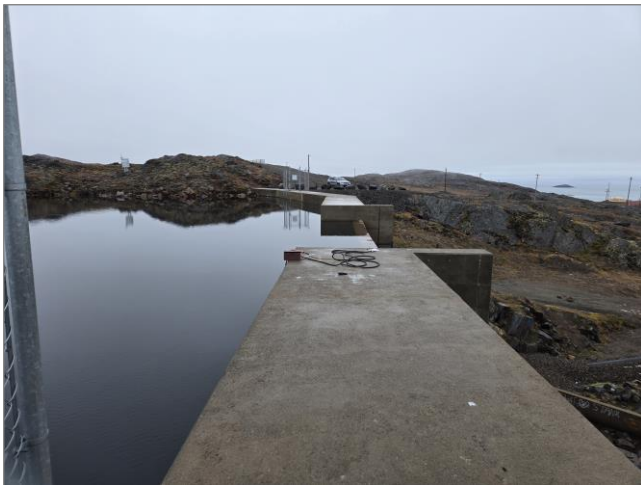
Figure 42 View across Crest. Unknown Sensor

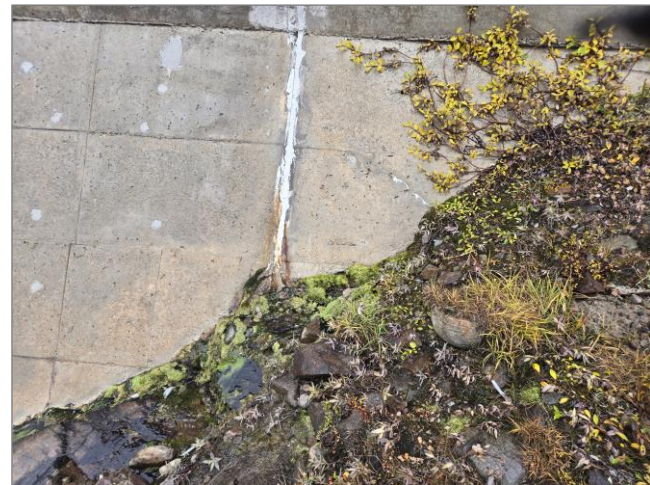
Figure 44 South Concrete Dam Seeping at Foundation

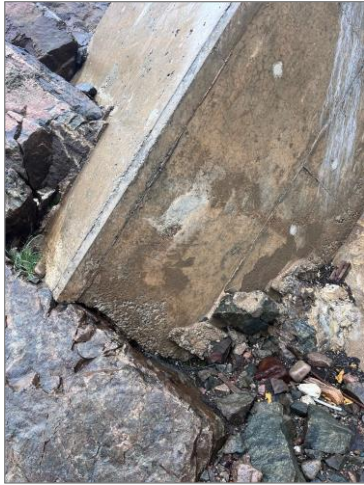
Figure 45 Minor Seepage at Concrete / Bedrock Foundation

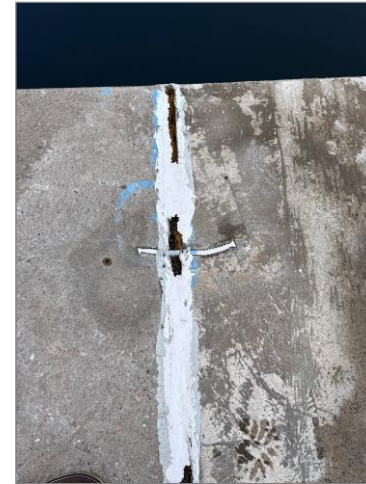
Figure 47 Expansion Joint Sealer – Rodent Activity

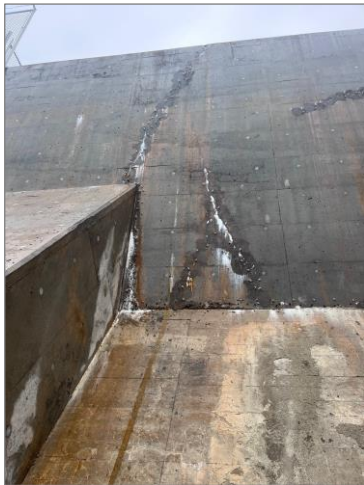
Figure 46 Crack Repair – Injectors Not Cut Flush

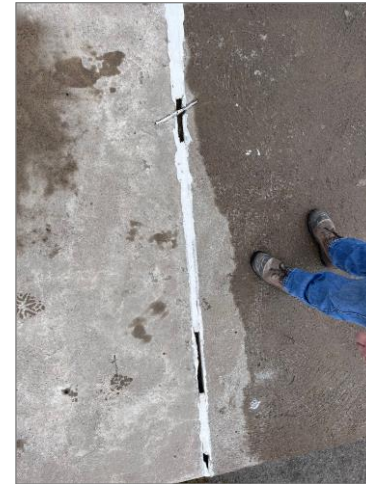
Figure 48 Expansion Joint Sealer - Removed by Rodents
