**Re: Water Licence Inspection**

The City of Iqaluit Water Licence Inspection was performed on October 17, 2003. I would like to thank Brad Sokach and his staff for their time and assistance during the inspection.

## MUNICIPAL WATER USE INSPECTION REPORT

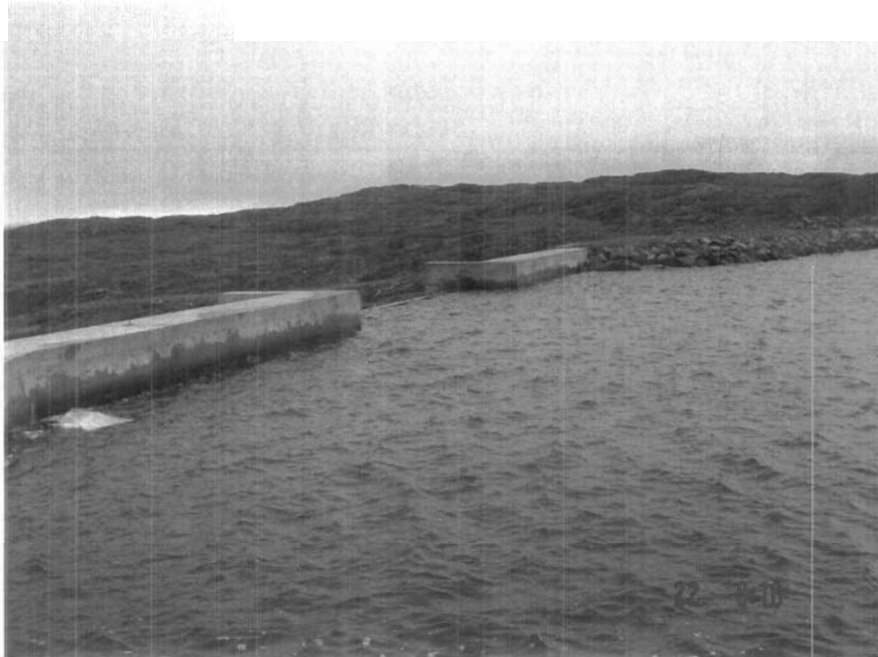
**Freshwater Reservoir-Lake Geraldine (figure 1)**

Grab samples of Lake Geraldine were taken approximately 20 m above the spillway. All parameters measured were within the *Summary of Guidelines for Canadian Drinking Water Quality 2003*. However, there is no signage identifying the reservoir as the drinking water source for the City of Iqaluit. Warning signs should be placed around the reservoir to ensure people realize that Lake Geraldine supplies the communities freshwater.

Figure 1. Lake Geraldine above the spillway of the freshwater source for the City of Iqaluit.

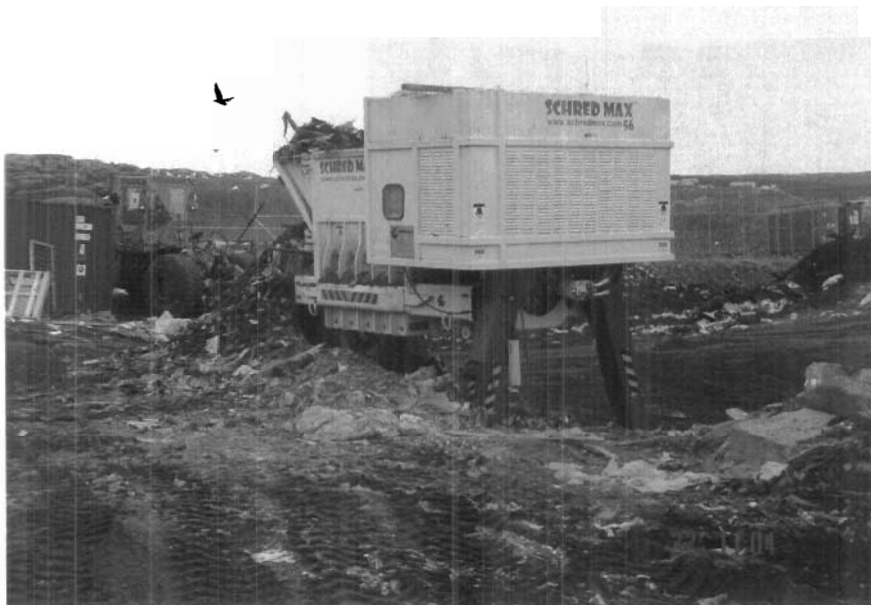
Figure 2. Shredder at the City of Iqaluit landfill facility.

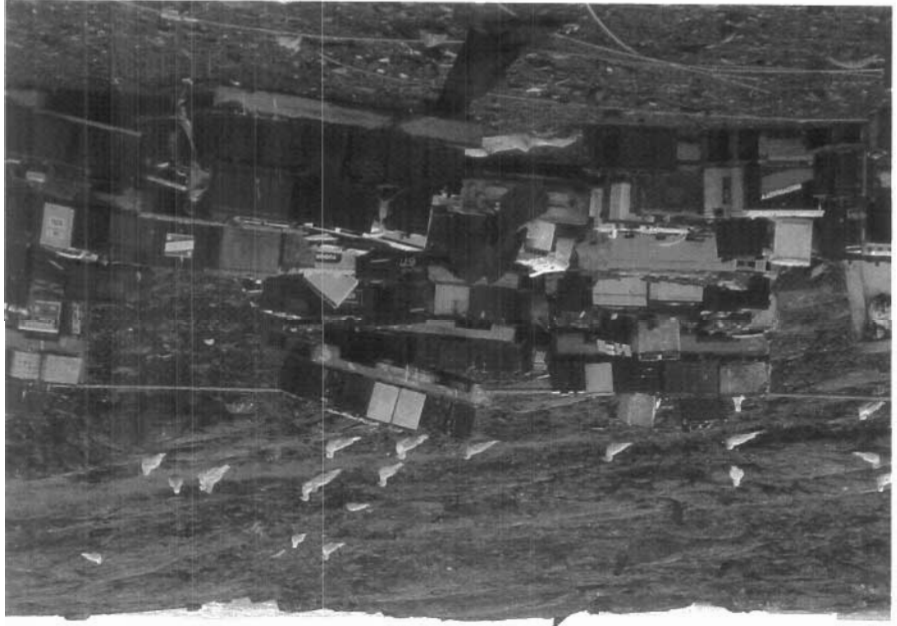
Figure 3. Segregated hazardous materials stored in the fenced off area reserved for hazardous waste just North of the City of Iqaluit landfill.

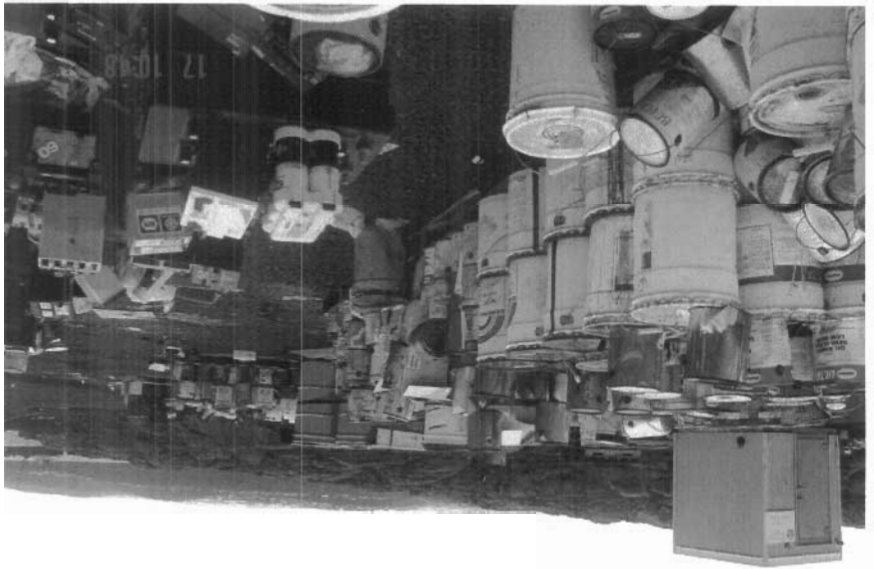
Figure 4. Lead acid batteries piled in the City of Iqaluit landfill.

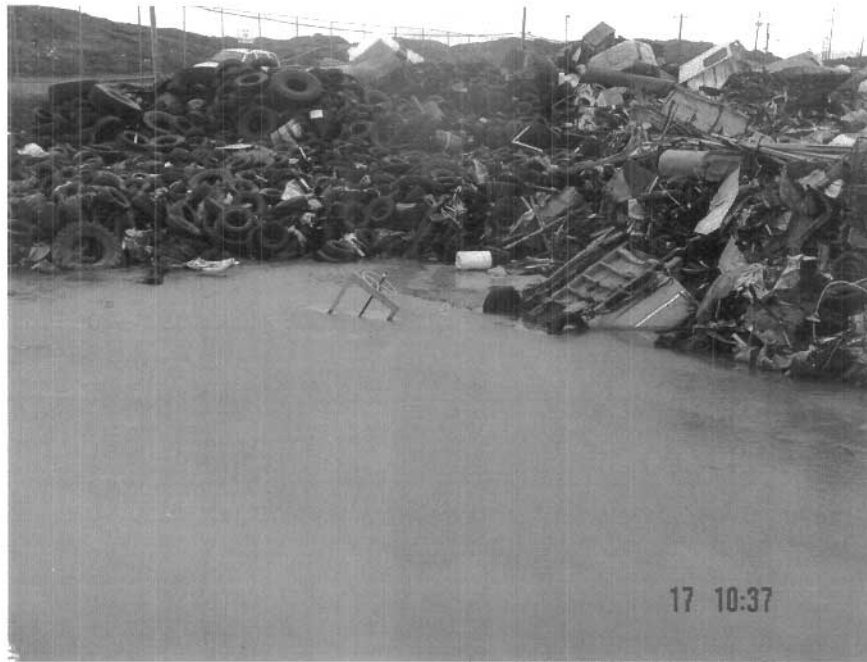
One of the most serious problems currently faced at the landfill is the infiltration of water leading to the uncontrolled transport of contaminants towards Frobisher Bay (figure 5). The culvert put in place to control the movement of leachate off site is inoperable (figure 6). Darcy Reist informed me that he is aware of the problem and that the engineers are working on fixing the problem. The valve either needs to be repaired or blocked before the spring thaw so that the leachate can be tested before it is released. Otherwise the municipality may be acting in contravention of section 12 (3) of the NWNSRTA.

The addition of berms and a drainage ditch were designed to prevent infiltration and the transport of contaminated leachate off the landfill site. However, the significant ponding in the South end of the landfill suggests the desired result was not achieved. At the time of the inspection, the discharge culvert was clogged with ice; when this melts there will be a significant flow of landfill leachate off site towards Frobisher Bay. The area is known to contain contaminants in addition to municipal landfill waste (Environmental Sciences Group, 1995) and uncontrolled release will result in contravention of the NWNSRTA. The leachate is a deep rust colour and plumes of hydrocarbons can be observed when the sediment in the ditch below the culvert is disturbed (figure 7). Samples taken of the landfill leachate should indicate the level of contamination in the diversion ditch below the discharge culvert.

Figure 5. Collection of water at South end of Iqaluit landfill with unsegregated waste visible.

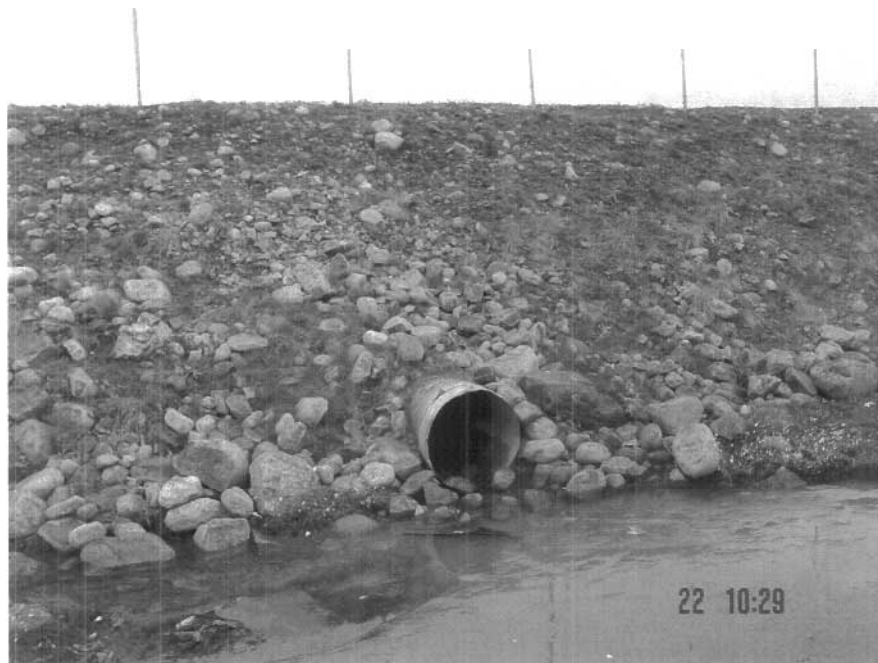
Figure 6. Plugged discharge culvert at the South end of the City of Iqaluit landfill.

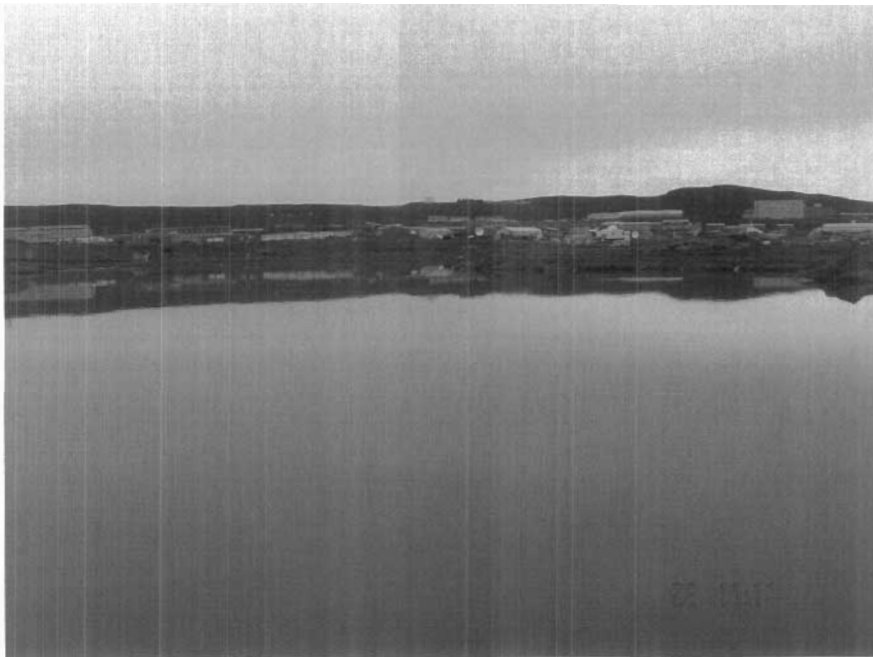
The sewage lagoon is operating beyond its capacity as there is less than 1 metre of free board in the lagoon and the retention time is less than optimal (Figure 10). Never the less samples of the effluent discharged from the Iqaluit sewage lagoon (figure 11 and figure 12) were within licenced parameters as well as the *Canadian Water Quality Guidelines for the Protection of Aquatic Life 2002*. The level of sewage treatment will almost certainly be addressed through the development of a new sewage treatment facility, however the new facility may not address the large number of spills in the community and the potential threat to public health that they pose. There have been a number of uncontrolled discharges of raw sewage into Koojessie Inlet near the breakwater. One discharge occurred near the Northwestel building, flowing through the ditch past the Elders Centre. These discharges have apparently occurred because of blockages in the utilidoor system and, on one occasion, an apparent wiring error.

Figure 10. Sewage lagoon for the City of Iqaluit

**Comments:** There is insufficient freeboard in the lagoon. The lagoon discharges constantly in order to keep up with the sewage loading in the lagoon. Hopefully the newest sewage treatment plant will address the capacity problems. Samples of the lagoon effluent should reveal the effectiveness of the primary treatment.

Appropriate action must be taken to eliminate, or at least reduce the frequency of these discharges.

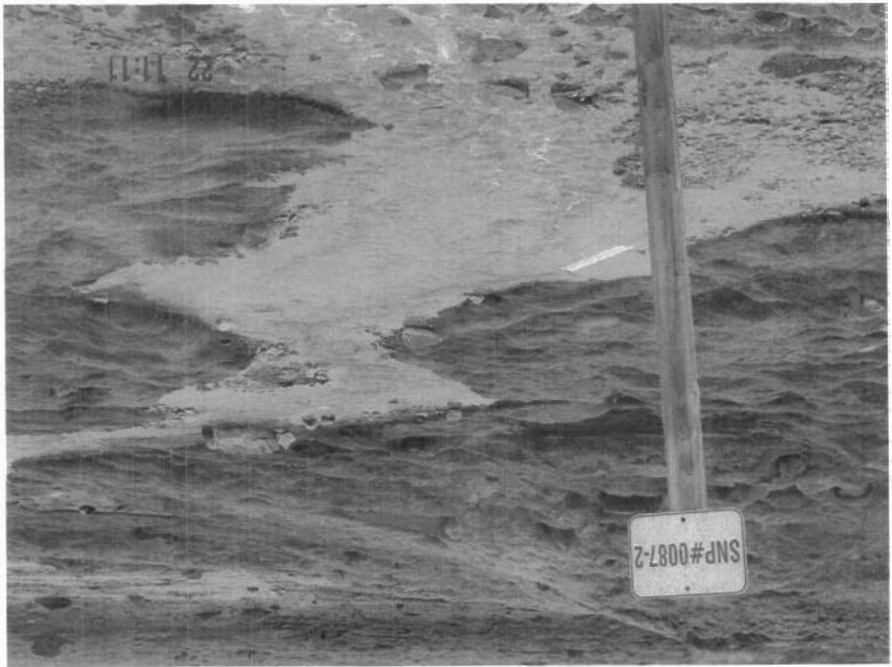
Figure 11. Discharge point for the City of Iqaluit sewage lagoon.

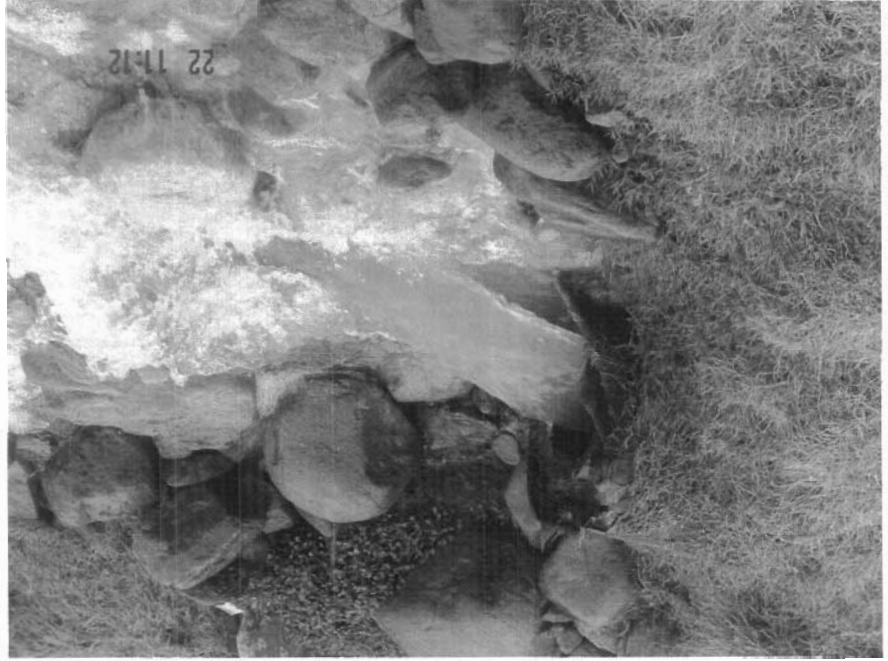
Figure 12. The sample site at the discharge pipe for the City of Iqaluit sewage lagoon.
