Re: Water Licence Inspection

The City of Iqaluit Water Licence Inspection was performed on October 17, 2003. I would like to thank Brad Sokach and his staff for their time and assistance during the inspection.

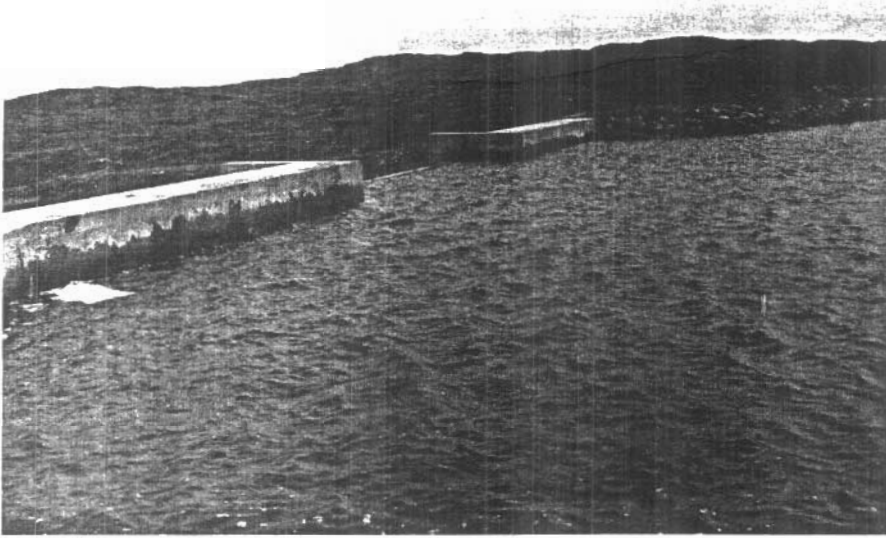
Grab samples of Lake Geraldine were taken approximately 20 m above the spillway. All parameters measured were within the *Summary of Guidelines for Canadian Drinking Water Quality 2003*. However, there is no signage identifying the reservoir as the drinking water source for the City of Iqaluit. Warning signs should be placed around the reservoir to ensure people realize that Lake Geraldine supplies the communities freshwater.

Figure 1. Lake Geraldine above the spillway of the freshwater source for the City of Iqaluit.

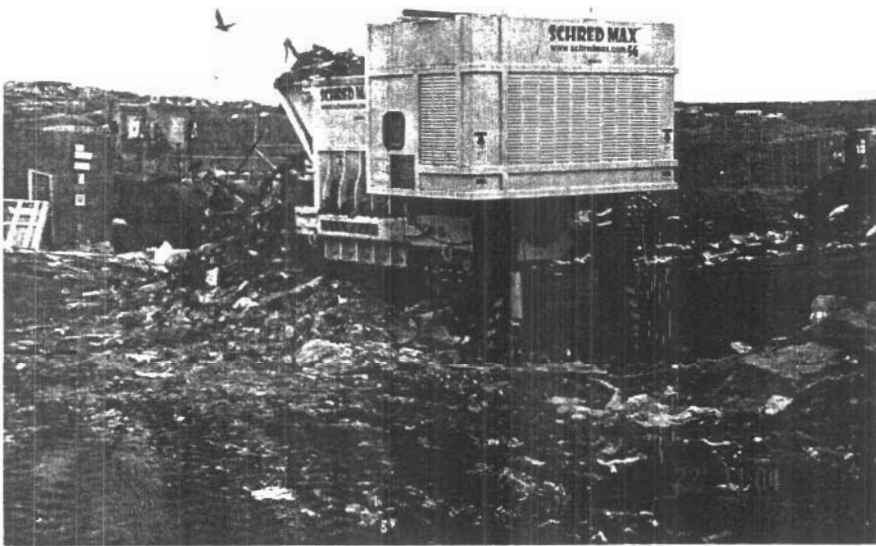
The current municipal landfill utilizes a mechanical shredder (figure 2) in combination with compaction and covering to maximize the capacity of the landfill. Efforts have been made to segregate waste in the landfill with a fenced-off area just north of the landfill set aside for hazardous waste (figure 3). Materials are reasonably segregated although further work needs to be done. At the time of the inspection a large number of lead acid batteries were piled in the landfill site (figure 4). Hazardous materials need to be stored according to the *Nunavut Hazardous Waste Management Manual 2003*. The overall appearance of the landfill has improved greatly since the shredder has been added to the operation and Darcy Reist appears to be doing a good job of compacting the incoming waste.

Figure 2. Shredder at the City of Iqaluit landfill facility.

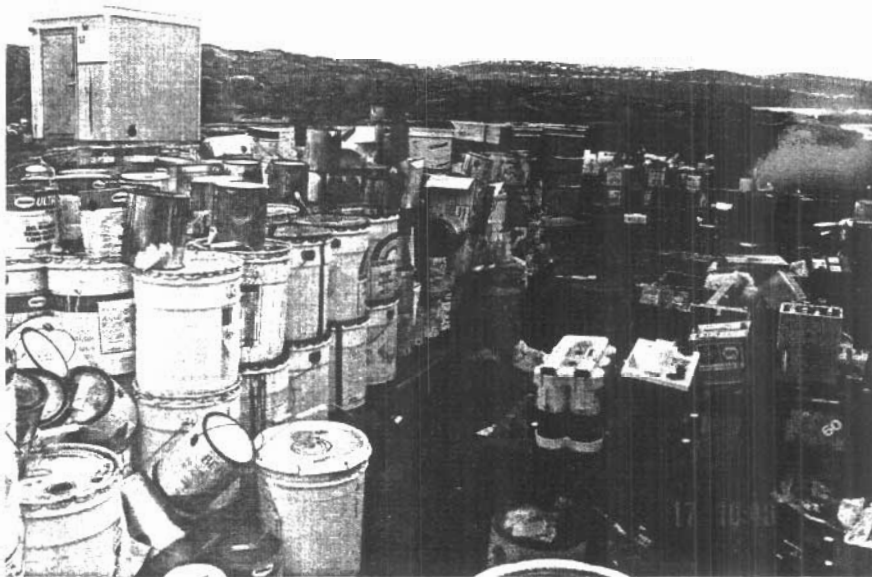
Figure 3. Segregated hazardous materials stored in the fenced off area reserved for hazardous waste just North of the City of Iqaluit landfill.

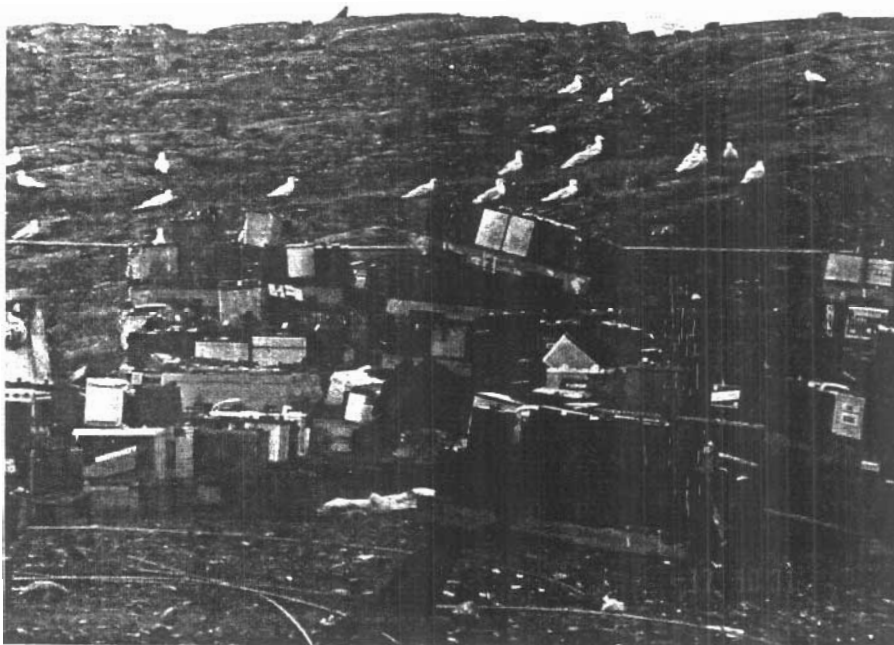
Figure 4. Lead acid batteries piled in the City of Iqaluit landfill.

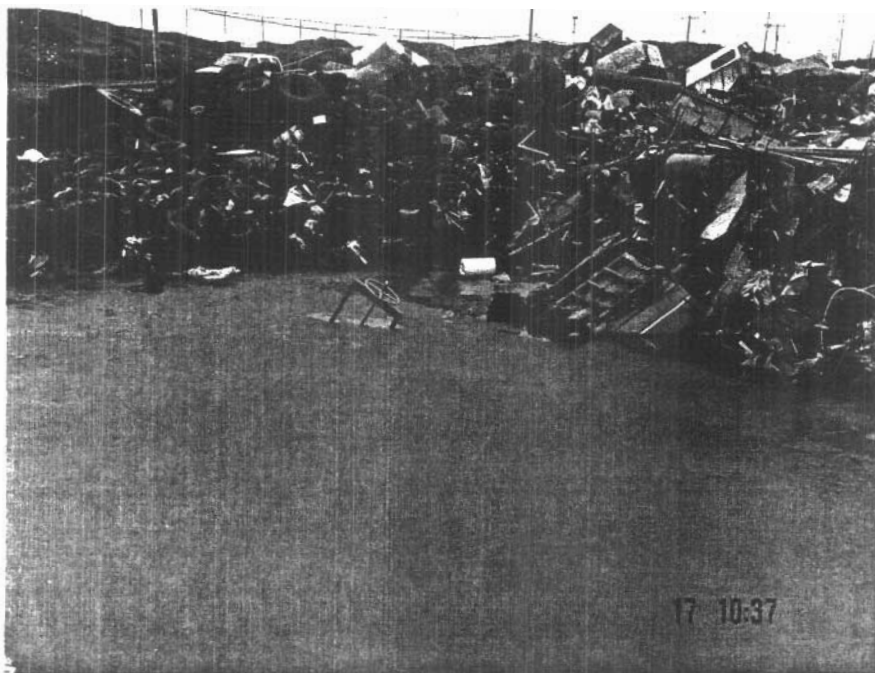
One of the most serious problems currently faced at the landfill is the infiltration of water leading to the uncontrolled transport of contaminants towards Frobisher Bay (figure 5). The culvert put in place to control the movement of leachate off site is inoperable (figure 6). Darcy Reist informed me that he is aware of the problem and that the engineers are working on fixing the problem. The valve either needs to be repaired or blocked before the spring thaw so that the leachate can be tested before it is released. Otherwise the municipality may be acting in contravention of section 12 (3) of the NWNSRTA.

The addition of berms and a drainage ditch were designed to prevent infiltration and the transport of contaminated leachate off the landfill site. However, the significant ponding in the South end of the landfill suggests the desired result was not achieved. At the time of the inspection, the discharge culvert was clogged with ice; when this melts there will be a significant flow of landfill leachate off site towards Frobisher Bay. The area is known to contain contaminants in addition to municipal landfill waste (Environmental Sciences Group, 1995) and uncontrolled release will result in contravention of the NWNSRTA. The leachate is a deep rust colour and plumes of hydrocarbons can be observed when the sediment in the ditch below the culvert is disturbed (figure 7). Samples taken of the landfill leachate should indicate the level of contamination in the diversion ditch below the discharge culvert.

Figure 5. Collection of water at South end of Iqaluit landfill with unsegregated waste visible.

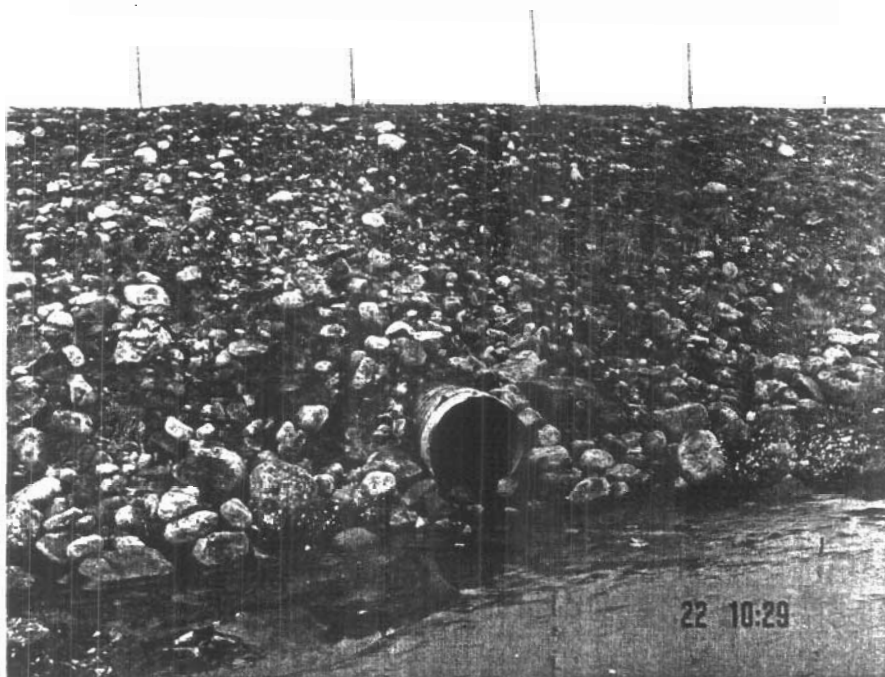
Figure 6. Plugged discharge culvert at the South end of the City of Iqaluit landfill.

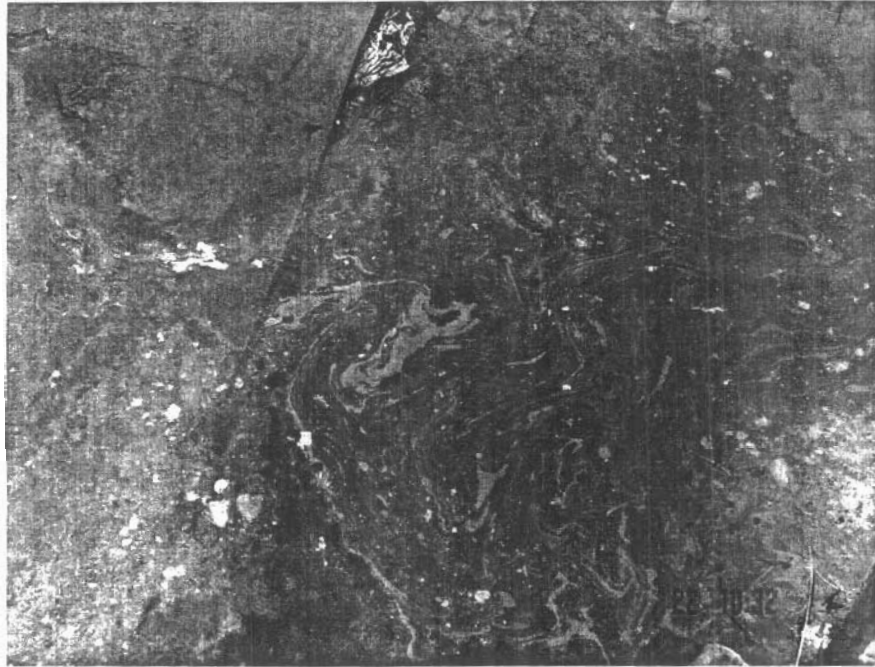
Figure 7. Plume of hydrocarbons visible in the ditch below the discharge culvert in the City of Iqaluit landfill.

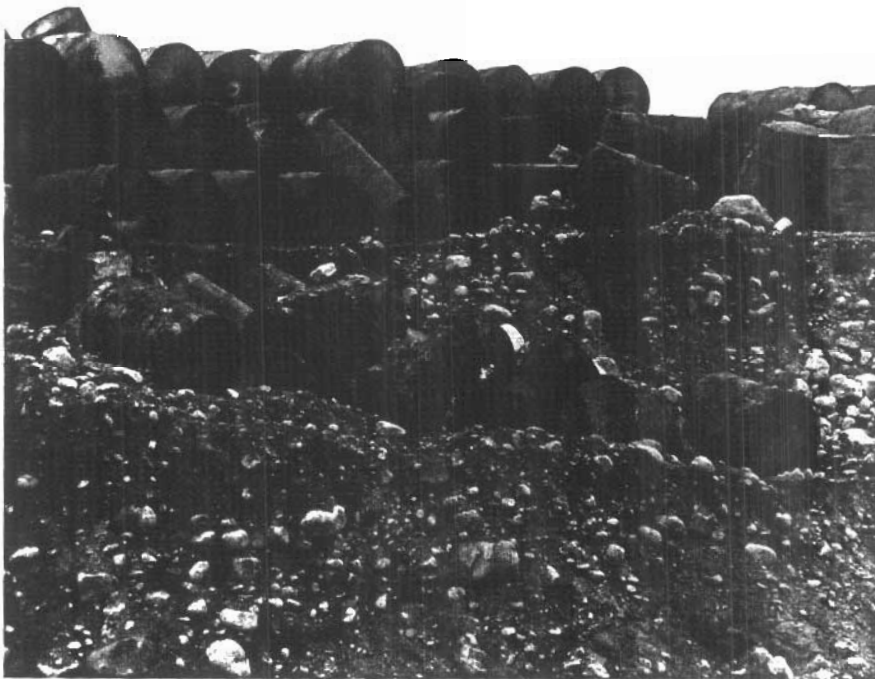
There are a significant number of old, leaky and rusted out barrels of asphalt tar in and around the North 40 metal dump (figure 8). It is my understanding that they were left there when the airstrip was paved. It is likely that the majority of Volatile Organic Carbon has already off gassed from the asphalt tar, never the less, the asphalt tar and rusted drums are improperly disposed industrial/municipal waste. These barrels need to be crushed and landfilled in an appropriate facility. If any unsolidified asphalt tar remains it should be collected and reused or contained and as hazardous waste.

Figure 8. Old asphalt tar drums stockpiled in the North 40 at the old metal dump/ gravel quarry.

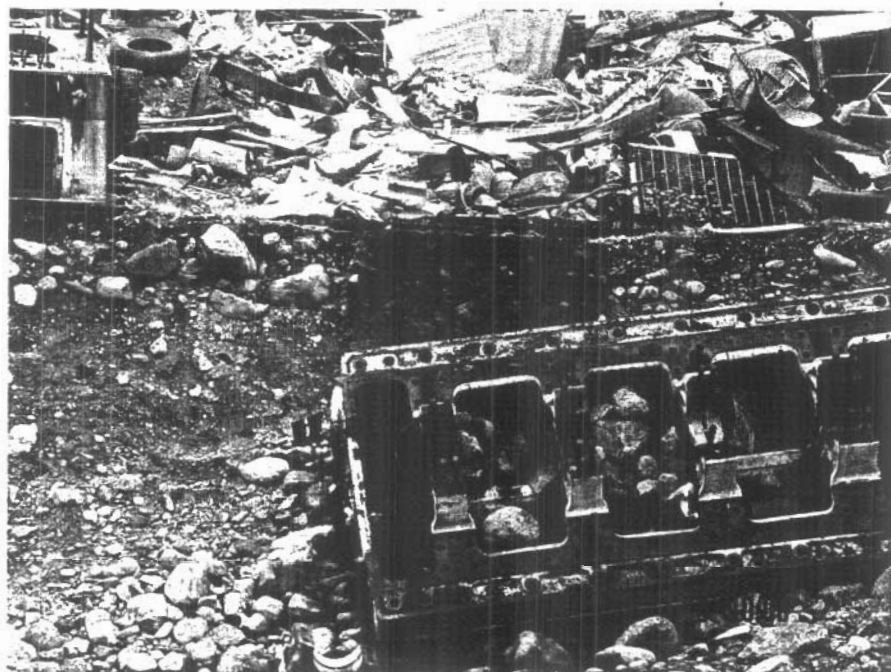
The removal of sand and gravel from the area could result in the incorporation of contaminated soils into construction activities within the town (figure 9) . Two sites were identified in 1995 by the ESG as requiring remediation. The first site, in the Northwest end of the North 40, was identified as containing soils exceeding the CCME Guidelines for *Copper* (119 mg/kg Cu > 91 mg/kg *Canadian Soil Quality Guidelines for the Protection of Environmental and Human Health 1999*). The other site, located in the south end of the North 40, contained lead at a concentration of 249 mg/kg which approaches the maximum concentration for a Commercial land use (260 mg/kg) but exceeds the maximum for a Residential/ Parkland land use (140 mg/kg). As the sand and gravel in the North 40 is used throughout the community it seems reasonable to apply the residential criteria. If the city has any information on reclamation performed with respect to these sites I would be interested in looking it over.

Figure 9. A small spill of hydrocarbons in the former Iqaluit metal dump.

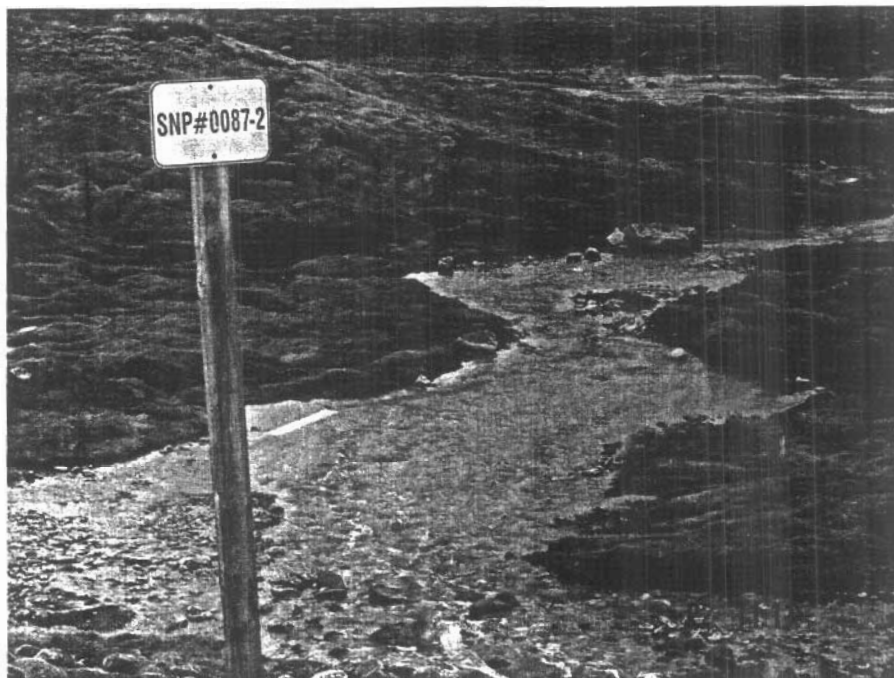
Figure 11. Discharge point for the City of Iqaluit sewage lagoon.

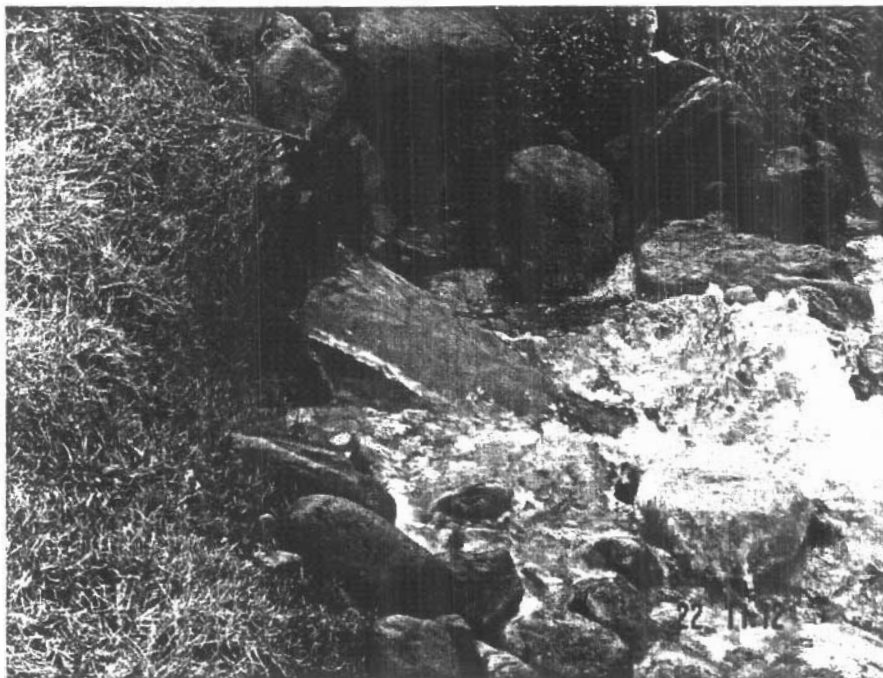
Figure 12. The sample site at the discharge pipe for the City of Iqaluit sewage lagoon.
