DAM SAFETY INSPECTION REPORT

CITY OF IQALUIT

Lake Geraldine Dam Safety Inspection

October 2014

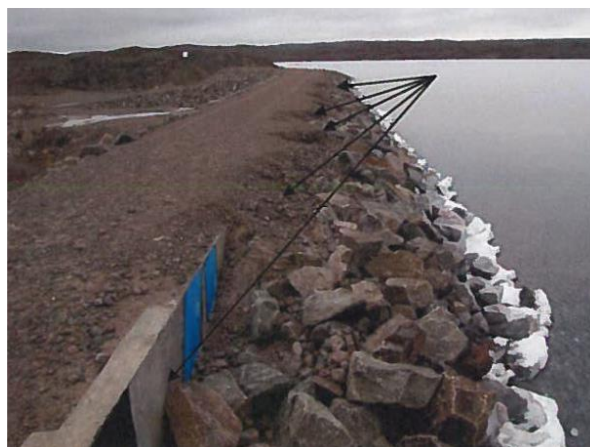
Wave action in 2010 damaged the North and Central Berm to the point of eroding and overtopping the berm during a storm (Figure 2-1 below). No detailed records of the pool elevation during the storm, estimates of wave run-up or damage or repair were available for review during the site visit. The crest was repaired and armored in 2012. The wave damage event occurred with the reservoir at full pool (reportedly) with approximately 1 m of freeboard.

Figure 2-1: Photograph of wave erosion on upstream side of Central Berm in 2010.

Based condition of the armor on the upstream side of the North and Central Berms and the damage that was caused in 2010 when the reservoir was a normal pool, it is likely that without additional armor, future storms including the IDF will cause similar or worse damage. Under the IDF there is less than 50 cm of freeboard during the 2010 storm there was approximately 1 m of freeboard.

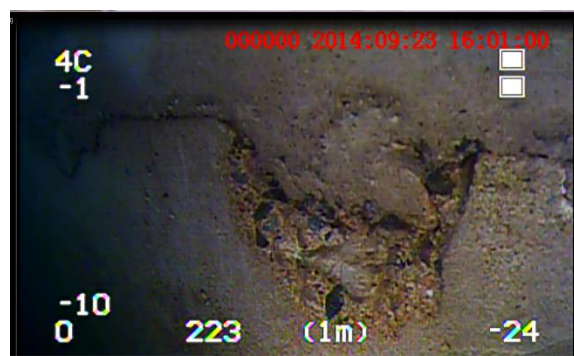
Concrete spalling was noted along the contact between the 2006 lift and the earlier 1995 crest. The linear nature of the staining, coincident with the 2006 lift line and the geometry of the spalls or pop-outs, suggests the spalling is related to 2006 construction products, such as the water stop, or the execution of the work. Joint filler is missing in some of the lower section of the 2006 construction and is completely absent from the older concrete.

Figure 3-5: Spalling 2 m below crest, 7 m east of blue A.

- Repair concrete spalling and fill joints on upstream faces of concrete structures by **autumn 2016**.
- Complete this work sooner if there are changes to site conditions such as seepage that are linked to concrete condition. If conditions deteriorate, repairs should be initiated as soon as practical.
- Record and document all repairs for inclusion in the project file.
- Inspect the upstream faces of the concrete structures during the **5-year DSRs** and time the inspection to gain as much visual inspection of the upstream face as possible. Document findings in the DSRs.
- Provide descriptions of observations that allow for repeatability.

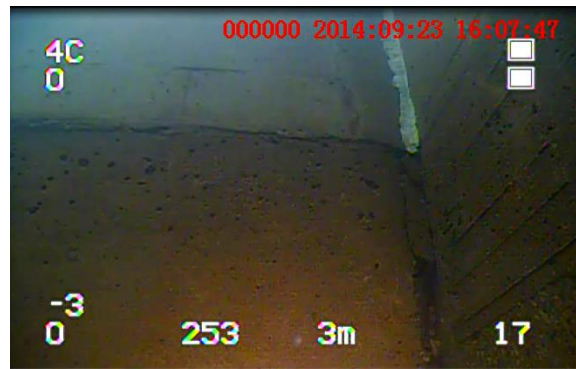
Figure 3-6: Joint filler of J1 terminates at 2 m below the crest at the 1995 and 2006 construction contact. ROV camera directed upward.

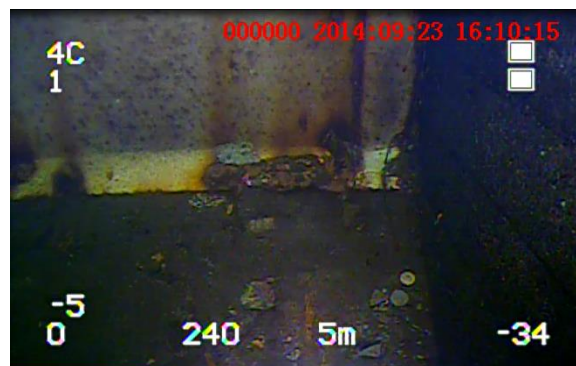
Figure 3-8: Corrosion of steel plate along spillway at El 106.7 m, corner junction at J1 (refer to Section A-A dwg S2, 2006).

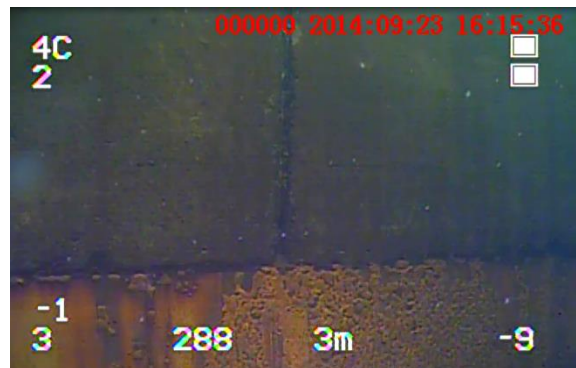
Figure 3-11: Joint filler missing from J2, photograph of contact with steel plate El 106.7 m.

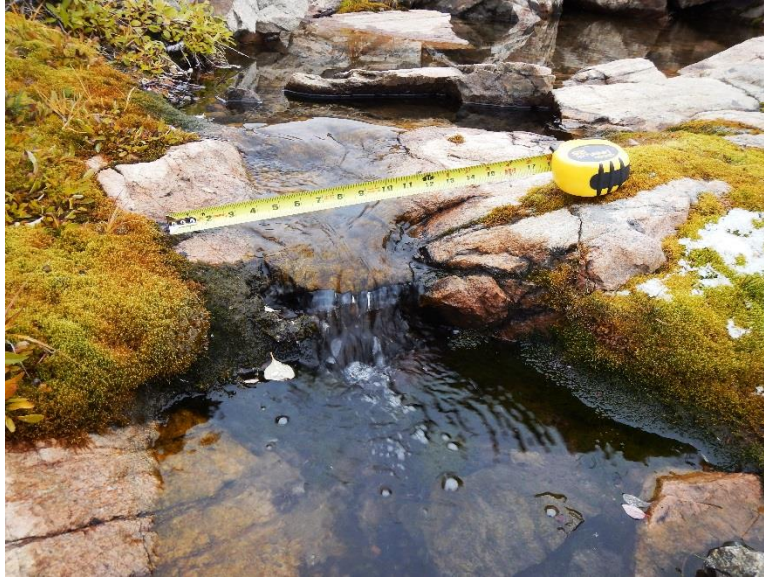
Clear seepage in the range of 10 litre/minute was observed at the Central Berm toe near the termination of the rock armor (photographs shown in Figures 3-18 and 3-19). Ponding from the seepage is directly below Station 1+10 and coincides with a natural draw in the bedrock topography (Figure 3-20), suggesting that the reservoir seepage may be traveling along the contact between the dam and the bedrock. Based on a review of earlier reports, there has been no change in seepage rate.

Figure 3-18: Photograph of seepage at Station 1+10.

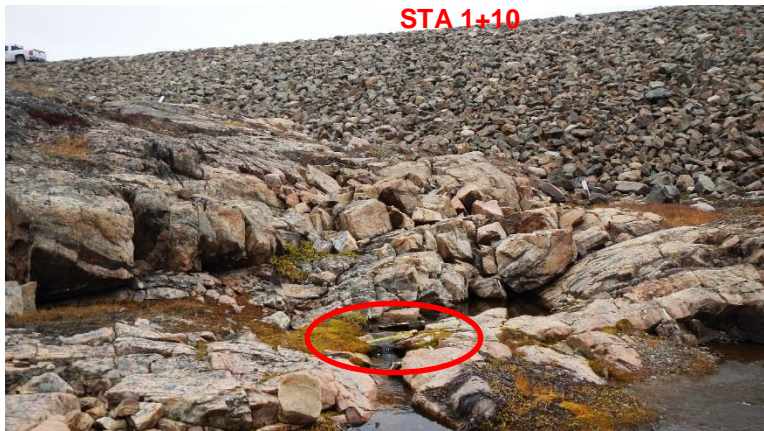
Figure 3-19: Photograph of seepage measure location circled red below Station 1+10.

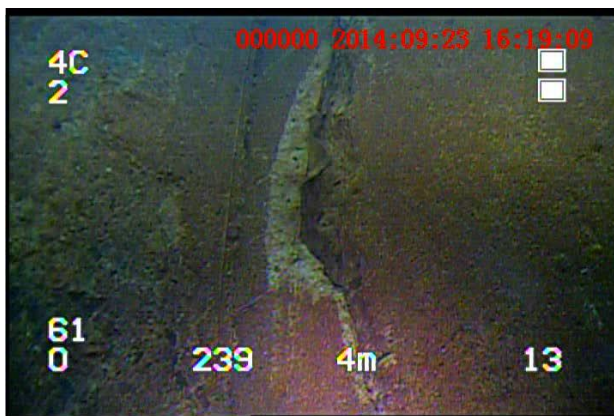
J3 continuing down showing crack until it reaches top of old structure.

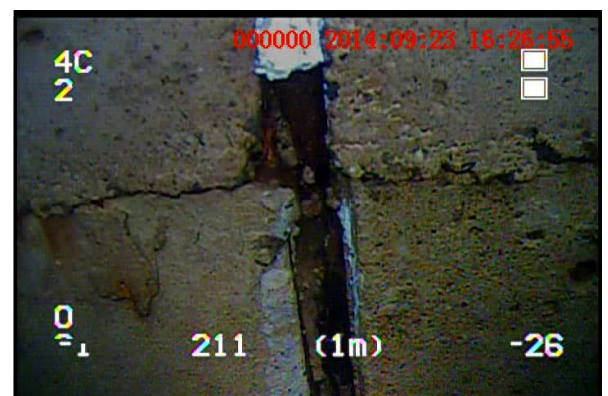
Spalling in horizontal Joint between J3 & J4

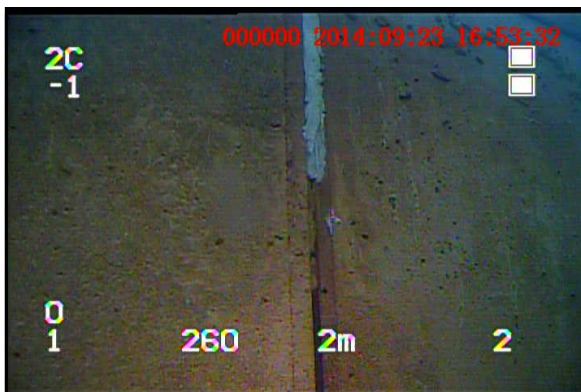
J5, white caulking ending at 2m mark
